NC School District/300 Davie County/High School

Central Davie Academy

Campus Assessment Report

March 7, 2017

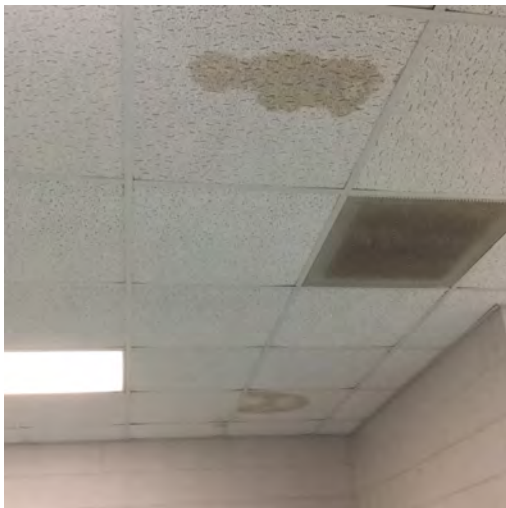
System: C3030 - Ceiling Finishes

Location: Throughout the building
Distress: Beyond Service Life
Category: Deferred Maintenance
Priority: 3 - Necessary/Not Yet Critical (Years 2-5)
Correction: Renew System
Qty: 10,733.00
Unit of Measure: S.F.
Estimate: \$126,800.00
Assessor Name: Somnath Das
Date Created: 02/14/2017

Notes: Though the ceiling system is generally well maintained, there are some stained and mis-matched ceiling tile, and the system is beyond its expected useful life. System renewal is recommended.

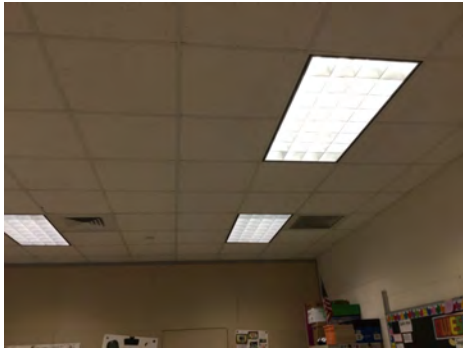
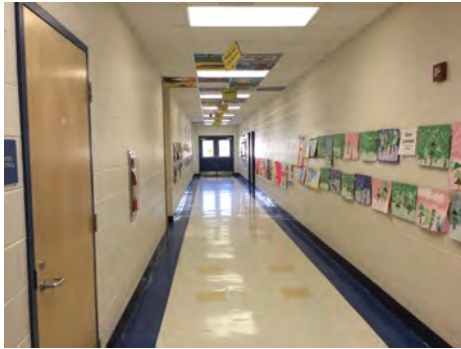
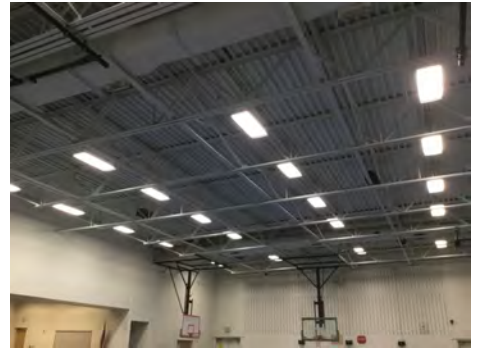
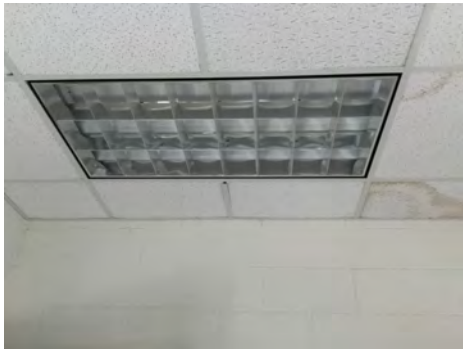
System: D5020 - Lighting

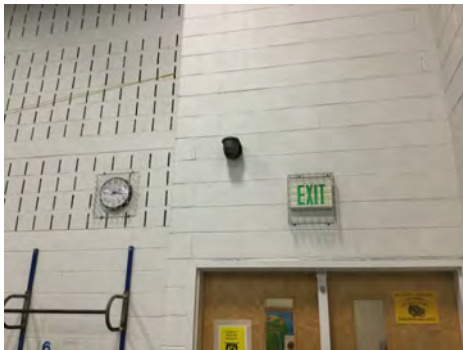
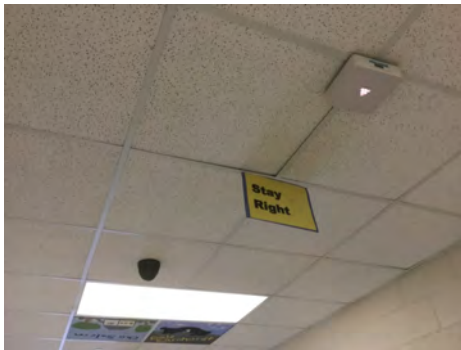
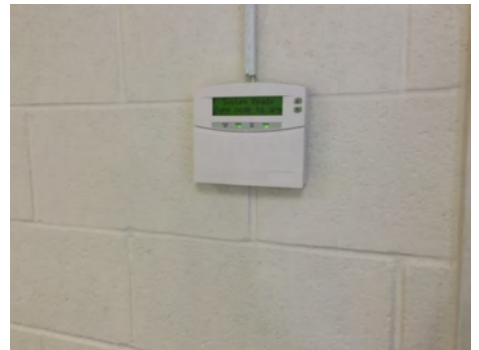
System: D5030810 - Security & Detection Systems

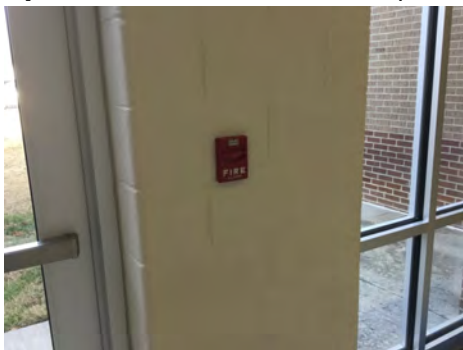
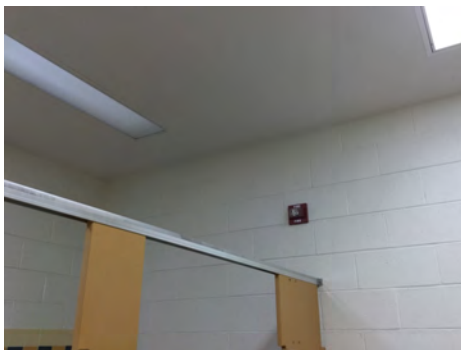
System: D5030910 - Fire Alarm Systems

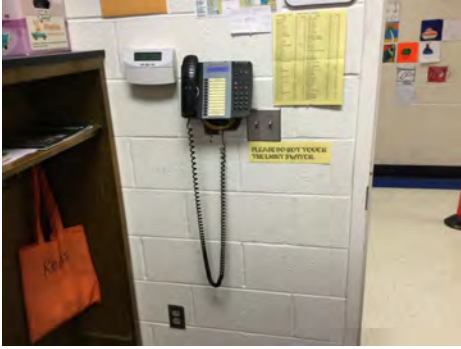
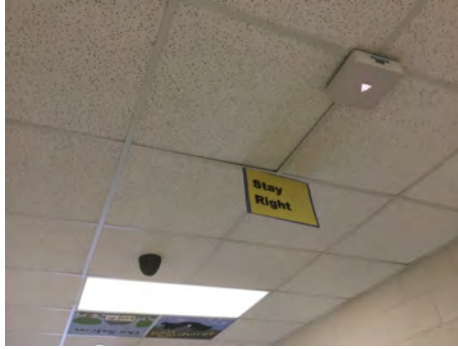
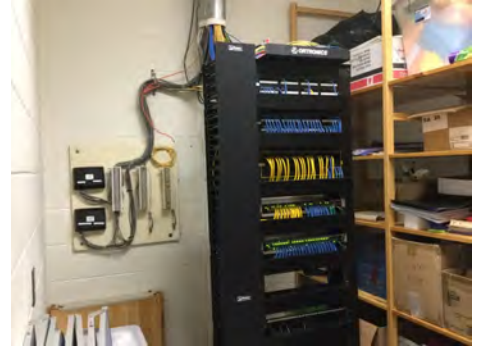
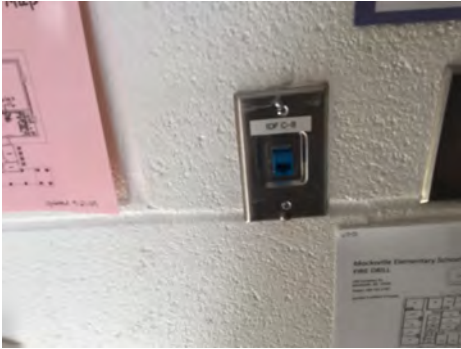
System: D5030920 - Data Communication

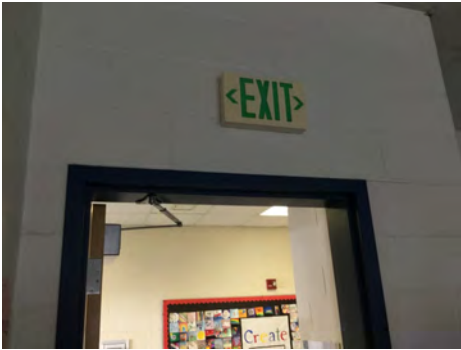
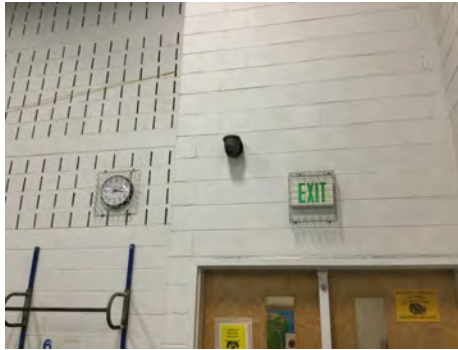
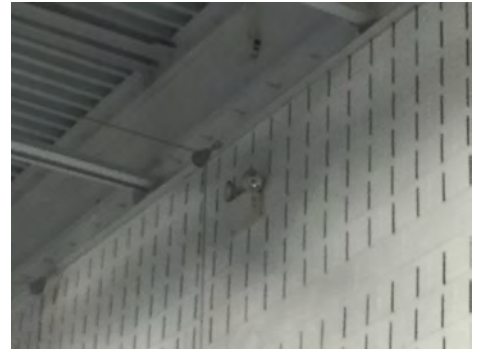
System: D5090 - Other Electrical Systems

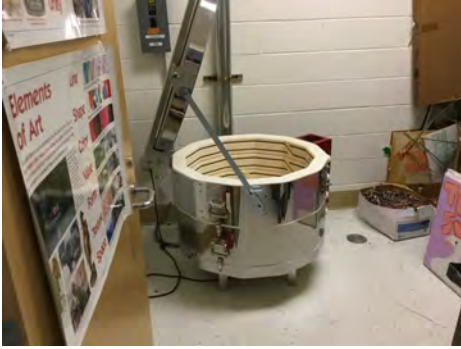
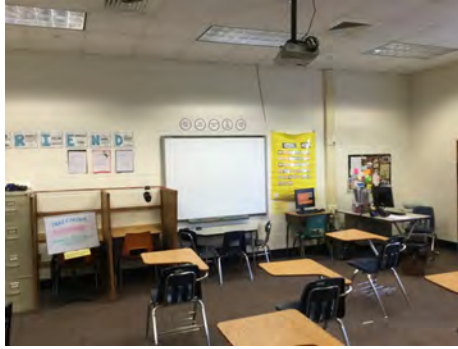
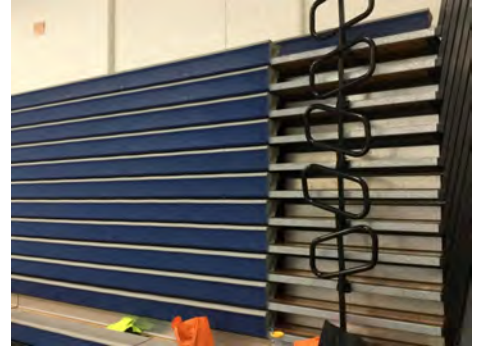
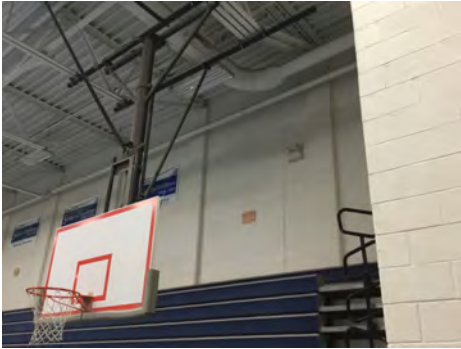
System: E1020 - Institutional Equipment

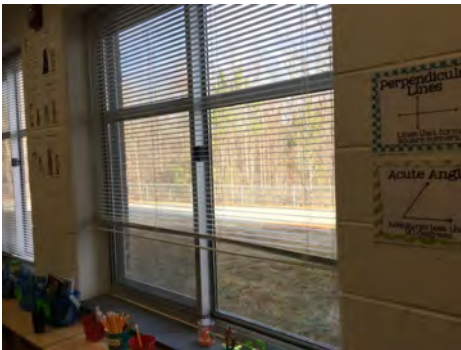
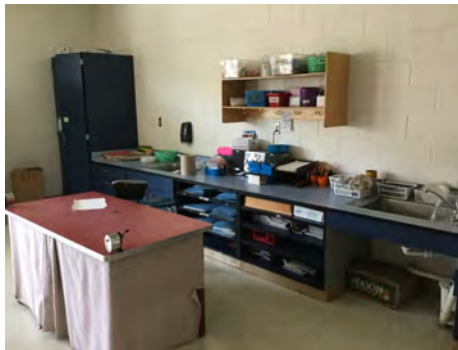
System: E2010 - Fixed Furnishings

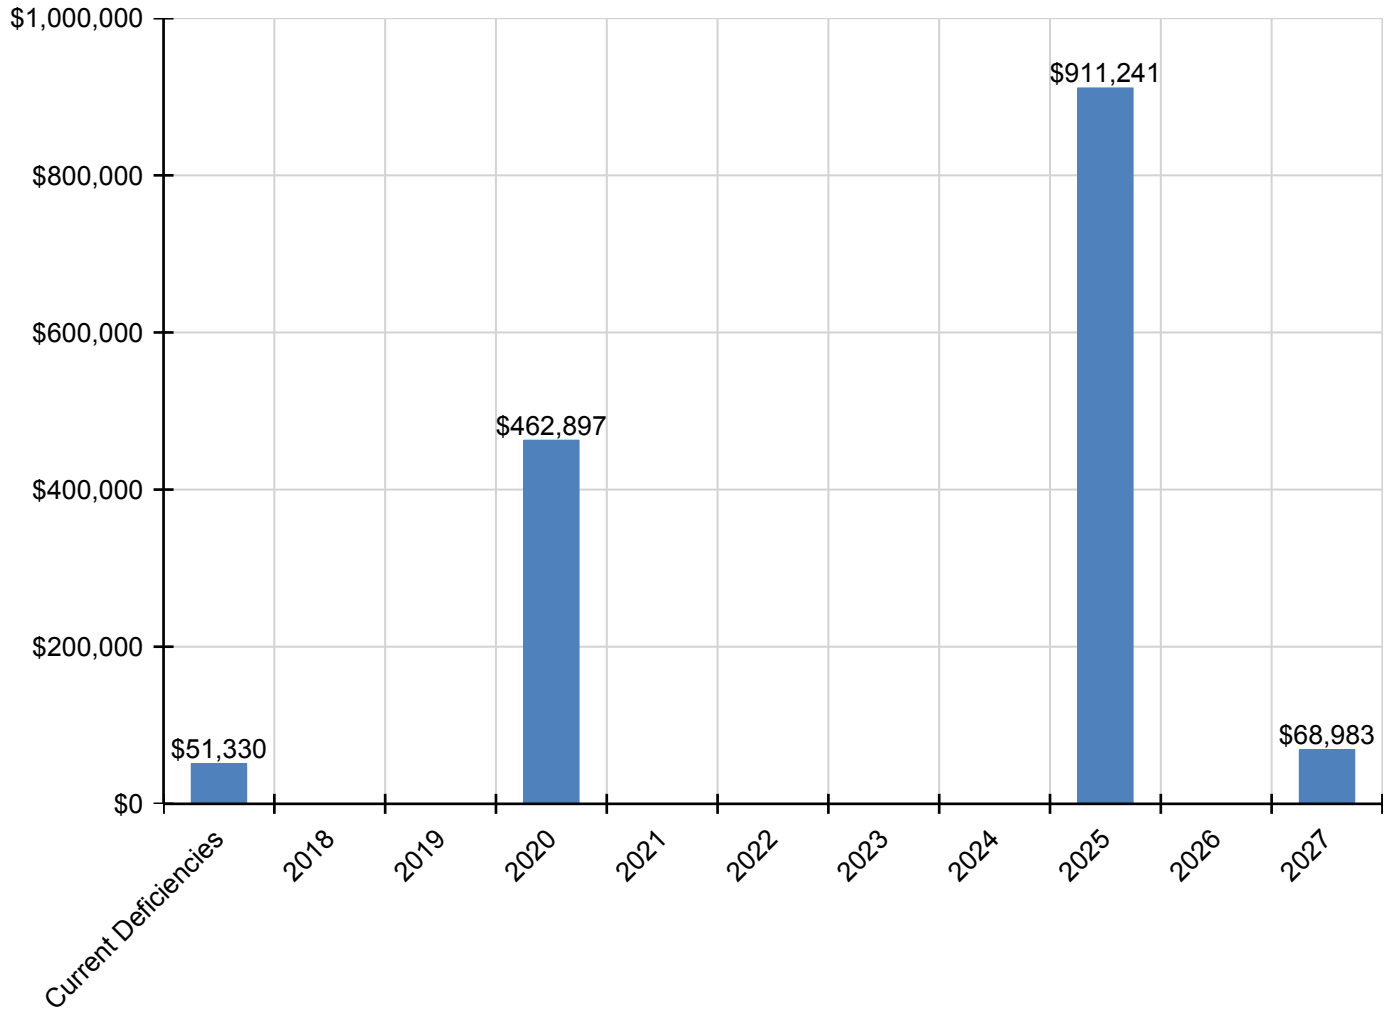
Forecasted Capital Renewal Requirement

The following chart shows the current building deficiencies and forecasting capital renewal or sustainment requirements over the next ten years.

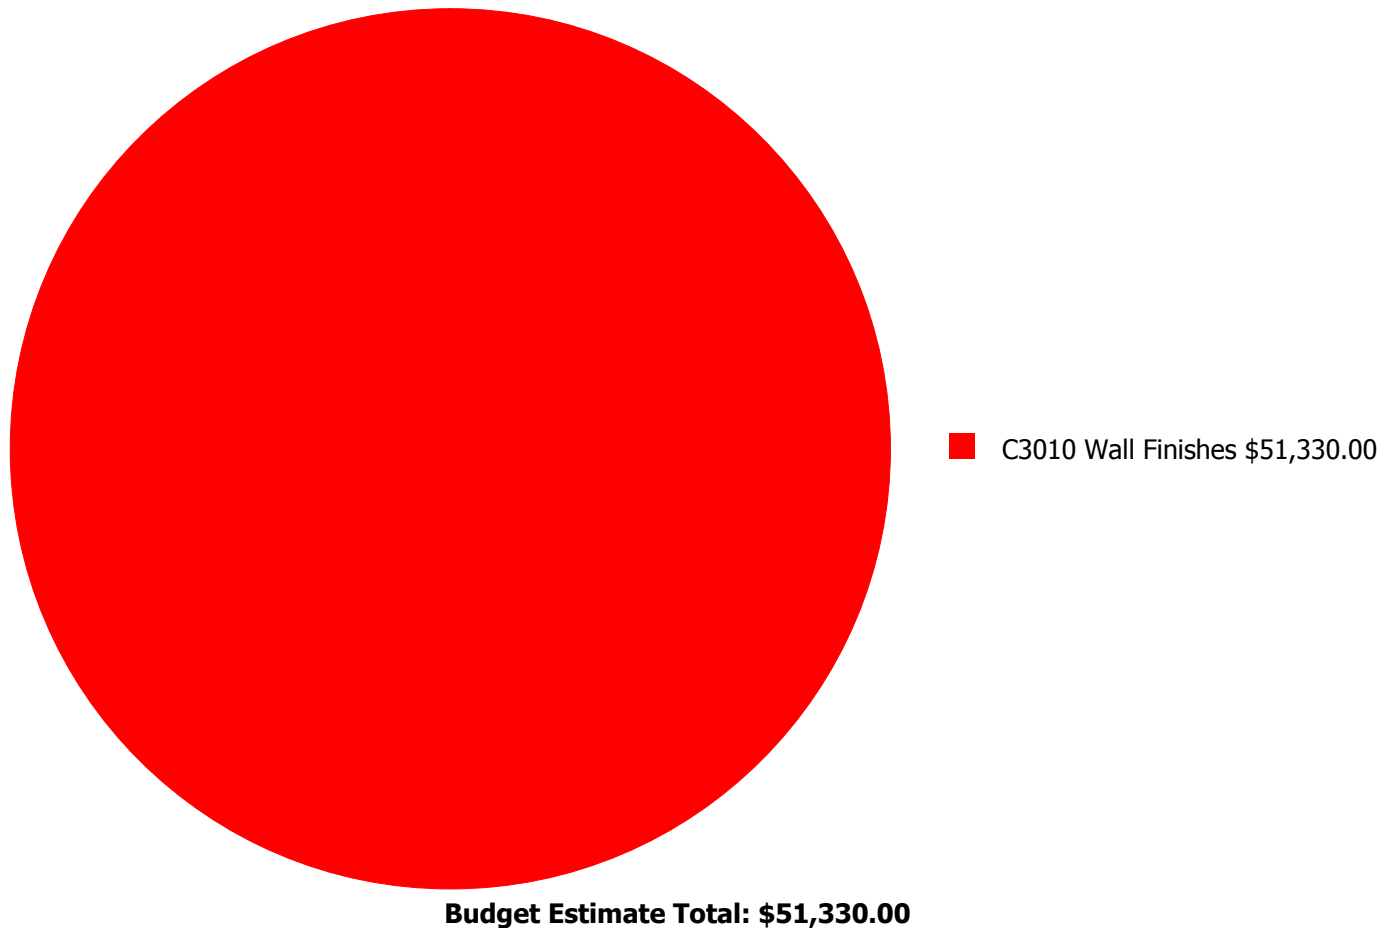
Deficiency Summary by System

Current deficiencies included assemblies that have reached or exceeded their design life or components of the assemblies that are in need of repair. Assemblies that have reached their design life are identified as current deficiencies and assigned the distress 'Beyond Useful Life'. The following chart lists all current deficiencies associated with this facility.

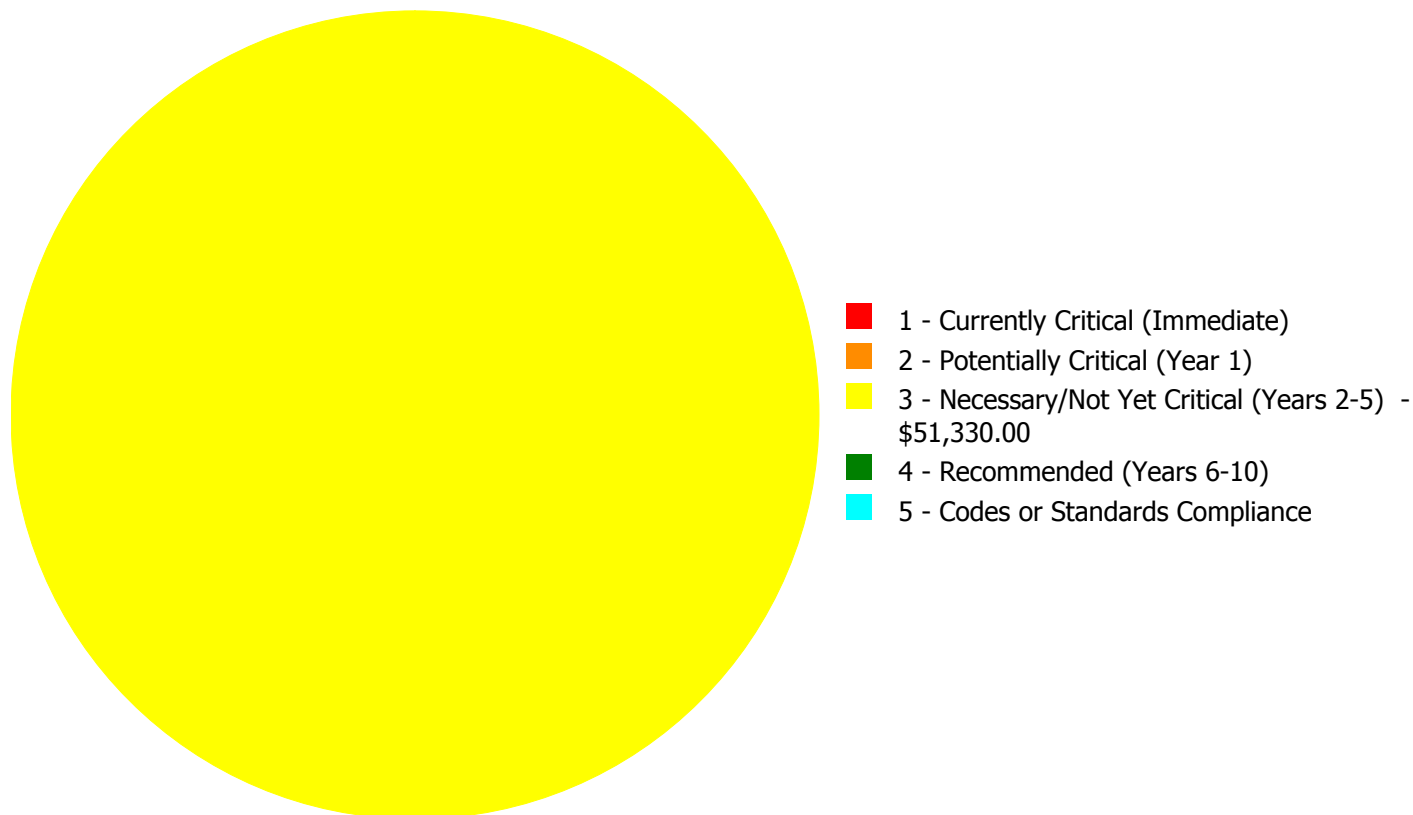
Deficiency Summary by Priority

The following chart shows the total repair costs broken down by priority. Assessors assigned deficiencies within eCOMET to one of the following priority categories:

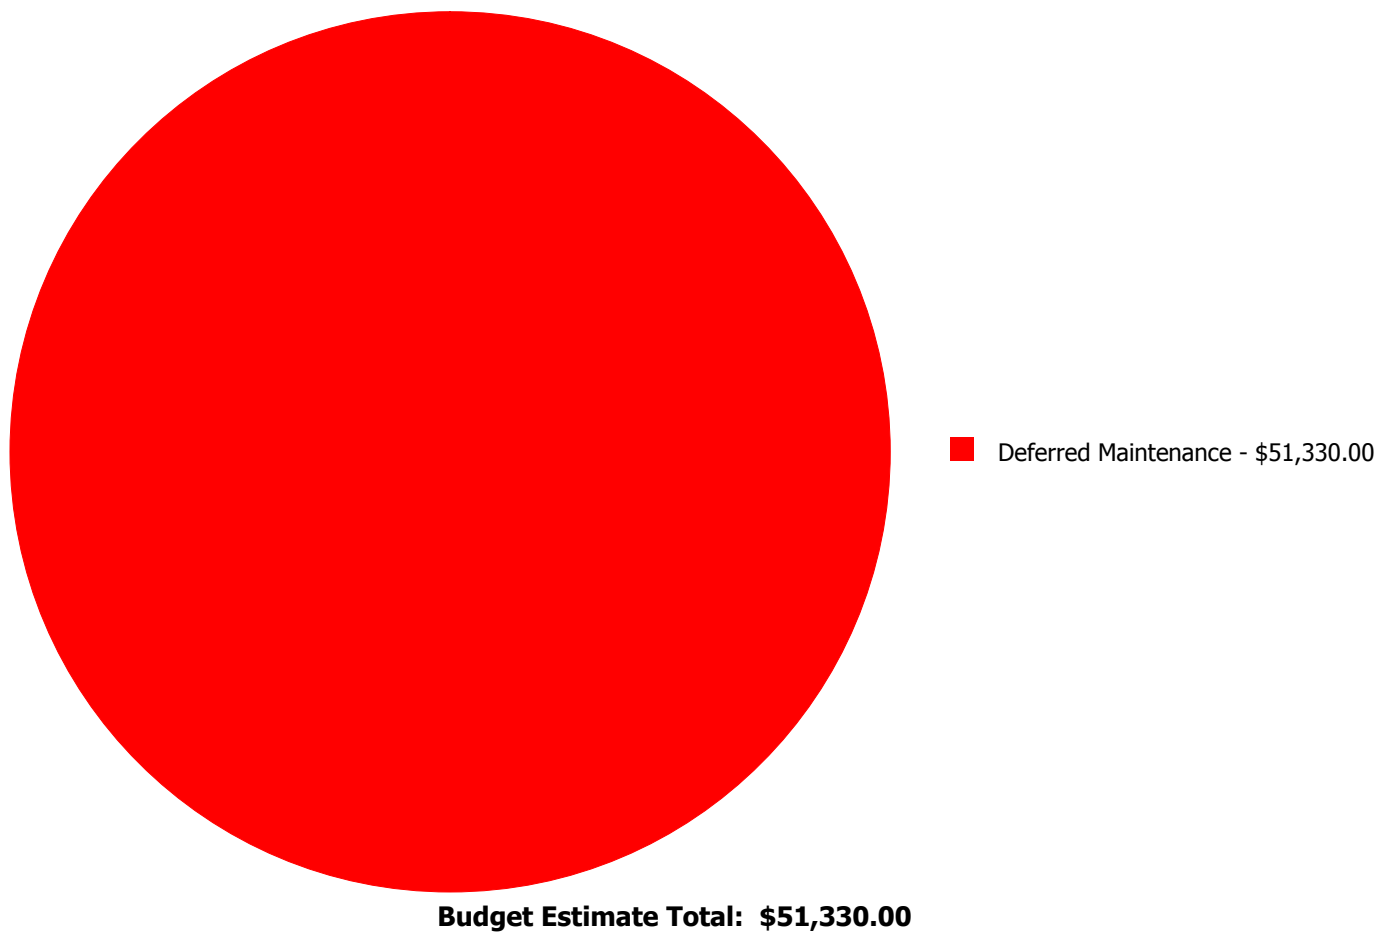
Deficiency Summary by Category

The following chart shows the total repair costs broken down by deficiency categories. Assessors assigned deficiencies to one of the following categories:

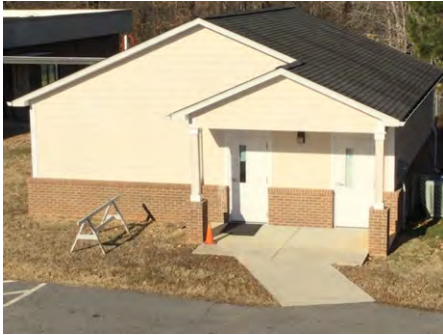
1). Southeast Elevation - Feb 13, 2017

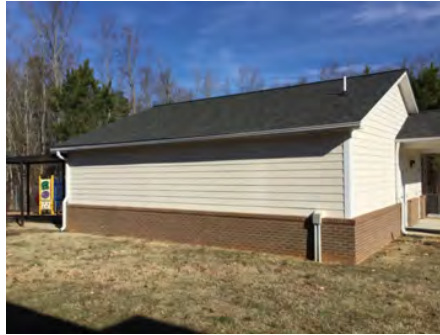
2). Southwest Elevation - Feb 13, 2017

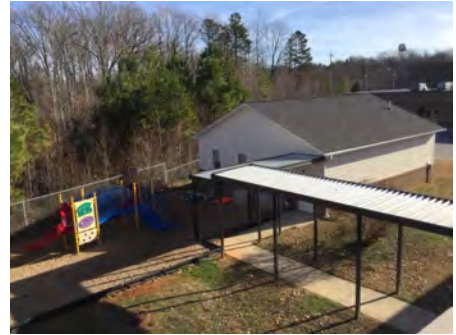
3). Northwest Elevation - Feb 13, 2017

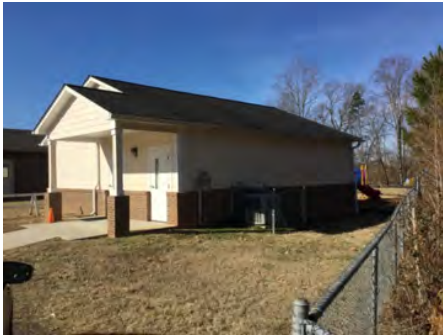
4). Northeast Elevation - Feb 13, 2017

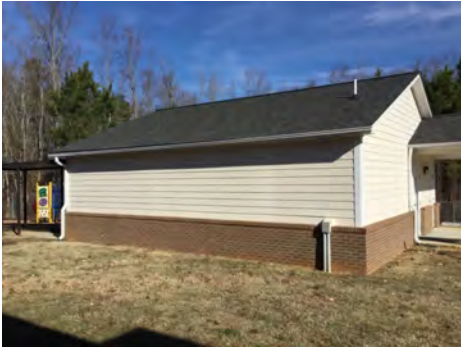
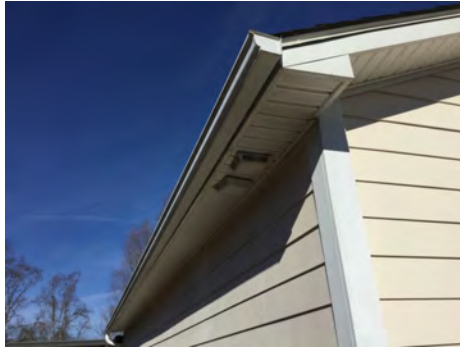
System: B2010 - Exterior Walls

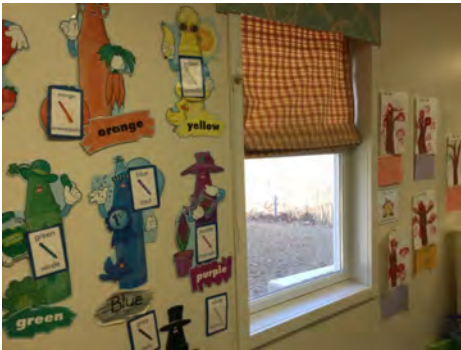
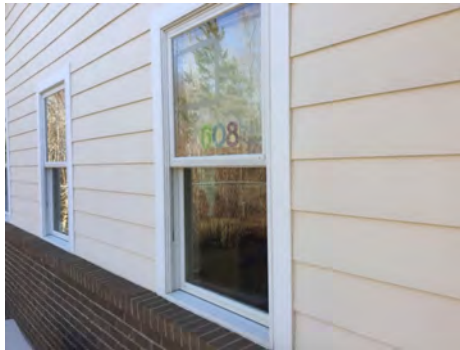
System: B2020 - Exterior Windows

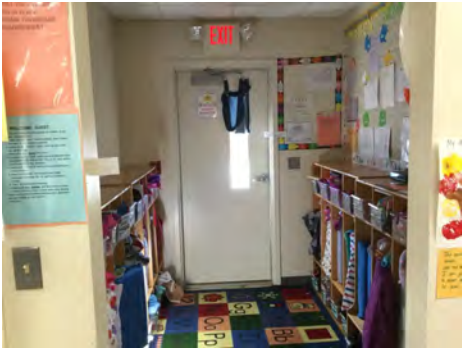
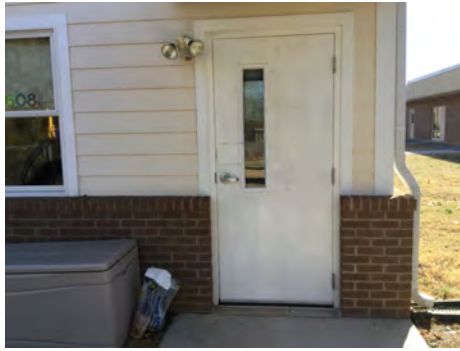
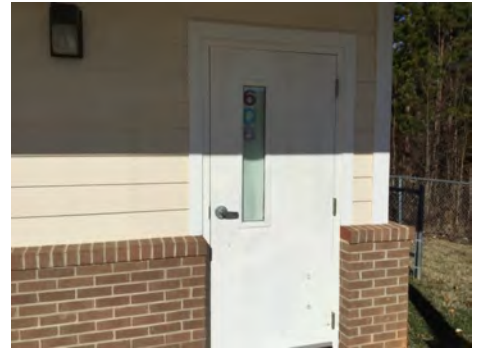
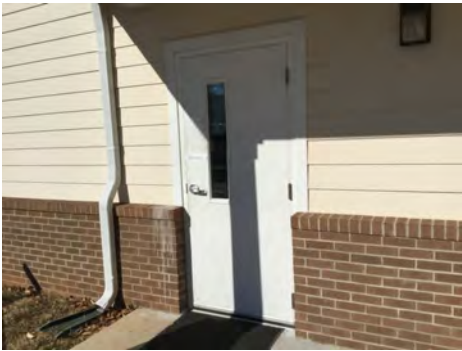
System: B2030 - Exterior Doors

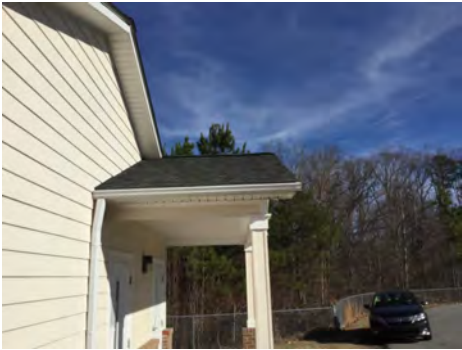
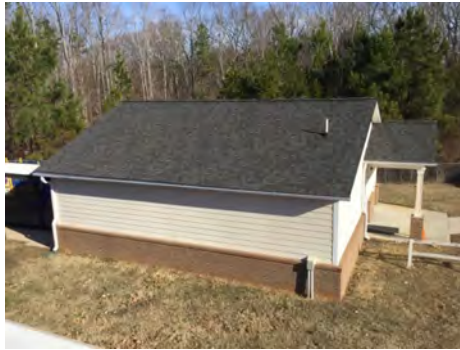
System: B3010140 - Asphalt Shingles

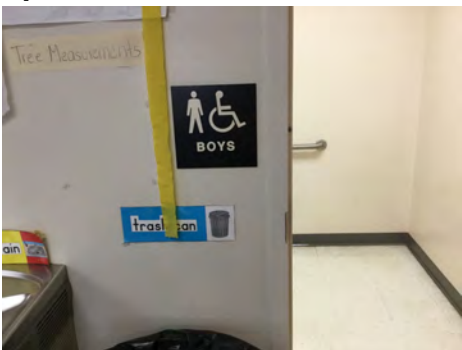
System: C1010 - Partitions

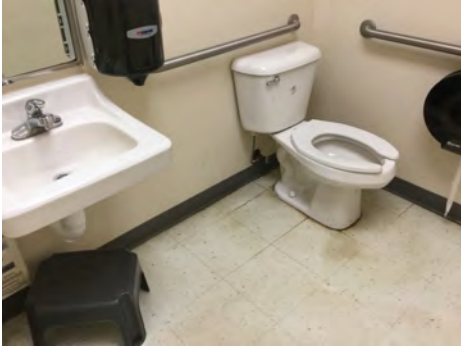
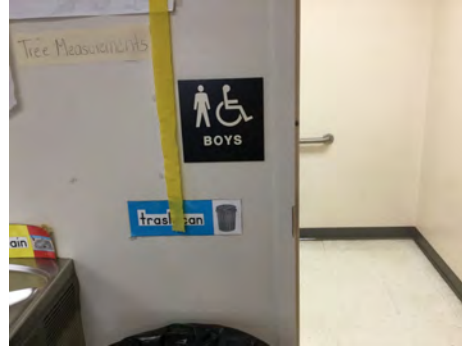
System: C1030 - Fittings

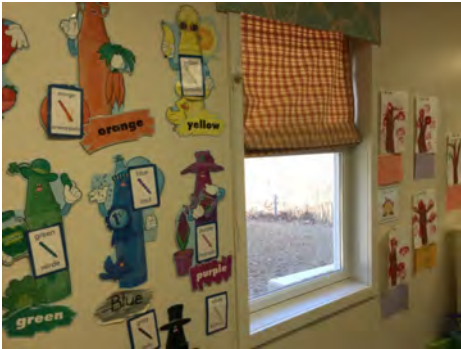
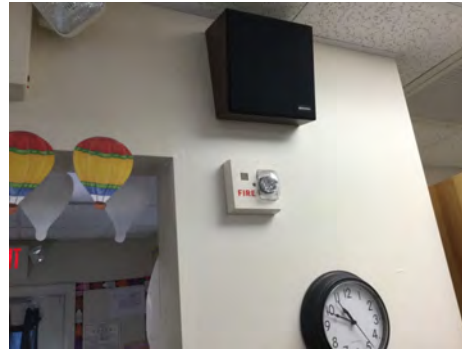
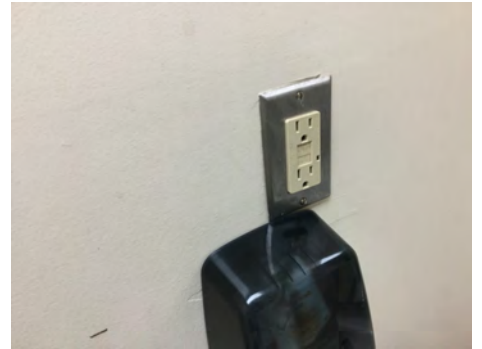
System: C3010 - Wall Finishes

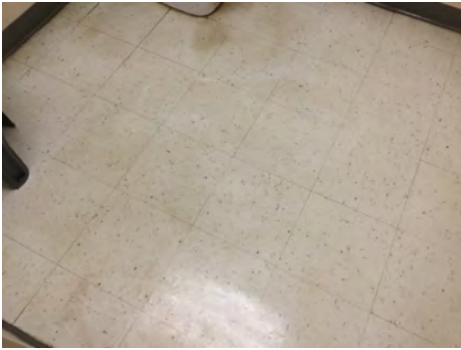
System: C3020 - Floor Finishes

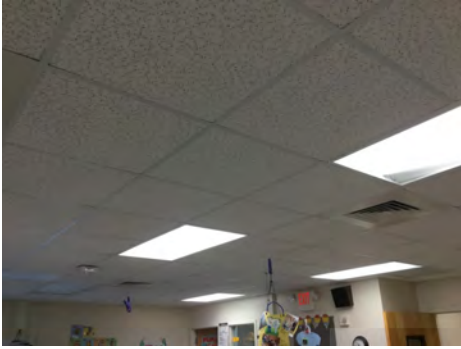
System: C3030 - Ceiling Finishes

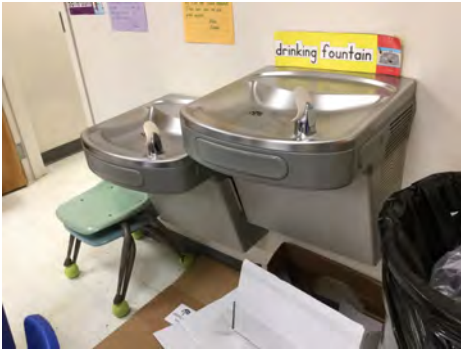
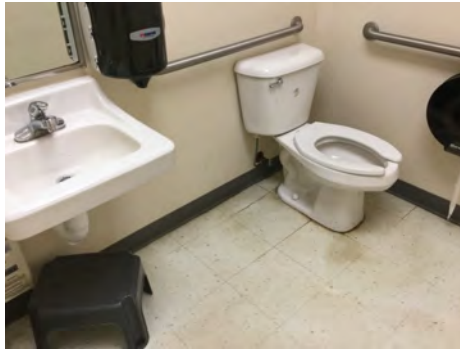
System: D2010 - Plumbing Fixtures

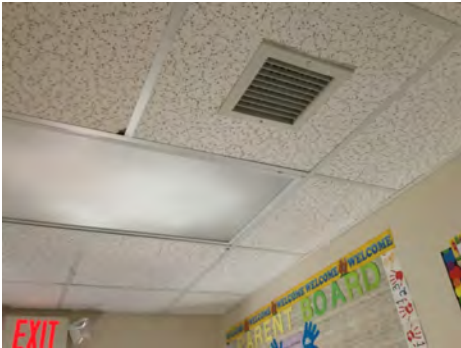
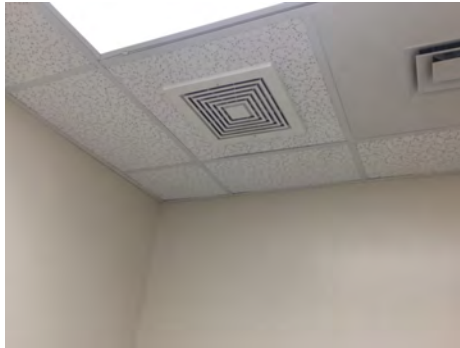
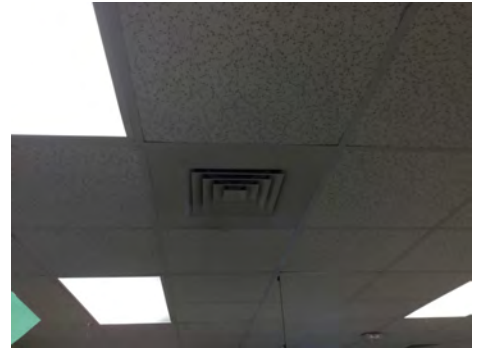
System: D3040 - Distribution Systems

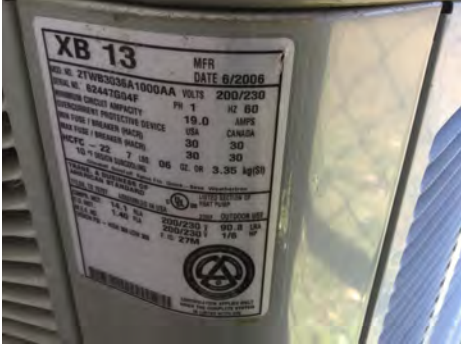
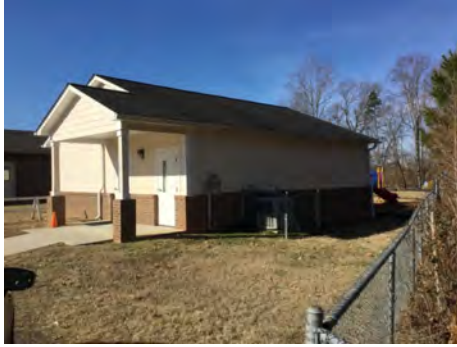
System: D3050 - Terminal & Package Units

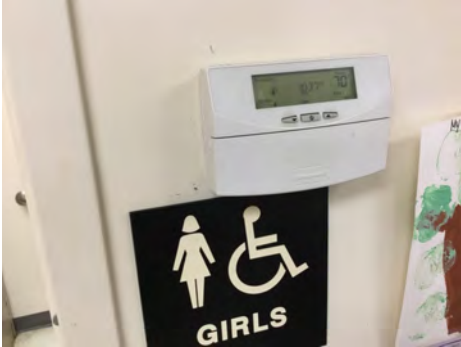
System: D3060 - Controls & Instrumentation

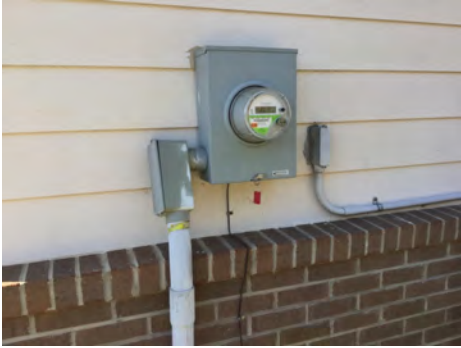
System: D5010 - Electrical Service/Distribution

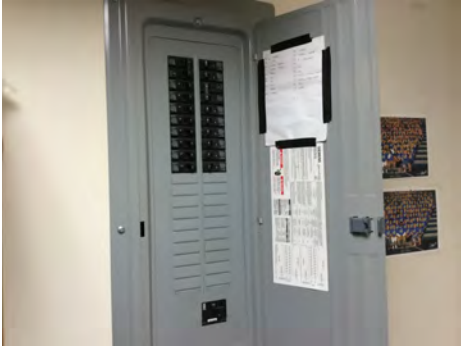
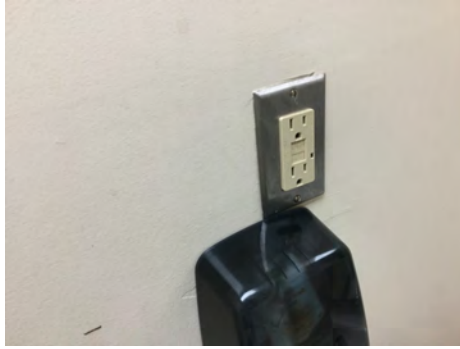
System: D5020 - Branch Wiring

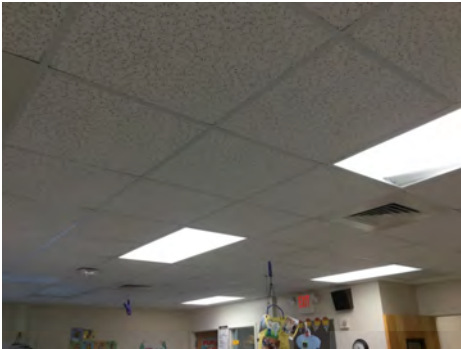
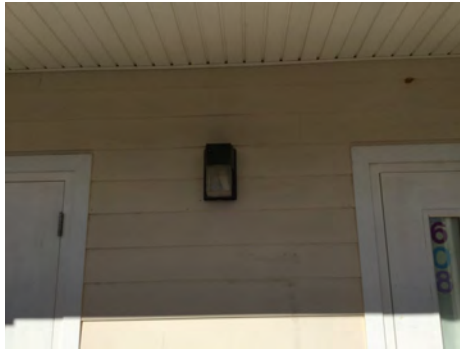
System: D5020 - Lighting

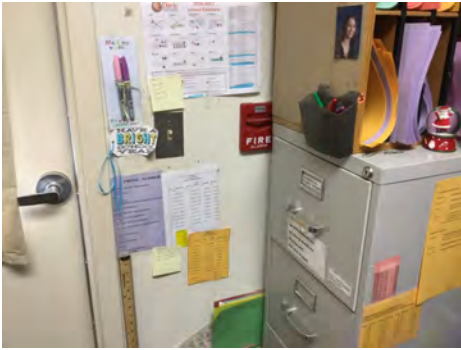
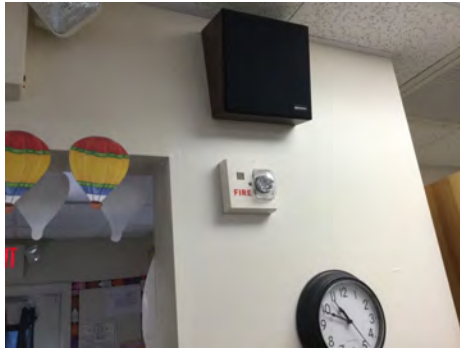
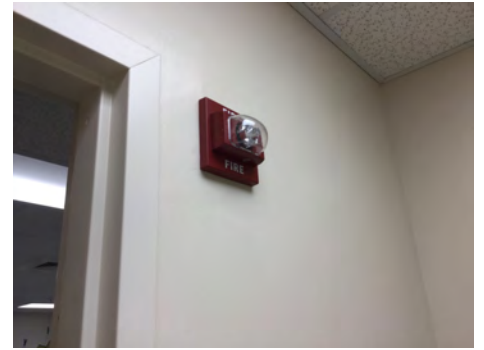
System: D5030910 - Fire Alarm Systems

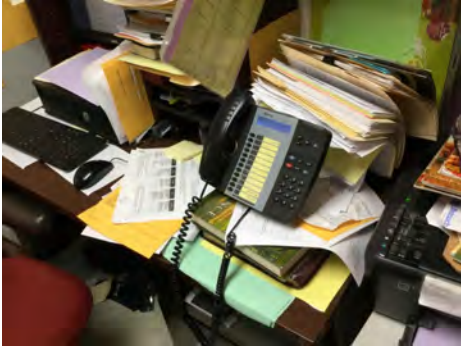
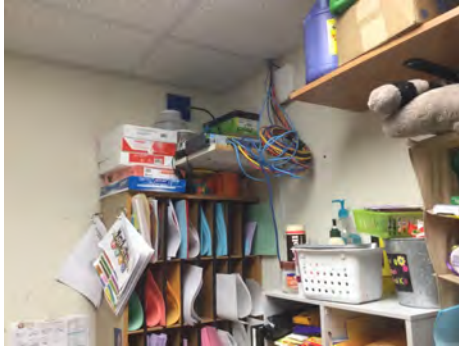
System: D5030920 - Data Communication

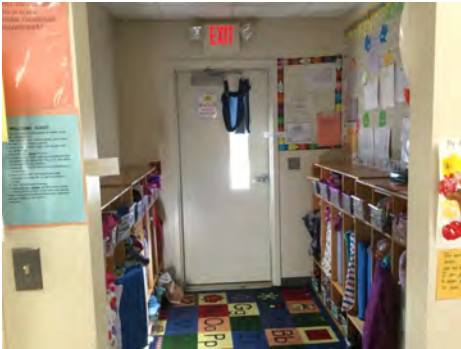
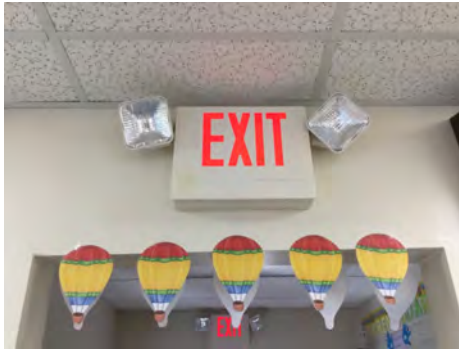
System: D5090 - Other Electrical Systems

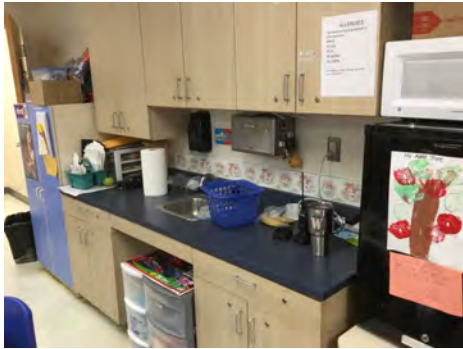
System: E2010 - Fixed Furnishings

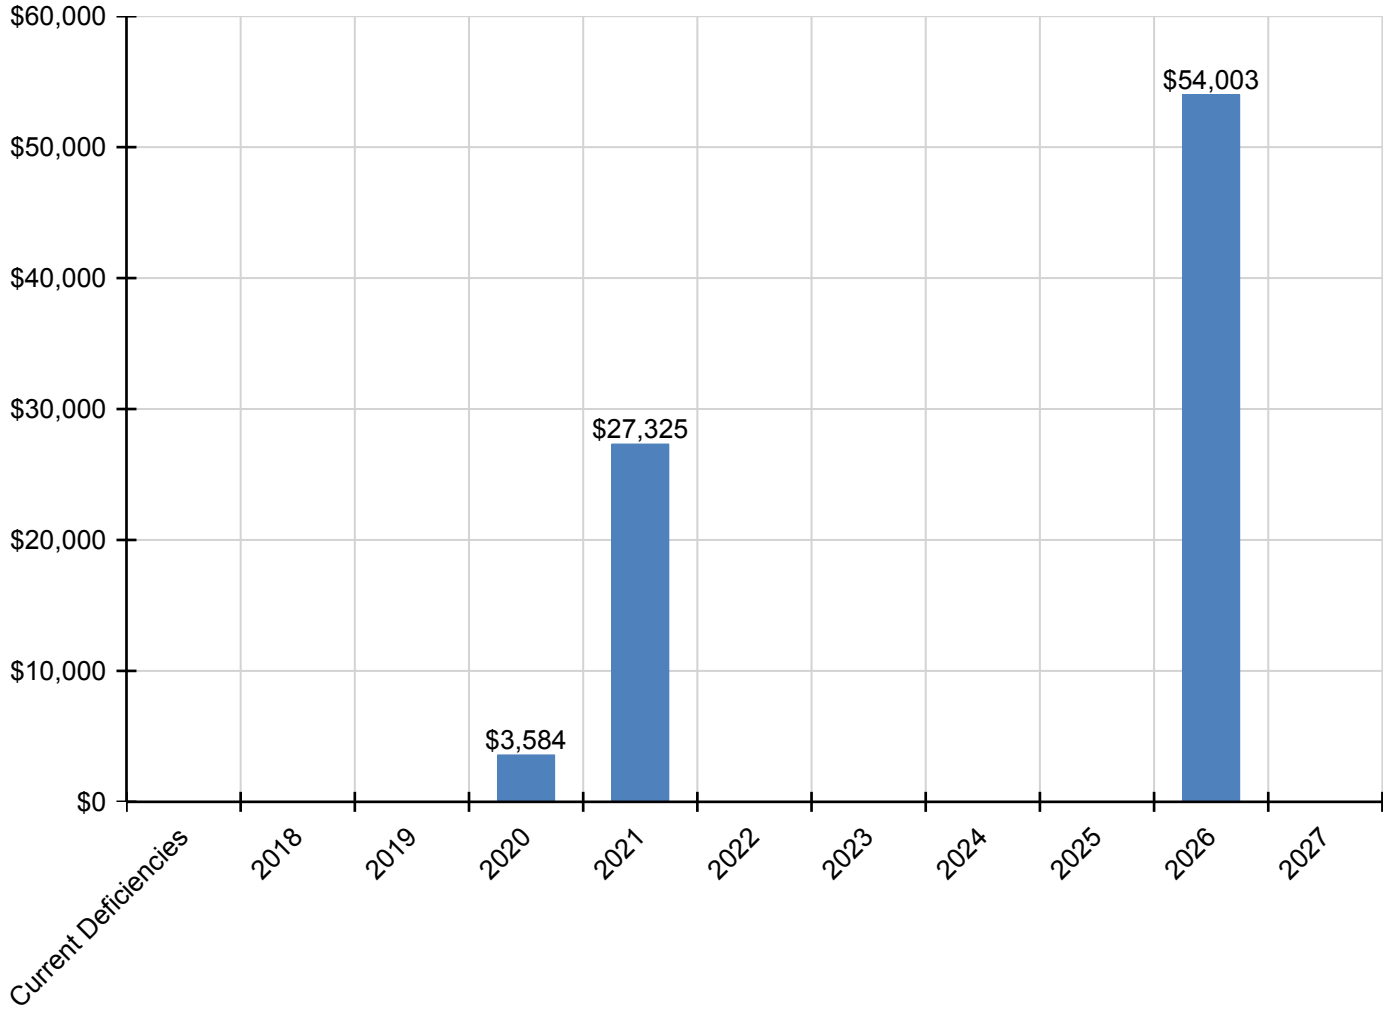
Forecasted Capital Renewal Requirement

The following chart shows the current building deficiencies and forecasting capital renewal or sustainment requirements over the next ten years.

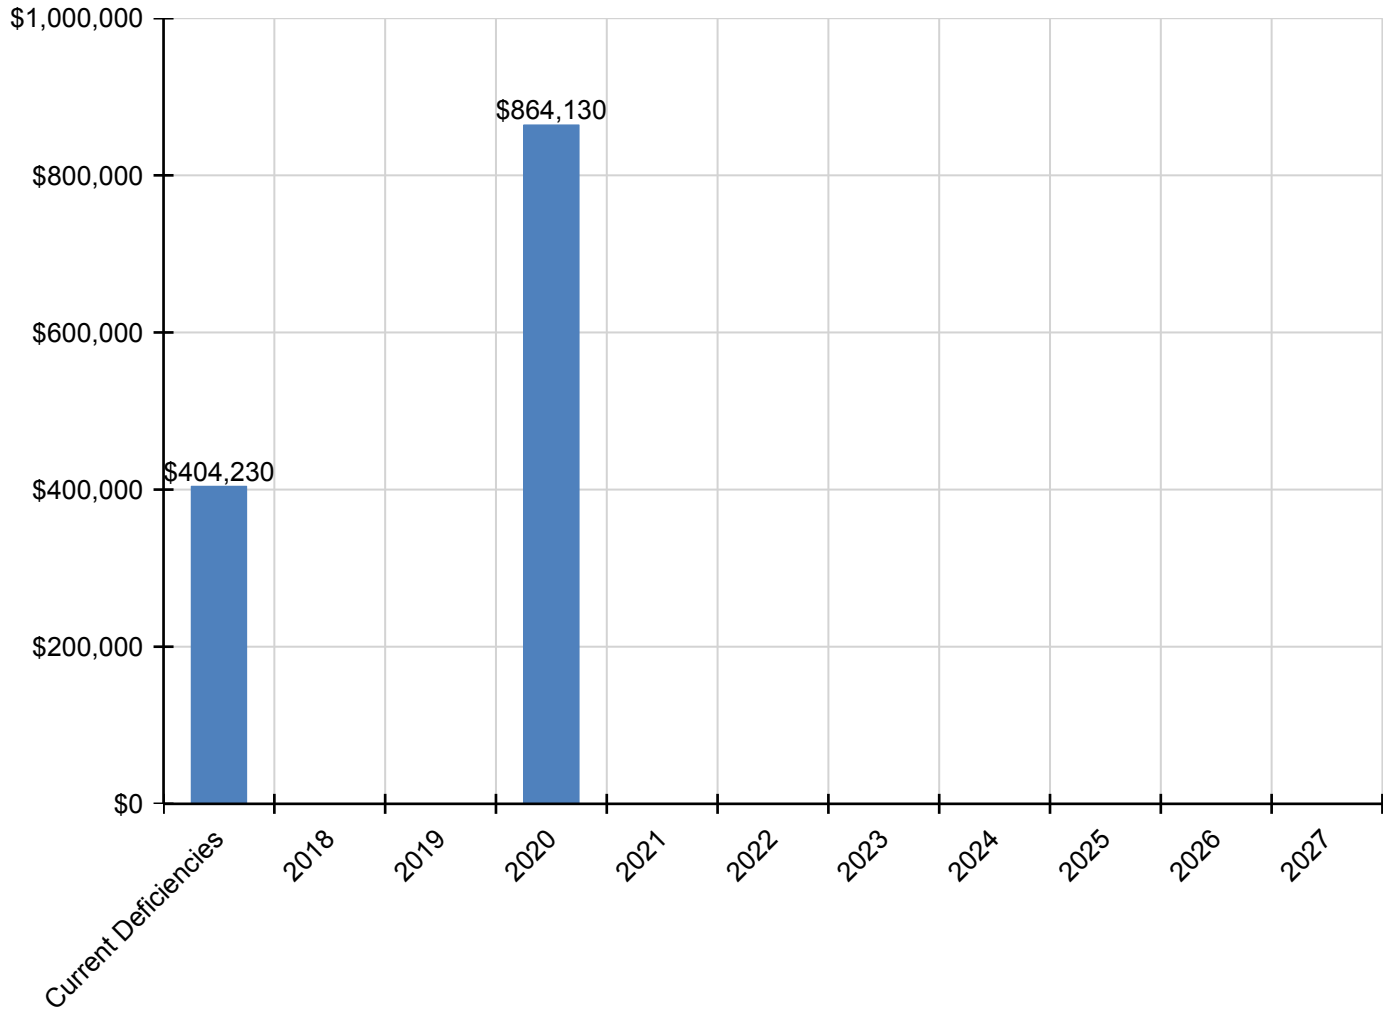
Forecasted Capital Renewal Requirement

The following chart shows the current building deficiencies and forecasting capital renewal or sustainment requirements over the next ten years.

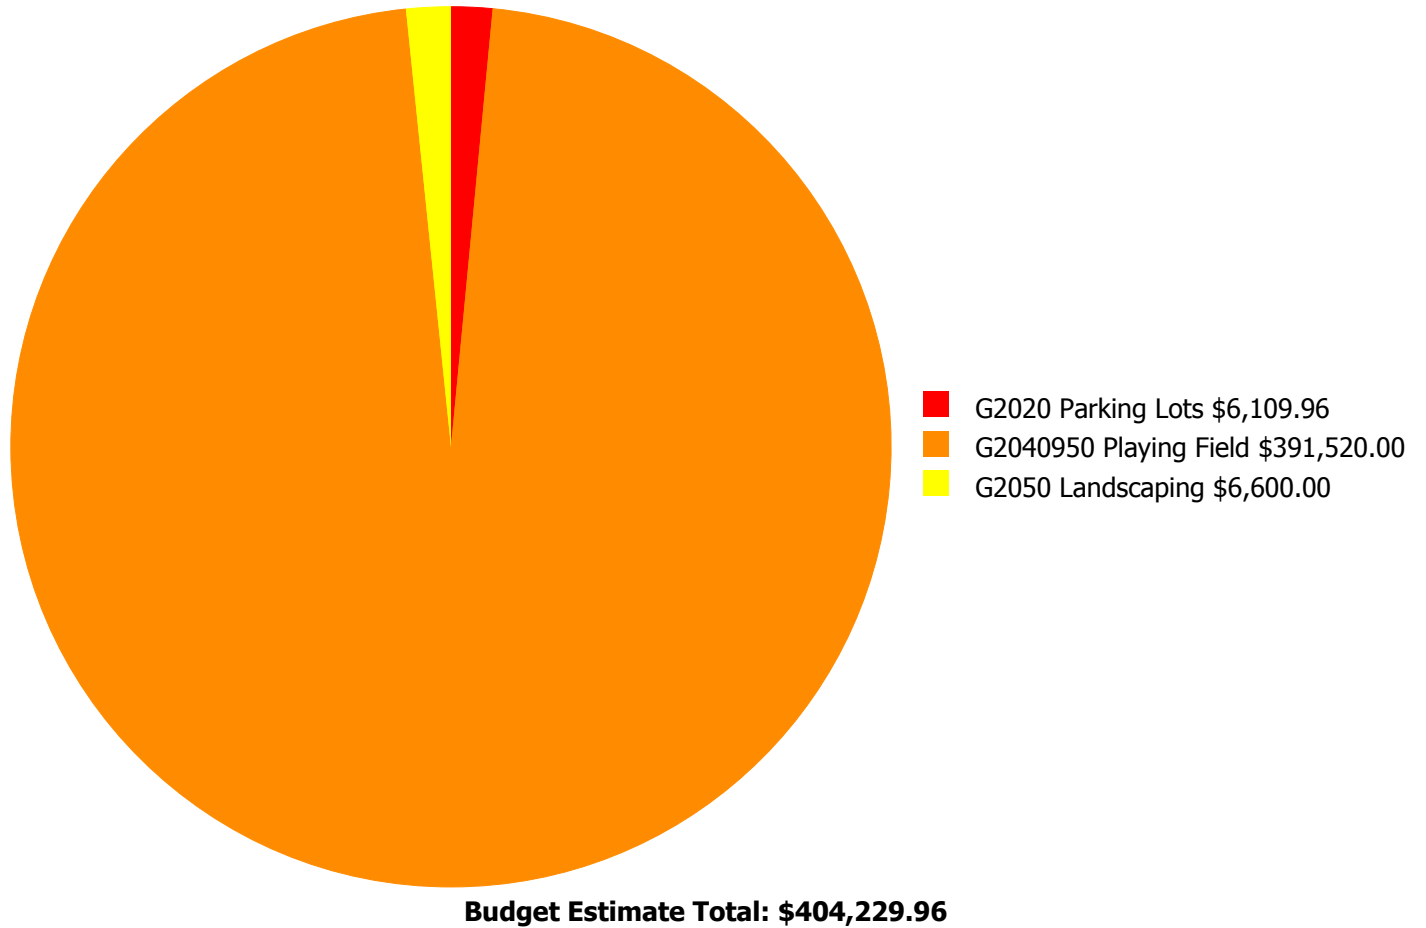
Deficiency Summary by System

Current deficiencies included assemblies that have reached or exceeded their design life or components of the assemblies that are in need of repair. Assemblies that have reached their design life are identified as current deficiencies and assigned the distress 'Beyond Useful Life'. The following chart lists all current deficiencies associated with this facility.

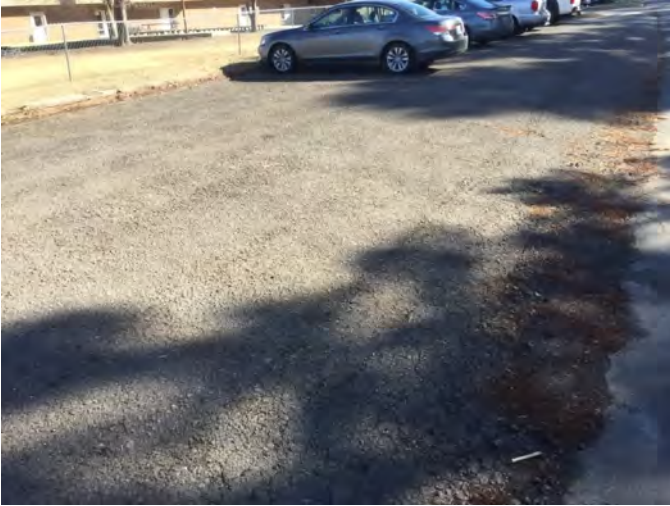
System: G2020 - Parking Lots

Location: West lot, south side of building
Distress: Beyond Service Life
Category: Deferred Maintenance
Priority: 3 - Necessary/Not Yet Critical (Years 2-5)
Correction: Parking lot repair and resurface
Qty: 4.50
Unit of Measure: M.S.F.
Estimate: \$6,109.96
Assessor Name: Ann Buerger Linden
Date Created: 02/13/2017

Notes: The parking lot is aged, has many repairs , and should be re-surfaced.

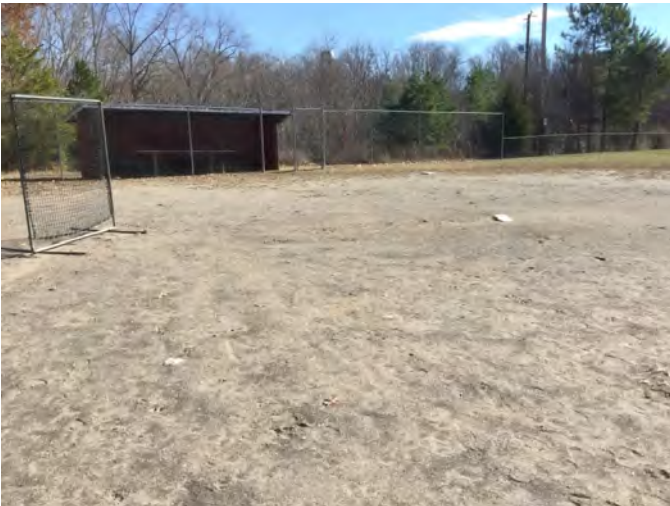
System: G2040950 - Playing Field

Location: Northeast end of site
Distress: Beyond Service Life
Category: Deferred Maintenance
Priority: 3 - Necessary/Not Yet Critical (Years 2-5)
Correction: Renew System
Qty: 78,398.00
Unit of Measure: S.F.
Estimate: \$391,520.00
Assessor Name: Ann Buerger Linden
Date Created: 12/13/2016

Notes: The ball field is in dilapidated condition. System renewal is recommended.

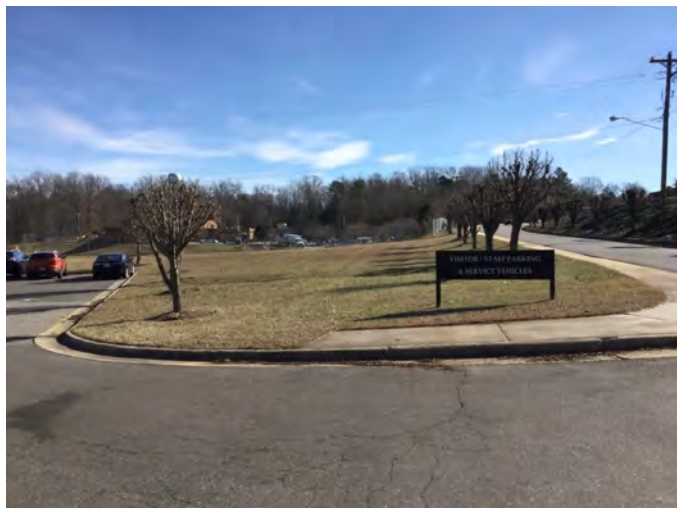
System: G2050 - Landscaping

Location: Site
Distress: Inadequate
Category: Deferred Maintenance
Priority: 3 - Necessary/Not Yet Critical (Years 2-5)
Correction: Grading study
Qty: 1.00
Unit of Measure: Ea.
Estimate: \$6,600.00
Assessor Name: Ann Buerger Linden
Date Created: 02/14/2017

Notes: The site reportedly floods during rain storms. The road is higher than the building site. A grading study is recommended.
