NC School District/300 Davie County/High School

Central Davie Academy

Campus Assessment Report

March 7, 2017

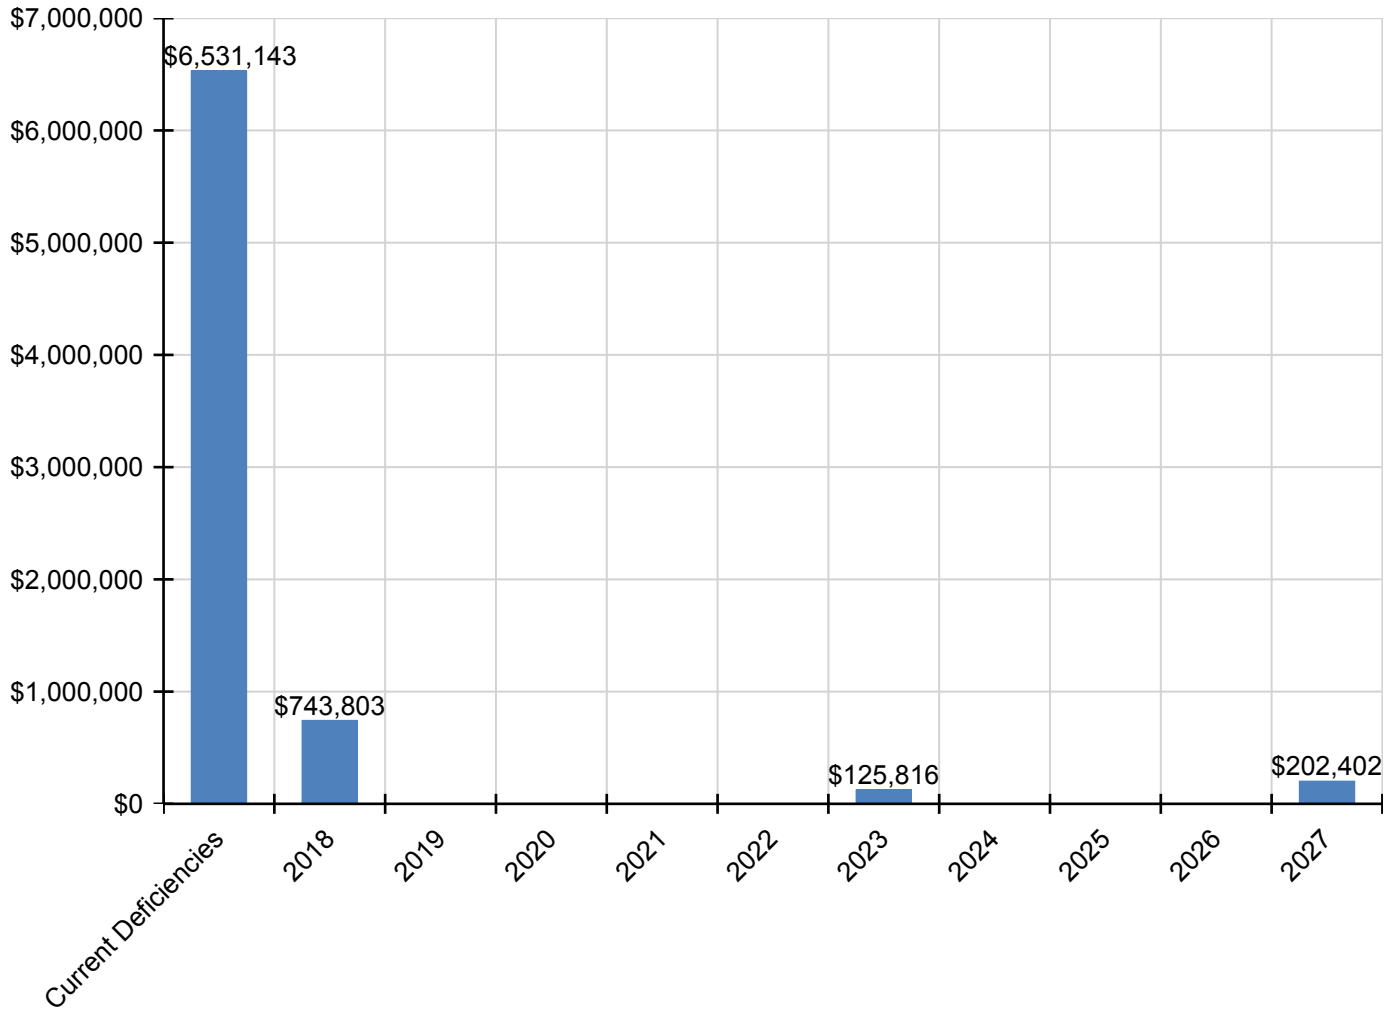
Forecasted Capital Renewal Requirement

The following chart shows the current building deficiencies and forecasting capital renewal or sustainment requirements over the next ten years.

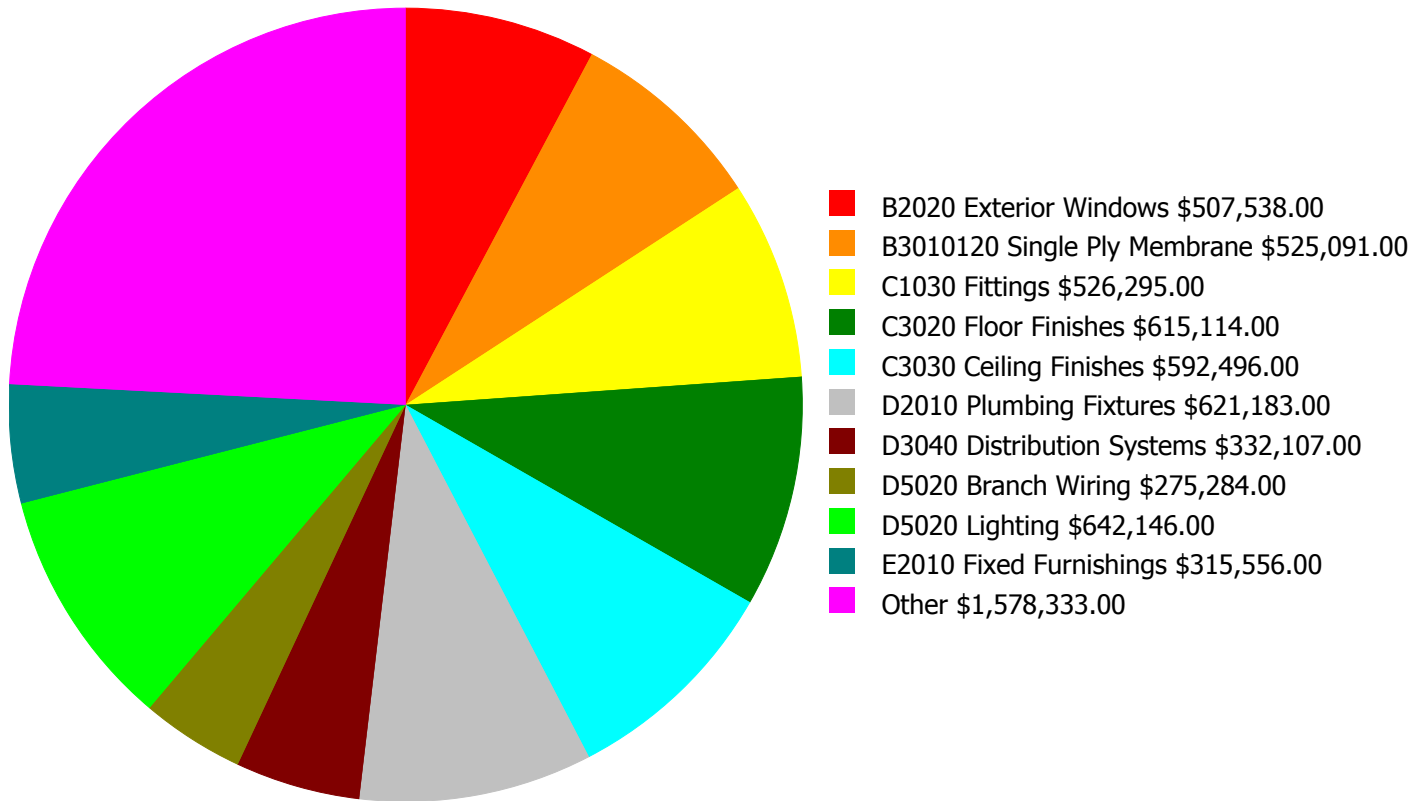
Deficiency Summary by System

Current deficiencies included assemblies that have reached or exceeded their design life or components of the assemblies that are in need of repair. Assemblies that have reached their design life are identified as current deficiencies and assigned the distress 'Beyond Useful Life'. The following chart lists all current deficiencies associated with this facility.

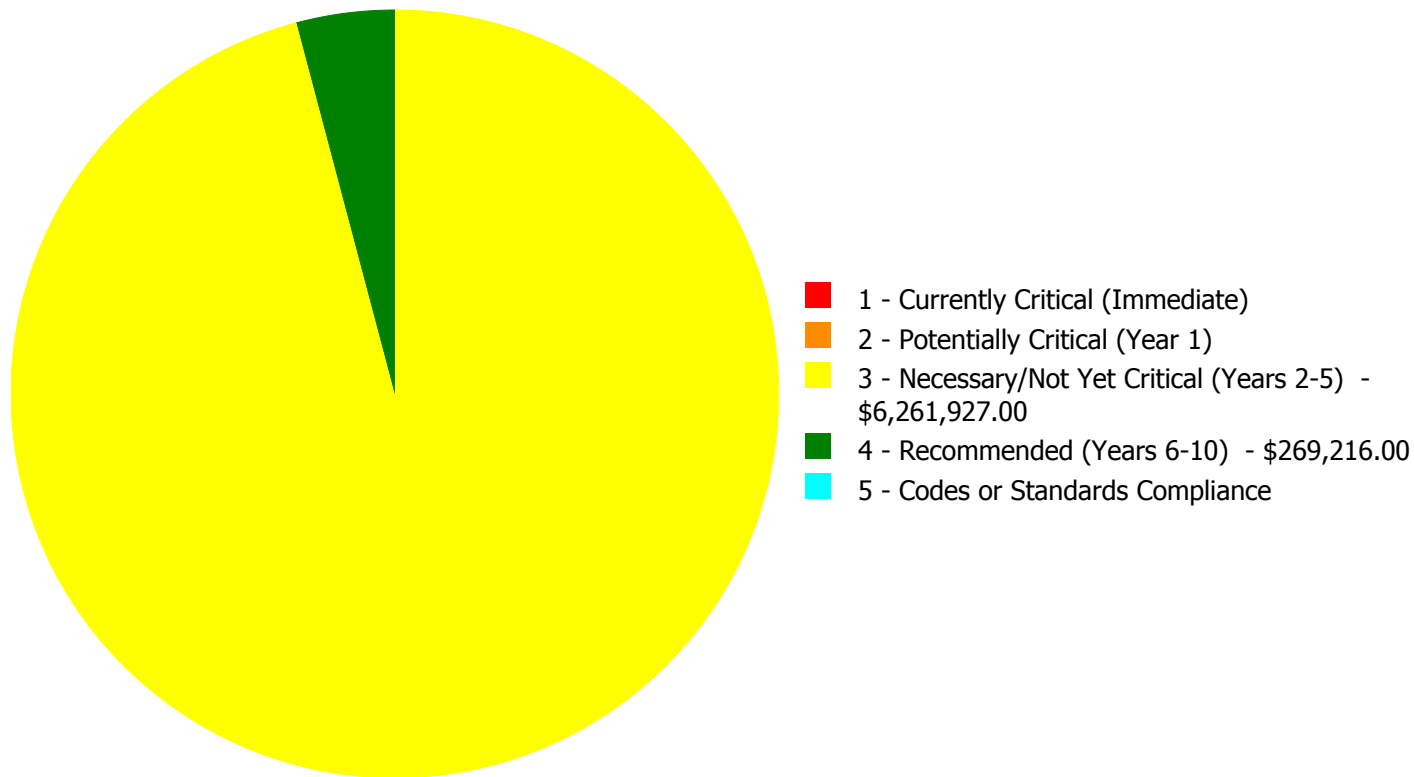
Deficiency Summary by Priority

The following chart shows the total repair costs broken down by priority. Assessors assigned deficiencies within eCOMET to one of the following priority categories:

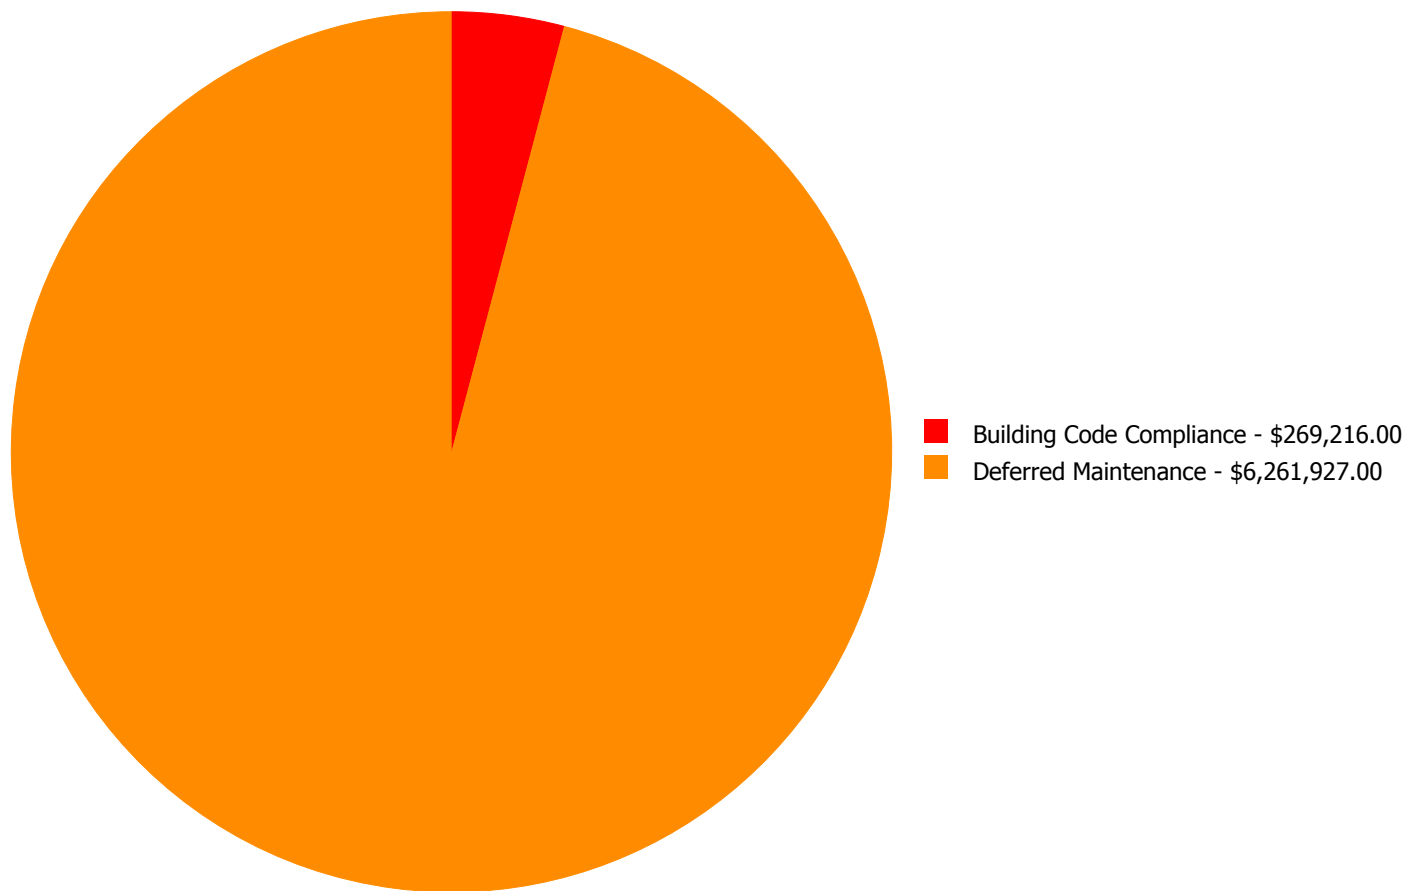
Deficiency Summary by Category

The following chart shows the total repair costs broken down by deficiency categories. Assessors assigned deficiencies to one of the following categories:

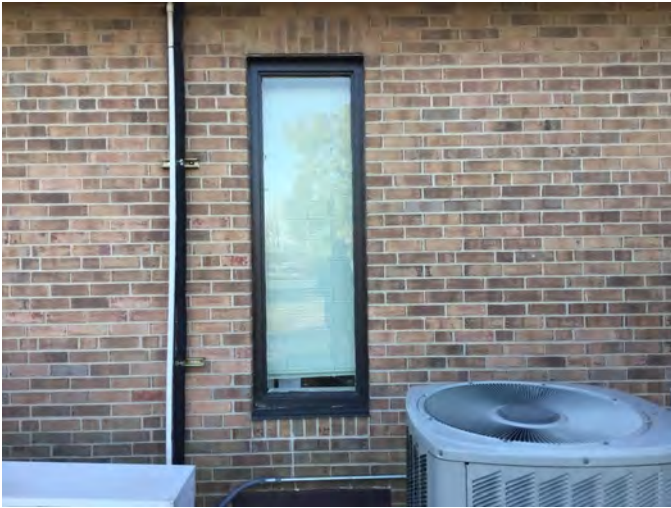
System: B2020 - Exterior Windows

Location: Exterior Walls
Distress: Beyond Service Life
Category: Deferred Maintenance
Priority: 3 - Necessary/Not Yet Critical (Years 2-5)
Correction: Renew System
Qty: 50,152.00
Unit of Measure: S.F.
Estimate: \$507,538.00
Assessor Name: Somnath Das
Date Created: 01/19/2017

Notes: The exterior windows are aged, rusted, not energy efficient and should be replaced.

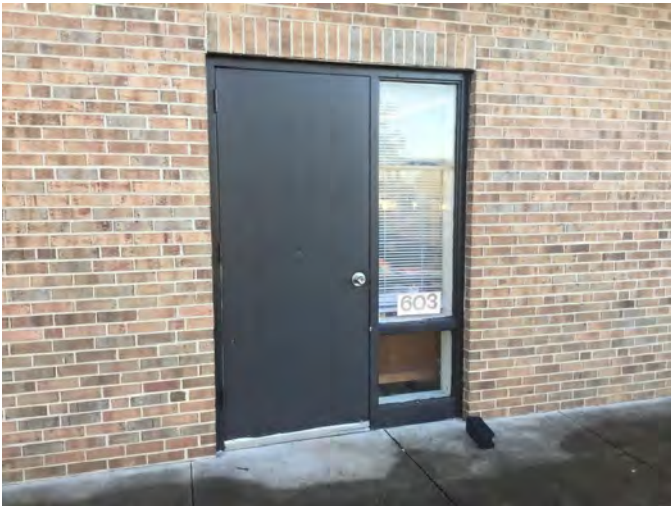
System: B2030 - Exterior Doors

Location: Exterior Walls
Distress: Beyond Service Life
Category: Deferred Maintenance
Priority: 3 - Necessary/Not Yet Critical (Years 2-5)
Correction: Renew System
Qty: 50,152.00
Unit of Measure: S.F.
Estimate: \$56,271.00
Assessor Name: Somnath Das
Date Created: 01/19/2017

Notes: The exterior doors are aged, rusted and should be replaced.

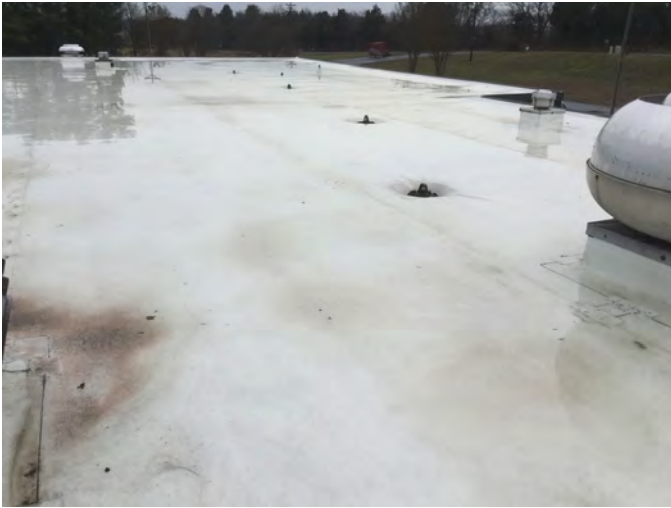
System: B3010120 - Single Ply Membrane

Location: Roof
Distress: Beyond Service Life
Category: Deferred Maintenance
Priority: 3 - Necessary/Not Yet Critical (Years 2-5)
Correction: Renew System
Qty: 50,152.00
Unit of Measure: S.F.
Estimate: \$525,091.00
Assessor Name: Somnath Das
Date Created: 01/19/2017

Notes: The membrane roof covering is aged, showing signs of failure and should be replaced.

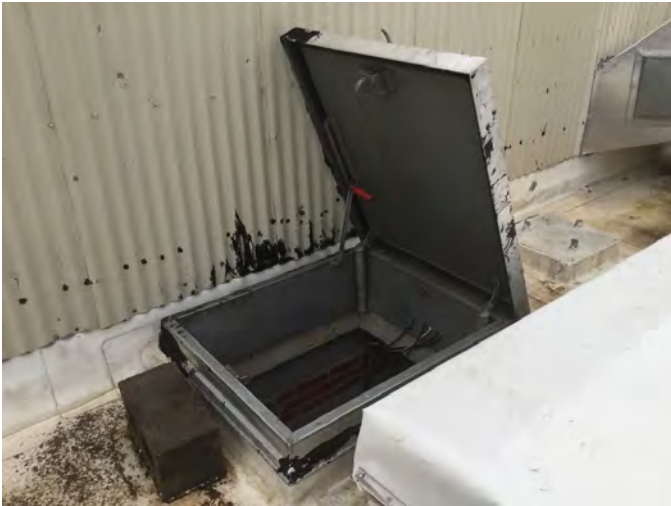
System: B3020 - Roof Openings

Location: Roof
Distress: Beyond Service Life
Category: Deferred Maintenance
Priority: 3 - Necessary/Not Yet Critical (Years 2-5)
Correction: Renew System
Qty: 50,152.00
Unit of Measure: S.F.
Estimate: \$15,998.00
Assessor Name: Somnath Das
Date Created: 01/19/2017

Notes: Roof hatch does not comply with OSHA standards; roof opening protection and proper extension of fixed ladder to platform is not provided.

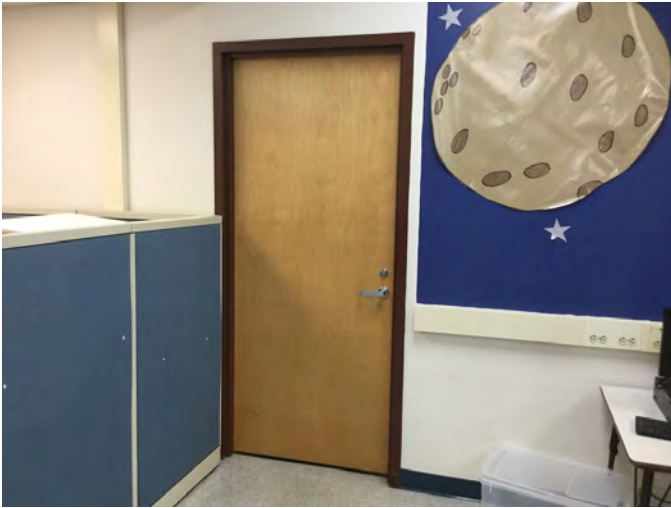
System: C1020 - Interior Doors

Location: Throughout the Building
Distress: Beyond Service Life
Category: Deferred Maintenance
Priority: 3 - Necessary/Not Yet Critical (Years 2-5)
Correction: Renew System
Qty: 50,152.00
Unit of Measure: S.F.
Estimate: \$136,815.00
Assessor Name: Somnath Das
Date Created: 01/19/2017

Notes: The interior doors are aged, failing, most hardware is not ADA or code compliant and should be replaced.

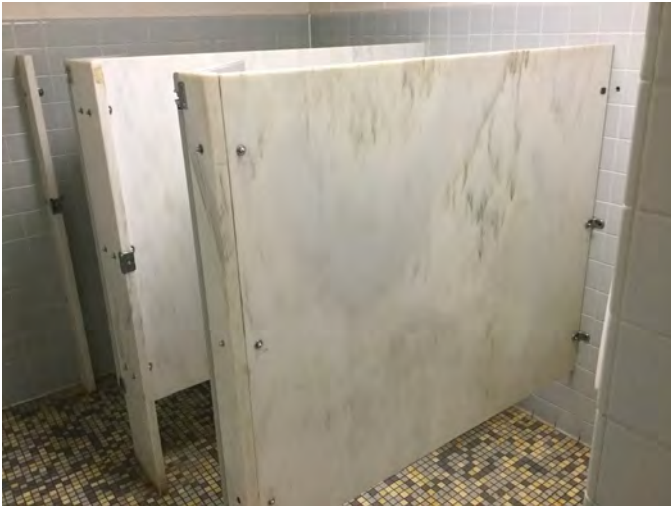
System: C1030 - Fittings

Location: Throughout the Building
Distress: Beyond Service Life
Category: Deferred Maintenance
Priority: 3 - Necessary/Not Yet Critical (Years 2-5)
Correction: Renew System
Qty: 50,152.00
Unit of Measure: S.F.
Estimate: \$526,295.00
Assessor Name: Somnath Das
Date Created: 01/19/2017

Notes: The fittings throughout the building are aged, in marginal condition, handrails and room signage are not ADA compliant and should be replaced.

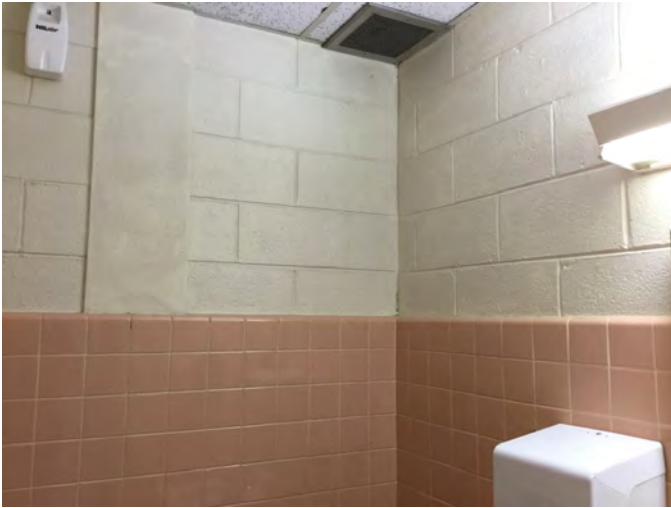
System: C3010 - Wall Finishes

Location: Throughout the Building
Distress: Beyond Service Life
Category: Deferred Maintenance
Priority: 3 - Necessary/Not Yet Critical (Years 2-5)
Correction: Renew System
Qty: 50,152.00
Unit of Measure: S.F.
Estimate: \$150,606.00
Assessor Name: Somnath Das
Date Created: 01/19/2017

Notes: The wall finishes are aged, scuffed, fading, stained and should be replaced.

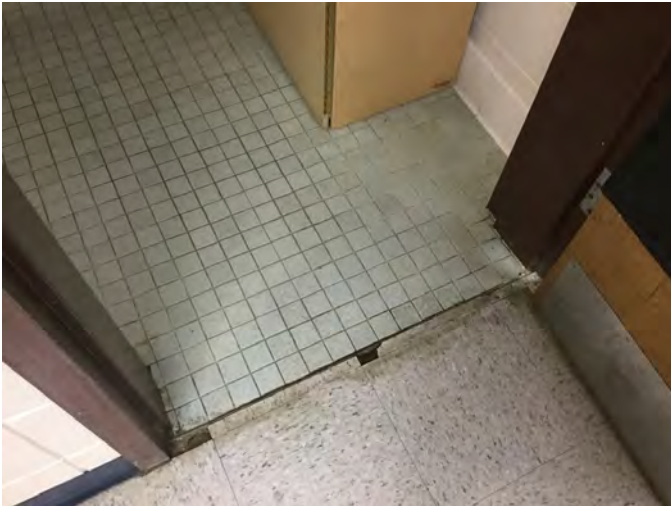
System: C3020 - Floor Finishes

Location: Throughout the Building
Distress: Beyond Service Life
Category: Deferred Maintenance
Priority: 3 - Necessary/Not Yet Critical (Years 2-5)
Correction: Renew System
Qty: 50,152.00
Unit of Measure: S.F.
Estimate: \$615,114.00
Assessor Name: Somnath Das
Date Created: 01/19/2017

Notes: The original flooring is in poor conditions and should be replaced.

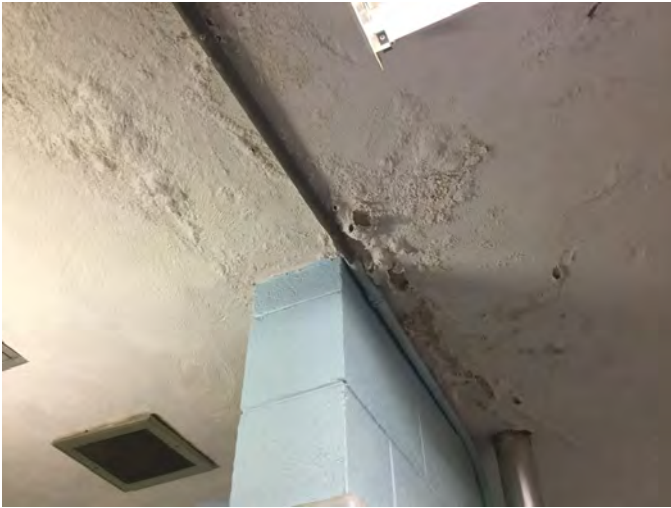
System: C3030 - Ceiling Finishes

Location: Throughout the Building
Distress: Beyond Service Life
Category: Deferred Maintenance
Priority: 3 - Necessary/Not Yet Critical (Years 2-5)
Correction: Renew System
Qty: 50,152.00
Unit of Measure: S.F.
Estimate: \$592,496.00
Assessor Name: Somnath Das
Date Created: 01/19/2017

Notes: The original ceiling finishes are aged, failing and should be replaced.

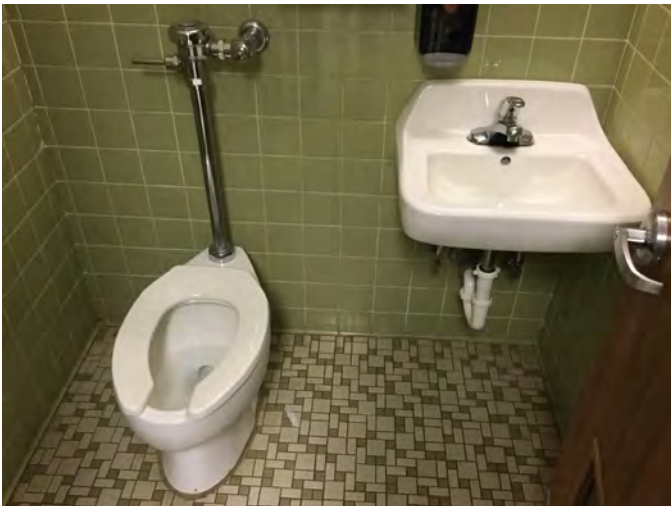
System: D2010 - Plumbing Fixtures

Location: Throughout the Building
Distress: Beyond Service Life
Category: Deferred Maintenance
Priority: 3 - Necessary/Not Yet Critical (Years 2-5)
Correction: Renew System
Qty: 50,152.00
Unit of Measure: S.F.
Estimate: \$621,183.00
Assessor Name: Somnath Das
Date Created: 01/19/2017

Notes: Plumbing fixtures are in operational conditions. However, they are aged, not ADA compliant, and should be scheduled for replacement.

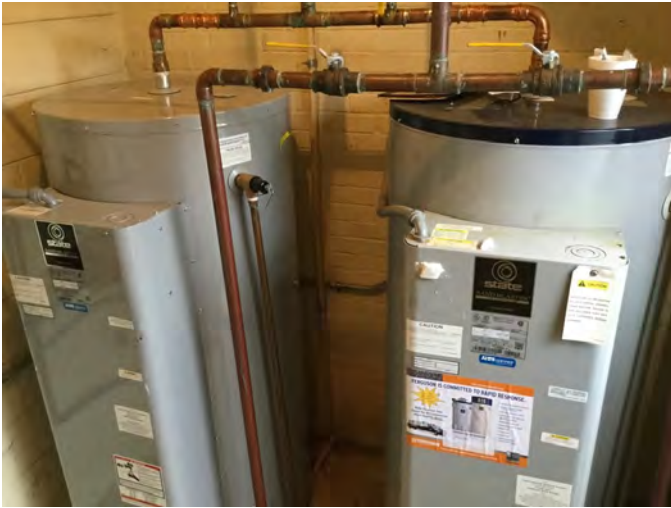
System: D2020 - Domestic Water Distribution

Location: Throughout the Building
Distress: Beyond Service Life
Category: Deferred Maintenance
Priority: 3 - Necessary/Not Yet Critical (Years 2-5)
Correction: Renew System
Qty: 50,152.00
Unit of Measure: S.F.
Estimate: \$52,961.00
Assessor Name: Somnath Das
Date Created: 01/19/2017

Notes: The domestic water distribution system is aged and should be replaced.

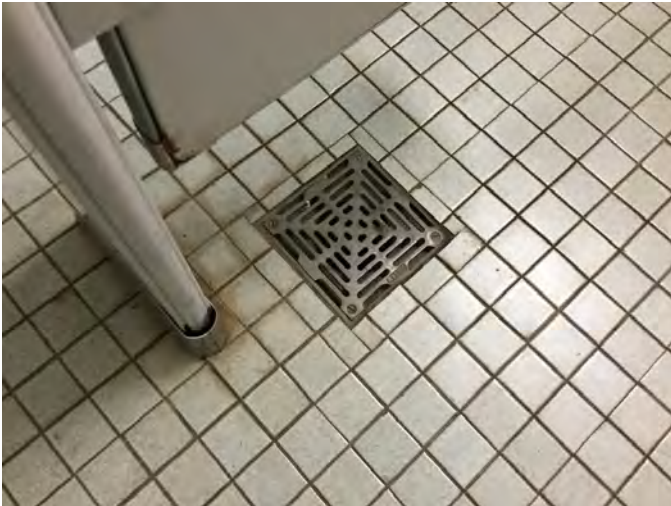
System: D2030 - Sanitary Waste

Location: Throughout the Building
Distress: Beyond Service Life
Category: Deferred Maintenance
Priority: 3 - Necessary/Not Yet Critical (Years 2-5)
Correction: Renew System
Qty: 50,152.00
Unit of Measure: S.F.
Estimate: \$83,854.00
Assessor Name: Somnath Das
Date Created: 01/19/2017

Notes: The sanitary waste system is beyond its expected service life and should be replaced.

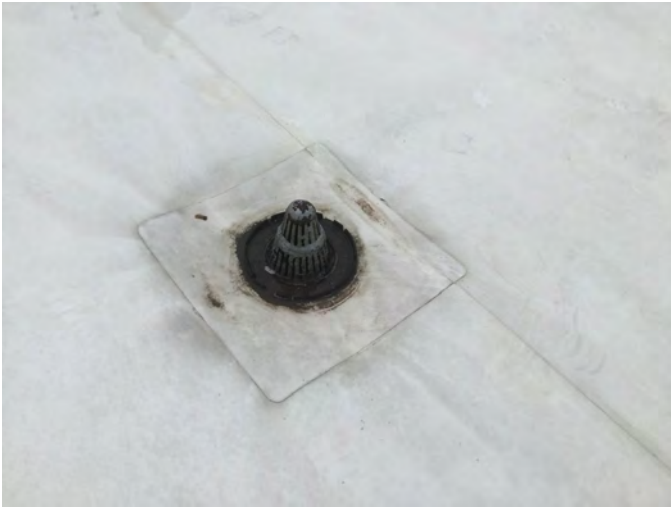
System: D2040 - Rain Water Drainage

Location: Throughout the Building
Distress: Beyond Service Life
Category: Deferred Maintenance
Priority: 3 - Necessary/Not Yet Critical (Years 2-5)
Correction: Renew System
Qty: 50,152.00
Unit of Measure: S.F.
Estimate: \$75,027.00
Assessor Name: Somnath Das
Date Created: 01/19/2017

Notes: The rain water drainage system is aged and should be replaced.

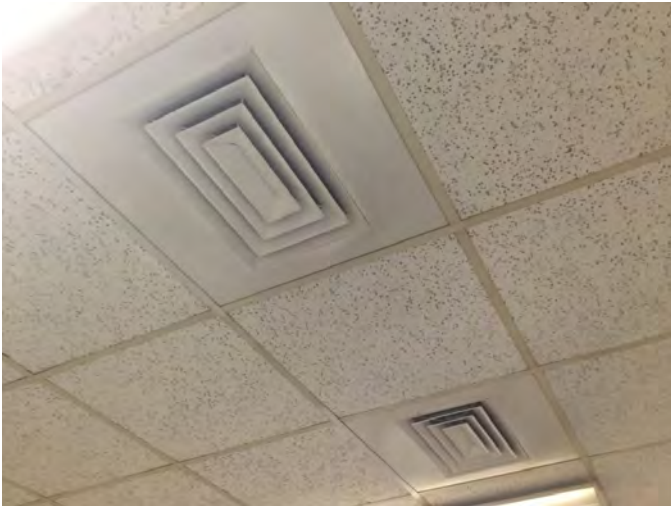
System: D3040 - Distribution Systems

Location: Throughout the Building
Distress: Beyond Service Life
Category: Deferred Maintenance
Priority: 3 - Necessary/Not Yet Critical (Years 2-5)
Correction: Renew System
Qty: 50,152.00
Unit of Measure: S.F.
Estimate: \$332,107.00
Assessor Name: Somnath Das
Date Created: 01/19/2017

Notes: Distribution systems are aged, becoming logistically unsupportable, and should be replaced.

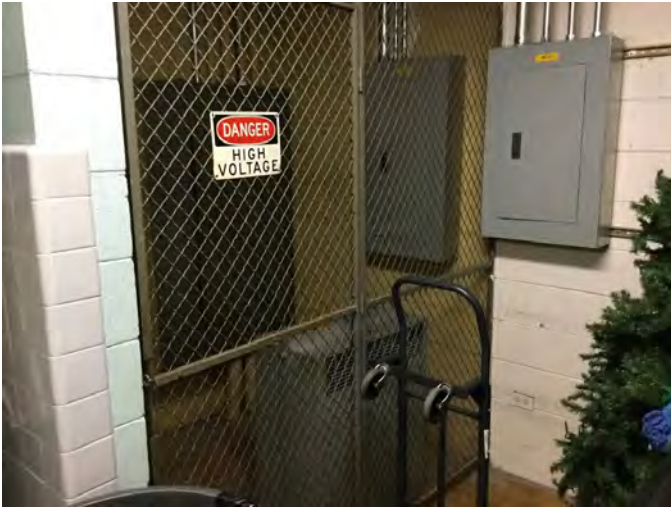
System: D5010 - Electrical Service/Distribution

Location: Throughout the Building
Distress: Beyond Service Life
Category: Deferred Maintenance
Priority: 3 - Necessary/Not Yet Critical (Years 2-5)
Correction: Renew System
Qty: 50,152.00
Unit of Measure: S.F.
Estimate: \$91,026.00
Assessor Name: Somnath Das
Date Created: 01/19/2017

Notes: The original electrical service is operating but is in poor condition and should be replaced.

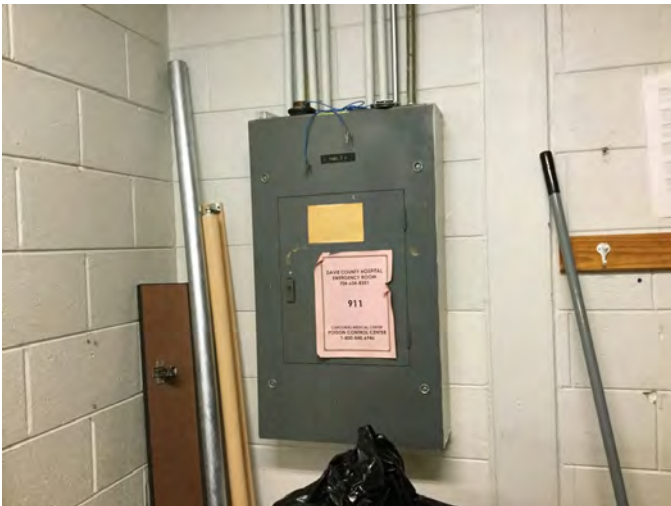
System: D5020 - Branch Wiring

Location: Throughout the Building
Distress: Beyond Service Life
Category: Deferred Maintenance
Priority: 3 - Necessary/Not Yet Critical (Years 2-5)
Correction: Renew System
Qty: 50,152.00
Unit of Measure: S.F.
Estimate: \$275,284.00
Assessor Name: Somnath Das
Date Created: 01/19/2017

Notes: The original branch wiring system is operating but is aged, in marginal condition, and should be replaced.

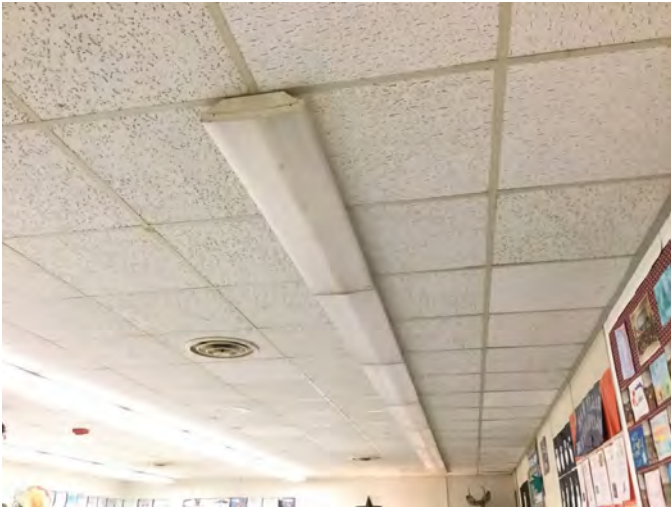
System: D5020 - Lighting

Location: Throughout the Building
Distress: Beyond Service Life
Category: Deferred Maintenance
Priority: 3 - Necessary/Not Yet Critical (Years 2-5)
Correction: Renew System
Qty: 50,152.00
Unit of Measure: S.F.
Estimate: \$642,146.00
Assessor Name: Somnath Das
Date Created: 01/19/2017

Notes: The original lighting system is operating but is aged, in marginal condition, and should be replaced.

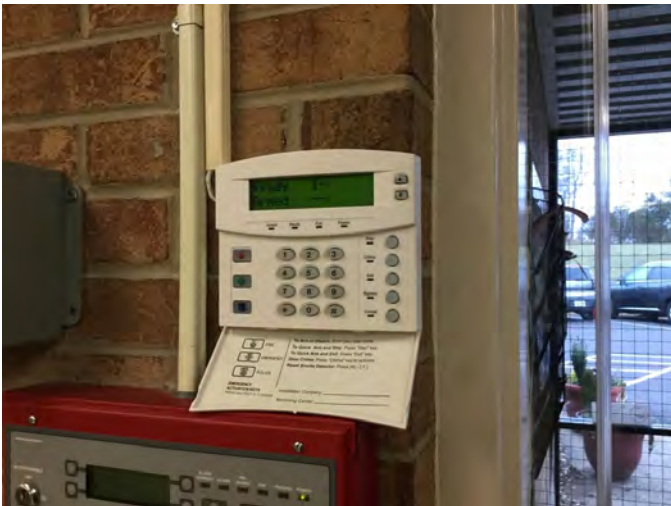
System: D5030810 - Security & Detection Systems

Location: Throughout the Building
Distress: Beyond Service Life
Category: Deferred Maintenance
Priority: 3 - Necessary/Not Yet Critical (Years 2-5)
Correction: Renew System
Qty: 50,152.00
Unit of Measure: S.F.
Estimate: \$100,956.00
Assessor Name: Somnath Das
Date Created: 01/19/2017

Notes: The security and detection system is beyond its expected service life and should be scheduled for replacement.

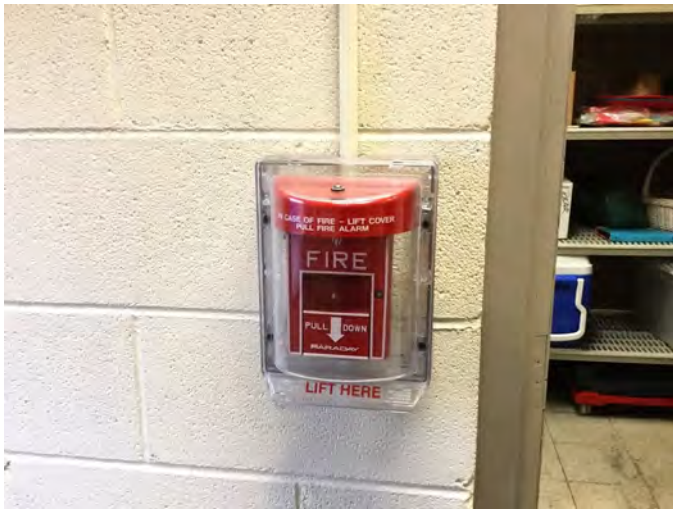
System: D5030910 - Fire Alarm Systems

Location: Throughout the Building
Distress: Beyond Service Life
Category: Deferred Maintenance
Priority: 3 - Necessary/Not Yet Critical (Years 2-5)
Correction: Renew System
Qty: 50,152.00
Unit of Measure: S.F.
Estimate: \$182,603.00
Assessor Name: Somnath Das
Date Created: 01/19/2017

Notes: The fire alarm system is beyond its expected service life and should be scheduled for replacement.

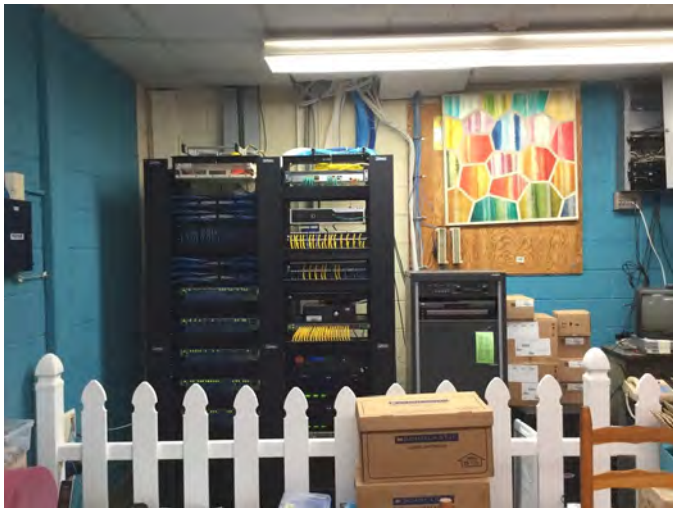
System: D5030920 - Data Communication

Location: Throughout the Building
Distress: Beyond Service Life
Category: Deferred Maintenance
Priority: 3 - Necessary/Not Yet Critical (Years 2-5)
Correction: Renew System
Qty: 50,152.00
Unit of Measure: S.F.
Estimate: \$237,219.00
Assessor Name: Somnath Das
Date Created: 01/19/2017

Notes: The data communication system is beyond its expected service life and should be scheduled for replacement.

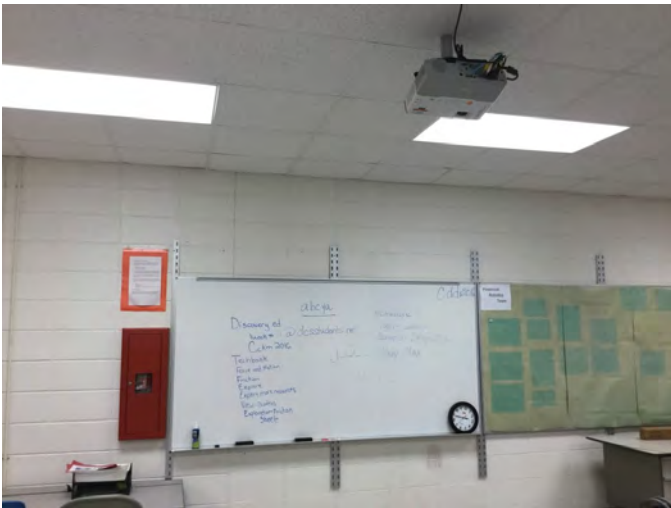
System: E1020 - Institutional Equipment

Location: Throughout the Building
Distress: Beyond Service Life
Category: Deferred Maintenance
Priority: 3 - Necessary/Not Yet Critical (Years 2-5)
Correction: Renew System
Qty: 50,152.00
Unit of Measure: S.F.
Estimate: \$16,550.00
Assessor Name: Somnath Das
Date Created: 01/19/2017

Notes: The institutional equipment is in deteriorating conditions and should be replaced.

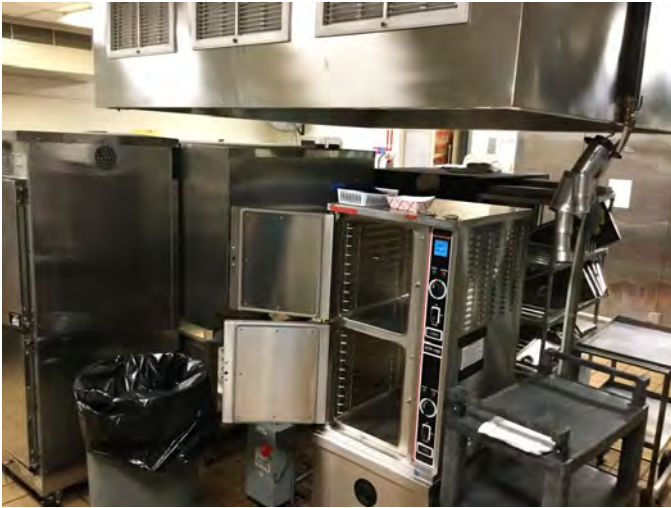
System: E1090 - Other Equipment

Location: Throughout the Building
Distress: Beyond Service Life
Category: Deferred Maintenance
Priority: 3 - Necessary/Not Yet Critical (Years 2-5)
Correction: Renew System
Qty: 50,152.00
Unit of Measure: S.F.
Estimate: \$102,611.00
Assessor Name: Somnath Das
Date Created: 01/19/2017

Notes: The other equipment system is beyond its expected service life and should be scheduled for replacement.

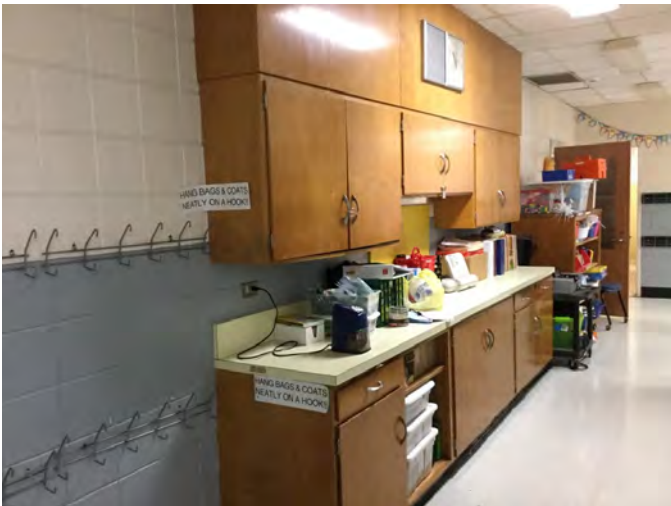
System: E2010 - Fixed Furnishings

Location: Throughout the Building
Distress: Beyond Service Life
Category: Deferred Maintenance
Priority: 3 - Necessary/Not Yet Critical (Years 2-5)
Correction: Renew System
Qty: 50,152.00
Unit of Measure: S.F.
Estimate: \$315,556.00
Assessor Name: Somnath Das
Date Created: 01/19/2017

Notes: The fixed furnishings are aged, in marginal condition, and should be replaced.

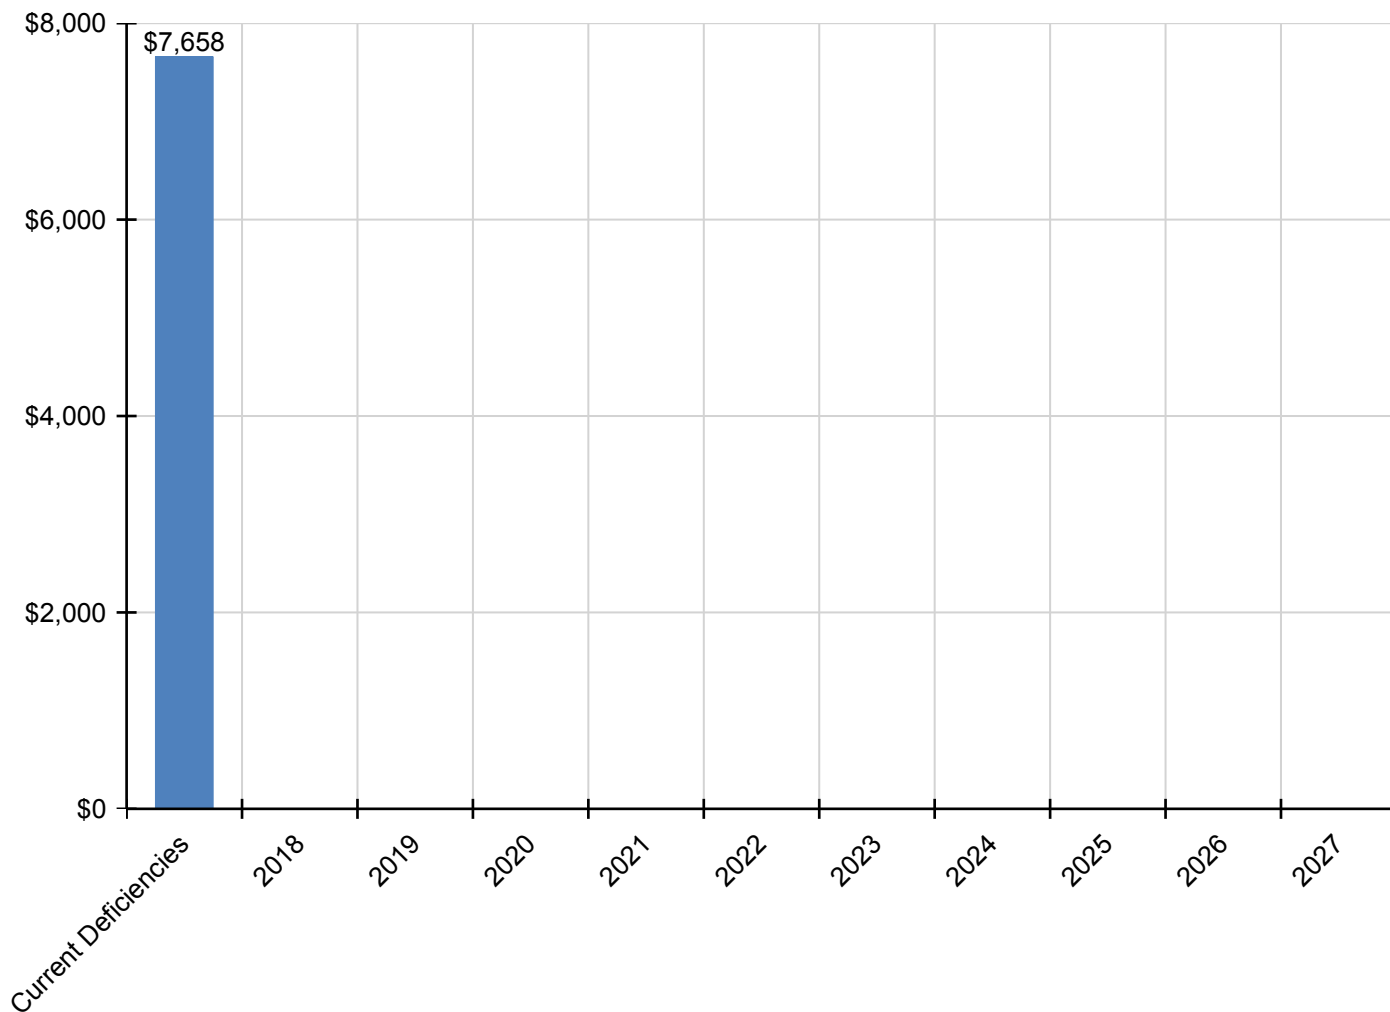
Forecasted Capital Renewal Requirement

The following chart shows the current building deficiencies and forecasting capital renewal or sustainment requirements over the next ten years.

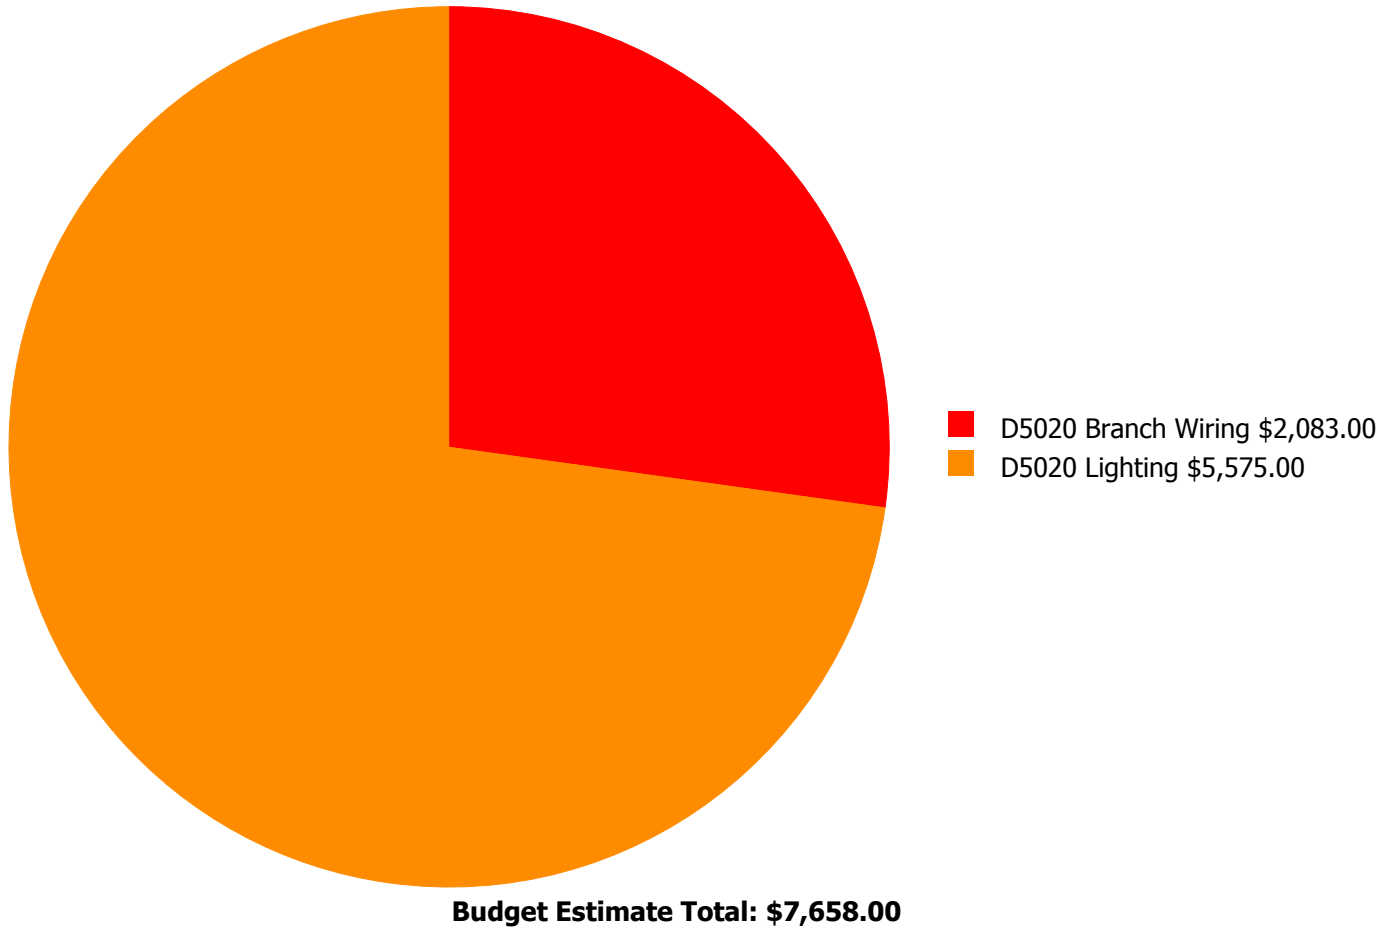
Deficiency Summary by System

Current deficiencies included assemblies that have reached or exceeded their design life or components of the assemblies that are in need of repair. Assemblies that have reached their design life are identified as current deficiencies and assigned the distress 'Beyond Useful Life'. The following chart lists all current deficiencies associated with this facility.

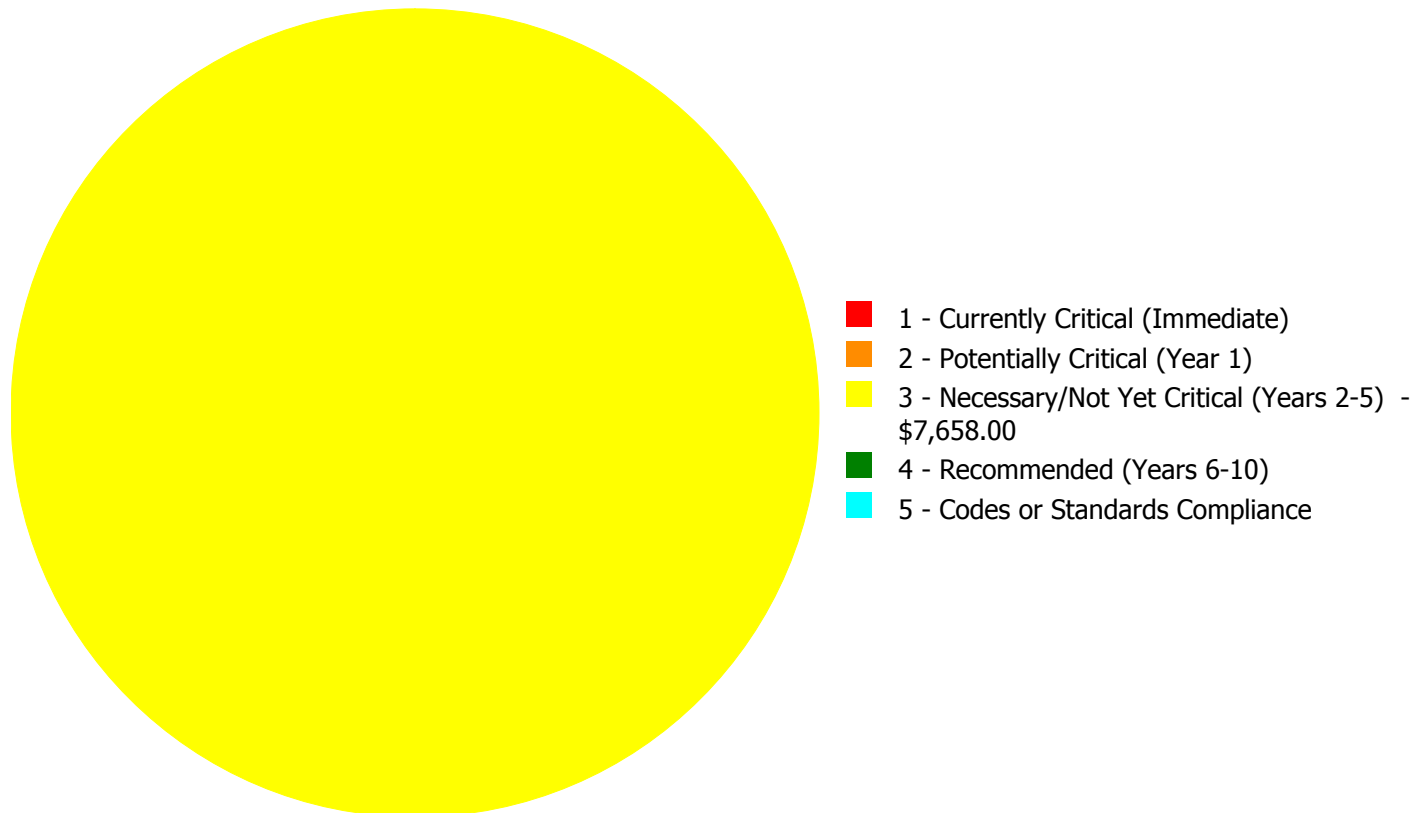
Deficiency Summary by Priority

The following chart shows the total repair costs broken down by priority. Assessors assigned deficiencies within eCOMET to one of the following priority categories:

Budget Estimate Total: \$7,658.00

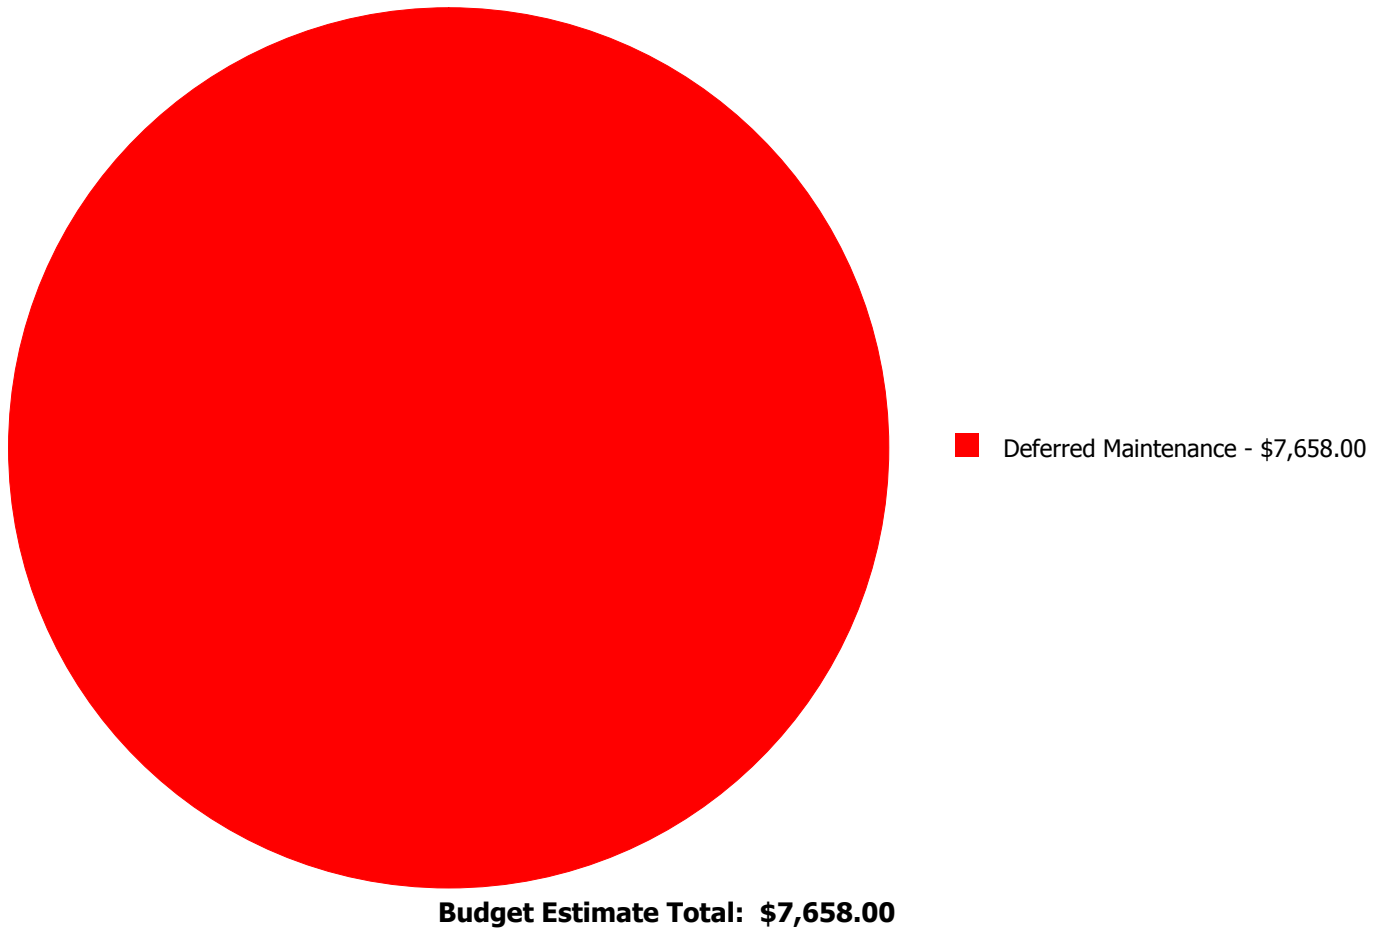
Deficiency Summary by Category

The following chart shows the total repair costs broken down by deficiency categories. Assessors assigned deficiencies to one of the following categories:

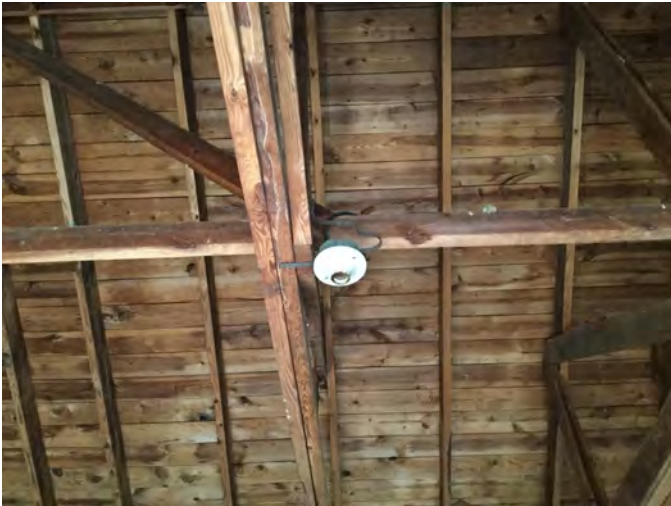
System: D5020 - Branch Wiring

Location: Throughout the Building
Distress: Beyond Service Life
Category: Deferred Maintenance
Priority: 3 - Necessary/Not Yet Critical (Years 2-5)
Correction: Renew System
Qty: 529.00
Unit of Measure: S.F.
Estimate: \$2,083.00
Assessor Name: Eduardo Lopez
Date Created: 02/11/2017

Notes: The original branch wiring system is operating but is aged, in marginal condition, and should be replaced.

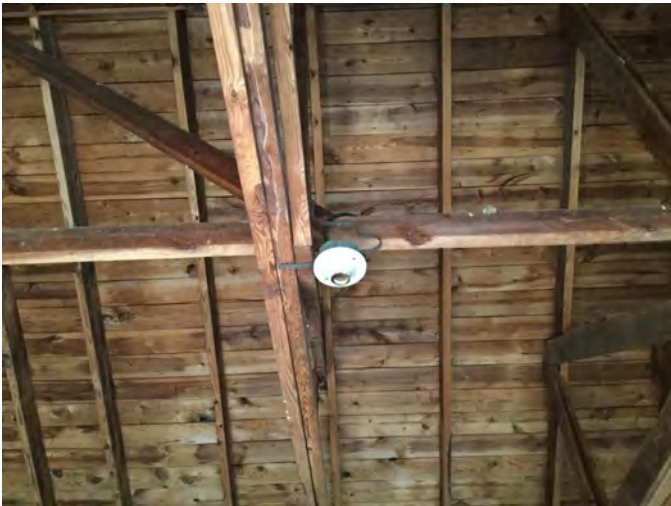
System: D5020 - Lighting

Location: Throughout the Building
Distress: Beyond Service Life
Category: Deferred Maintenance
Priority: 3 - Necessary/Not Yet Critical (Years 2-5)
Correction: Renew System
Qty: 529.00
Unit of Measure: S.F.
Estimate: \$5,575.00
Assessor Name: Eduardo Lopez
Date Created: 02/11/2017

Notes: The original lighting system is operating but is aged, in marginal condition, and should be replaced.
