NC School District/300 Davie County/High School

Central Davie Academy

Campus Assessment Report

March 7, 2017

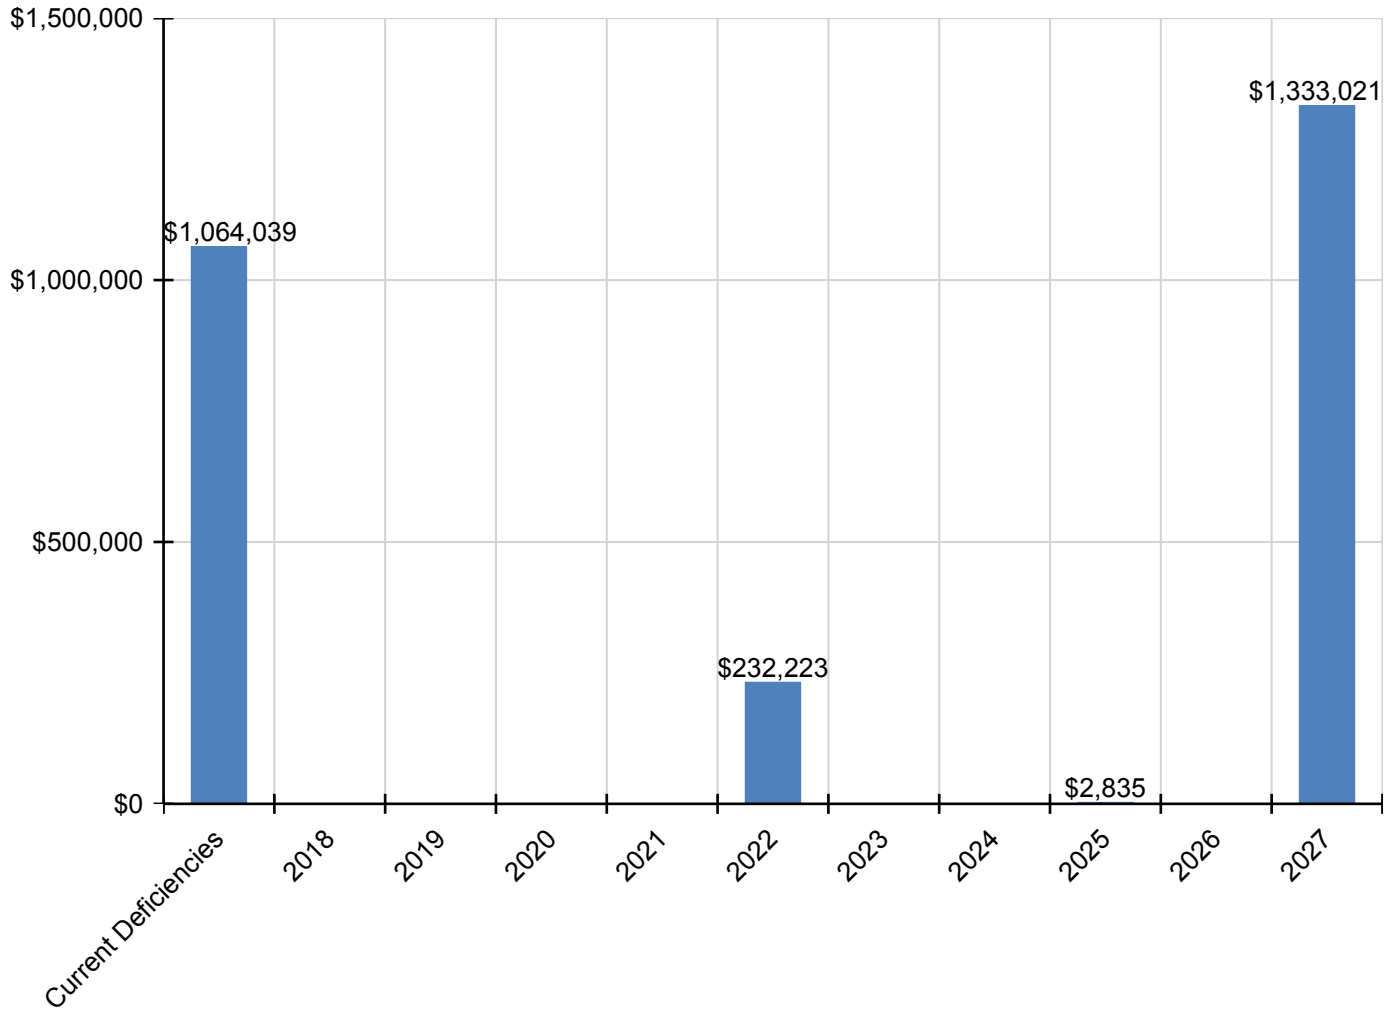
Forecasted Capital Renewal Requirement

The following chart shows the current building deficiencies and forecasting capital renewal or sustainment requirements over the next ten years.

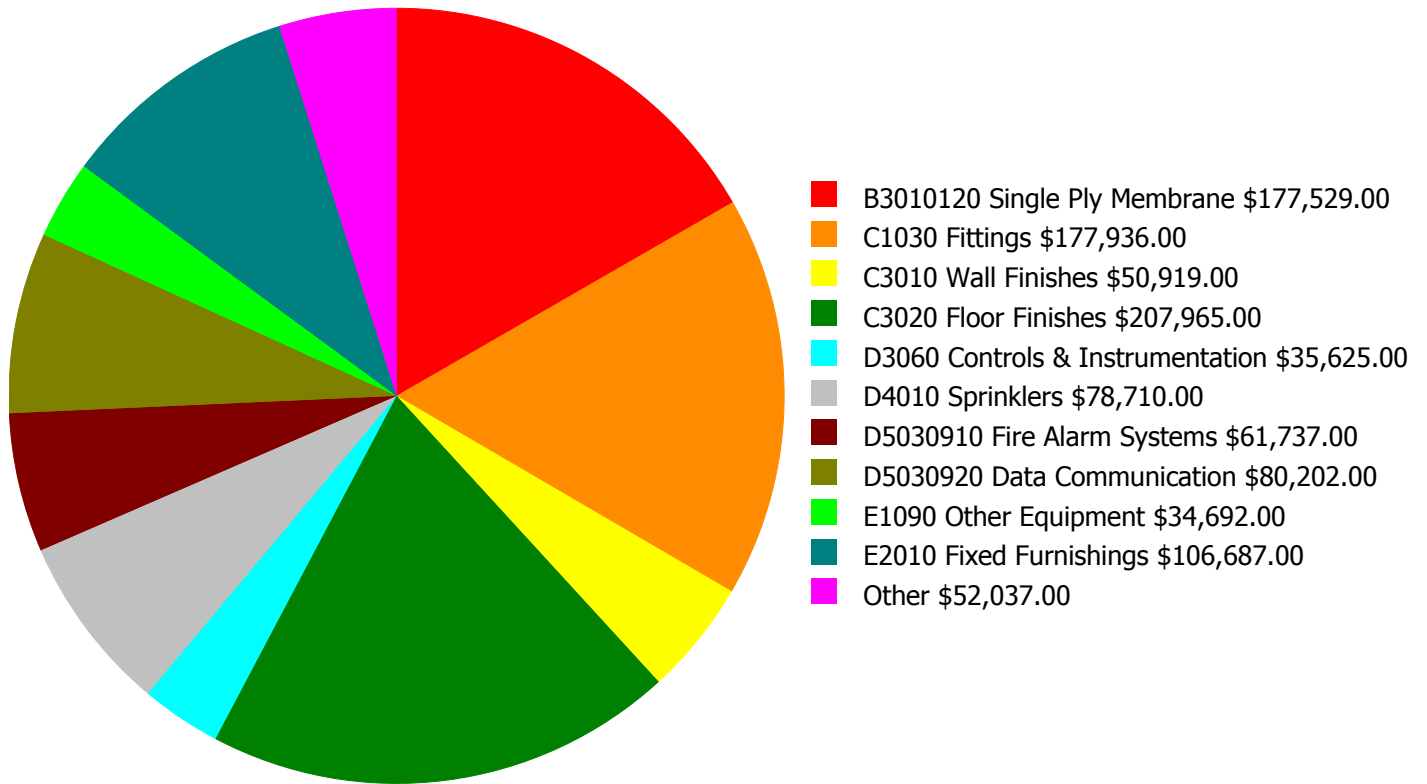
Deficiency Summary by System

Current deficiencies included assemblies that have reached or exceeded their design life or components of the assemblies that are in need of repair. Assemblies that have reached their design life are identified as current deficiencies and assigned the distress 'Beyond Useful Life'. The following chart lists all current deficiencies associated with this facility.

Budget Estimate Total: \$1,064,039.00

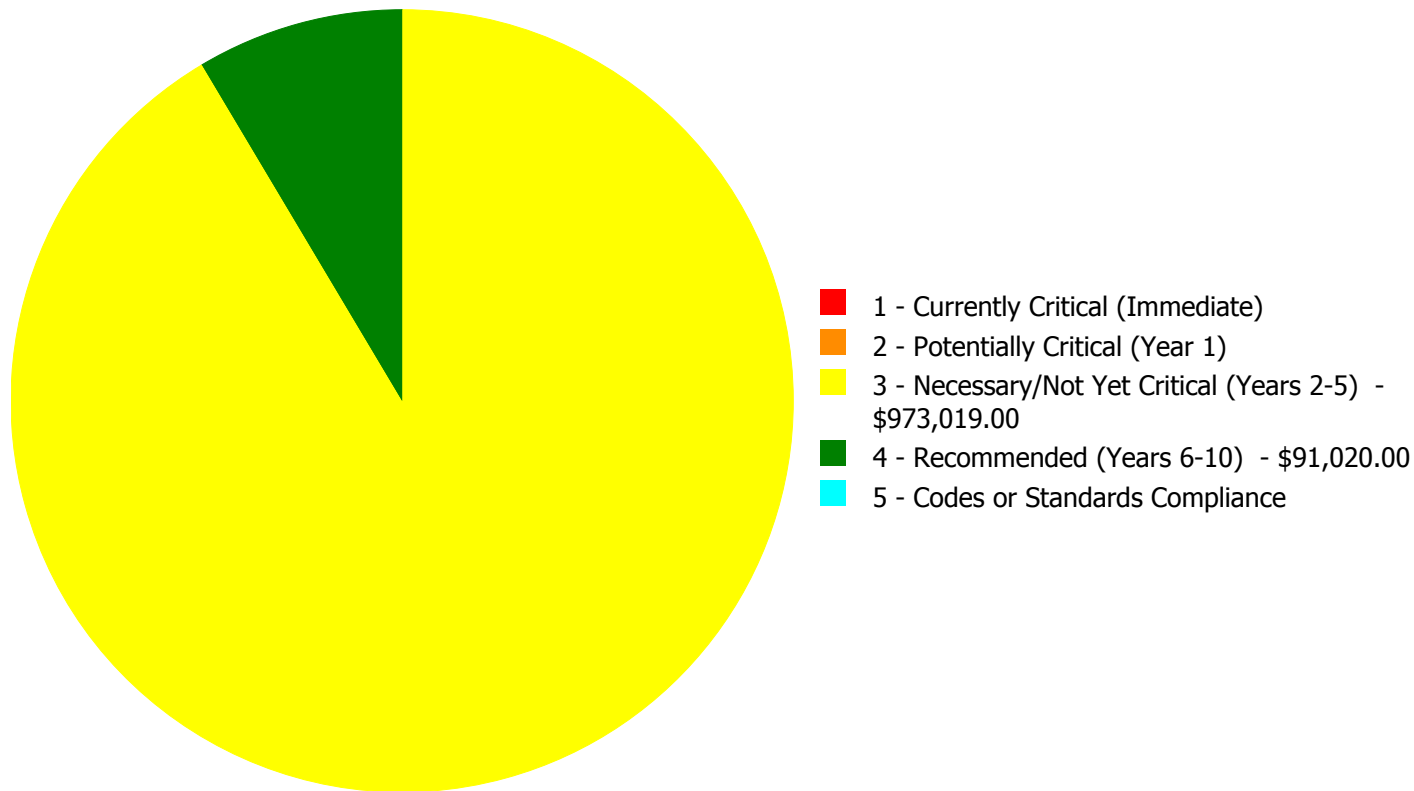
Deficiency Summary by Priority

The following chart shows the total repair costs broken down by priority. Assessors assigned deficiencies within eCOMET to one of the following priority categories:

Budget Estimate Total: \$1,064,039.00

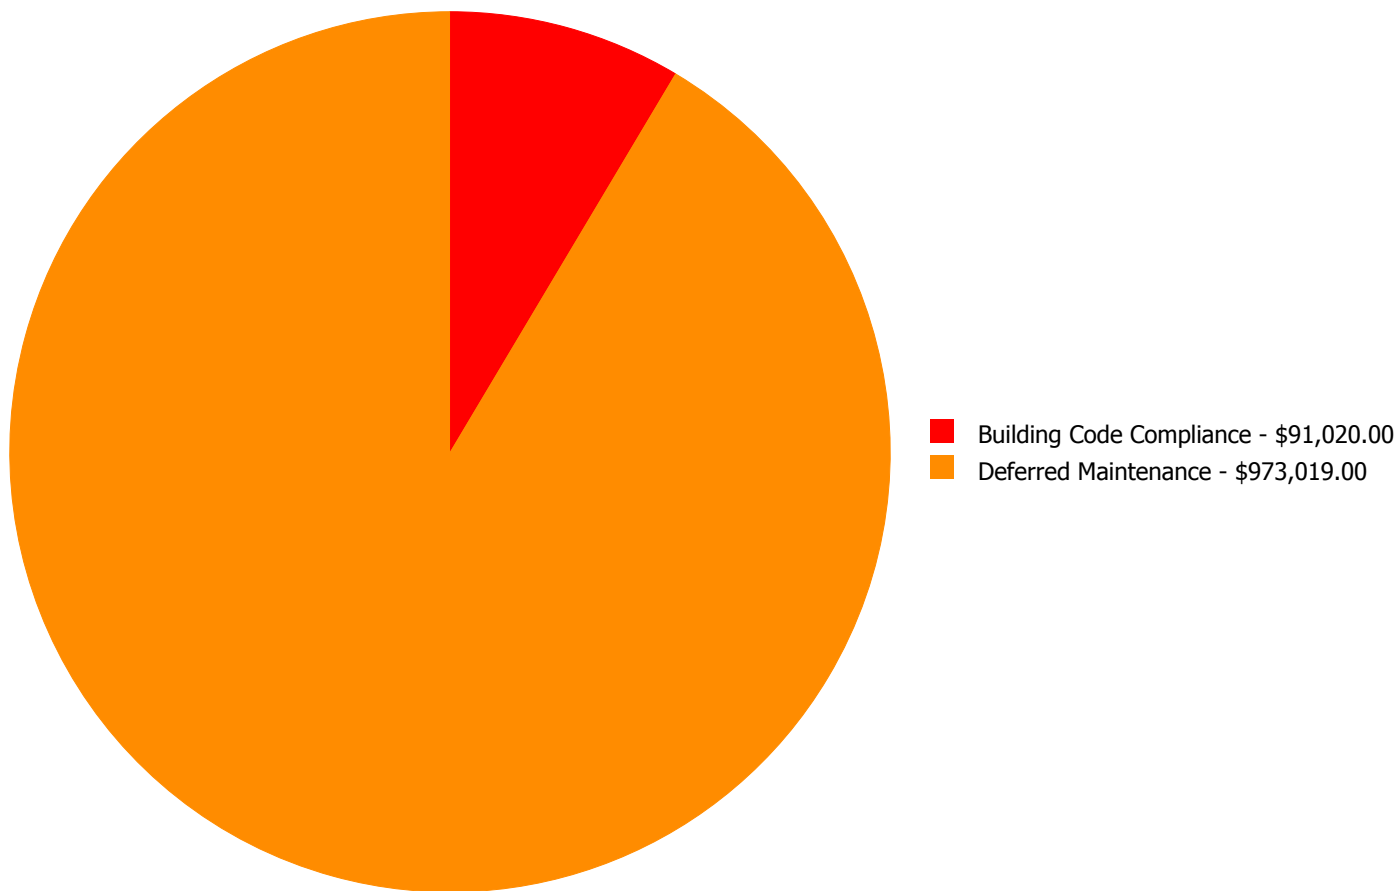
Deficiency Summary by Category

The following chart shows the total repair costs broken down by deficiency categories. Assessors assigned deficiencies to one of the following categories:

Budget Estimate Total: \$1,064,039.00

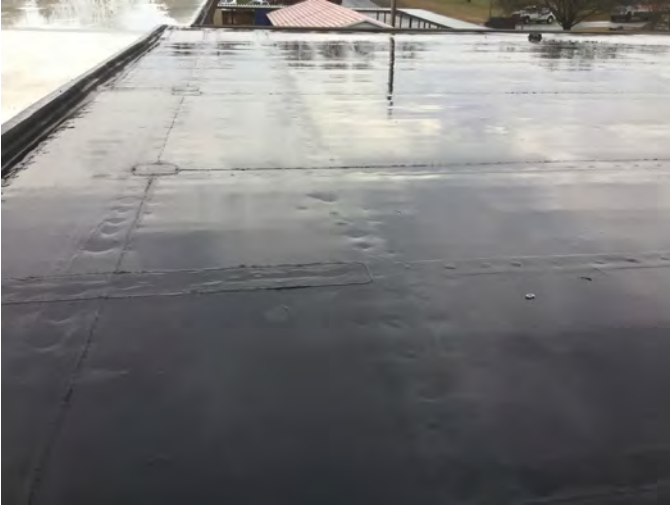
System: B3010120 - Single Ply Membrane

Location: Roof
Distress: Beyond Service Life
Category: Deferred Maintenance
Priority: 3 - Necessary/Not Yet Critical (Years 2-5)
Correction: Renew System
Qty: 16,956.00
Unit of Measure: S.F.
Estimate: \$177,529.00
Assessor Name: Eduardo Lopez
Date Created: 01/19/2017

Notes: The membrane roof covering is aged, showing signs of failure and should be replaced.

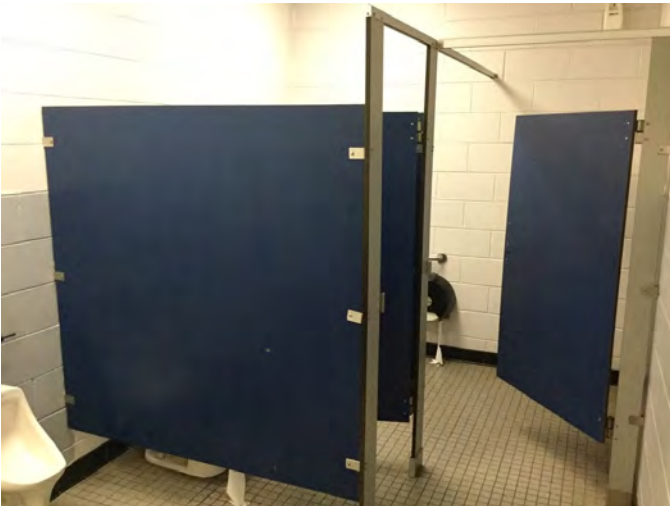
System: C1030 - Fittings

Location: Throughout the Building
Distress: Beyond Service Life
Category: Deferred Maintenance
Priority: 3 - Necessary/Not Yet Critical (Years 2-5)
Correction: Renew System
Qty: 16,956.00
Unit of Measure: S.F.
Estimate: \$177,936.00
Assessor Name: Eduardo Lopez
Date Created: 01/19/2017

Notes: The fittings throughout the building are aged, in marginal condition, handrails and room signage are not ADA compliant and should be replaced.

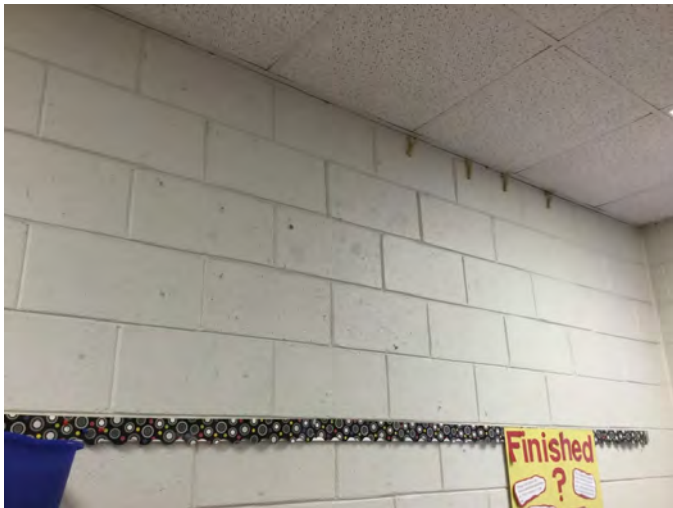
System: C3010 - Wall Finishes

Location: Throughout the Building
Distress: Beyond Service Life
Category: Deferred Maintenance
Priority: 3 - Necessary/Not Yet Critical (Years 2-5)
Correction: Renew System
Qty: 16,956.00
Unit of Measure: S.F.
Estimate: \$50,919.00
Assessor Name: Eduardo Lopez
Date Created: 01/19/2017

Notes: The wall finishes are aged, scuffed, fading, stained and should be replaced.

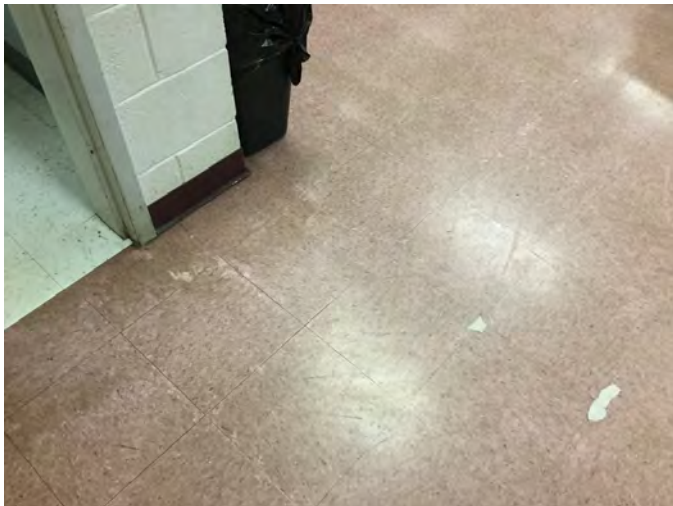
System: C3020 - Floor Finishes

Location: Throughout the Building
Distress: Beyond Service Life
Category: Deferred Maintenance
Priority: 3 - Necessary/Not Yet Critical (Years 2-5)
Correction: Renew System
Qty: 16,956.00
Unit of Measure: S.F.
Estimate: \$207,965.00
Assessor Name: Eduardo Lopez
Date Created: 01/19/2017

Notes: The original flooring is in poor conditions and should be replaced.

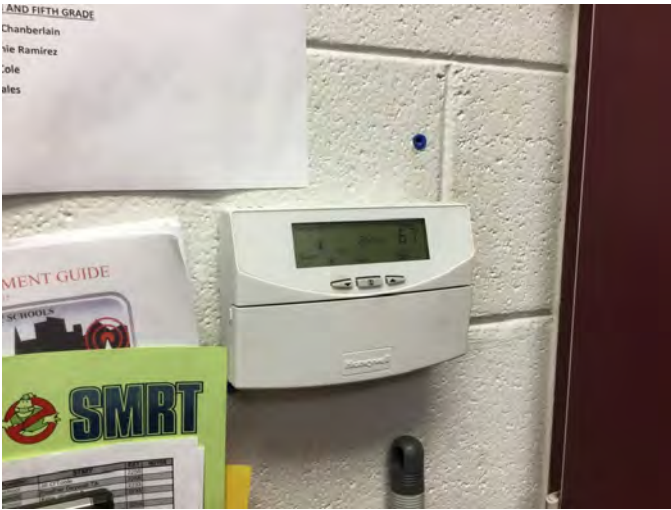
System: D3060 - Controls & Instrumentation

Location: Throughout the Building
Distress: Beyond Service Life
Category: Deferred Maintenance
Priority: 3 - Necessary/Not Yet Critical (Years 2-5)
Correction: Renew System
Qty: 16,956.00
Unit of Measure: S.F.
Estimate: \$35,625.00
Assessor Name: Eduardo Lopez
Date Created: 01/19/2017

Notes: The controls and instrumentation system is in marginal condition and should be schedule for replacement.

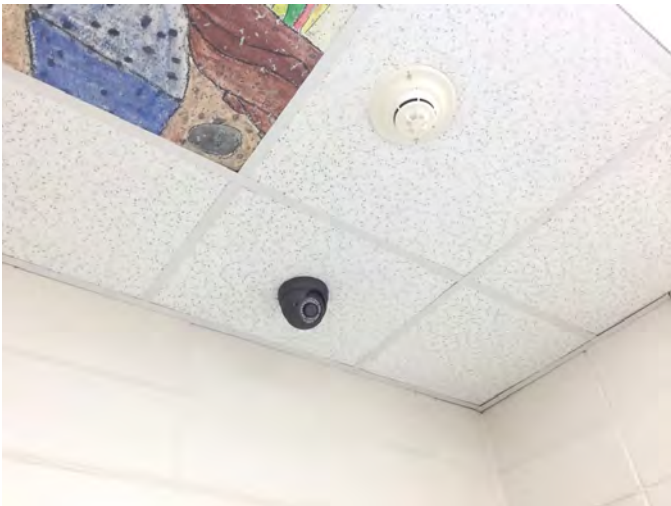
System: D5030810 - Security & Detection Systems

Location: Throughout the Building
Distress: Beyond Service Life
Category: Deferred Maintenance
Priority: 3 - Necessary/Not Yet Critical (Years 2-5)
Correction: Renew System
Qty: 16,956.00
Unit of Measure: S.F.
Estimate: \$34,132.00
Assessor Name: Eduardo Lopez
Date Created: 01/19/2017

Notes: The security and detection system is beyond its expected service life and should be scheduled for replacement.

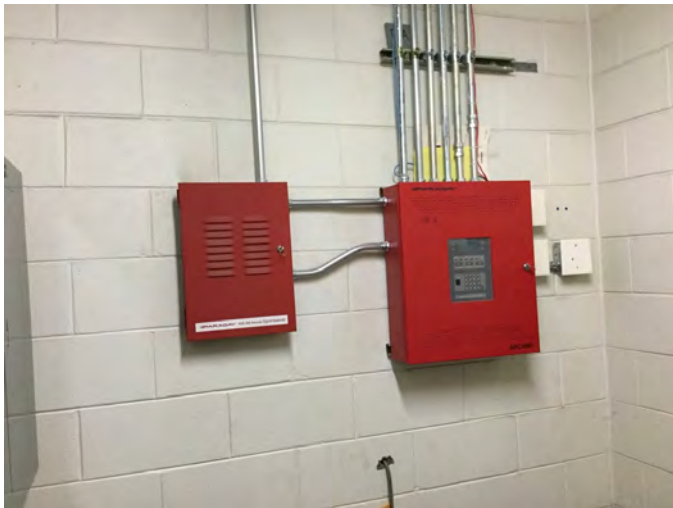
System: D5030910 - Fire Alarm Systems

Location: Throughout the Building
Distress: Beyond Service Life
Category: Deferred Maintenance
Priority: 3 - Necessary/Not Yet Critical (Years 2-5)
Correction: Renew System
Qty: 16,956.00
Unit of Measure: S.F.
Estimate: \$61,737.00
Assessor Name: Eduardo Lopez
Date Created: 01/19/2017

Notes: The fire alarm system is beyond its expected service life and should be scheduled for replacement.

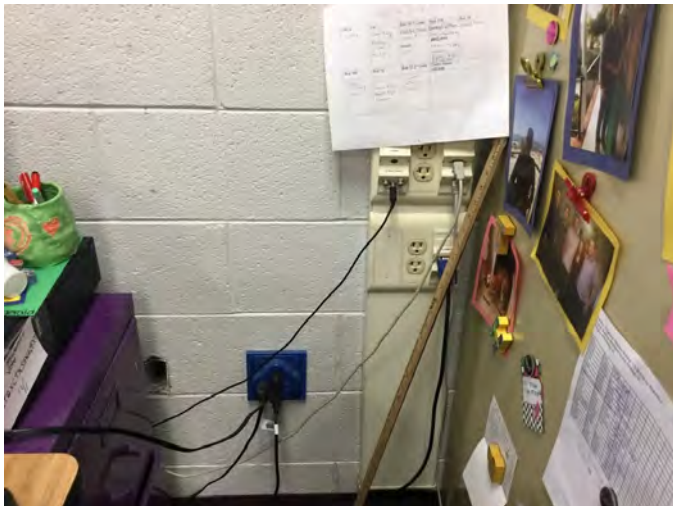
System: D5030920 - Data Communication

Location: Throughout the Building
Distress: Beyond Service Life
Category: Deferred Maintenance
Priority: 3 - Necessary/Not Yet Critical (Years 2-5)
Correction: Renew System
Qty: 16,956.00
Unit of Measure: S.F.
Estimate: \$80,202.00
Assessor Name: Eduardo Lopez
Date Created: 01/19/2017

Notes: The data communication system is beyond its expected service life and should be scheduled for replacement.

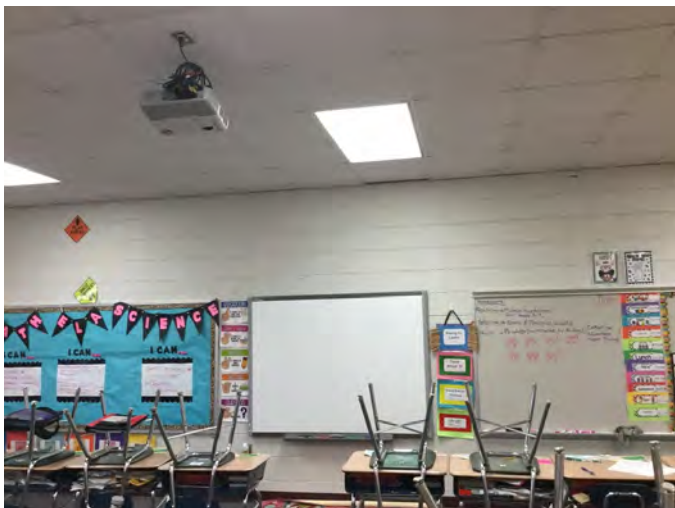
System: E1020 - Institutional Equipment

Location: Throughout the Building
Distress: Beyond Service Life
Category: Deferred Maintenance
Priority: 3 - Necessary/Not Yet Critical (Years 2-5)
Correction: Renew System
Qty: 16,956.00
Unit of Measure: S.F.
Estimate: \$5,595.00
Assessor Name: Eduardo Lopez
Date Created: 01/19/2017

Notes: The institutional equipment is in deteriorating conditions and should be replaced.

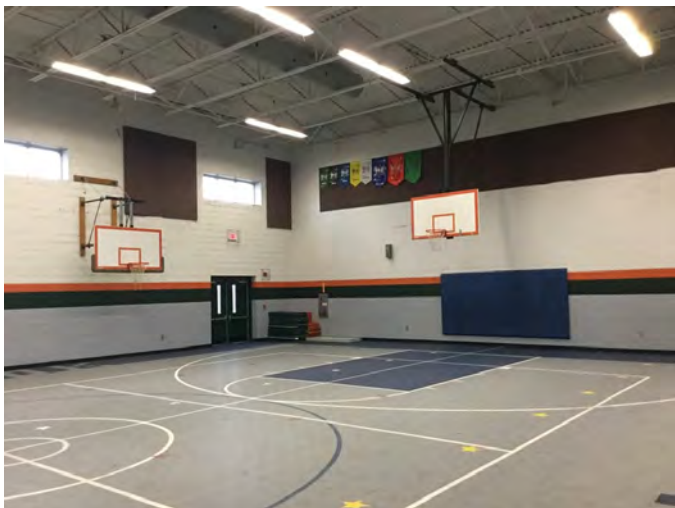
System: E1090 - Other Equipment

Location: Throughout the Building
Distress: Beyond Service Life
Category: Deferred Maintenance
Priority: 3 - Necessary/Not Yet Critical (Years 2-5)
Correction: Renew System
Qty: 16,956.00
Unit of Measure: S.F.
Estimate: \$34,692.00
Assessor Name: Eduardo Lopez
Date Created: 01/19/2017

Notes: The other equipment is in deteriorating conditions and should be replaced.

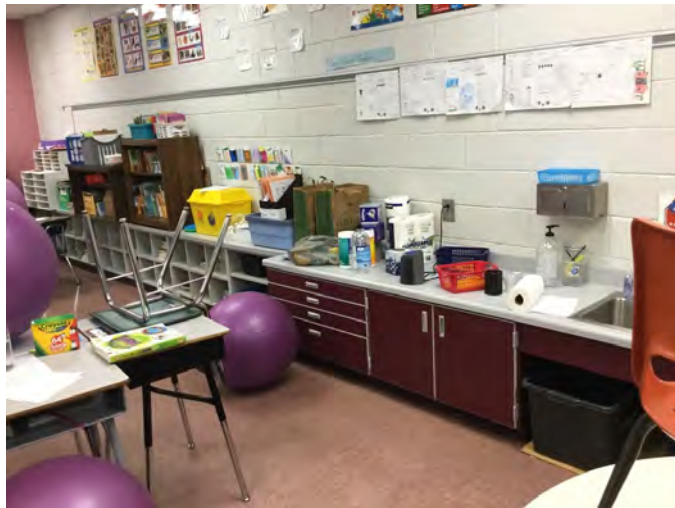
System: E2010 - Fixed Furnishings

Location: Throughout the Building
Distress: Beyond Service Life
Category: Deferred Maintenance
Priority: 3 - Necessary/Not Yet Critical (Years 2-5)
Correction: Renew System
Qty: 16,956.00
Unit of Measure: S.F.
Estimate: \$106,687.00
Assessor Name: Eduardo Lopez
Date Created: 01/19/2017

Notes: The fixed furnishings are aged, in marginal condition, and should be replaced.

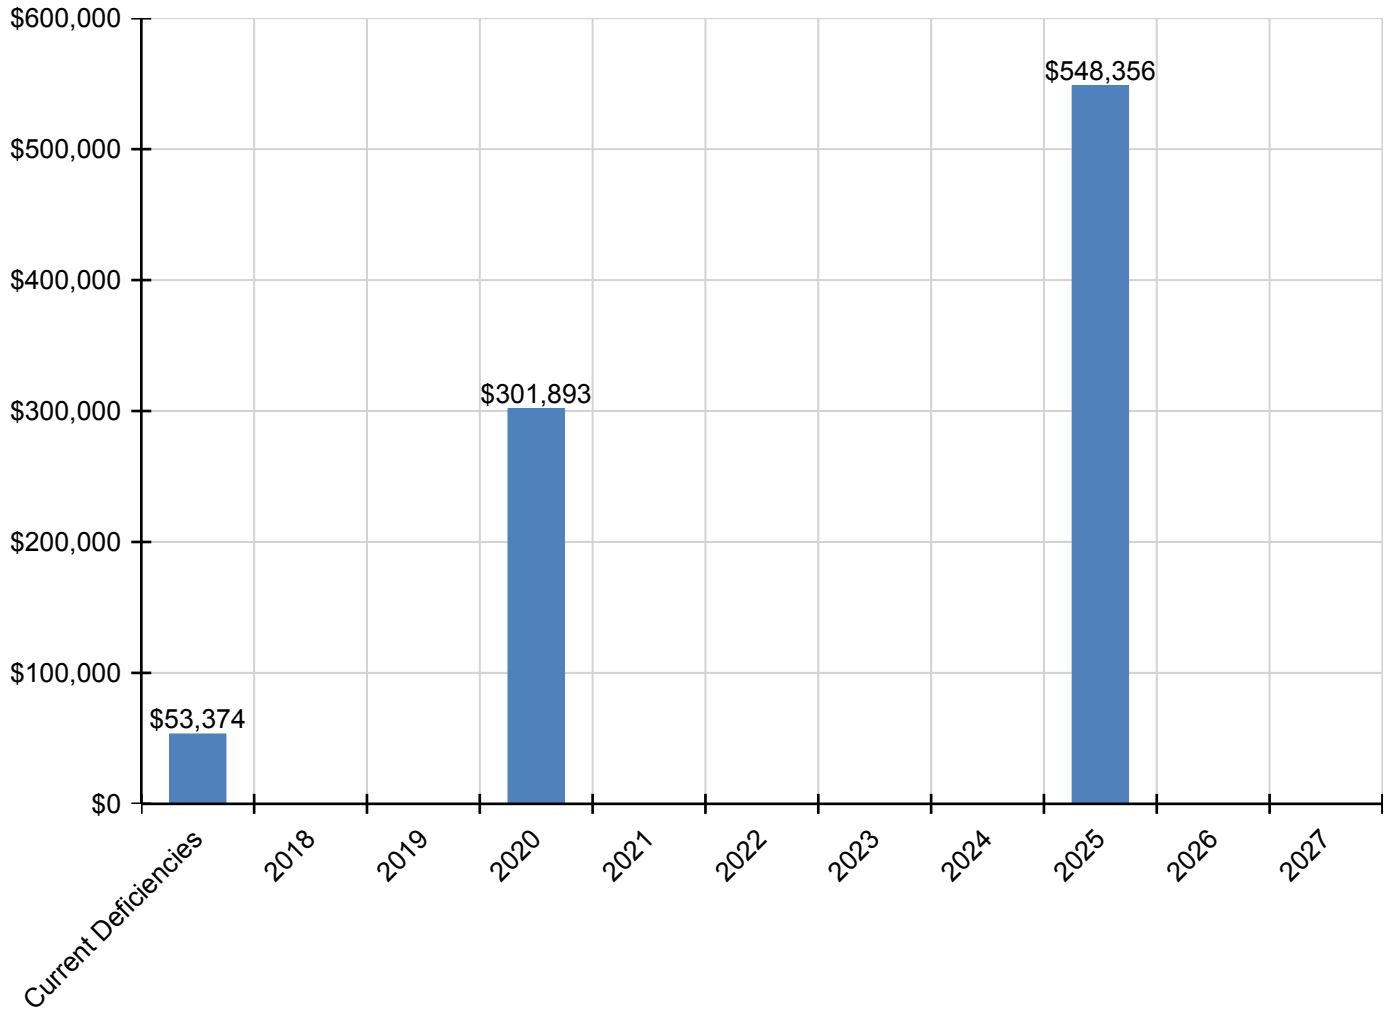
Forecasted Capital Renewal Requirement

The following chart shows the current building deficiencies and forecasting capital renewal or sustainment requirements over the next ten years.

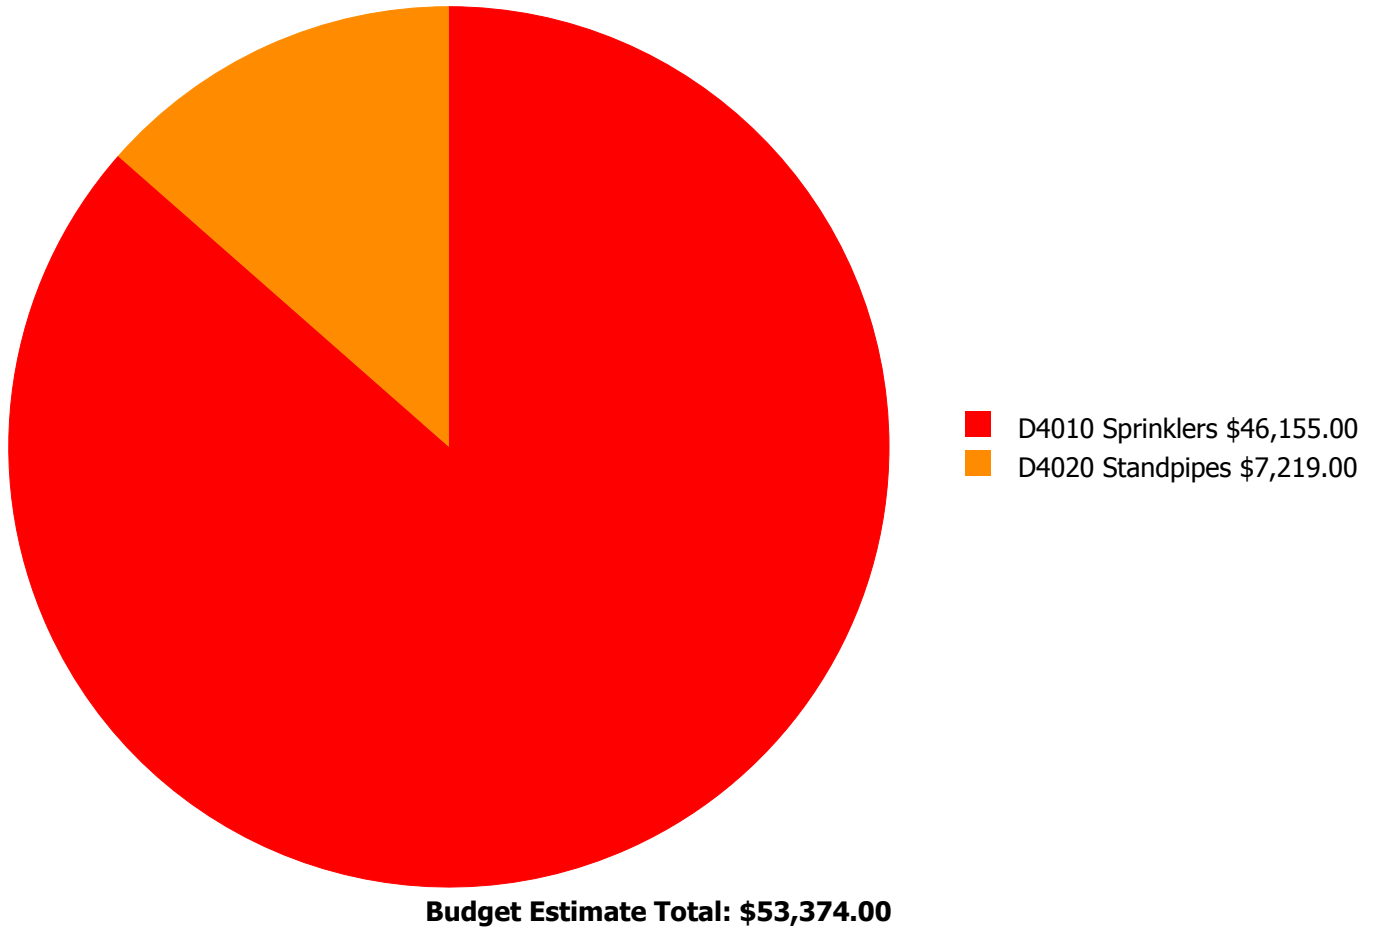
Deficiency Summary by System

Current deficiencies included assemblies that have reached or exceeded their design life or components of the assemblies that are in need of repair. Assemblies that have reached their design life are identified as current deficiencies and assigned the distress 'Beyond Useful Life'. The following chart lists all current deficiencies associated with this facility.

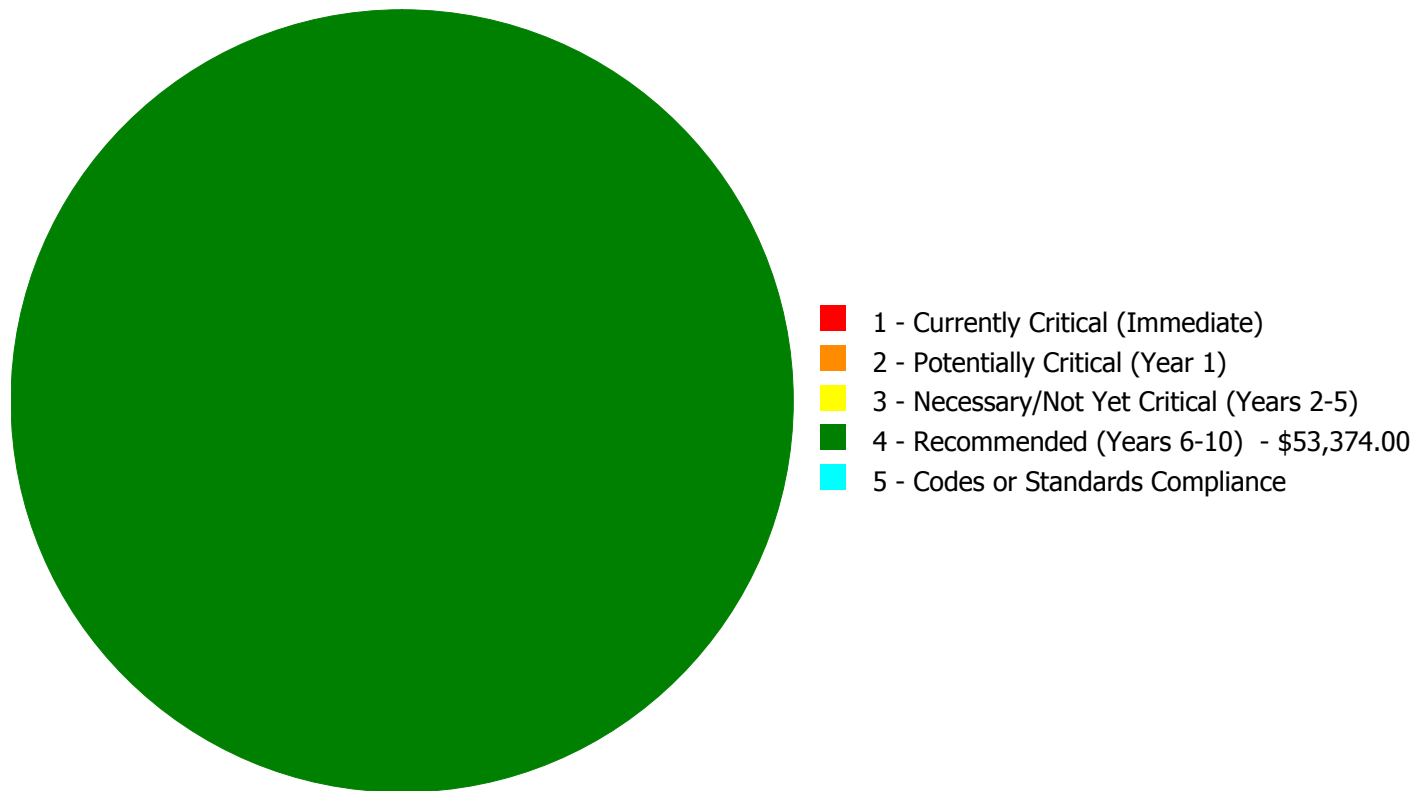
Deficiency Summary by Priority

The following chart shows the total repair costs broken down by priority. Assessors assigned deficiencies within eCOMET to one of the following priority categories:

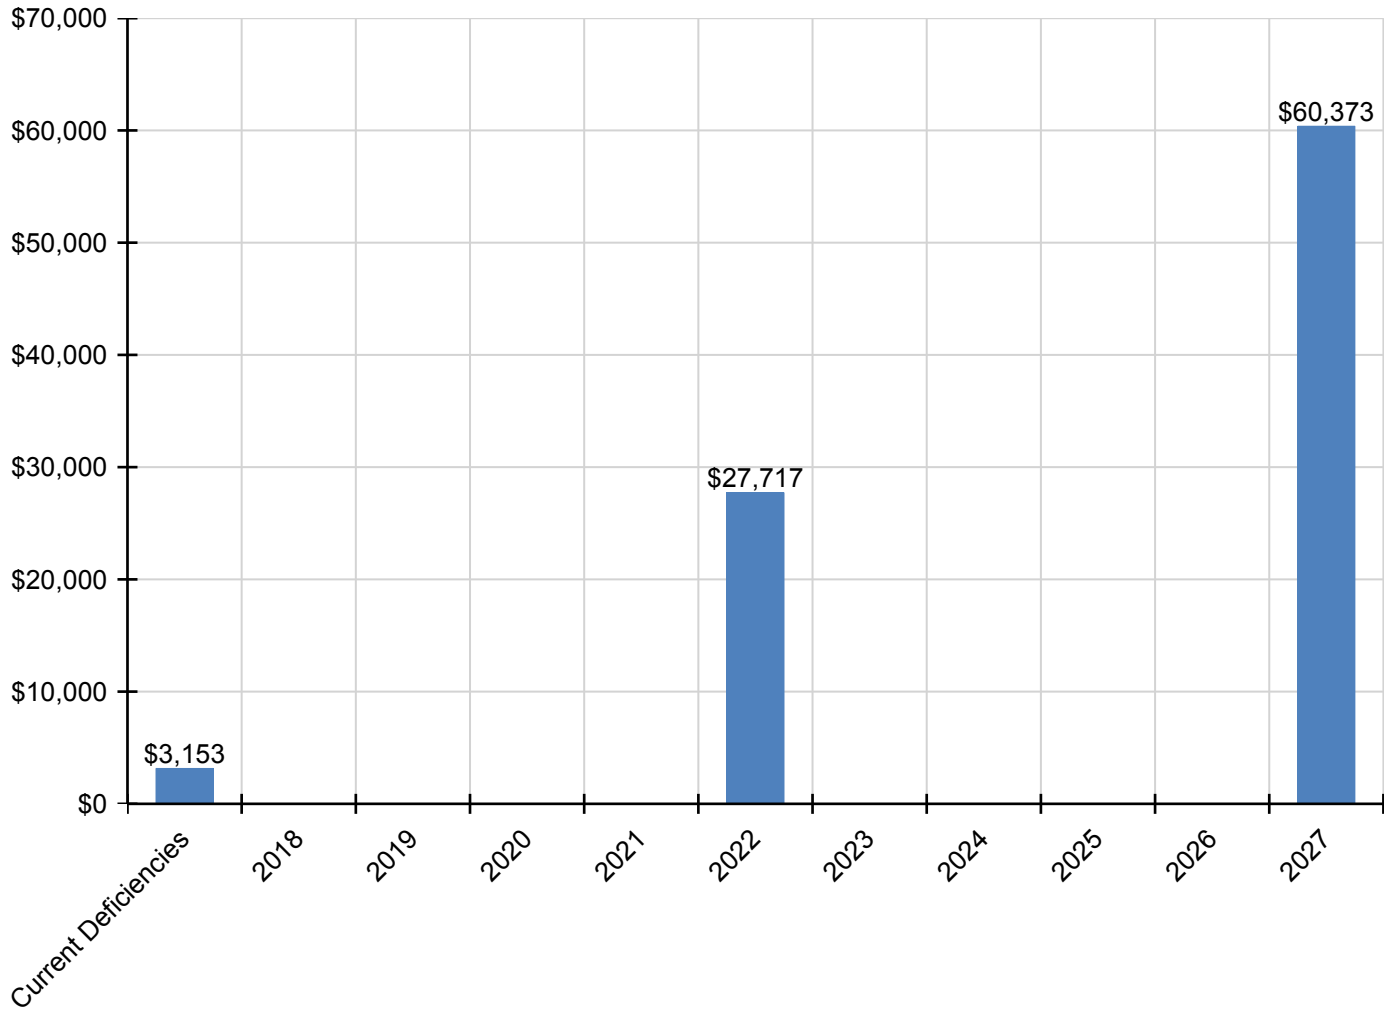
Forecasted Capital Renewal Requirement

The following chart shows the current building deficiencies and forecasting capital renewal or sustainment requirements over the next ten years.

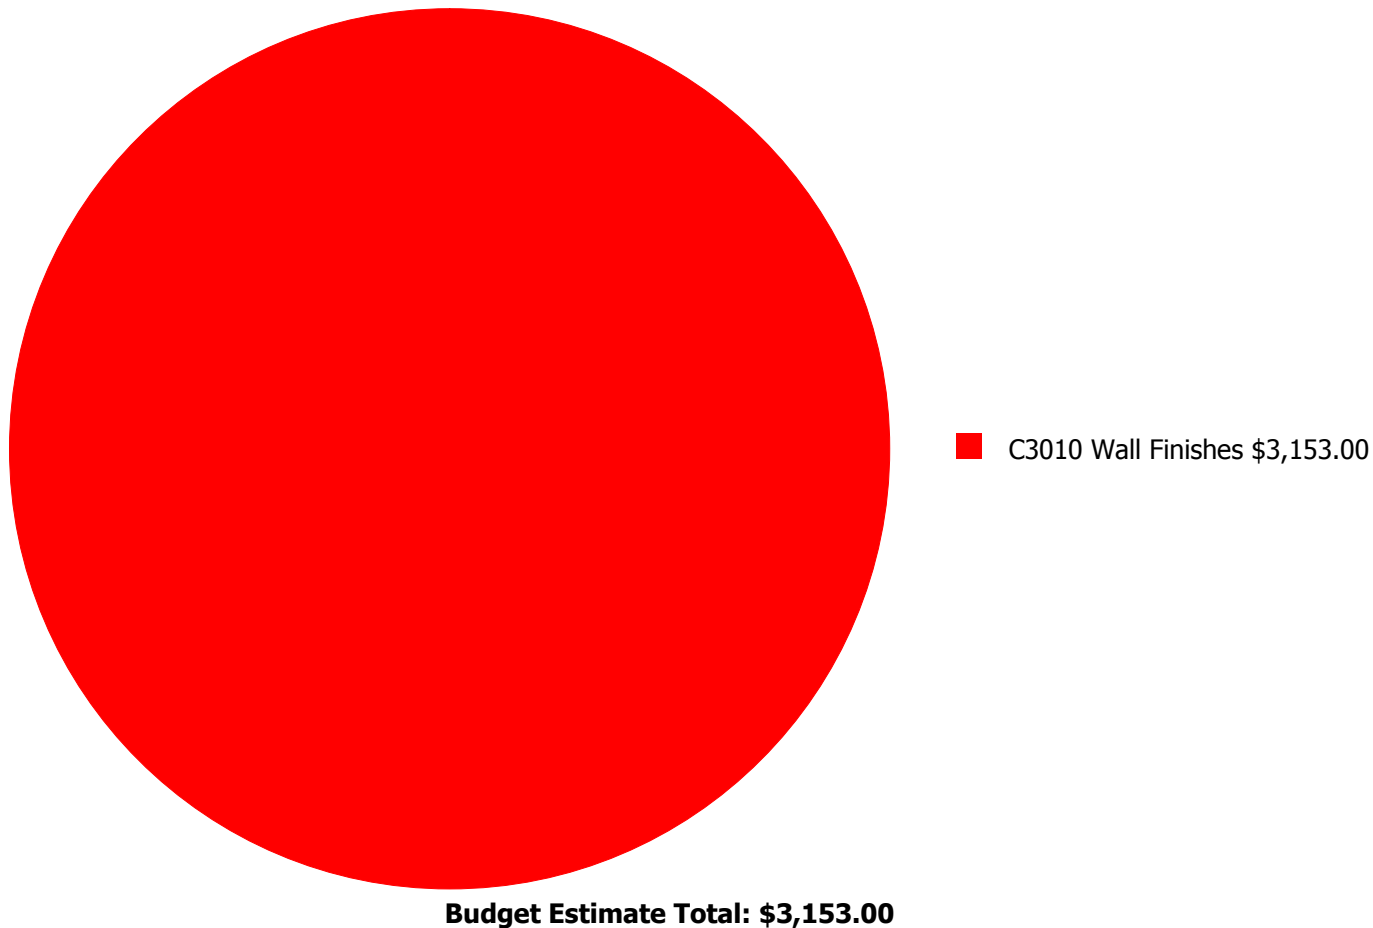
Deficiency Summary by System

Current deficiencies included assemblies that have reached or exceeded their design life or components of the assemblies that are in need of repair. Assemblies that have reached their design life are identified as current deficiencies and assigned the distress 'Beyond Useful Life'. The following chart lists all current deficiencies associated with this facility.

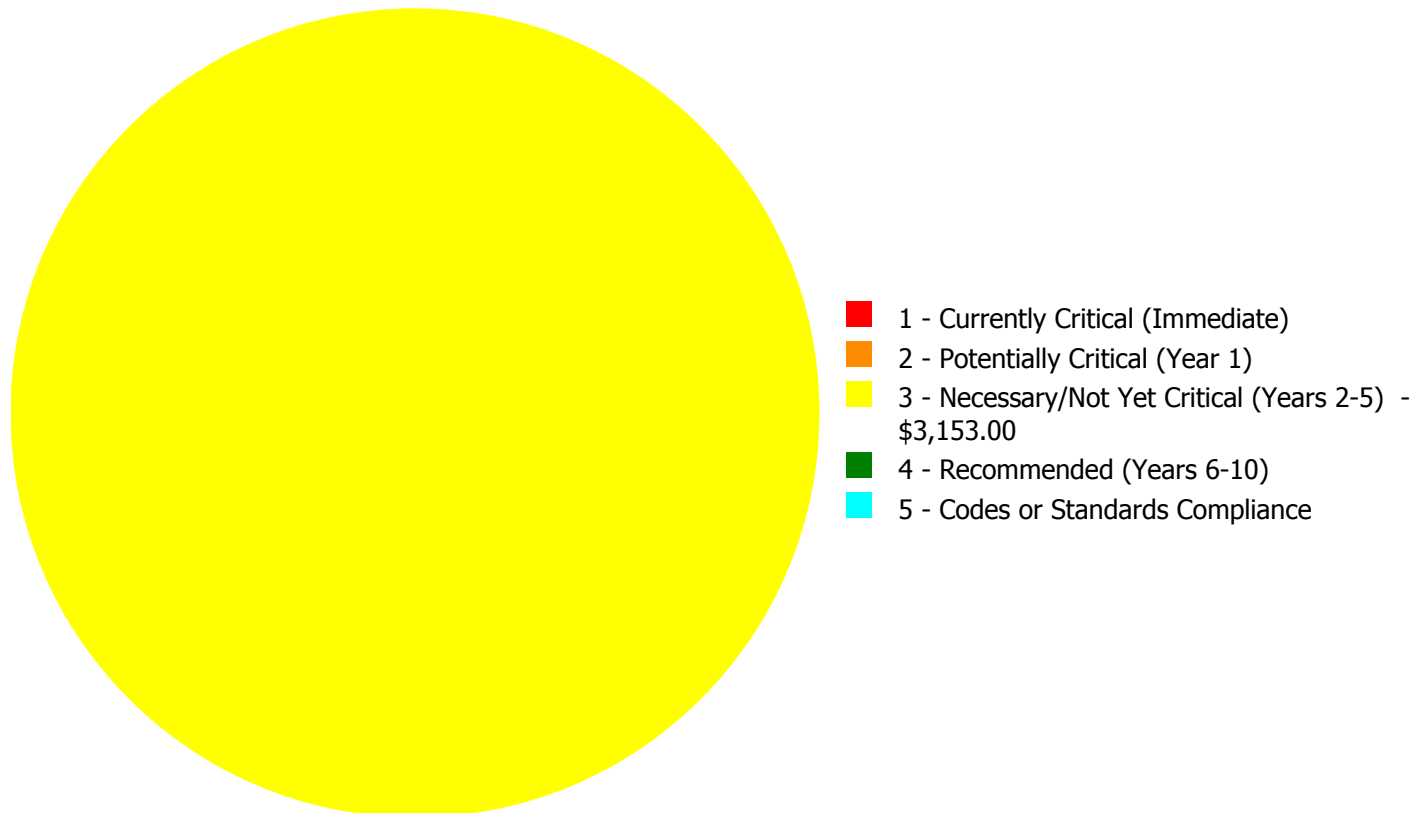
Deficiency Summary by Priority

The following chart shows the total repair costs broken down by priority. Assessors assigned deficiencies within eCOMET to one of the following priority categories:

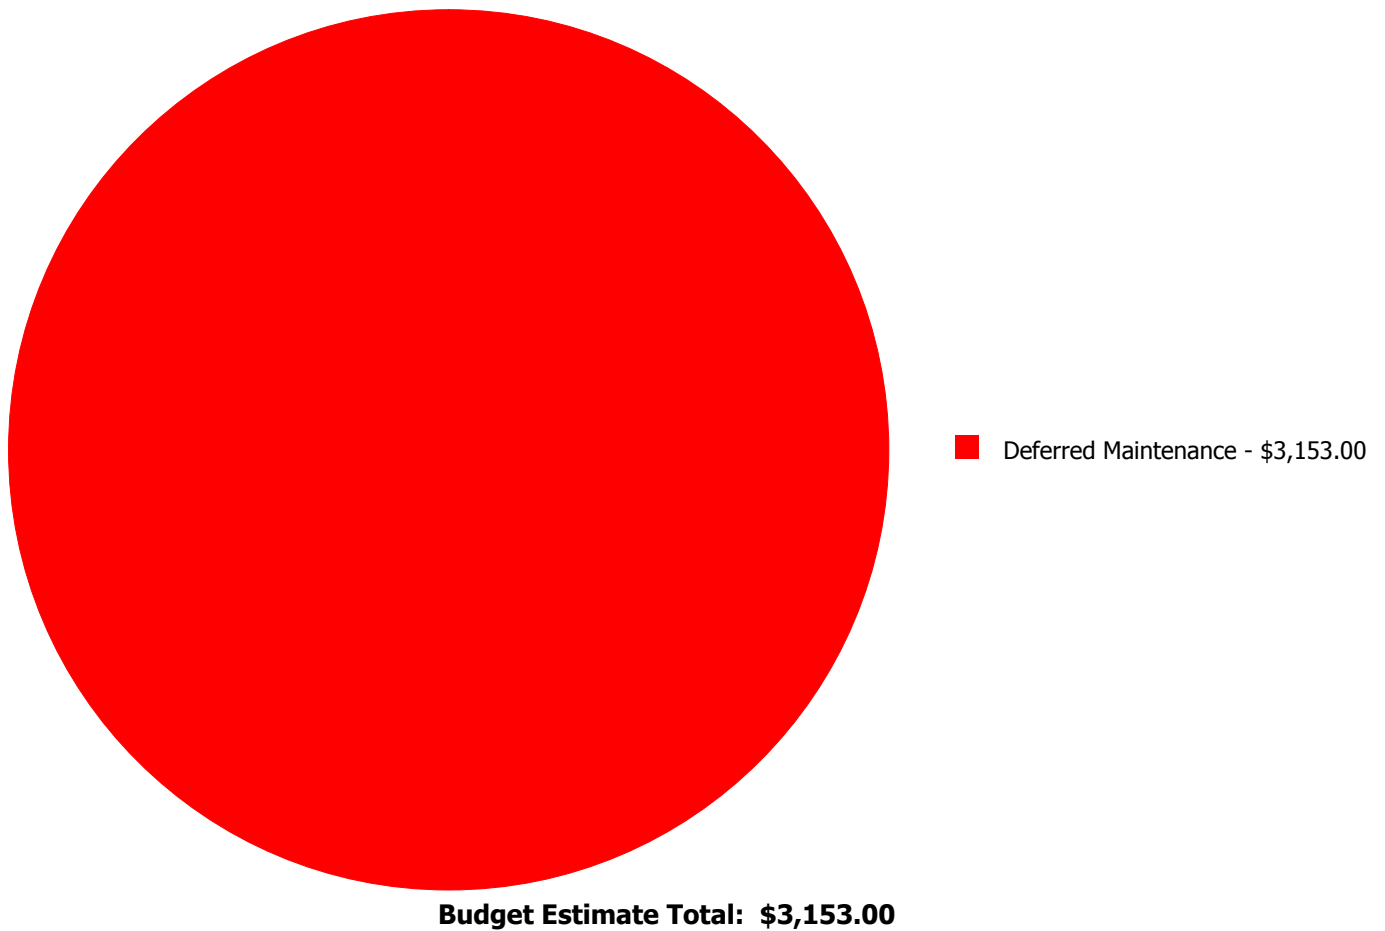
Deficiency Summary by Category

The following chart shows the total repair costs broken down by deficiency categories. Assessors assigned deficiencies to one of the following categories:

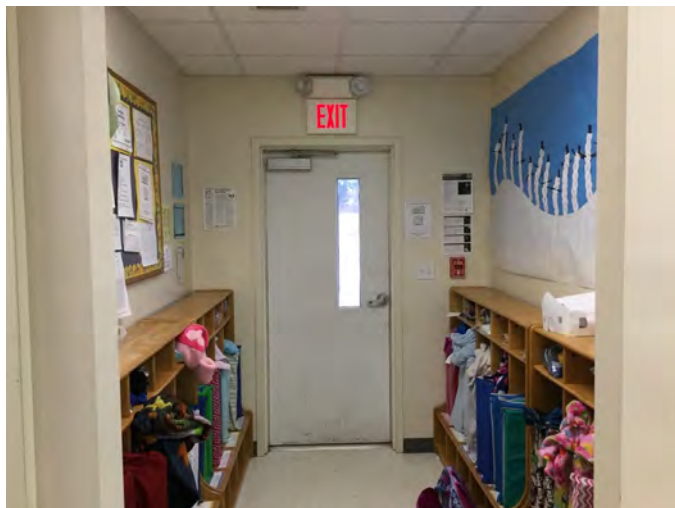
System: C3010 - Wall Finishes

Location: Throughout the Building
Distress: Beyond Service Life
Category: Deferred Maintenance
Priority: 3 - Necessary/Not Yet Critical (Years 2-5)
Correction: Renew System
Qty: 1,050.00
Unit of Measure: S.F.
Estimate: \$3,153.00
Assessor Name: Terence Davis
Date Created: 01/19/2017

Notes: The wall finishes are aged, scuffed, fading, stained and should be replaced.

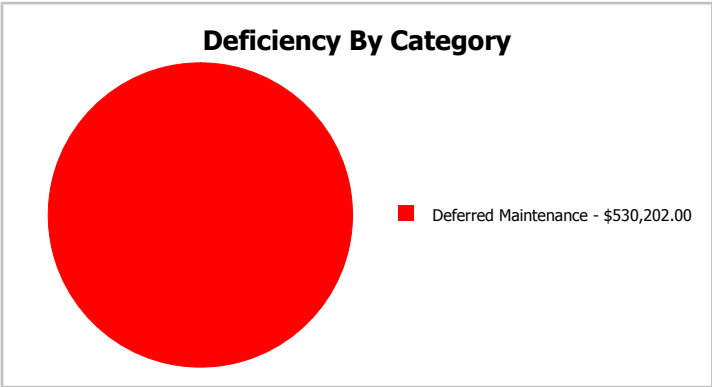
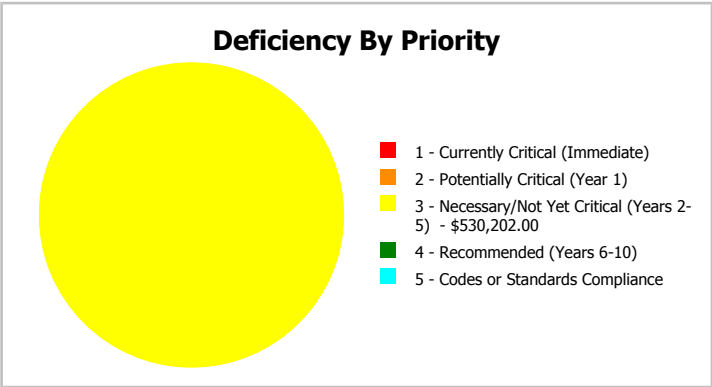
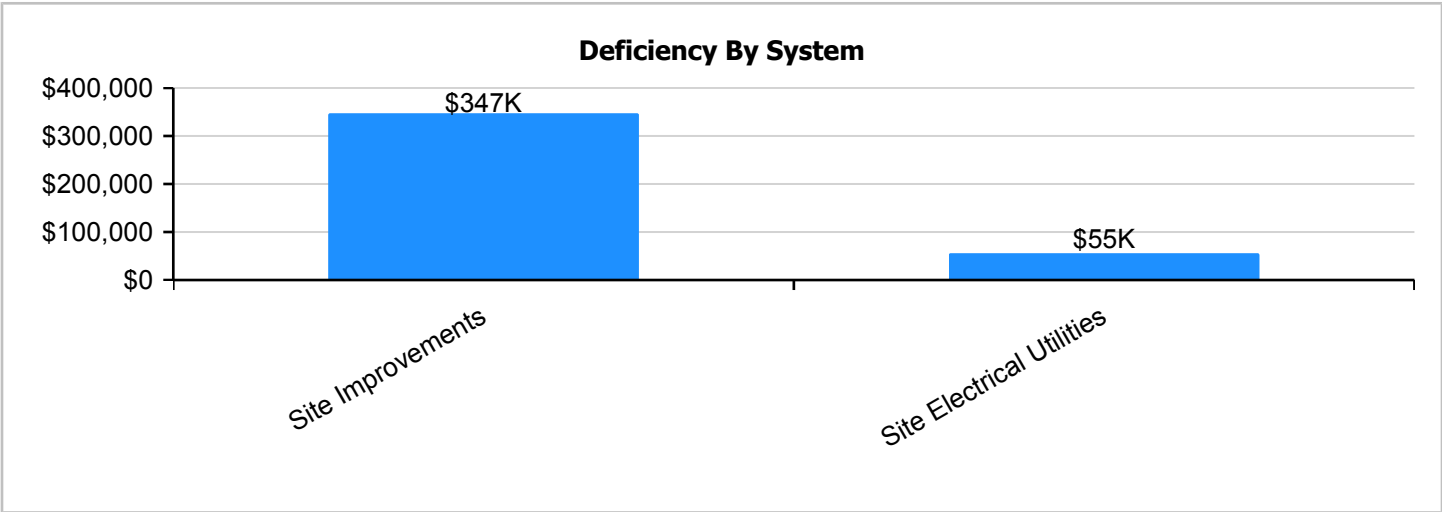
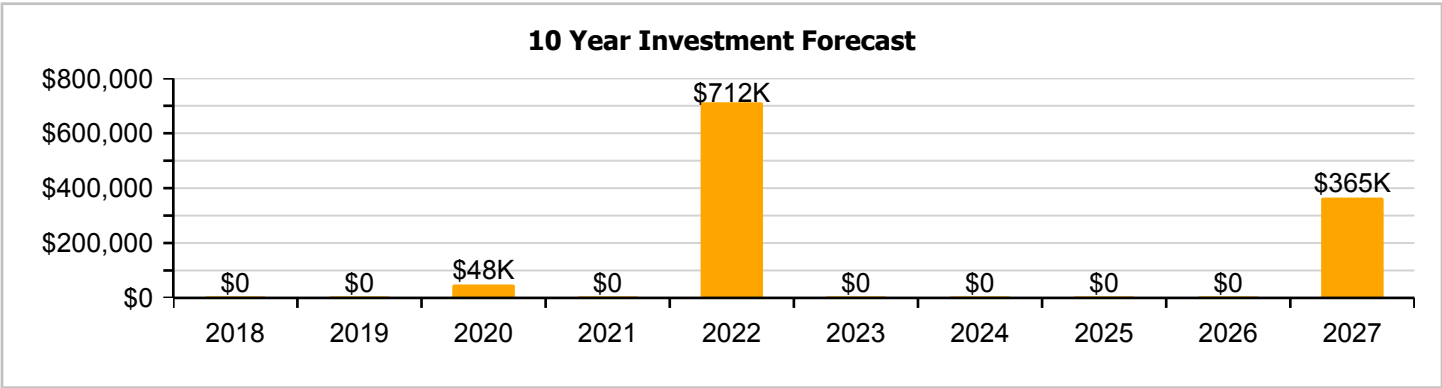
Dashboard Summary

Function:	ES -Elementary School	Gross Area:	78,630
Year Built:	1970	Last Renovation:	1997
Repair Cost:	\$530,202	Replacement Value:	\$2,314,081
FCI:	22.91 %	RSLI%:	30.42 %

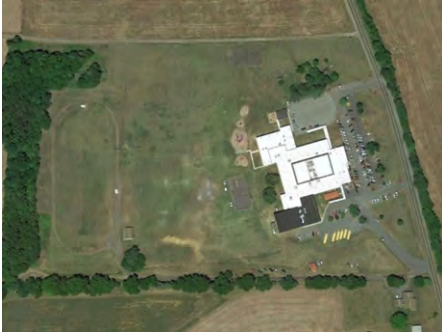
- 1). Aerial Image of Pinebrook Elementary School - Feb 24, 2017
