NC School District/300 Davie County/High School

Central Davie Academy

Campus Assessment Report

March 7, 2017

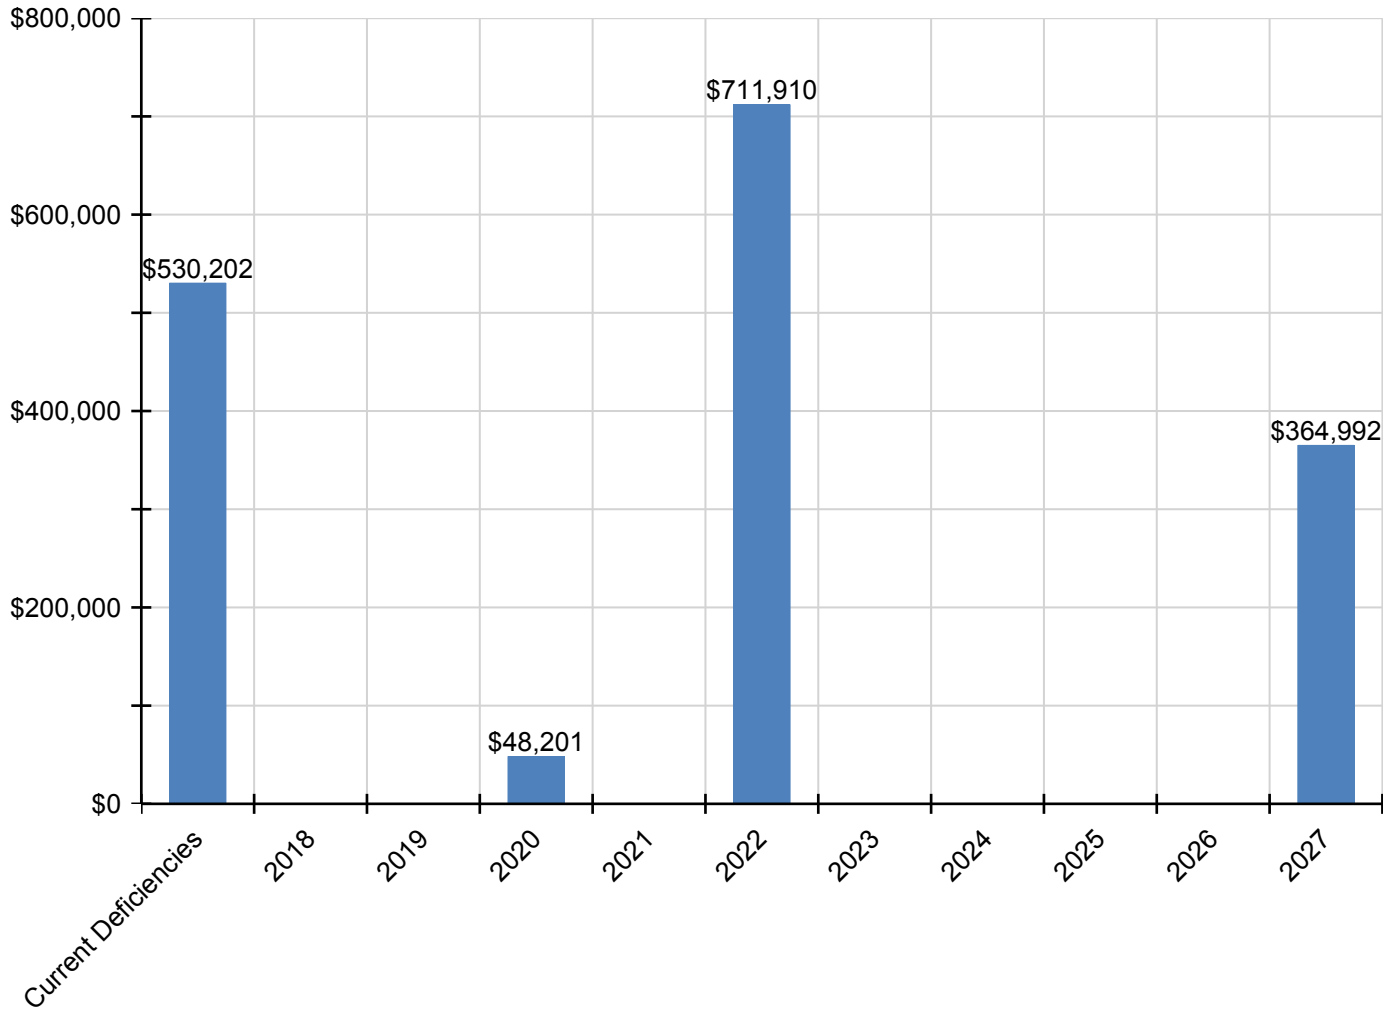
Forecasted Capital Renewal Requirement

The following chart shows the current building deficiencies and forecasting capital renewal or sustainment requirements over the next ten years.

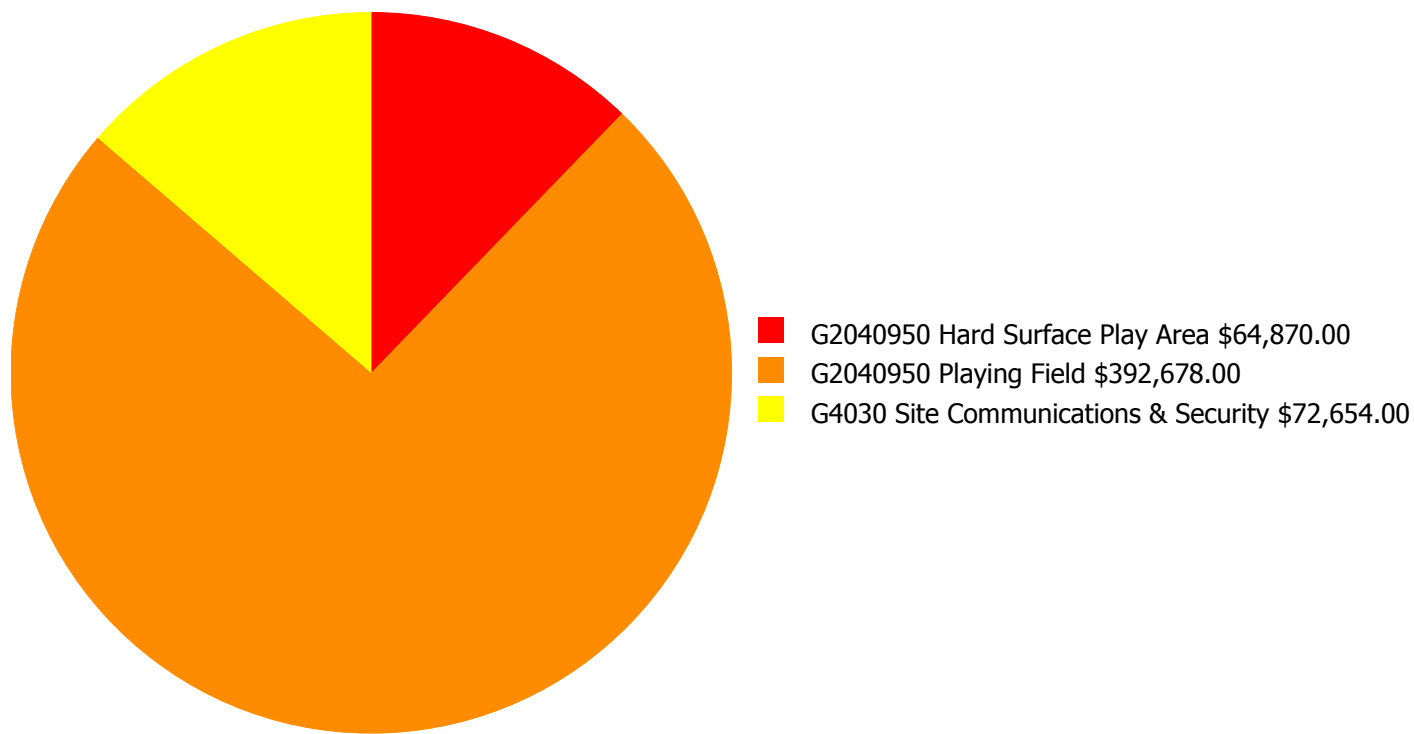
Deficiency Summary by System

Current deficiencies included assemblies that have reached or exceeded their design life or components of the assemblies that are in need of repair. Assemblies that have reached their design life are identified as current deficiencies and assigned the distress 'Beyond Useful Life'. The following chart lists all current deficiencies associated with this facility.

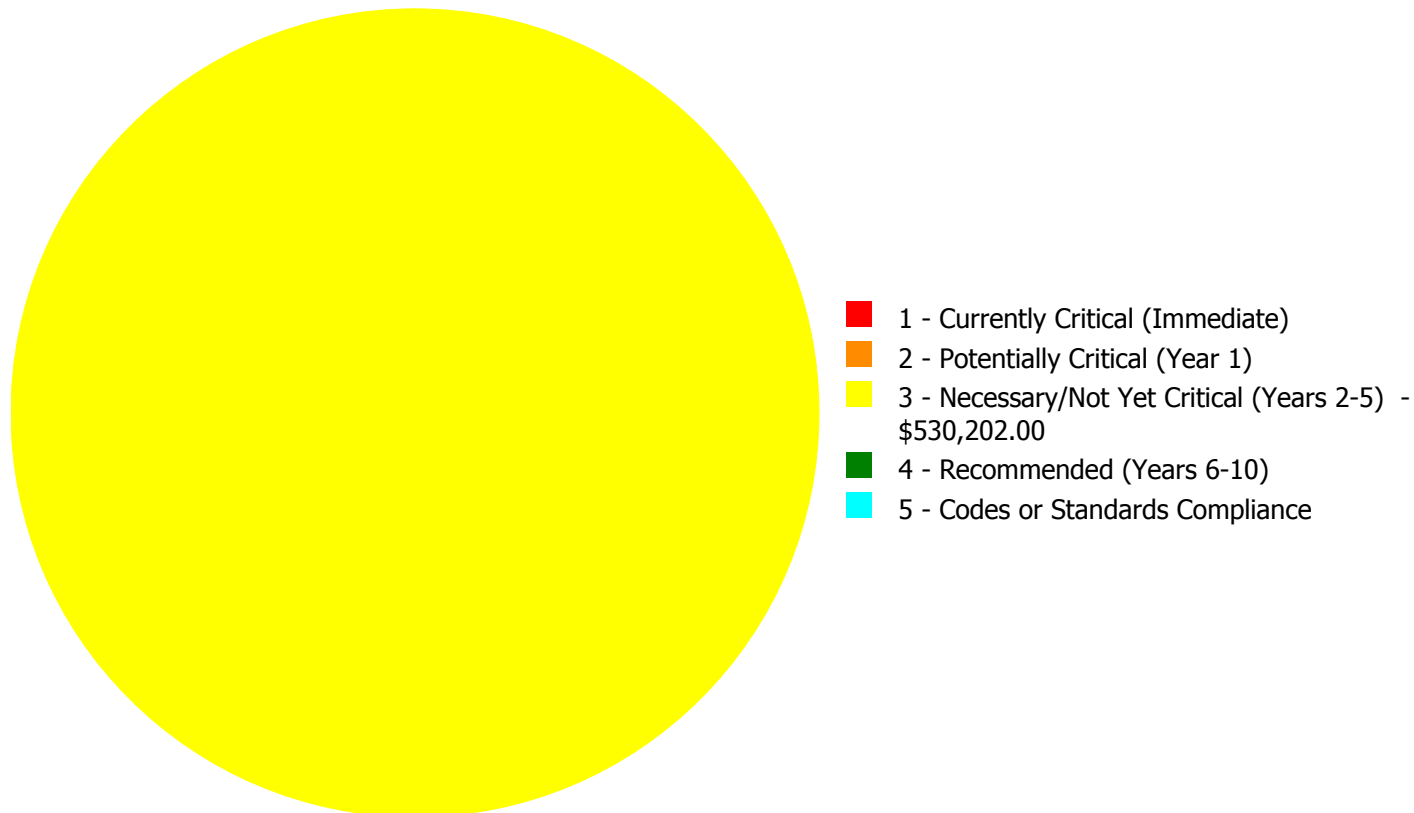
Deficiency Summary by Priority

The following chart shows the total repair costs broken down by priority. Assessors assigned deficiencies within eCOMET to one of the following priority categories:

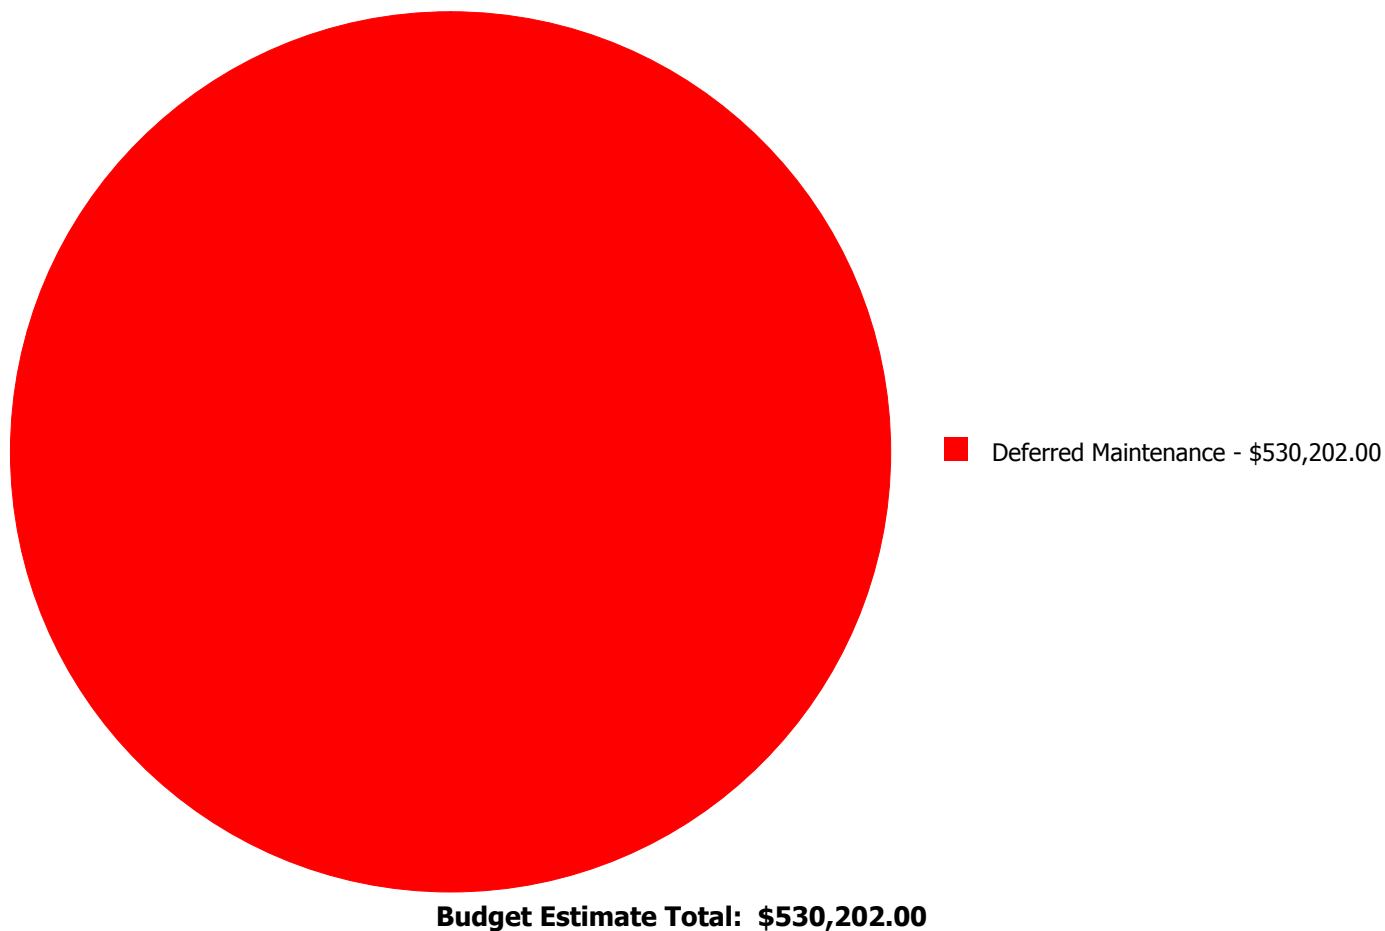
Deficiency Summary by Category

The following chart shows the total repair costs broken down by deficiency categories. Assessors assigned deficiencies to one of the following categories:

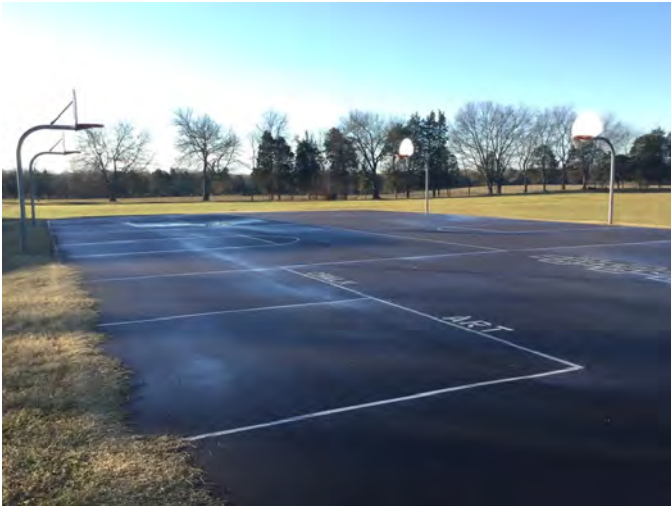
System: G2040950 - Hard Surface Play Area

Location: Site
Distress: Beyond Service Life
Category: Deferred Maintenance
Priority: 3 - Necessary/Not Yet Critical (Years 2-5)
Correction: Renew System
Qty: 78,630.00
Unit of Measure: S.F.
Estimate: \$64,870.00
Assessor Name: Somnath Das
Date Created: 01/19/2017

Notes: System is beyond service life and should be replaced.

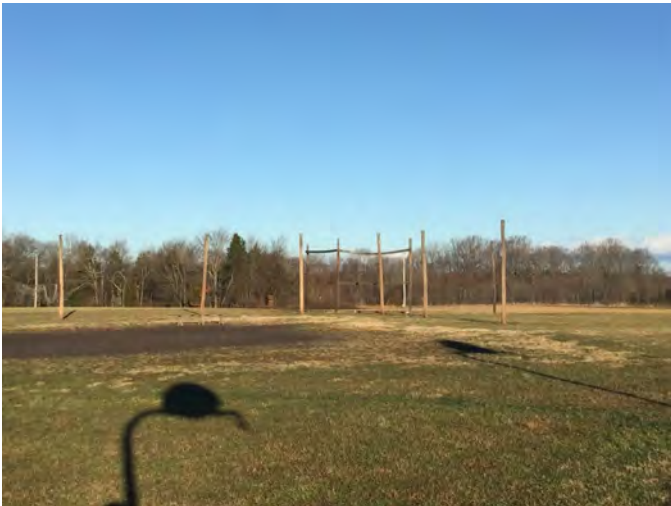
System: G2040950 - Playing Field

Location: Site
Distress: Beyond Service Life
Category: Deferred Maintenance
Priority: 3 - Necessary/Not Yet Critical (Years 2-5)
Correction: Renew System
Qty: 78,630.00
Unit of Measure: S.F.
Estimate: \$392,678.00
Assessor Name: Somnath Das
Date Created: 01/19/2017

Notes: System is beyond service life and should be replaced.

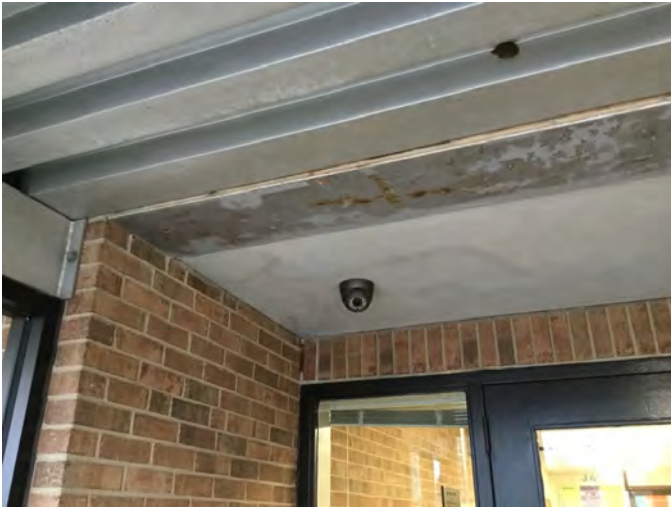
System: G4030 - Site Communications & Security

Location: Throughout the building
Distress: Beyond Service Life
Category: Deferred Maintenance
Priority: 3 - Necessary/Not Yet Critical (Years 2-5)
Correction: Renew System
Qty: 78,630.00
Unit of Measure: S.F.
Estimate: \$72,654.00
Assessor Name: Somnath Das
Date Created: 01/19/2017

Notes: System is beyond service life and should be replaced.

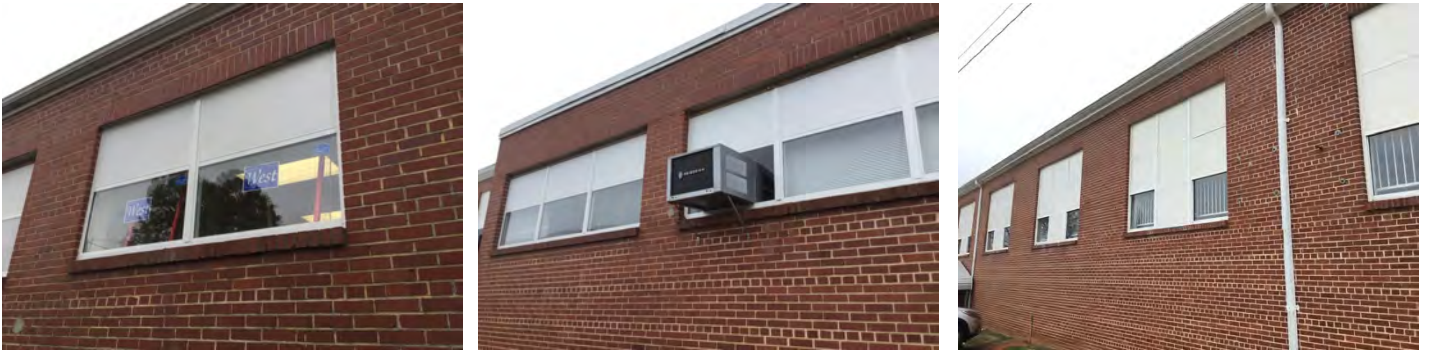
System: B2020 - Exterior Windows

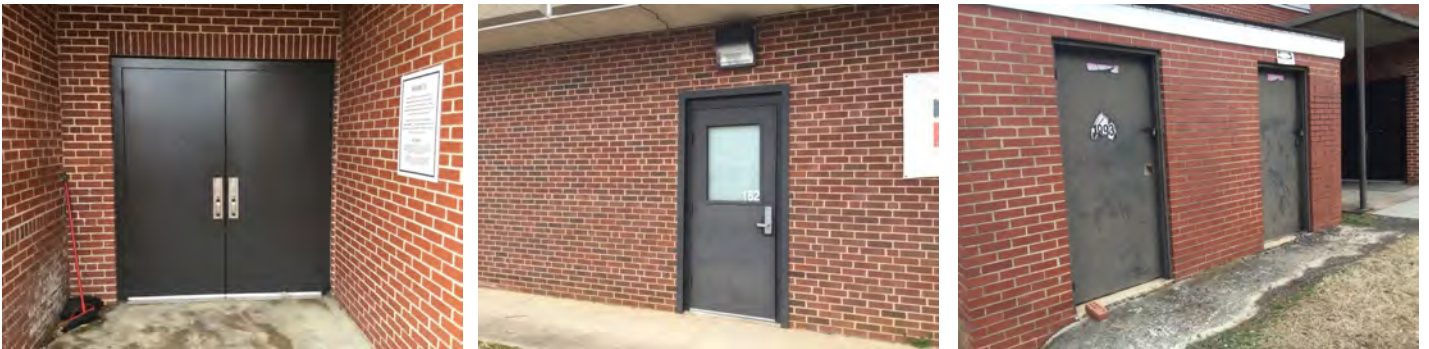
System: B2030 - Exterior Doors

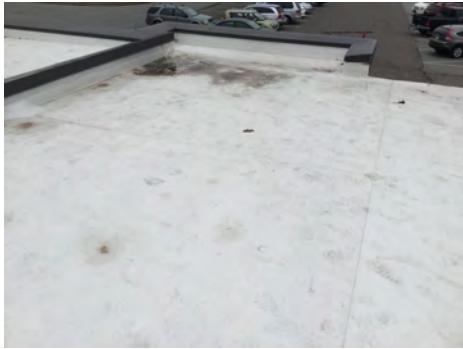
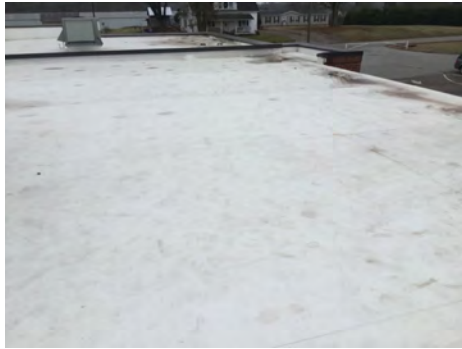
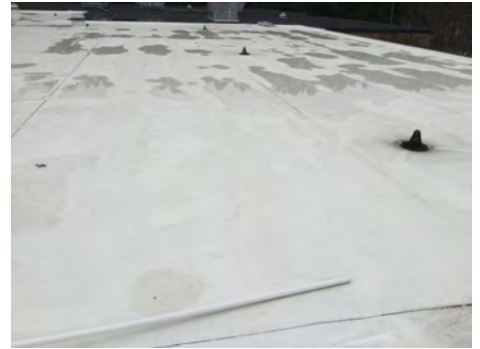
System: B3010120 - Single Ply Membrane

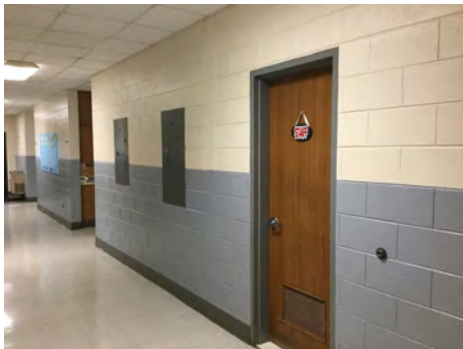
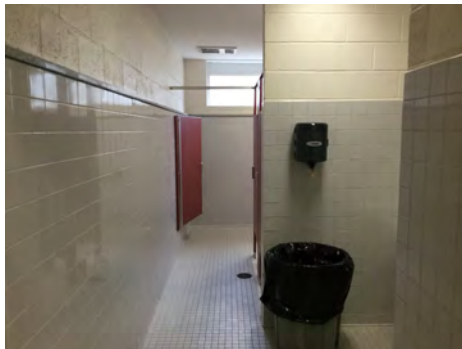
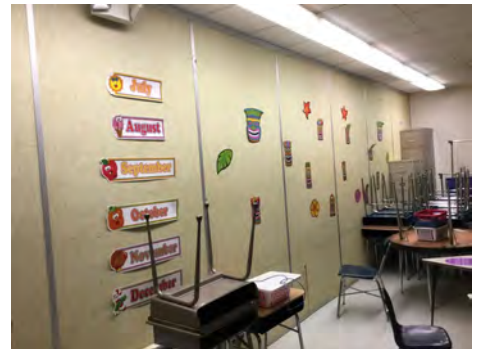
System: C1010 - Partitions

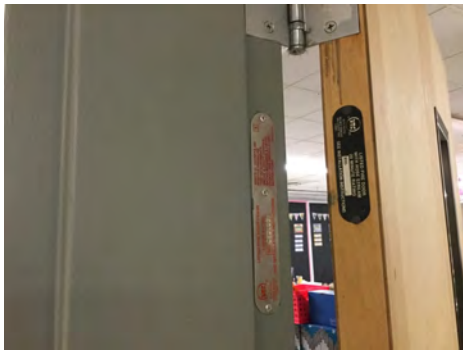
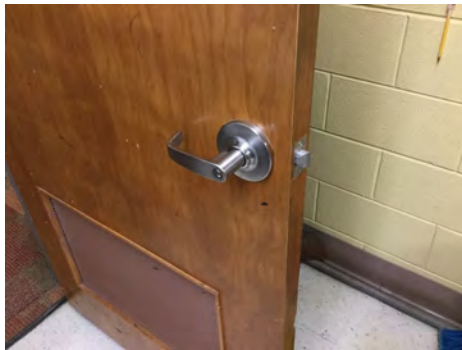
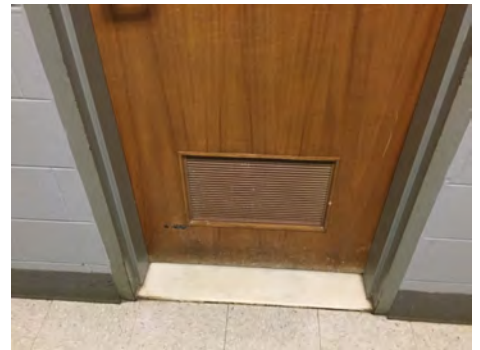
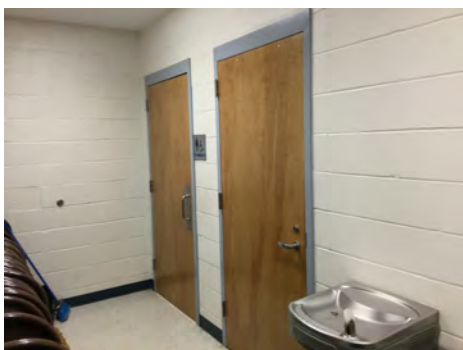
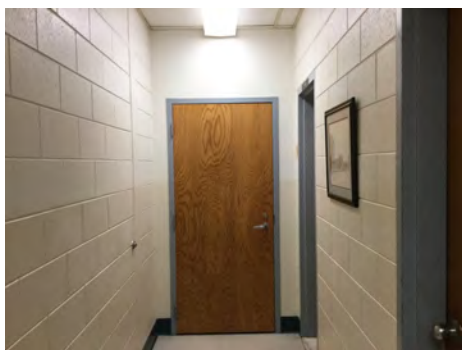
System: C1020 - Interior Doors

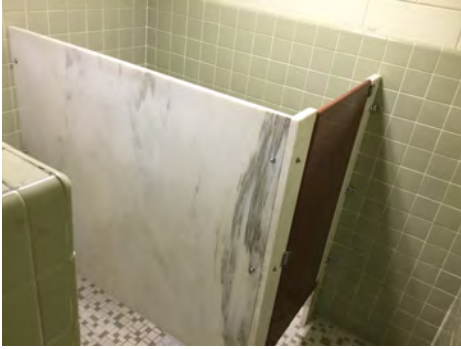
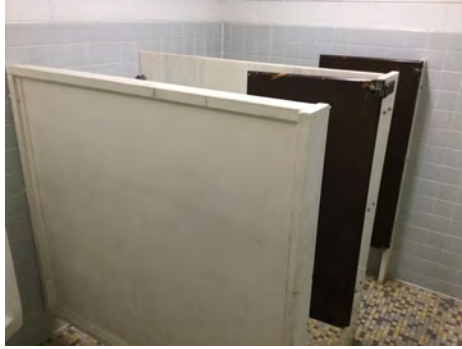
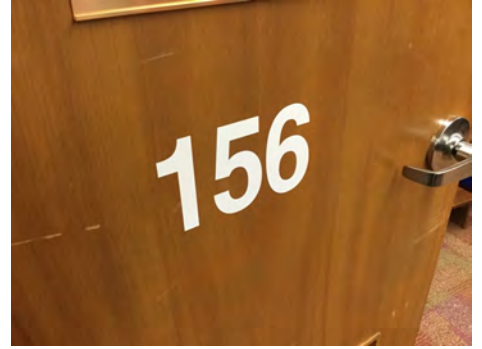
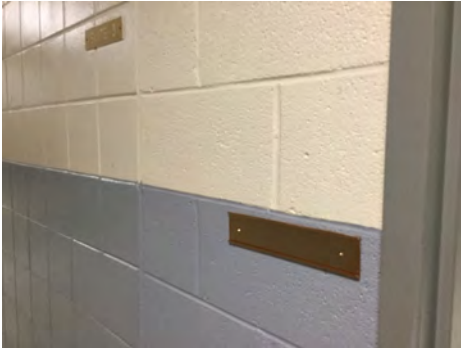
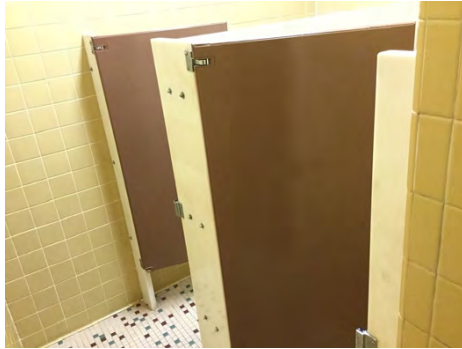
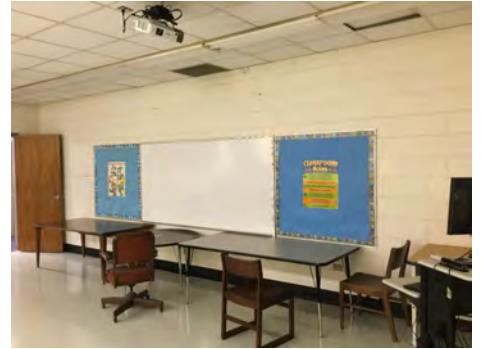
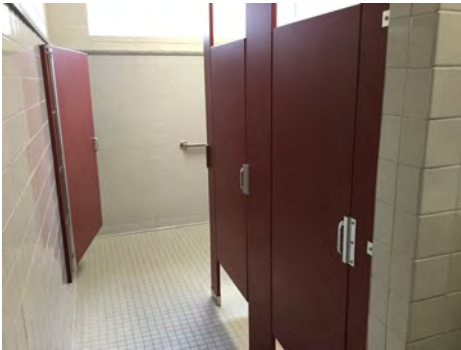
System: C1030 - Fittings

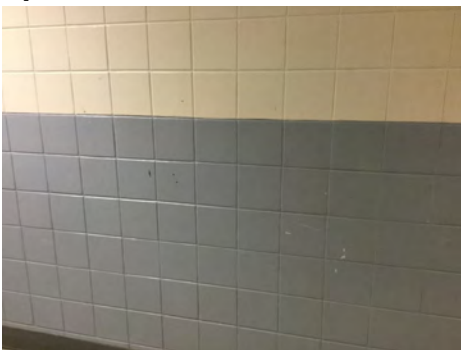
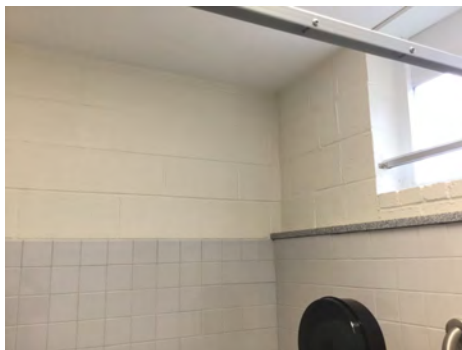
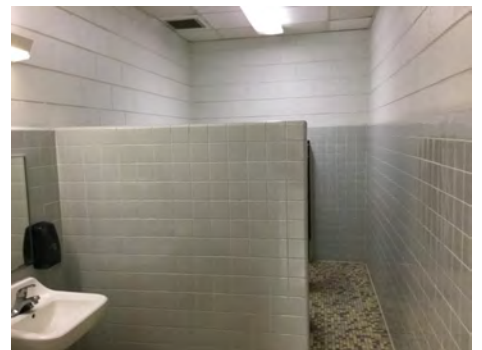
System: C3010 - Wall Finishes

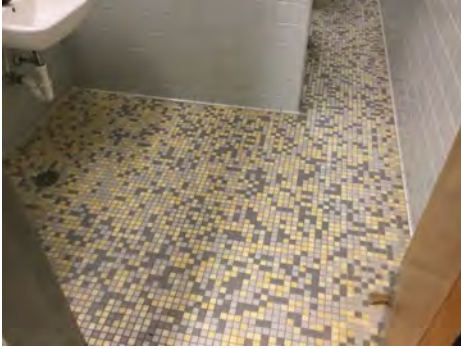
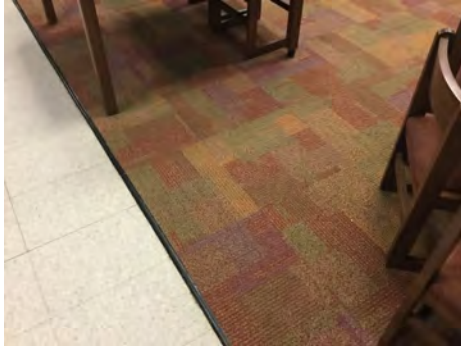
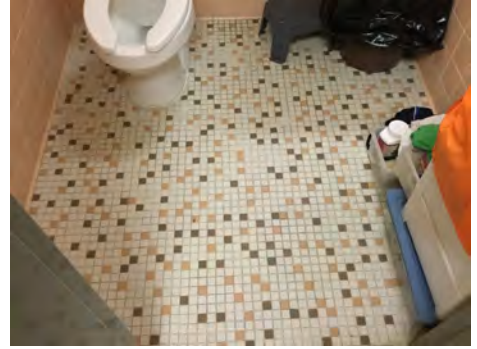
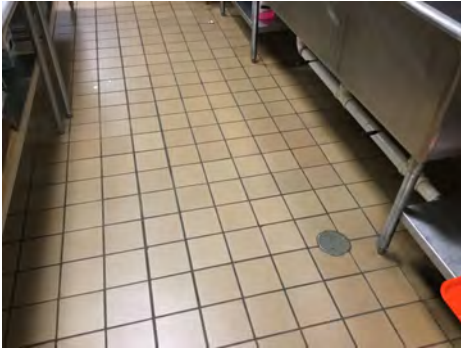
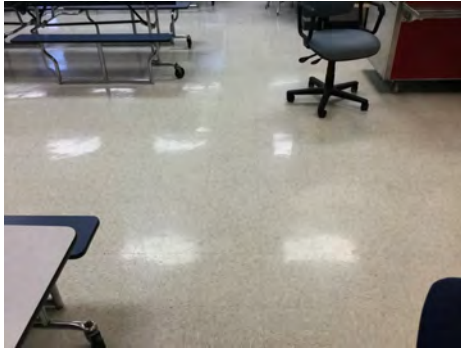
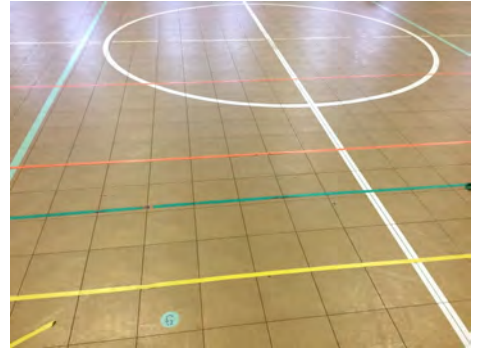
System: C3020 - Floor Finishes

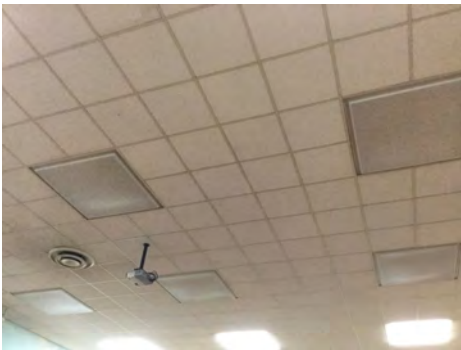
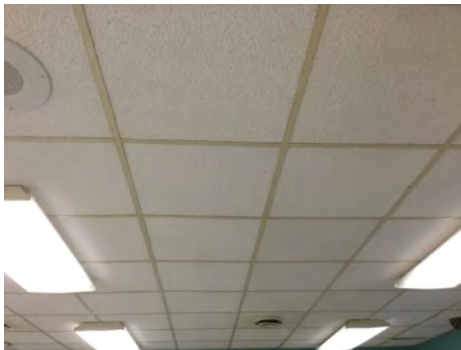
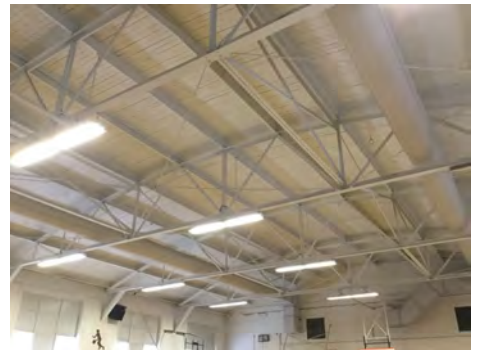
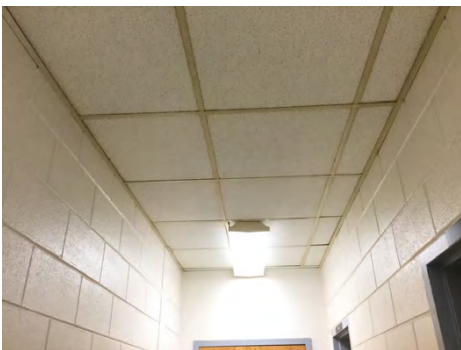
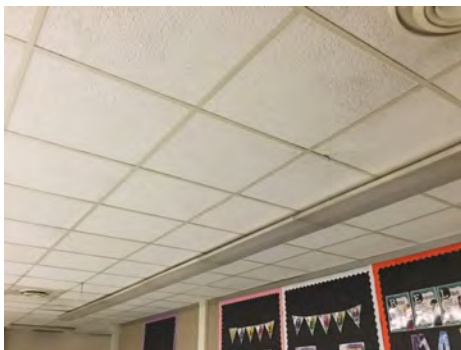
System: C3030 - Ceiling Finishes

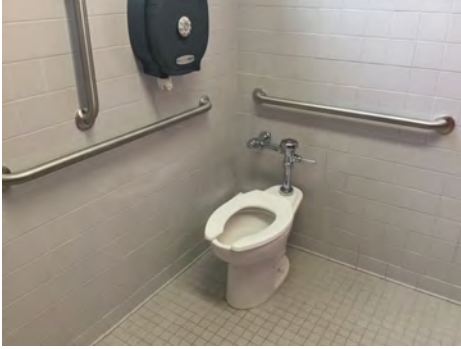
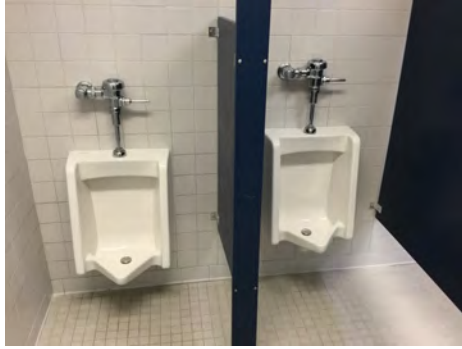
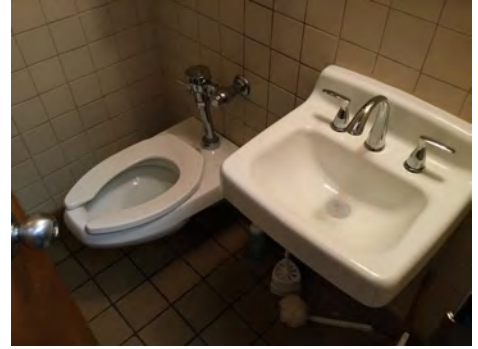
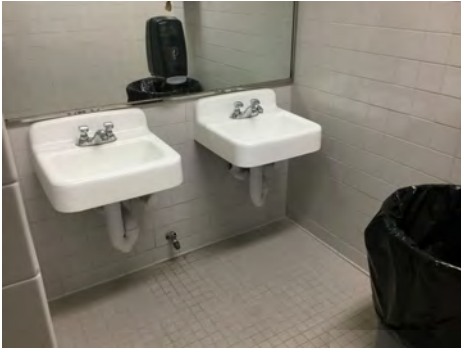
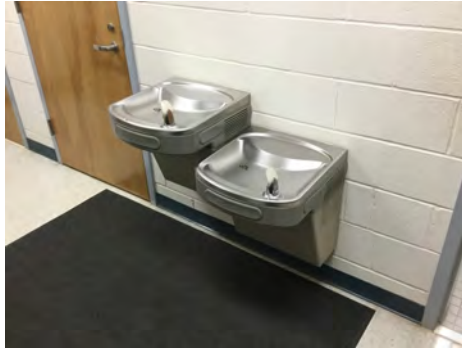
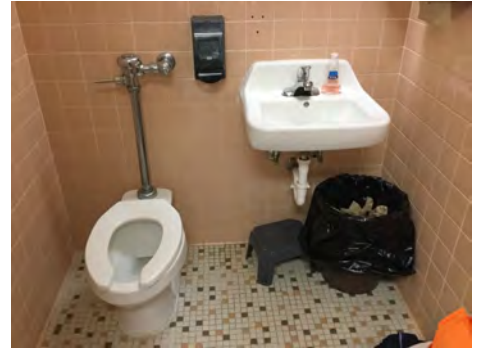
System: D2010 - Plumbing Fixtures

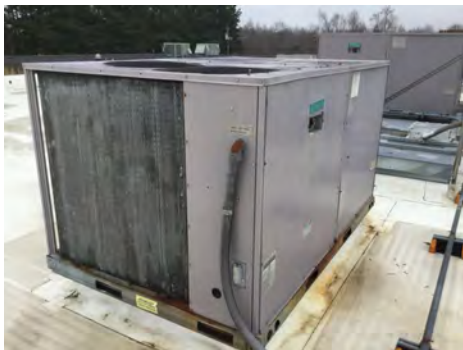
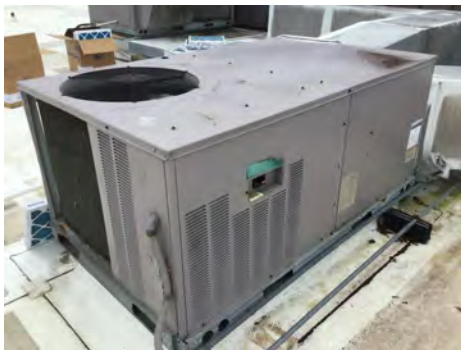
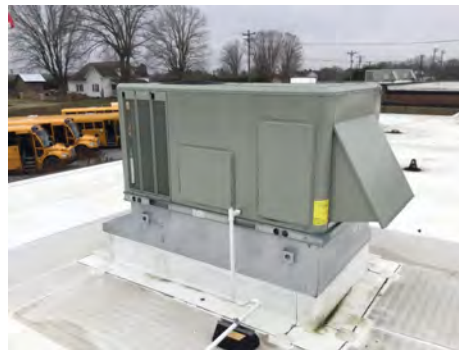
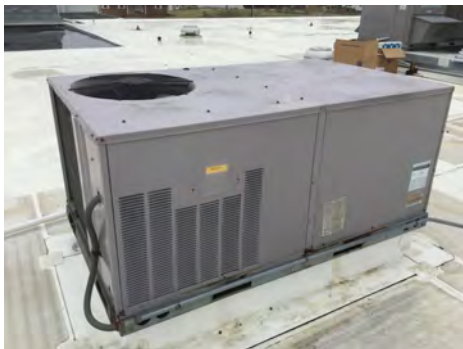
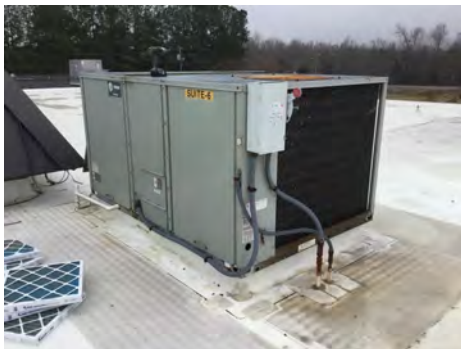
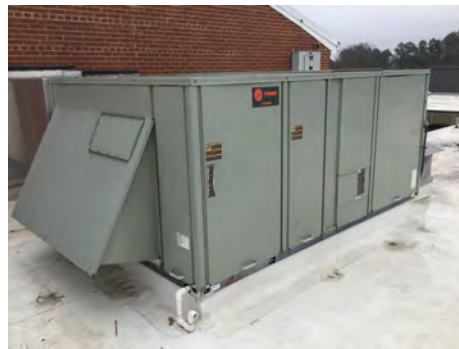
System: D3050 - Terminal & Package Units

Note: Different dates between 2003 and 2016

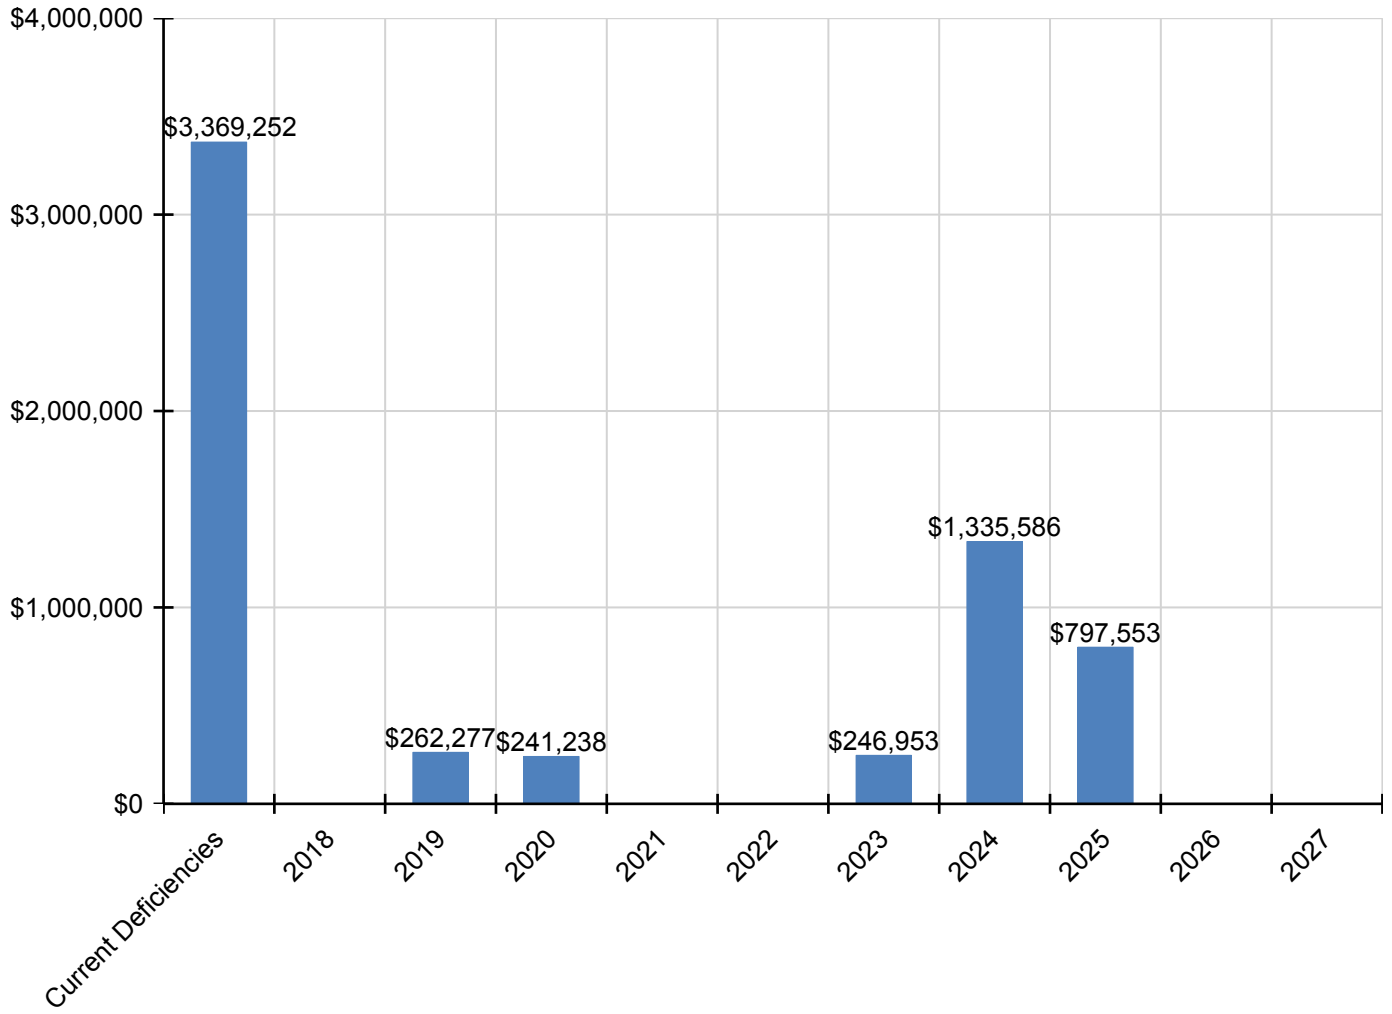
Forecasted Capital Renewal Requirement

The following chart shows the current building deficiencies and forecasting capital renewal or sustainment requirements over the next ten years.

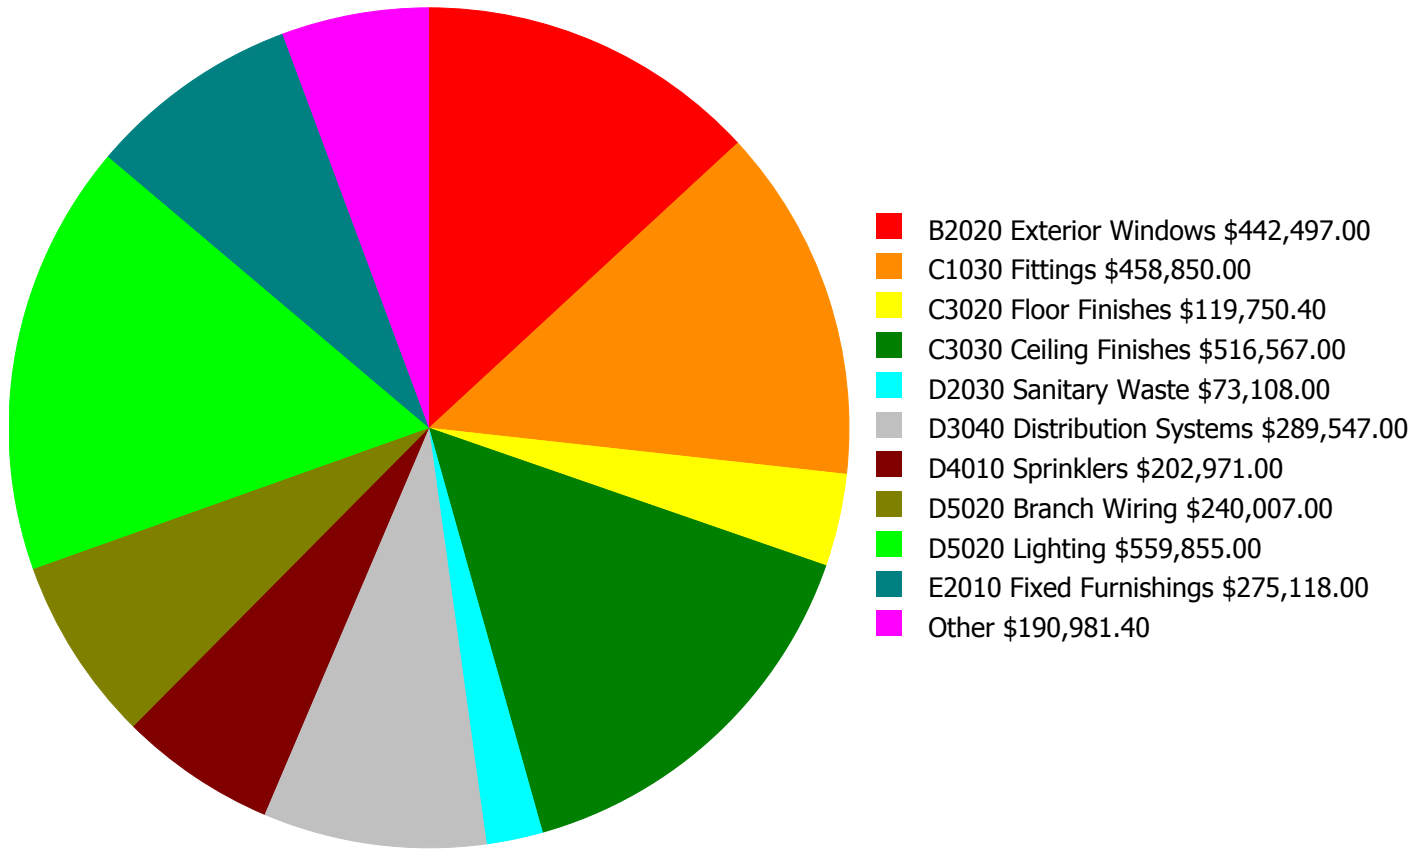
Deficiency Summary by System

Current deficiencies included assemblies that have reached or exceeded their design life or components of the assemblies that are in need of repair. Assemblies that have reached their design life are identified as current deficiencies and assigned the distress 'Beyond Useful Life'. The following chart lists all current deficiencies associated with this facility.

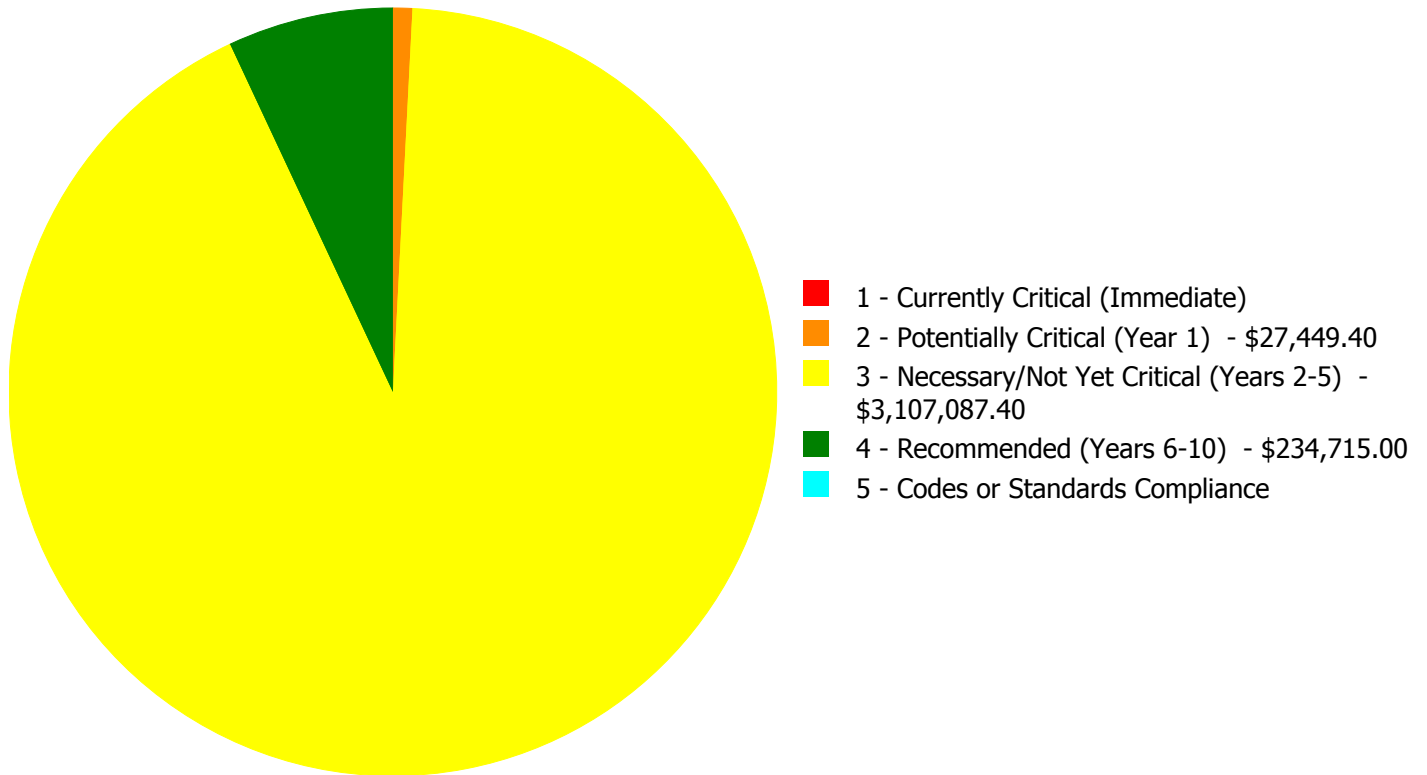
Deficiency Summary by Priority

The following chart shows the total repair costs broken down by priority. Assessors assigned deficiencies within eCOMET to one of the following priority categories:

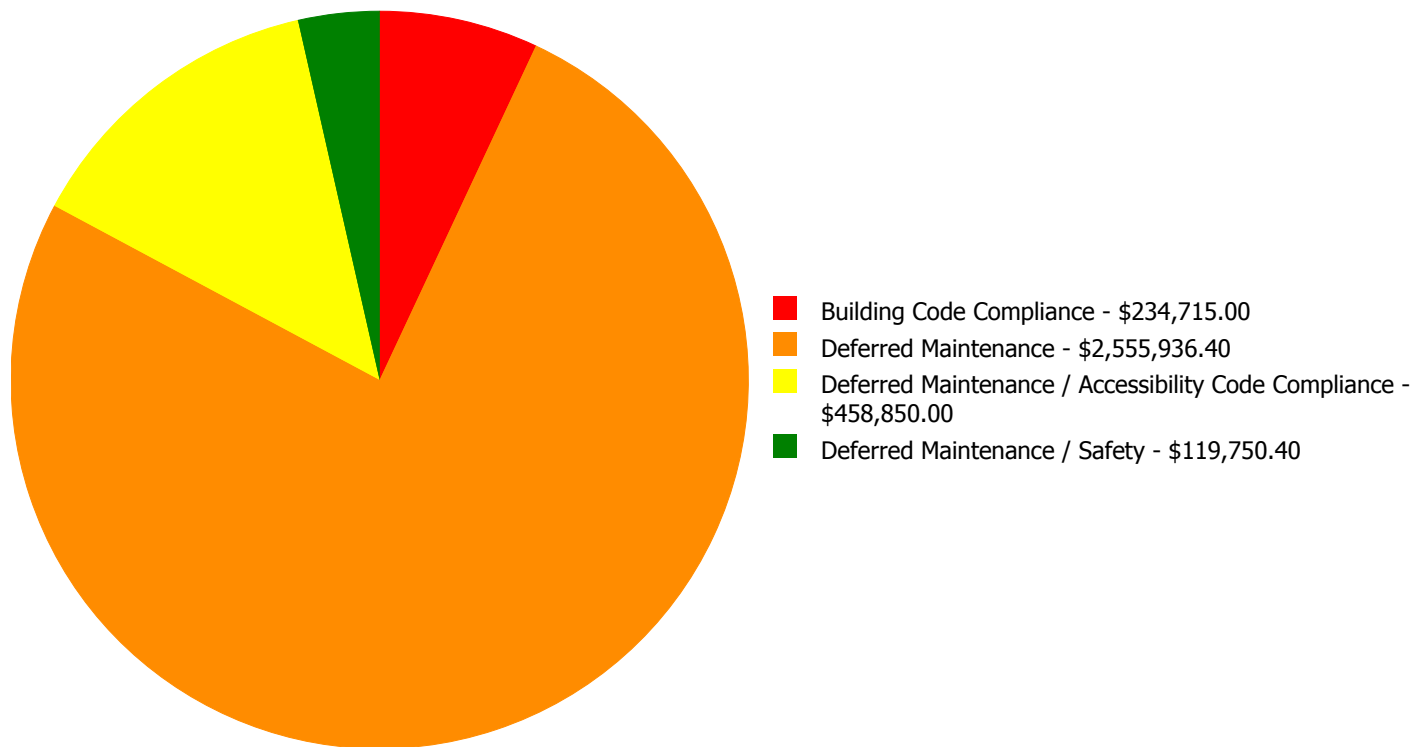
Deficiency Summary by Category

The following chart shows the total repair costs broken down by deficiency categories. Assessors assigned deficiencies to one of the following categories:

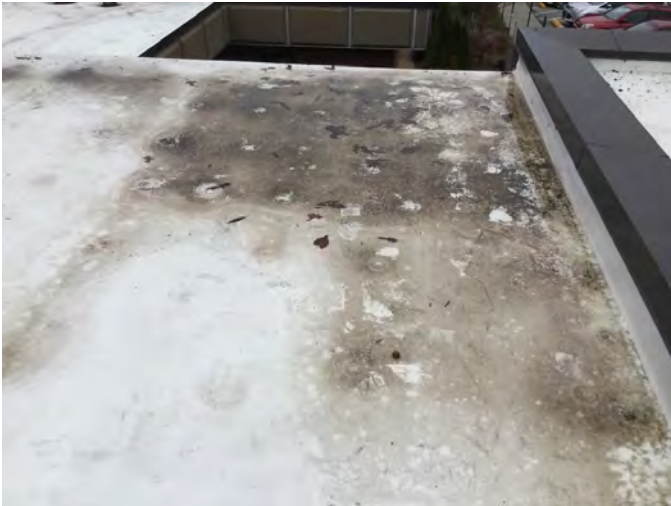
System: B3010120 - Single Ply Membrane

Location: Above Cafeteria and Kitchen
Distress: Inadequate
Category: Deferred Maintenance
Priority: 2 - Potentially Critical (Year 1)
Correction: Minor thermoplastic membrane repairs, 2% of roof area
Qty: 50.00
Unit of Measure: Sq.
Estimate: \$27,449.40
Assessor Name: Eduardo Lopez
Date Created: 01/24/2017

Notes: The low-slope roof deck is not adequate for rain water to drain toward roof drains, creating ponding and eventually seeping into the building. Provide effective cricket design in areas around roof drains.

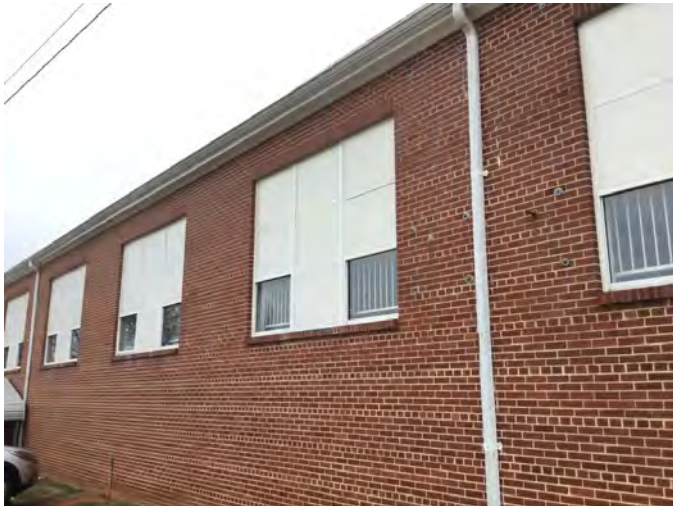
System: B2020 - Exterior Windows

Location: Exterior Walls
Distress: Beyond Service Life
Category: Deferred Maintenance
Priority: 3 - Necessary/Not Yet Critical (Years 2-5)
Correction: Renew System
Qty: 43,725.00
Unit of Measure: S.F.
Estimate: \$442,497.00
Assessor Name: Eduardo Lopez
Date Created: 01/24/2017

Notes: The exterior windows are aged, not energy efficient and should be replaced.

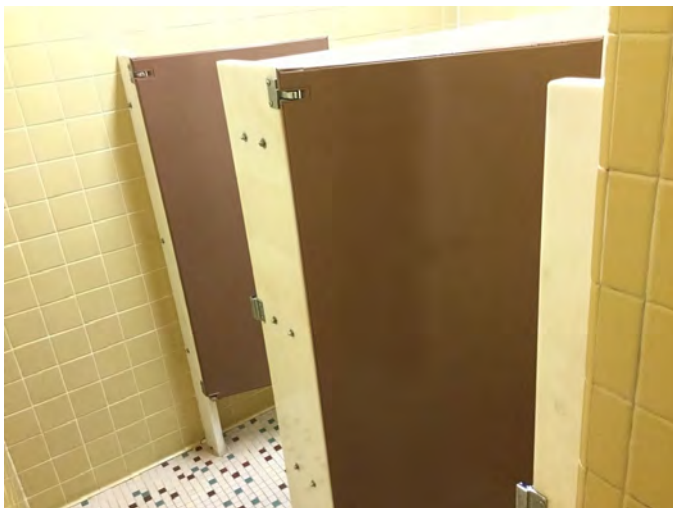
System: C1030 - Fittings

Location: Throughout the Building
Distress: Beyond Service Life
Category: Deferred Maintenance / Accessibility Code Compliance
Priority: 3 - Necessary/Not Yet Critical (Years 2-5)
Correction: Renew System
Qty: 43,725.00
Unit of Measure: S.F.
Estimate: \$458,850.00
Assessor Name: Eduardo Lopez
Date Created: 01/19/2017

Notes: The fittings throughout the building are aged, in marginal condition, room signage are not ADA compliant and should be replaced.

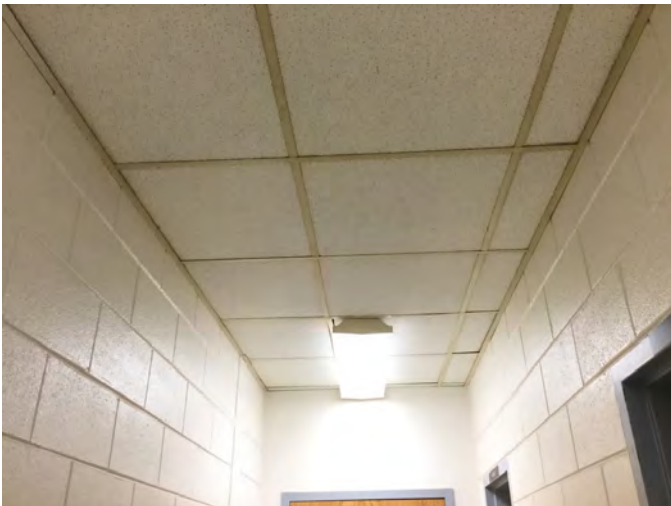
System: C3030 - Ceiling Finishes

Location: Throughout the Building
Distress: Beyond Service Life
Category: Deferred Maintenance
Priority: 3 - Necessary/Not Yet Critical (Years 2-5)
Correction: Renew System
Qty: 43,725.00
Unit of Measure: S.F.
Estimate: \$516,567.00
Assessor Name: Eduardo Lopez
Date Created: 01/24/2017

Notes: The ceiling tiles have been replaced as needed. However the grid shows signs of aging and should be replaced.

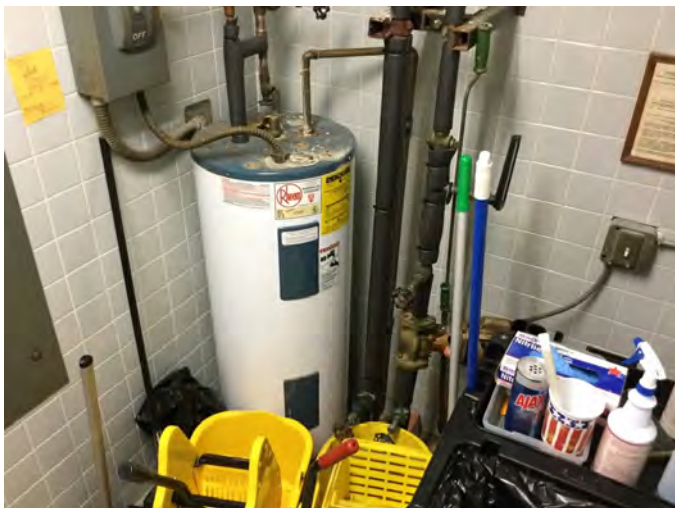
System: D2020 - Domestic Water Distribution

Location: Throughout the Building
Distress: Beyond Service Life
Category: Deferred Maintenance
Priority: 3 - Necessary/Not Yet Critical (Years 2-5)
Correction: Renew System
Qty: 43,725.00
Unit of Measure: S.F.
Estimate: \$46,174.00
Assessor Name: Eduardo Lopez
Date Created: 01/19/2017

Notes: The domestic water distribution system is aged and should be replaced.

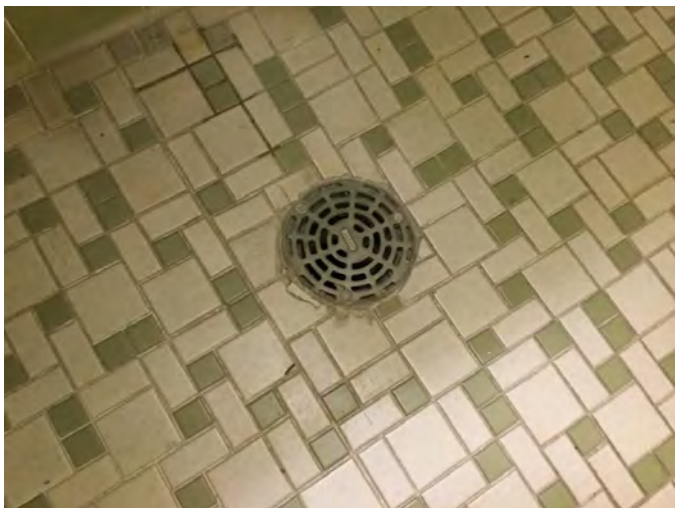
System: D2030 - Sanitary Waste

Location: Throughout the Building
Distress: Beyond Service Life
Category: Deferred Maintenance
Priority: 3 - Necessary/Not Yet Critical (Years 2-5)
Correction: Renew System
Qty: 43,725.00
Unit of Measure: S.F.
Estimate: \$73,108.00
Assessor Name: Eduardo Lopez
Date Created: 01/19/2017

Notes: The sanitary waste system is beyond its expected service life and should be replaced.

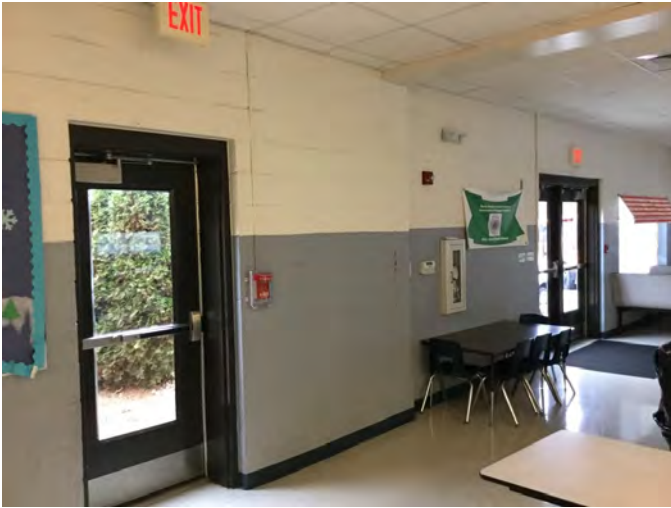
System: D5090 - Other Electrical Systems

Location: 1950, 1970 Main Building
Distress: Beyond Service Life
Category: Deferred Maintenance
Priority: 3 - Necessary/Not Yet Critical (Years 2-5)
Correction: Renew System
Qty: 43,725.00
Unit of Measure: S.F.
Estimate: \$5,772.00
Assessor Name: Eduardo Lopez
Date Created: 02/27/2017
