NC School District/300 Davie County/High School

Central Davie Academy

Campus Assessment Report

March 7, 2017

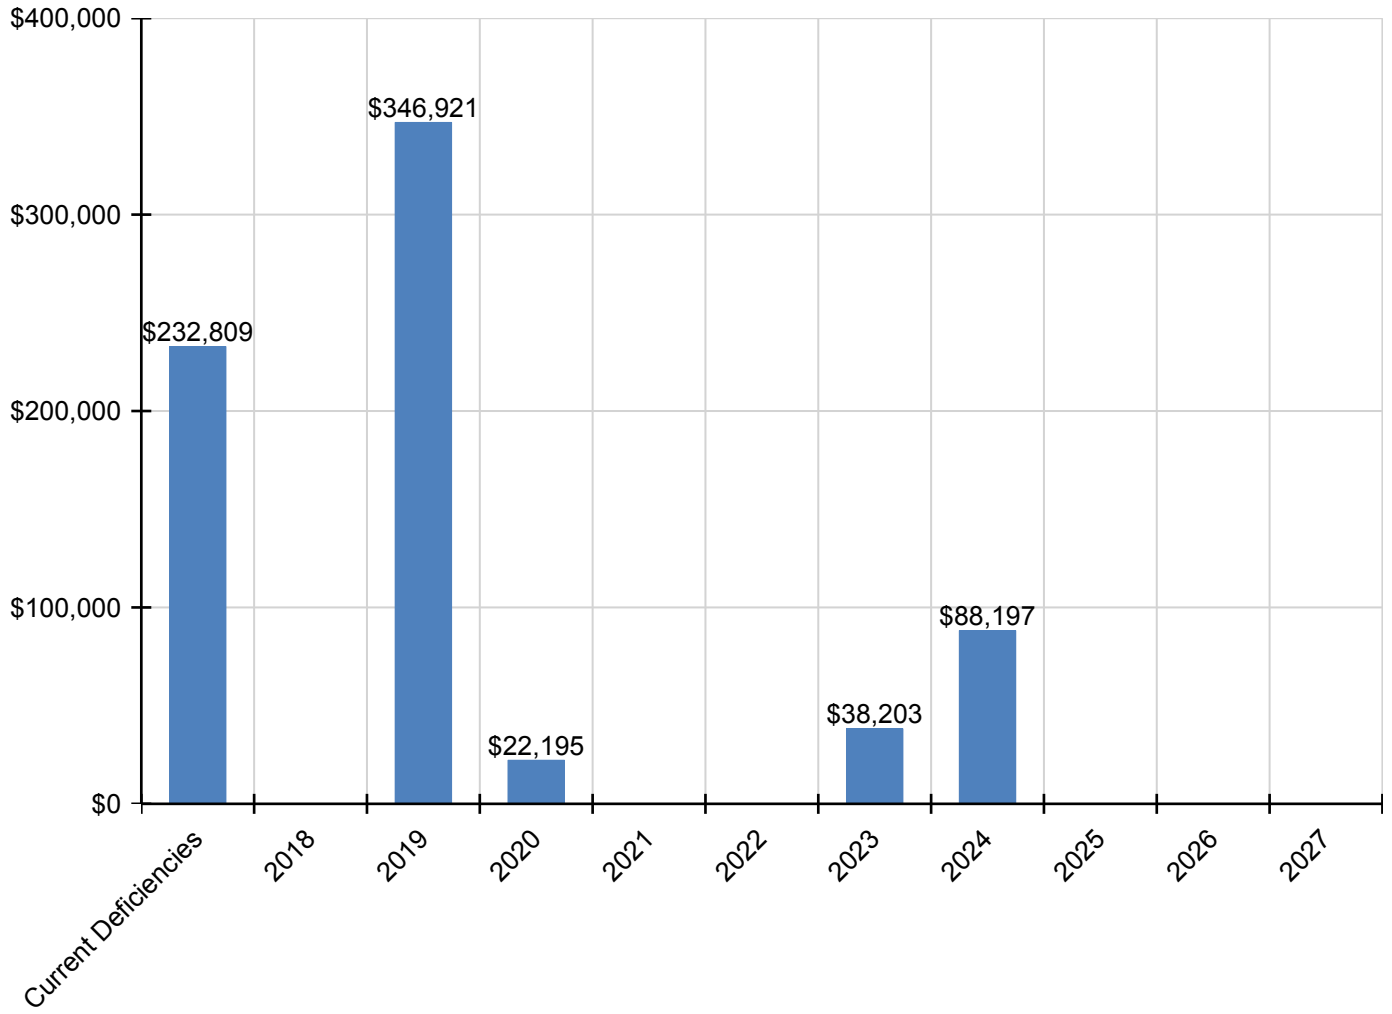
Forecasted Capital Renewal Requirement

The following chart shows the current building deficiencies and forecasting capital renewal or sustainment requirements over the next ten years.

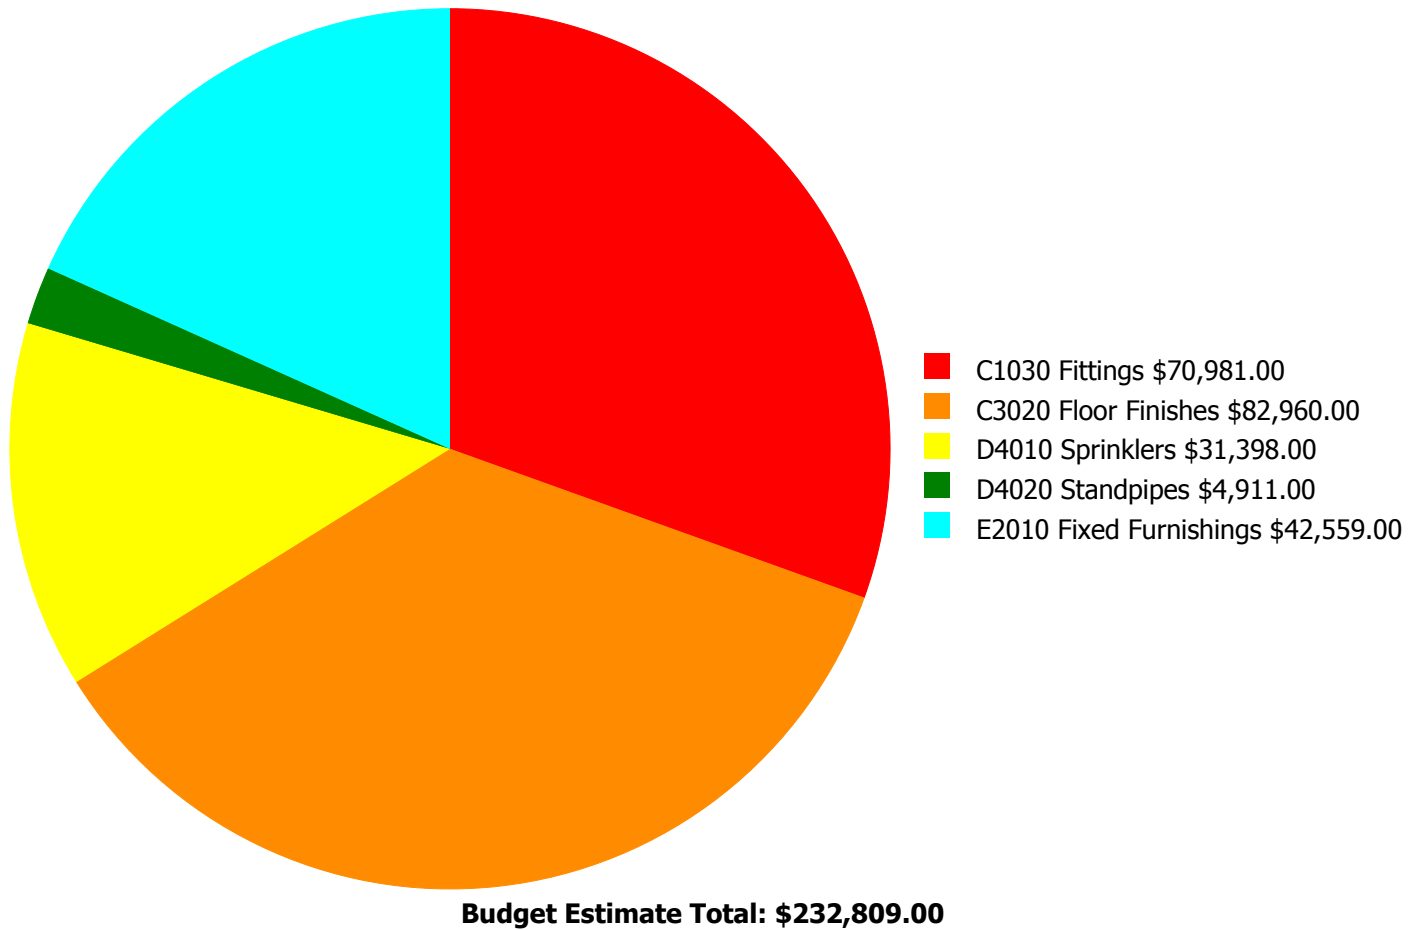
Deficiency Summary by System

Current deficiencies included assemblies that have reached or exceeded their design life or components of the assemblies that are in need of repair. Assemblies that have reached their design life are identified as current deficiencies and assigned the distress 'Beyond Useful Life'. The following chart lists all current deficiencies associated with this facility.

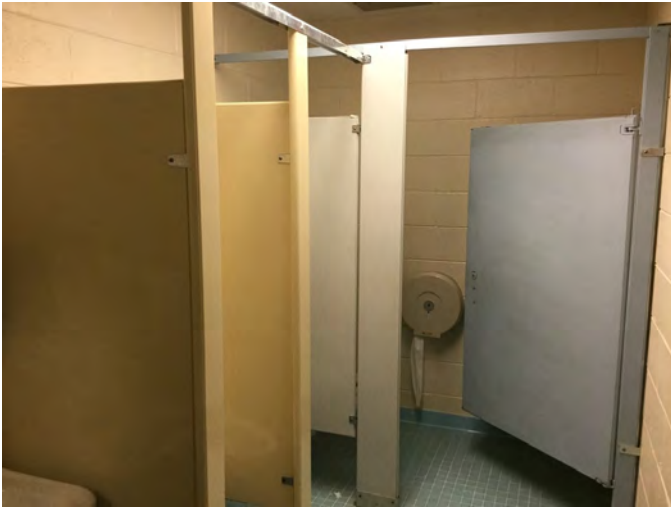
System: C1030 - Fittings

Location: Throughout the Building
Distress: Beyond Service Life
Category: Deferred Maintenance / Accessibility Code Compliance
Priority: 3 - Necessary/Not Yet Critical (Years 2-5)
Correction: Renew System
Qty: 6,764.00
Unit of Measure: S.F.
Estimate: \$70,981.00
Assessor Name: Eduardo Lopez
Date Created: 01/23/2017

Notes: The fittings throughout the building are aged, in marginal condition, room signage are not ADA compliant and should be replaced.

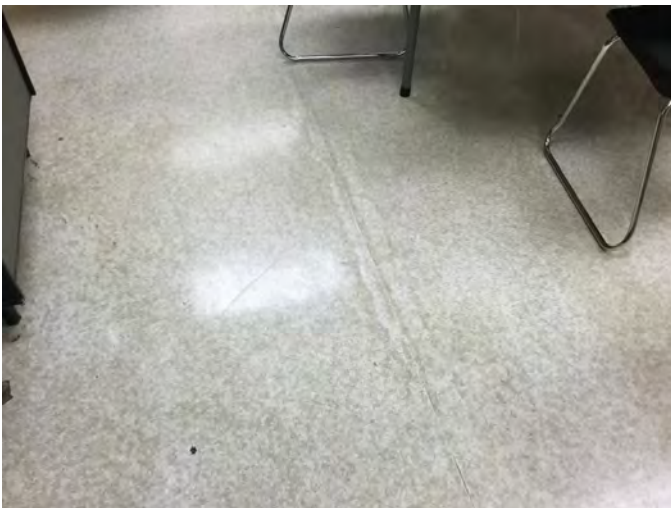
System: C3020 - Floor Finishes

Location: Throughout the Building
Distress: Beyond Service Life
Category: Deferred Maintenance
Priority: 3 - Necessary/Not Yet Critical (Years 2-5)
Correction: Renew System
Qty: 6,764.00
Unit of Measure: S.F.
Estimate: \$82,960.00
Assessor Name: Eduardo Lopez
Date Created: 01/23/2017

Notes: The original flooring is in poor conditions and should be replaced.

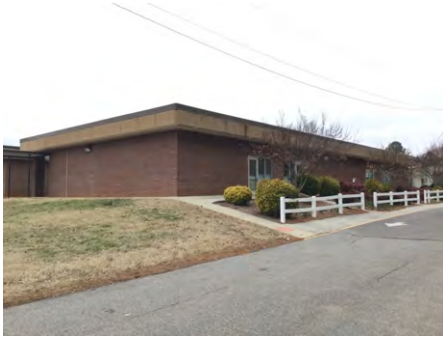
1). Southeast Elevation - Jan 23, 2017

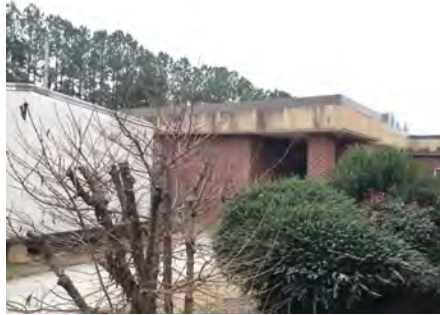
2). North Elevation - Jan 23, 2017

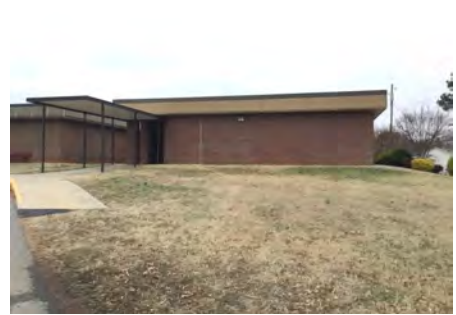
3). South Elevation - Jan 23, 2017

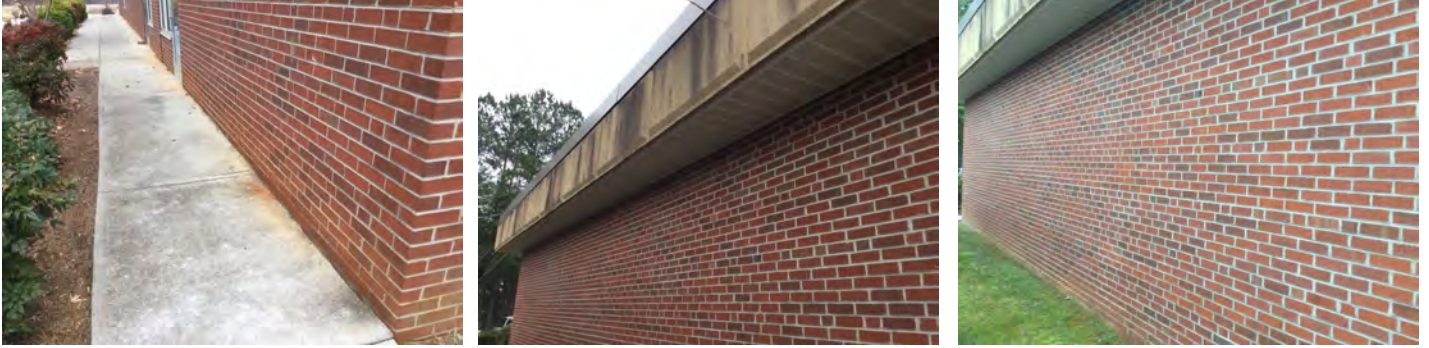
System: B2010 - Exterior Walls

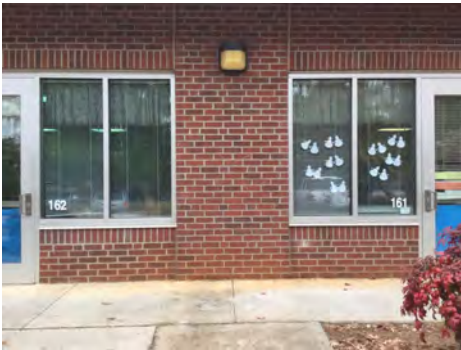
System: B2020 - Exterior Windows

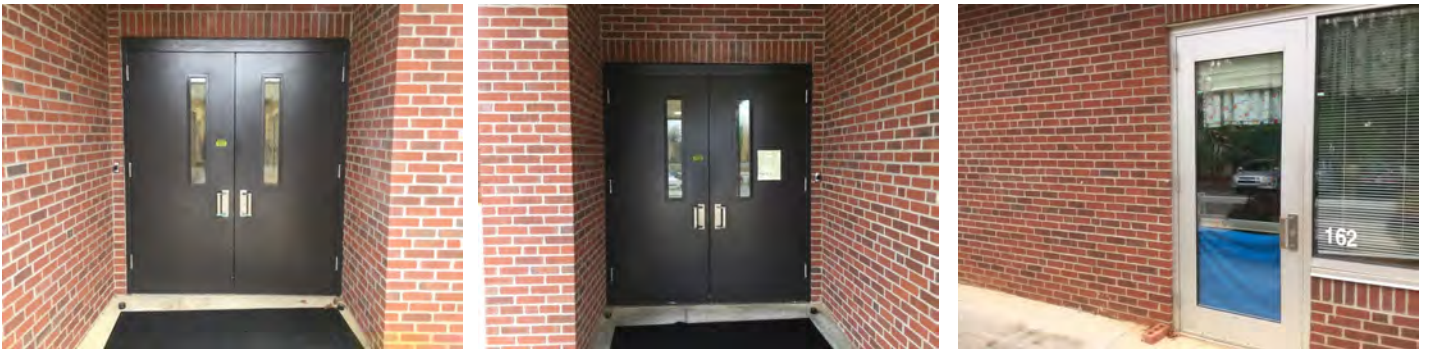
System: B2030 - Exterior Doors

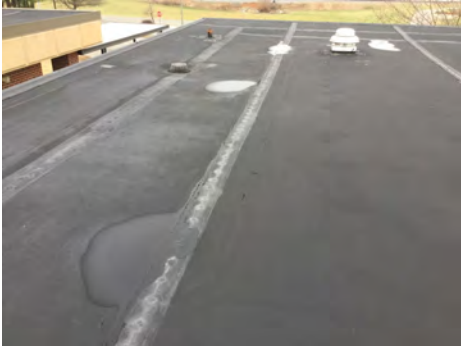
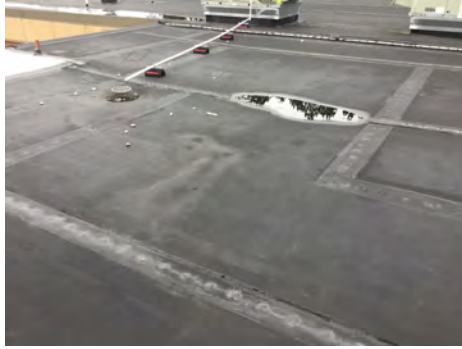
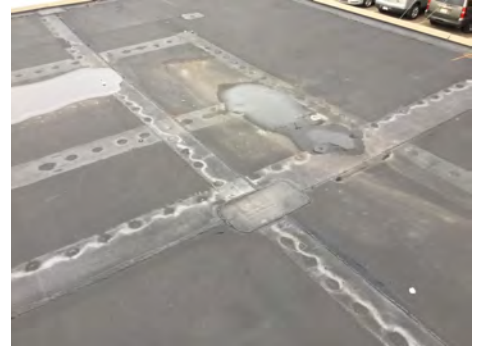
System: B3010120 - Single Ply Membrane

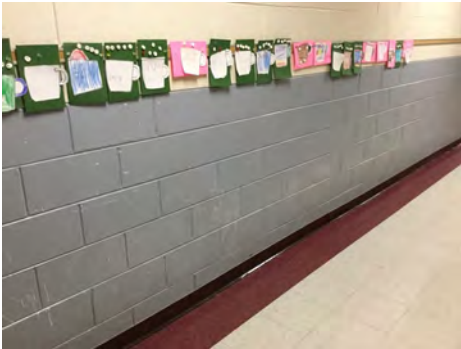
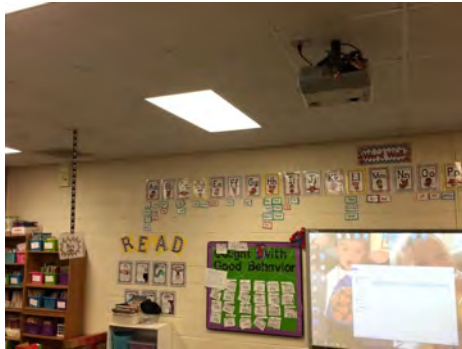
System: C1010 - Partitions

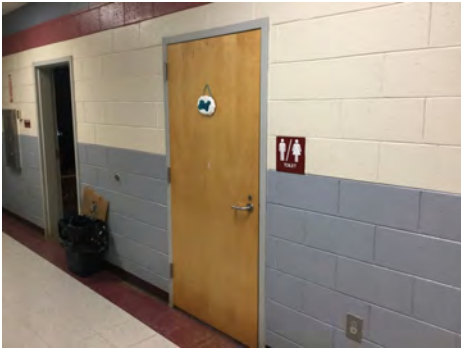
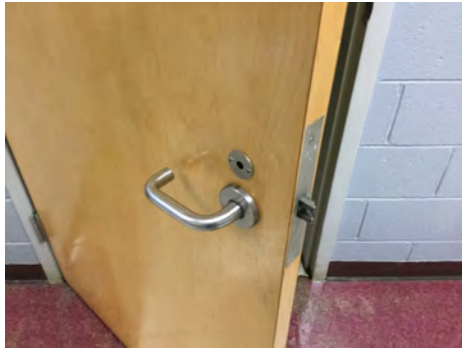
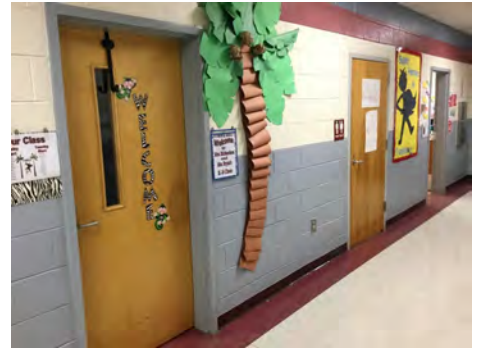
System: C1020 - Interior Doors

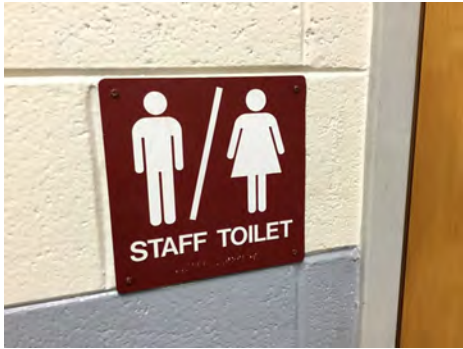
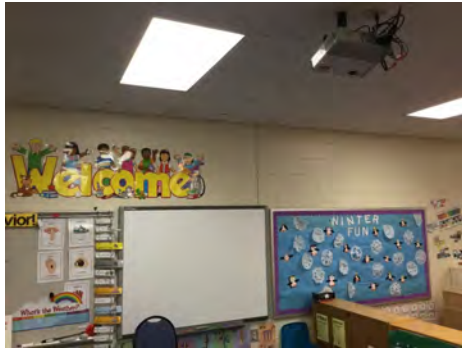
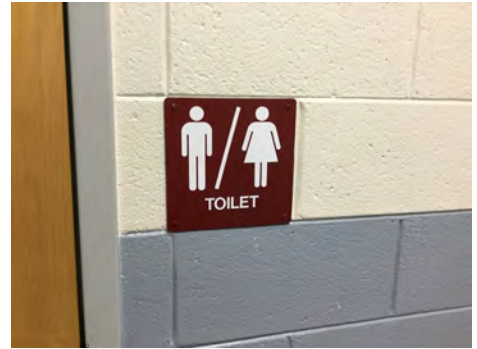
System: C1030 - Fittings

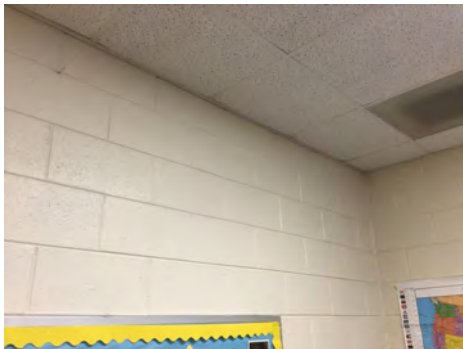
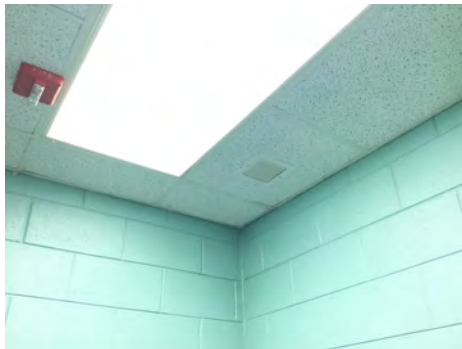
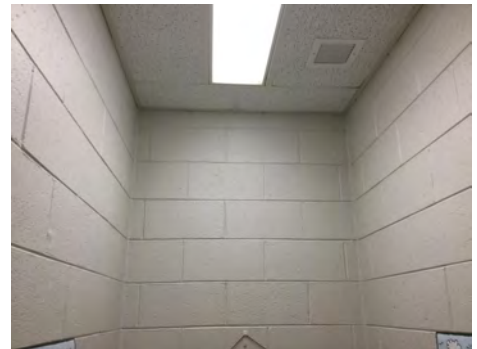
System: C3010 - Wall Finishes

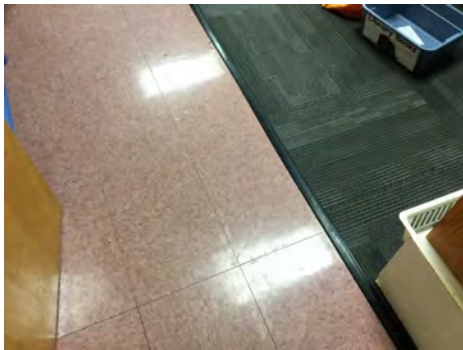
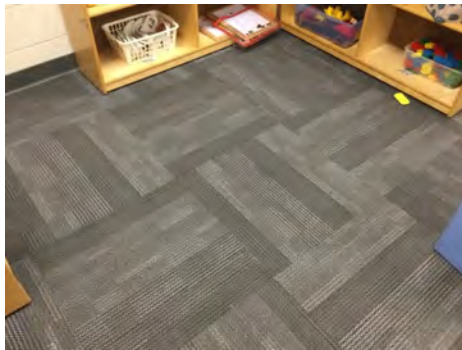
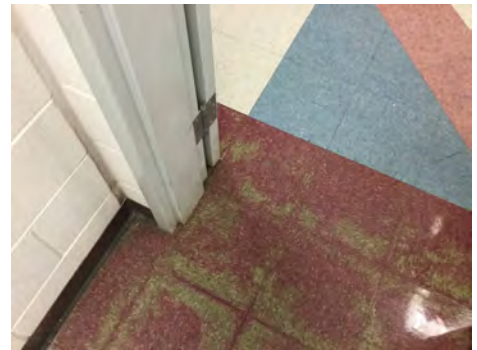
System: C3020 - Floor Finishes

Note: Carpet replaced in 2016

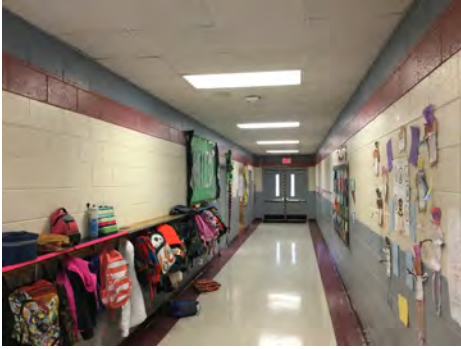
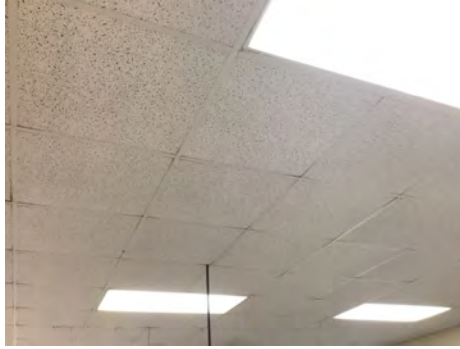
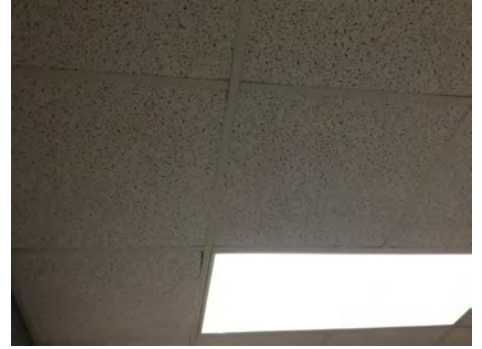
System: C3030 - Ceiling Finishes

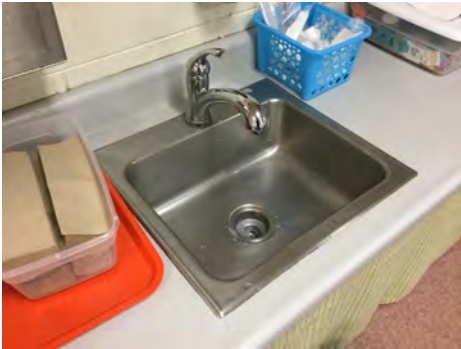
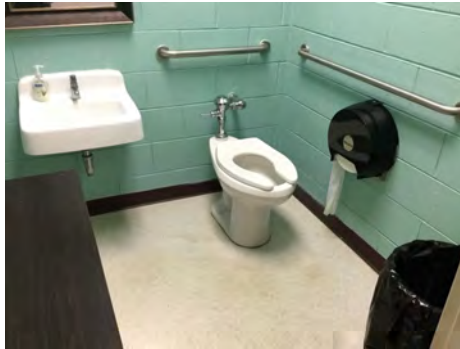
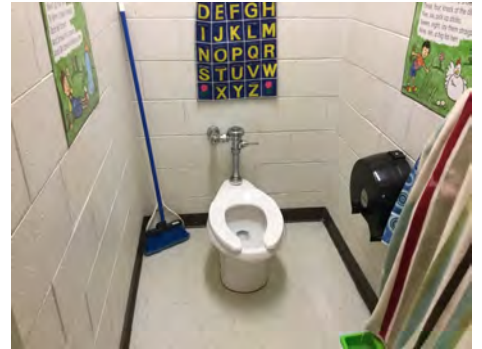
System: D2010 - Plumbing Fixtures

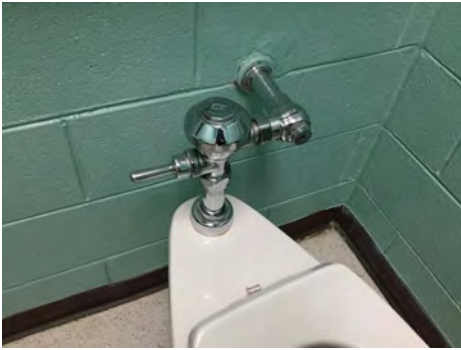
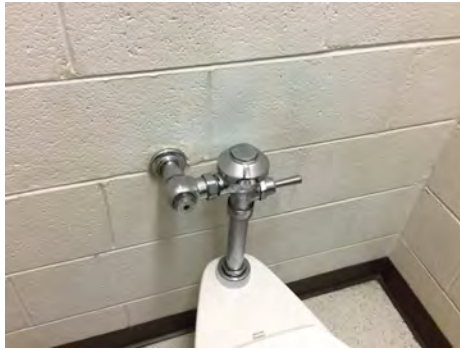
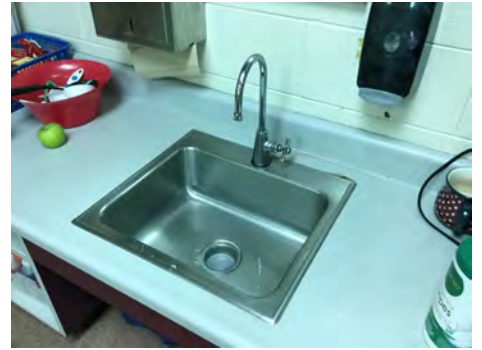
System: D2020 - Domestic Water Distribution

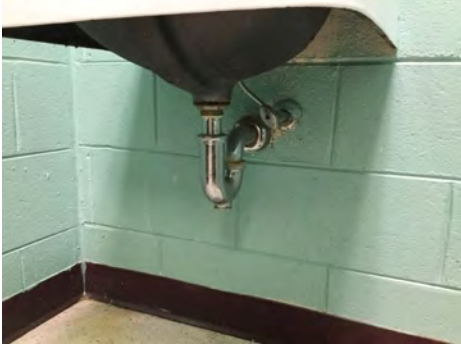
System: D2030 - Sanitary Waste

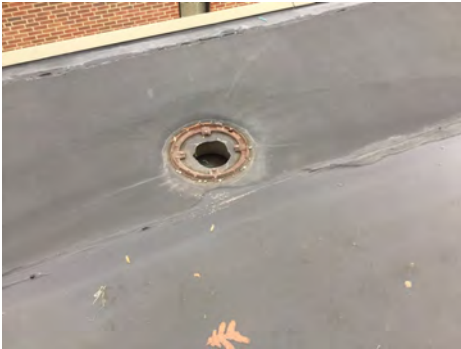
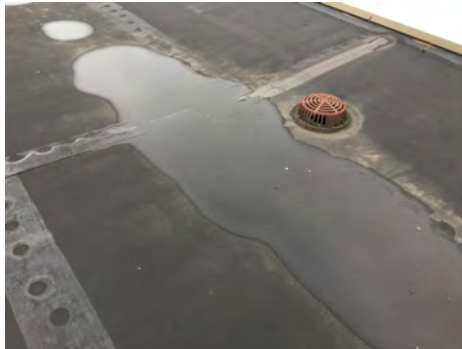
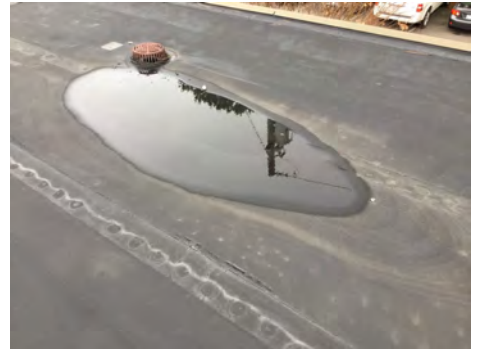
System: D2040 - Rain Water Drainage

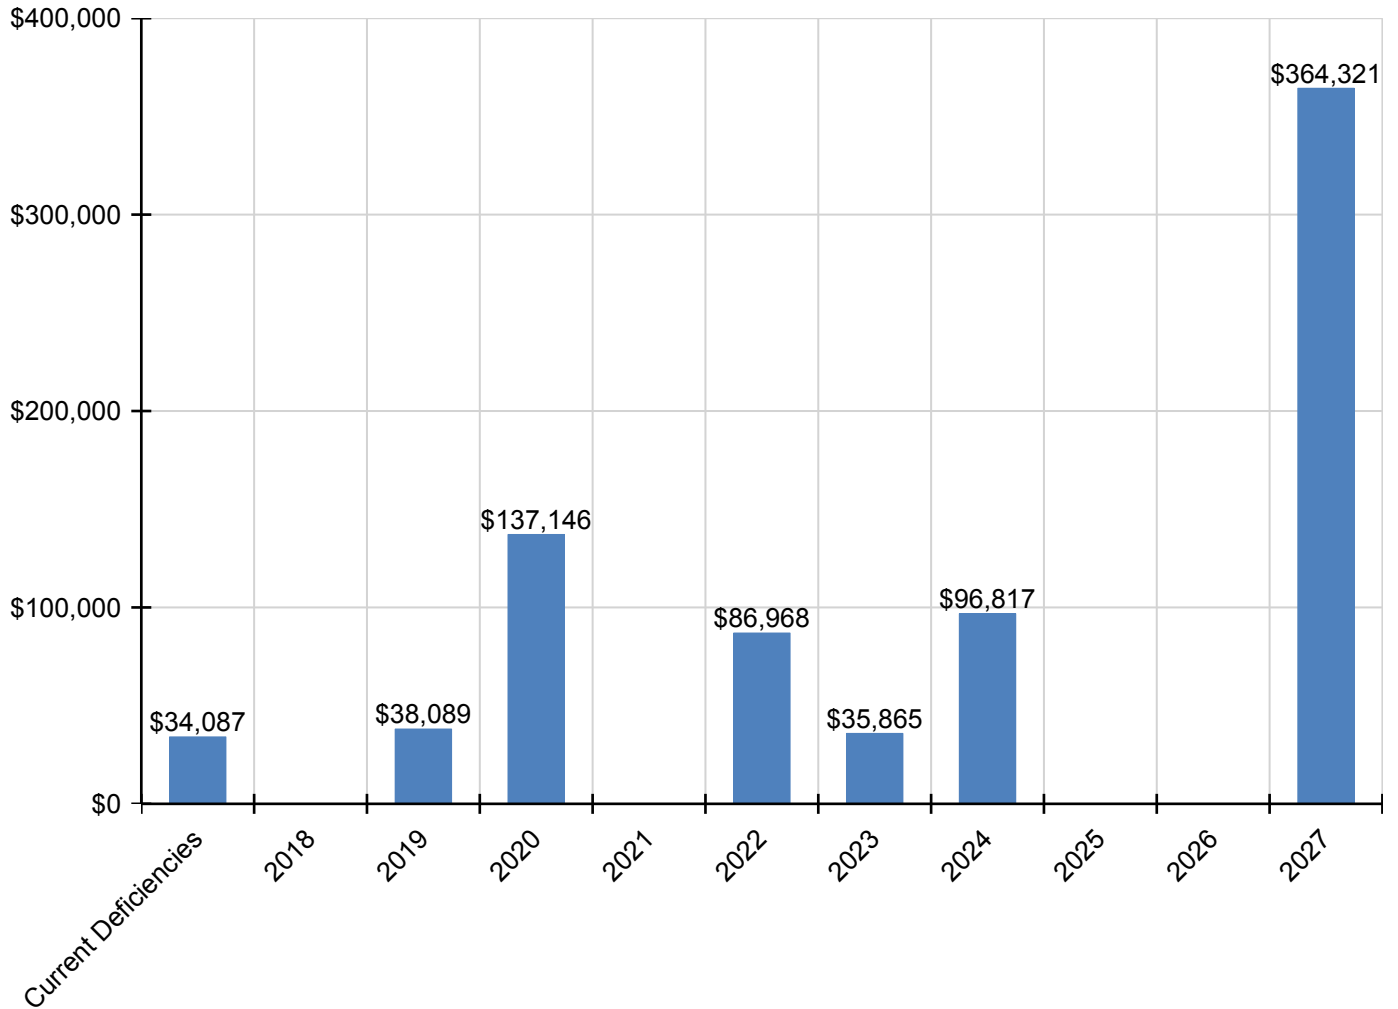
Forecasted Capital Renewal Requirement

The following chart shows the current building deficiencies and forecasting capital renewal or sustainment requirements over the next ten years.

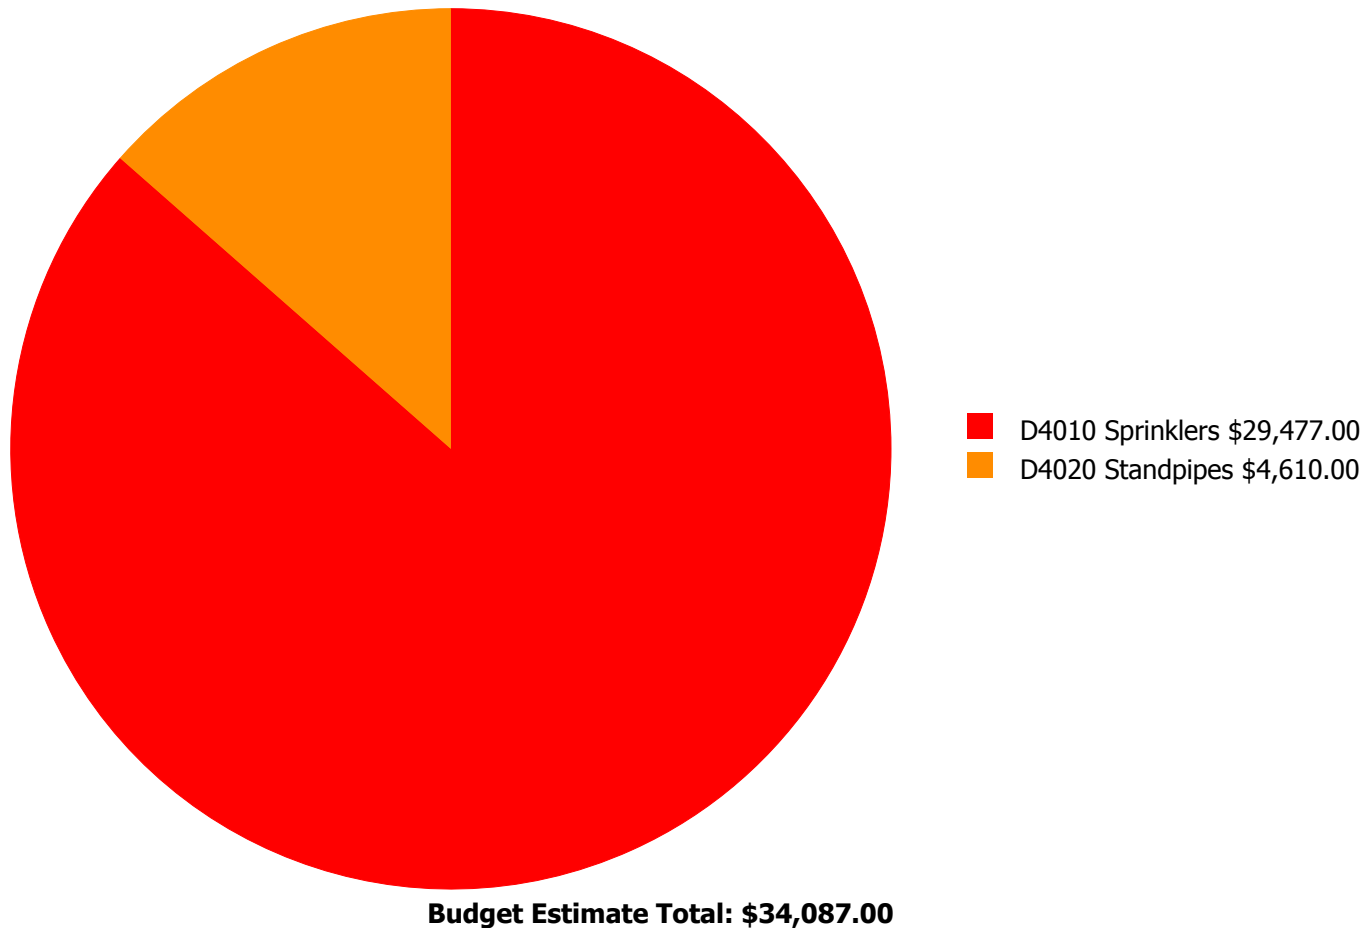
Deficiency Summary by System

Current deficiencies included assemblies that have reached or exceeded their design life or components of the assemblies that are in need of repair. Assemblies that have reached their design life are identified as current deficiencies and assigned the distress 'Beyond Useful Life'. The following chart lists all current deficiencies associated with this facility.

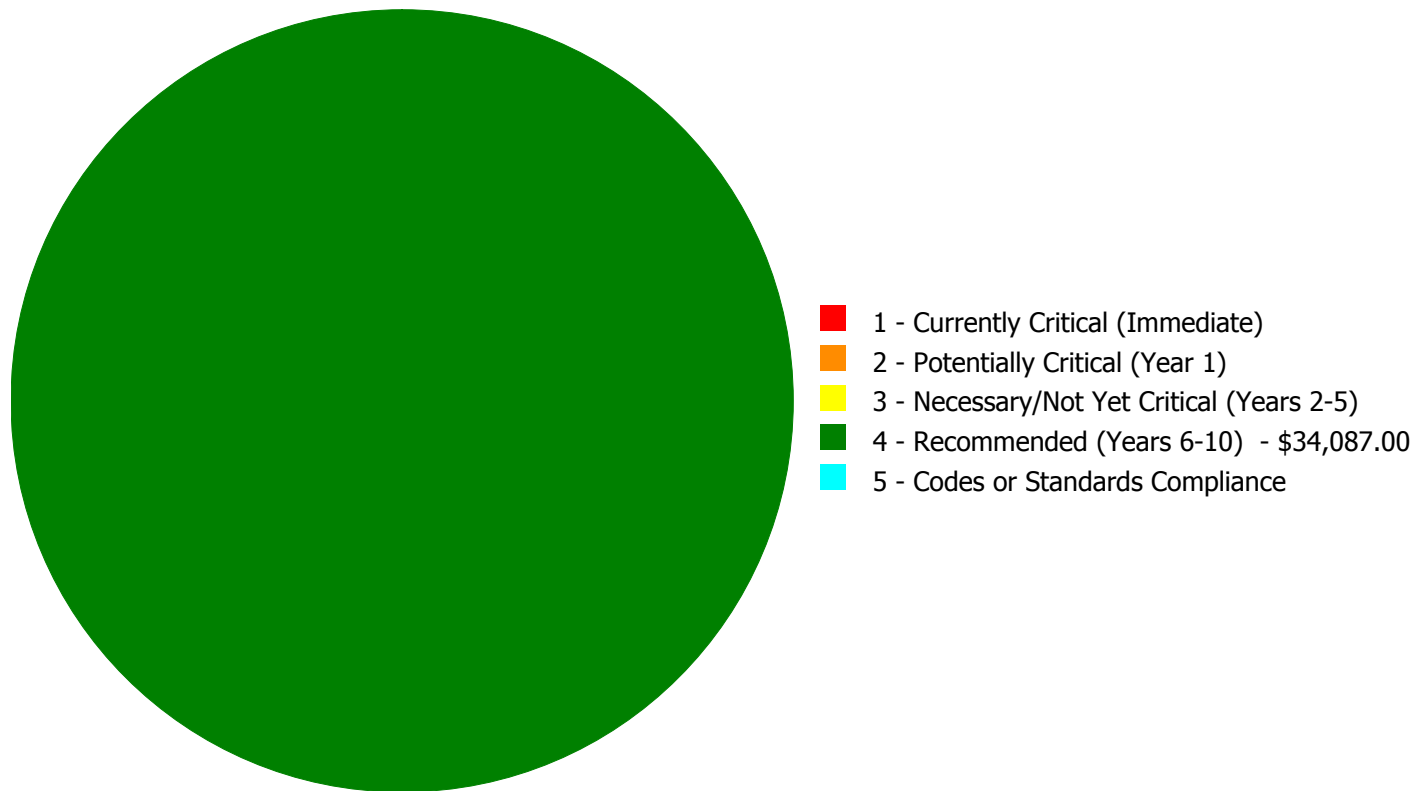
Deficiency Summary by Priority

The following chart shows the total repair costs broken down by priority. Assessors assigned deficiencies within eCOMET to one of the following priority categories:

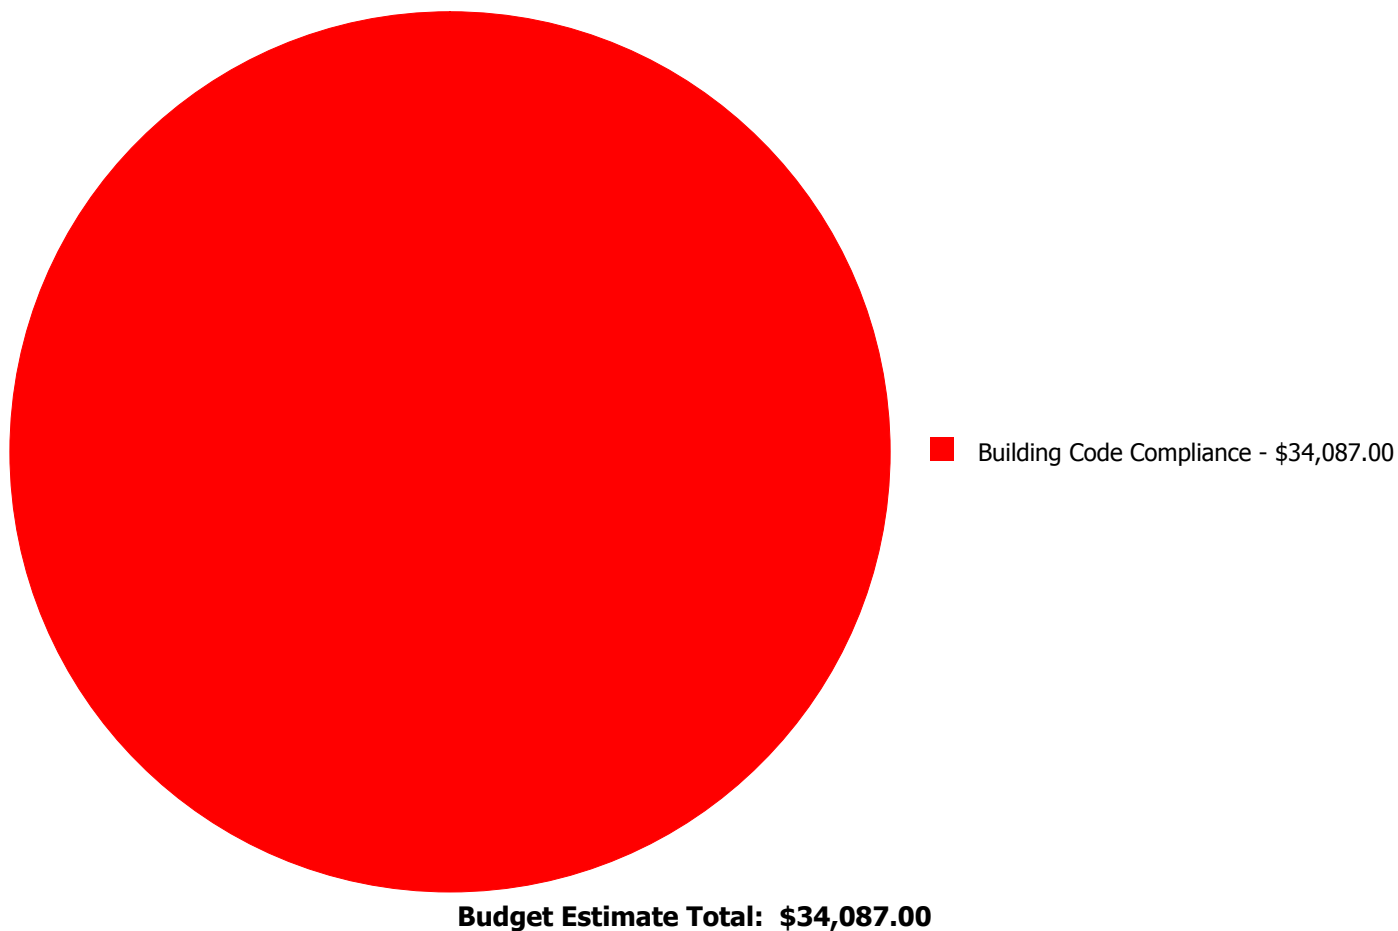
Deficiency Summary by Category

The following chart shows the total repair costs broken down by deficiency categories. Assessors assigned deficiencies to one of the following categories:

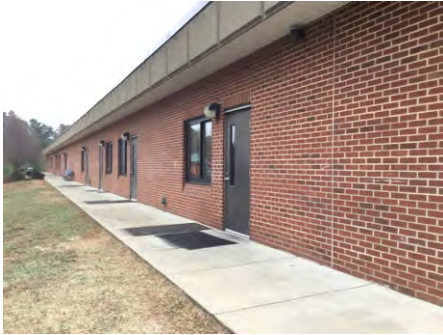
1). Northwest Elevation - Jan 23, 2017

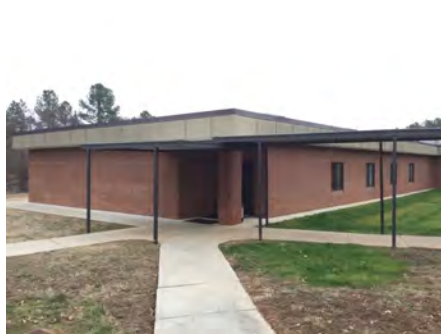
2). Southwest Elevation - Jan 23, 2017

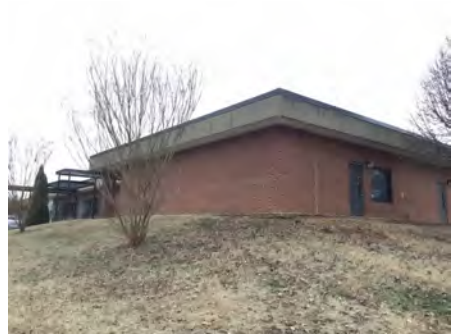
3). East Elevation - Jan 23, 2017

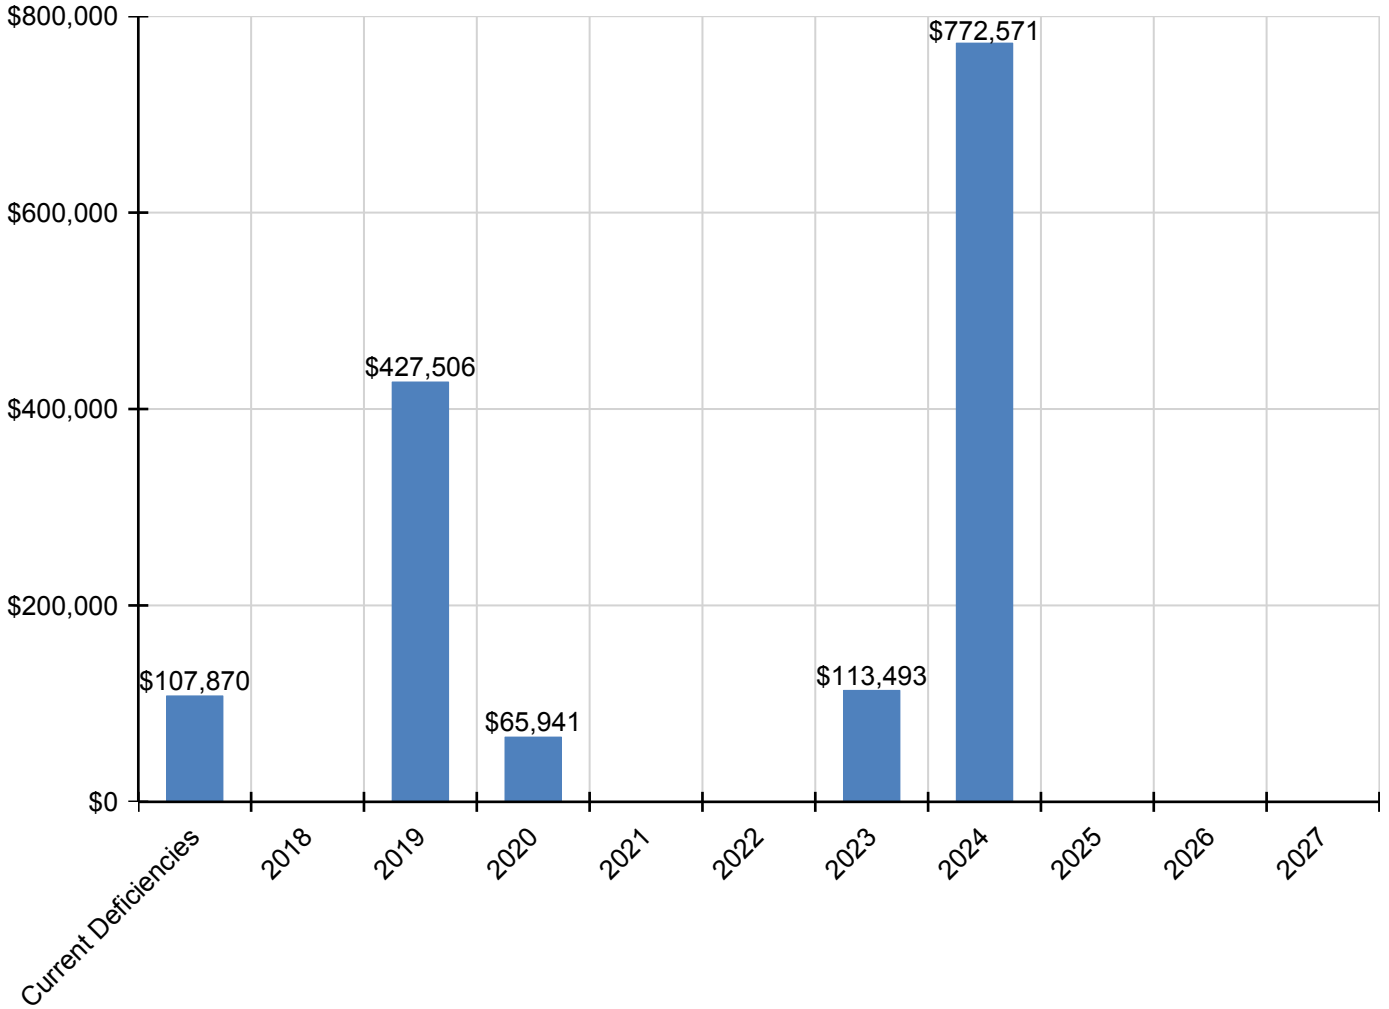
Forecasted Capital Renewal Requirement

The following chart shows the current building deficiencies and forecasting capital renewal or sustainment requirements over the next ten years.

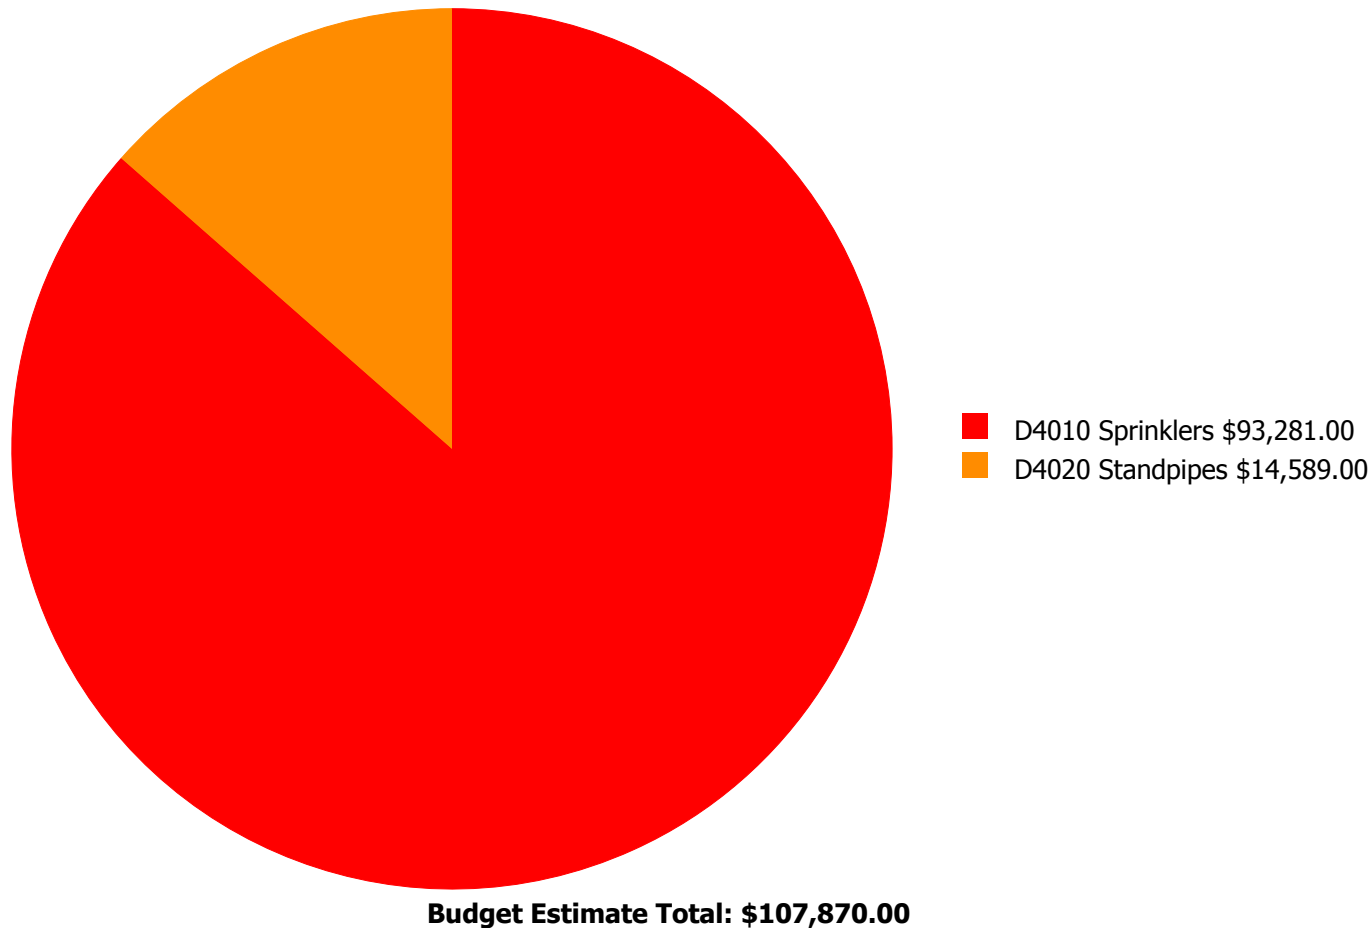
Deficiency Summary by System

Current deficiencies included assemblies that have reached or exceeded their design life or components of the assemblies that are in need of repair. Assemblies that have reached their design life are identified as current deficiencies and assigned the distress 'Beyond Useful Life'. The following chart lists all current deficiencies associated with this facility.

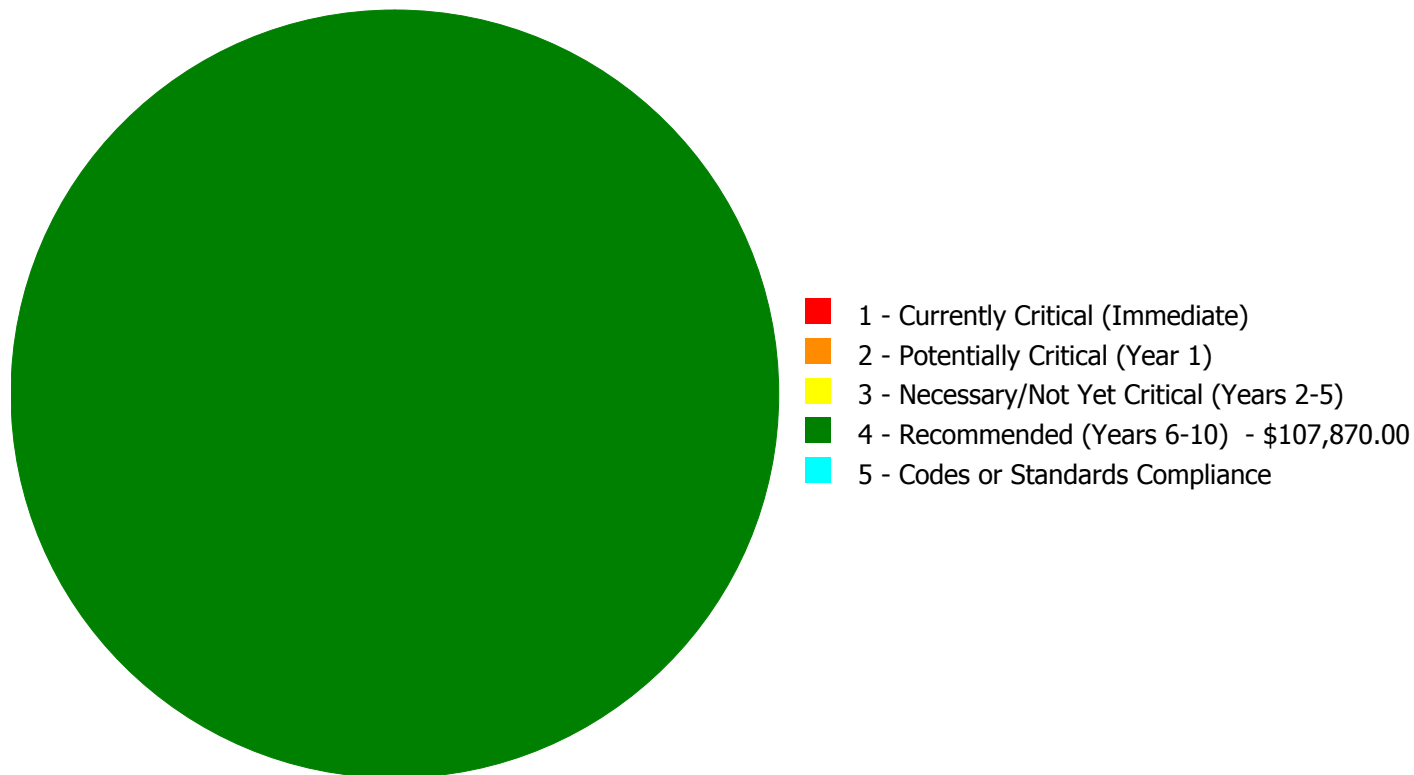
Deficiency Summary by Priority

The following chart shows the total repair costs broken down by priority. Assessors assigned deficiencies within eCOMET to one of the following priority categories:

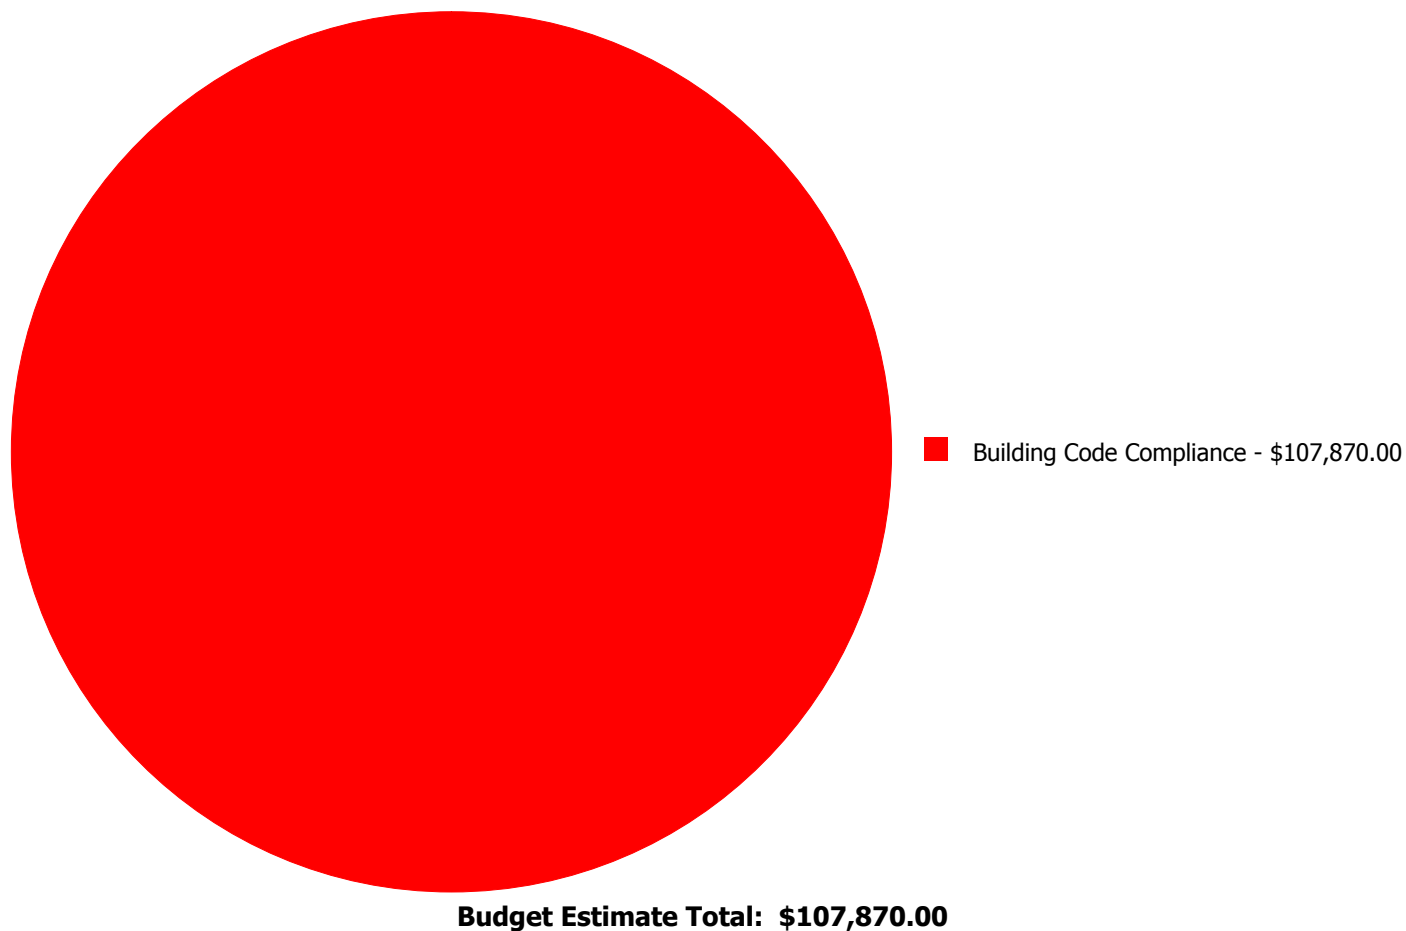
Deficiency Summary by Category

The following chart shows the total repair costs broken down by deficiency categories. Assessors assigned deficiencies to one of the following categories:

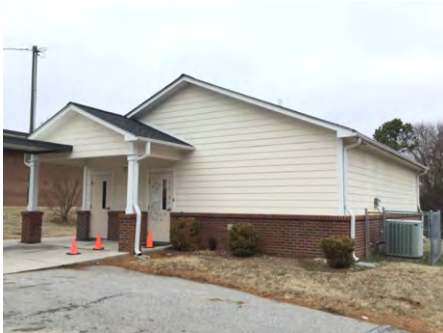
1). South Elevation - Jan 23, 2017

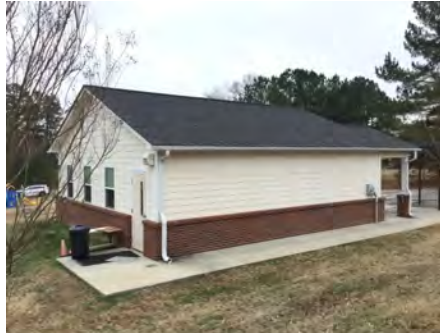
2). West Elevation - Jan 23, 2017

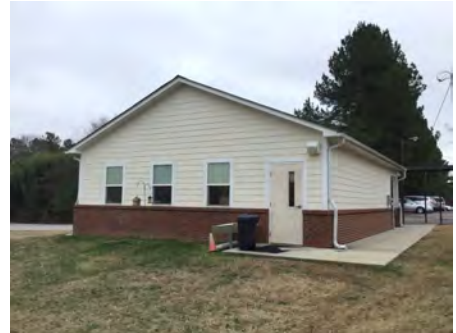
3). North Elevation - Jan 23, 2017

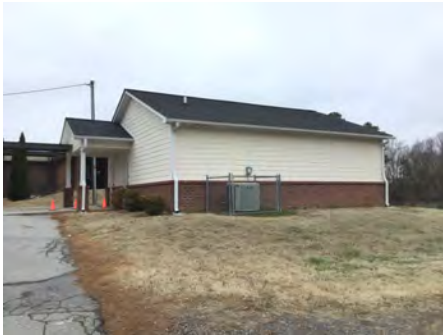
4). East Elevation - Jan 23, 2017
