NC School District/300 Davie County/High School

Central Davie Academy

Campus Assessment Report

March 7, 2017

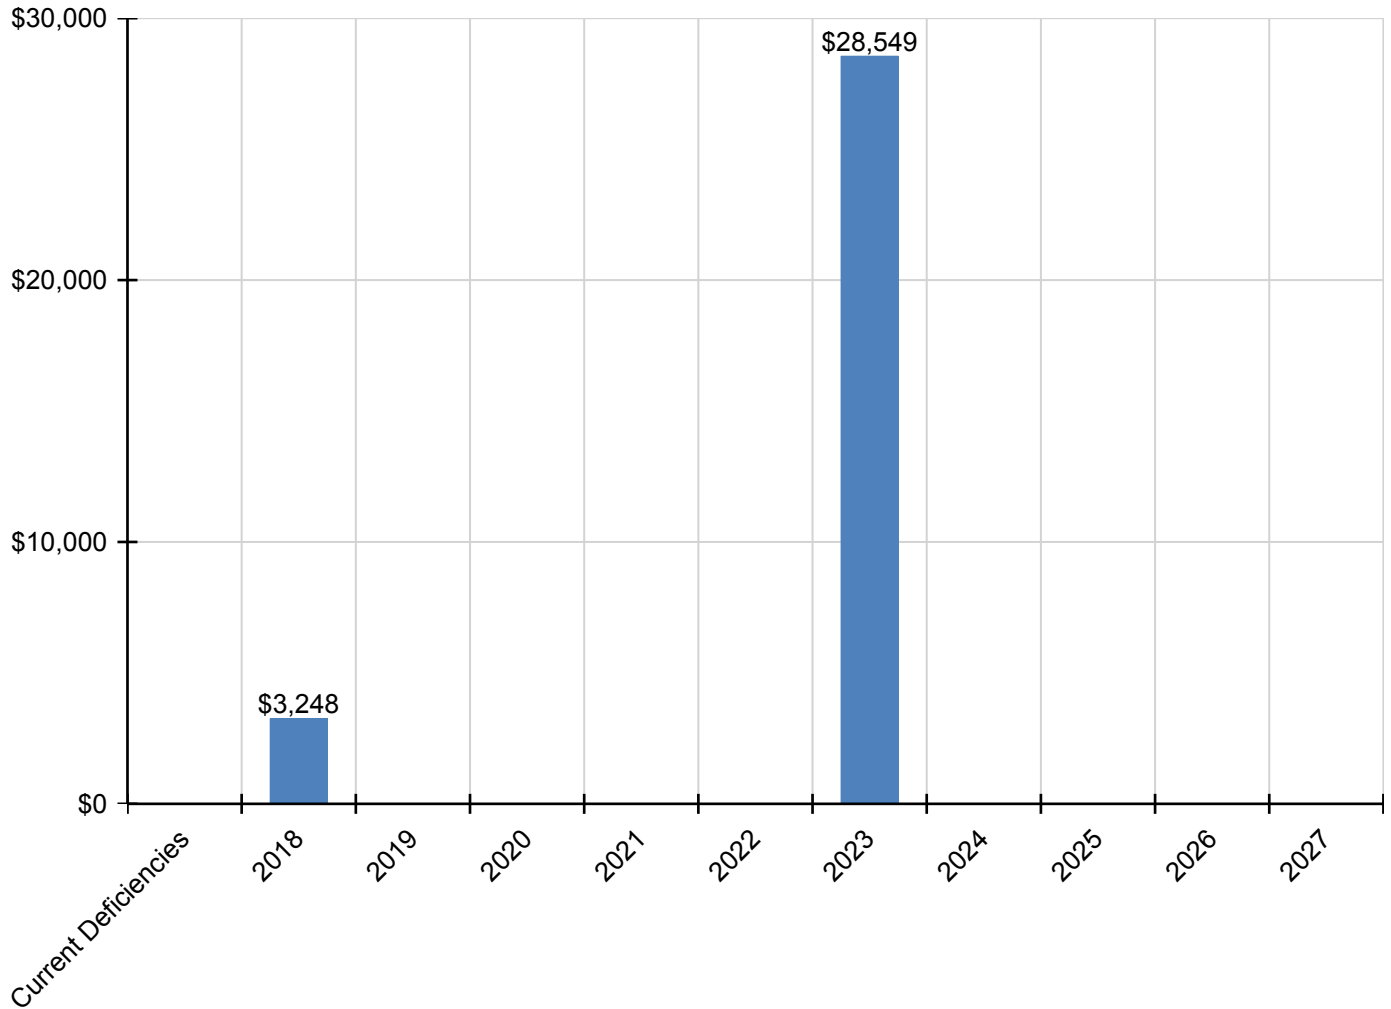
Forecasted Capital Renewal Requirement

The following chart shows the current building deficiencies and forecasting capital renewal or sustainment requirements over the next ten years.

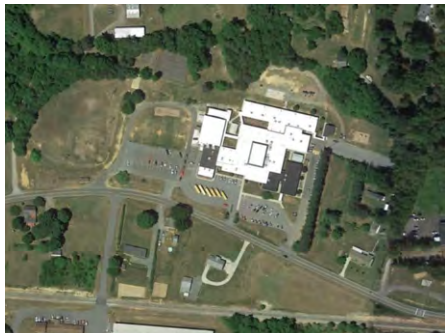
- 1). Aerial Image of Shadey Grove Elementary
- Feb 24, 2017

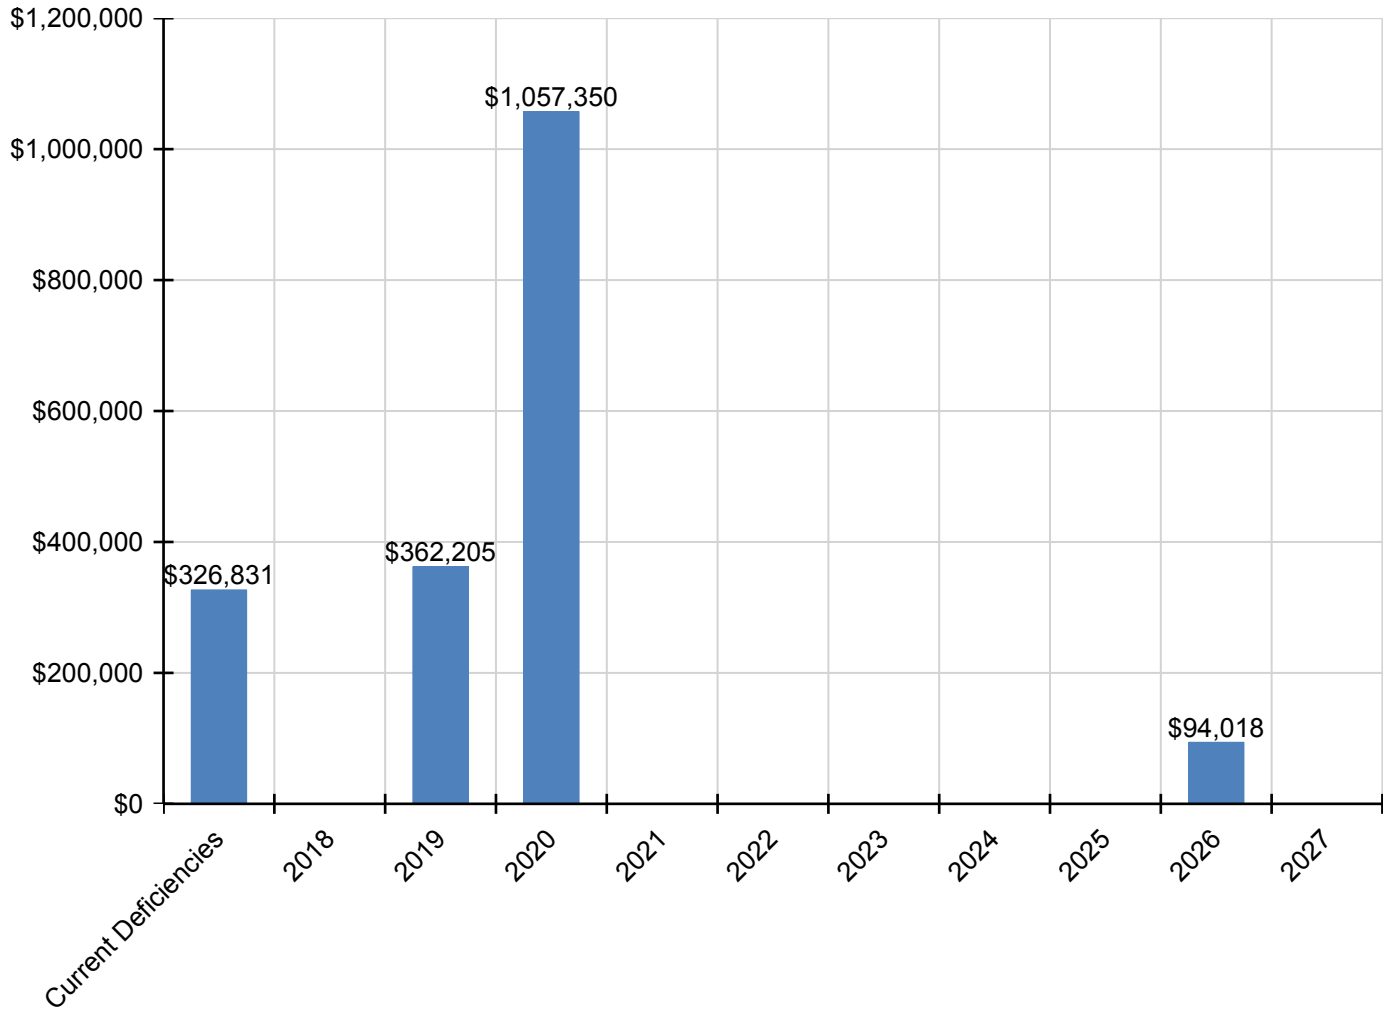
Forecasted Capital Renewal Requirement

The following chart shows the current building deficiencies and forecasting capital renewal or sustainment requirements over the next ten years.

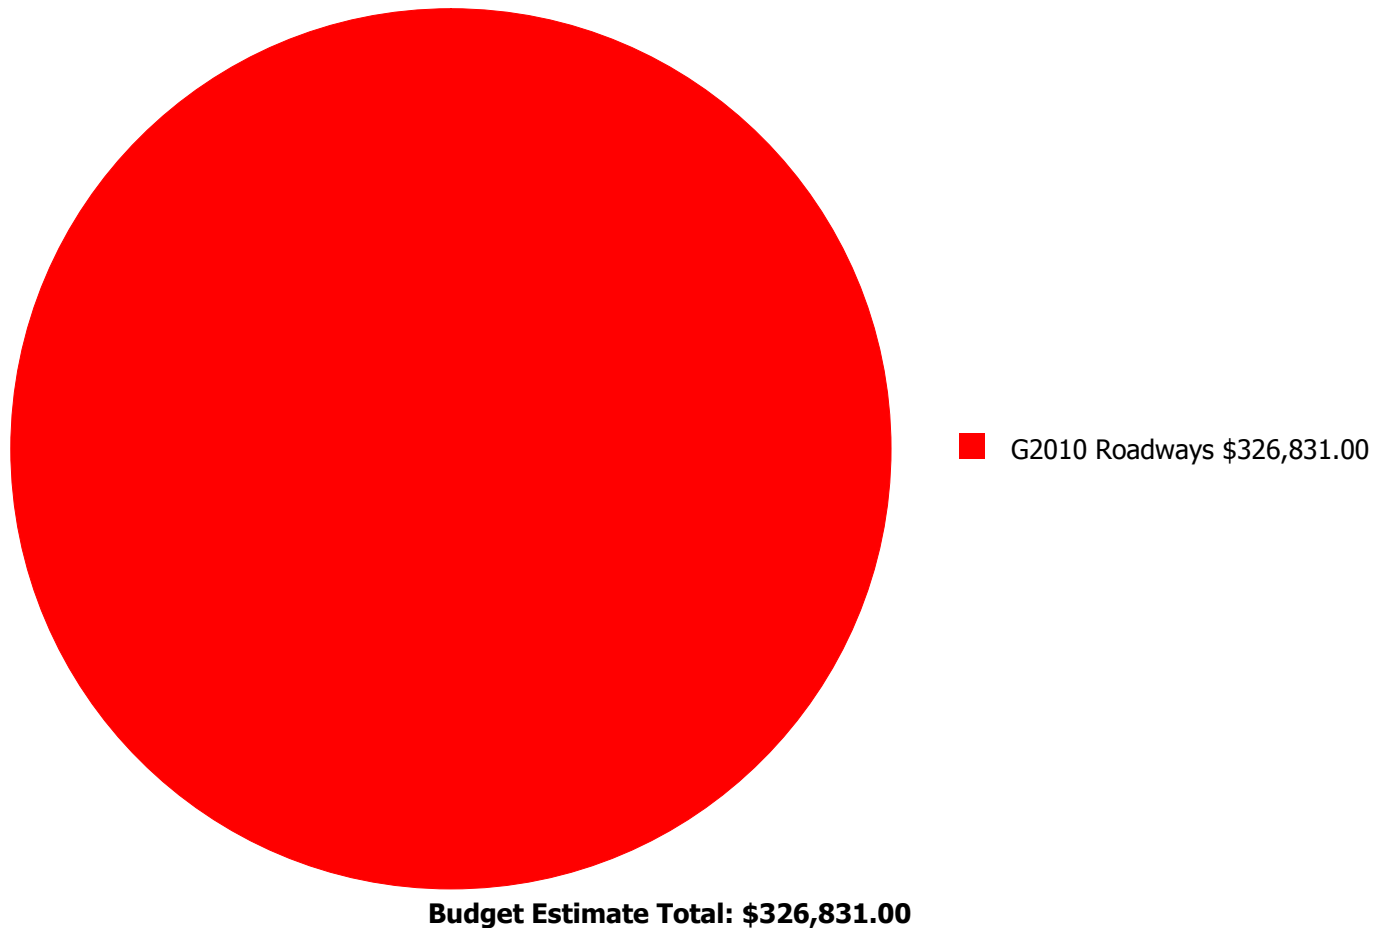
Deficiency Summary by System

Current deficiencies included assemblies that have reached or exceeded their design life or components of the assemblies that are in need of repair. Assemblies that have reached their design life are identified as current deficiencies and assigned the distress 'Beyond Useful Life'. The following chart lists all current deficiencies associated with this facility.

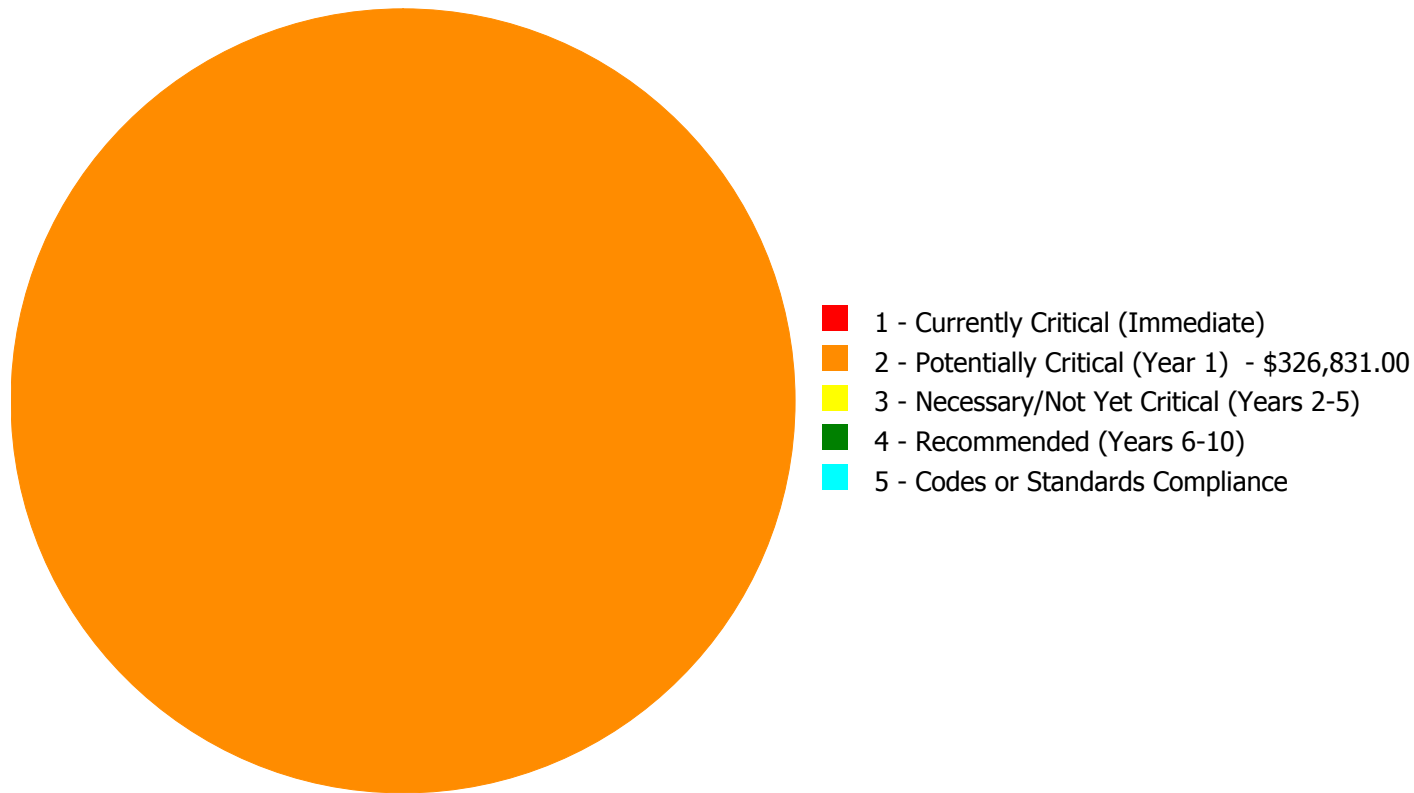
Deficiency Summary by Priority

The following chart shows the total repair costs broken down by priority. Assessors assigned deficiencies within eCOMET to one of the following priority categories:

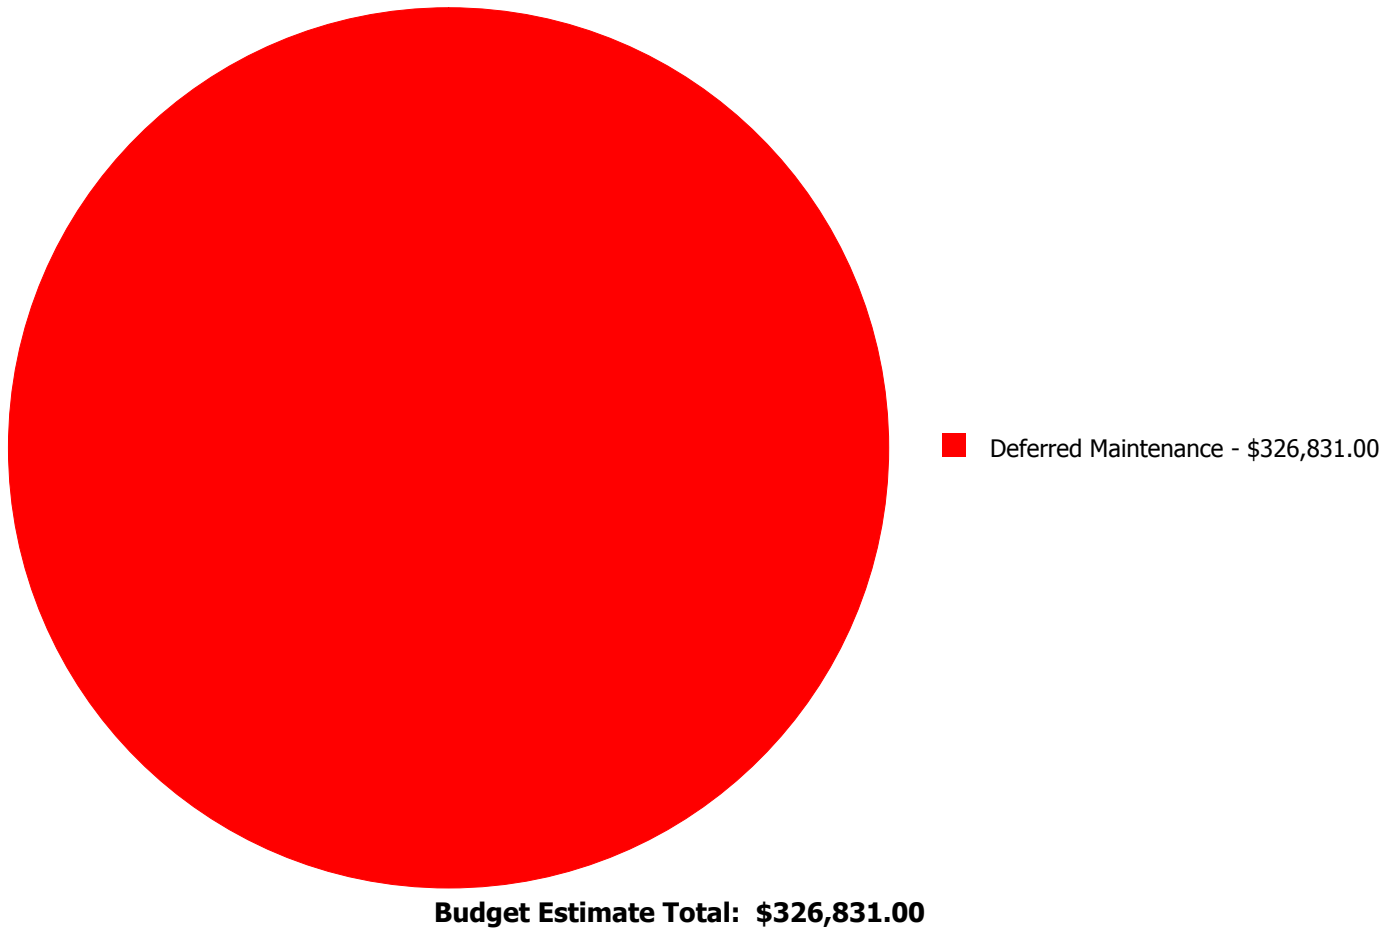
Deficiency Summary by Category

The following chart shows the total repair costs broken down by deficiency categories. Assessors assigned deficiencies to one of the following categories:

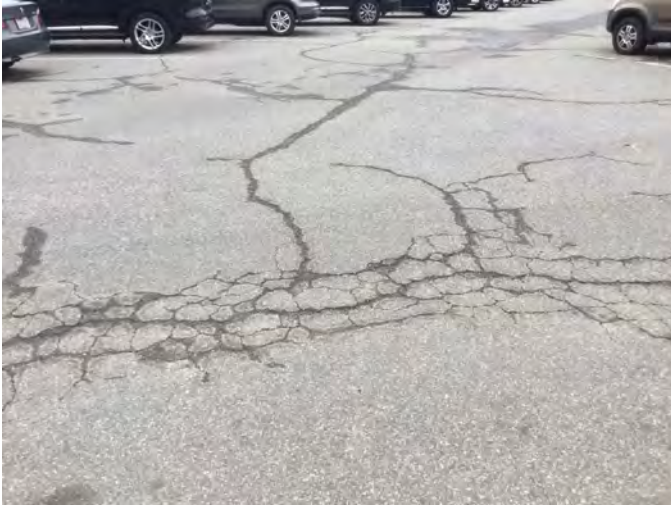
System: G2010 - Roadways

Location: Site
Distress: Beyond Service Life
Category: Deferred Maintenance
Priority: 2 - Potentially Critical (Year 1)
Correction: Renew System
Qty: 77,984.00
Unit of Measure: S.F.
Estimate: \$326,831.00
Assessor Name: Eduardo Lopez
Date Created: 01/24/2017

Notes: The asphalt roadway is aged, has many road cuts, cracks, potholes and repairs, and should be replaced.

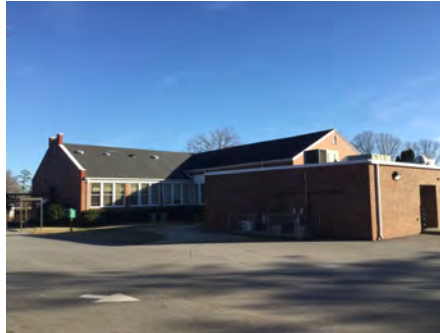
3). West Elevation, 1940 Bldg - Feb 10, 2017

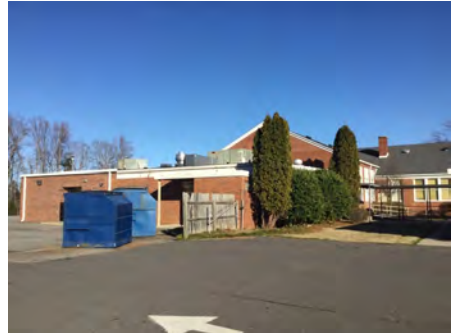
4). West Elevation, Media - Feb 10, 2017

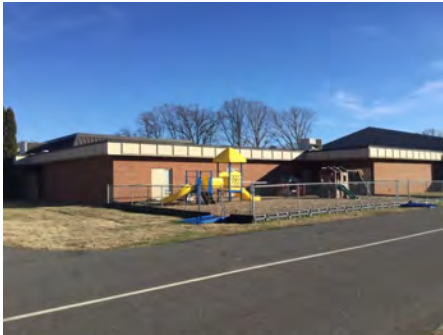
5). Southwest Elevation, Gym - Feb 10, 2017

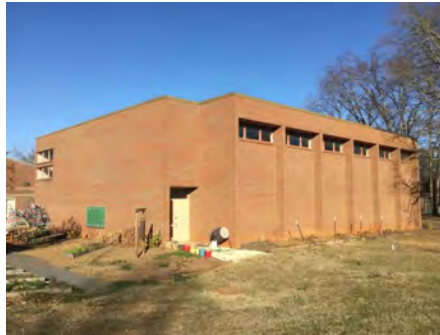
6). Southeast Elevation, Gym - Feb 10, 2017

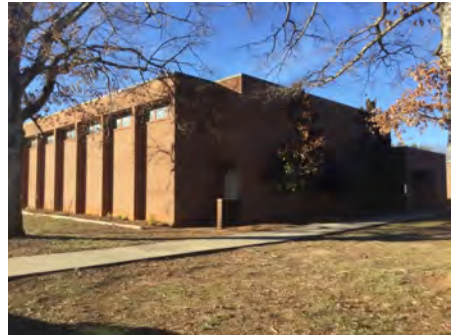
7). Northeast Elevation, Gym - Feb 10, 2017

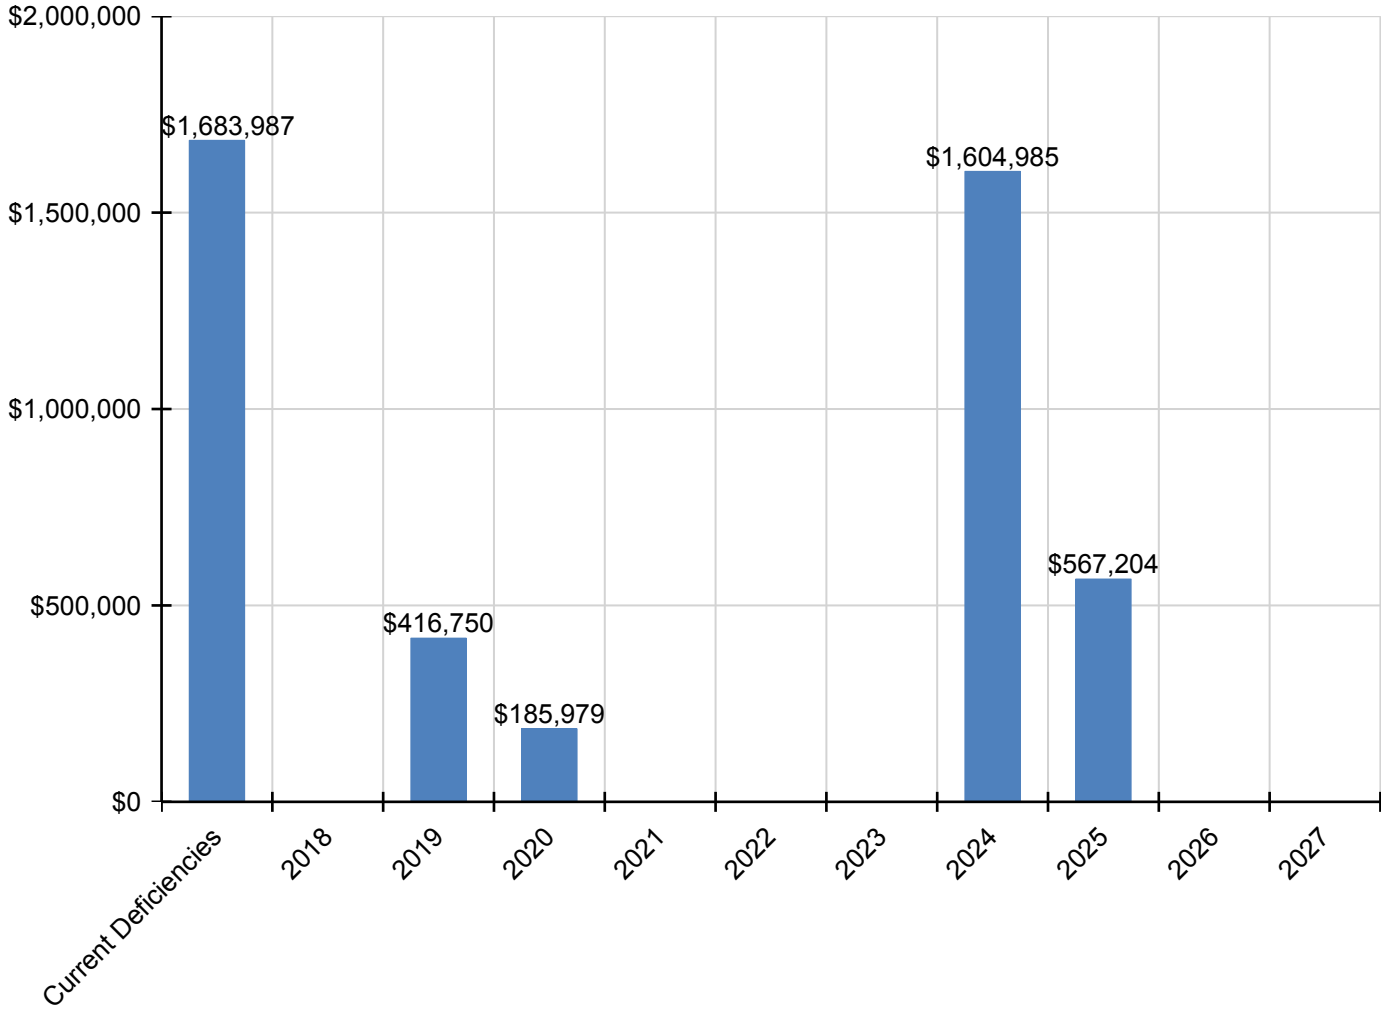
Forecasted Capital Renewal Requirement

The following chart shows the current building deficiencies and forecasting capital renewal or sustainment requirements over the next ten years.

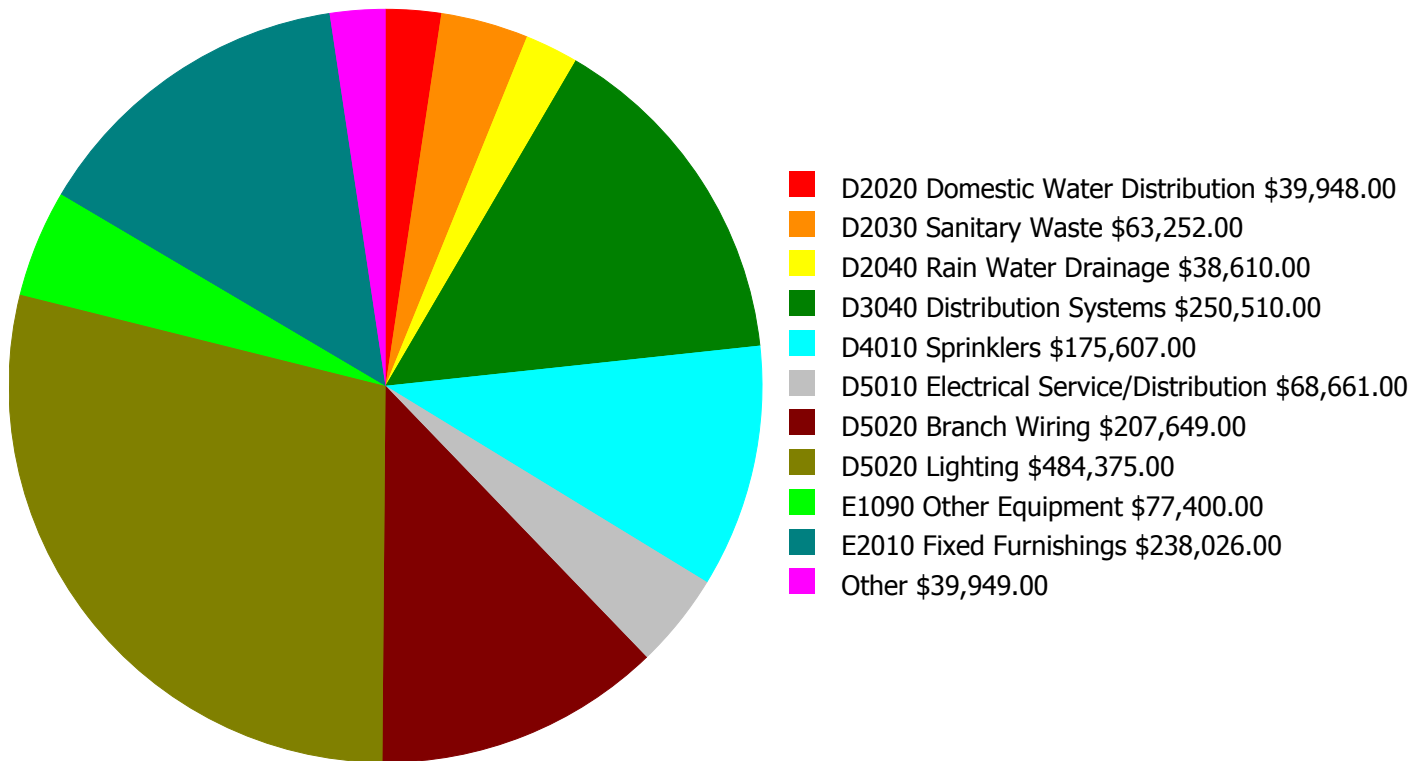
Deficiency Summary by System

Current deficiencies included assemblies that have reached or exceeded their design life or components of the assemblies that are in need of repair. Assemblies that have reached their design life are identified as current deficiencies and assigned the distress 'Beyond Useful Life'. The following chart lists all current deficiencies associated with this facility.

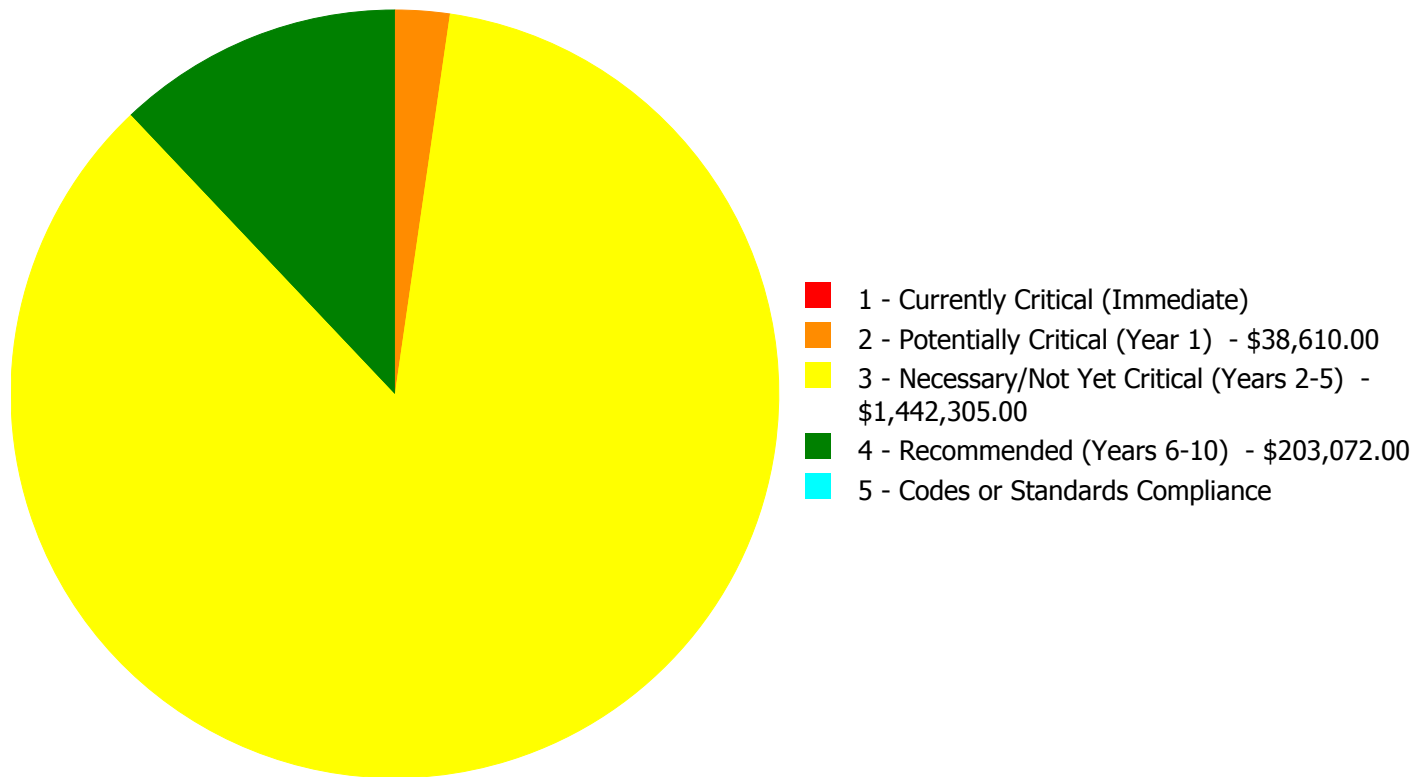
Deficiency Summary by Priority

The following chart shows the total repair costs broken down by priority. Assessors assigned deficiencies within eCOMET to one of the following priority categories:

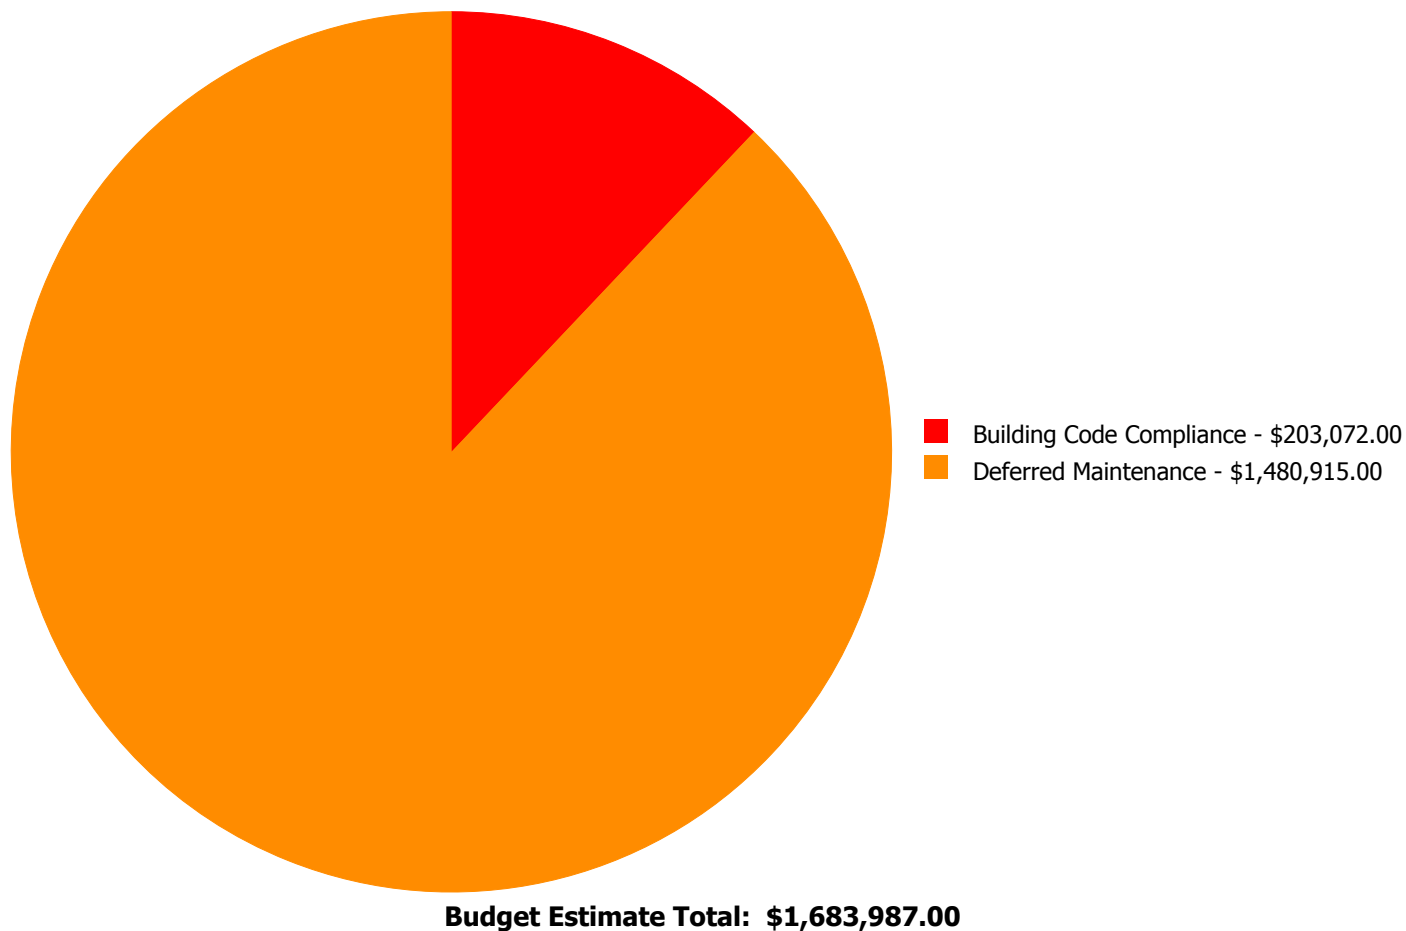
Deficiency Summary by Category

The following chart shows the total repair costs broken down by deficiency categories. Assessors assigned deficiencies to one of the following categories:

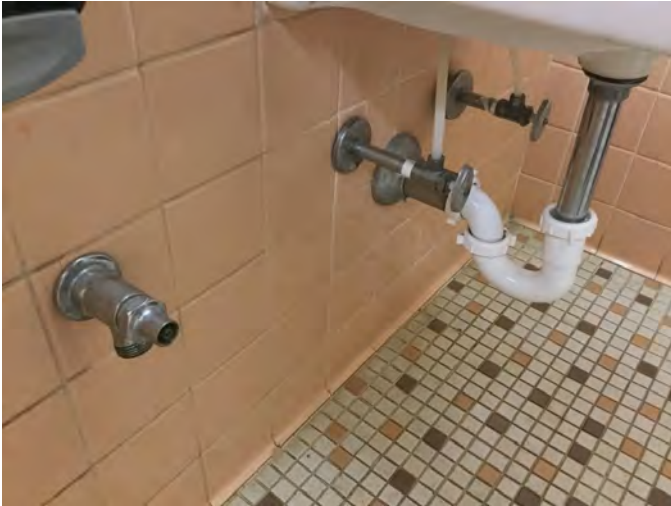
System: D2020 - Domestic Water Distribution

Location: Throughout the Building
Distress: Beyond Service Life
Category: Deferred Maintenance
Priority: 3 - Necessary/Not Yet Critical (Years 2-5)
Correction: Renew System
Qty: 37,830.00
Unit of Measure: S.F.
Estimate: \$39,948.00
Assessor Name: Eduardo Lopez
Date Created: 02/15/2017

Notes: The domestic water distribution system is aged and should be replaced.

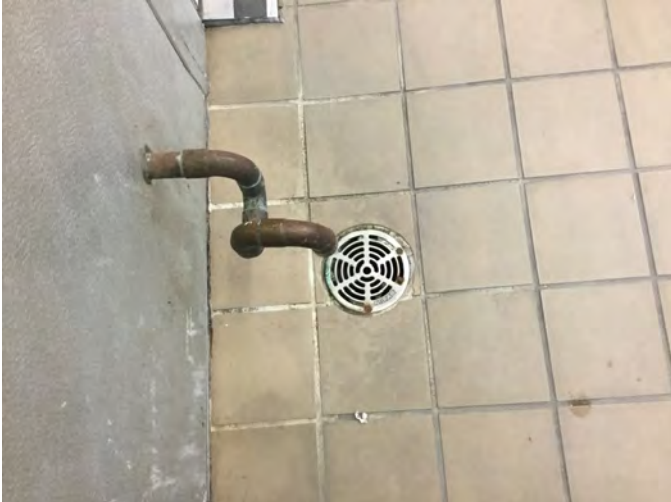
System: D2030 - Sanitary Waste

Location: Throughout the Building
Distress: Beyond Service Life
Category: Deferred Maintenance
Priority: 3 - Necessary/Not Yet Critical (Years 2-5)
Correction: Renew System
Qty: 37,830.00
Unit of Measure: S.F.
Estimate: \$63,252.00
Assessor Name: Eduardo Lopez
Date Created: 02/15/2017

Notes: The sanitary waste system is beyond its expected service life and should be replaced.

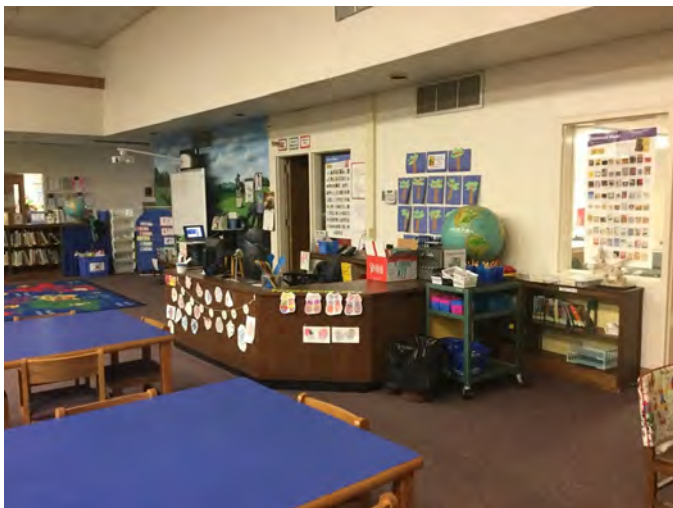
System: E1020 - Institutional Equipment

Location: Throughout the Building
Distress: Beyond Service Life
Category: Deferred Maintenance
Priority: 3 - Necessary/Not Yet Critical (Years 2-5)
Correction: Renew System
Qty: 37,830.00
Unit of Measure: S.F.
Estimate: \$12,484.00
Assessor Name: Eduardo Lopez
Date Created: 02/15/2017

Notes: The institutional equipment is in deteriorating conditions and should be replaced.

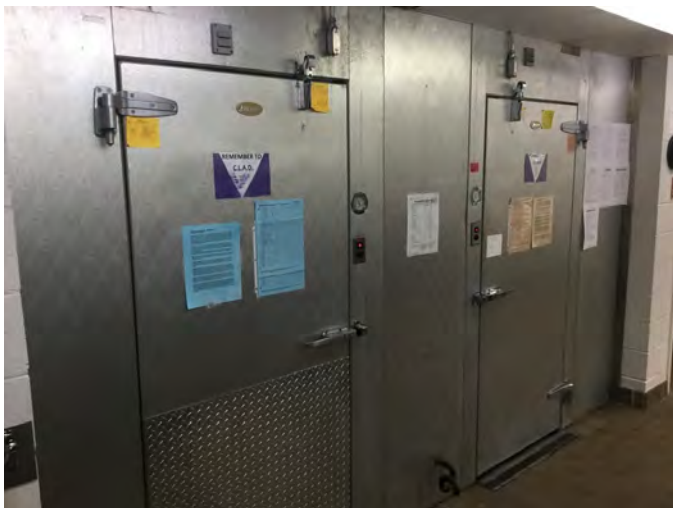
System: E1090 - Other Equipment

Location: Throughout the Building
Distress: Beyond Service Life
Category: Deferred Maintenance
Priority: 3 - Necessary/Not Yet Critical (Years 2-5)
Correction: Renew System
Qty: 37,830.00
Unit of Measure: S.F.
Estimate: \$77,400.00
Assessor Name: Eduardo Lopez
Date Created: 02/15/2017

Notes: The other equipment is in deteriorating conditions and should be replaced.

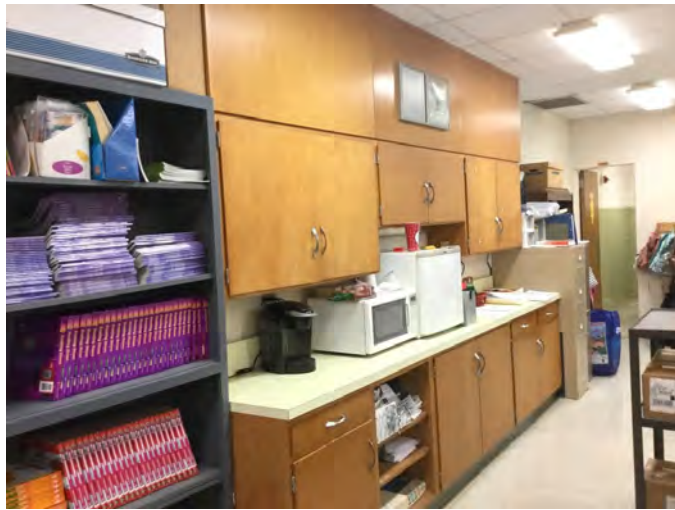
System: E2010 - Fixed Furnishings

Location: Throughout the Building
Distress: Beyond Service Life
Category: Deferred Maintenance
Priority: 3 - Necessary/Not Yet Critical (Years 2-5)
Correction: Renew System
Qty: 37,830.00
Unit of Measure: S.F.
Estimate: \$238,026.00
Assessor Name: Eduardo Lopez
Date Created: 02/15/2017

Notes: The fixed furnishings are aged, in marginal condition, and should be replaced.

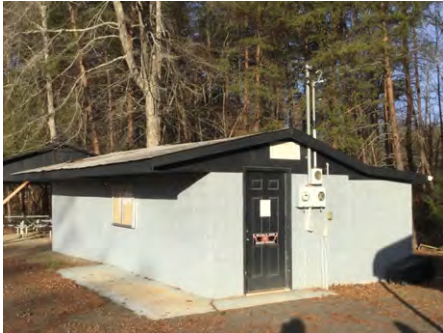
1). Southeast Elevation - Feb 10, 2017

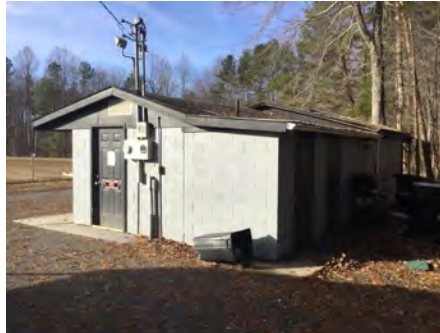
2). Northeast Elevation - Feb 10, 2017

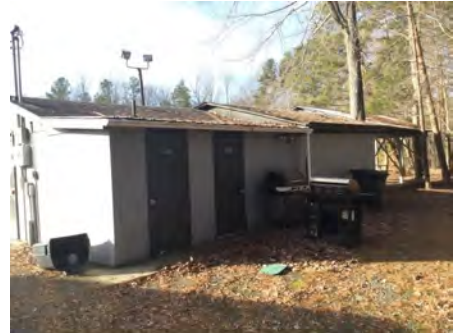
3). North Elevation - Feb 10, 2017

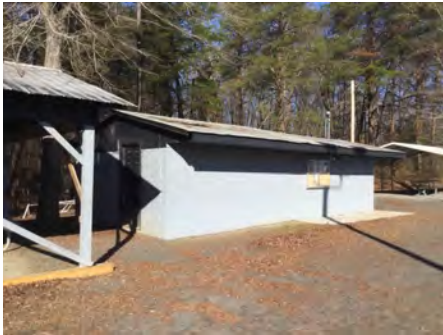
4). Southwest Elevation - Feb 10, 2017

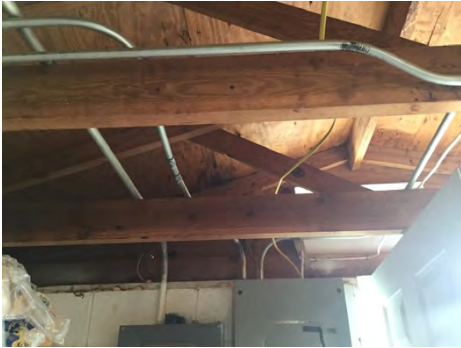
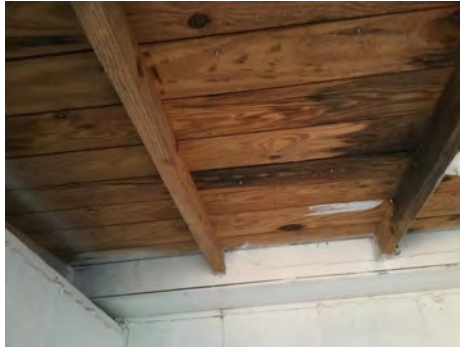
System: B1020 - Roof Construction

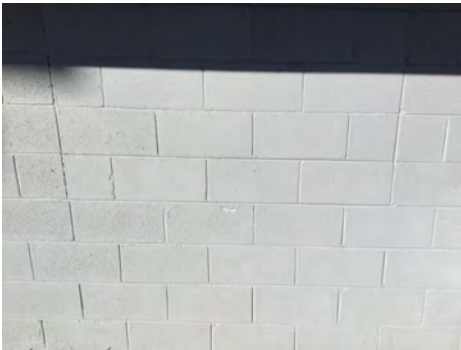
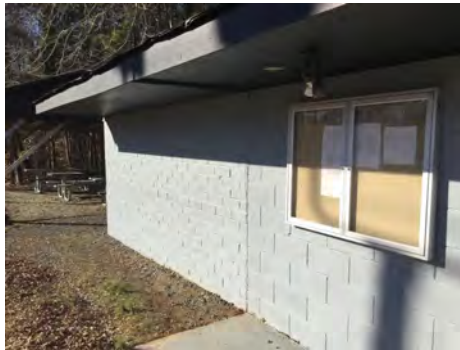
System: B2010 - Exterior Walls

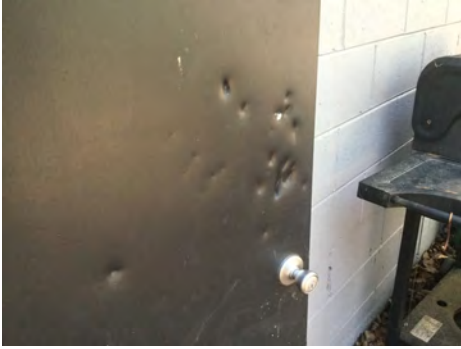
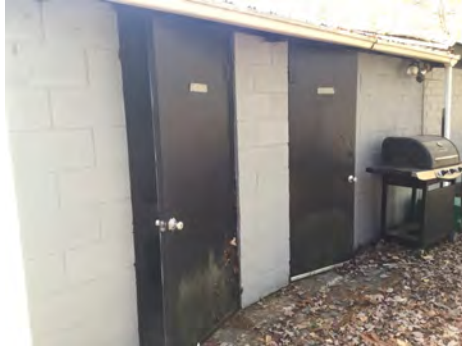
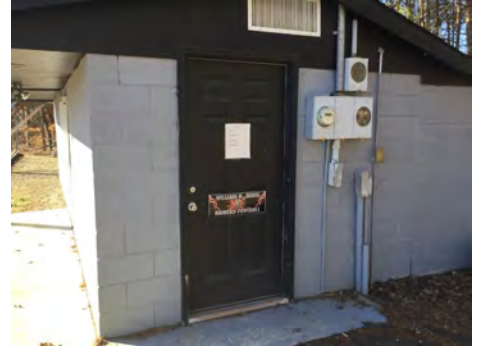
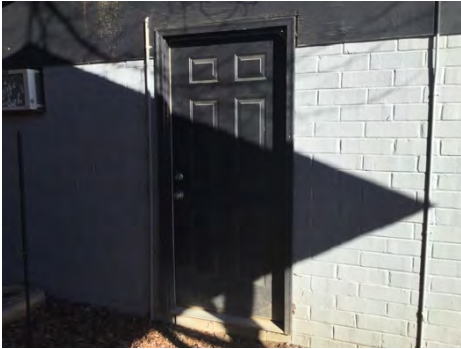
System: B2030 - Exterior Doors

Notes: The exterior doors are aged, rusted or damaged and should be replaced.

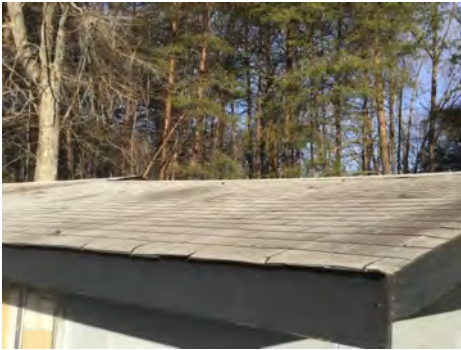
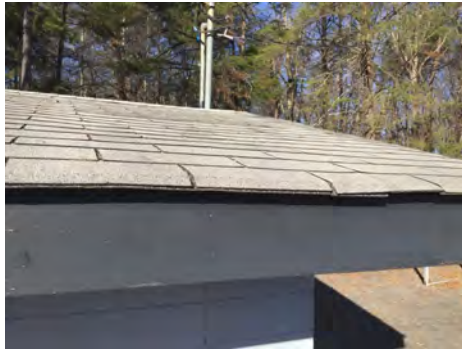
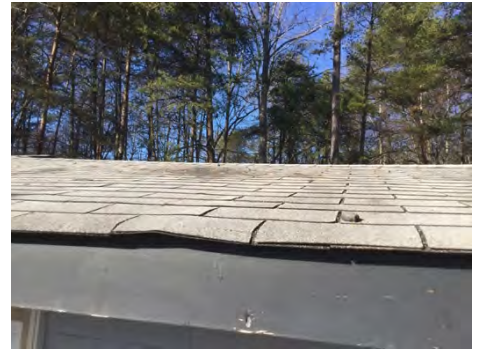
System: B3010140 - Asphalt Shingles

Notes: The asphalt shingles roof coverings are aging, showing signs of failure and should be replaced.

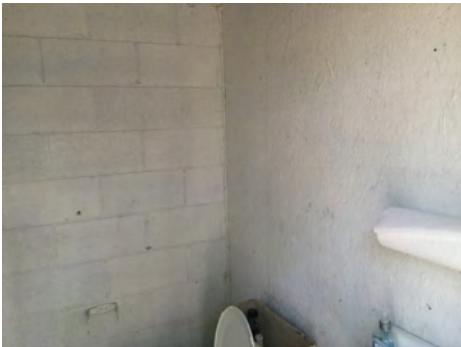
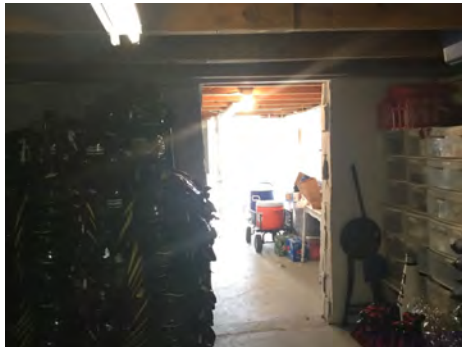
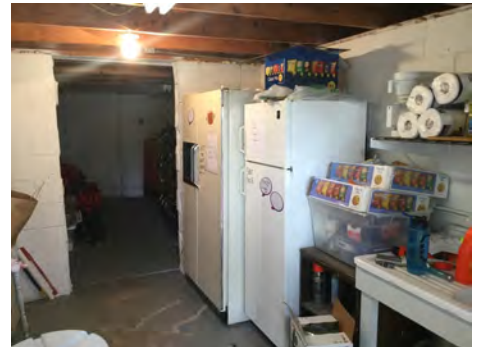
System: C1010 - Partitions

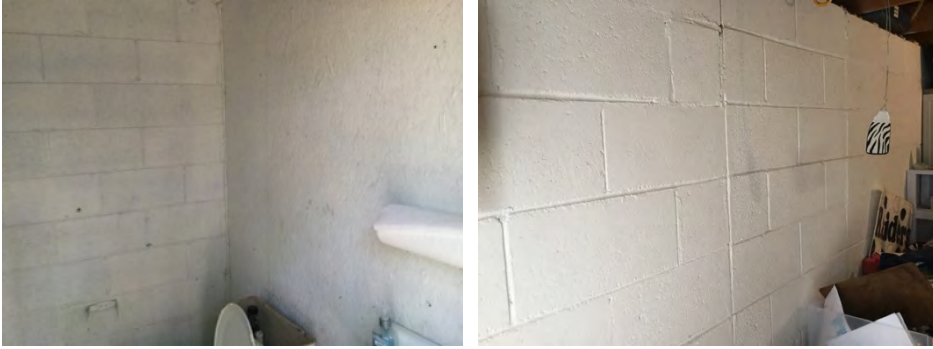
System: C3010 - Wall Finishes

Notes: The wall finishes are aged, scuffed, fading, stained and should be replaced.

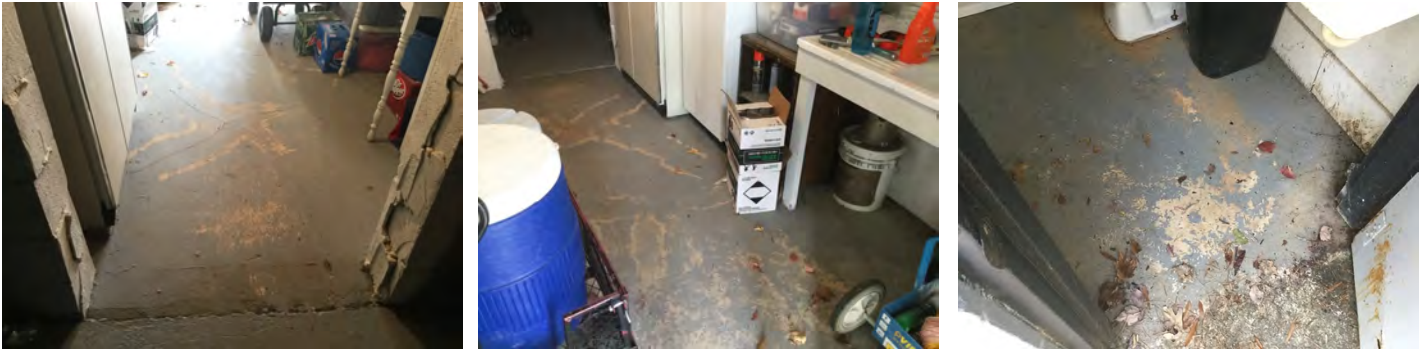
System: C3020 - Floor Finishes

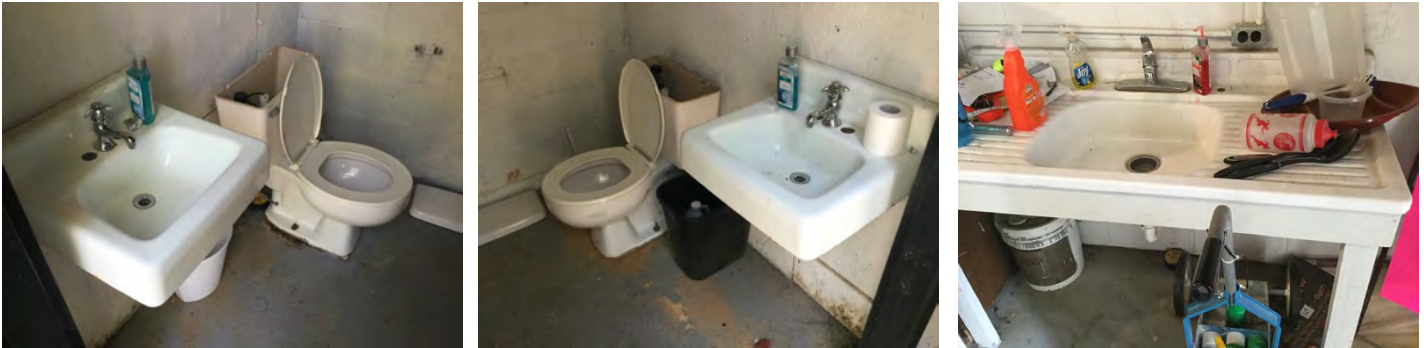
System: D2010 - Plumbing Fixtures

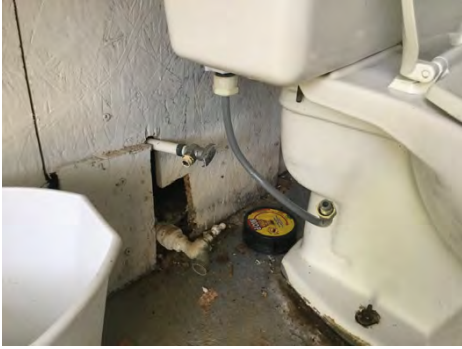
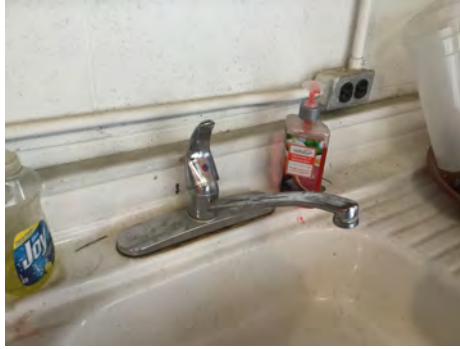
System: D2020 - Domestic Water Distribution

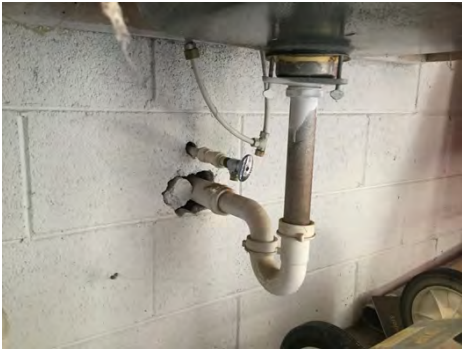
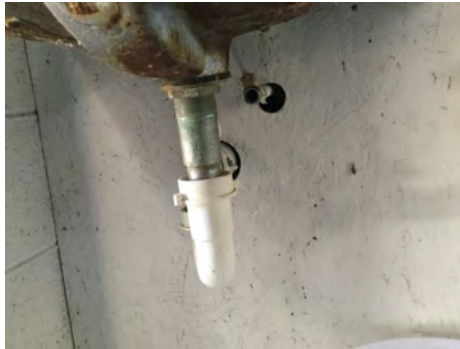
System: D2030 - Sanitary Waste

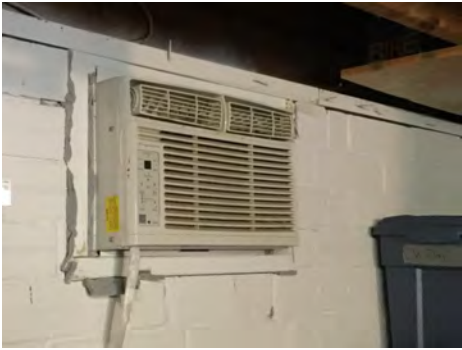
System: D3050 - Terminal & Package Units

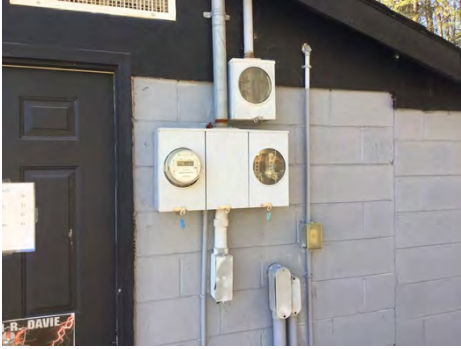
System: D5010 - Electrical Service/Distribution

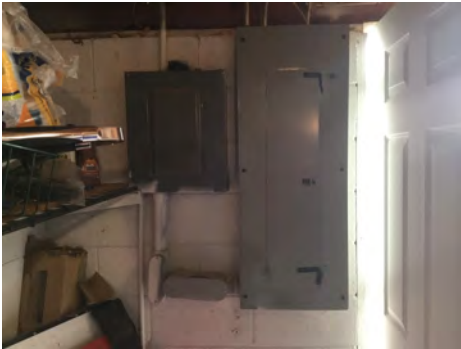
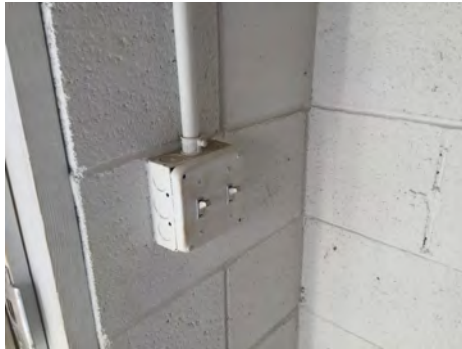
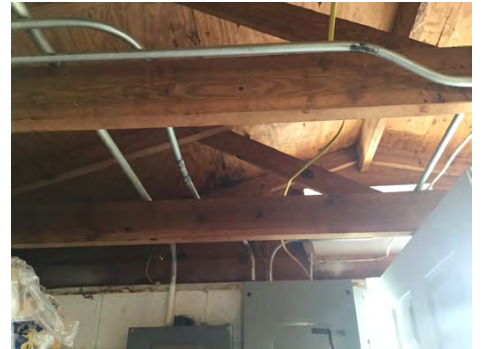
System: D5020 - Branch Wiring

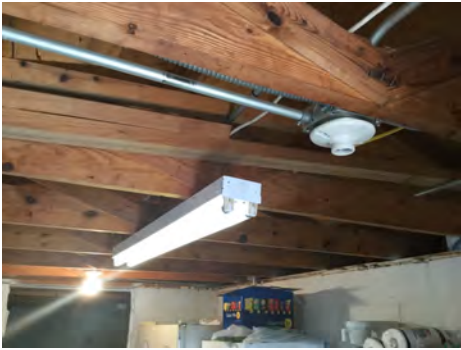
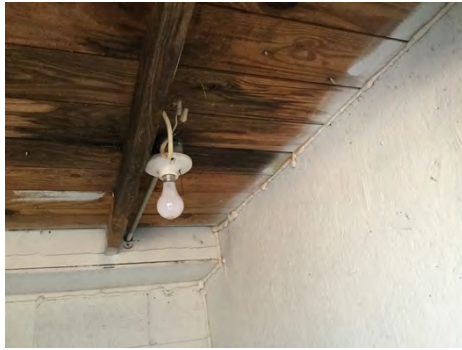
System: D5020 - Lighting
