NC School District/300 Davie County/High School

Central Davie Academy

Campus Assessment Report

March 7, 2017

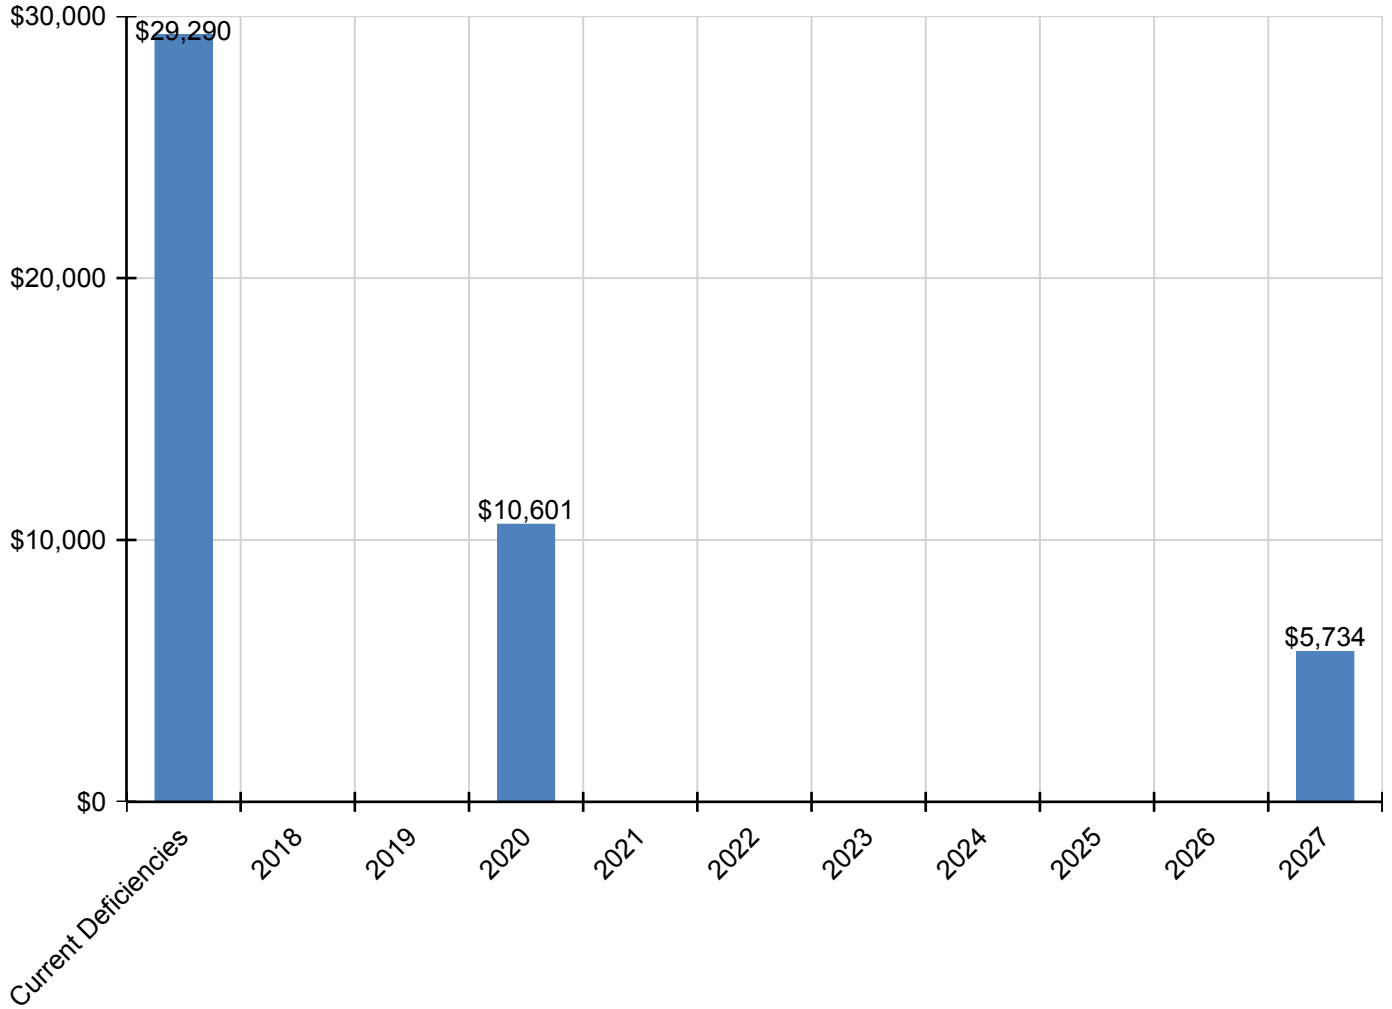
Forecasted Capital Renewal Requirement

The following chart shows the current building deficiencies and forecasting capital renewal or sustainment requirements over the next ten years.

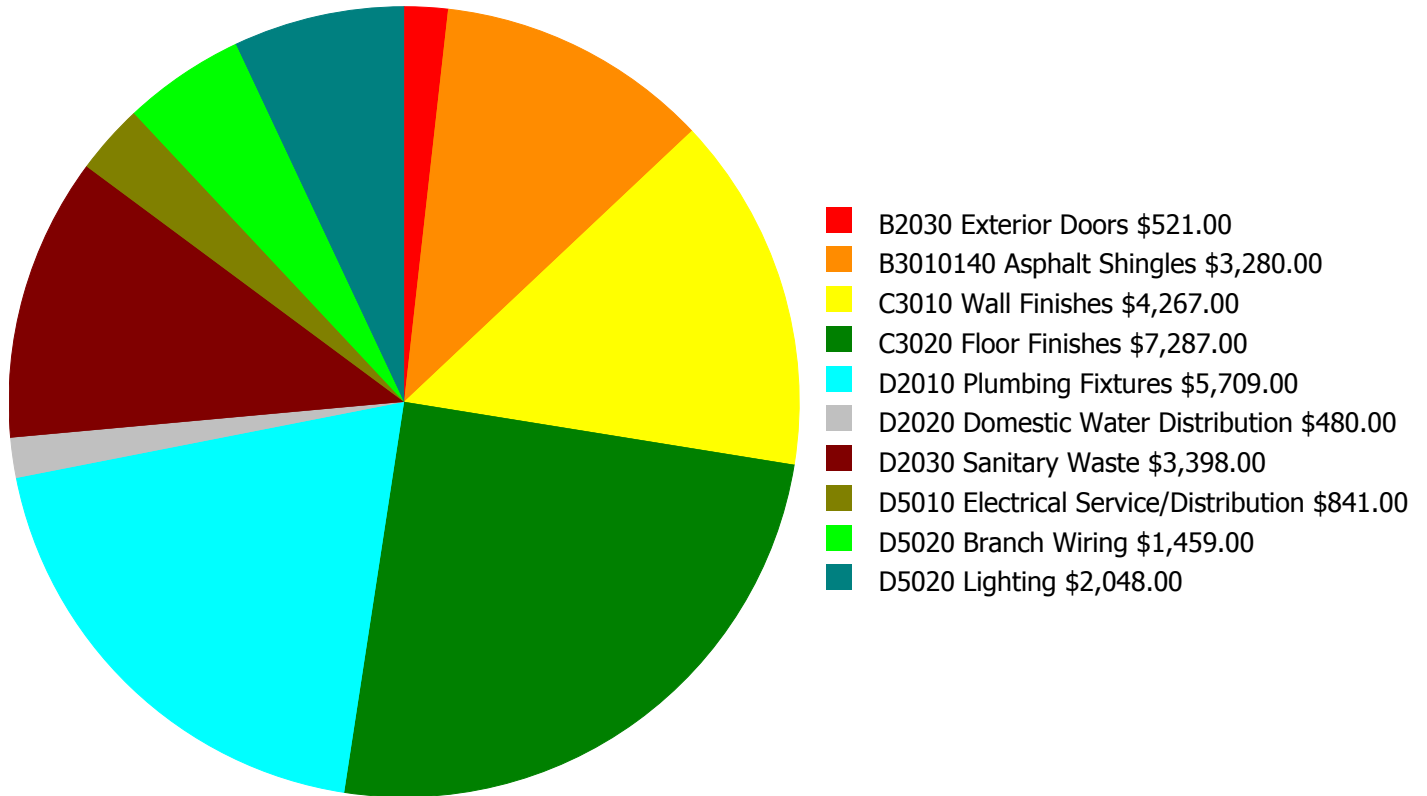
Deficiency Summary by System

Current deficiencies included assemblies that have reached or exceeded their design life or components of the assemblies that are in need of repair. Assemblies that have reached their design life are identified as current deficiencies and assigned the distress 'Beyond Useful Life'. The following chart lists all current deficiencies associated with this facility.

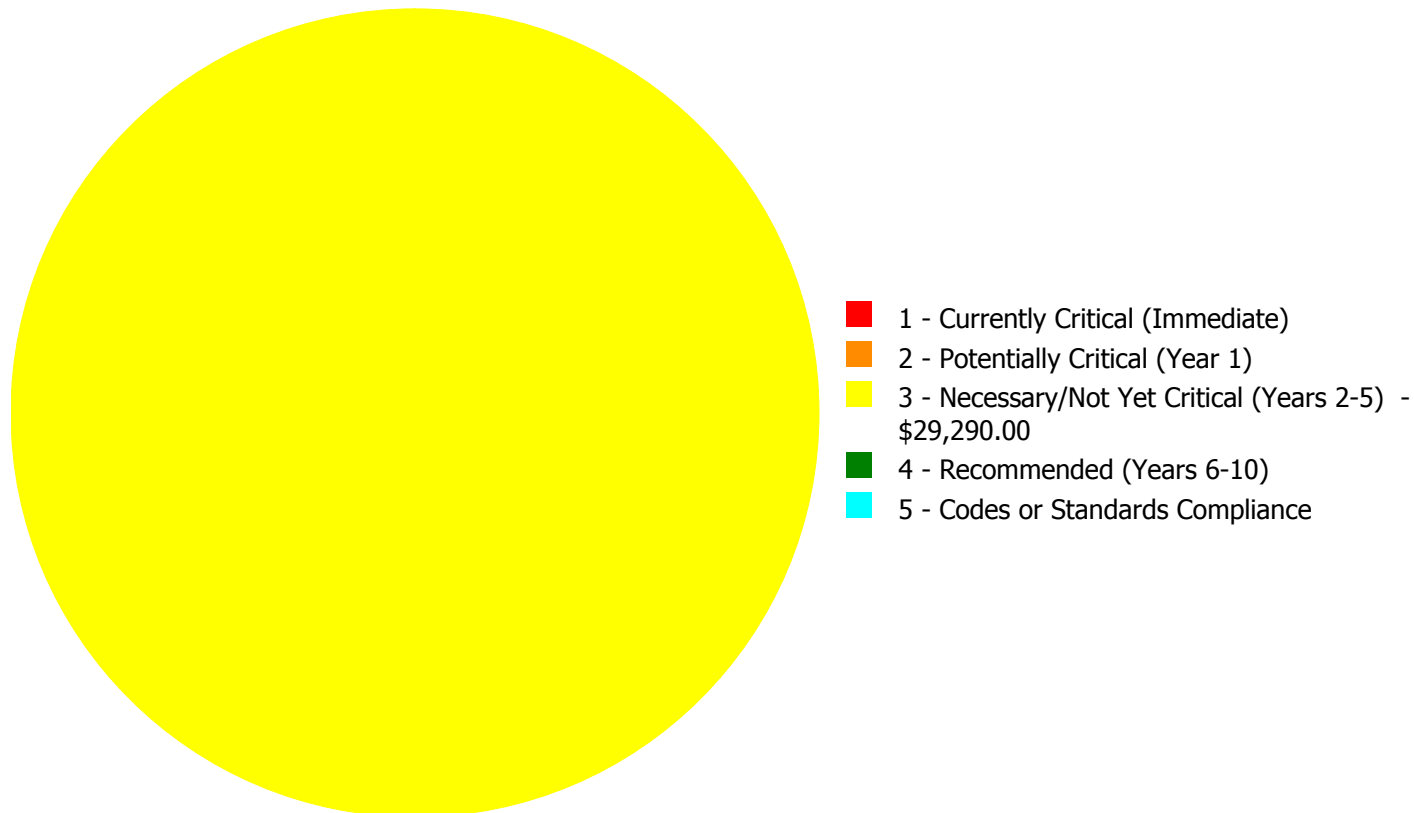
Deficiency Summary by Priority

The following chart shows the total repair costs broken down by priority. Assessors assigned deficiencies within eCOMET to one of the following priority categories:

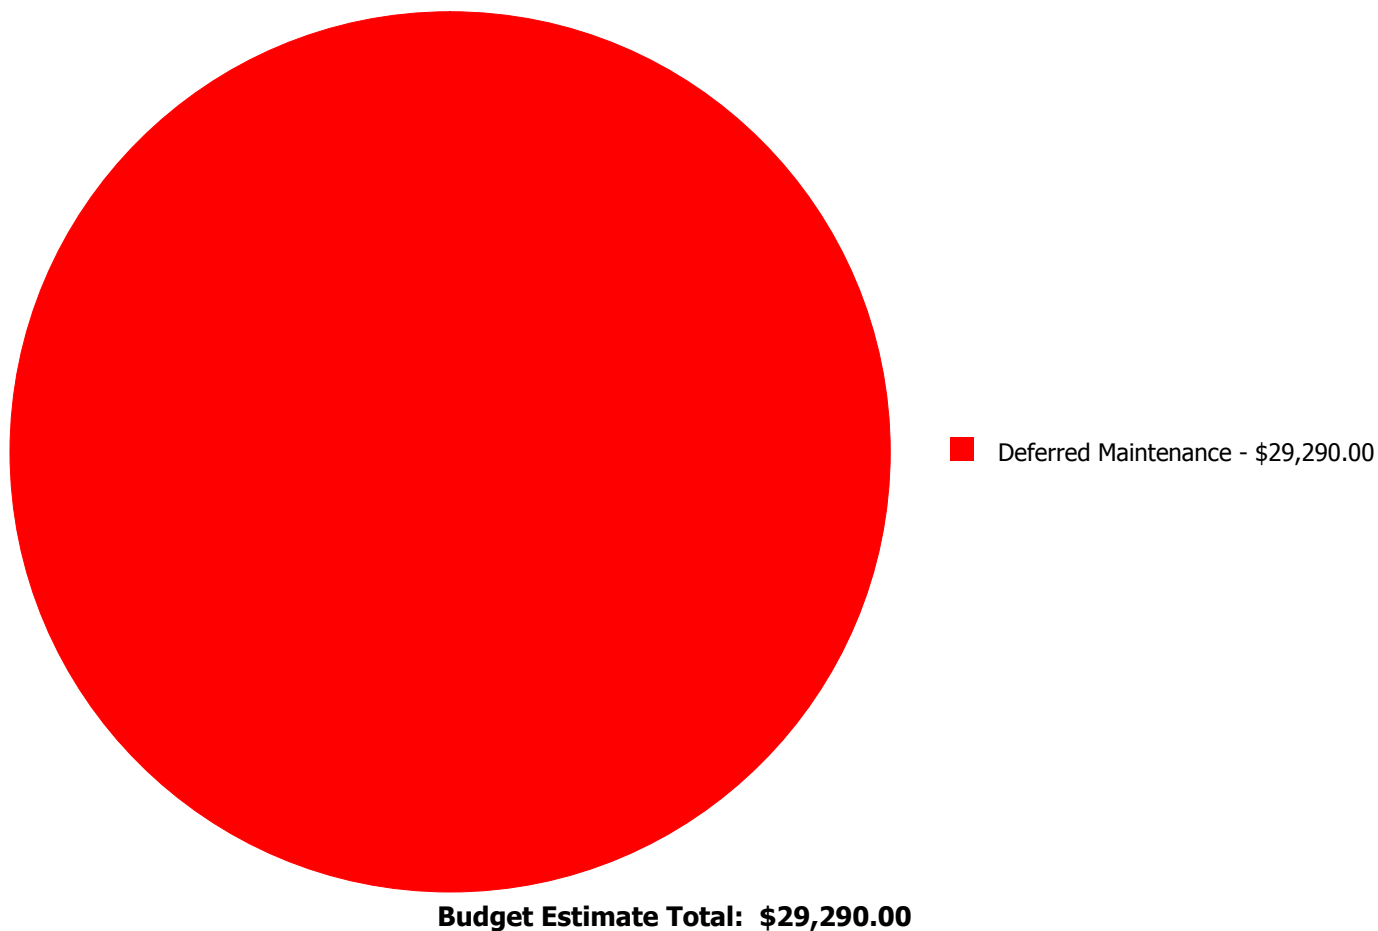
Deficiency Summary by Category

The following chart shows the total repair costs broken down by deficiency categories. Assessors assigned deficiencies to one of the following categories:

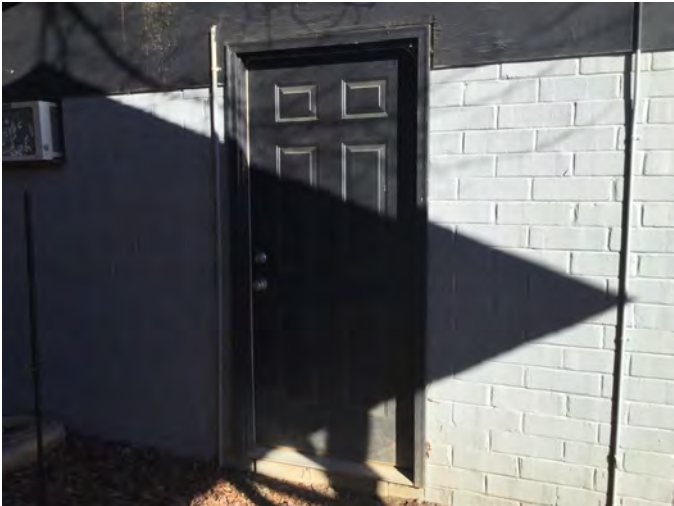
System: B2030 - Exterior Doors

Location: Exterior Walls
Distress: Beyond Service Life
Category: Deferred Maintenance
Priority: 3 - Necessary/Not Yet Critical (Years 2-5)
Correction: Renew System
Qty: 520.00
Unit of Measure: S.F.
Estimate: \$521.00
Assessor Name: Eduardo Lopez
Date Created: 02/12/2017

Notes: The exterior doors are aged, rusted or damaged and should be replaced.

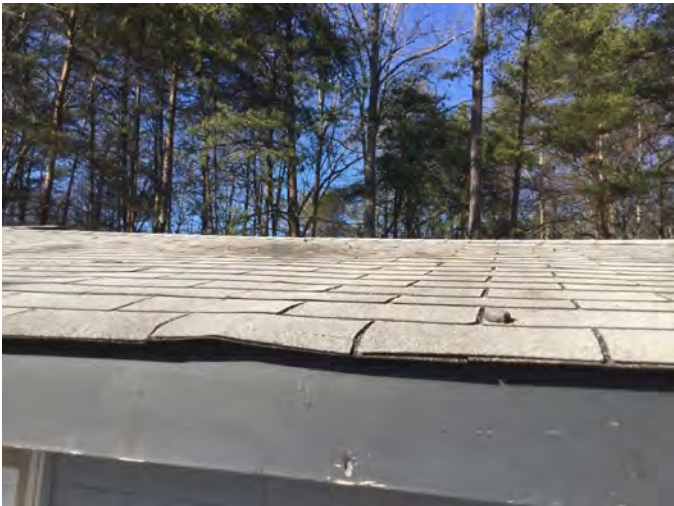
System: B3010140 - Asphalt Shingles

Location: Roof
Distress: Beyond Service Life
Category: Deferred Maintenance
Priority: 3 - Necessary/Not Yet Critical (Years 2-5)
Correction: Renew System
Qty: 520.00
Unit of Measure: S.F.
Estimate: \$3,280.00
Assessor Name: Eduardo Lopez
Date Created: 02/12/2017

Notes: The asphalt shingles roof coverings are aging, showing signs of failure and should be replaced.

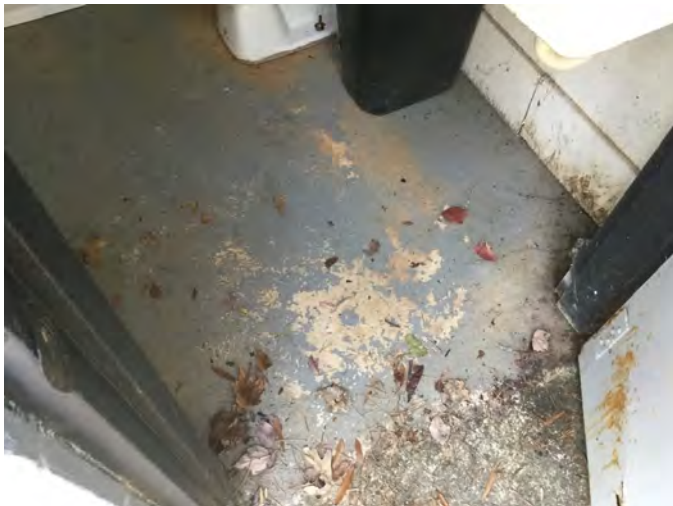
System: C3020 - Floor Finishes

Location: Throughout the Building
Distress: Beyond Service Life
Category: Deferred Maintenance
Priority: 3 - Necessary/Not Yet Critical (Years 2-5)
Correction: Renew System
Qty: 520.00
Unit of Measure: S.F.
Estimate: \$7,287.00
Assessor Name: Eduardo Lopez
Date Created: 02/12/2017

Notes: The wall finishes are aged, scuffed, fading, stained and should be replaced.

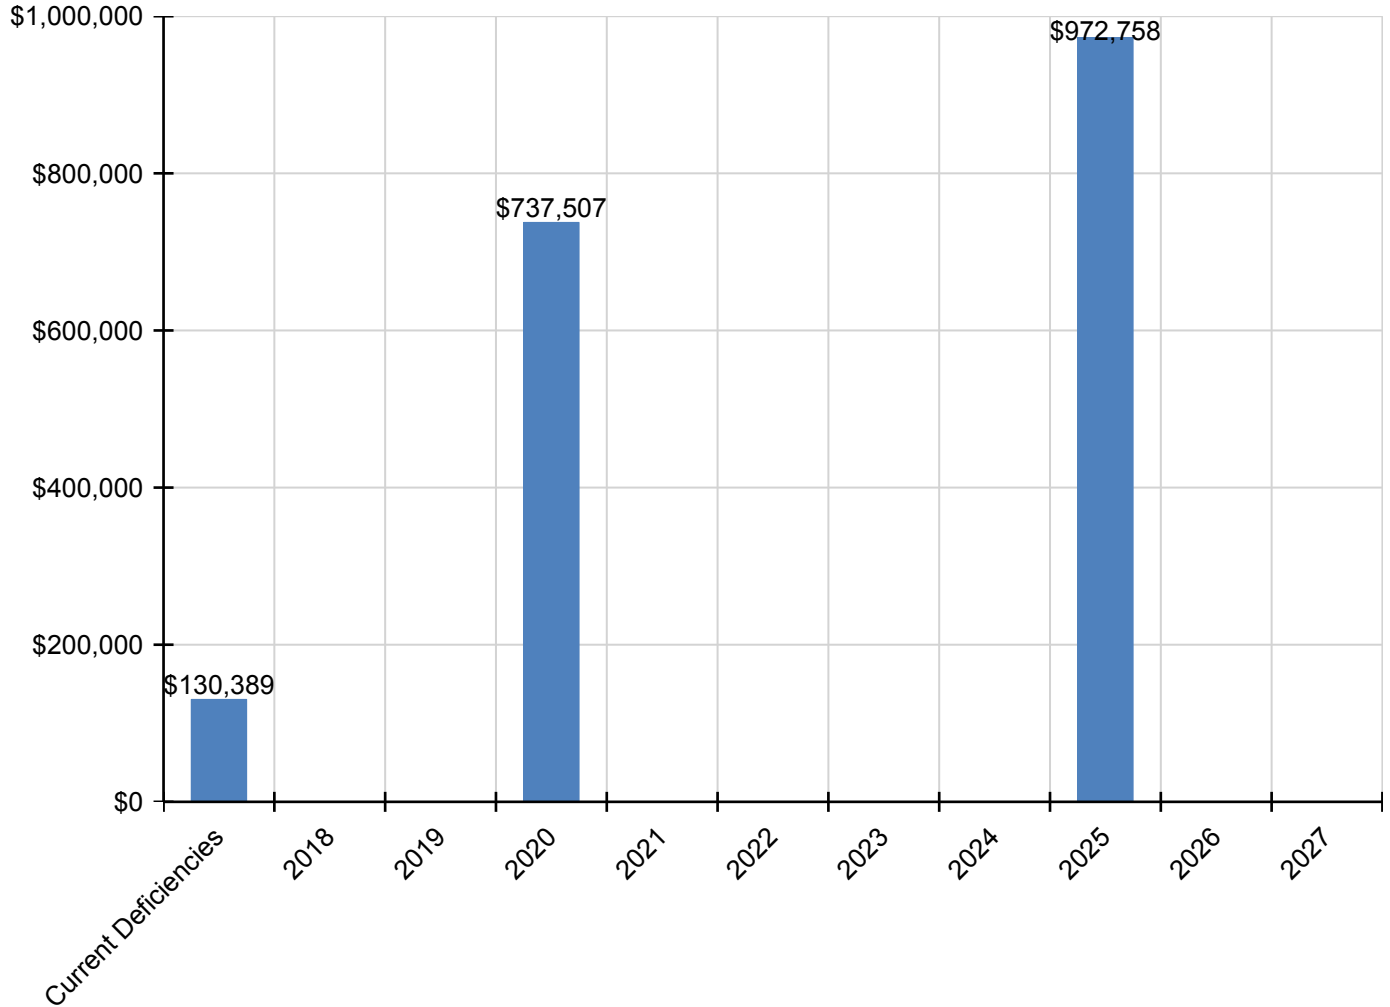
Forecasted Capital Renewal Requirement

The following chart shows the current building deficiencies and forecasting capital renewal or sustainment requirements over the next ten years.

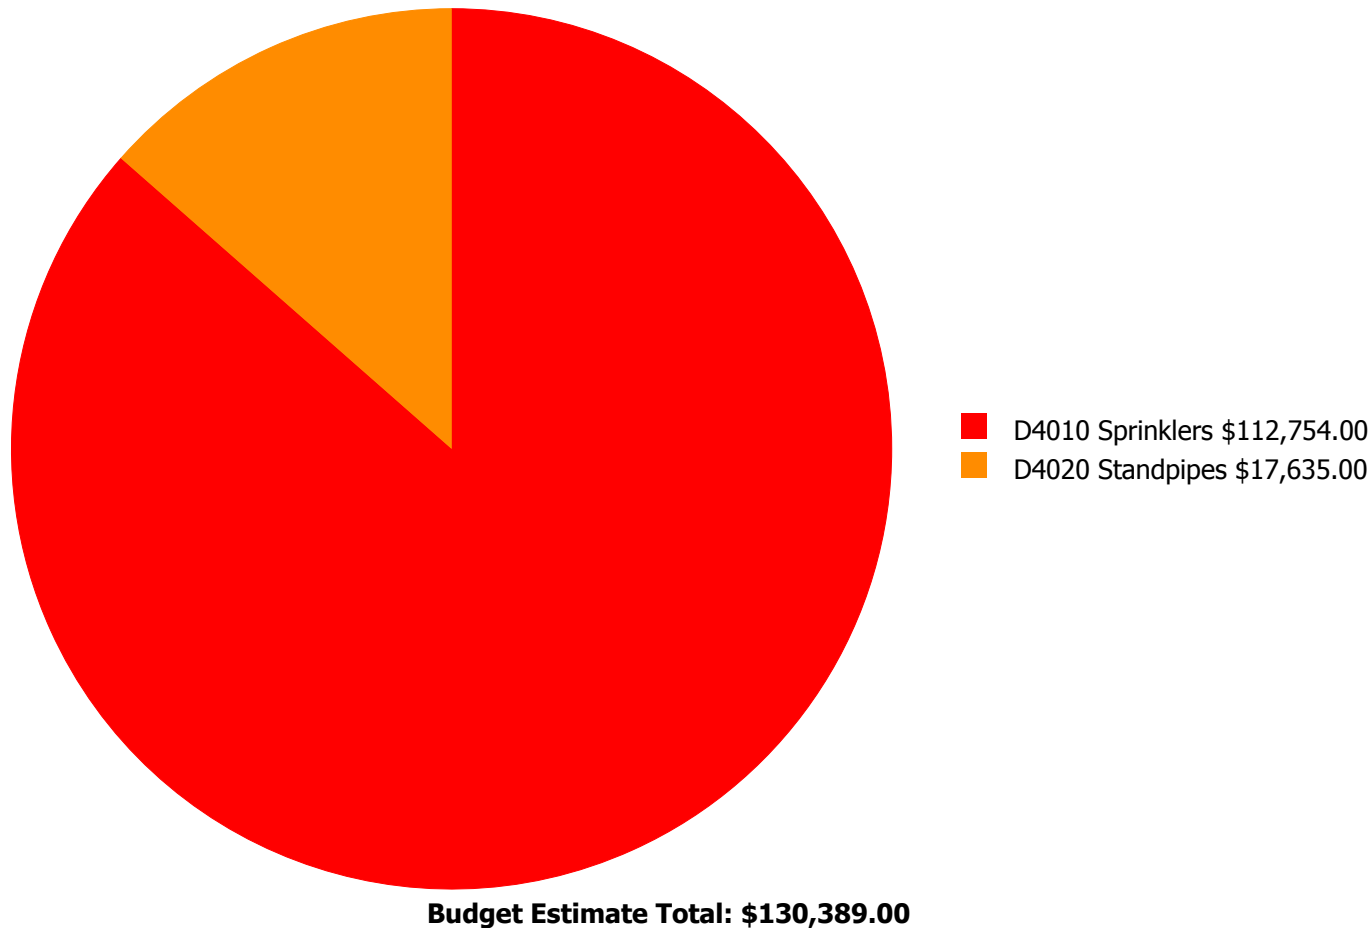
Deficiency Summary by System

Current deficiencies included assemblies that have reached or exceeded their design life or components of the assemblies that are in need of repair. Assemblies that have reached their design life are identified as current deficiencies and assigned the distress 'Beyond Useful Life'. The following chart lists all current deficiencies associated with this facility.

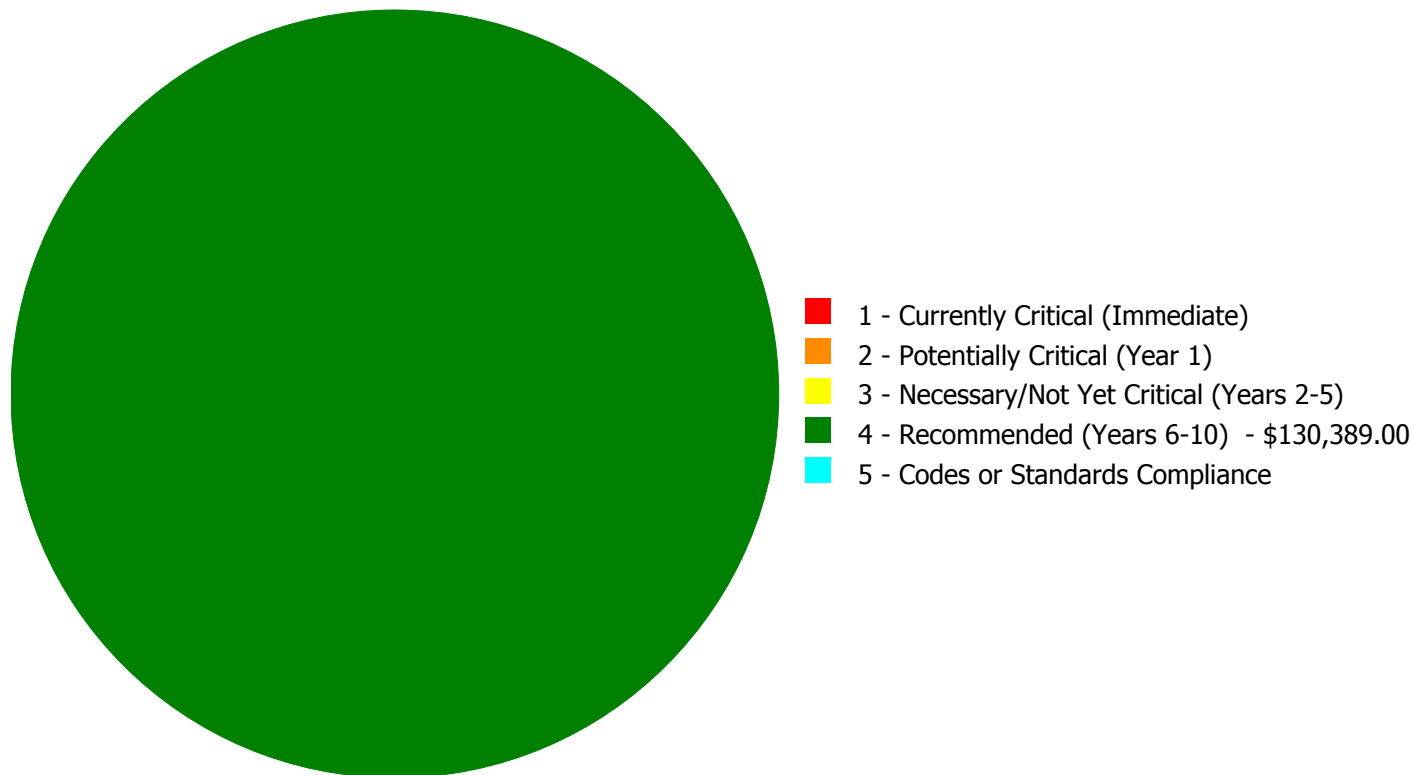
Deficiency Summary by Priority

The following chart shows the total repair costs broken down by priority. Assessors assigned deficiencies within eCOMET to one of the following priority categories:

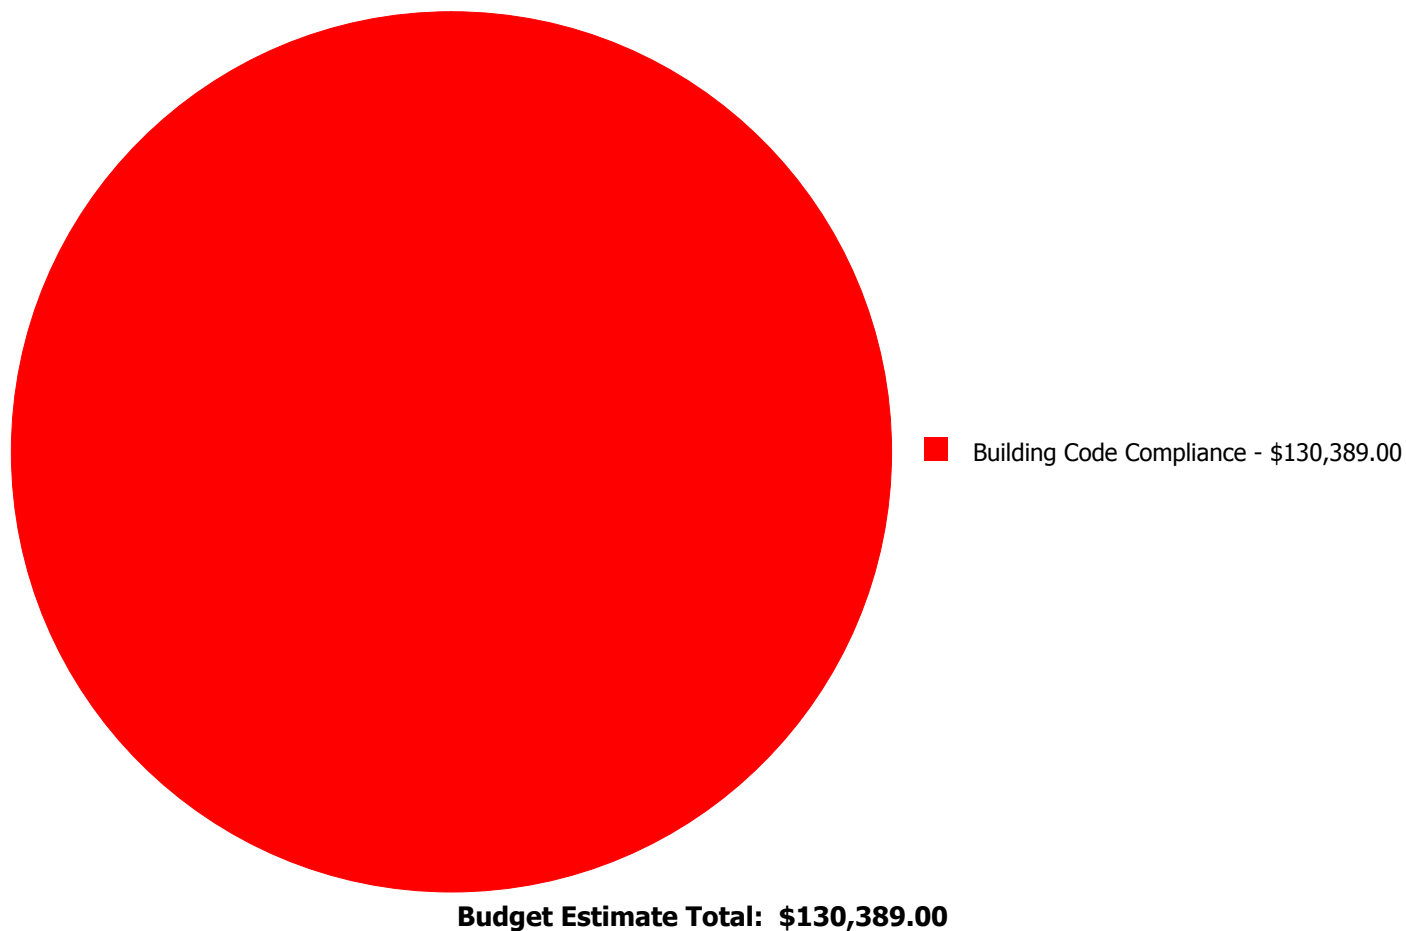
Deficiency Summary by Category

The following chart shows the total repair costs broken down by deficiency categories. Assessors assigned deficiencies to one of the following categories:

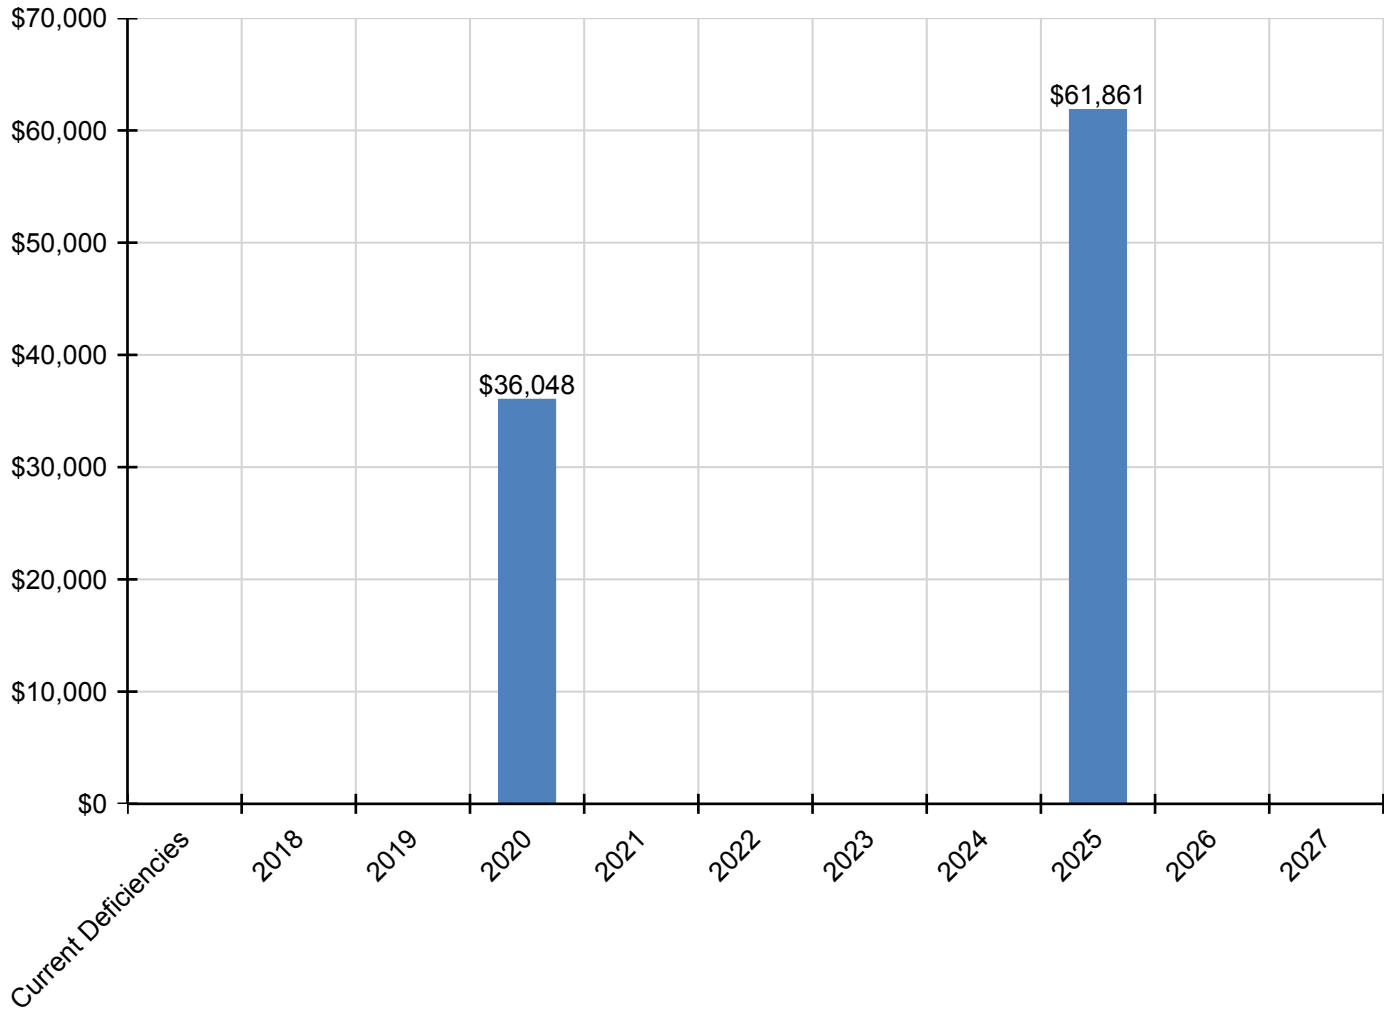
Forecasted Capital Renewal Requirement

The following chart shows the current building deficiencies and forecasting capital renewal or sustainment requirements over the next ten years.

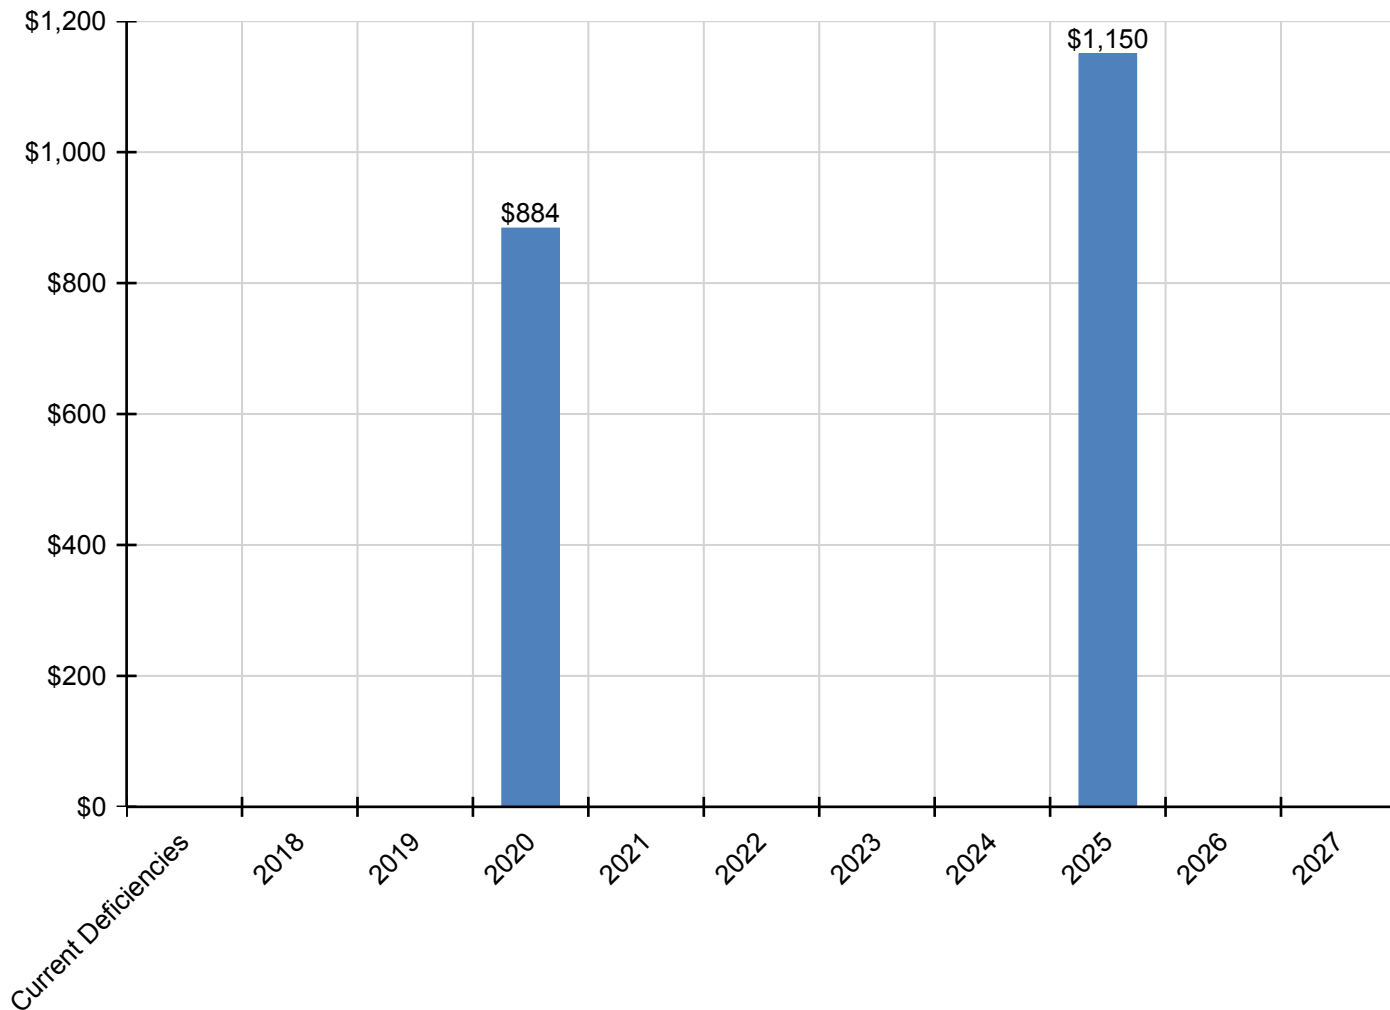
Forecasted Capital Renewal Requirement

The following chart shows the current building deficiencies and forecasting capital renewal or sustainment requirements over the next ten years.

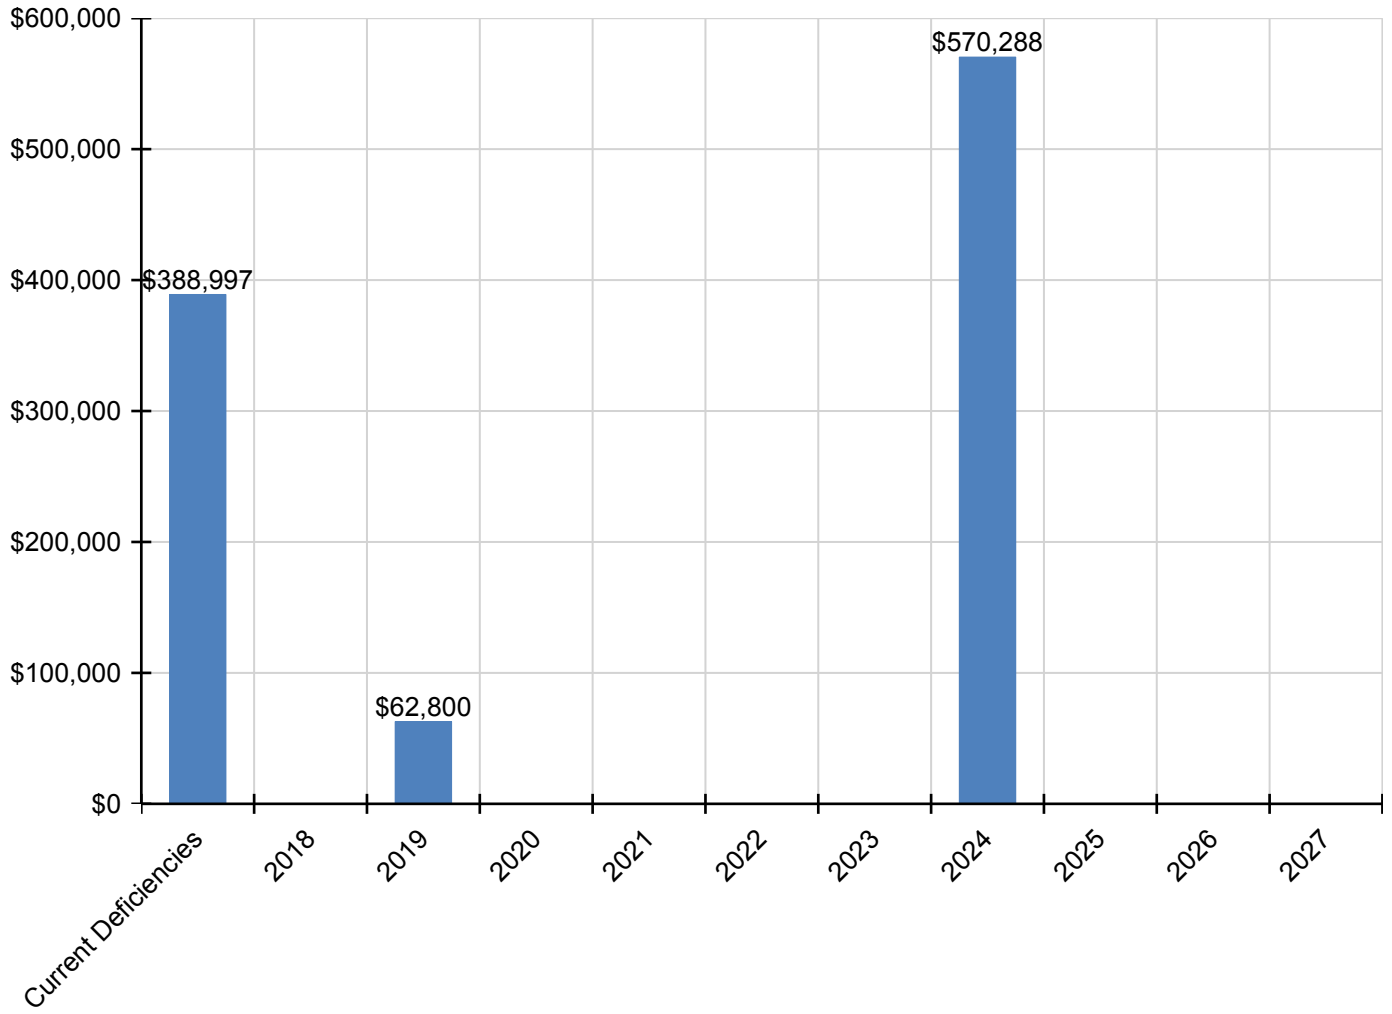
Forecasted Capital Renewal Requirement

The following chart shows the current building deficiencies and forecasting capital renewal or sustainment requirements over the next ten years.

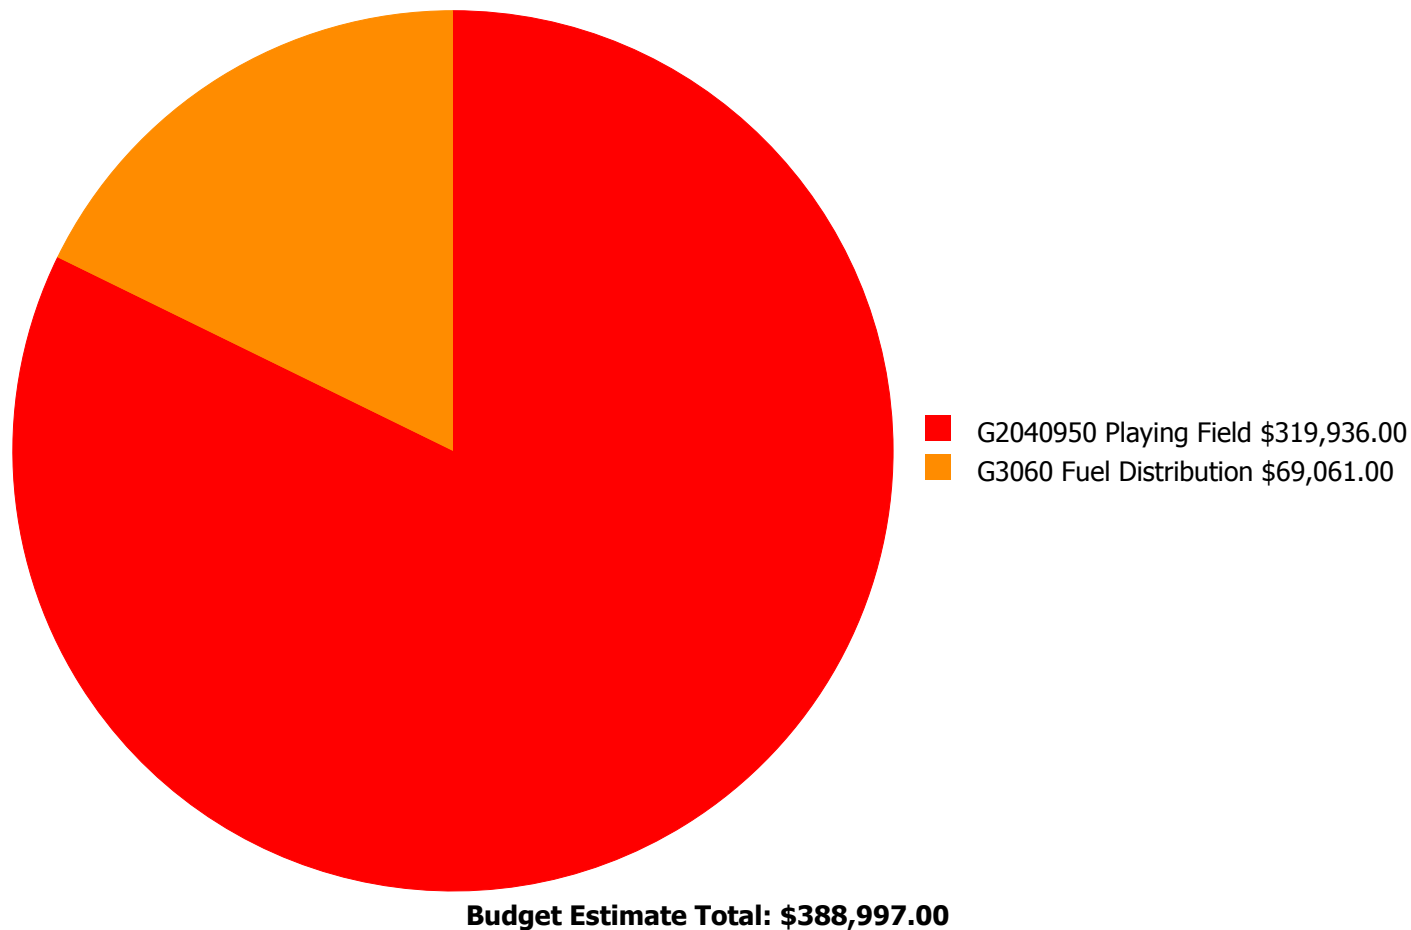
Deficiency Summary by System

Current deficiencies included assemblies that have reached or exceeded their design life or components of the assemblies that are in need of repair. Assemblies that have reached their design life are identified as current deficiencies and assigned the distress 'Beyond Useful Life'. The following chart lists all current deficiencies associated with this facility.

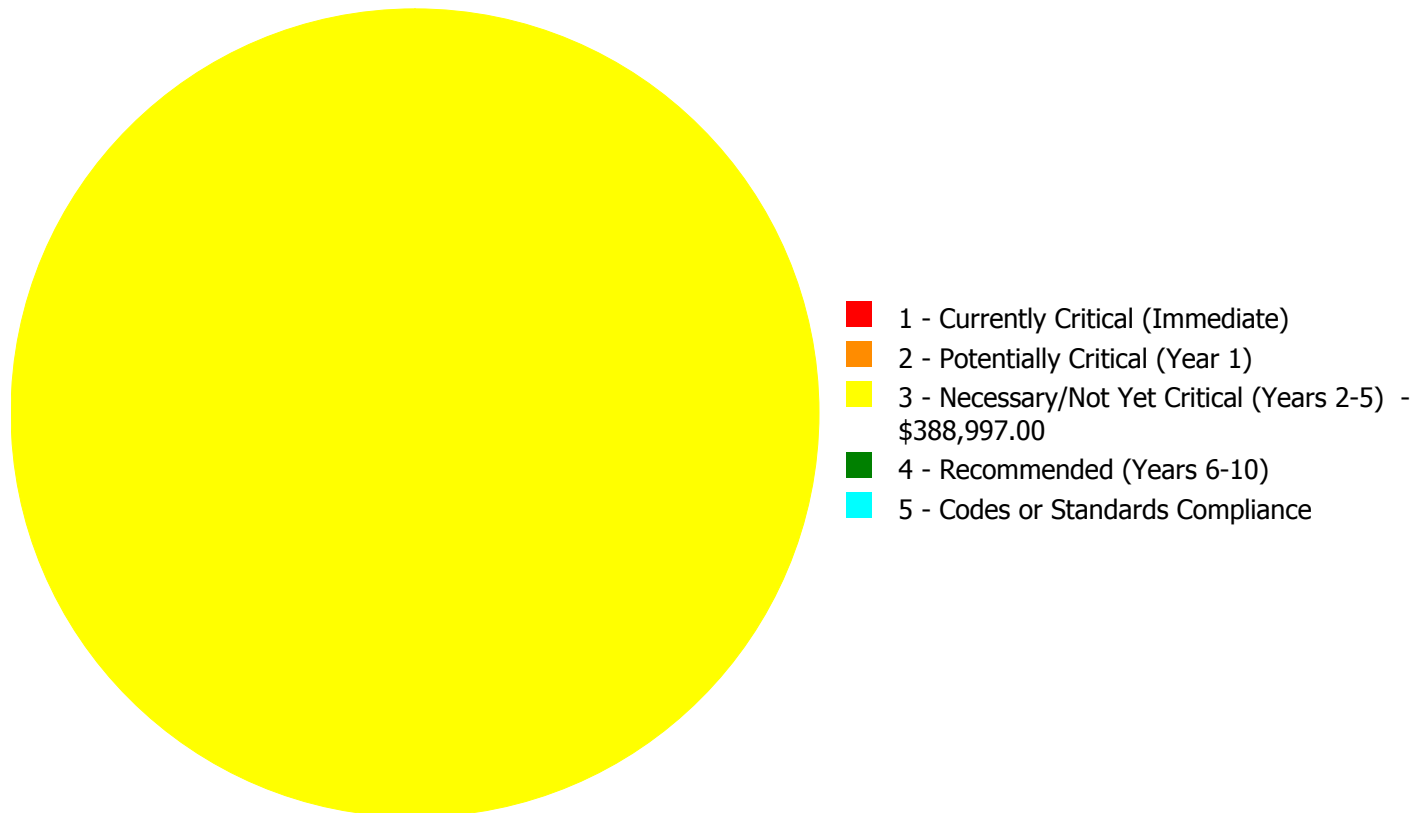
Deficiency Summary by Priority

The following chart shows the total repair costs broken down by priority. Assessors assigned deficiencies within eCOMET to one of the following priority categories:

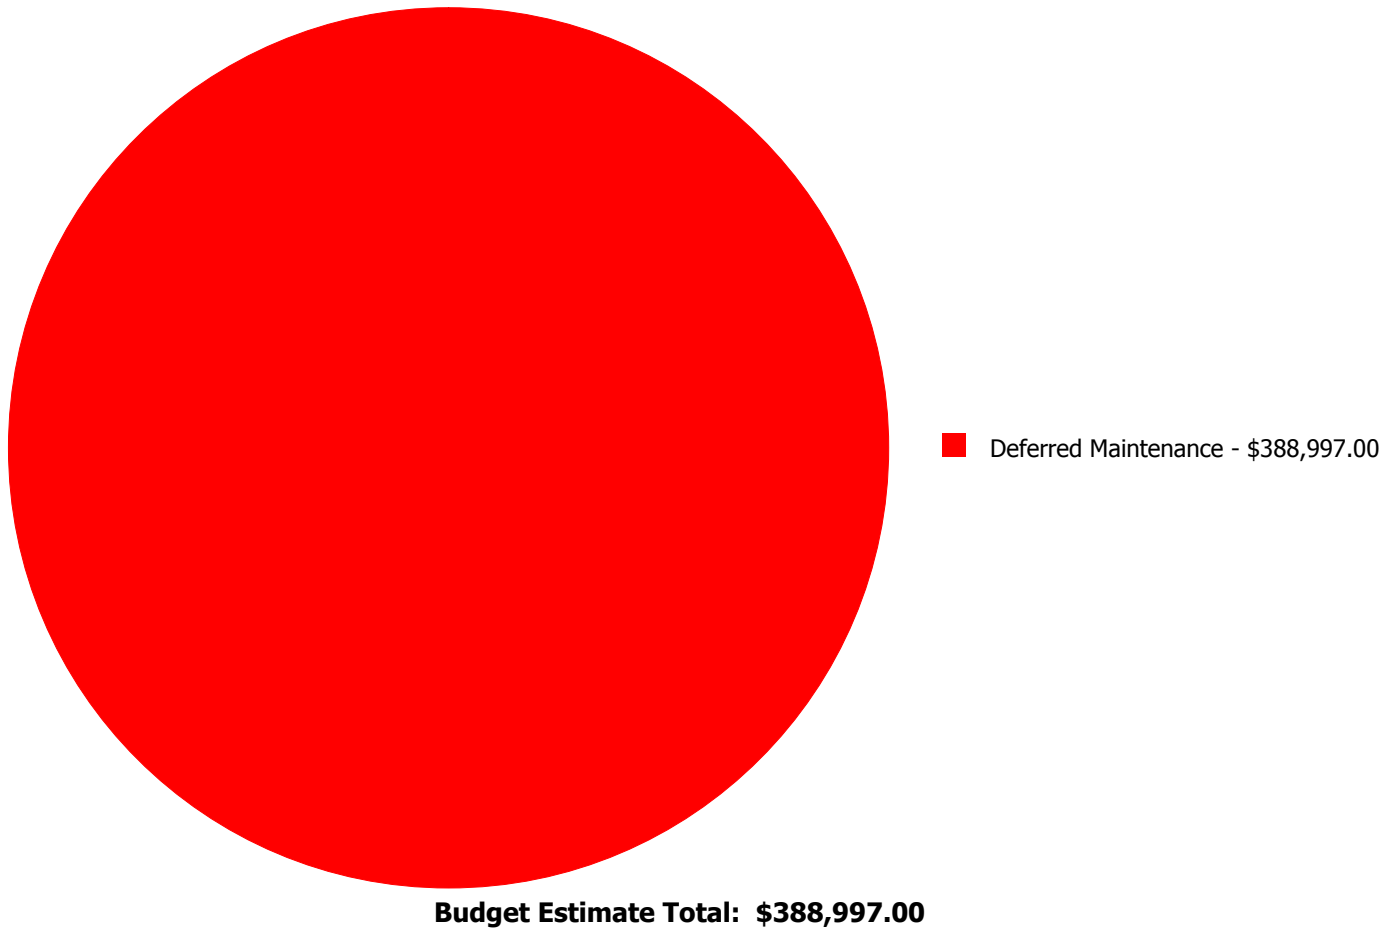
Deficiency Summary by Category

The following chart shows the total repair costs broken down by deficiency categories. Assessors assigned deficiencies to one of the following categories:

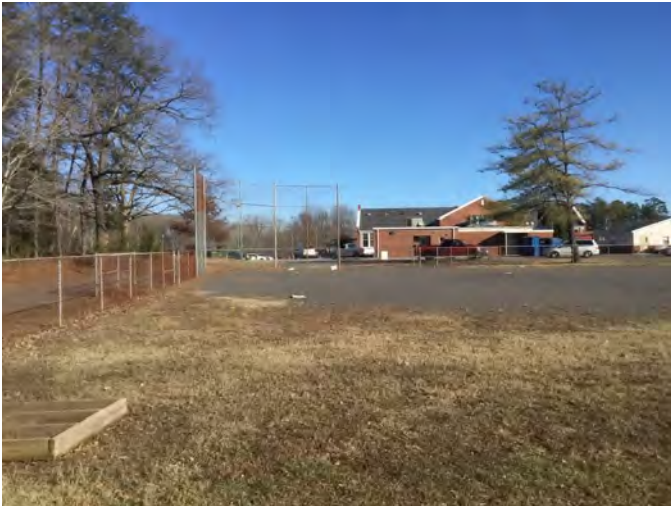
System: G2040950 - Playing Field

Location: Site
Distress: Beyond Service Life
Category: Deferred Maintenance
Priority: 3 - Necessary/Not Yet Critical (Years 2-5)
Correction: Renew System
Qty: 64,064.00
Unit of Measure: S.F.
Estimate: \$319,936.00
Assessor Name: Eduardo Lopez
Date Created: 02/12/2017

Notes: The playing field is in poor conditions, beyond service life and should be scheduled for replaced.
