NC School District/520 Jones County/High School

Jones Senior High

Campus Assessment Report

March 8, 2017

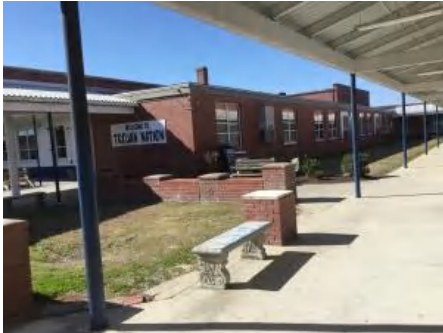
1). North Elevation - Feb 20, 2017

The photo album consists of the various cardinal directions of the building..

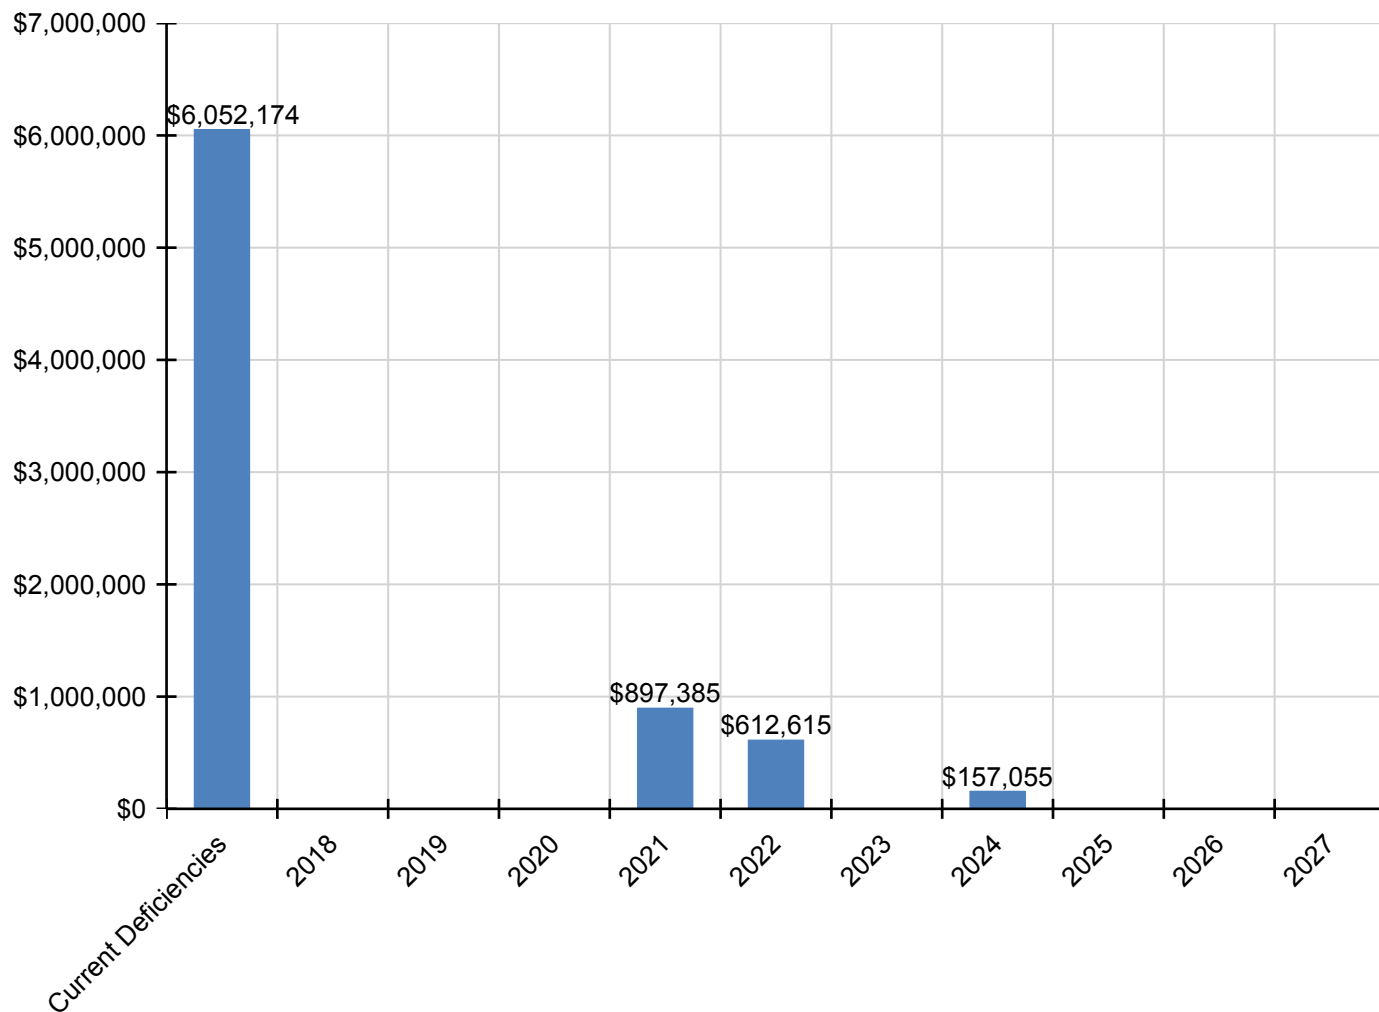
Forecasted Capital Renewal Requirement

The following chart shows the current building deficiencies and forecasting capital renewal or sustainment requirements over the next ten years.

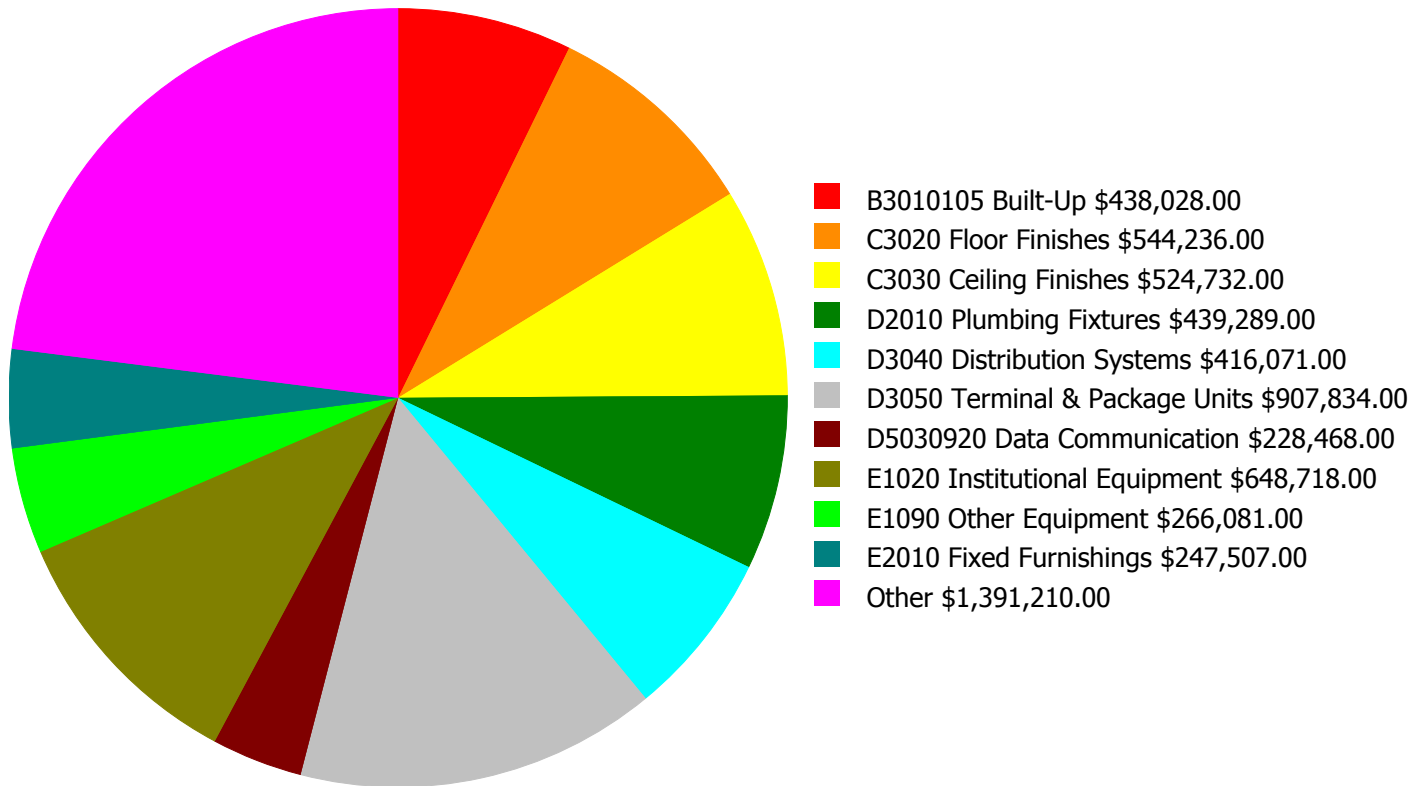
Deficiency Summary by System

Current deficiencies included assemblies that have reached or exceeded their design life or components of the assemblies that are in need of repair. Assemblies that have reached their design life are identified as current deficiencies and assigned the distress 'Beyond Useful Life'. The following chart lists all current deficiencies associated with this facility.

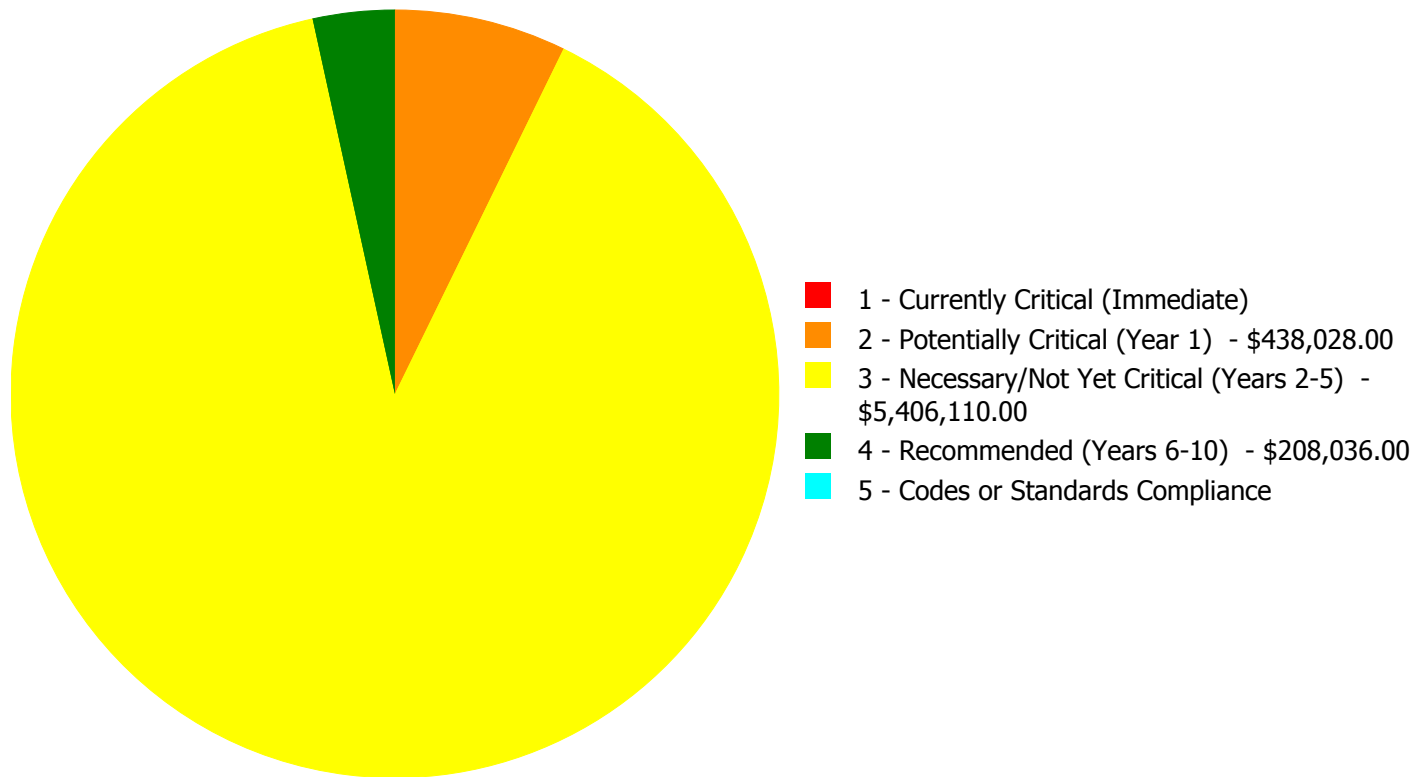
Deficiency Summary by Priority

The following chart shows the total repair costs broken down by priority. Assessors assigned deficiencies within eCOMET to one of the following priority categories:

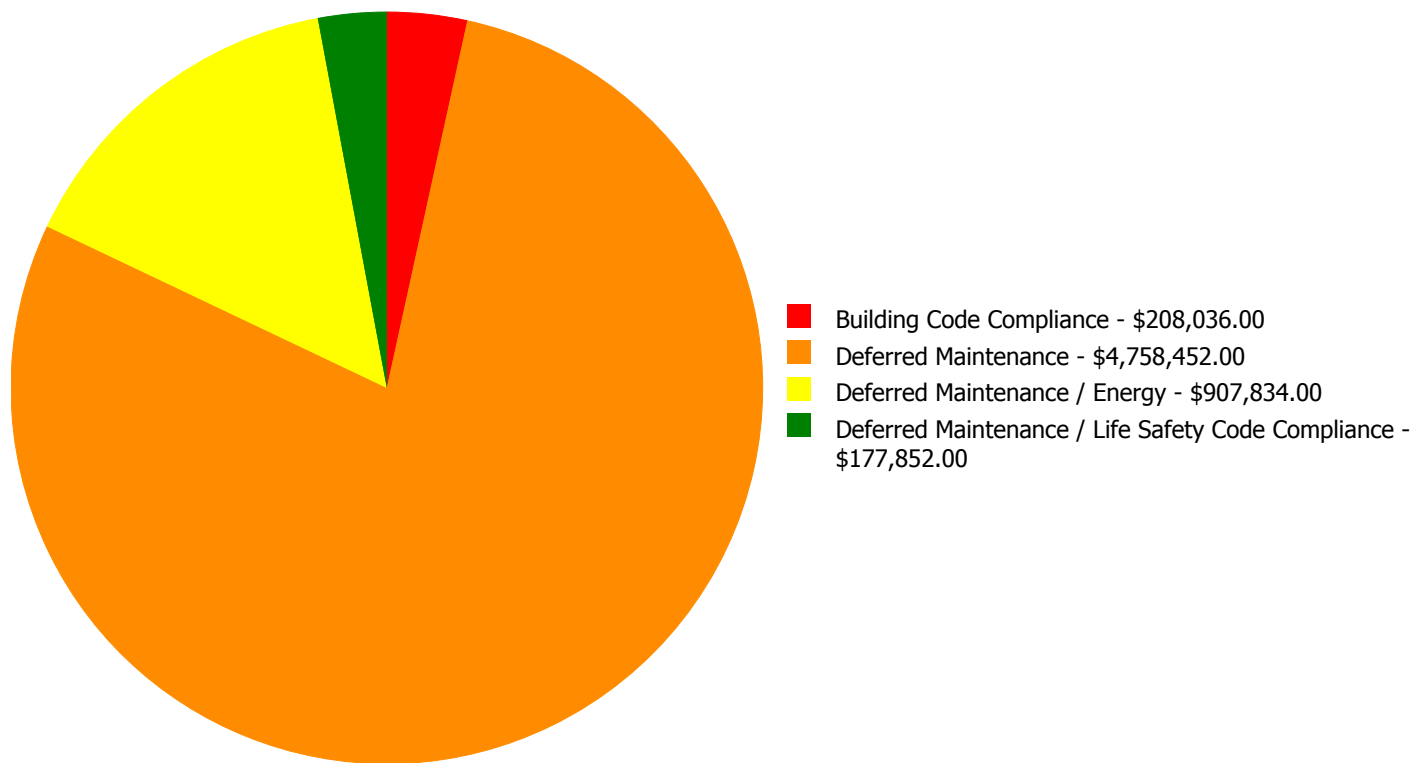
Deficiency Summary by Category

The following chart shows the total repair costs broken down by deficiency categories. Assessors assigned deficiencies to one of the following categories:

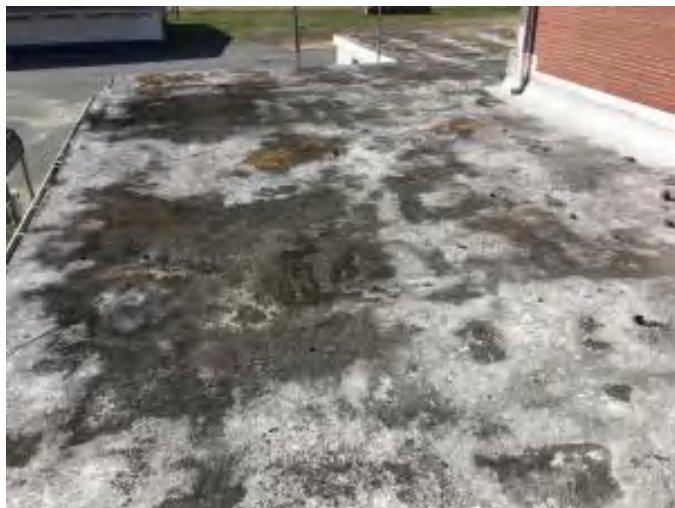
System: B3010105 - Built-Up

Location: Roof
Distress: Beyond Service Life
Category: Deferred Maintenance
Priority: 2 - Potentially Critical (Year 1)
Correction: Renew System
Qty: 35,465.00
Unit of Measure: S.F.
Estimate: \$438,028.00
Assessor Name: Terence Davis
Date Created: 02/17/2017

Notes: The majority of the building roof is foam over built-up roofing. The foam is in very poor condition with blistering, loss of coating, and UV damage to exposed foam. System replacement, including gutters and downspouts, is recommended.

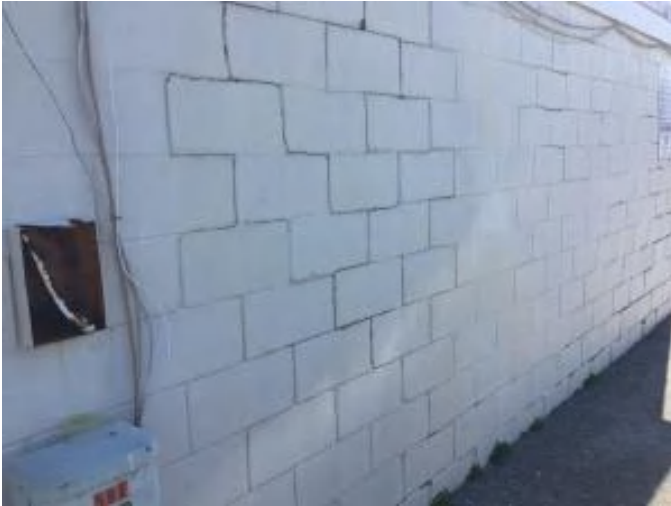
System: B2010 - Exterior Walls

Location: Exterior walls
Distress: Damaged
Category: Deferred Maintenance
Priority: 3 - Necessary/Not Yet Critical (Years 2-5)
Correction: Point clay brick wall, 1st floor
Qty: 50.00
Unit of Measure: C.S.F.
Estimate: \$75,108.00
Assessor Name: Terence Davis
Date Created: 02/20/2017

Notes: Exterior walls have some cracking, particularly at the locker room, which appears to an addition. Brick mortar is failing in some locations. Infilled windows at the gym are problematic. A general tune-up is recommended.

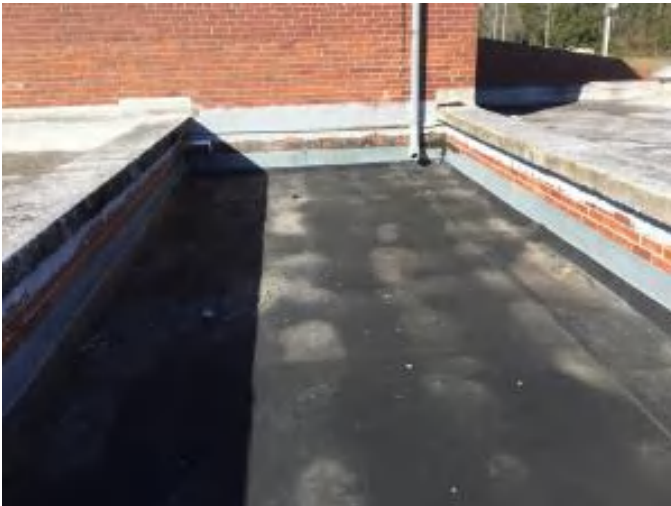
System: B3010120 - Single Ply Membrane

Location: Office wing
Distress: Beyond Service Life
Category: Deferred Maintenance
Priority: 3 - Necessary/Not Yet Critical (Years 2-5)
Correction: Renew System
Qty: 6,750.00
Unit of Measure: S.F.
Estimate: \$70,673.00
Assessor Name: Terence Davis
Date Created: 02/17/2017

Notes: The EPDM roof is beyond its expected useful life. Although no leaks were reported, system renewal is recommended to ensure the water tightness of the building envelope.

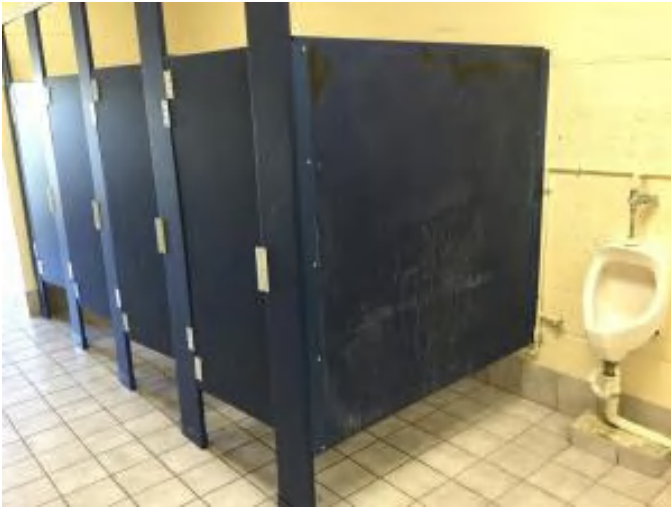
System: C1030 - Fittings

Location: Throughout the building
Distress: Beyond Service Life
Category: Deferred Maintenance
Priority: 3 - Necessary/Not Yet Critical (Years 2-5)
Correction: Renew System
Qty: 42,215.00
Unit of Measure: S.F.
Estimate: \$73,370.00
Assessor Name: Terence Davis
Date Created: 02/17/2017

Notes: Building fittings are of variable ages, but as a system are expired. Interior signage is not ADA code compliant. Restrooms are not typically ADA code compliant. System renewal is recommended.

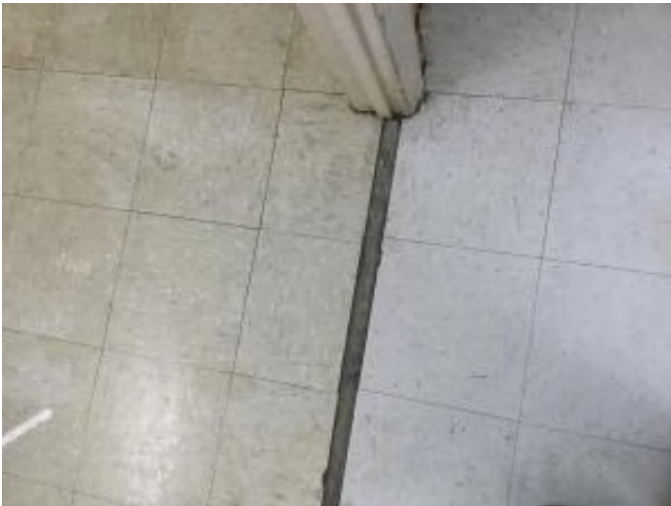
System: C3020 - Floor Finishes

Location: Throughout the building
Distress: Beyond Service Life
Category: Deferred Maintenance
Priority: 3 - Necessary/Not Yet Critical (Years 2-5)
Correction: Renew System
Qty: 42,215.00
Unit of Measure: S.F.
Estimate: \$544,236.00
Assessor Name: Terence Davis
Date Created: 02/17/2017

Notes: Floor finishes are generally beyond their expected useful life. Asbestos containing mastic is encapsulated beneath floor finishes. System renewal including complete abatement is recommended.

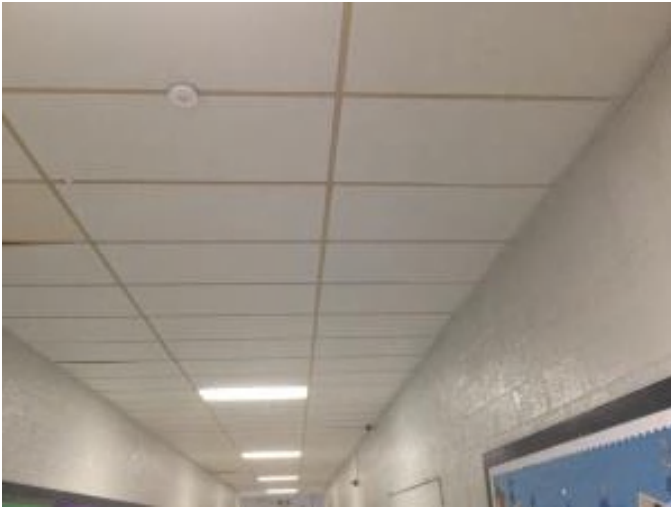
System: C3030 - Ceiling Finishes

Location: Throughout the building
Distress: Beyond Service Life
Category: Deferred Maintenance
Priority: 3 - Necessary/Not Yet Critical (Years 2-5)
Correction: Renew System
Qty: 42,215.00
Unit of Measure: S.F.
Estimate: \$524,732.00
Assessor Name: Terence Davis
Date Created: 02/17/2017

Notes: The ceiling tiles have been replaced as needed. However the grids are yellowed and many tiles are sagging or damaged. System renewal is recommended.

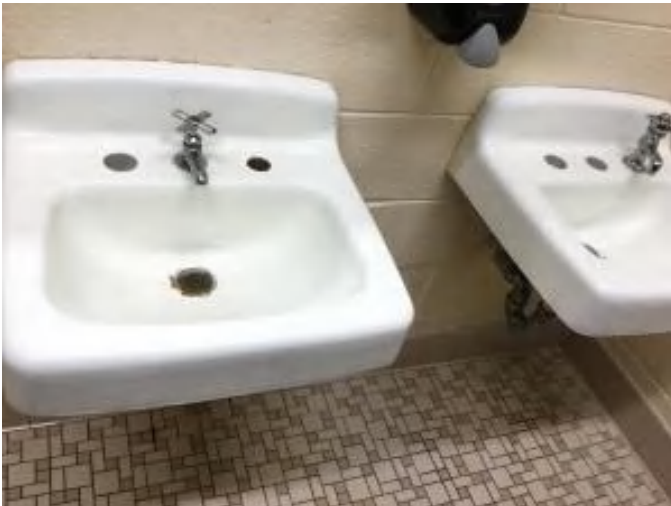
System: D2010 - Plumbing Fixtures

Location: Throughout the building
Distress: Beyond Service Life
Category: Deferred Maintenance
Priority: 3 - Necessary/Not Yet Critical (Years 2-5)
Correction: Renew System
Qty: 42,215.00
Unit of Measure: S.F.
Estimate: \$439,289.00
Assessor Name: Terence Davis
Date Created: 02/17/2017

Notes: It appears that many fixtures have been replaced, likely with the 1992 addition and general upgrade. Fixtures are not typically low-flow water saving styles. Many older fixtures are still present. In general, ADA compliance is lacking. System renewal is recommended.

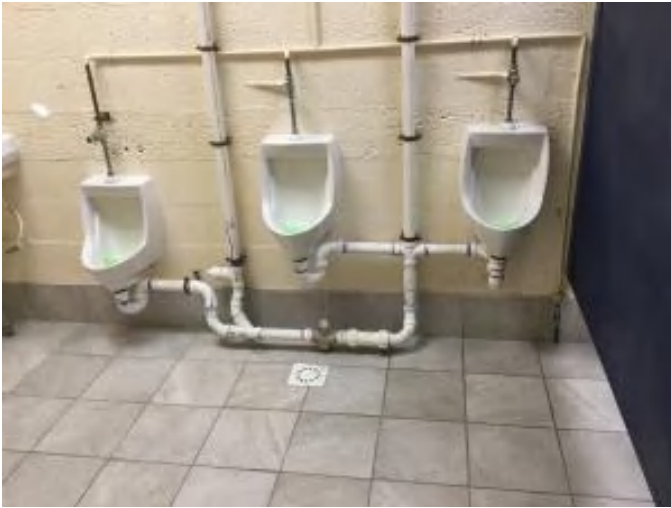
System: D2020 - Domestic Water Distribution

Location: Throughout the building
Distress: Beyond Service Life
Category: Deferred Maintenance
Priority: 3 - Necessary/Not Yet Critical (Years 2-5)
Correction: Renew System
Qty: 42,215.00
Unit of Measure: S.F.
Estimate: \$81,728.00
Assessor Name: Terence Davis
Date Created: 02/17/2017

Notes: Renovations have not been comprehensively made to the domestic water distribution system. System renewal is recommended.

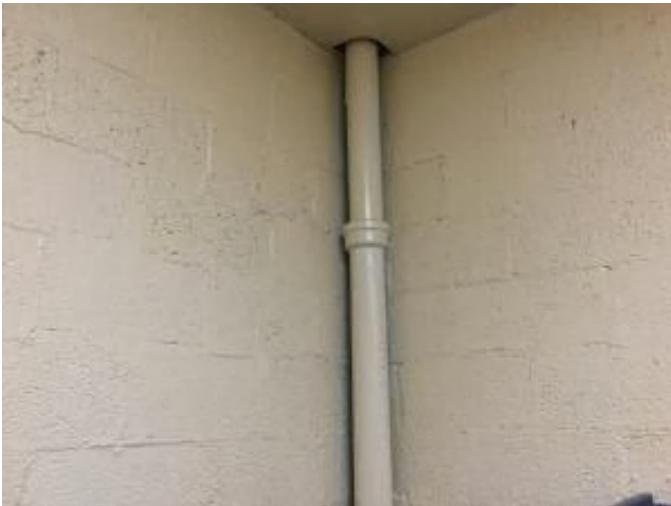
System: D2030 - Sanitary Waste

Location: Throughout the building
Distress: Beyond Service Life
Category: Deferred Maintenance
Priority: 3 - Necessary/Not Yet Critical (Years 2-5)
Correction: Renew System
Qty: 42,215.00
Unit of Measure: S.F.
Estimate: \$128,629.00
Assessor Name: Terence Davis
Date Created: 02/17/2017

Notes: The sanitary waste system as a whole is largely original with some surface retrofits. The system is expired and system renewal is recommended.

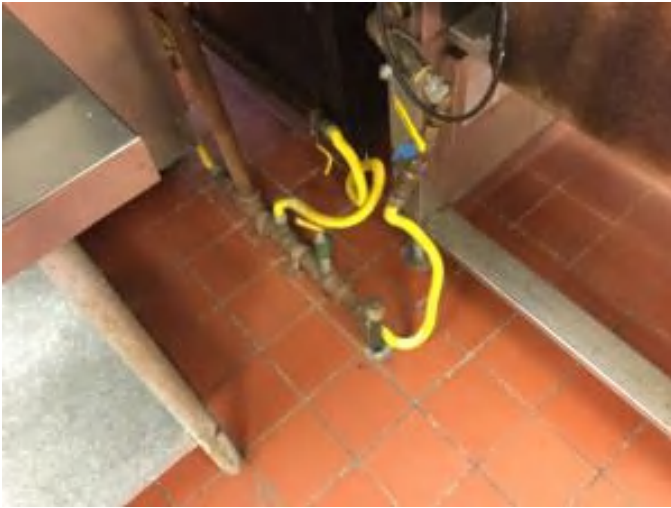
System: D2090 - Other Plumbing Systems -Propane

Location: Kitchen
Distress: Beyond Service Life
Category: Deferred Maintenance
Priority: 3 - Necessary/Not Yet Critical (Years 2-5)
Correction: Renew System
Qty: 42,215.00
Unit of Measure: S.F.
Estimate: \$7,430.00
Assessor Name: Terence Davis
Date Created: 02/17/2017

Notes: The propane piping system is expired. System renewal is recommended.

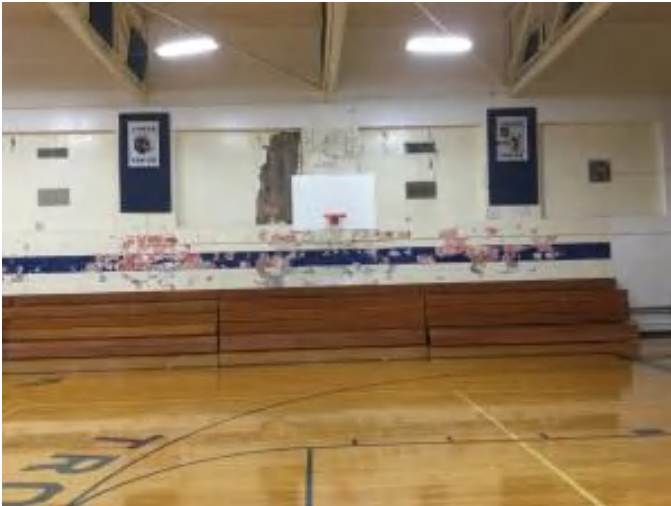
System: D3040 - Distribution Systems

Location: Throughout the building
Distress: Inadequate
Category: Deferred Maintenance
Priority: 3 - Necessary/Not Yet Critical (Years 2-5)
Correction: Renew System
Qty: 42,215.00
Unit of Measure: S.F.
Estimate: \$416,071.00
Assessor Name: Terence Davis
Date Created: 02/17/2017

Notes: HVAC distribution systems are both expired and inadequate. Wall mounted units in the gym do not provide adequate circulation. Toilet room exhaust systems are antiquated. Wall mounted units are fitted with ducts that they are not designed for, putting excess load on fan motors. The masonry shop does not have adequate filtration. System renewal is recommended.

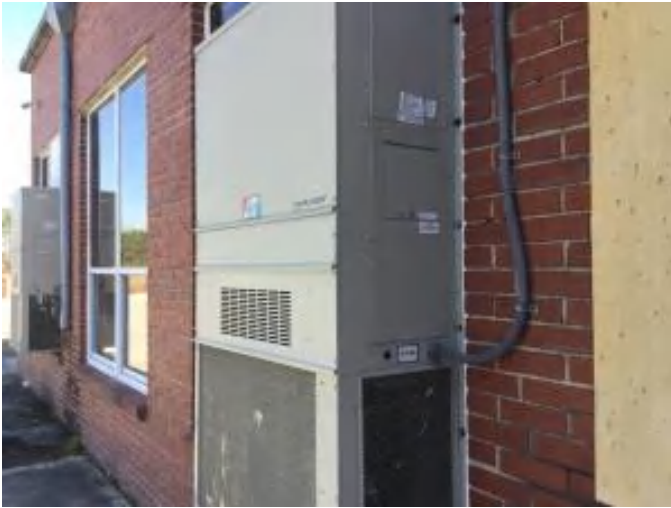
System: D3050 - Terminal & Package Units

Location: Throughout the building
Distress: Beyond Service Life
Category: Deferred Maintenance / Energy
Priority: 3 - Necessary/Not Yet Critical (Years 2-5)
Correction: Renew System
Qty: 42,215.00
Unit of Measure: S.F.
Estimate: \$907,834.00
Assessor Name: Terence Davis
Date Created: 02/17/2017

Notes: Wall mounted heat pumps have exceeded their useful life and are not energy efficient. Independent cooling is not provided for data rooms. System renewal is recommended.

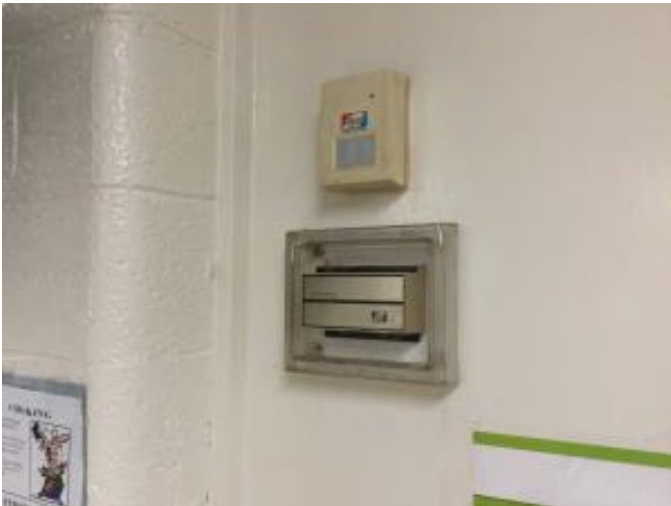
System: D3060 - Controls & Instrumentation

Location: Throughout the building
Distress: Beyond Service Life
Category: Deferred Maintenance
Priority: 3 - Necessary/Not Yet Critical (Years 2-5)
Correction: Renew System
Qty: 42,215.00
Unit of Measure: S.F.
Estimate: \$131,880.00
Assessor Name: Terence Davis
Date Created: 02/17/2017

Notes: Building controls are locally controlled and are obsolete, having been installed with the 1992 HVAC upgrade.. Installation of a modern digital system with remote monitoring and control capability for energy conservation is recommended.

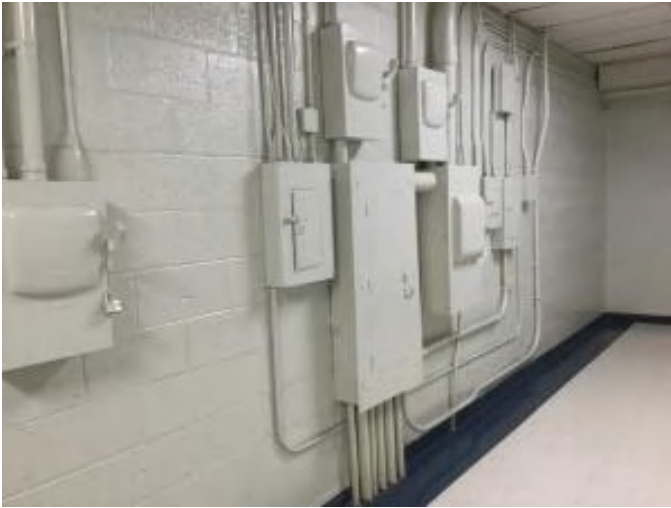
System: D5010 - Electrical Service/Distribution

Location: Main electrical service
Distress: Beyond Service Life
Category: Deferred Maintenance
Priority: 3 - Necessary/Not Yet Critical (Years 2-5)
Correction: Renew System
Qty: 42,215.00
Unit of Measure: S.F.
Estimate: \$78,942.00
Assessor Name: Terence Davis
Date Created: 02/17/2017

Notes: The main electrical service has been added on to, but has not been upgraded overall. Service is located in a corridor vs. a dedicated electrical equipment room. System renewal is recommended.

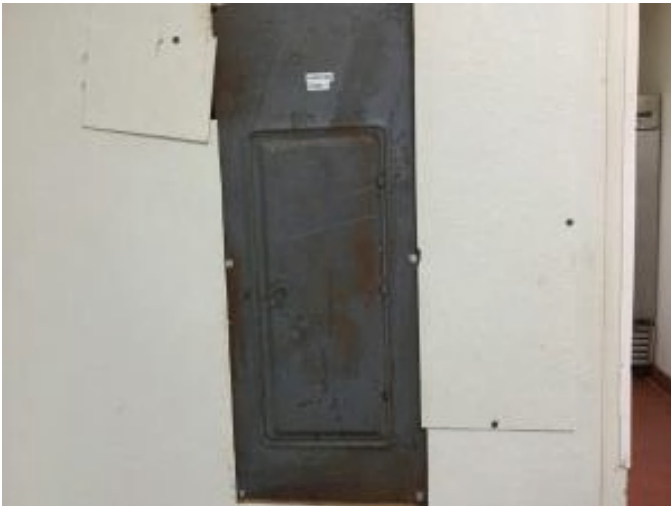
System: D5020 - Branch Wiring

Location: Throughout the building
Distress: Beyond Service Life
Category: Deferred Maintenance
Priority: 3 - Necessary/Not Yet Critical (Years 2-5)
Correction: Renew System
Qty: 42,215.00
Unit of Measure: S.F.
Estimate: \$226,146.00
Assessor Name: Terence Davis
Date Created: 02/17/2017

Notes: The branch wiring system has been added on to over the years, but a comprehensive upgrade has never been implemented. There are few spare circuits and circuits are overloaded. There are insufficient outlets to meet modern requirements. Equipment is obsolete.

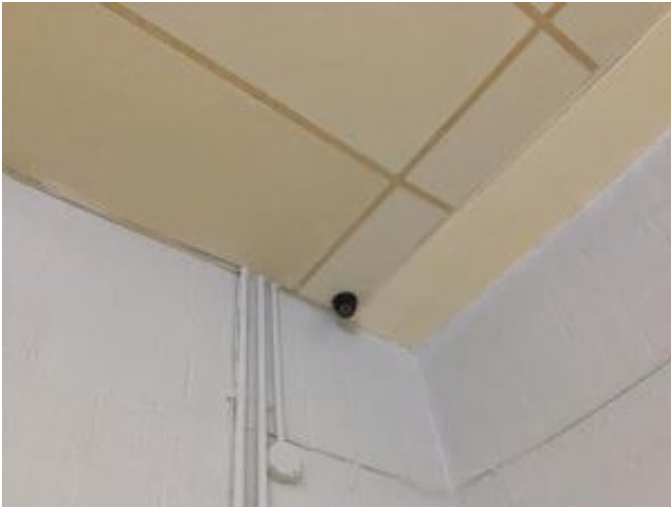
System: D5030810 - Security & Detection Systems

Location: Throughout the building
Distress: Beyond Service Life
Category: Deferred Maintenance
Priority: 3 - Necessary/Not Yet Critical (Years 2-5)
Correction: Renew System
Qty: 42,215.00
Unit of Measure: S.F.
Estimate: \$97,517.00
Assessor Name: Terence Davis
Date Created: 02/20/2017

Notes: Although reportedly only 10 years old, the security system is inadequate. It cannot be monitored properly in the principal's office. System renewal is recommended.

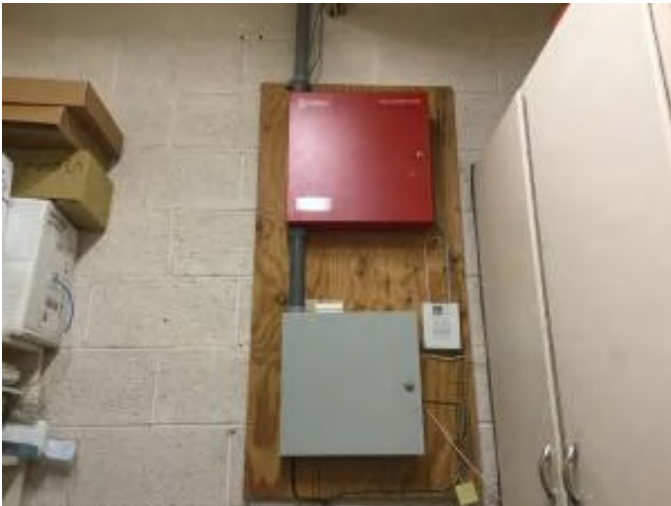
System: D5030910 - Fire Alarm Systems

Location: Throughout the building
Distress: Beyond Service Life
Category: Deferred Maintenance / Life Safety Code Compliance
Priority: 3 - Necessary/Not Yet Critical (Years 2-5)
Correction: Renew System
Qty: 42,215.00
Unit of Measure: S.F.
Estimate: \$177,852.00
Assessor Name: Terence Davis
Date Created: 02/17/2017

Notes: The fire alarm system is original and beyond its expected life. System renewal to current codes is recommended to ensure reliability of this life safety system.

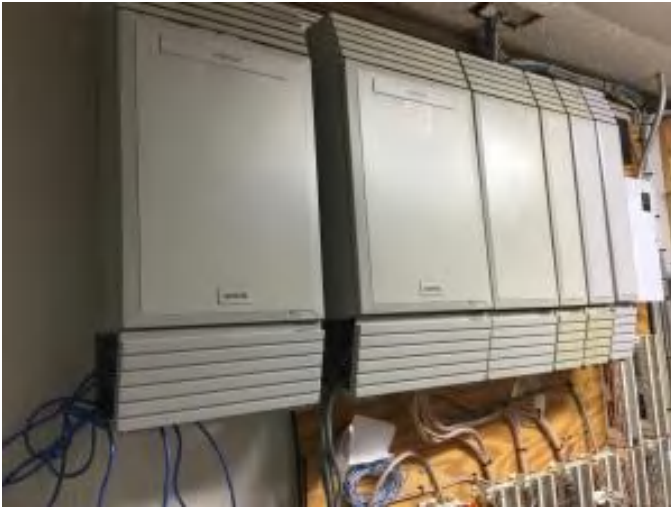
System: D5030920 - Data Communication

Location: Throughout the building
Distress: Beyond Service Life
Category: Deferred Maintenance
Priority: 3 - Necessary/Not Yet Critical (Years 2-5)
Correction: Renew System
Qty: 42,215.00
Unit of Measure: S.F.
Estimate: \$228,468.00
Assessor Name: Terence Davis
Date Created: 02/17/2017

Notes: The telephone system dates to the early '90s. The PA system is through the phone system. System renewal is recommended.

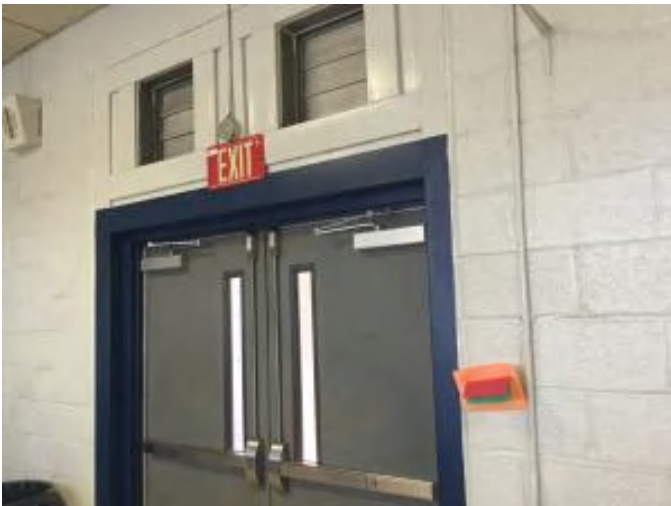
System: D5090 - Other Electrical Systems

Location: Throughout the building
Distress: Beyond Service Life
Category: Deferred Maintenance
Priority: 3 - Necessary/Not Yet Critical (Years 2-5)
Correction: Renew System
Qty: 42,215.00
Unit of Measure: S.F.
Estimate: \$33,899.00
Assessor Name: Terence Davis
Date Created: 02/17/2017

Notes: Egress lighting is beyond its expected useful life. System renewal, including review of distribution/adequacy of the system is recommended.

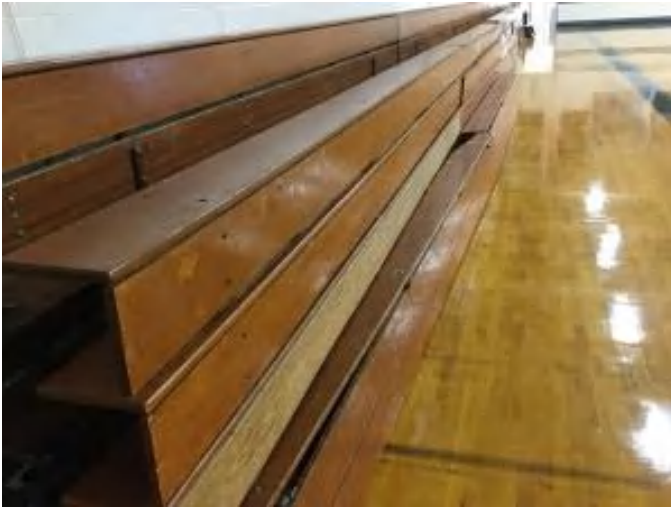
System: E1020 - Institutional Equipment

Location: Throughout the building
Distress: Beyond Service Life
Category: Deferred Maintenance
Priority: 3 - Necessary/Not Yet Critical (Years 2-5)
Correction: Renew System
Qty: 42,215.00
Unit of Measure: S.F.
Estimate: \$648,718.00
Assessor Name: Terence Davis
Date Created: 02/17/2017

Notes: Institutional equipment is generally beyond its expected useful life. System renewal is recommended.

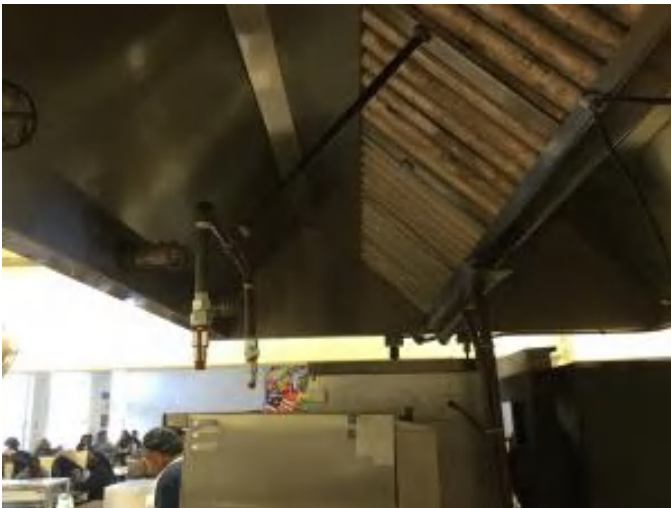
System: E1090 - Other Equipment

Location: Kitchen
Distress: Beyond Service Life
Category: Deferred Maintenance
Priority: 3 - Necessary/Not Yet Critical (Years 2-5)
Correction: Renew System
Qty: 42,215.00
Unit of Measure: S.F.
Estimate: \$266,081.00
Assessor Name: Terence Davis
Date Created: 02/17/2017

Notes: Kitchen equipment is generally beyond its expected useful life. System renewal is recommended.

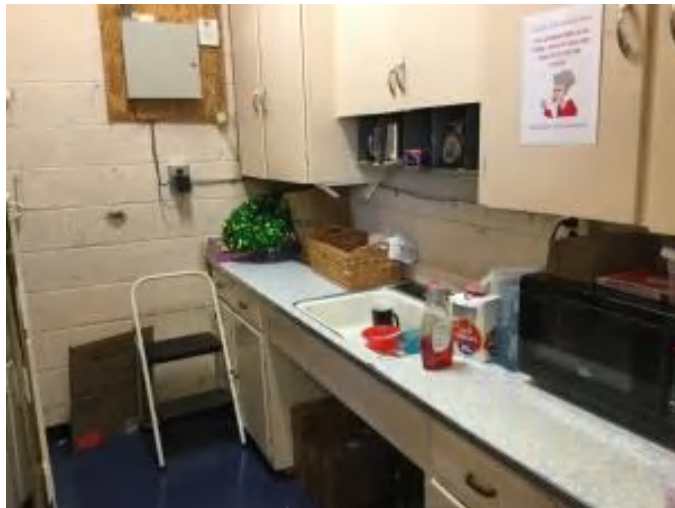
System: E2010 - Fixed Furnishings

Location: Throughout the building
Distress: Beyond Service Life
Category: Deferred Maintenance
Priority: 3 - Necessary/Not Yet Critical (Years 2-5)
Correction: Renew System
Qty: 42,215.00
Unit of Measure: S.F.
Estimate: \$247,507.00
Assessor Name: Terence Davis
Date Created: 02/17/2017

Notes: Fixed furnishing are typically original and in fair to poor condition. System renewal is recommended.

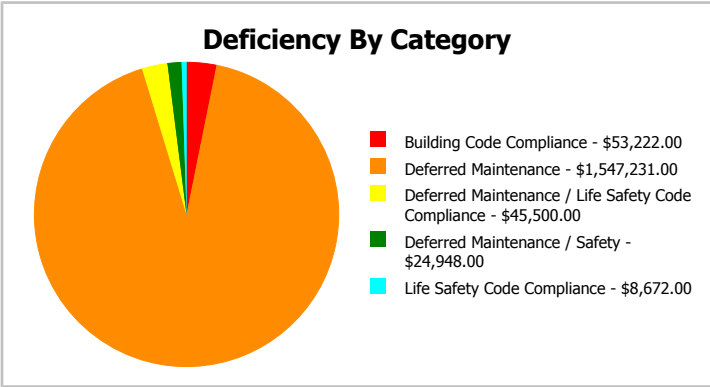
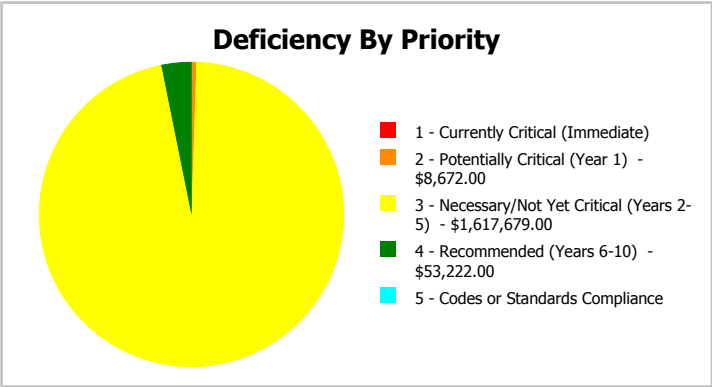
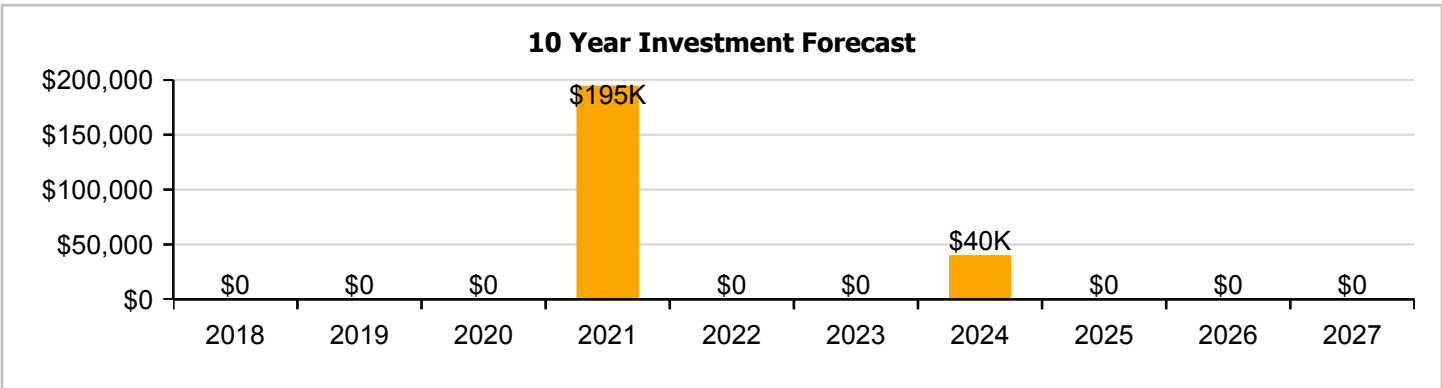
Dashboard Summary

Function:	HS -High School	Gross Area:	10,800
Year Built:	1969	Last Renovation:	
Repair Cost:	\$1,679,573	Replacement Value:	\$2,158,704
FCI:	77.80 %	RSLI%:	12.91 %

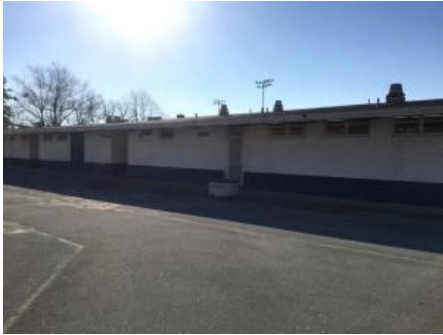
1). North Elevation - Feb 20, 2017

The photo album consists of the various cardinal directions of the building..

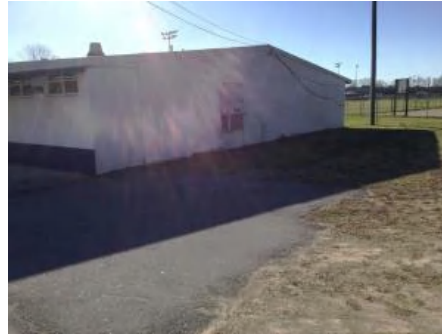
2). West Elevation - Feb 20, 2017

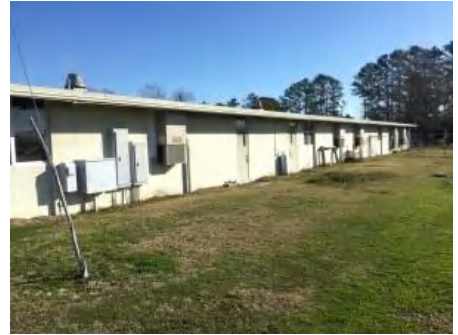
3). South Elevation - Feb 20, 2017

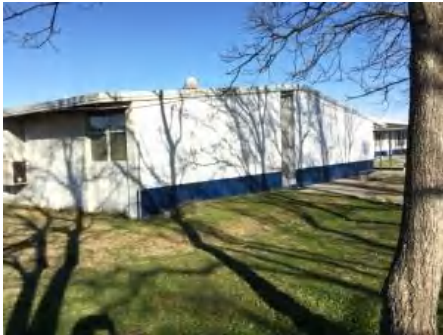
4). East Elevation - Feb 20, 2017

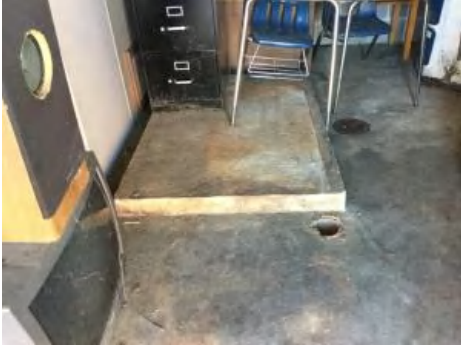
System: A1030 - Slab on Grade

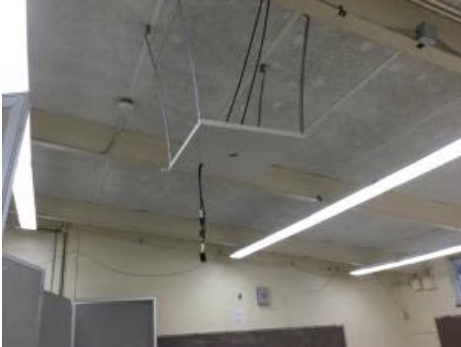
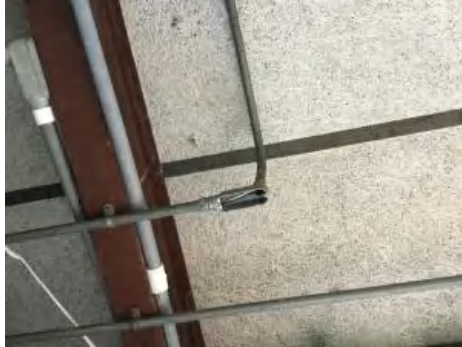
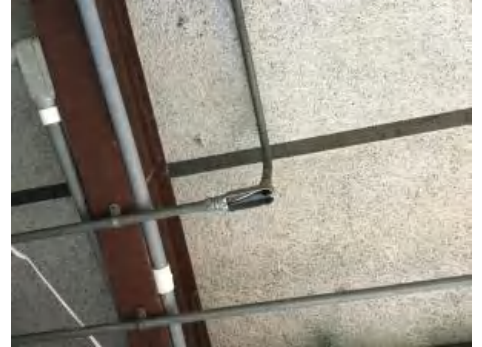
System: B1020 - Roof Construction

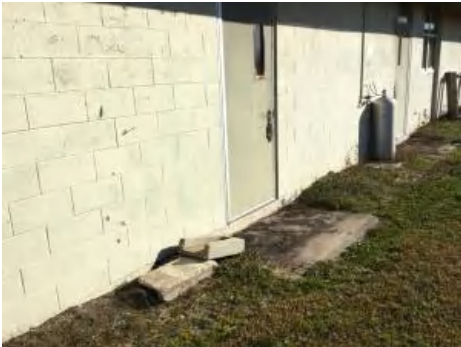
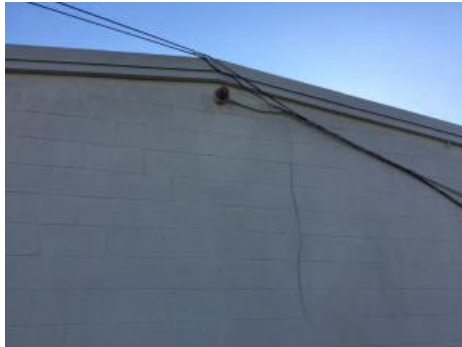
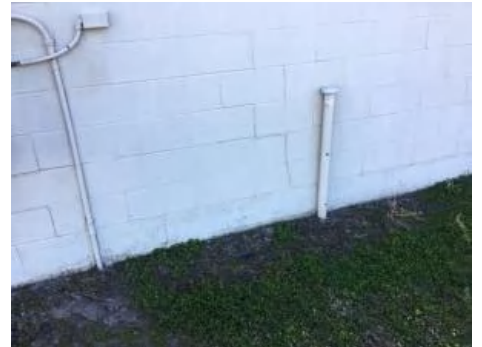
System: B2010 - Exterior Walls

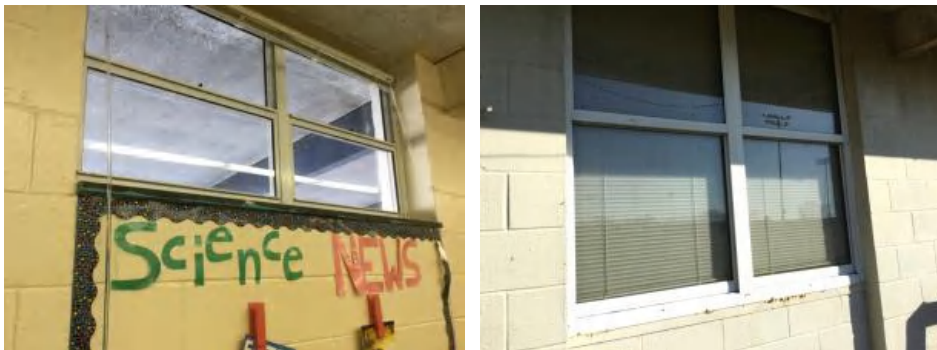
System: B2020 - Exterior Windows

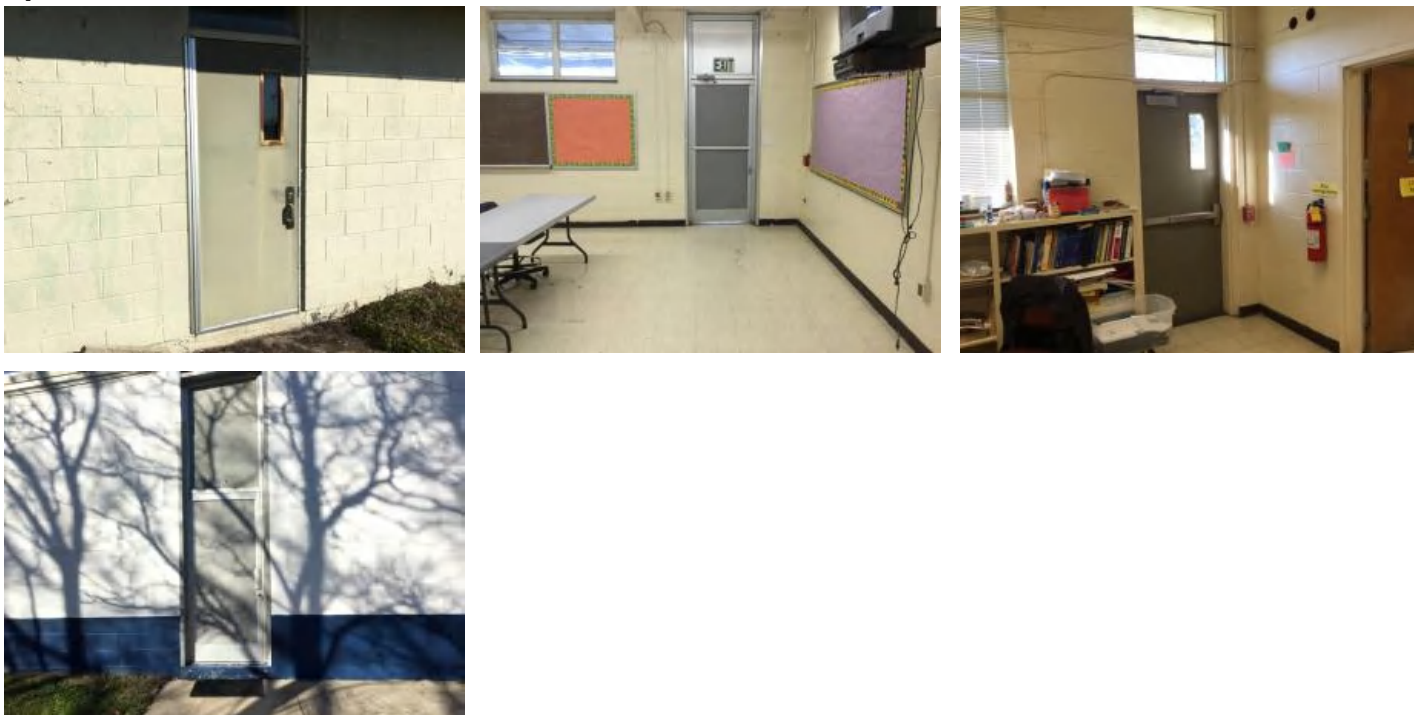
System: B2030 - Exterior Doors

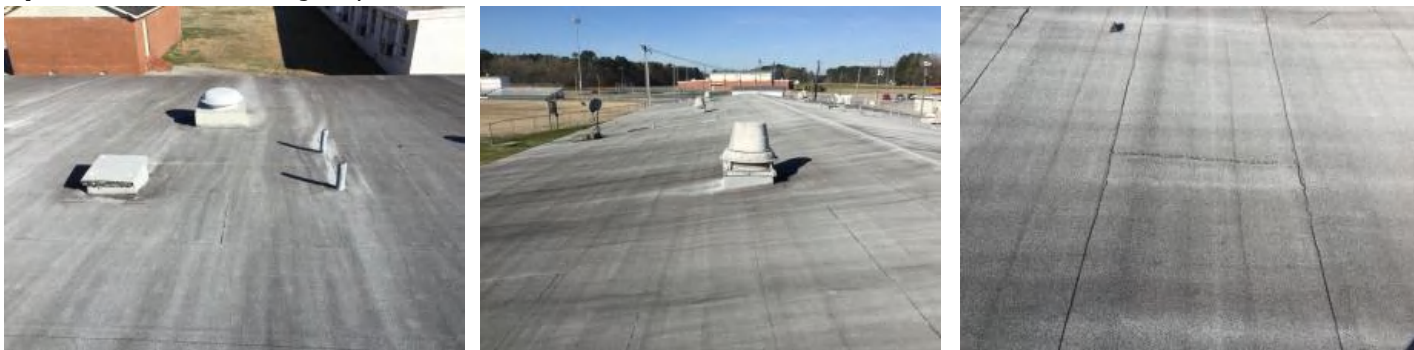
System: B3010120 - Single Ply Membrane

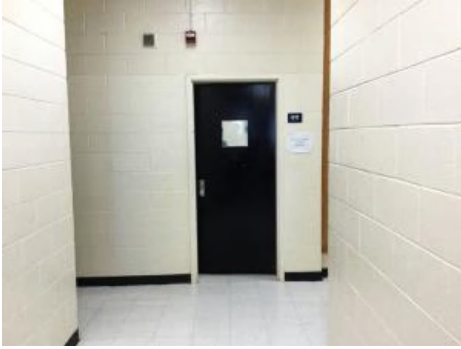
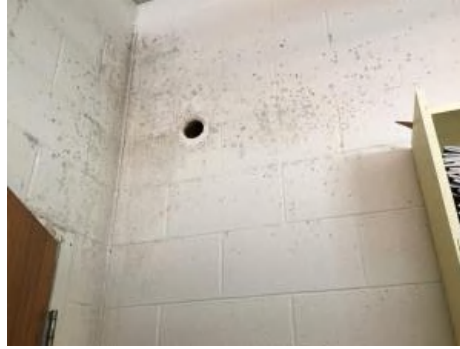
System: C1010 - Partitions

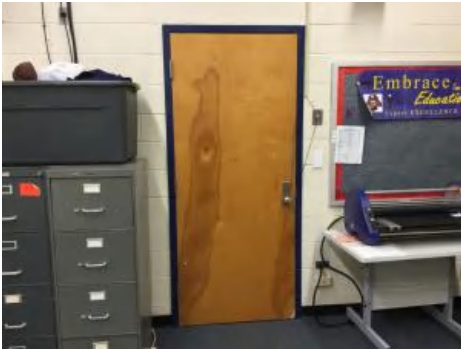
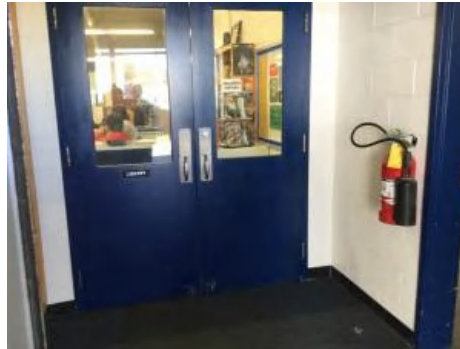
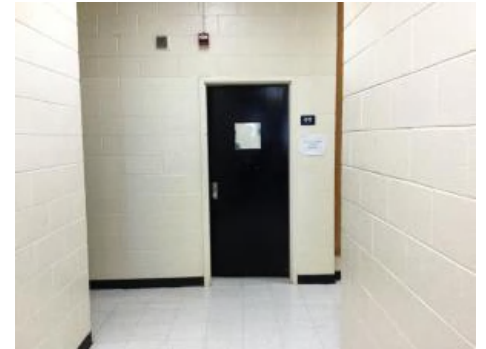
System: C1020 - Interior Doors

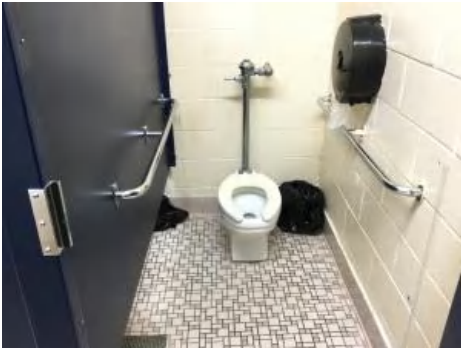
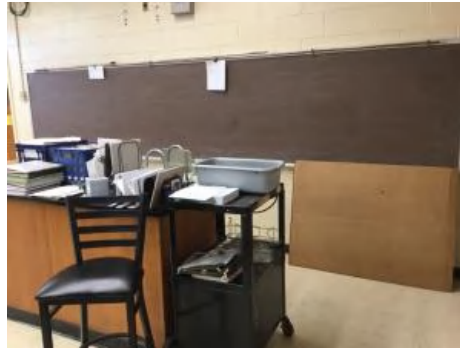
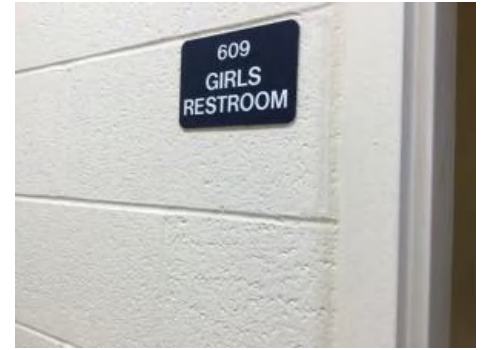
System: C1030 - Fittings

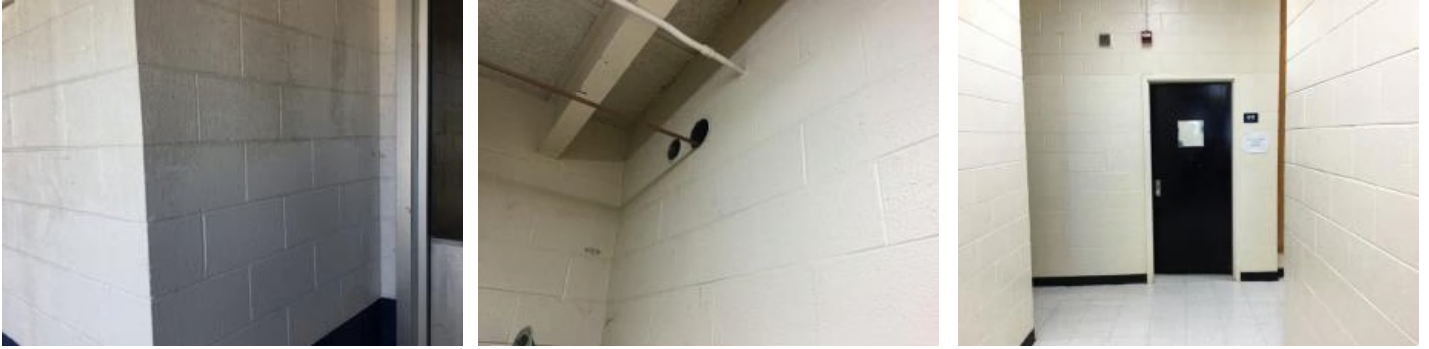
System: C3010 - Wall Finishes

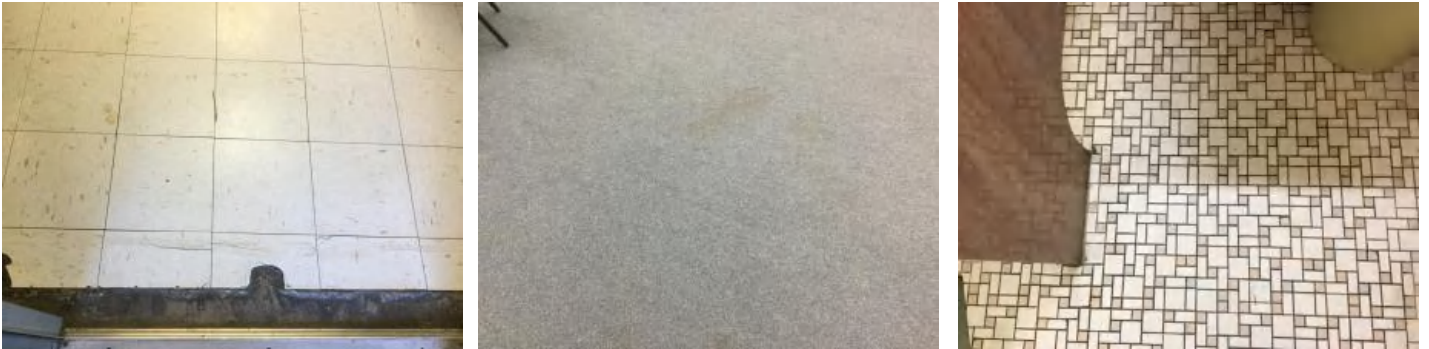
System: C3020 - Floor Finishes
