NC School District/520 Jones County/High School

Jones Senior High

Campus Assessment Report

March 8, 2017

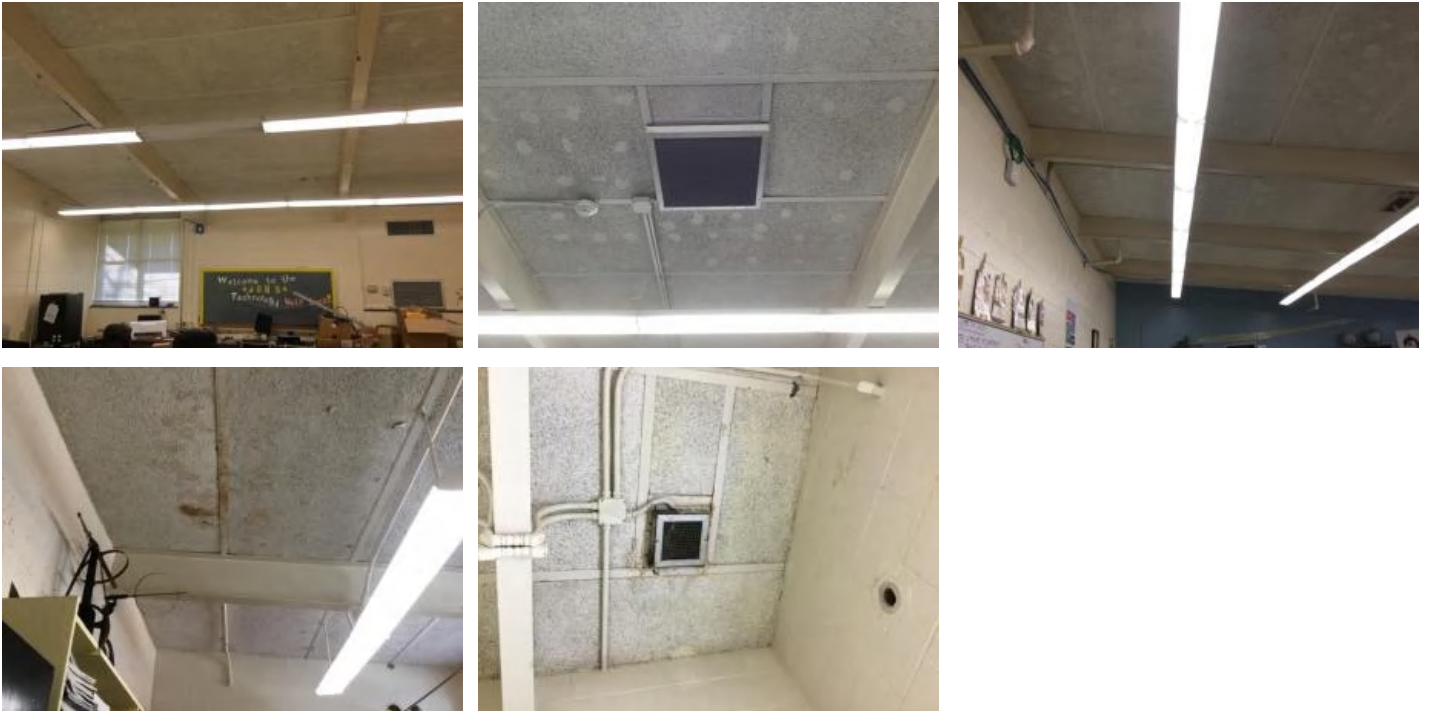
System: C3030 - Ceiling Finishes

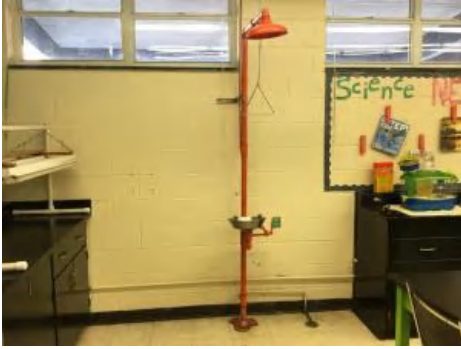
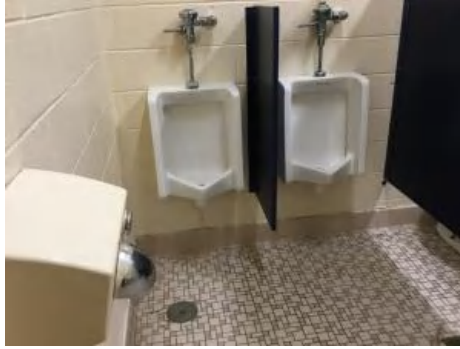
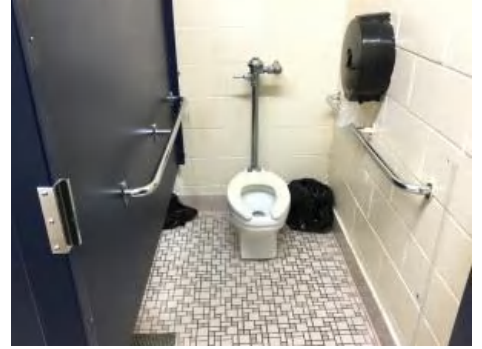
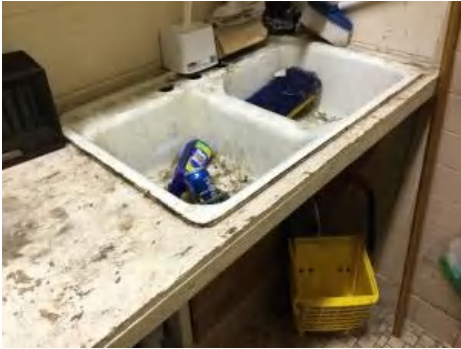
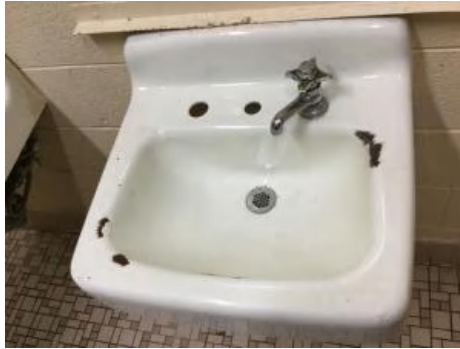
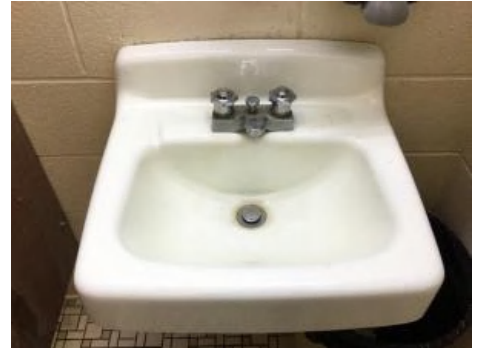
System: D2010 - Plumbing Fixtures

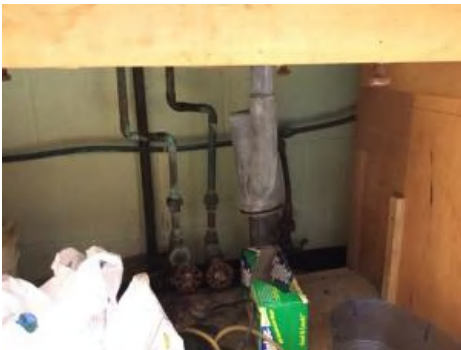
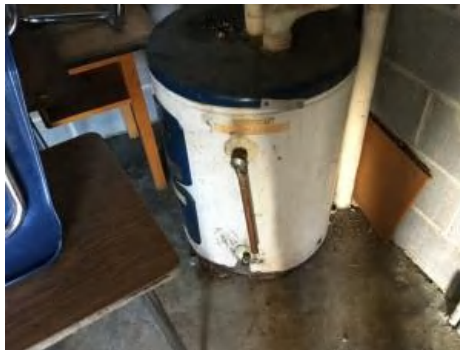
System: D2020 - Domestic Water Distribution

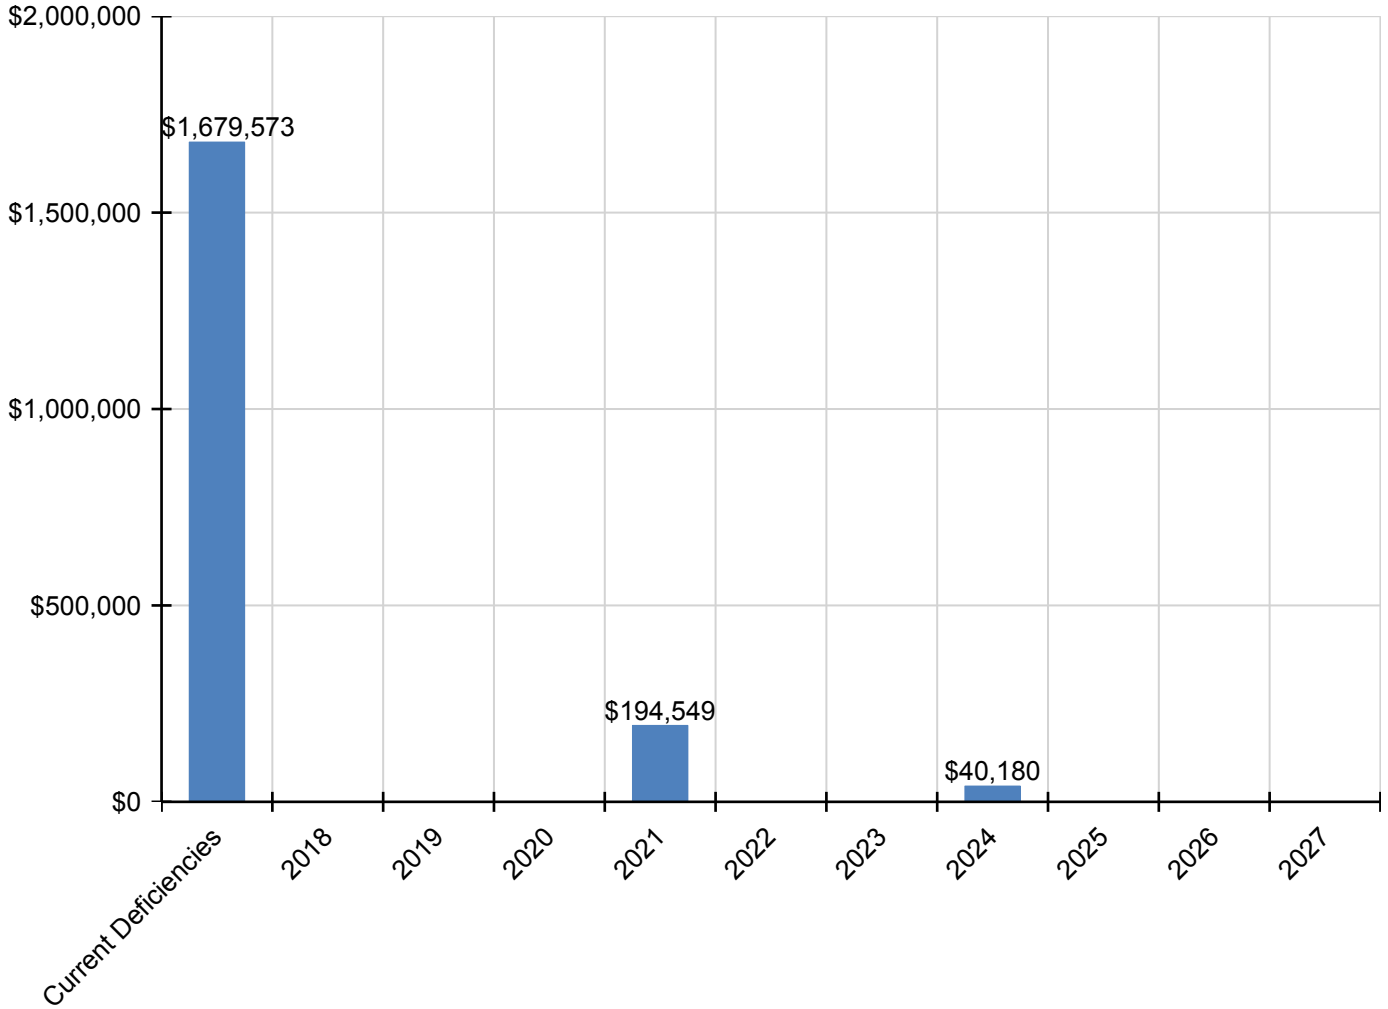
Forecasted Capital Renewal Requirement

The following chart shows the current building deficiencies and forecasting capital renewal or sustainment requirements over the next ten years.

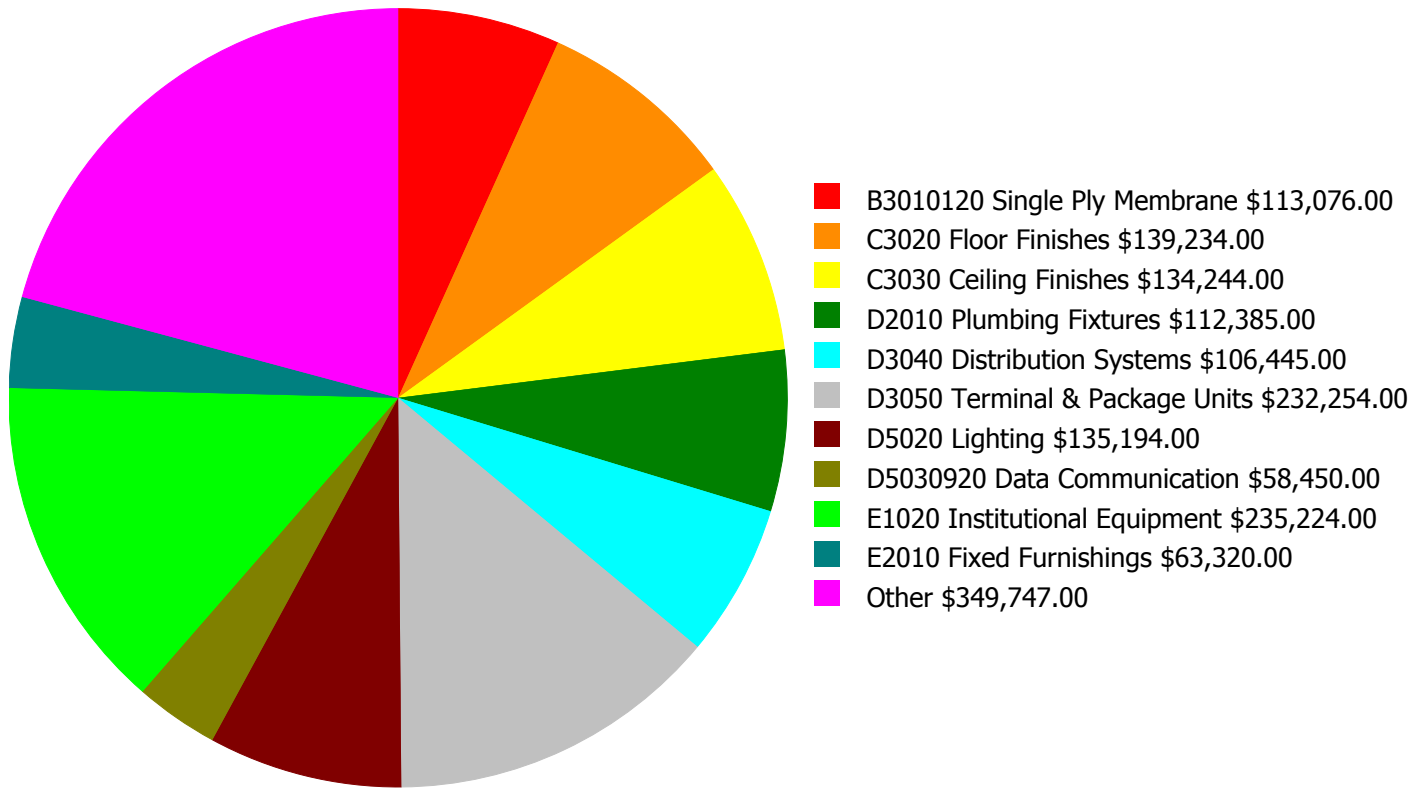
Deficiency Summary by System

Current deficiencies included assemblies that have reached or exceeded their design life or components of the assemblies that are in need of repair. Assemblies that have reached their design life are identified as current deficiencies and assigned the distress 'Beyond Useful Life'. The following chart lists all current deficiencies associated with this facility.

Budget Estimate Total: \$1,679,573.00

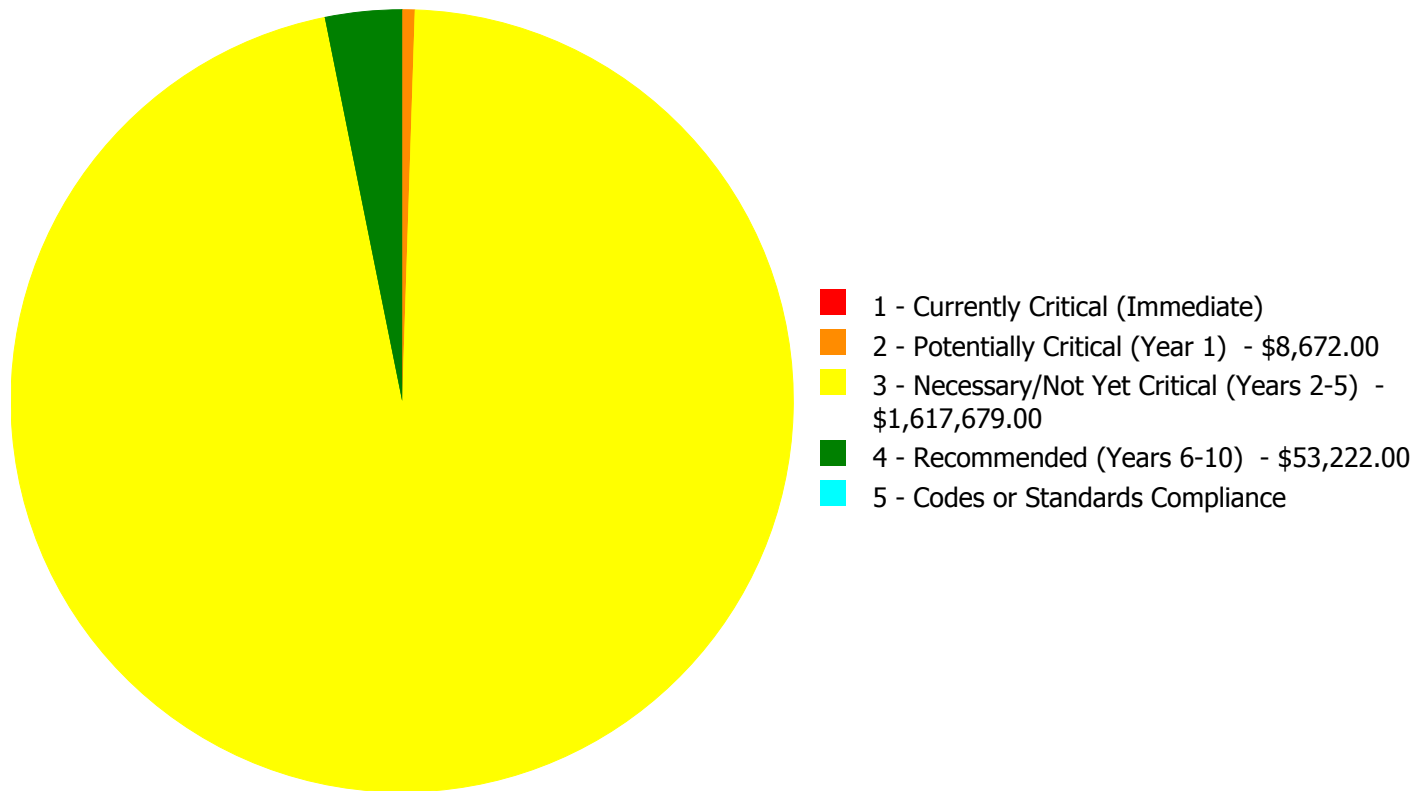
Deficiency Summary by Priority

The following chart shows the total repair costs broken down by priority. Assessors assigned deficiencies within eCOMET to one of the following priority categories:

Budget Estimate Total: \$1,679,573.00

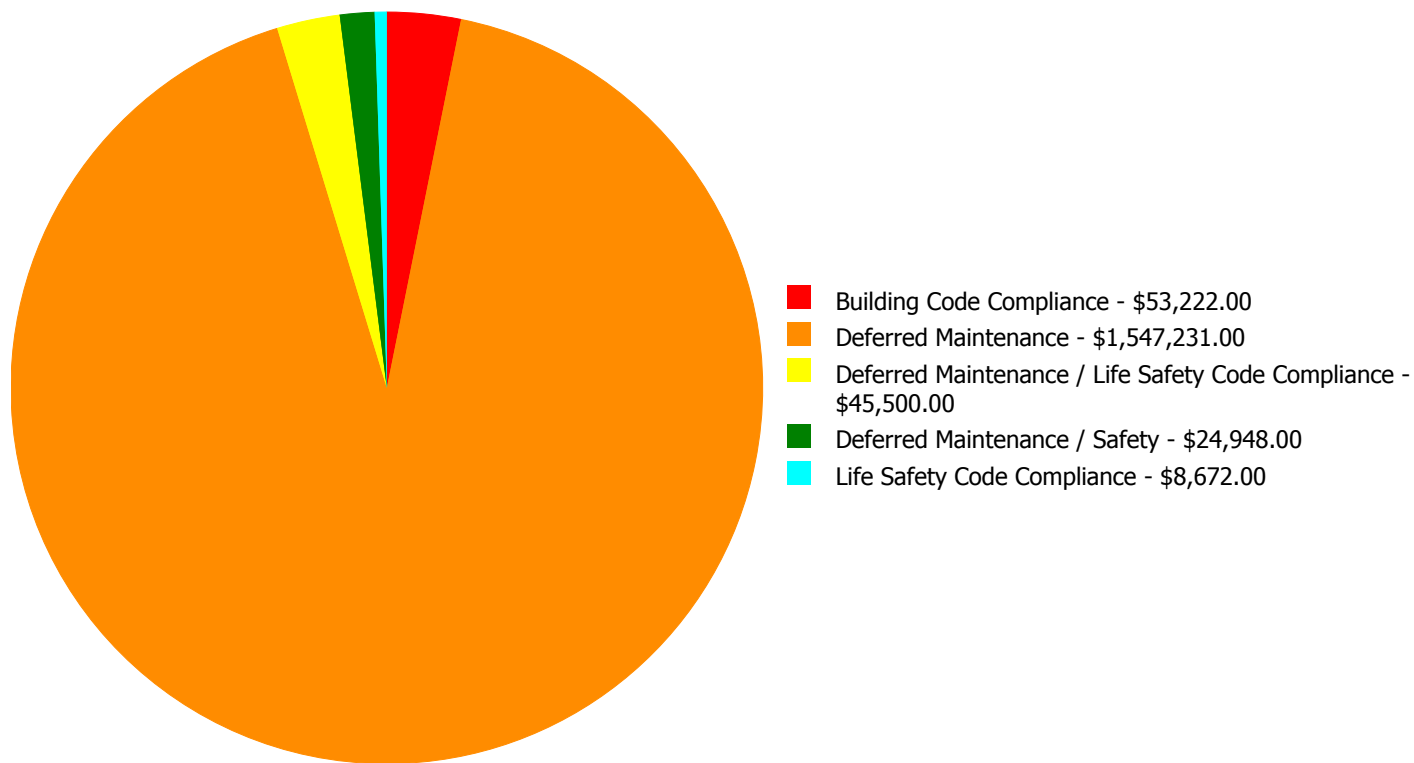
Deficiency Summary by Category

The following chart shows the total repair costs broken down by deficiency categories. Assessors assigned deficiencies to one of the following categories:

Budget Estimate Total: \$1,679,573.00

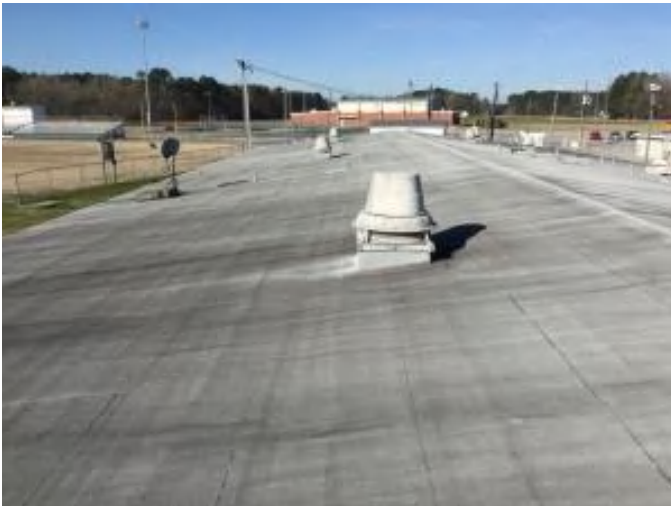
System: B3010120 - Single Ply Membrane

Location: Roof
Distress: Beyond Service Life
Category: Deferred Maintenance
Priority: 3 - Necessary/Not Yet Critical (Years 2-5)
Correction: Renew System
Qty: 10,800.00
Unit of Measure: S.F.
Estimate: \$113,076.00
Assessor Name: Terence Davis
Date Created: 02/17/2017

Notes: Though no active leaks are reported or observed, the roof membrane is beyond its expected useful life. System renewal is recommended.

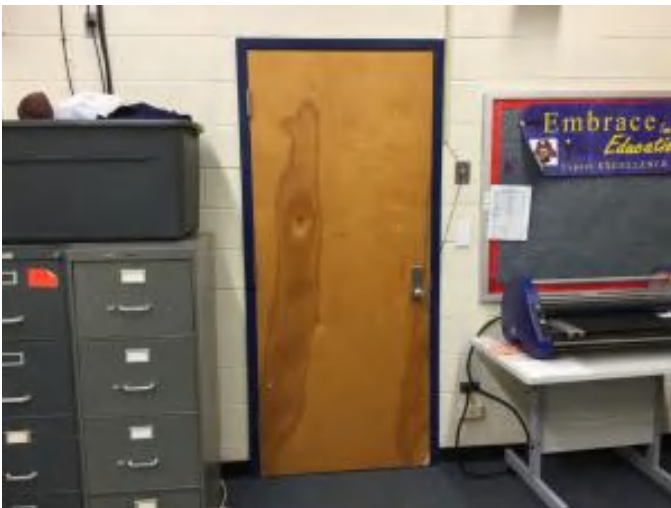
System: C1020 - Interior Doors

Location: Throughout the building
Distress: Beyond Service Life
Category: Deferred Maintenance
Priority: 3 - Necessary/Not Yet Critical (Years 2-5)
Correction: Renew System
Qty: 10,800.00
Unit of Measure: S.F.
Estimate: \$31,007.00
Assessor Name: Terence Davis
Date Created: 02/17/2017

Notes: Interior doors are beyond their expected useful life and typically do not have ADA compliant hardware. System renewal is recommended.

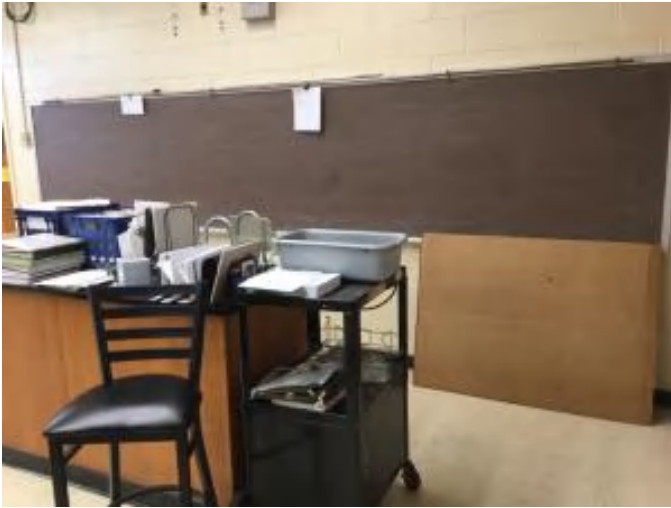
System: C1030 - Fittings

Location: Throughout the building
Distress: Beyond Service Life
Category: Deferred Maintenance
Priority: 3 - Necessary/Not Yet Critical (Years 2-5)
Correction: Renew System
Qty: 10,800.00
Unit of Measure: S.F.
Estimate: \$18,770.00
Assessor Name: Terence Davis
Date Created: 02/17/2017

Notes: Fittings are typically beyond their expected useful life. Signage and toilet rooms are not ADA compliant. System renewal is recommended.

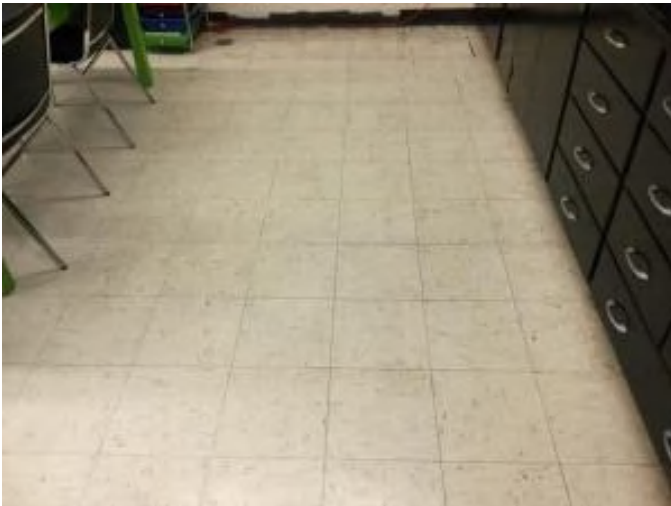
System: C3020 - Floor Finishes

Location: Throughout the building
Distress: Beyond Service Life
Category: Deferred Maintenance
Priority: 3 - Necessary/Not Yet Critical (Years 2-5)
Correction: Renew System
Qty: 10,800.00
Unit of Measure: S.F.
Estimate: \$139,234.00
Assessor Name: Terence Davis
Date Created: 02/17/2017

Notes: Floor finishes are generally beyond their expected useful life. Asbestos containing mastic is encapsulated beneath floor finishes. System renewal including complete abatement is recommended.

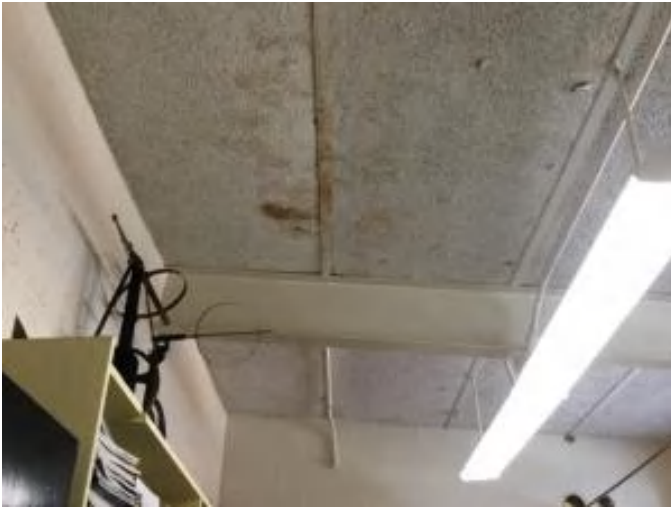
System: C3030 - Ceiling Finishes

Location: Throughout the building
Distress: Beyond Service Life
Category: Deferred Maintenance
Priority: 3 - Necessary/Not Yet Critical (Years 2-5)
Correction: Renew System
Qty: 10,800.00
Unit of Measure: S.F.
Estimate: \$134,244.00
Assessor Name: Terence Davis
Date Created: 02/17/2017

Notes: Ceiling finishes are in fair to poor condition. System renewal is recommended.

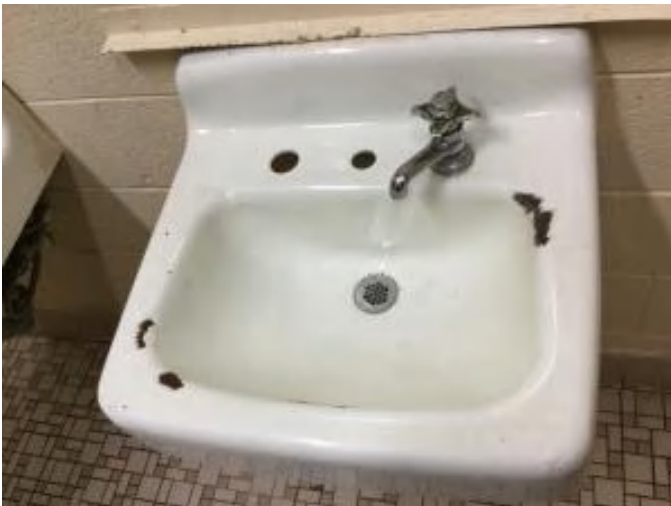
System: D2010 - Plumbing Fixtures

Location: Throughout the building
Distress: Beyond Service Life
Category: Deferred Maintenance
Priority: 3 - Necessary/Not Yet Critical (Years 2-5)
Correction: Renew System
Qty: 10,800.00
Unit of Measure: S.F.
Estimate: \$112,385.00
Assessor Name: Terence Davis
Date Created: 02/17/2017

Notes: Plumbing fixtures are in operational conditions. However, they are aged, not ADA compliant and should be replaced with low-flow water fixtures.

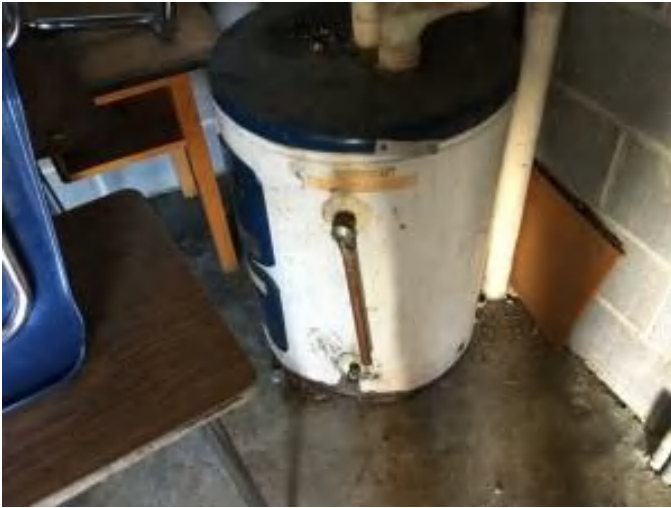
System: D2020 - Domestic Water Distribution

Location: Throughout the building
Distress: Beyond Service Life
Category: Deferred Maintenance
Priority: 3 - Necessary/Not Yet Critical (Years 2-5)
Correction: Renew System
Qty: 10,800.00
Unit of Measure: S.F.
Estimate: \$20,909.00
Assessor Name: Terence Davis
Date Created: 02/17/2017

Notes: The domestic water distribution system is largely original and beyond its expected life. System renewal is recommended.

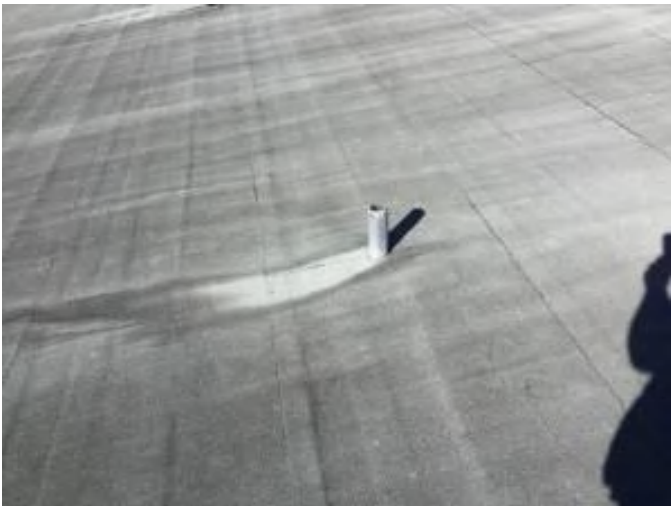
System: D2030 - Sanitary Waste

Location: Throughout the building
Distress: Beyond Service Life
Category: Deferred Maintenance
Priority: 3 - Necessary/Not Yet Critical (Years 2-5)
Correction: Renew System
Qty: 10,800.00
Unit of Measure: S.F.
Estimate: \$32,908.00
Assessor Name: Terence Davis
Date Created: 02/17/2017

Notes: The sanitary waste system is beyond its expected life. Though no active problems were observed or reported, renewal to ensure system integrity is recommended.

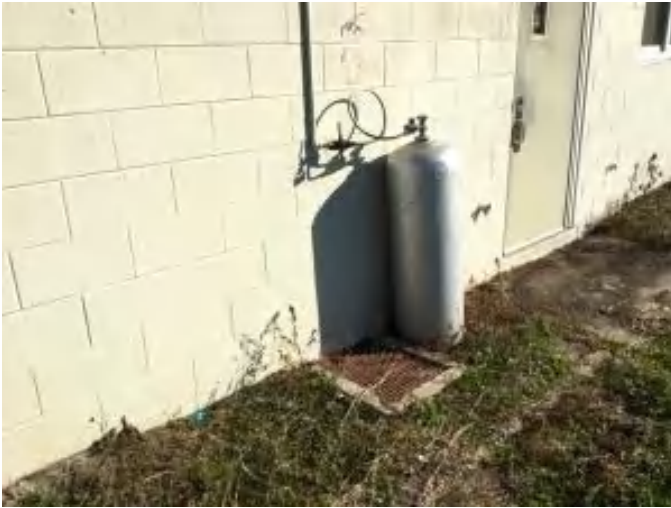
System: D2090 - Other Plumbing Systems

Location: Science labs
Distress: Beyond Service Life
Category: Deferred Maintenance
Priority: 3 - Necessary/Not Yet Critical (Years 2-5)
Correction: Renew System
Qty: 10,800.00
Unit of Measure: S.F.
Estimate: \$2,020.00
Assessor Name: Terence Davis
Date Created: 03/02/2017

Notes: Propane distribution systems are beyond their expected life. System renewal is recommended.

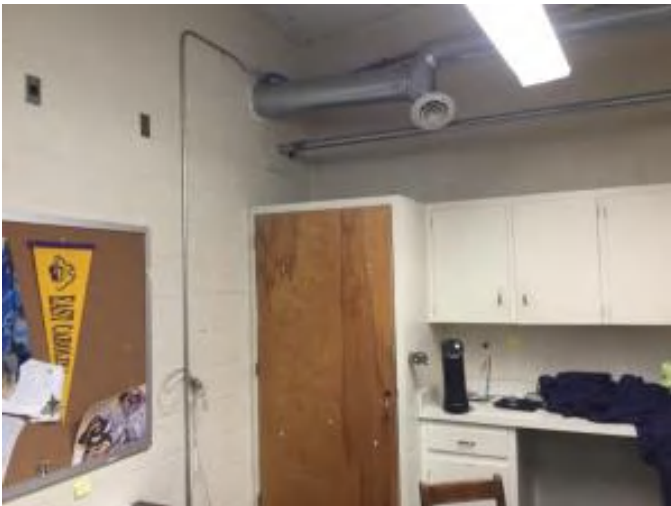
System: D3040 - Distribution Systems

Location: Throughout the building
Distress: Beyond Service Life
Category: Deferred Maintenance
Priority: 3 - Necessary/Not Yet Critical (Years 2-5)
Correction: Renew System
Qty: 10,800.00
Unit of Measure: S.F.
Estimate: \$106,445.00
Assessor Name: Terence Davis
Date Created: 02/17/2017

Notes: HVAC distribution systems are beyond their expected useful life. System renewal is recommended.

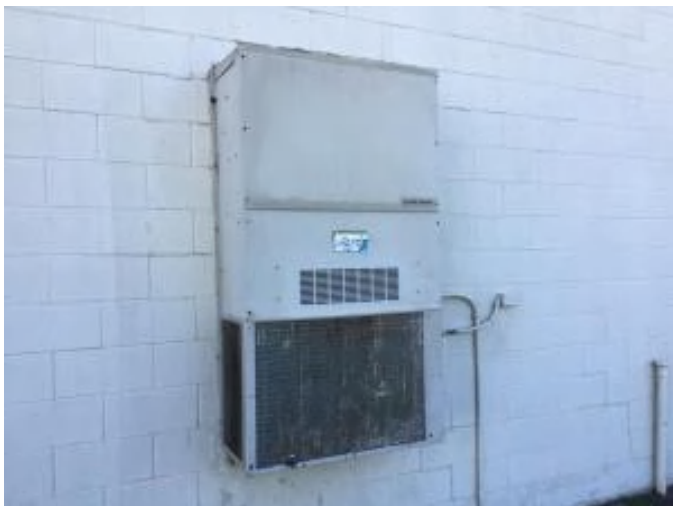
System: D3050 - Terminal & Package Units

Location: Throughout the bulding
Distress: Beyond Service Life
Category: Deferred Maintenance
Priority: 3 - Necessary/Not Yet Critical (Years 2-5)
Correction: Renew System
Qty: 10,800.00
Unit of Measure: S.F.
Estimate: \$232,254.00
Assessor Name: Terence Davis
Date Created: 02/17/2017

Notes: Wall mounted heat pumps have exceeded their useful life and are not energy efficient. Independent cooling is not provided for data rooms. System renewal is recommended.

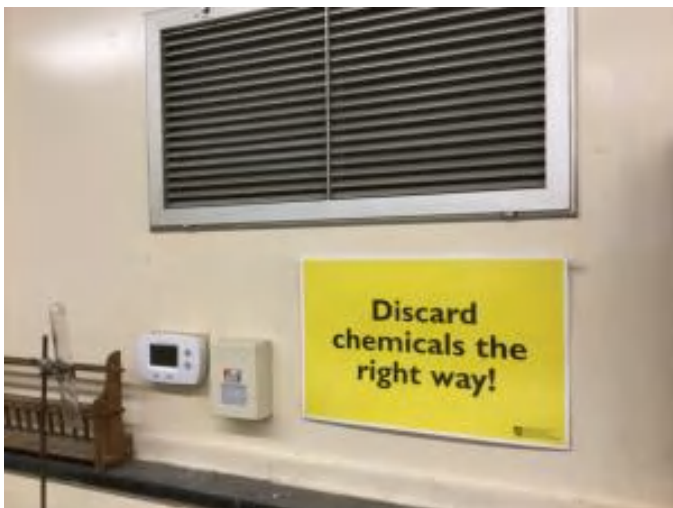
System: D3060 - Controls & Instrumentation

Location: Throughout the building
Distress: Beyond Service Life
Category: Deferred Maintenance
Priority: 3 - Necessary/Not Yet Critical (Years 2-5)
Correction: Renew System
Qty: 10,800.00
Unit of Measure: S.F.
Estimate: \$33,739.00
Assessor Name: Terence Davis
Date Created: 02/17/2017

Notes: Building controls are locally controlled and are obsolete, having been installed with the 1992 HVAC upgrade.. Installation of a modern digital system with remote monitoring and control capability for energy conservation is recommended.

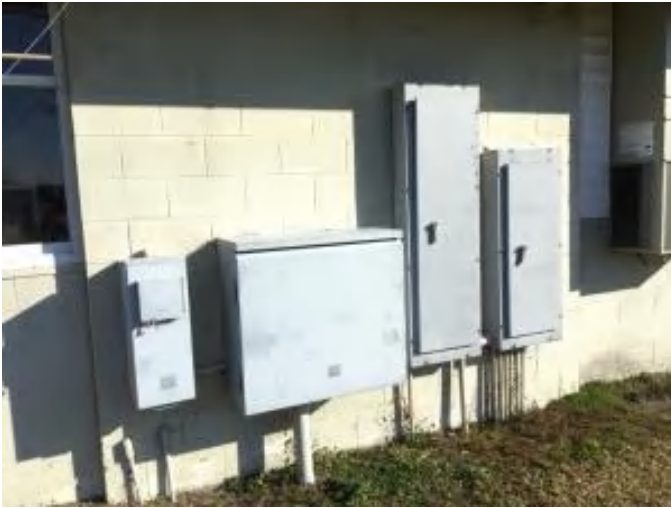
System: D5010 - Electrical Service/Distribution

Location: MDP
Distress: Beyond Service Life
Category: Deferred Maintenance
Priority: 3 - Necessary/Not Yet Critical (Years 2-5)
Correction: Renew System
Qty: 10,800.00
Unit of Measure: S.F.
Estimate: \$20,196.00
Assessor Name: Terence Davis
Date Created: 02/17/2017

Notes: The electric service was added onto for the 1992 HVAC upgrade, but the original system has never been replaced and is beyond its expected service life. System renewal is recommended.

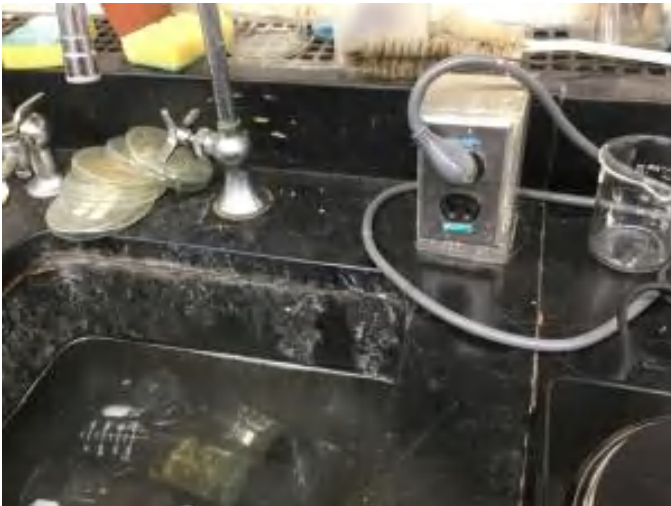
System: D5020 - Branch Wiring

Location: Throughout the building
Distress: Beyond Service Life
Category: Deferred Maintenance
Priority: 3 - Necessary/Not Yet Critical (Years 2-5)
Correction: Renew System
Qty: 10,800.00
Unit of Measure: S.F.
Estimate: \$57,856.00
Assessor Name: Terence Davis
Date Created: 02/17/2017

Notes: The branch wiring system is largely original and beyond its expected life. Circuits are overloaded. System renewal is recommended.

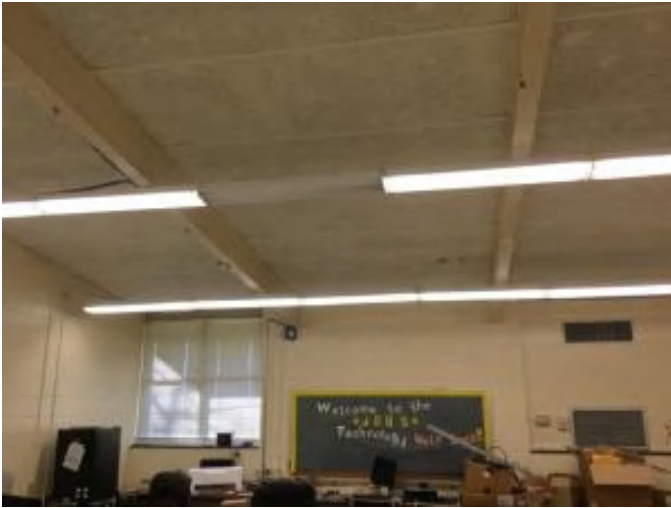
System: D5020 - Lighting

Location: Throughout the building
Distress: Beyond Service Life
Category: Deferred Maintenance
Priority: 3 - Necessary/Not Yet Critical (Years 2-5)
Correction: Renew System
Qty: 10,800.00
Unit of Measure: S.F.
Estimate: \$135,194.00
Assessor Name: Terence Davis
Date Created: 02/17/2017

Notes: Although fixtures have been retrofitted w// T-8 lamps, the lighting system is largely original and beyond its expected life. System renewal is recommended.

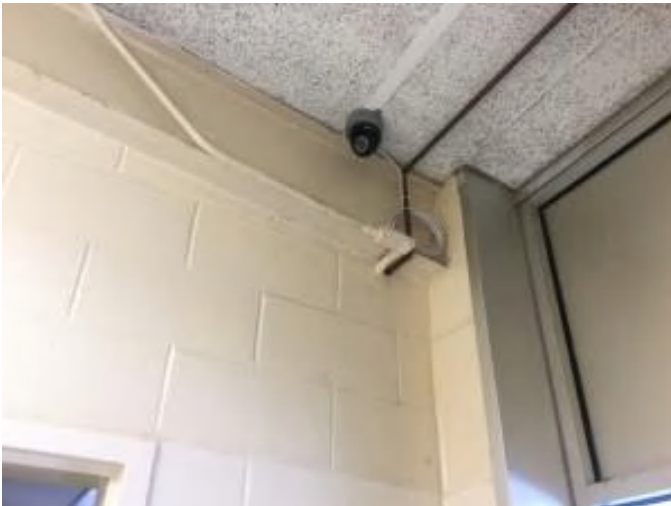
System: D5030810 - Security & Detection Systems

Location: Throughout the building
Distress: Inadequate
Category: Deferred Maintenance / Safety
Priority: 3 - Necessary/Not Yet Critical (Years 2-5)
Correction: Renew System
Qty: 10,800.00
Unit of Measure: S.F.
Estimate: \$24,948.00
Assessor Name: Terence Davis
Date Created: 02/20/2017

Notes: Although reportedly only 10 years old, the security system is inadequate. It cannot be monitored properly in the principal's office. System renewal is recommended.

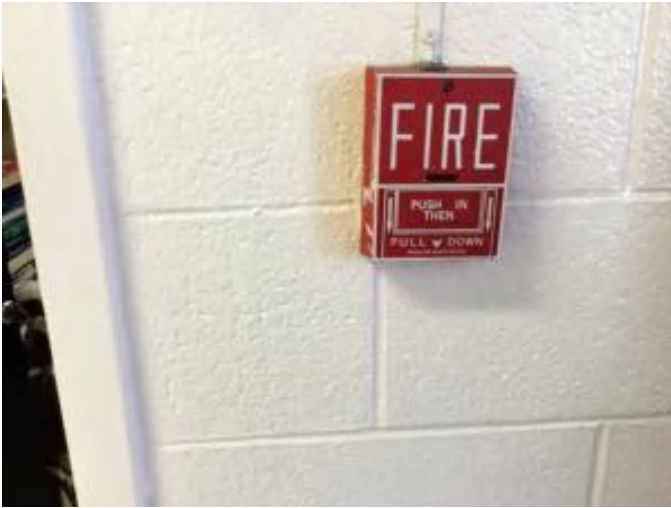
System: D5030910 - Fire Alarm Systems

Location: Throughout the building
Distress: Beyond Service Life
Category: Deferred Maintenance / Life Safety Code Compliance
Priority: 3 - Necessary/Not Yet Critical (Years 2-5)
Correction: Renew System
Qty: 10,800.00
Unit of Measure: S.F.
Estimate: \$45,500.00
Assessor Name: Terence Davis
Date Created: 02/17/2017

Notes: The fire alarm system is beyond its expected life. System renewal is recommended to ensure reliability and code compliance of this life safety system.

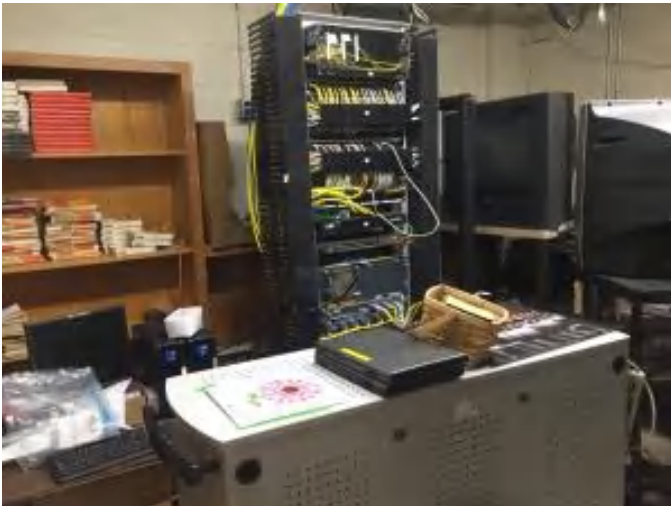
System: D5030920 - Data Communication

Location: Throughout the building
Distress: Beyond Service Life
Category: Deferred Maintenance
Priority: 3 - Necessary/Not Yet Critical (Years 2-5)
Correction: Renew System
Qty: 10,800.00
Unit of Measure: S.F.
Estimate: \$58,450.00
Assessor Name: Terence Davis
Date Created: 02/17/2017

Notes: Data and communications systems are beyond their expected service life. System renewal is recommended.

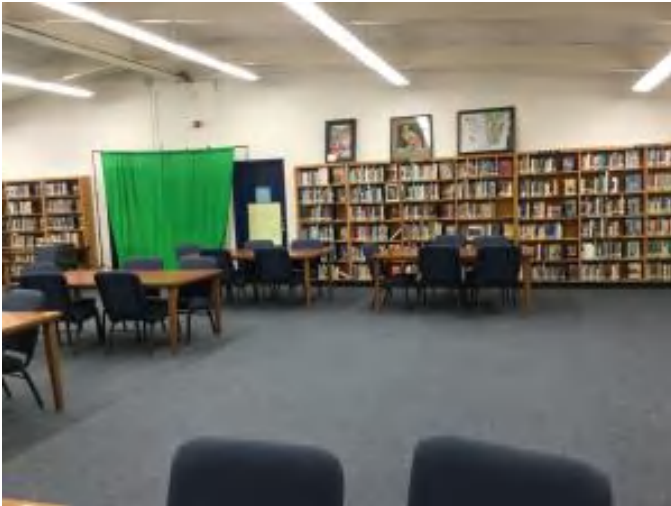
System: E1020 - Institutional Equipment

Location: Library, Science Classrooms
Distress: Beyond Service Life
Category: Deferred Maintenance
Priority: 3 - Necessary/Not Yet Critical (Years 2-5)
Correction: Renew System
Qty: 10,800.00
Unit of Measure: S.F.
Estimate: \$235,224.00
Assessor Name: Terence Davis
Date Created: 02/17/2017

Notes: Institutional equipment is original and in fair to poor condition. System renewal is recommended.

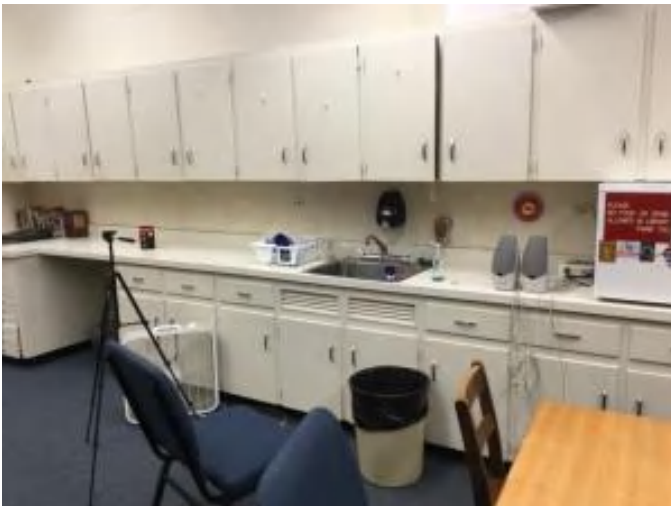
System: E2010 - Fixed Furnishings

Location: Library workroom
Distress: Beyond Service Life
Category: Deferred Maintenance
Priority: 3 - Necessary/Not Yet Critical (Years 2-5)
Correction: Renew System
Qty: 10,800.00
Unit of Measure: S.F.
Estimate: \$63,320.00
Assessor Name: Terence Davis
Date Created: 02/17/2017

Notes: Fixed furnishings are beyond their expected life and are in fair to poor condition. System renewal is recommended.

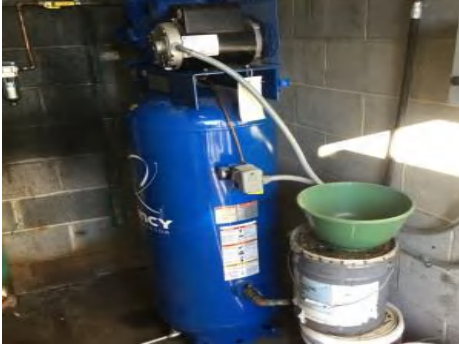
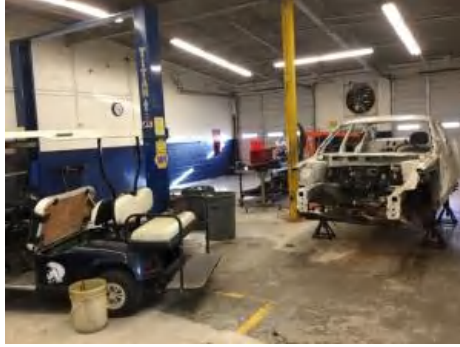
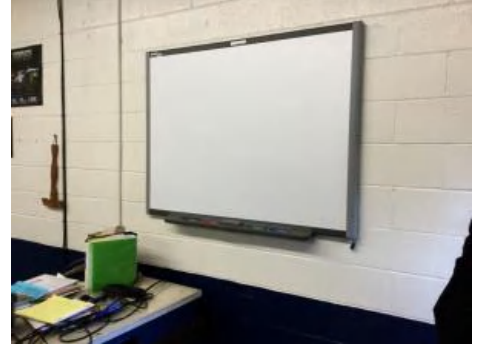
System: E1020 - Institutional Equipment

Note: Shop equipment is up to date

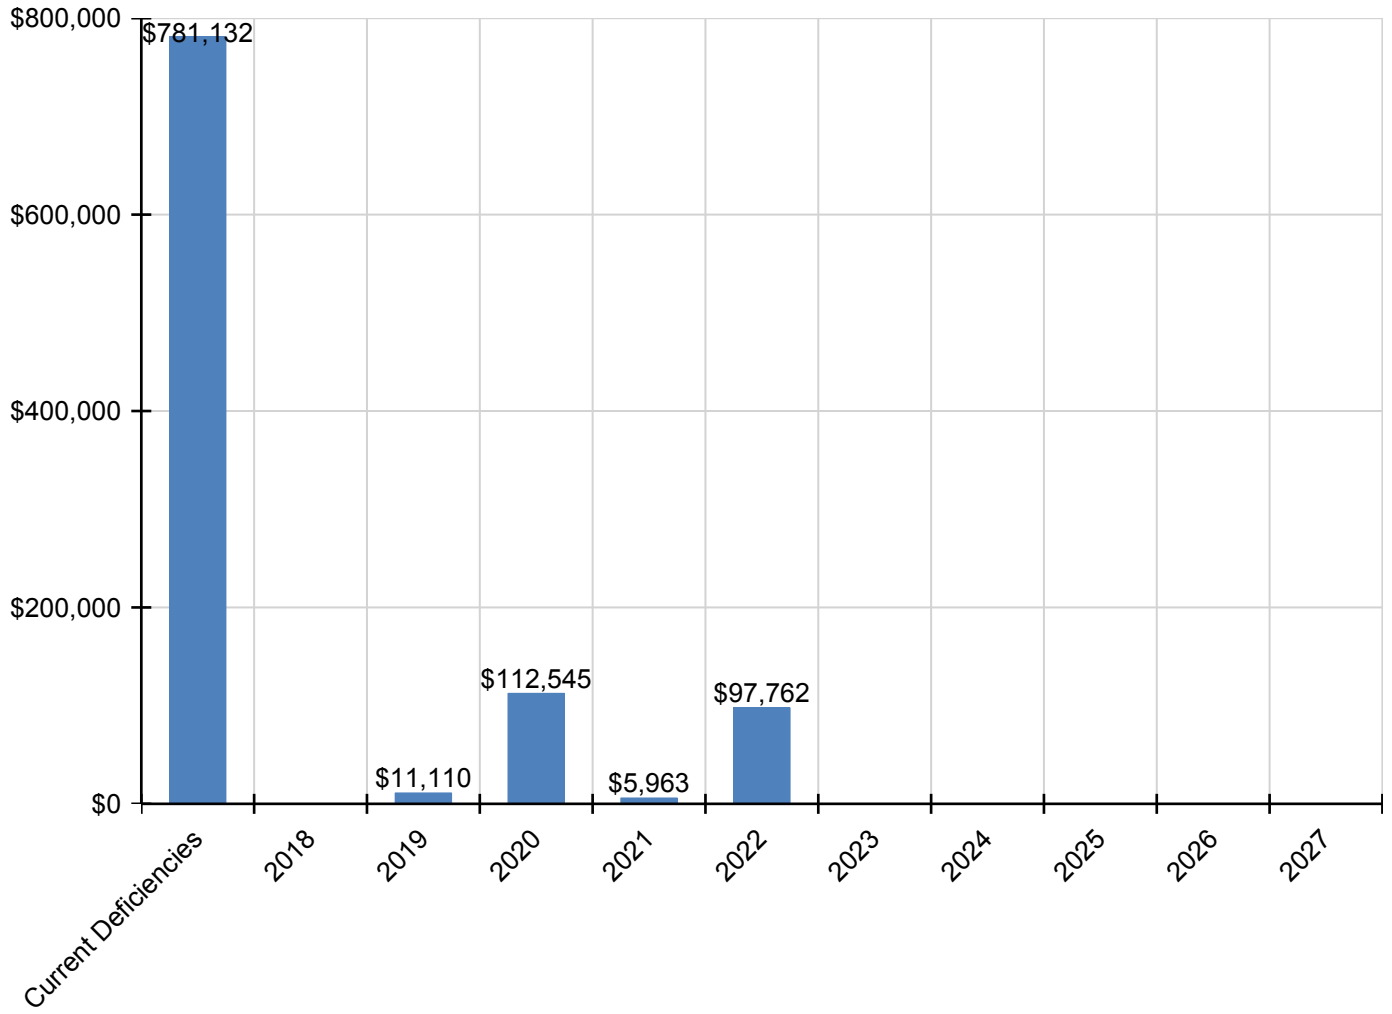
Forecasted Capital Renewal Requirement

The following chart shows the current building deficiencies and forecasting capital renewal or sustainment requirements over the next ten years.

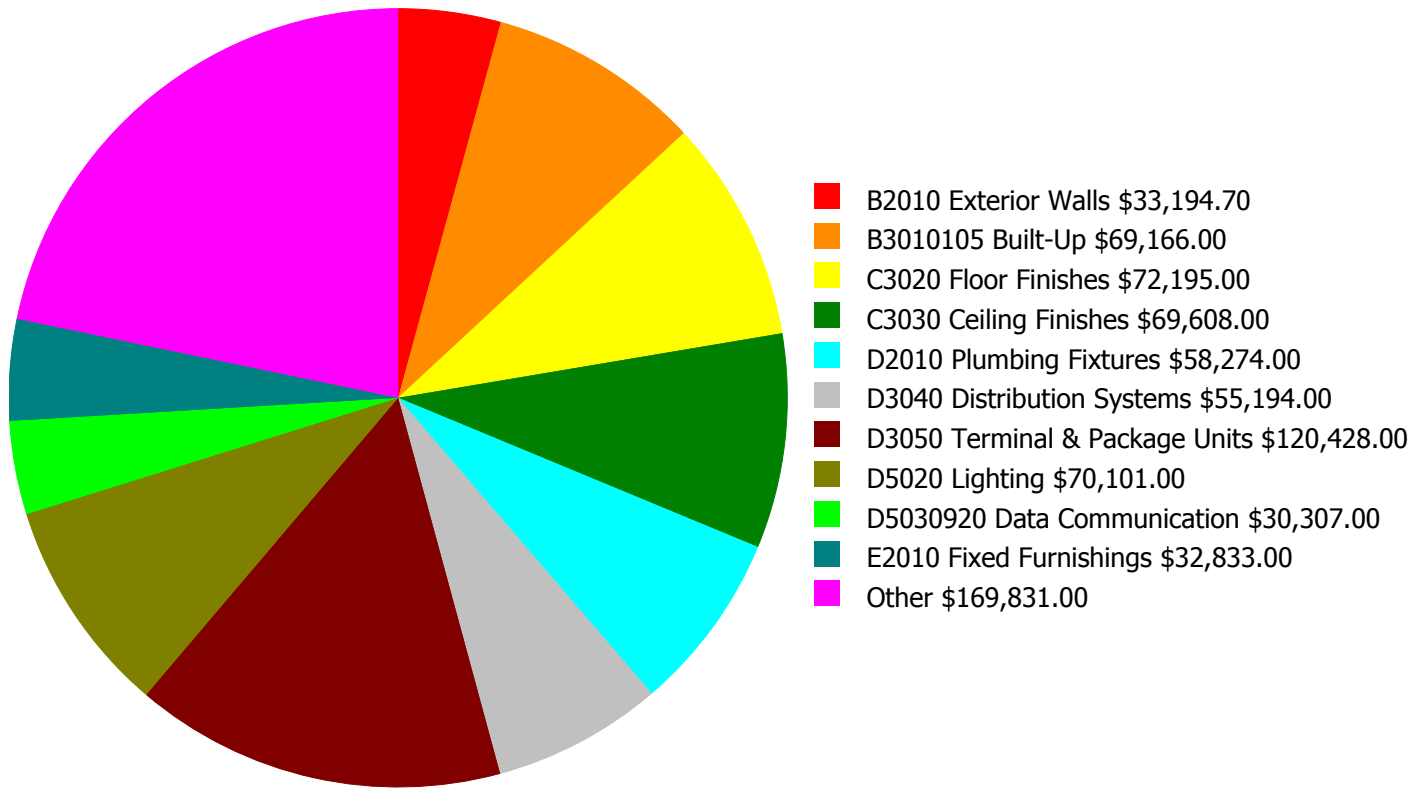
Deficiency Summary by System

Current deficiencies included assemblies that have reached or exceeded their design life or components of the assemblies that are in need of repair. Assemblies that have reached their design life are identified as current deficiencies and assigned the distress 'Beyond Useful Life'. The following chart lists all current deficiencies associated with this facility.

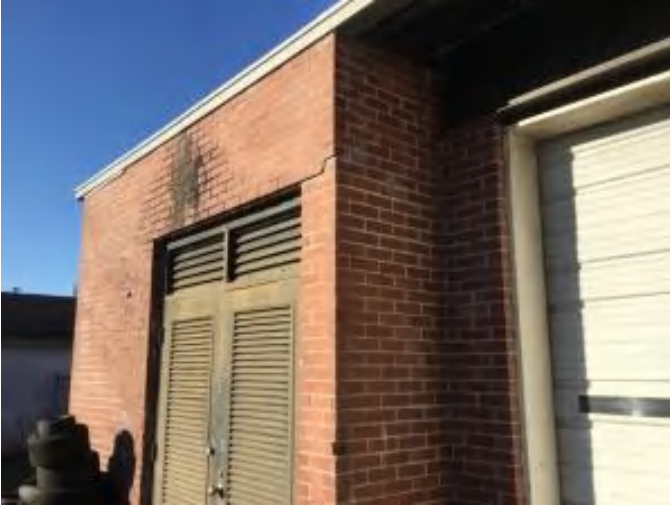
System: B2010 - Exterior Walls

Location: Exterior walls
Distress: Damaged
Category: Deferred Maintenance
Priority: 3 - Necessary/Not Yet Critical (Years 2-5)
Correction: Point clay brick wall, 1st floor
Qty: 20.00
Unit of Measure: C.S.F.
Estimate: \$33,194.70
Assessor Name: Terence Davis
Date Created: 02/21/2017

Notes: Exterior walls are in need of repairs, particularly around the compressor room.

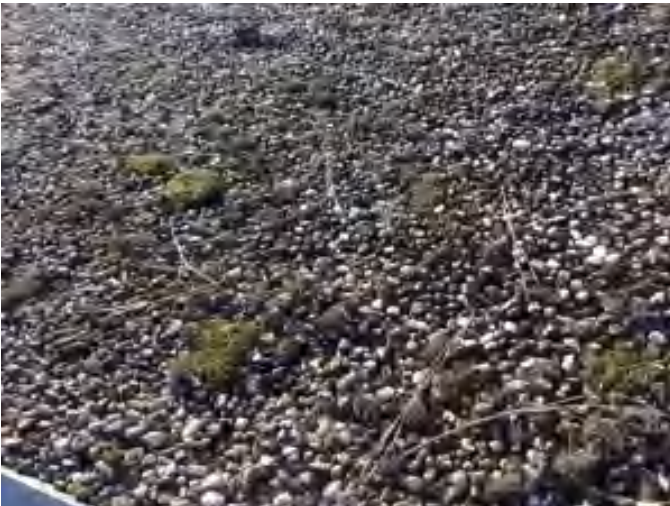
System: B3010105 - Built-Up

Location: Roof
Distress: Beyond Service Life
Category: Deferred Maintenance
Priority: 3 - Necessary/Not Yet Critical (Years 2-5)
Correction: Renew System
Qty: 5,600.00
Unit of Measure: S.F.
Estimate: \$69,166.00
Assessor Name: Terence Davis
Date Created: 02/17/2017

Notes: The roof covering is beyond its expected useful life. System renewal including gutters and downspouts is recommended.

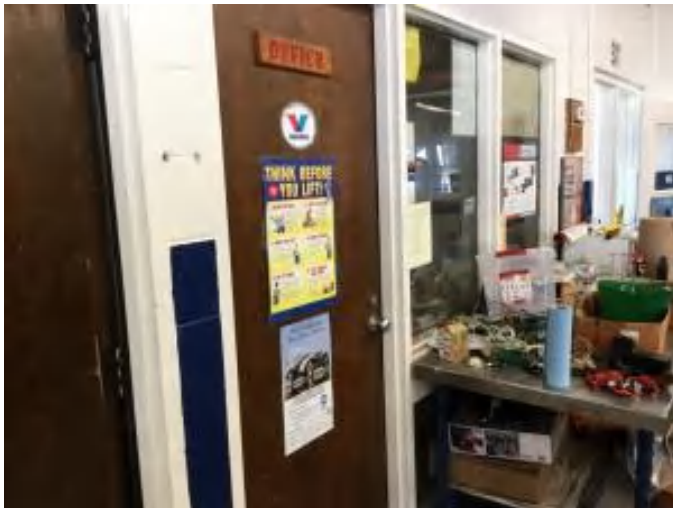
System: C1020 - Interior Doors

Location: Throughout the building
Distress: Beyond Service Life
Category: Deferred Maintenance
Priority: 3 - Necessary/Not Yet Critical (Years 2-5)
Correction: Renew System
Qty: 5,600.00
Unit of Measure: S.F.
Estimate: \$16,078.00
Assessor Name: Terence Davis
Date Created: 02/17/2017

Notes: Interior doors are typically original and in worn condition. Doors do not have ADA compliant hardware. System renewal is recommended.

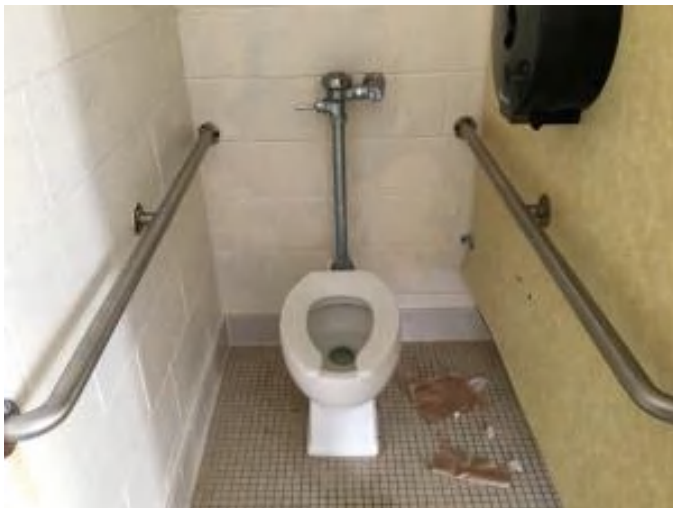
System: C1030 - Fittings

Location: Throughout the building
Distress: Beyond Service Life
Category: Deferred Maintenance
Priority: 3 - Necessary/Not Yet Critical (Years 2-5)
Correction: Renew System
Qty: 5,600.00
Unit of Measure: S.F.
Estimate: \$9,733.00
Assessor Name: Terence Davis
Date Created: 02/17/2017

Notes: Fittings are in fair to poor condition. Signage and toilet rooms are not code compliant. System renewal is recommended.

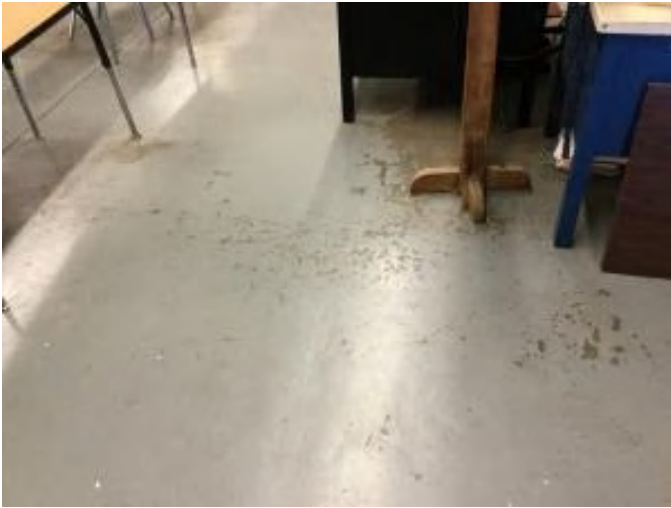
System: C3020 - Floor Finishes

Location: Throughout the building
Distress: Beyond Service Life
Category: Deferred Maintenance
Priority: 3 - Necessary/Not Yet Critical (Years 2-5)
Correction: Renew System
Qty: 5,600.00
Unit of Measure: S.F.
Estimate: \$72,195.00
Assessor Name: Terence Davis
Date Created: 02/17/2017

Notes: Floor finishes are beyond their expected useful life and in worn condition. System renewal is recommended.

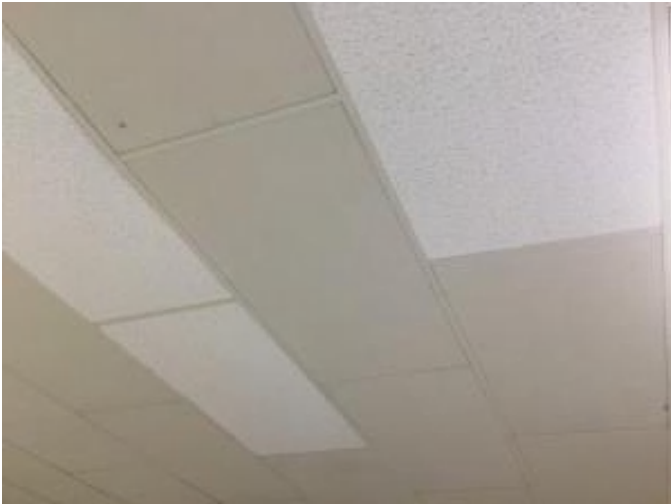
System: C3030 - Ceiling Finishes

Location: Throughout the building
Distress: Beyond Service Life
Category: Deferred Maintenance
Priority: 3 - Necessary/Not Yet Critical (Years 2-5)
Correction: Renew System
Qty: 5,600.00
Unit of Measure: S.F.
Estimate: \$69,608.00
Assessor Name: Terence Davis
Date Created: 02/17/2017

Notes: Ceilings are beyond their expected life and in fair to poor condition. System renewal is recommended.
