NC School District/520 Jones County/High School

Jones Senior High

Campus Assessment Report

March 8, 2017

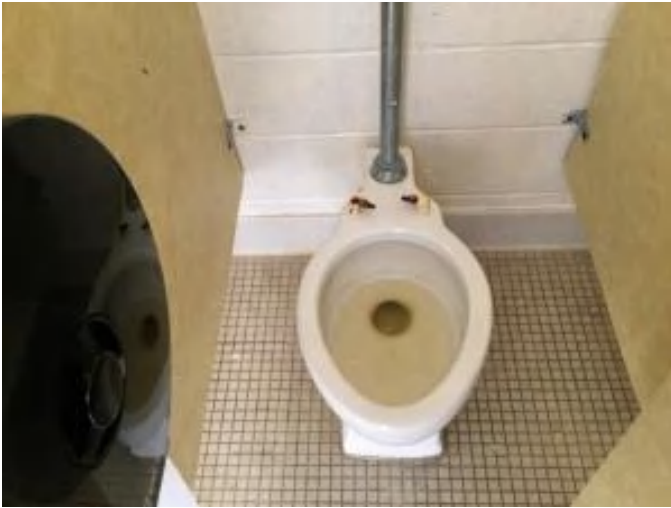
System: D2010 - Plumbing Fixtures

Location: Restrooms, shops
Distress: Beyond Service Life
Category: Deferred Maintenance
Priority: 3 - Necessary/Not Yet Critical (Years 2-5)
Correction: Renew System
Qty: 5,600.00
Unit of Measure: S.F.
Estimate: \$58,274.00
Assessor Name: Terence Davis
Date Created: 02/17/2017

Notes: Plumbing fixtures are in poor conditions and beyond their expected useful life. Restrooms and the drinking fountain are not ADA compliant. System renewal is recommended.

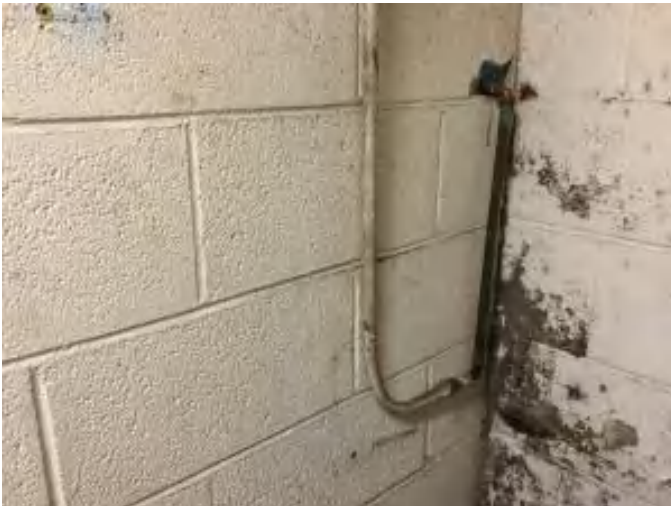
System: D2020 - Domestic Water Distribution

Location: Restrooms and shops
Distress: Beyond Service Life
Category: Deferred Maintenance
Priority: 3 - Necessary/Not Yet Critical (Years 2-5)
Correction: Renew System
Qty: 5,600.00
Unit of Measure: S.F.
Estimate: \$10,842.00
Assessor Name: Terence Davis
Date Created: 02/17/2017

Notes: The domestic water distribution system is aged and should be replaced.

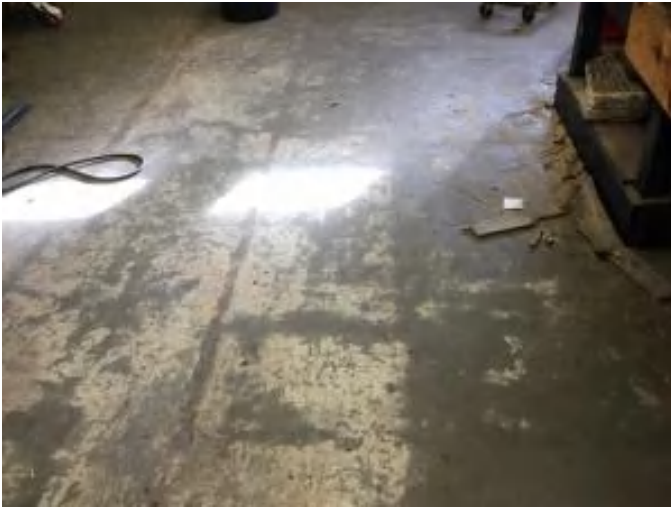
System: D2030 - Sanitary Waste

Location: Throughout the building
Distress: Beyond Service Life
Category: Deferred Maintenance
Priority: 3 - Necessary/Not Yet Critical (Years 2-5)
Correction: Renew System
Qty: 5,600.00
Unit of Measure: S.F.
Estimate: \$17,063.00
Assessor Name: Terence Davis
Date Created: 02/17/2017

Notes: The building sanitary waste system is original and beyond its expected useful life. There is no floor drain with an oil separator in the automotive shop. System renewal is recommended.

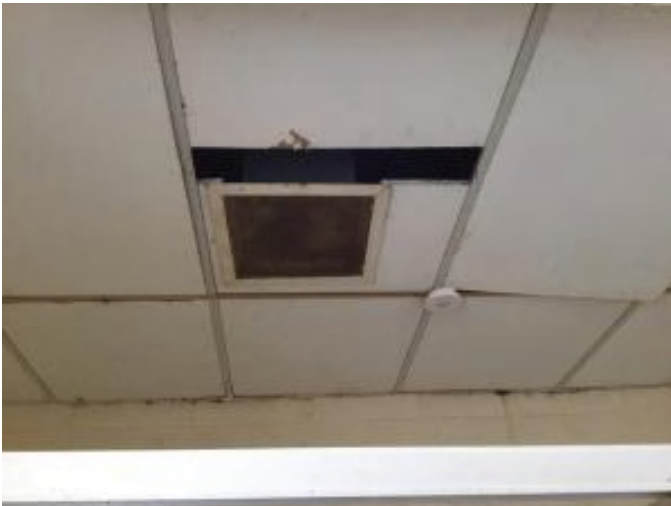
System: D3040 - Distribution Systems

Location: Throughout the building
Distress: Beyond Service Life
Category: Deferred Maintenance
Priority: 3 - Necessary/Not Yet Critical (Years 2-5)
Correction: Renew System
Qty: 5,600.00
Unit of Measure: S.F.
Estimate: \$55,194.00
Assessor Name: Terence Davis
Date Created: 02/17/2017

Notes: HVAC distribution systems are well beyond their expected useful life. System renewal is recommended.

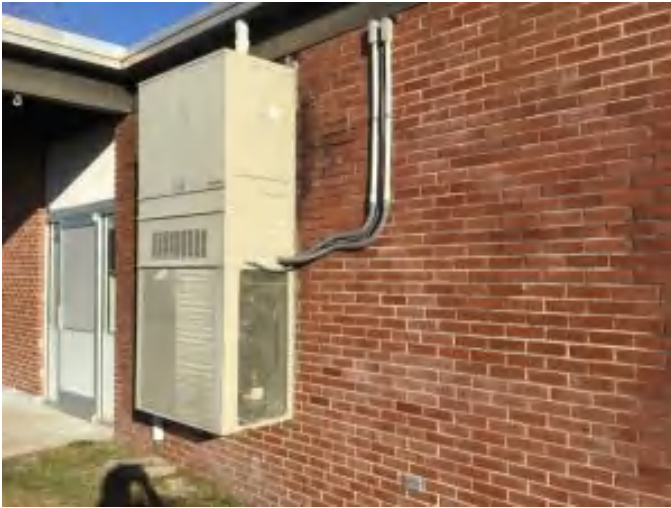
System: D3050 - Terminal & Package Units

Location: Throughout the buiding
Distress: Beyond Service Life
Category: Deferred Maintenance / Energy
Priority: 3 - Necessary/Not Yet Critical (Years 2-5)
Correction: Renew System
Qty: 5,600.00
Unit of Measure: S.F.
Estimate: \$120,428.00
Assessor Name: Terence Davis
Date Created: 02/17/2017

Notes: Wall mounted heat pumps and room air conditioning units are beyond their expected service life. System renewal with a more energy efficient system is recommended.

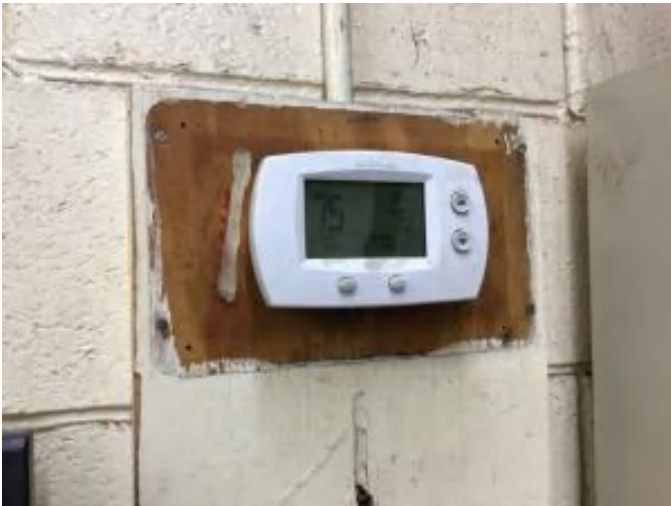
System: D3060 - Controls & Instrumentation

Location: Throughout the building
Distress: Beyond Service Life
Category: Deferred Maintenance
Priority: 3 - Necessary/Not Yet Critical (Years 2-5)
Correction: Renew System
Qty: 5,600.00
Unit of Measure: S.F.
Estimate: \$17,494.00
Assessor Name: Terence Davis
Date Created: 02/17/2017

Notes: Building controls are locally controlled. Installation of a modern digital system with remote monitoring and control capability for energy conservation is recommended.

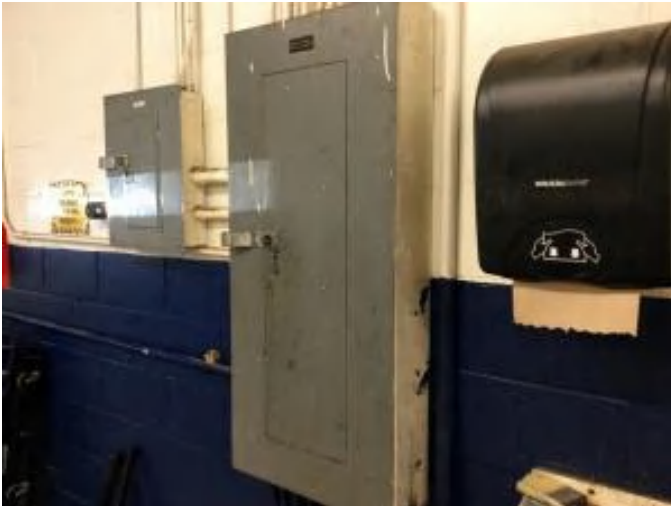
System: D5020 - Branch Wiring

Location: Throughout the building
Distress: Beyond Service Life
Category: Deferred Maintenance
Priority: 3 - Necessary/Not Yet Critical (Years 2-5)
Correction: Renew System
Qty: 5,600.00
Unit of Measure: S.F.
Estimate: \$29,999.00
Assessor Name: Terence Davis
Date Created: 02/17/2017

Notes: The branch wiring system is largely original and beyond its expected life. Circuits are overloaded. System renewal is recommended.

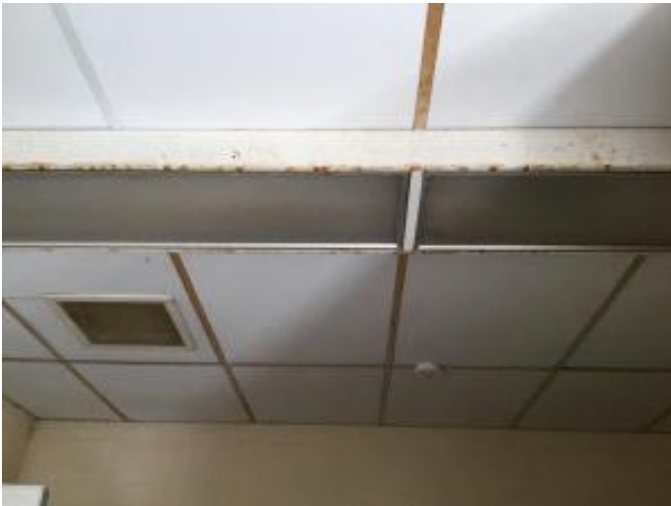
System: D5020 - Lighting

Location: Throughout the building
Distress: Beyond Service Life
Category: Deferred Maintenance
Priority: 3 - Necessary/Not Yet Critical (Years 2-5)
Correction: Renew System
Qty: 5,600.00
Unit of Measure: S.F.
Estimate: \$70,101.00
Assessor Name: Terence Davis
Date Created: 02/17/2017

Notes: Although fixtures have been retrofitted w// T-8 lamps, the lighting system is largely original and beyond its expected life. System renewal is recommended.

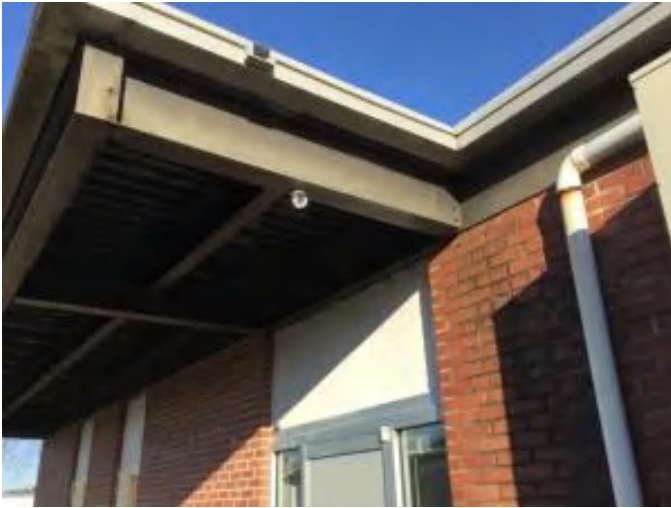
System: D5030810 - Security & Detection Systems

Location: Throughout the building
Distress: Inadequate
Category: Deferred Maintenance
Priority: 3 - Necessary/Not Yet Critical (Years 2-5)
Correction: Renew System
Qty: 5,600.00
Unit of Measure: S.F.
Estimate: \$12,936.00
Assessor Name: Terence Davis
Date Created: 02/17/2017

Notes: Although reportedly only 10 years old, the security system is inadequate. It cannot be monitored properly in the principal's office. System renewal is recommended.

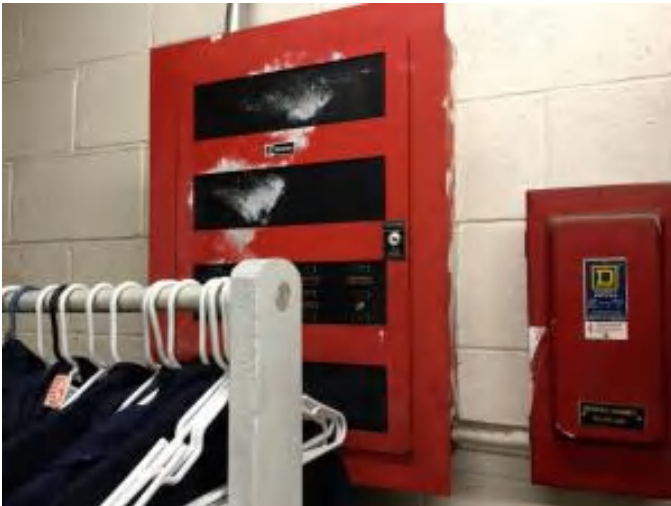
System: D5030910 - Fire Alarm Systems

Location: Throughout the building
Distress: Beyond Service Life
Category: Deferred Maintenance
Priority: 3 - Necessary/Not Yet Critical (Years 2-5)
Correction: Renew System
Qty: 5,600.00
Unit of Measure: S.F.
Estimate: \$23,593.00
Assessor Name: Terence Davis
Date Created: 02/17/2017

Notes: The fire alarm system is beyond its expected life. System renewal is recommended to ensure reliability of this life safety system.

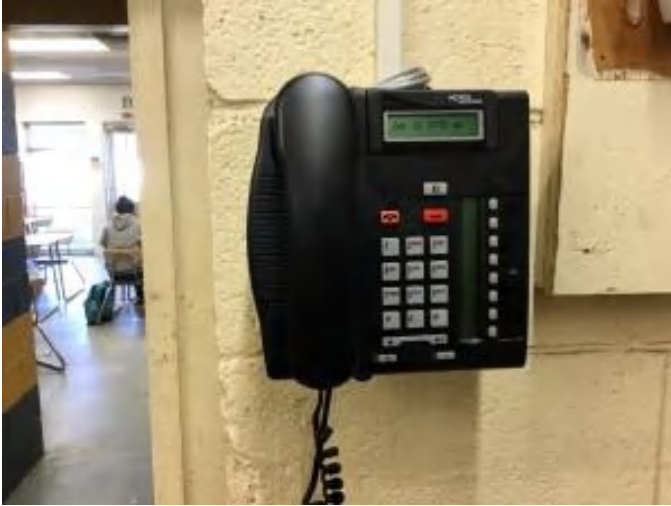
System: D5030920 - Data Communication

Location: Throughout the building
Distress: Beyond Service Life
Category: Deferred Maintenance
Priority: 3 - Necessary/Not Yet Critical (Years 2-5)
Correction: Renew System
Qty: 5,600.00
Unit of Measure: S.F.
Estimate: \$30,307.00
Assessor Name: Terence Davis
Date Created: 02/17/2017

Notes: Data and communications systems are beyond their expected service life. System renewal is recommended.

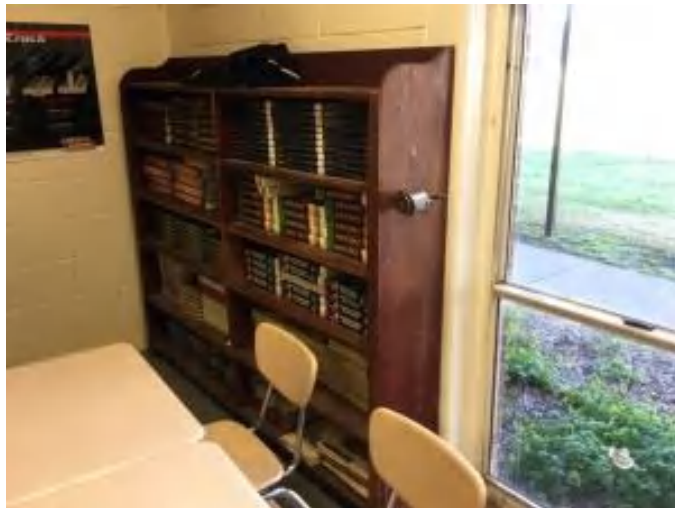
System: E2010 - Fixed Furnishings

Location: Throughout the building
Distress: Beyond Service Life
Category: Deferred Maintenance
Priority: 3 - Necessary/Not Yet Critical (Years 2-5)
Correction: Renew System
Qty: 5,600.00
Unit of Measure: S.F.
Estimate: \$32,833.00
Assessor Name: Terence Davis
Date Created: 02/17/2017

Notes: Fixed furnishings are beyond their expected life. System renewal is recommended.

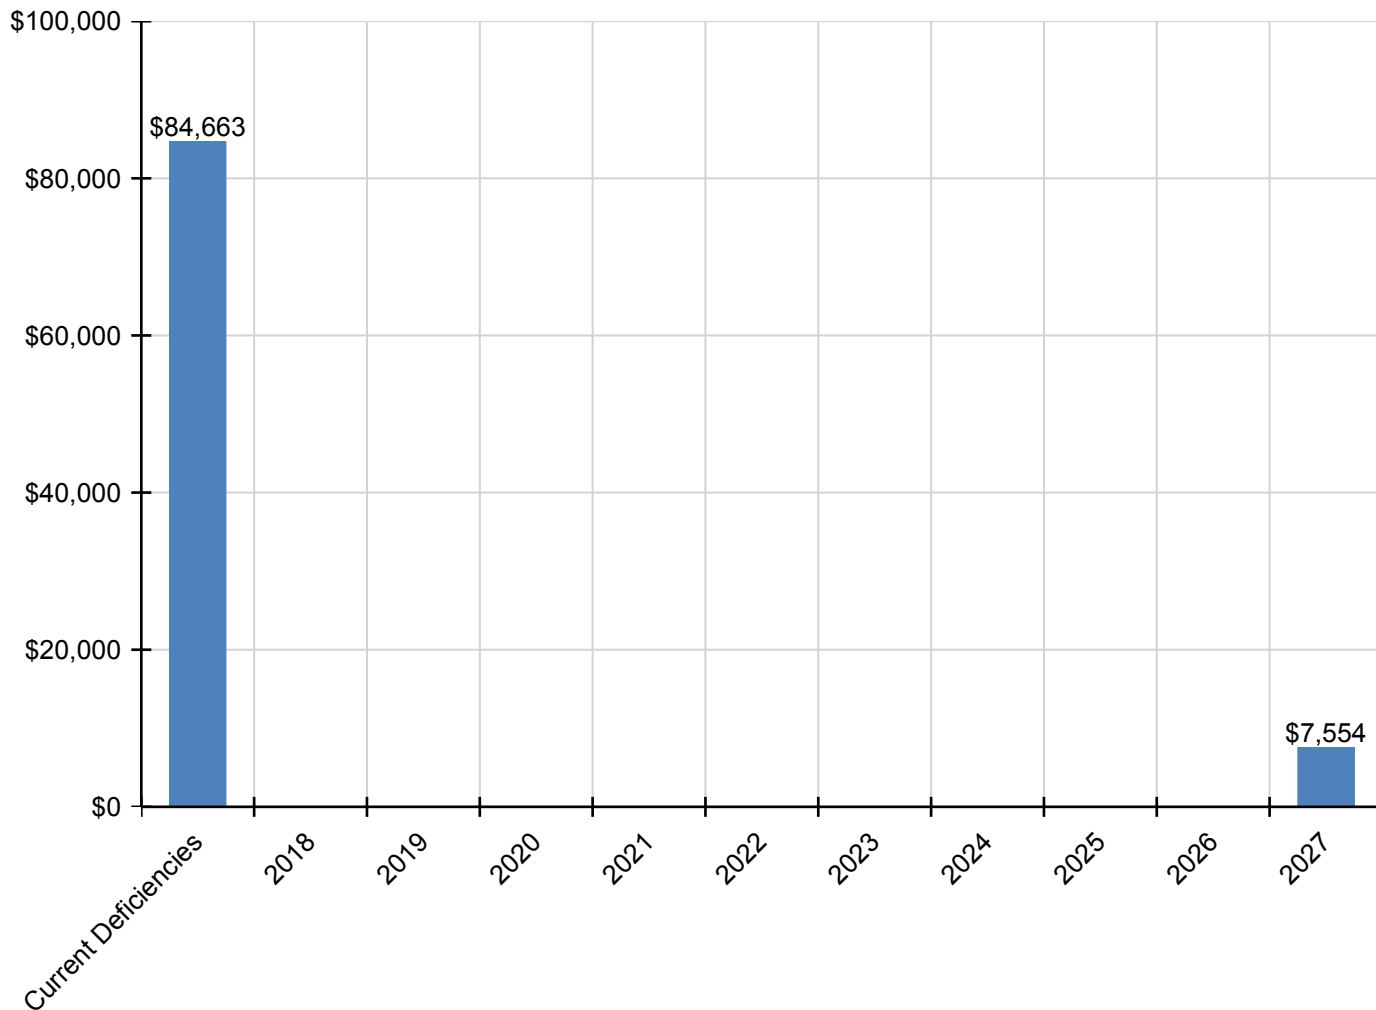
Forecasted Capital Renewal Requirement

The following chart shows the current building deficiencies and forecasting capital renewal or sustainment requirements over the next ten years.

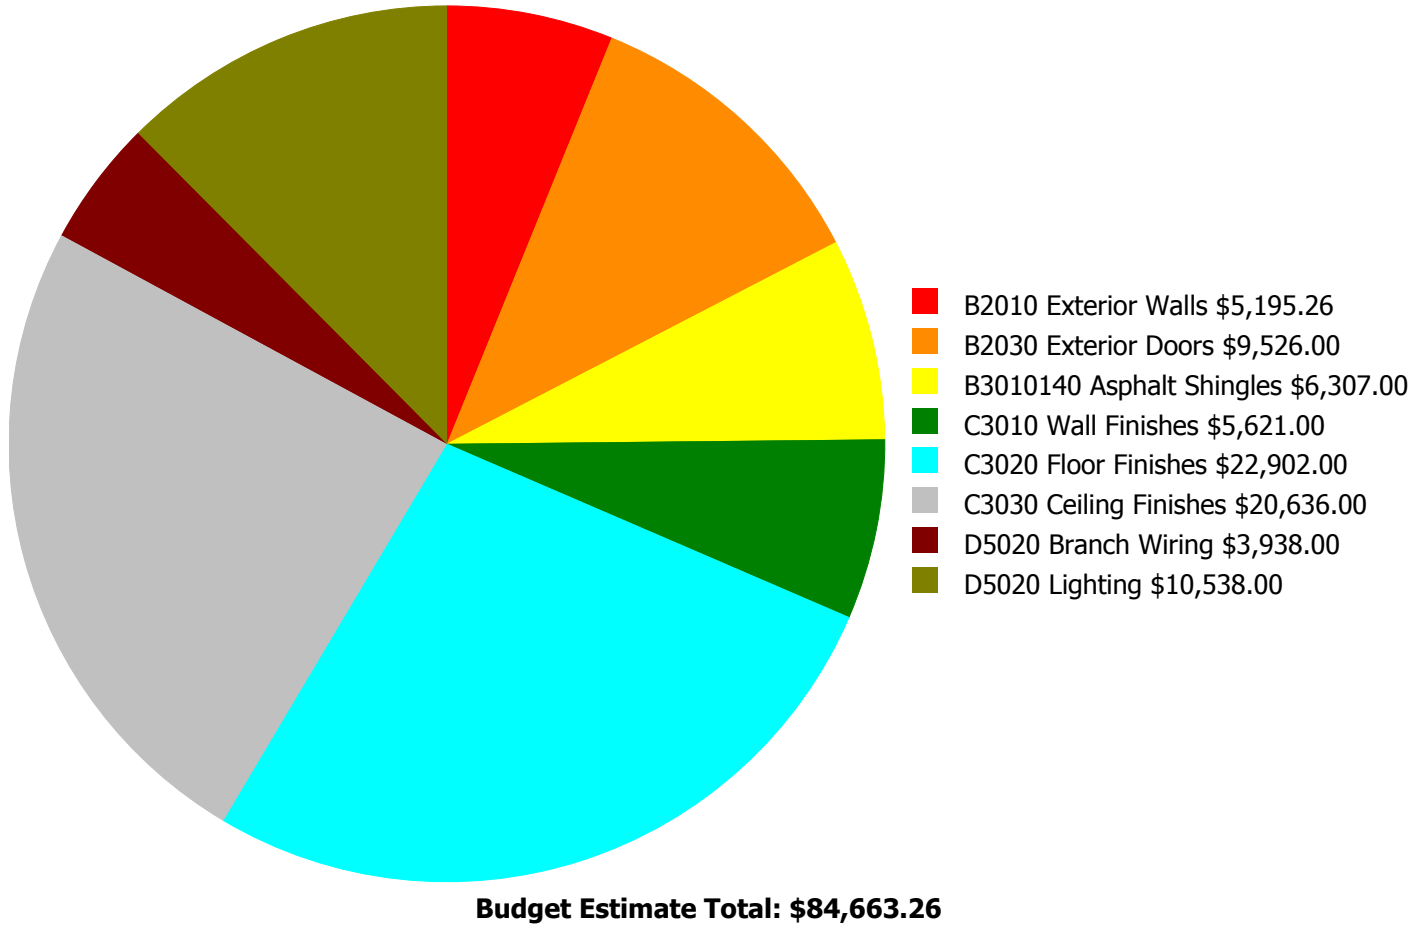
Deficiency Summary by System

Current deficiencies included assemblies that have reached or exceeded their design life or components of the assemblies that are in need of repair. Assemblies that have reached their design life are identified as current deficiencies and assigned the distress 'Beyond Useful Life'. The following chart lists all current deficiencies associated with this facility.

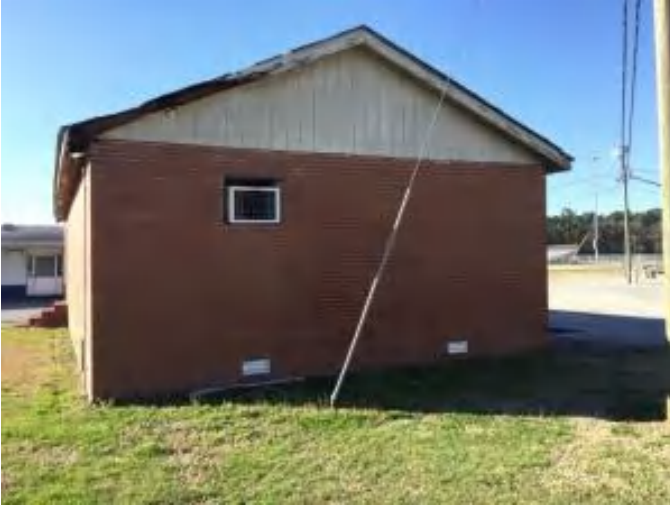
System: B2010 - Exterior Walls

Location: Gable ends and eaves
Distress: Damaged
Category: Deferred Maintenance
Priority: 3 - Necessary/Not Yet Critical (Years 2-5)
Correction: Spray refinish wood siding - 2nd floor
Qty: 2.00
Unit of Measure: C.S.F.
Estimate: \$5,195.26
Assessor Name: Ann Buerger Linden
Date Created: 02/21/2017

Notes: Gable ends are in need of painting. Fascia boards need to be replaced. Infill opening where room air conditioner is removed.

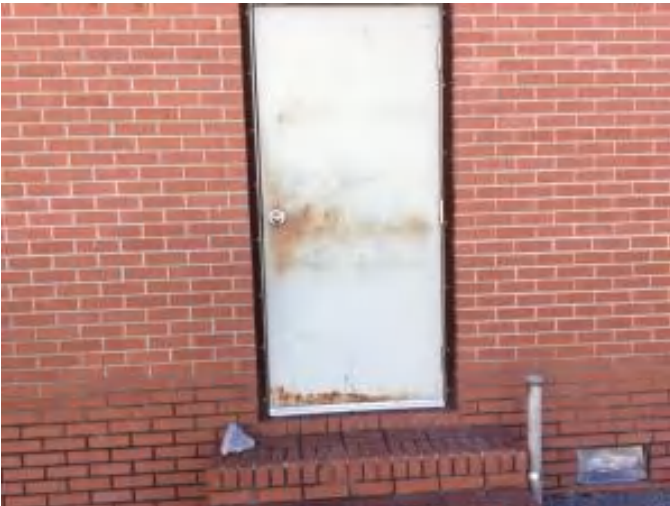
System: B2030 - Exterior Doors

Location: Exterior doors
Distress: Beyond Service Life
Category: Deferred Maintenance
Priority: 3 - Necessary/Not Yet Critical (Years 2-5)
Correction: Renew System
Qty: 1,000.00
Unit of Measure: S.F.
Estimate: \$9,526.00
Assessor Name: Ann Buerger Linden
Date Created: 02/17/2017

Notes: Exterior doors are rusted, poor condition, and beyond their expected useful life. Provide proper exterior landings. System renewal is recommended.

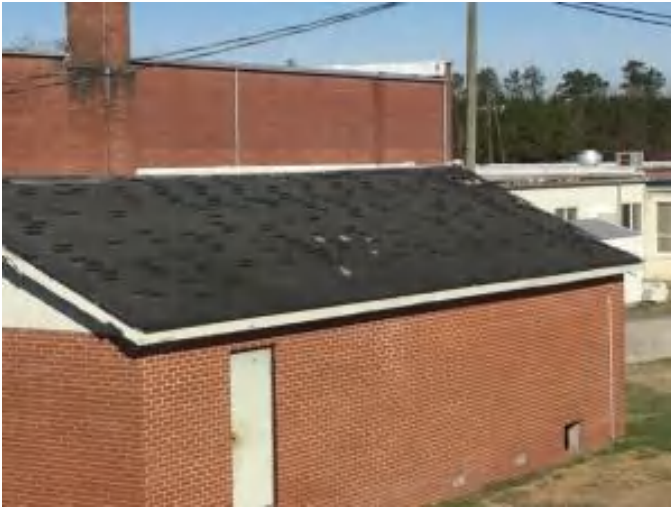
System: B3010140 - Asphalt Shingles

Location: Roof
Distress: Beyond Service Life
Category: Deferred Maintenance
Priority: 3 - Necessary/Not Yet Critical (Years 2-5)
Correction: Renew System
Qty: 1,000.00
Unit of Measure: S.F.
Estimate: \$6,307.00
Assessor Name: Ann Buerger Linden
Date Created: 02/17/2017

Notes: Asphalt shingles are beyond their expected life and leaking. System renewal is recommended.

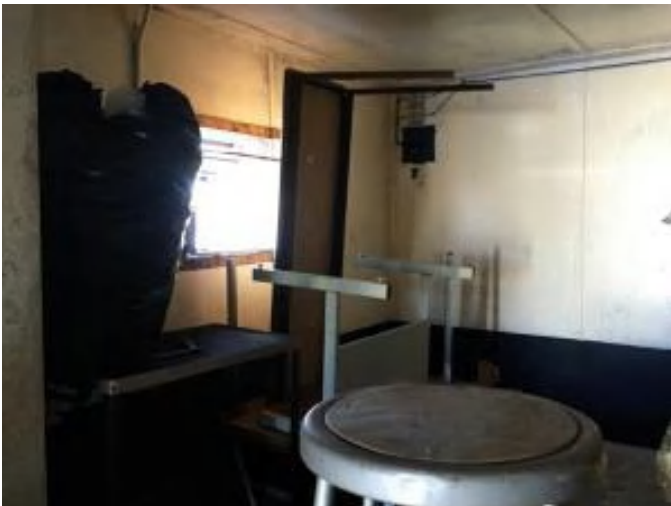
System: C3010 - Wall Finishes

Location: Throughout the building
Distress: Beyond Service Life
Category: Deferred Maintenance
Priority: 3 - Necessary/Not Yet Critical (Years 2-5)
Correction: Renew System
Qty: 1,000.00
Unit of Measure: S.F.
Estimate: \$5,621.00
Assessor Name: Ann Buerger Linden
Date Created: 02/17/2017

Notes: Wall finishes are in poor condition. System renewal is recommended.

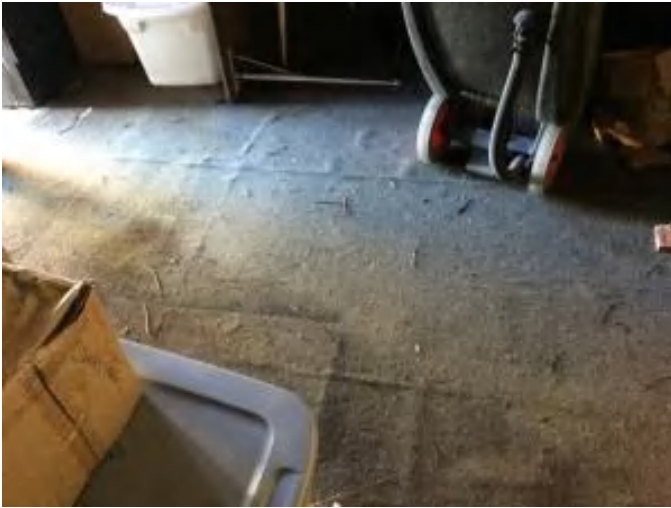
System: C3020 - Floor Finishes

Location: Throughout the building
Distress: Beyond Service Life
Category: Deferred Maintenance
Priority: 3 - Necessary/Not Yet Critical (Years 2-5)
Correction: Renew System
Qty: 1,000.00
Unit of Measure: S.F.
Estimate: \$22,902.00
Assessor Name: Ann Buerger Linden
Date Created: 02/17/2017

Notes: Floor finishes are in poor condition. System renewal is recommended.

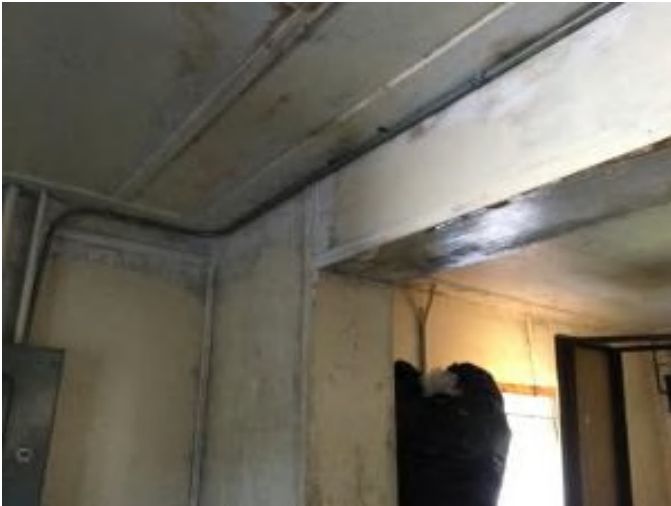
System: C3030 - Ceiling Finishes

Location: Throughout the building
Distress: Beyond Service Life
Category: Deferred Maintenance
Priority: 3 - Necessary/Not Yet Critical (Years 2-5)
Correction: Renew System
Qty: 1,000.00
Unit of Measure: S.F.
Estimate: \$20,636.00
Assessor Name: Ann Buerger Linden
Date Created: 02/17/2017

Notes: Ceilings are in poor condition with considerable water damage. System renewal is recommended.

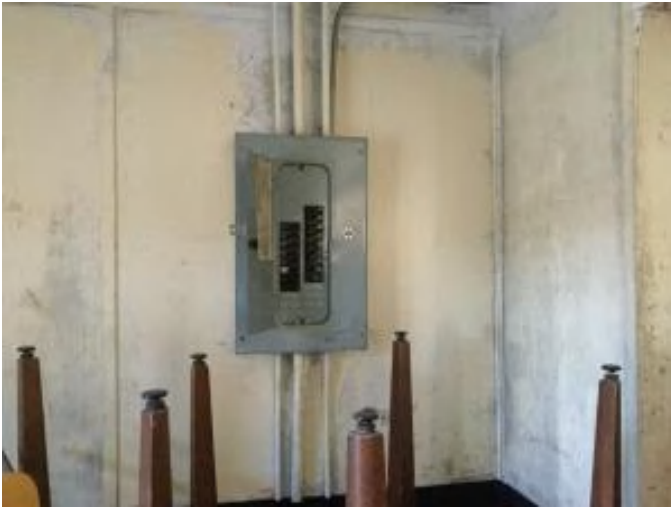
System: D5020 - Branch Wiring

Location: Throughout the building
Distress: Beyond Service Life
Category: Deferred Maintenance
Priority: 3 - Necessary/Not Yet Critical (Years 2-5)
Correction: Renew System
Qty: 1,000.00
Unit of Measure: S.F.
Estimate: \$3,938.00
Assessor Name: Ann Buerger Linden
Date Created: 02/17/2017

Notes: The branch wiring system is beyond its expected useful life. The building was shut down at the time of assessment. System renewal is recommended.

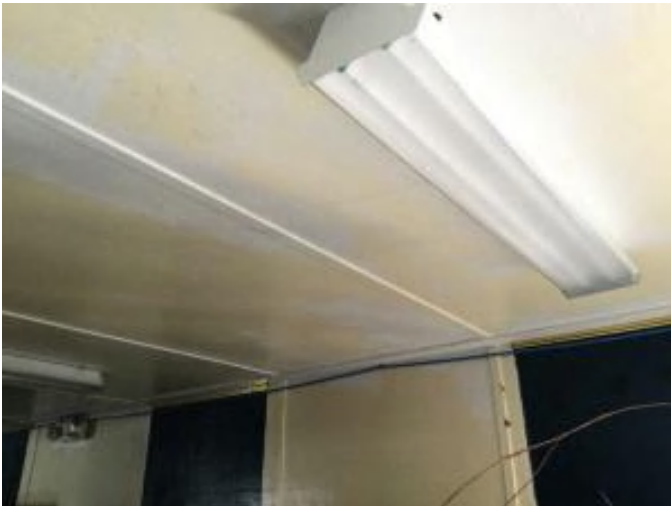
System: D5020 - Lighting

Location: Throught the building
Distress: Beyond Service Life
Category: Deferred Maintenance
Priority: 3 - Necessary/Not Yet Critical (Years 2-5)
Correction: Renew System
Qty: 1,000.00
Unit of Measure: S.F.
Estimate: \$10,538.00
Assessor Name: Ann Buerger Linden
Date Created: 02/17/2017

Notes: Lighting systems are beyond their expected useful life. System renewal is recommended.

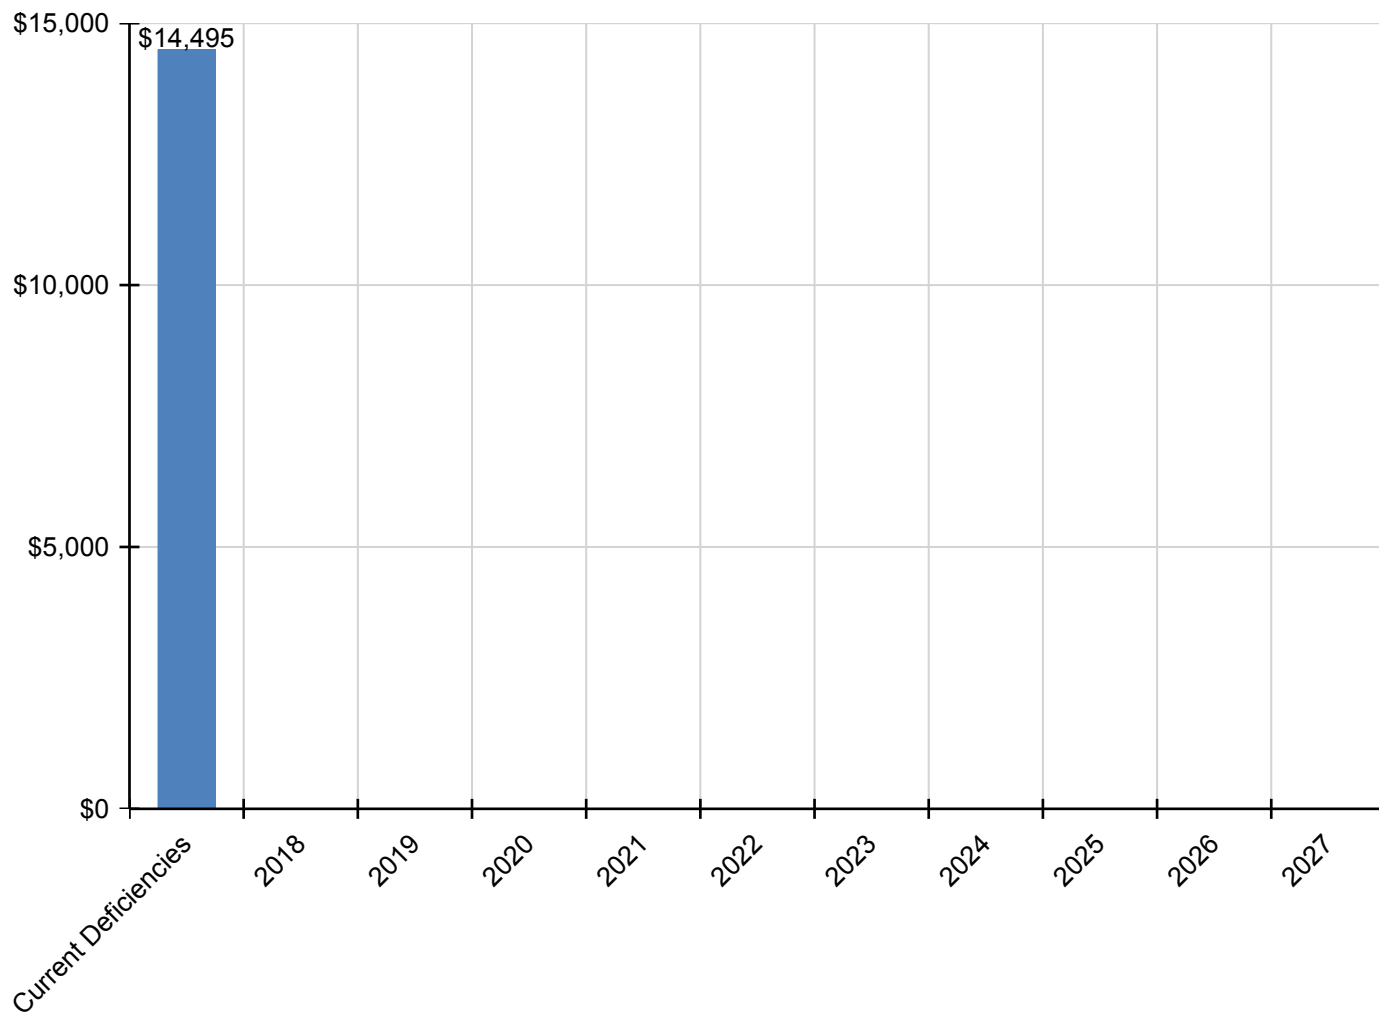
Forecasted Capital Renewal Requirement

The following chart shows the current building deficiencies and forecasting capital renewal or sustainment requirements over the next ten years.

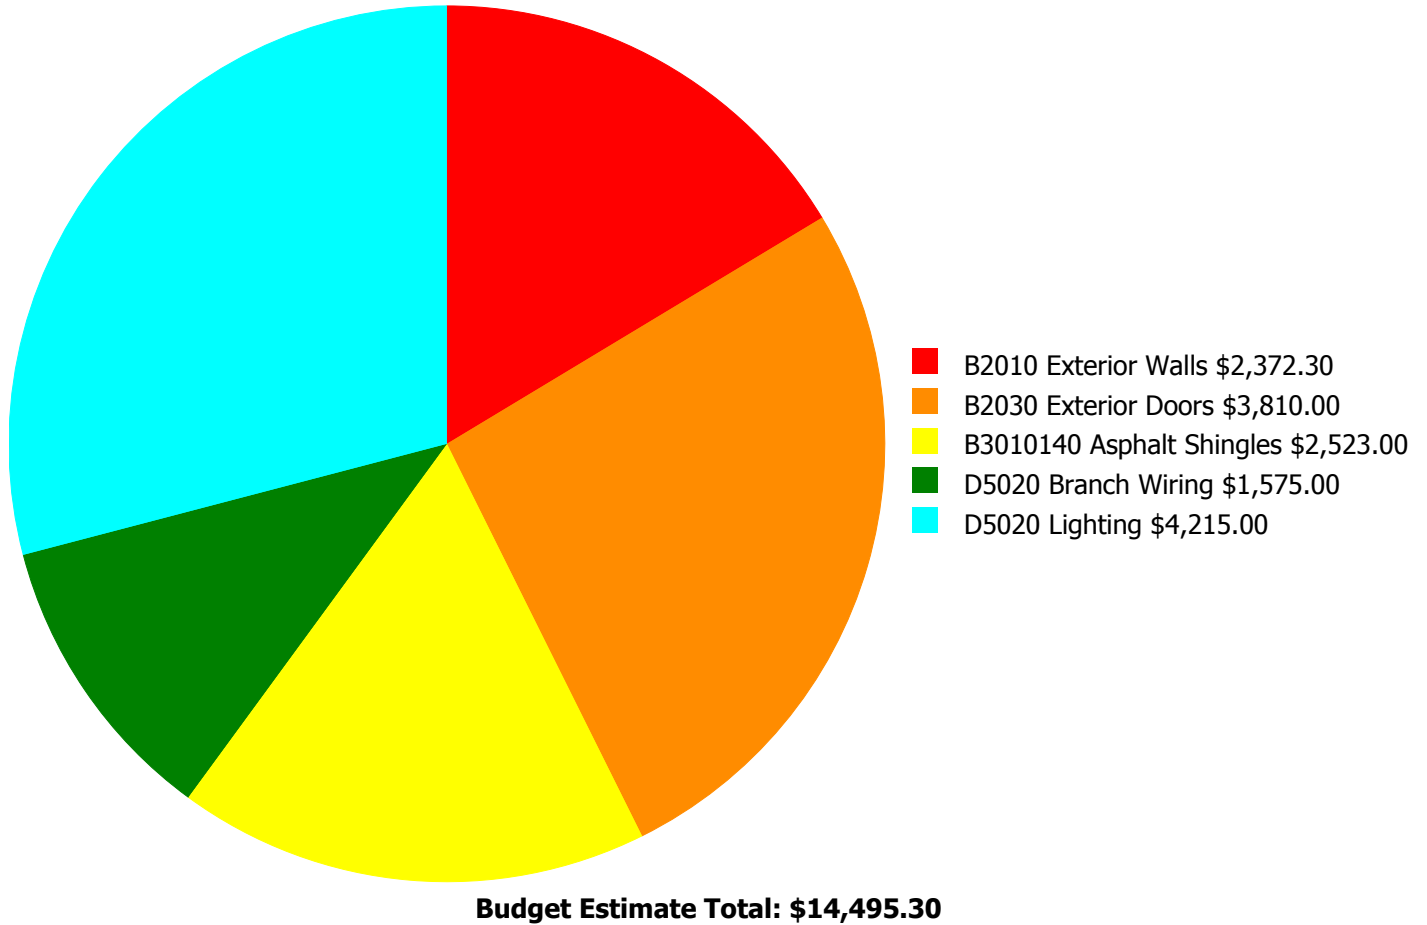
Deficiency Summary by System

Current deficiencies included assemblies that have reached or exceeded their design life or components of the assemblies that are in need of repair. Assemblies that have reached their design life are identified as current deficiencies and assigned the distress 'Beyond Useful Life'. The following chart lists all current deficiencies associated with this facility.

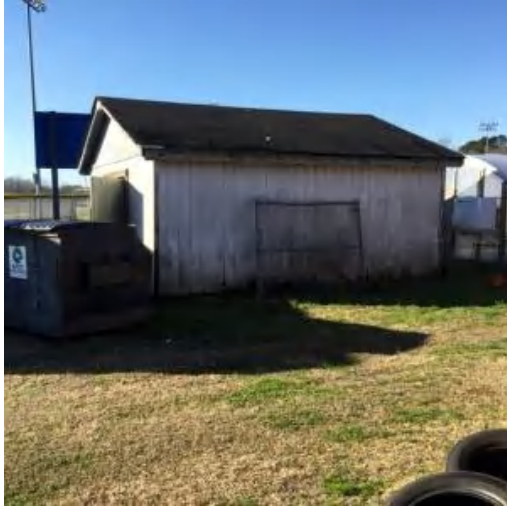
System: B2010 - Exterior Walls

Location: Exterior
Distress: Beyond Service Life
Category: Deferred Maintenance
Priority: 3 - Necessary/Not Yet Critical (Years 2-5)
Correction: Replace & finish wood clapboards, 1st floor
Qty: 5.00
Unit of Measure: C.S.F.
Estimate: \$2,372.30
Assessor Name: Ann Buerger Linden
Date Created: 02/22/2017

Notes: Exterior walls are deteriorated, particularly close to grade. Replacement of damaged siding, fascia boards, and painting is recommended.

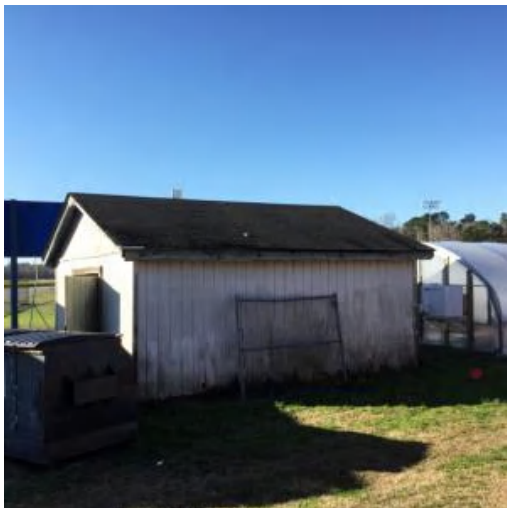
System: B3010140 - Asphalt Shingles

Location: Roof
Distress: Beyond Service Life
Category: Deferred Maintenance
Priority: 3 - Necessary/Not Yet Critical (Years 2-5)
Correction: Renew System
Qty: 400.00
Unit of Measure: S.F.
Estimate: \$2,523.00
Assessor Name: Ann Buerger Linden
Date Created: 02/22/2017

Notes: Roof shingles are in poor condition. System renewal is recommended.

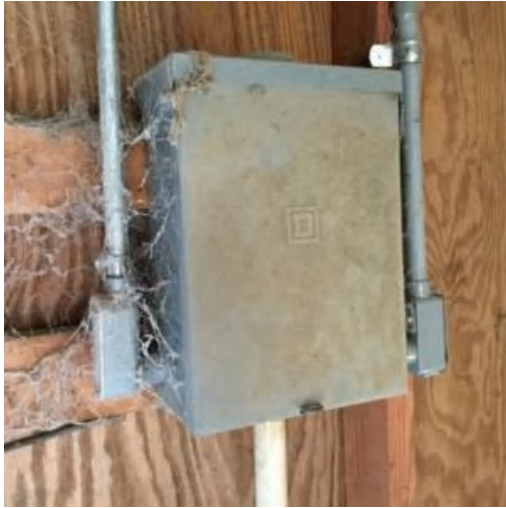
System: D5020 - Branch Wiring

Location: Interior
Distress: Beyond Service Life
Category: Deferred Maintenance
Priority: 3 - Necessary/Not Yet Critical (Years 2-5)
Correction: Renew System
Qty: 400.00
Unit of Measure: S.F.
Estimate: \$1,575.00
Assessor Name: Ann Buerger Linden
Date Created: 02/22/2017

Notes: The branch wiring system is beyond its expected life. System renewal is recommended.

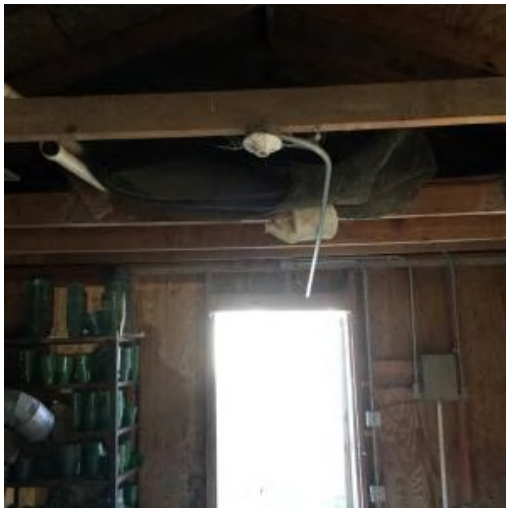
System: D5020 - Lighting

Location: Ceiling
Distress: Beyond Service Life
Category: Deferred Maintenance
Priority: 3 - Necessary/Not Yet Critical (Years 2-5)
Correction: Renew System
Qty: 400.00
Unit of Measure: S.F.
Estimate: \$4,215.00
Assessor Name: Ann Buerger Linden
Date Created: 02/22/2017

Notes: The lighting in this building is not functional. System renewal is recommended.

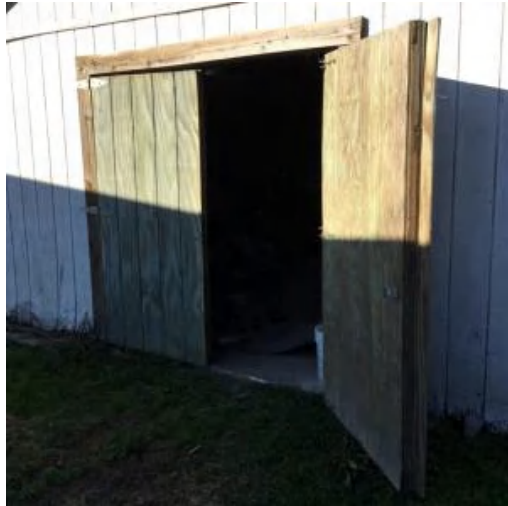
System: B2030 - Exterior Doors

Location: Entrance
Distress: Beyond Service Life
Category: Deferred Maintenance
Priority: 4 - Recommended (Years 6-10)
Correction: Renew System
Qty: 400.00
Unit of Measure: S.F.
Estimate: \$3,810.00
Assessor Name: Ann Buerger Linden
Date Created: 02/22/2017

Notes: The exterior door is in fair condition and beyond its expected life. Replacement is recommended.

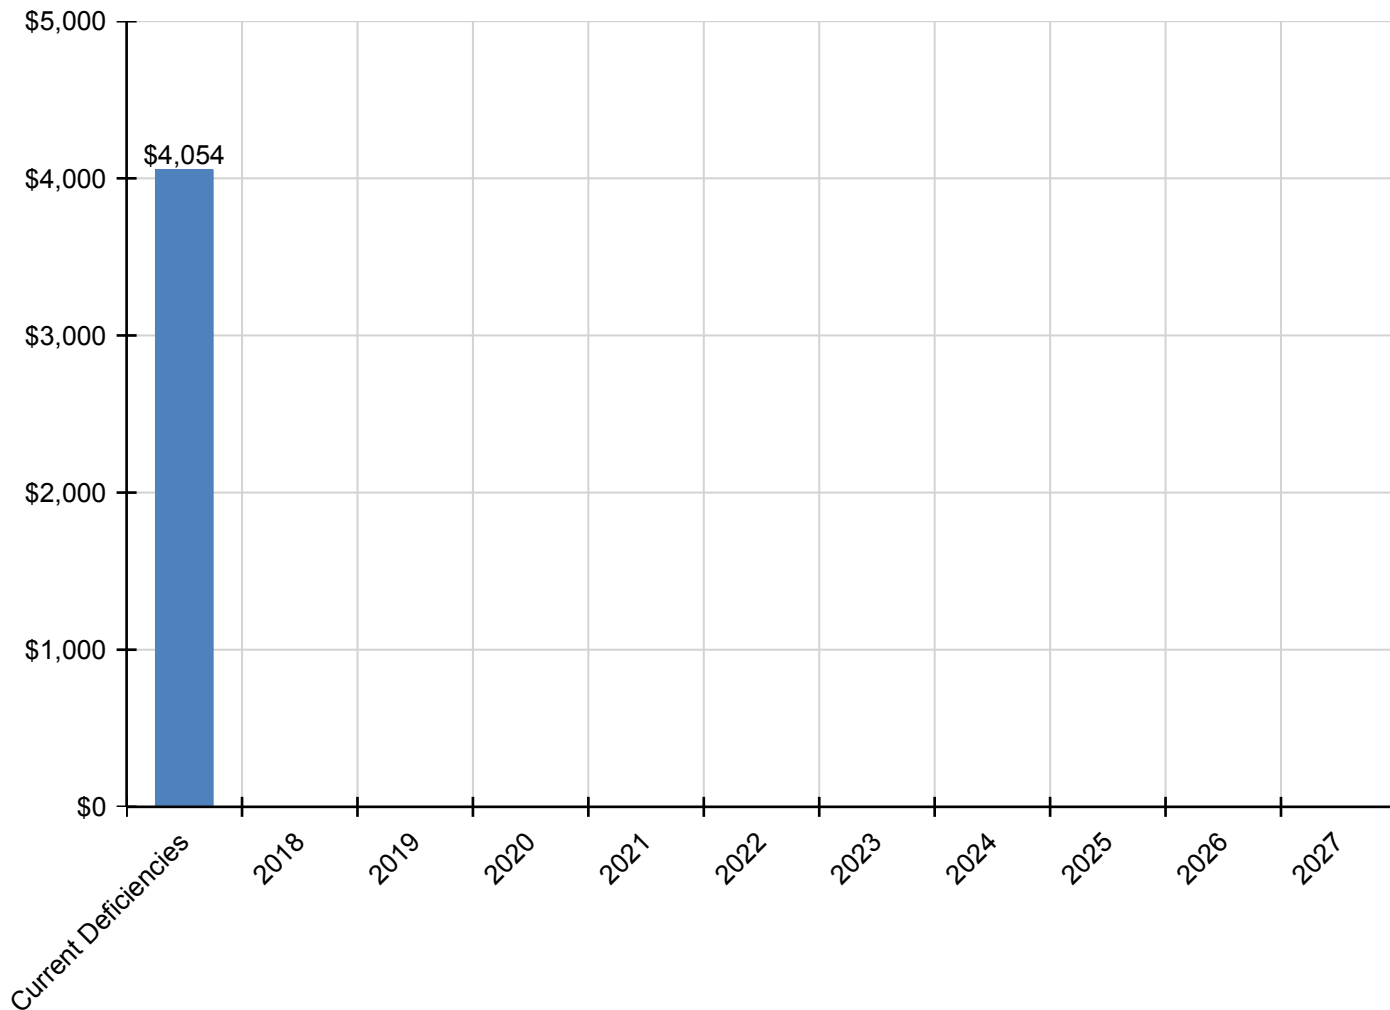
Forecasted Capital Renewal Requirement

The following chart shows the current building deficiencies and forecasting capital renewal or sustainment requirements over the next ten years.

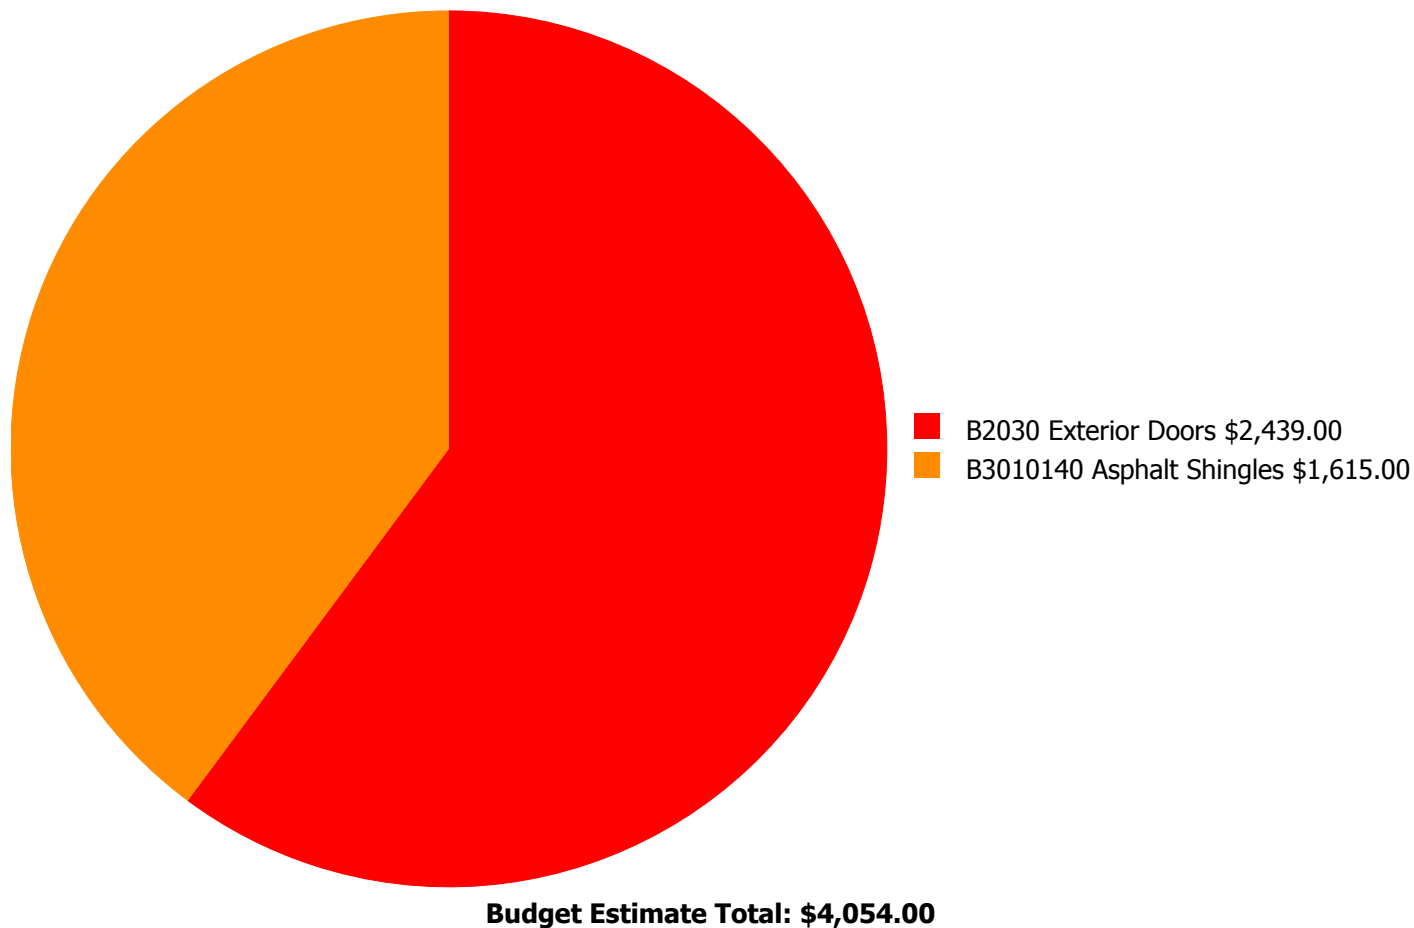
Deficiency Summary by System

Current deficiencies included assemblies that have reached or exceeded their design life or components of the assemblies that are in need of repair. Assemblies that have reached their design life are identified as current deficiencies and assigned the distress 'Beyond Useful Life'. The following chart lists all current deficiencies associated with this facility.

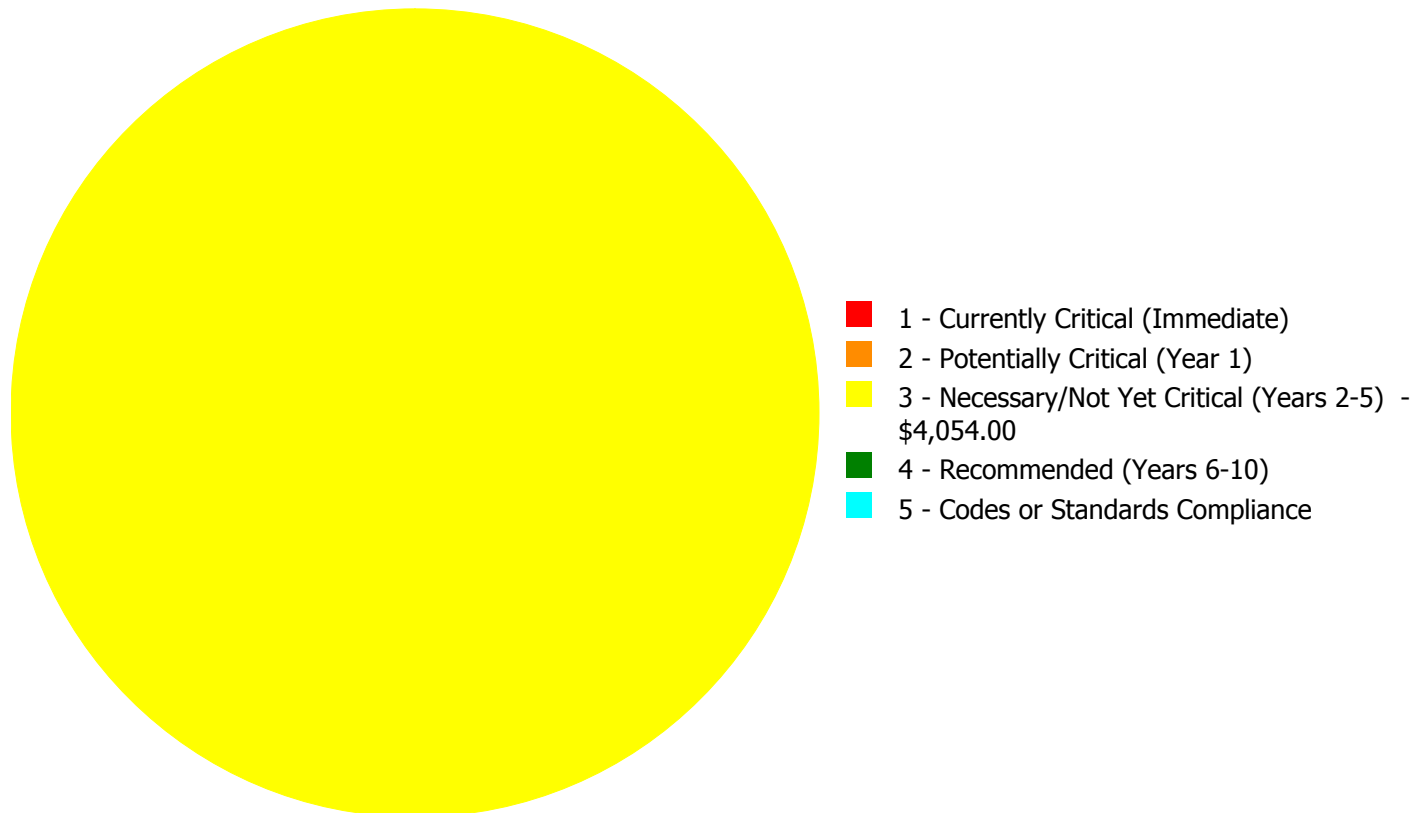
Deficiency Summary by Priority

The following chart shows the total repair costs broken down by priority. Assessors assigned deficiencies within eCOMET to one of the following priority categories:

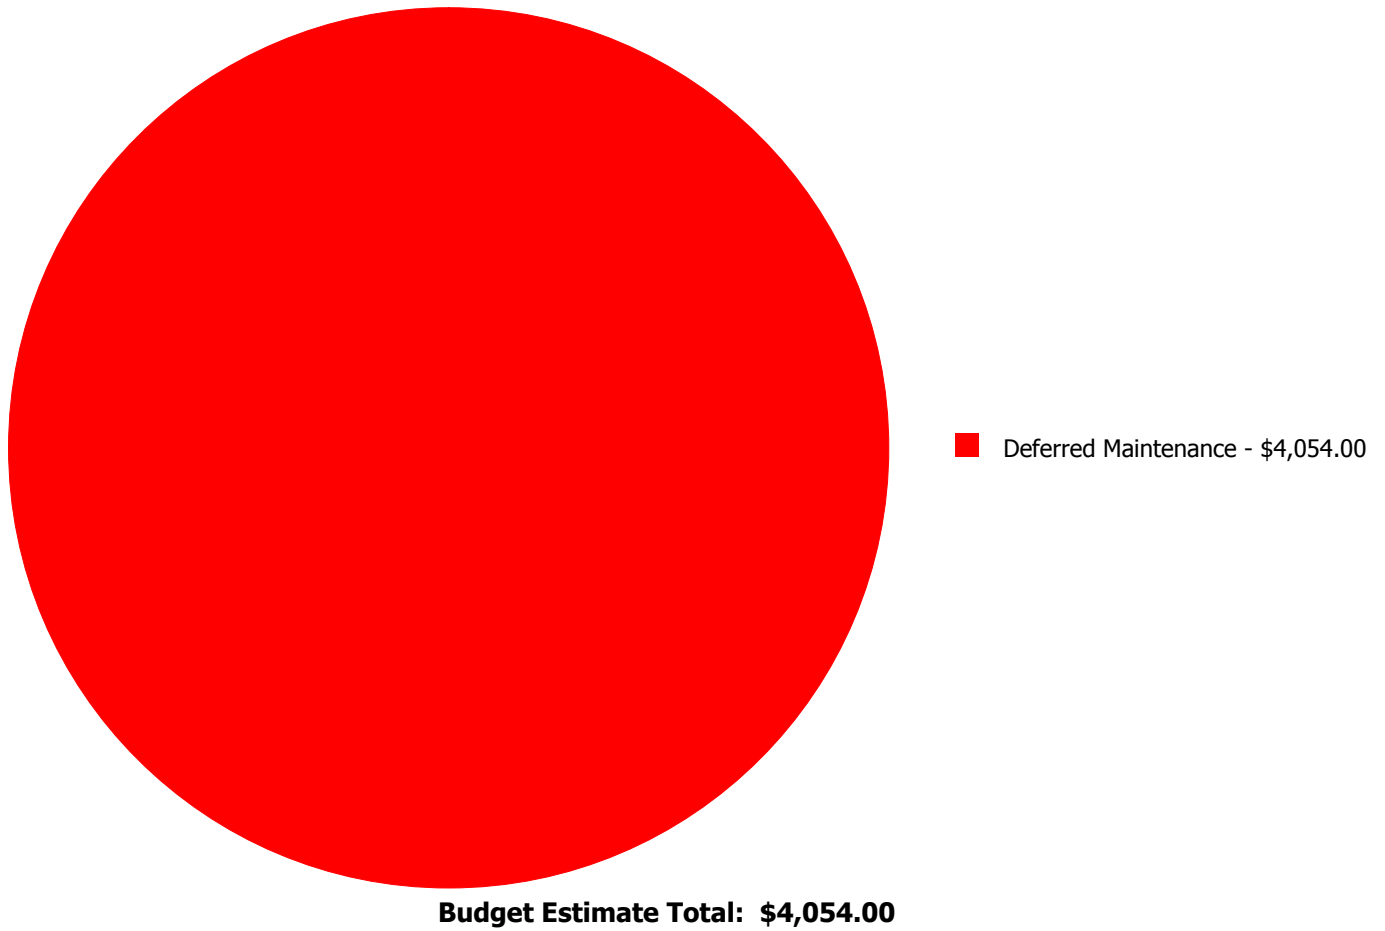
Deficiency Summary by Category

The following chart shows the total repair costs broken down by deficiency categories. Assessors assigned deficiencies to one of the following categories:

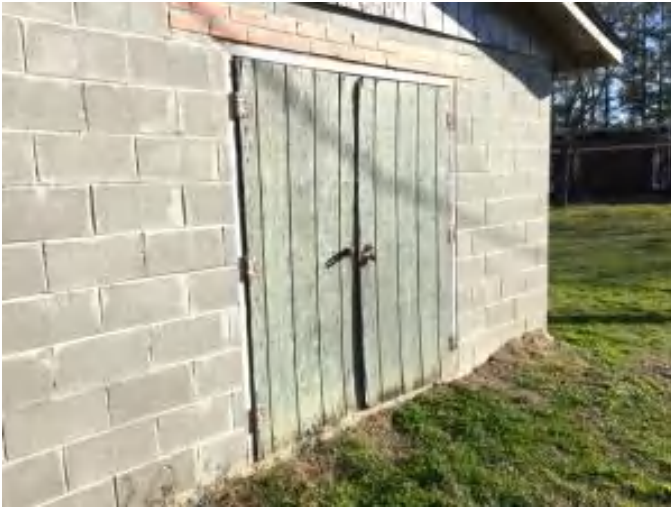
System: B2030 - Exterior Doors

Location: Exterior doors
Distress: Beyond Service Life
Category: Deferred Maintenance
Priority: 3 - Necessary/Not Yet Critical (Years 2-5)
Correction: Renew System
Qty: 256.00
Unit of Measure: S.F.
Estimate: \$2,439.00
Assessor Name: Ann Buerger Linden
Date Created: 02/17/2017

Notes: Exterior doors are in weathered condition. System renewal is recommended.
