NC School District/520 Jones County/High School

Jones Senior High

Campus Assessment Report

March 8, 2017

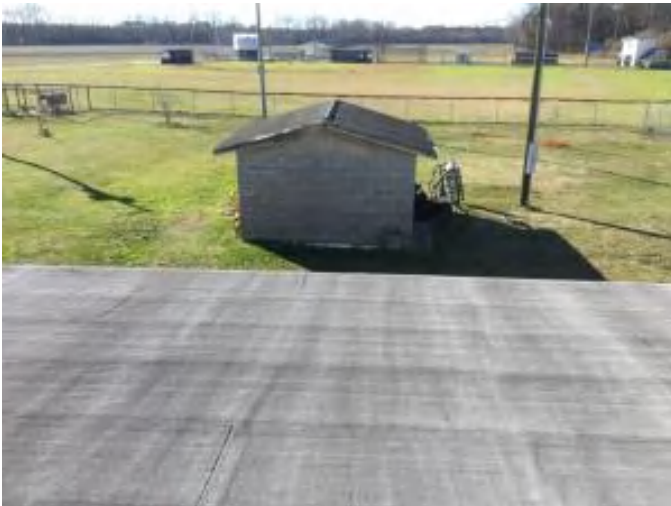
System: B3010140 - Asphalt Shingles

Location: Roof
Distress: Beyond Service Life
Category: Deferred Maintenance
Priority: 3 - Necessary/Not Yet Critical (Years 2-5)
Correction: Renew System
Qty: 256.00
Unit of Measure: S.F.
Estimate: \$1,615.00
Assessor Name: Ann Buerger Linden
Date Created: 02/17/2017

Notes: Asphalt shingles are in poor condition. System renewal is recommended.

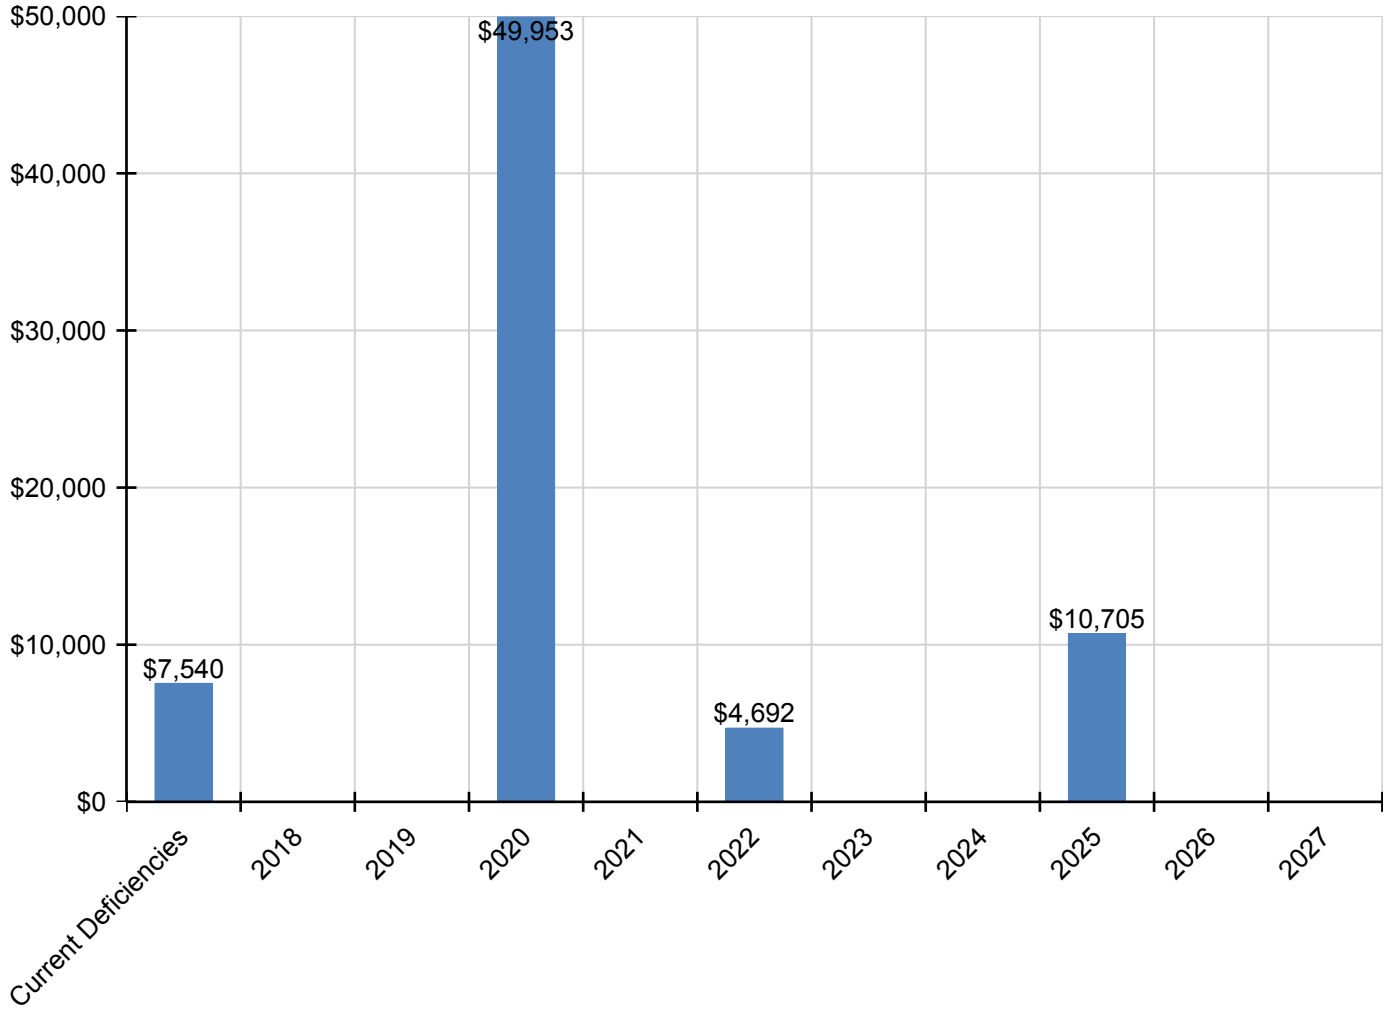
Forecasted Capital Renewal Requirement

The following chart shows the current building deficiencies and forecasting capital renewal or sustainment requirements over the next ten years.

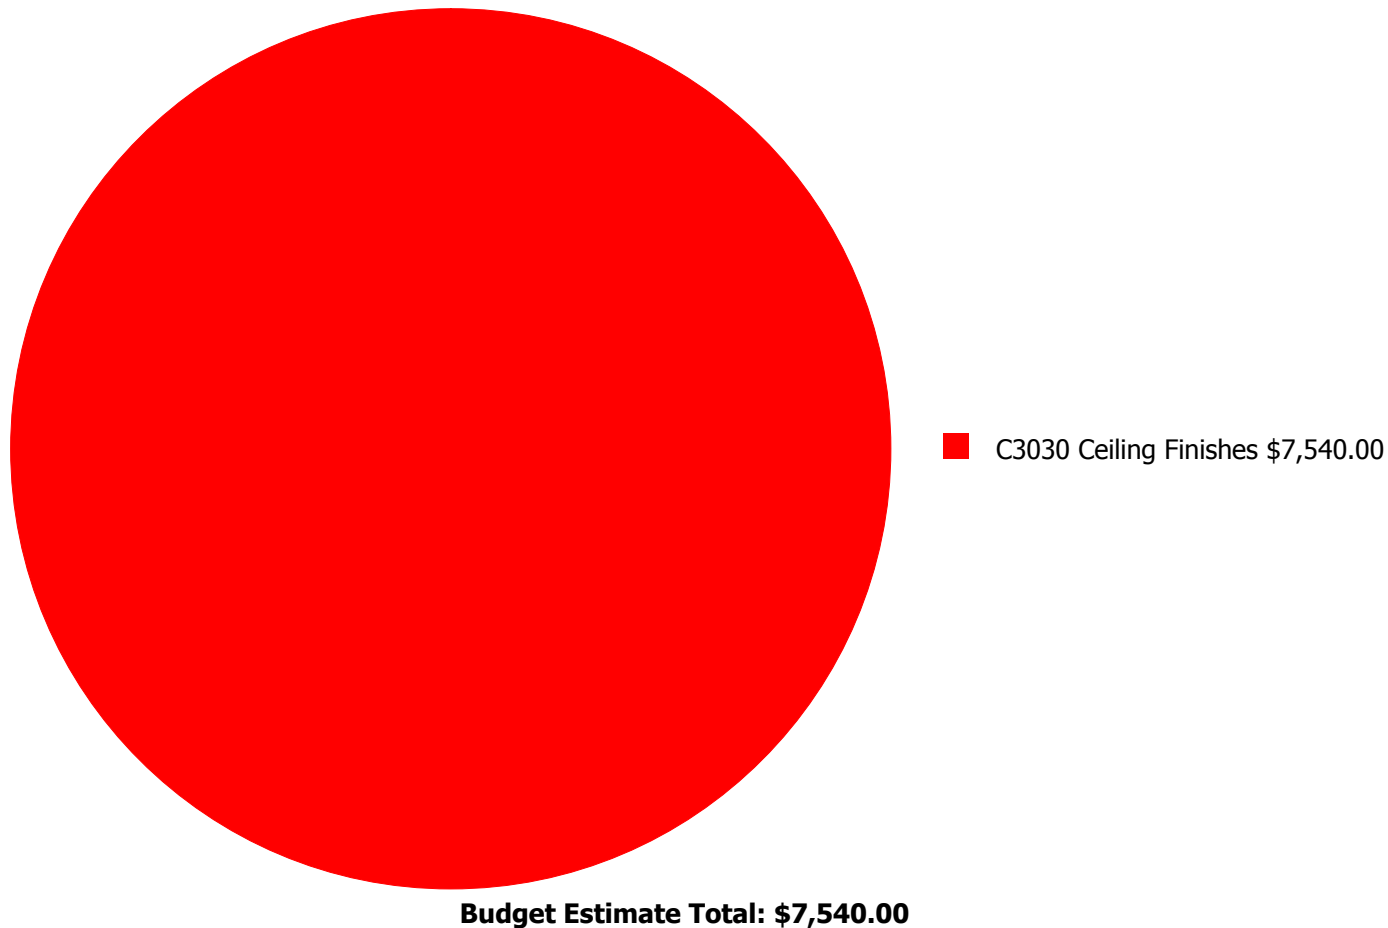
Deficiency Summary by System

Current deficiencies included assemblies that have reached or exceeded their design life or components of the assemblies that are in need of repair. Assemblies that have reached their design life are identified as current deficiencies and assigned the distress 'Beyond Useful Life'. The following chart lists all current deficiencies associated with this facility.

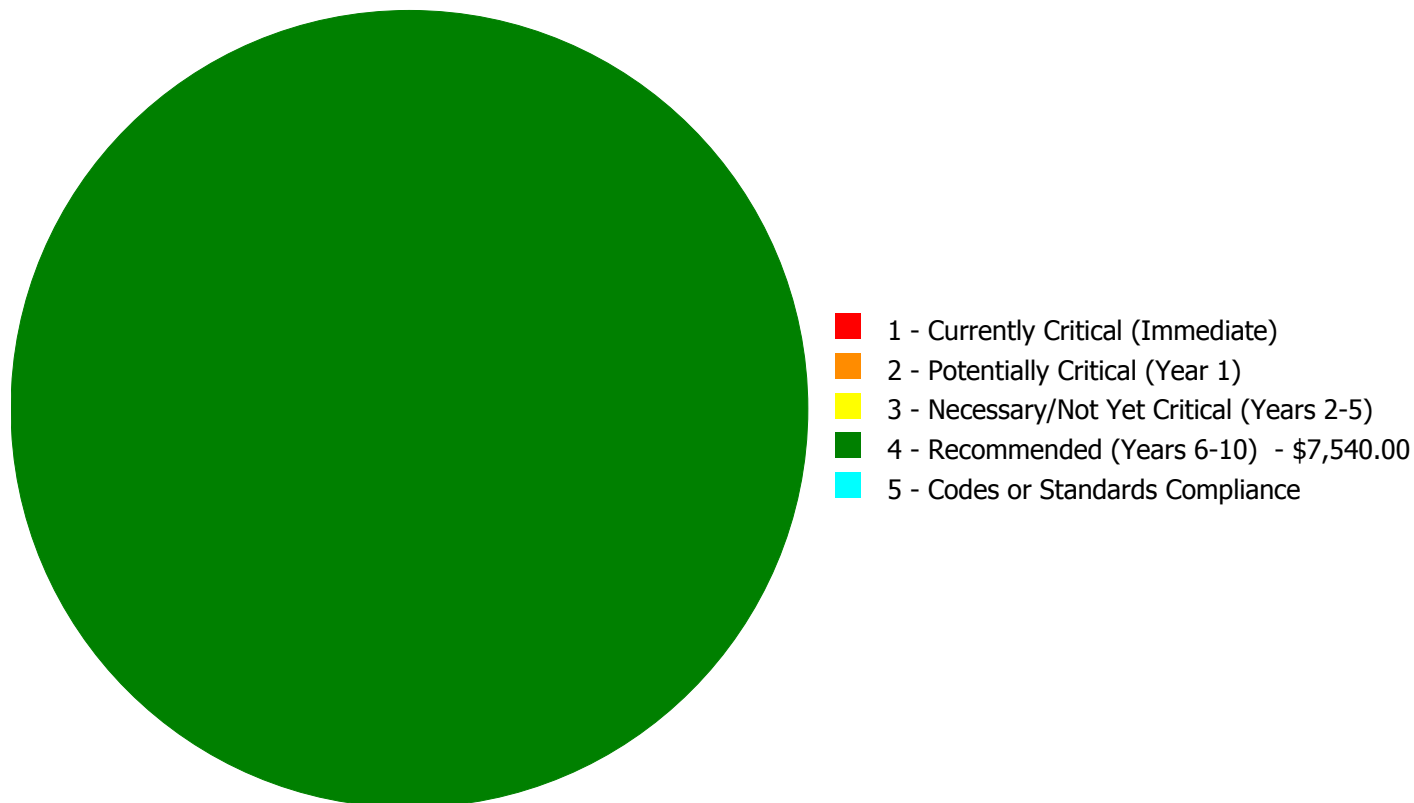
Deficiency Summary by Priority

The following chart shows the total repair costs broken down by priority. Assessors assigned deficiencies within eCOMET to one of the following priority categories:

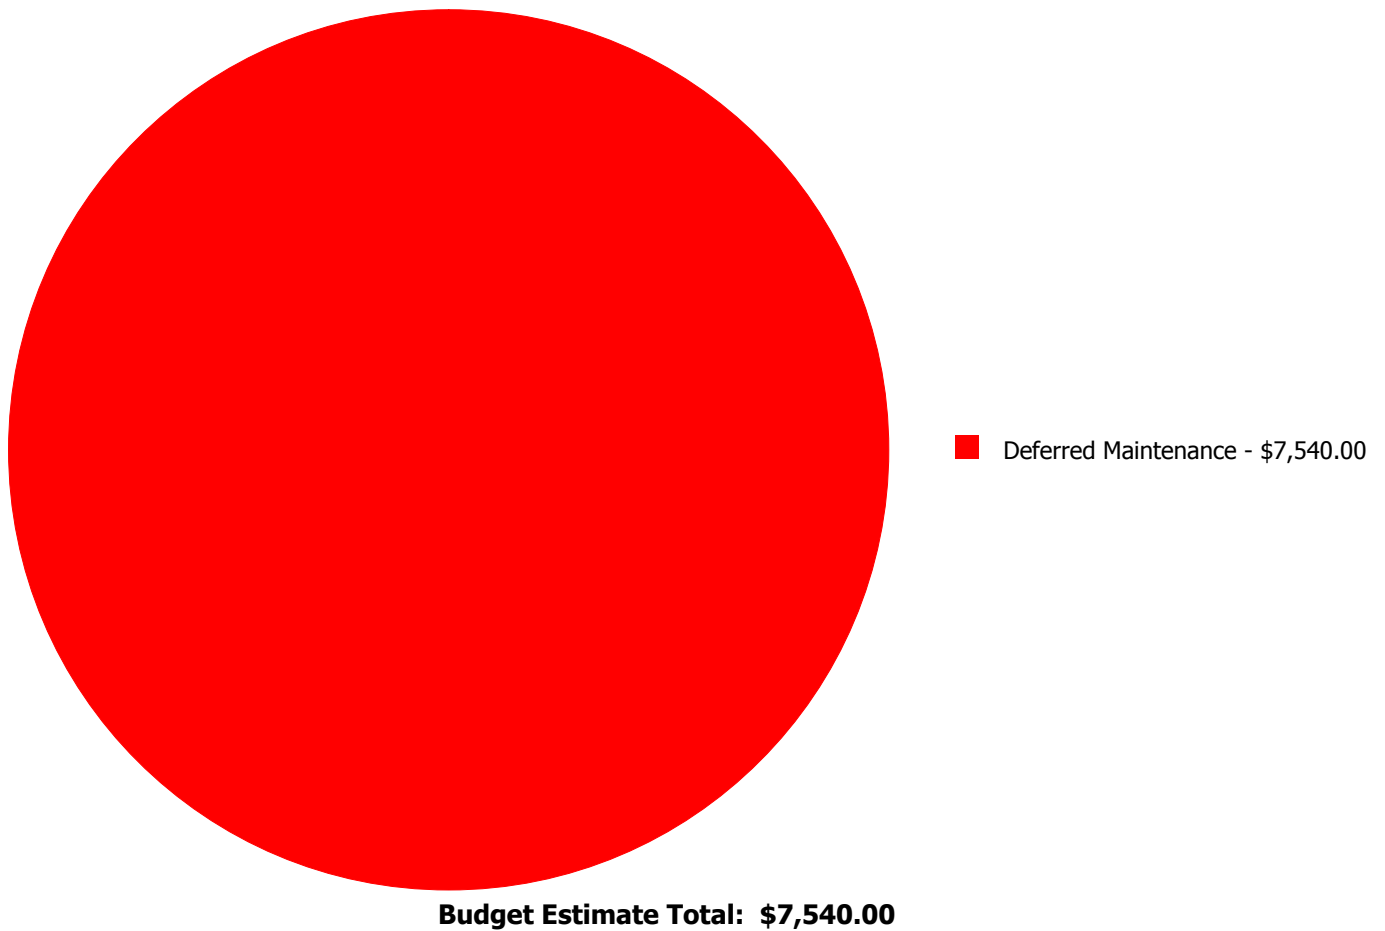
Deficiency Summary by Category

The following chart shows the total repair costs broken down by deficiency categories. Assessors assigned deficiencies to one of the following categories:

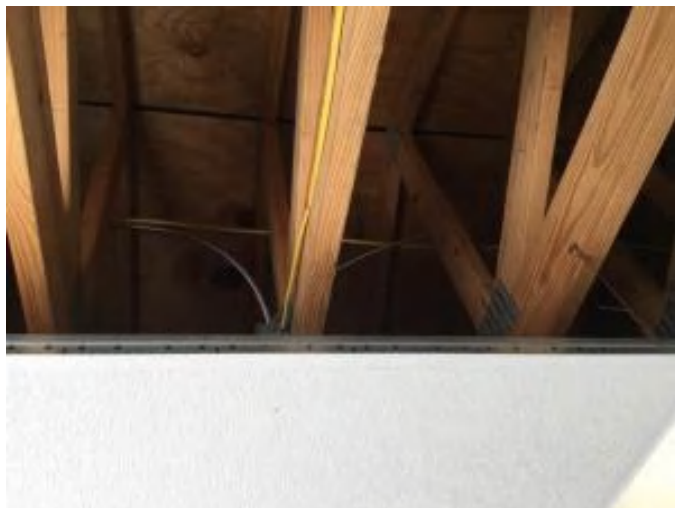
System: C3030 - Ceiling Finishes

Location: Interior ceilings
Distress: Beyond Service Life
Category: Deferred Maintenance
Priority: 4 - Recommended (Years 6-10)
Correction: Renew System
Qty: 720.00
Unit of Measure: S.F.
Estimate: \$7,540.00
Assessor Name: Ann Buerger Linden
Date Created: 02/17/2017

Notes: Interior ceilings are in generally fair to good condition with a few missing tiles. System renewal is recommended.

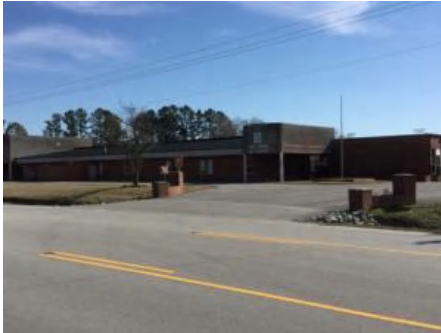
1). Partial North Elevation - Feb 24, 2017

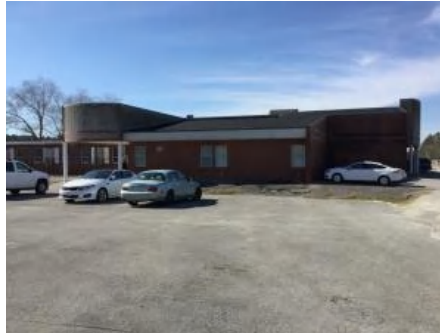
2). East Elevation - Feb 24, 2017

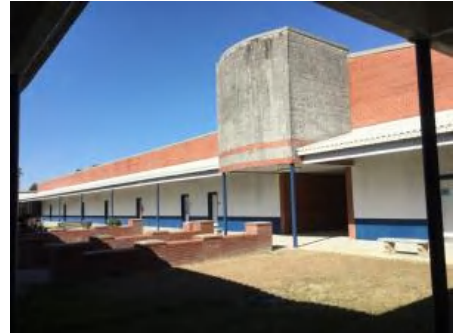
3). South Elevation - Feb 20, 2017

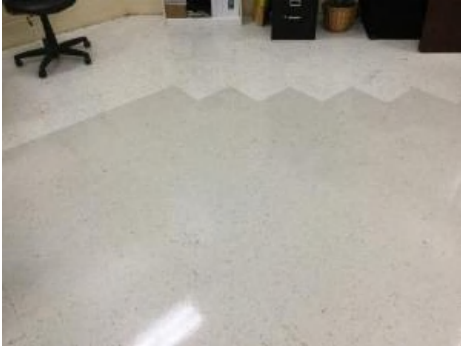
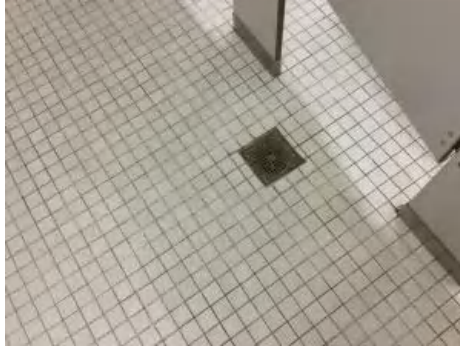
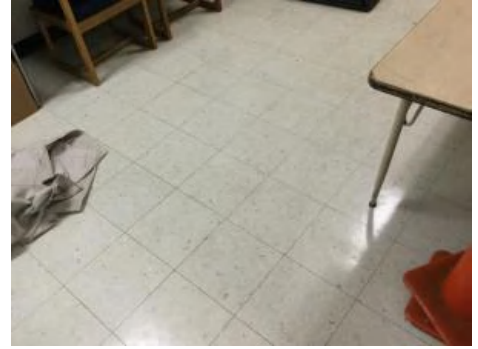
System: C3020 - Floor Finishes

Note: Floor finishes are well maintained in overall good to fair condition. System renewal pushed 5 years.

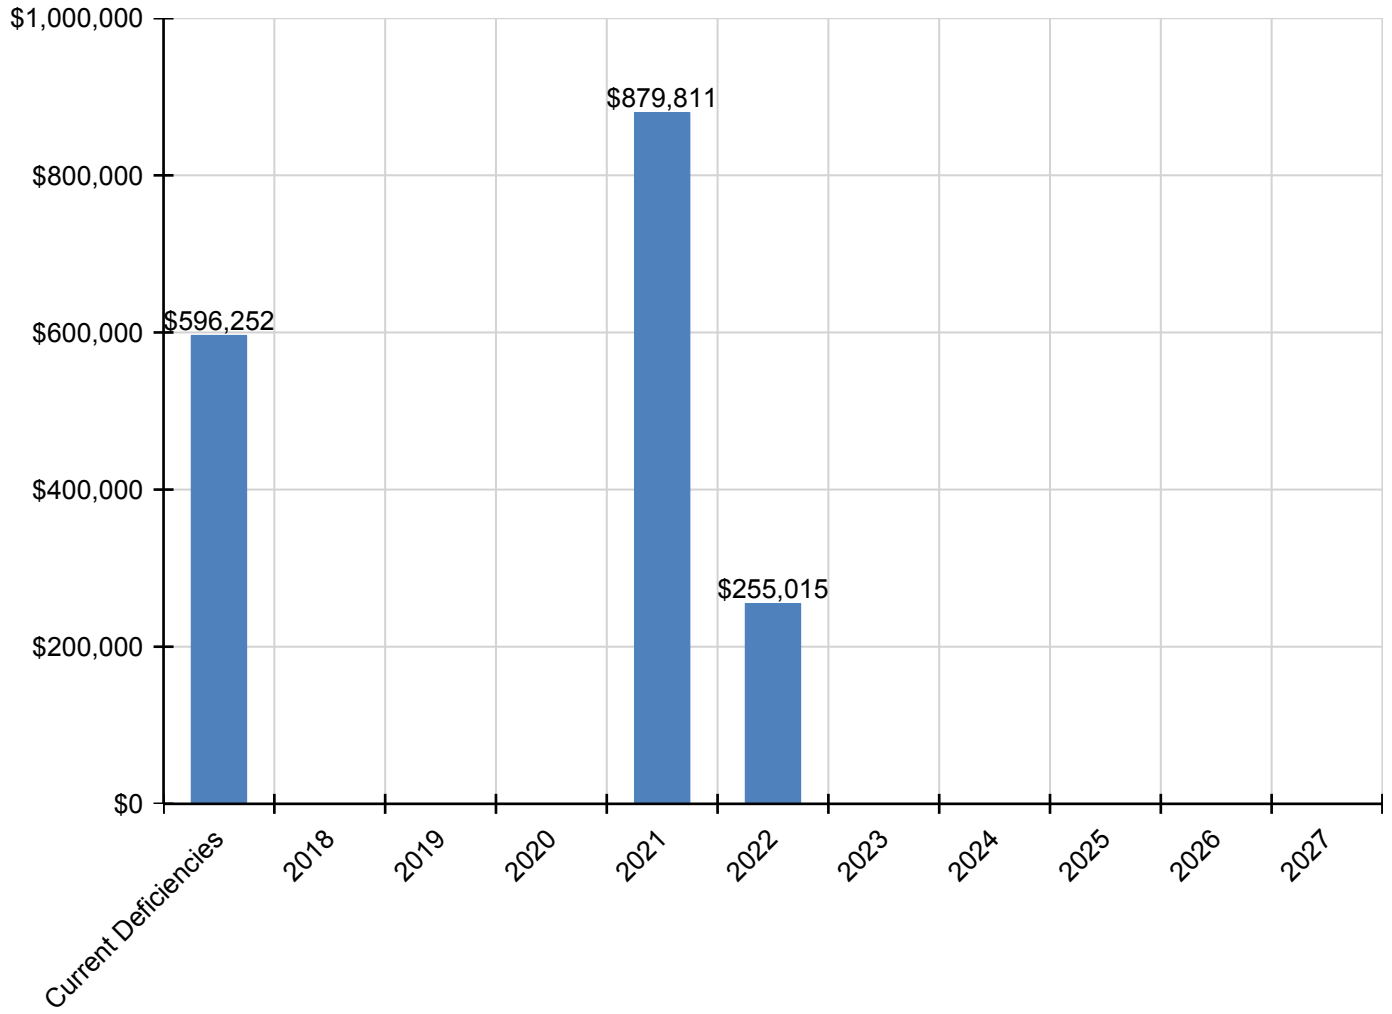
Forecasted Capital Renewal Requirement

The following chart shows the current building deficiencies and forecasting capital renewal or sustainment requirements over the next ten years.

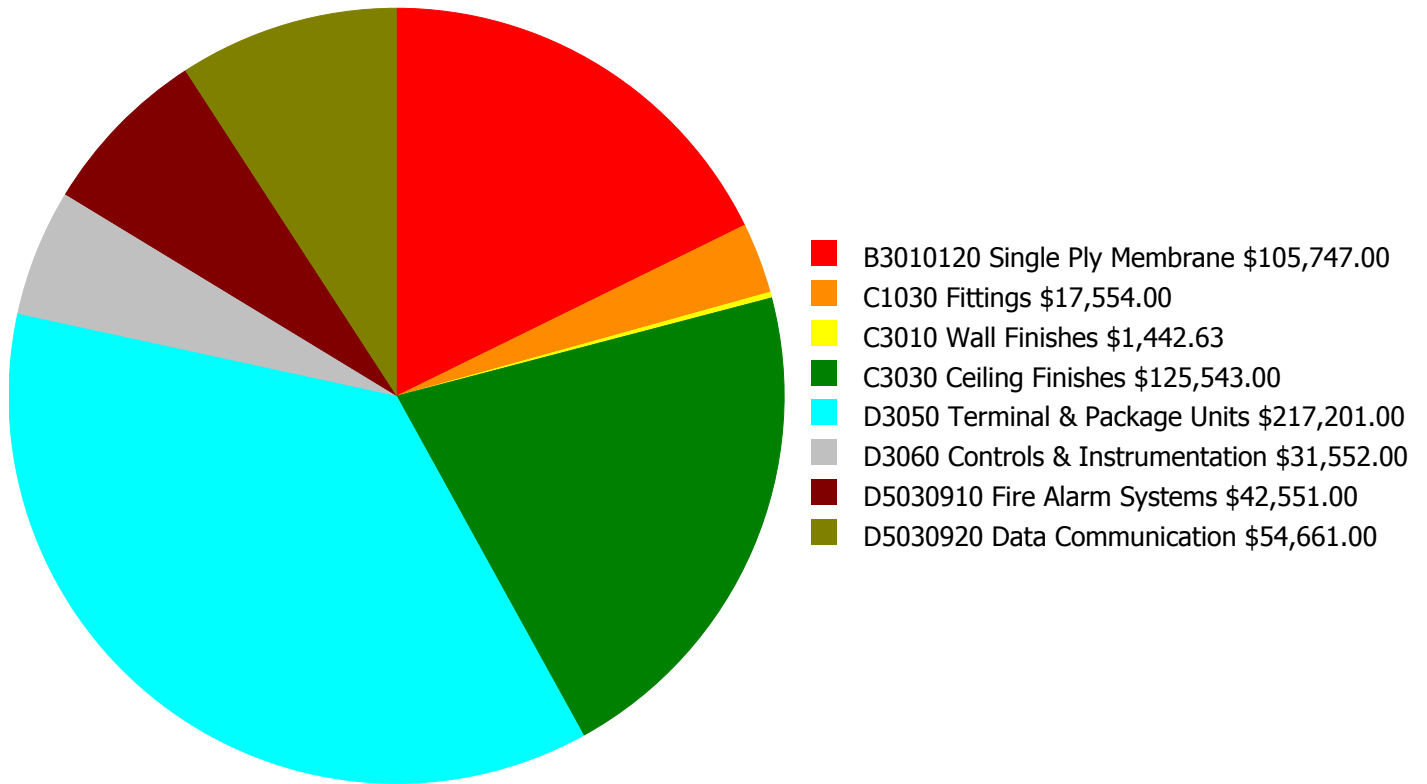
Deficiency Summary by System

Current deficiencies included assemblies that have reached or exceeded their design life or components of the assemblies that are in need of repair. Assemblies that have reached their design life are identified as current deficiencies and assigned the distress 'Beyond Useful Life'. The following chart lists all current deficiencies associated with this facility.

Budget Estimate Total: \$596,251.63

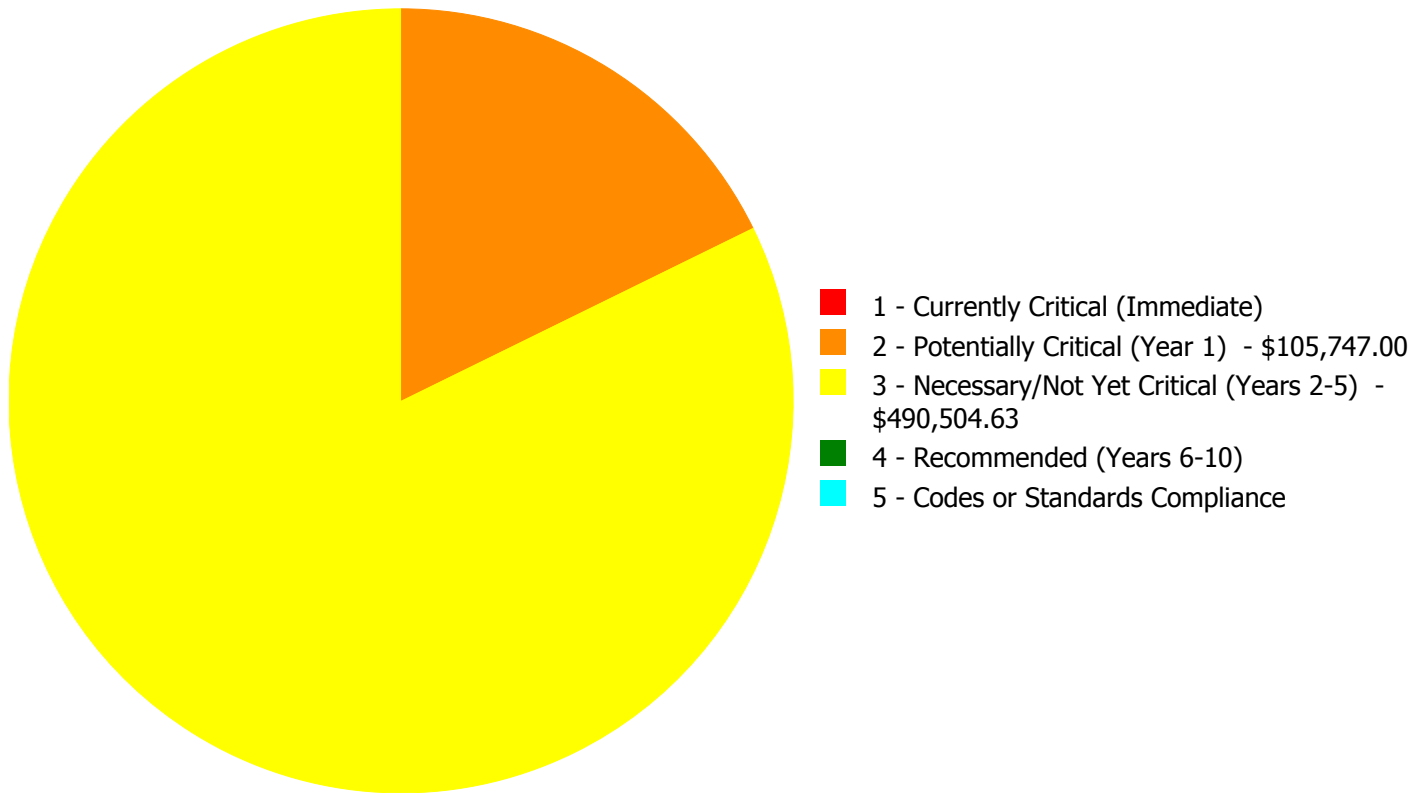
Deficiency Summary by Priority

The following chart shows the total repair costs broken down by priority. Assessors assigned deficiencies within eCOMET to one of the following priority categories:

Budget Estimate Total: \$596,251.63

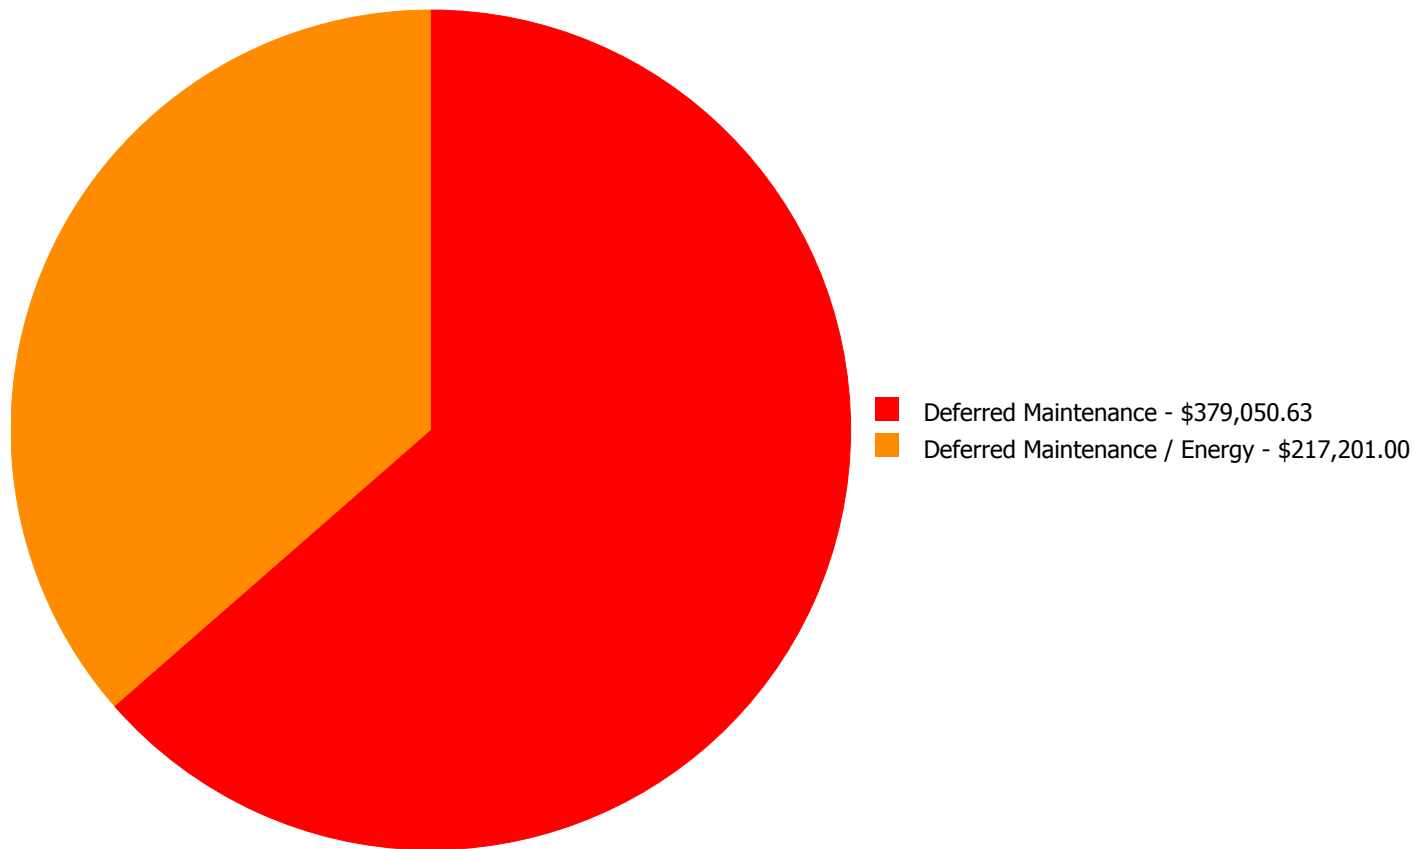
Deficiency Summary by Category

The following chart shows the total repair costs broken down by deficiency categories. Assessors assigned deficiencies to one of the following categories:

Budget Estimate Total: \$596,251.63

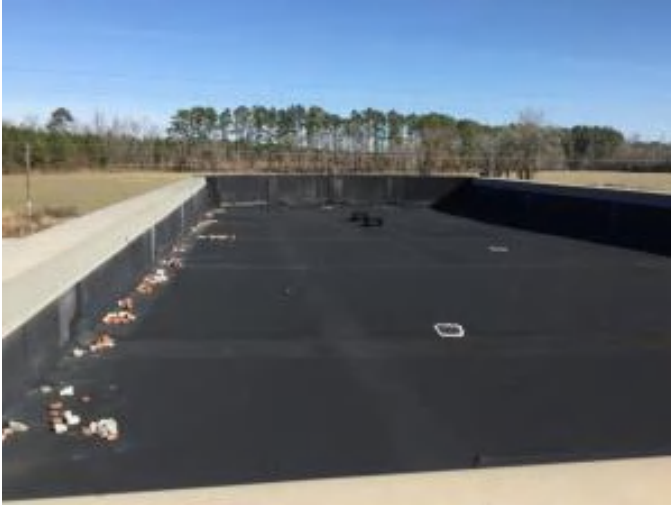
System: B3010120 - Single Ply Membrane

Location: Roofs
Distress: Beyond Service Life
Category: Deferred Maintenance
Priority: 2 - Potentially Critical (Year 1)
Correction: Renew System
Qty: 10,100.00
Unit of Measure: S.F.
Estimate: \$105,747.00
Assessor Name: Terence Davis
Date Created: 02/17/2017

Notes: The original single ply membrane has exceeded its expected useful life. Interior damage to finishes is evident, particularly in the gym lobby and music room portions of the building. System renewal is recommended.

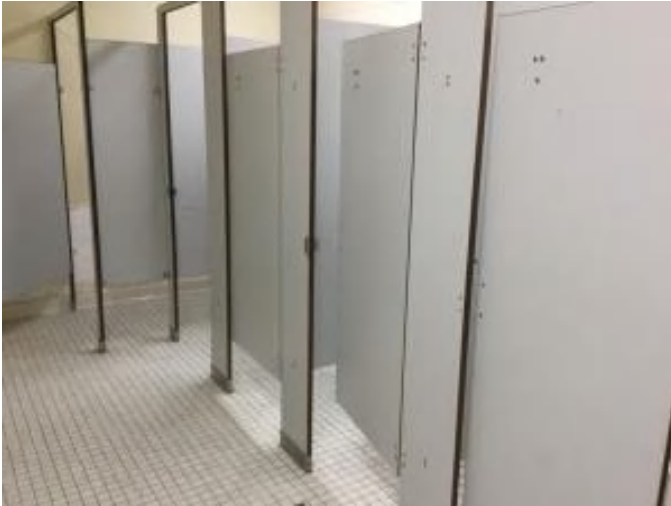
System: C1030 - Fittings

Location: Throughout the building
Distress: Beyond Service Life
Category: Deferred Maintenance
Priority: 3 - Necessary/Not Yet Critical (Years 2-5)
Correction: Renew System
Qty: 10,100.00
Unit of Measure: S.F.
Estimate: \$17,554.00
Assessor Name: Terence Davis
Date Created: 02/17/2017

Notes: Fittings in general are beyond their expected useful life. Toilet partitions and accessories and signage are not ADA compliant. Blackboards are obsolete. System renewal is recommended.

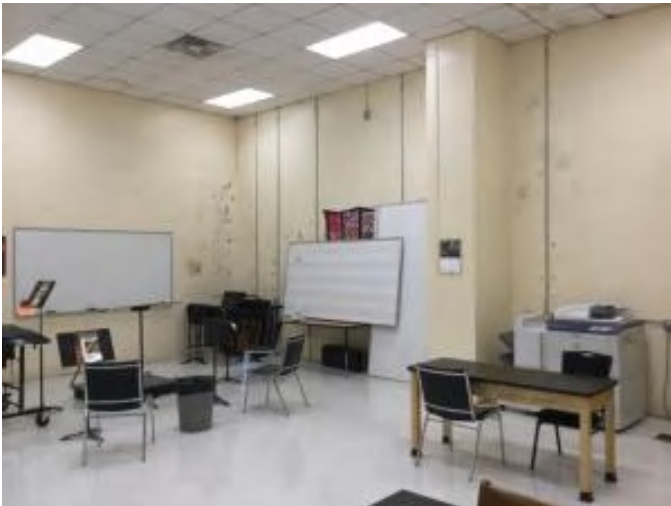
System: C3010 - Wall Finishes

Location: Gym lobby RRs and music room
Distress: Damaged
Category: Deferred Maintenance
Priority: 3 - Necessary/Not Yet Critical (Years 2-5)
Correction: Refinish plaster wall
Qty: 30.00
Unit of Measure: S.Y.
Estimate: \$1,442.63
Assessor Name: Terence Davis
Date Created: 02/24/2017

Notes: Interior wall finishes are generally well maintained. However walls of the toilet rooms that are part of the original exterior wall construction and the music room are affected by roof leaks. Painting, including any necessary prep work, is recommended.

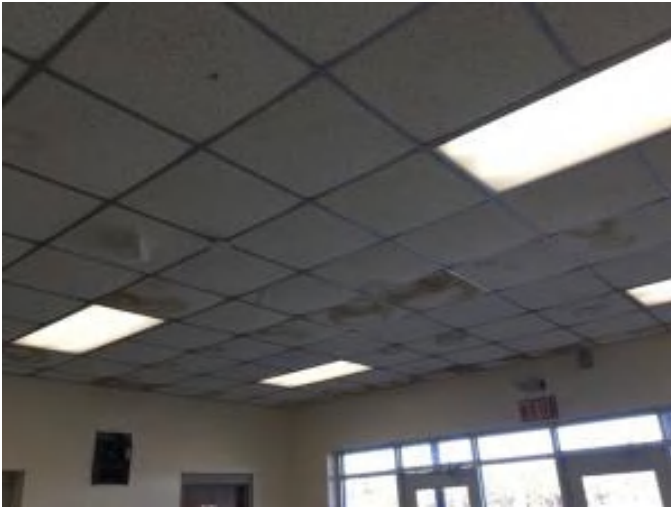
System: C3030 - Ceiling Finishes

Location: Throughout the building
Distress: Beyond Service Life
Category: Deferred Maintenance
Priority: 3 - Necessary/Not Yet Critical (Years 2-5)
Correction: Renew System
Qty: 10,100.00
Unit of Measure: S.F.
Estimate: \$125,543.00
Assessor Name: Terence Davis
Date Created: 02/17/2017

Notes: Ceiling finishes are beyond their useful life. Areas with particularly bad water damage are in the gym lobby addition and the music room. Roof repairs should be undertaken before ceilings are replaced.

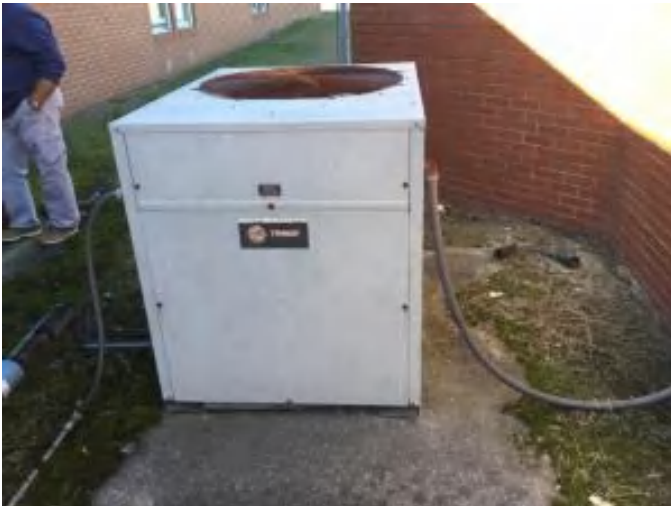
System: D3050 - Terminal & Package Units

Location: Mechanical yard
Distress: Beyond Service Life
Category: Deferred Maintenance / Energy
Priority: 3 - Necessary/Not Yet Critical (Years 2-5)
Correction: Renew System
Qty: 10,100.00
Unit of Measure: S.F.
Estimate: \$217,201.00
Assessor Name: Terence Davis
Date Created: 02/17/2017

Notes: The ground mount condenser units have exceeded their expected useful life. System renewal is recommended.

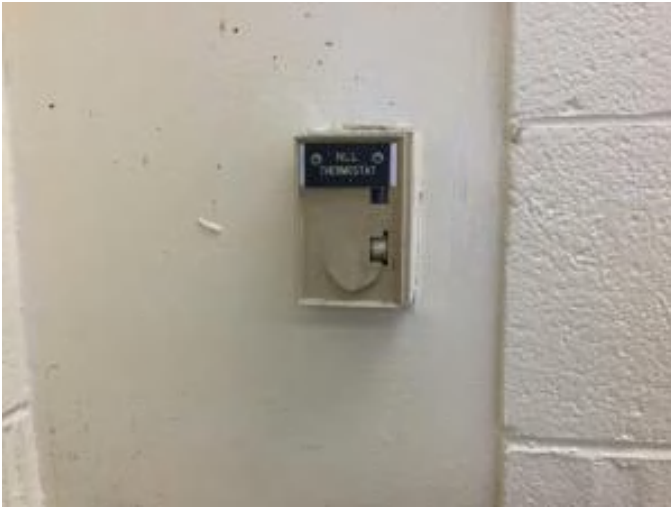
System: D3060 - Controls & Instrumentation

Location: Throughout the building
Distress: Beyond Service Life
Category: Deferred Maintenance
Priority: 3 - Necessary/Not Yet Critical (Years 2-5)
Correction: Renew System
Qty: 10,100.00
Unit of Measure: S.F.
Estimate: \$31,552.00
Assessor Name: Terence Davis
Date Created: 02/17/2017

Notes: Building controls are locally controlled. Installation of a modern digital system with remote monitoring and control capability for energy conservation is recommended.

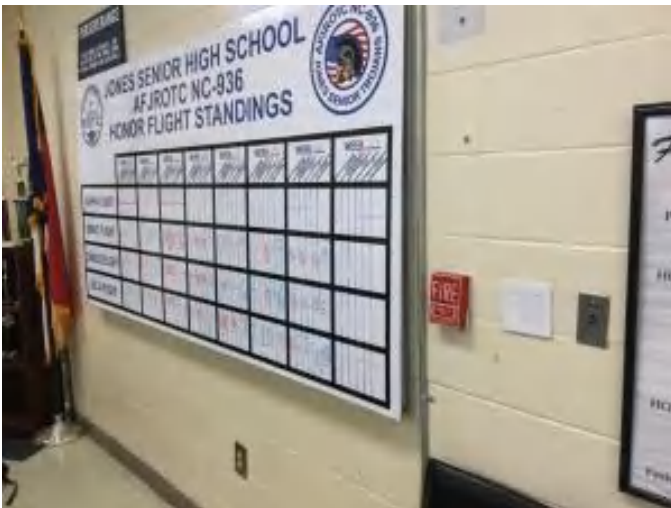
System: D5030910 - Fire Alarm Systems

Location: Throughout the building
Distress: Beyond Service Life
Category: Deferred Maintenance
Priority: 3 - Necessary/Not Yet Critical (Years 2-5)
Correction: Renew System
Qty: 10,100.00
Unit of Measure: S.F.
Estimate: \$42,551.00
Assessor Name: Terence Davis
Date Created: 02/17/2017

Notes: The fire alarm system is original and beyond its expected life. System renewal to current codes is recommended to ensure reliability of this life safety system.

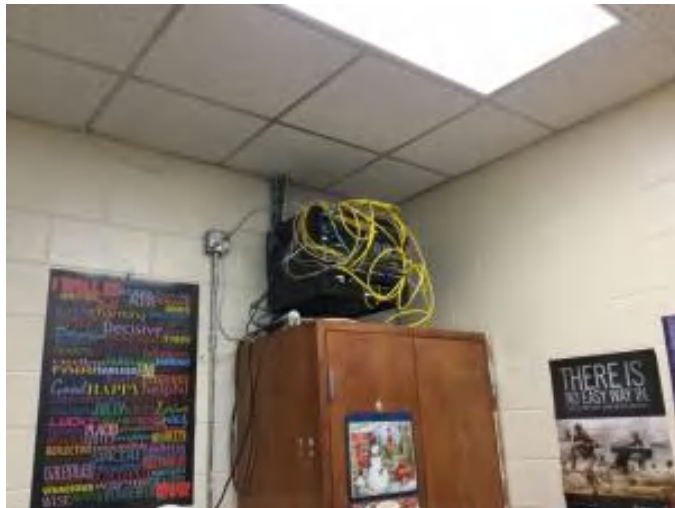
System: D5030920 - Data Communication

Location: Throughout the building
Distress: Beyond Service Life
Category: Deferred Maintenance
Priority: 3 - Necessary/Not Yet Critical (Years 2-5)
Correction: Renew System
Qty: 10,100.00
Unit of Measure: S.F.
Estimate: \$54,661.00
Assessor Name: Terence Davis
Date Created: 02/17/2017

Notes: Data and communications systems are beyond their expected useful life. The PA system is inadequate. System renewal is recommended.

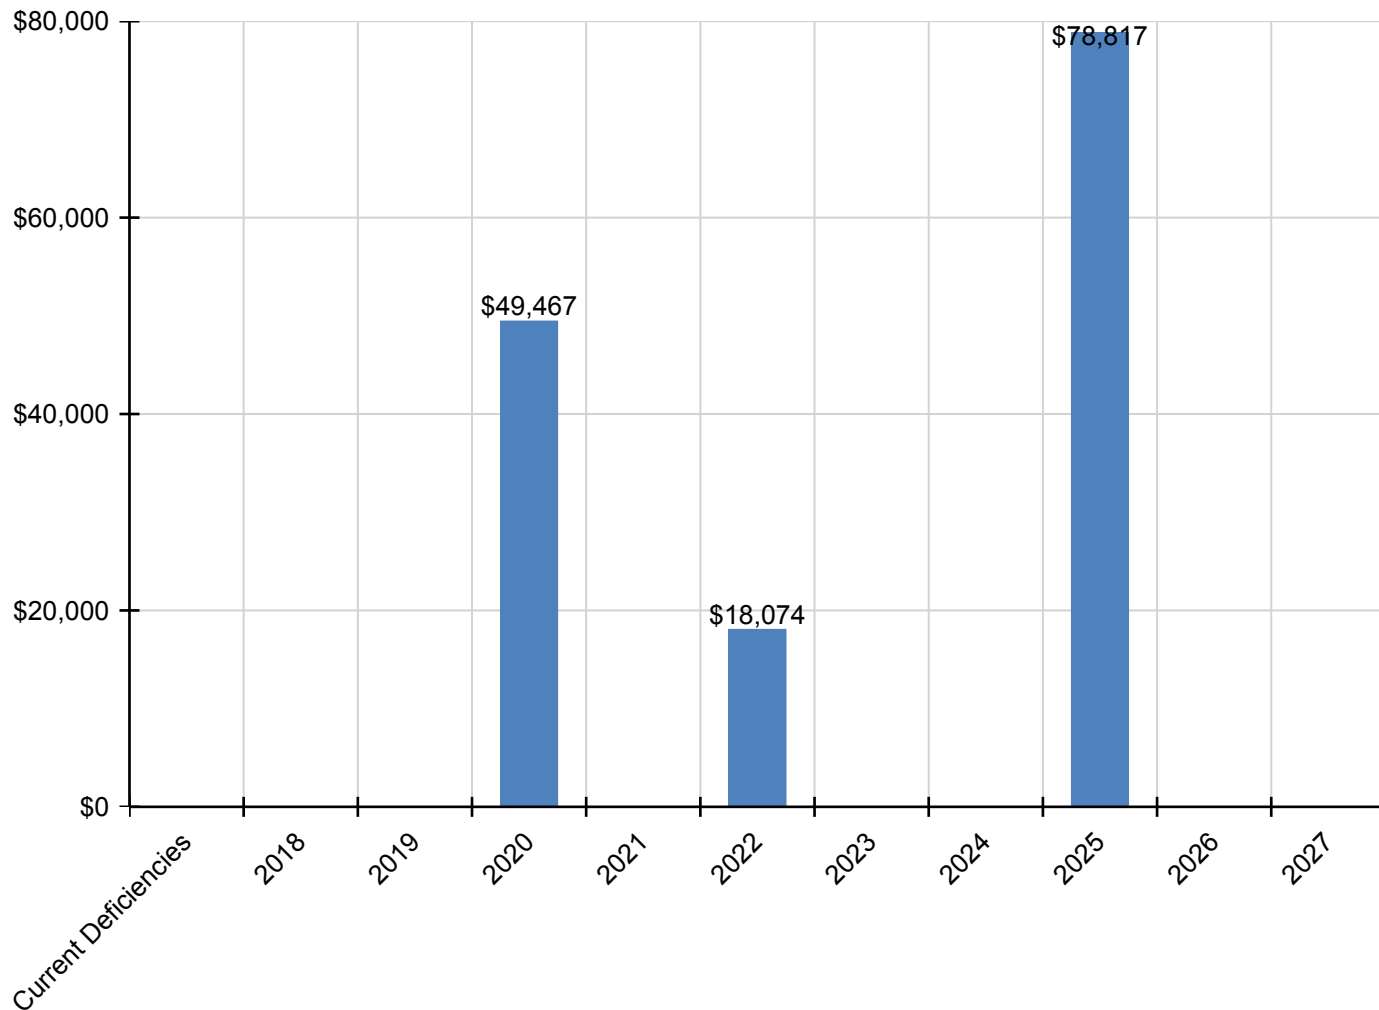
Forecasted Capital Renewal Requirement

The following chart shows the current building deficiencies and forecasting capital renewal or sustainment requirements over the next ten years.

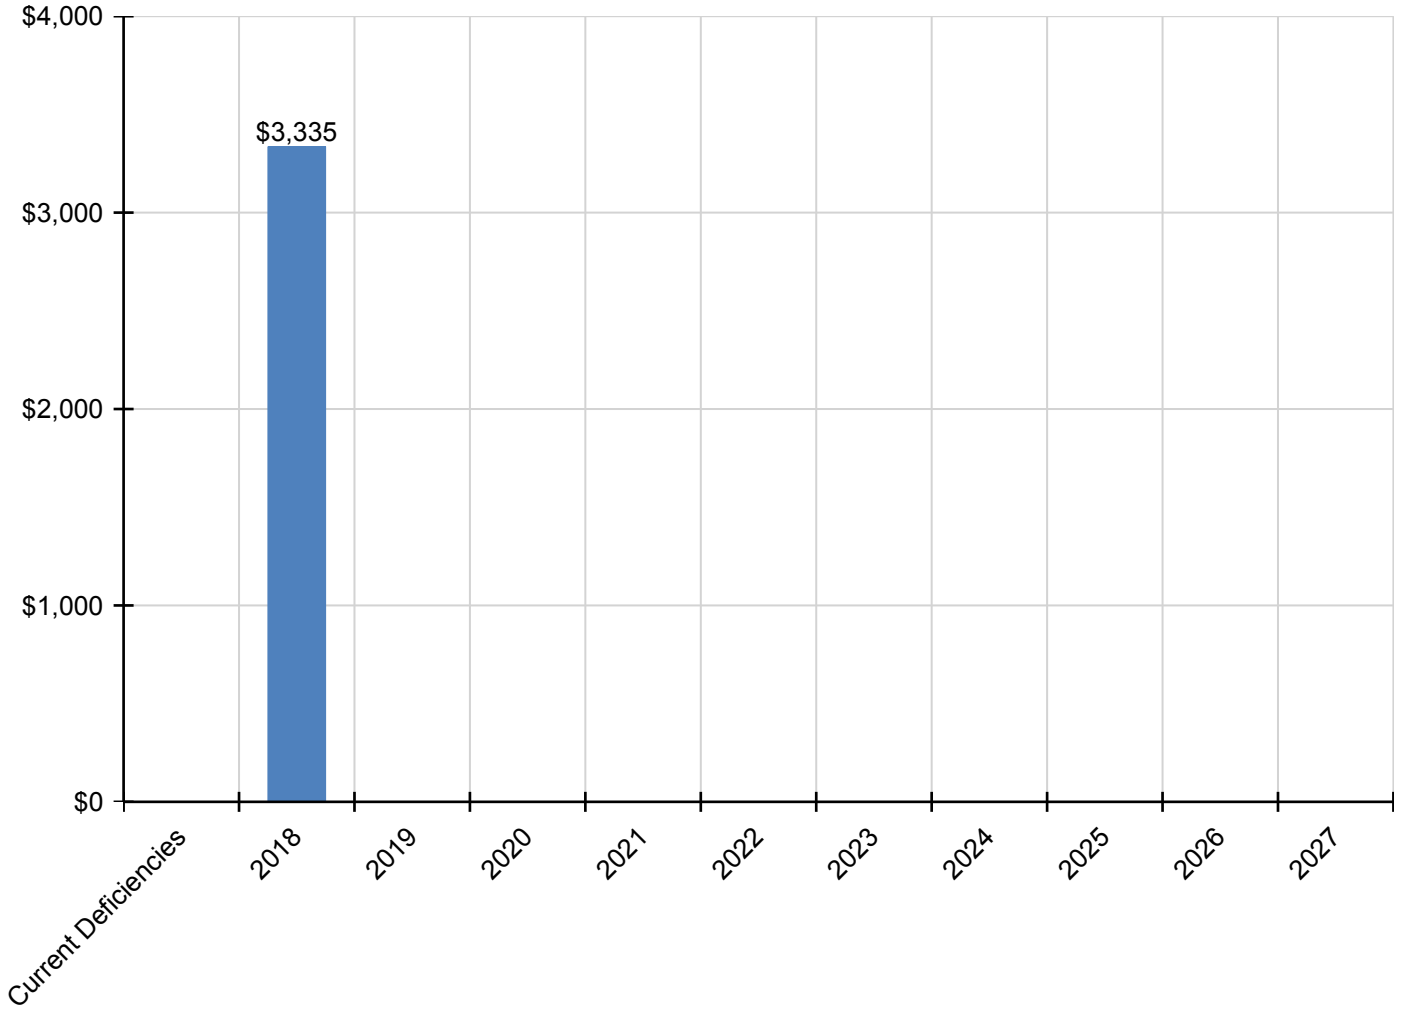
Forecasted Capital Renewal Requirement

The following chart shows the current building deficiencies and forecasting capital renewal or sustainment requirements over the next ten years.

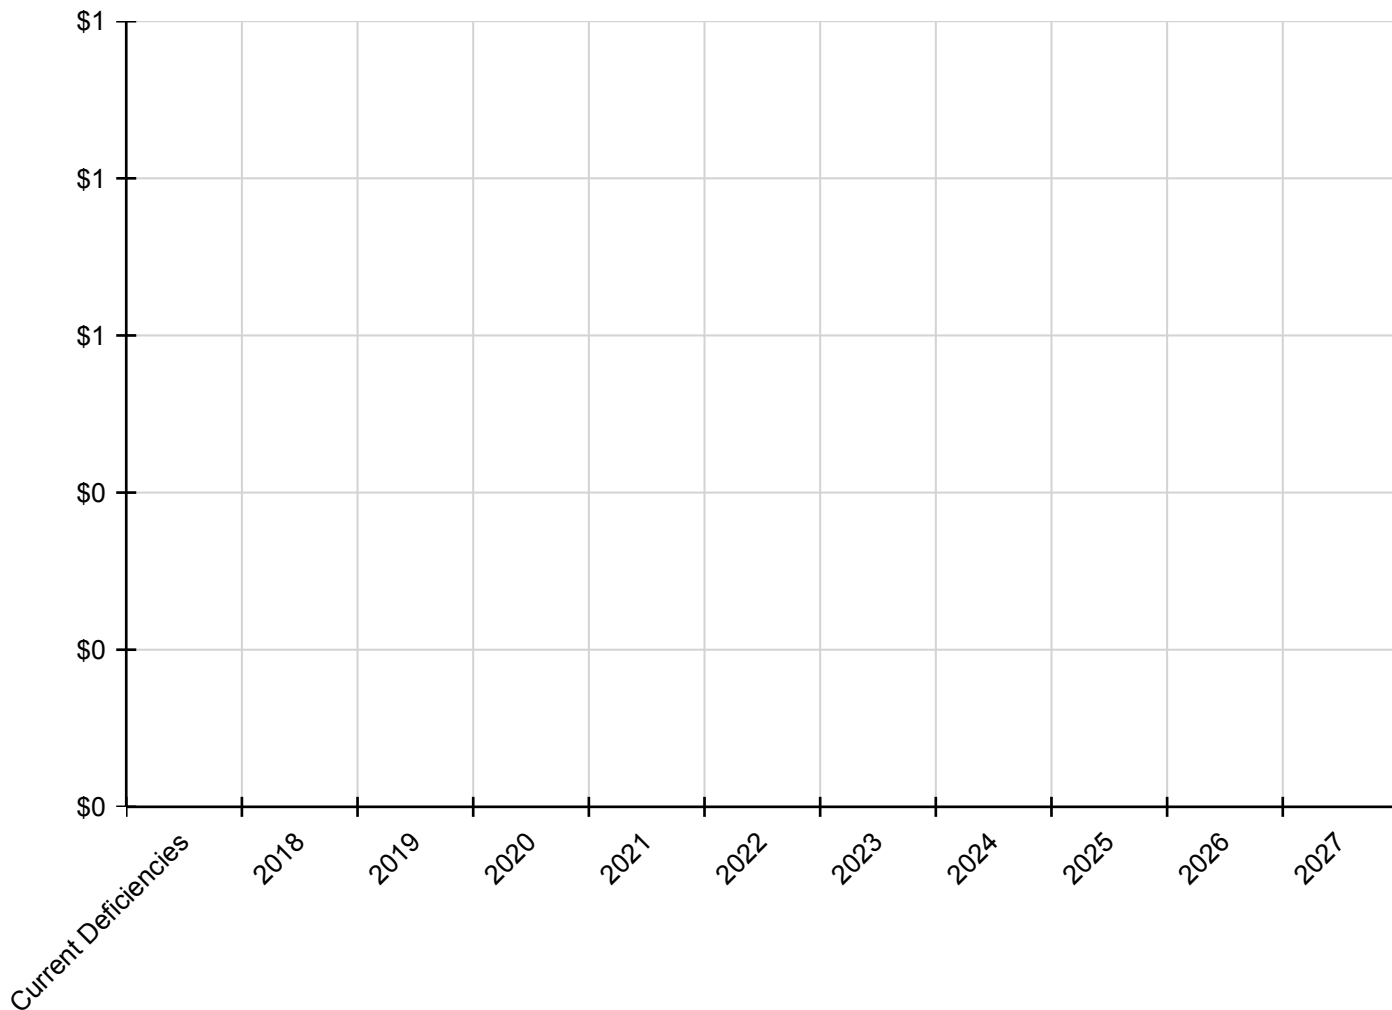
Forecasted Capital Renewal Requirement

The following chart shows the current building deficiencies and forecasting capital renewal or sustainment requirements over the next ten years.

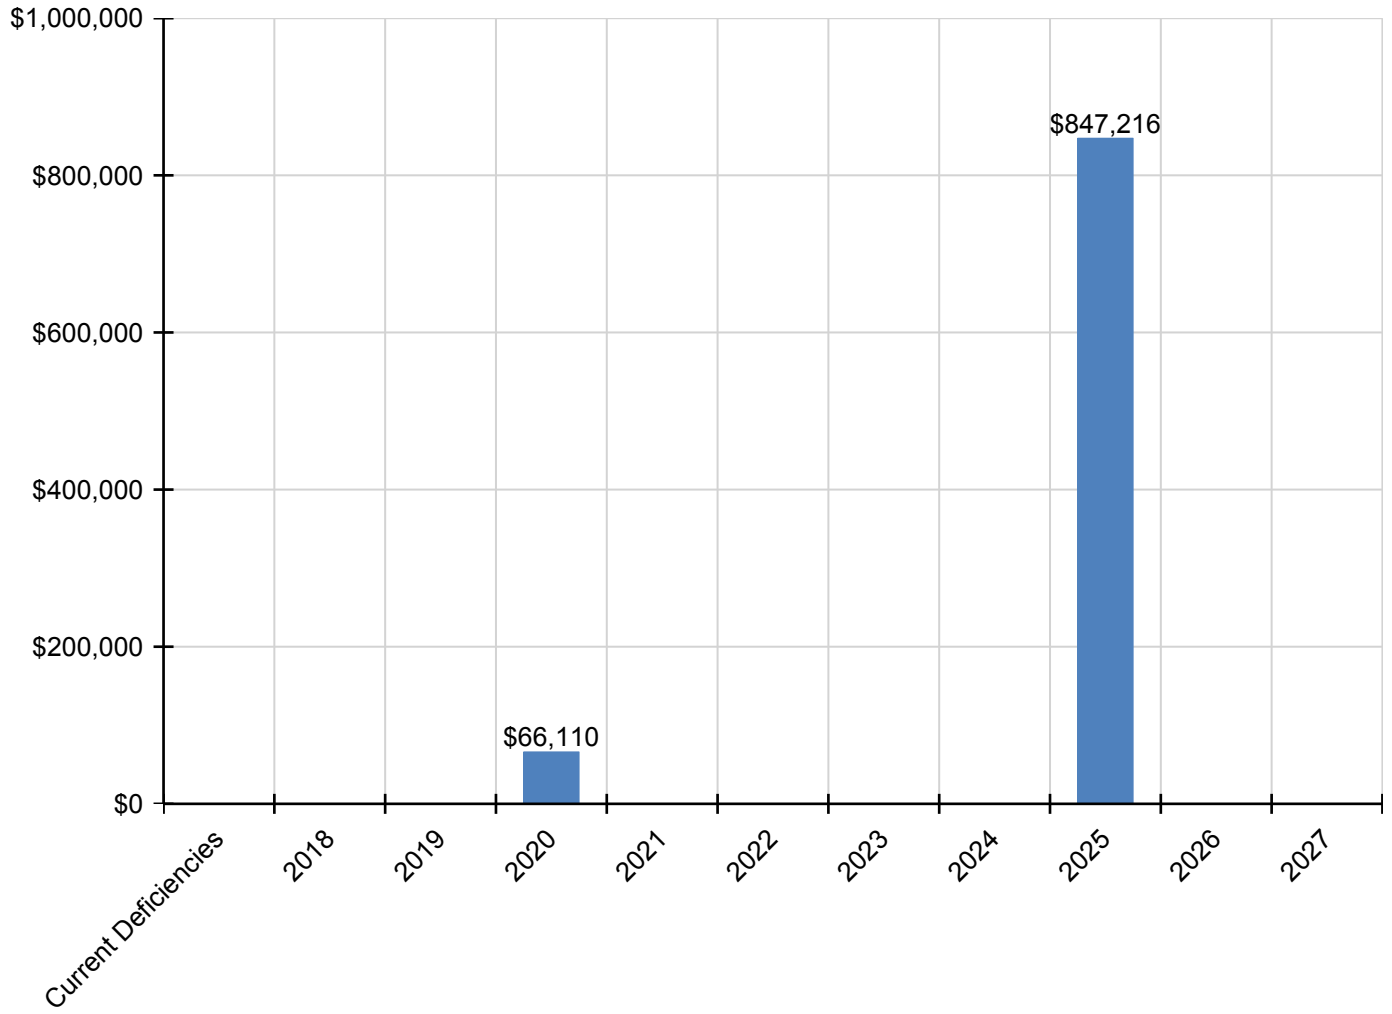
Forecasted Capital Renewal Requirement

The following chart shows the current building deficiencies and forecasting capital renewal or sustainment requirements over the next ten years.

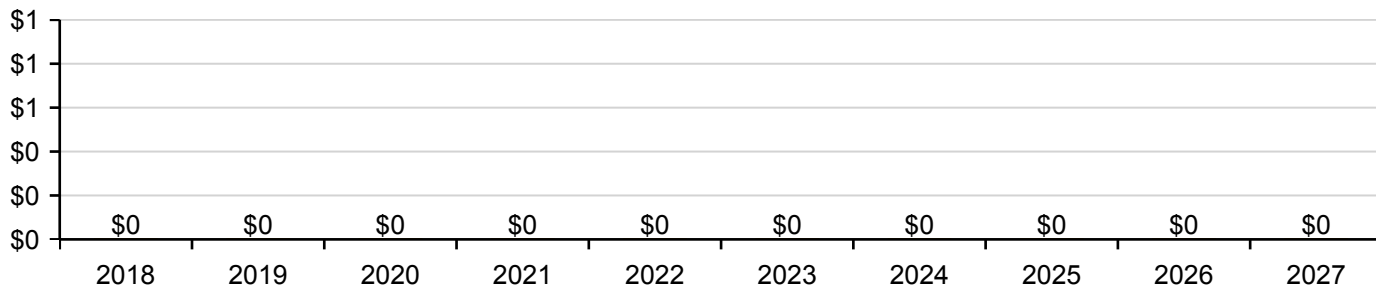
10 Year Investment Forecast

The following chart shows the current building deficiencies and forecasting capital renewal or sustainment requirements over the next ten years.

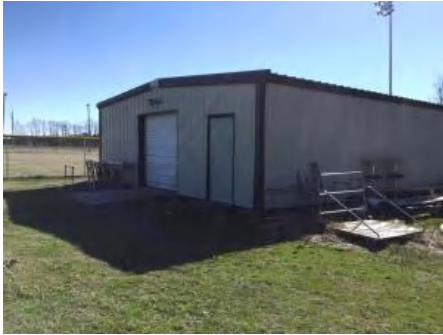
1). Northeast Elevation - Feb 21, 2017

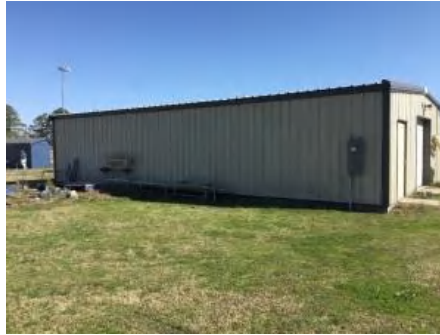
2). Northwest Elevation - Feb 21, 2017

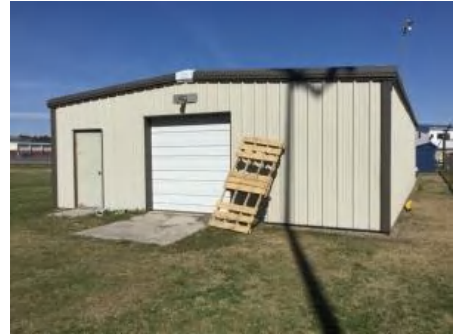
3). Southwest Elevation - Feb 21, 2017
