NC School District/520 Jones County/High School

Jones Senior High

Campus Assessment Report

March 8, 2017

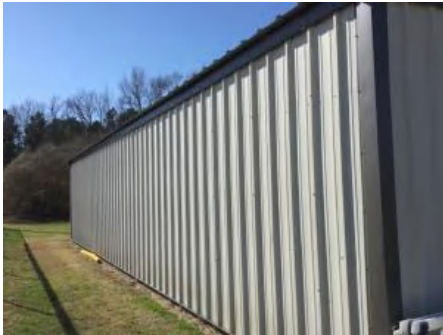
4). Southeast Elevation - Feb 21, 2017

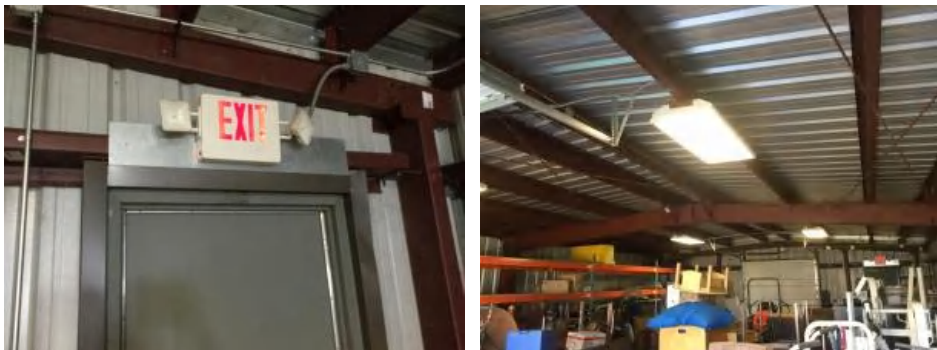
System: D5020 - Lighting

Note: Includes egress lighting and emergency exit signage

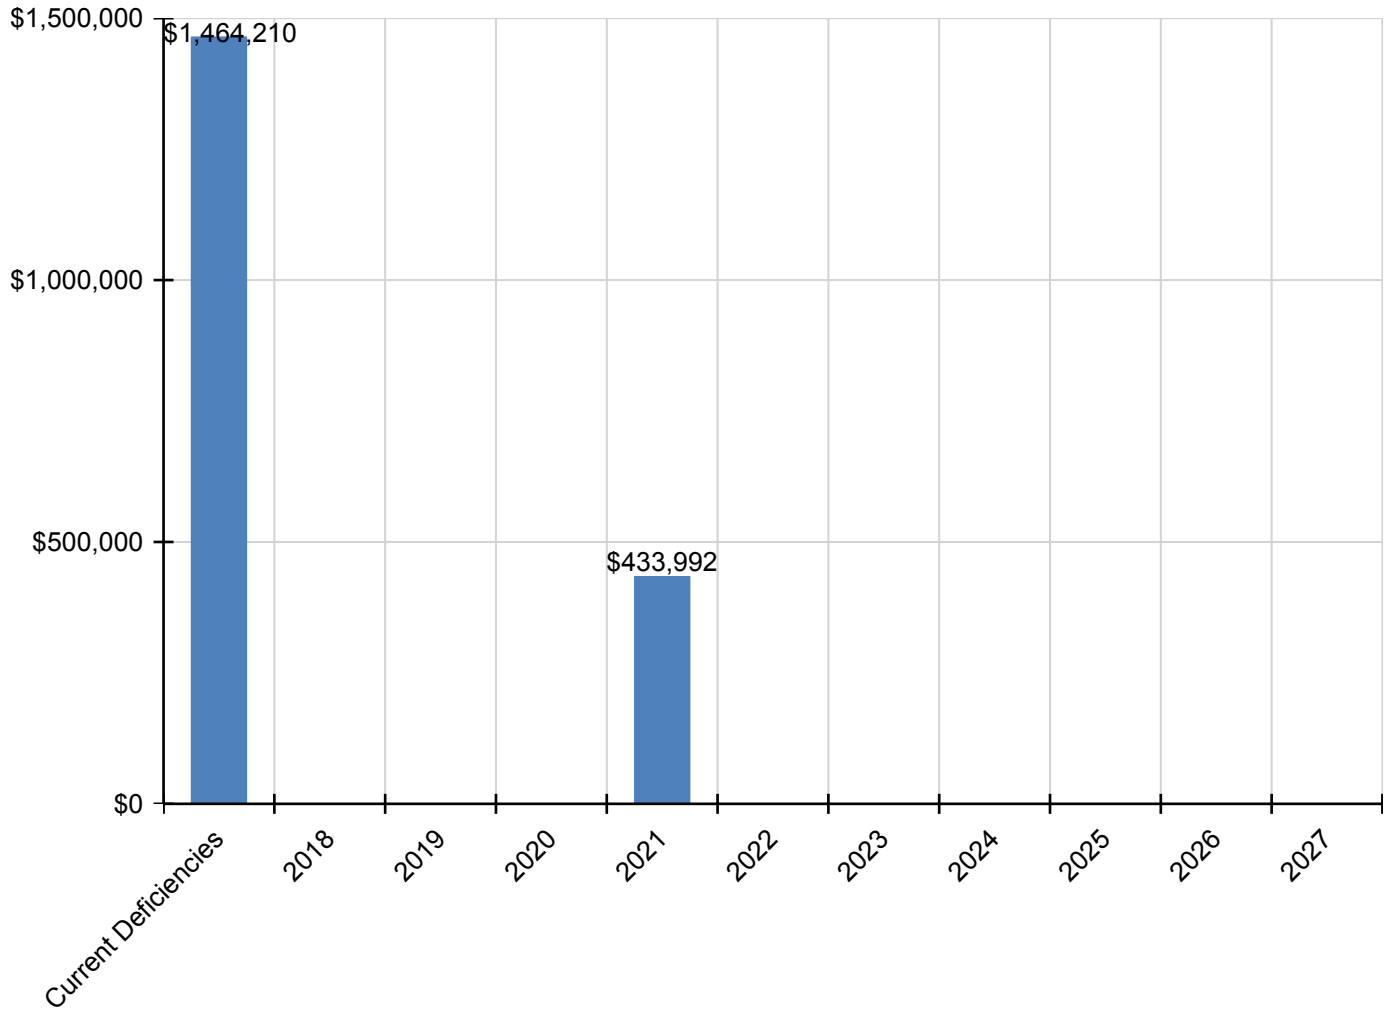
Forecasted Capital Renewal Requirement

The following chart shows the current building deficiencies and forecasting capital renewal or sustainment requirements over the next ten years.

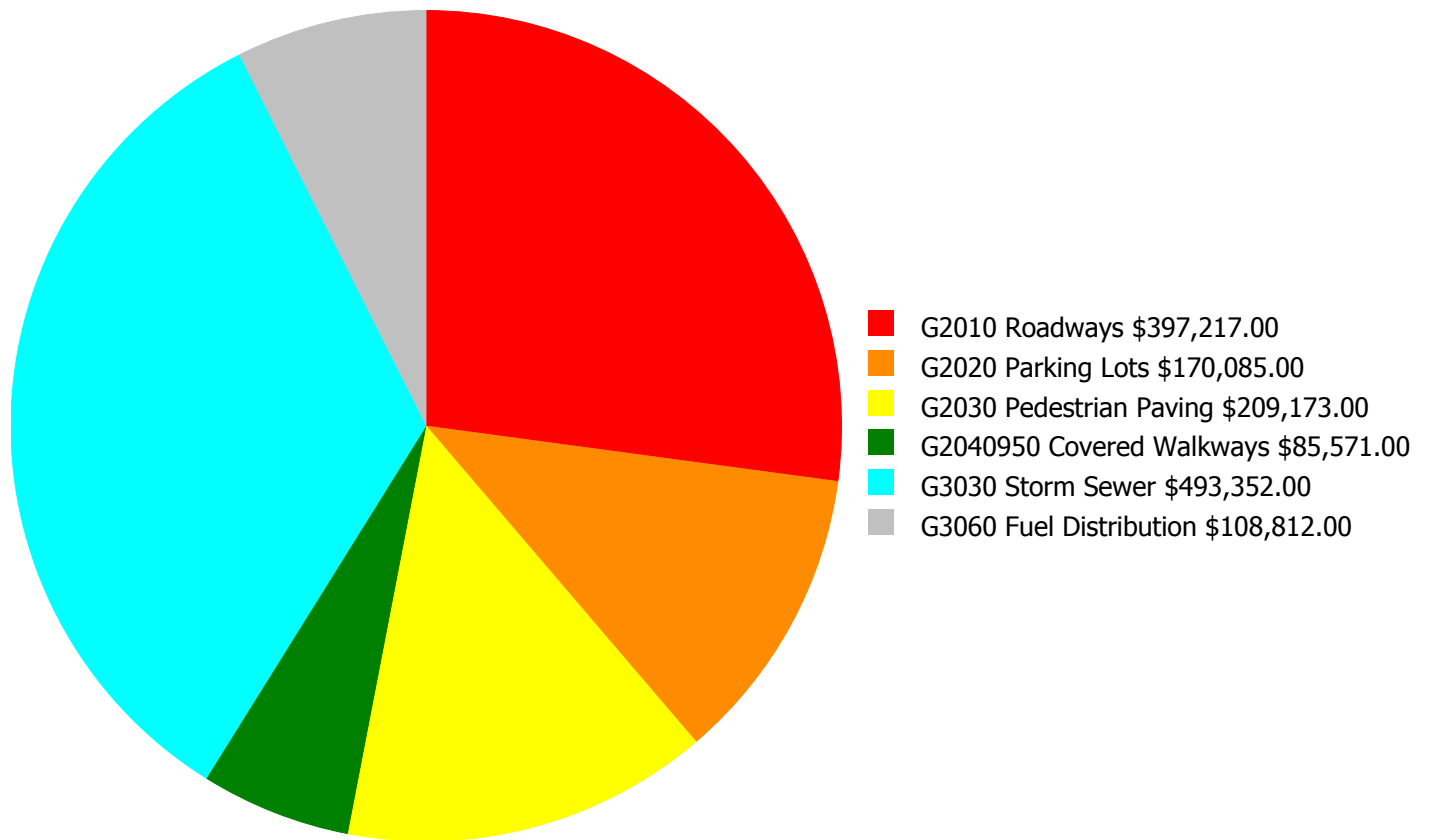
Deficiency Summary by System

Current deficiencies included assemblies that have reached or exceeded their design life or components of the assemblies that are in need of repair. Assemblies that have reached their design life are identified as current deficiencies and assigned the distress 'Beyond Useful Life'. The following chart lists all current deficiencies associated with this facility.

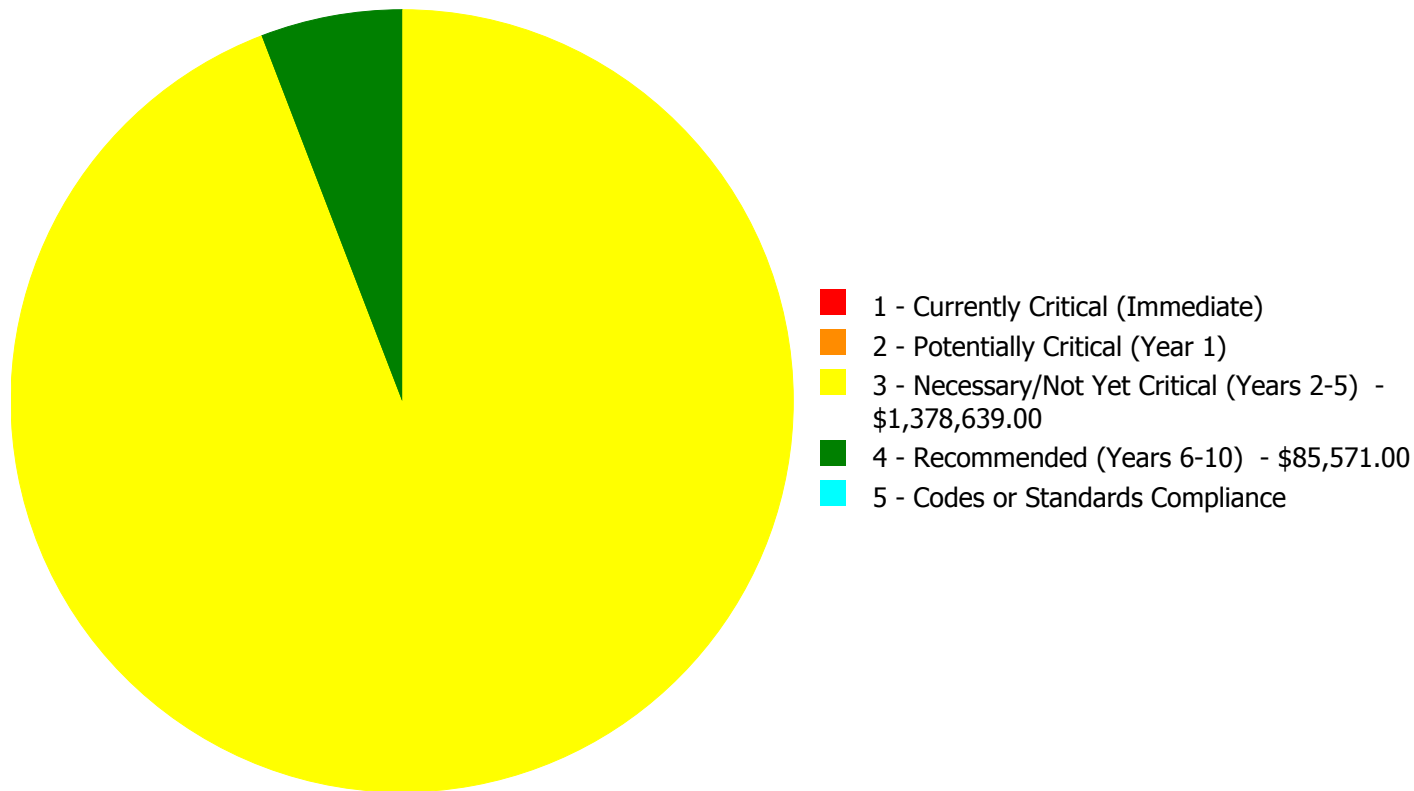
Deficiency Summary by Priority

The following chart shows the total repair costs broken down by priority. Assessors assigned deficiencies within eCOMET to one of the following priority categories:

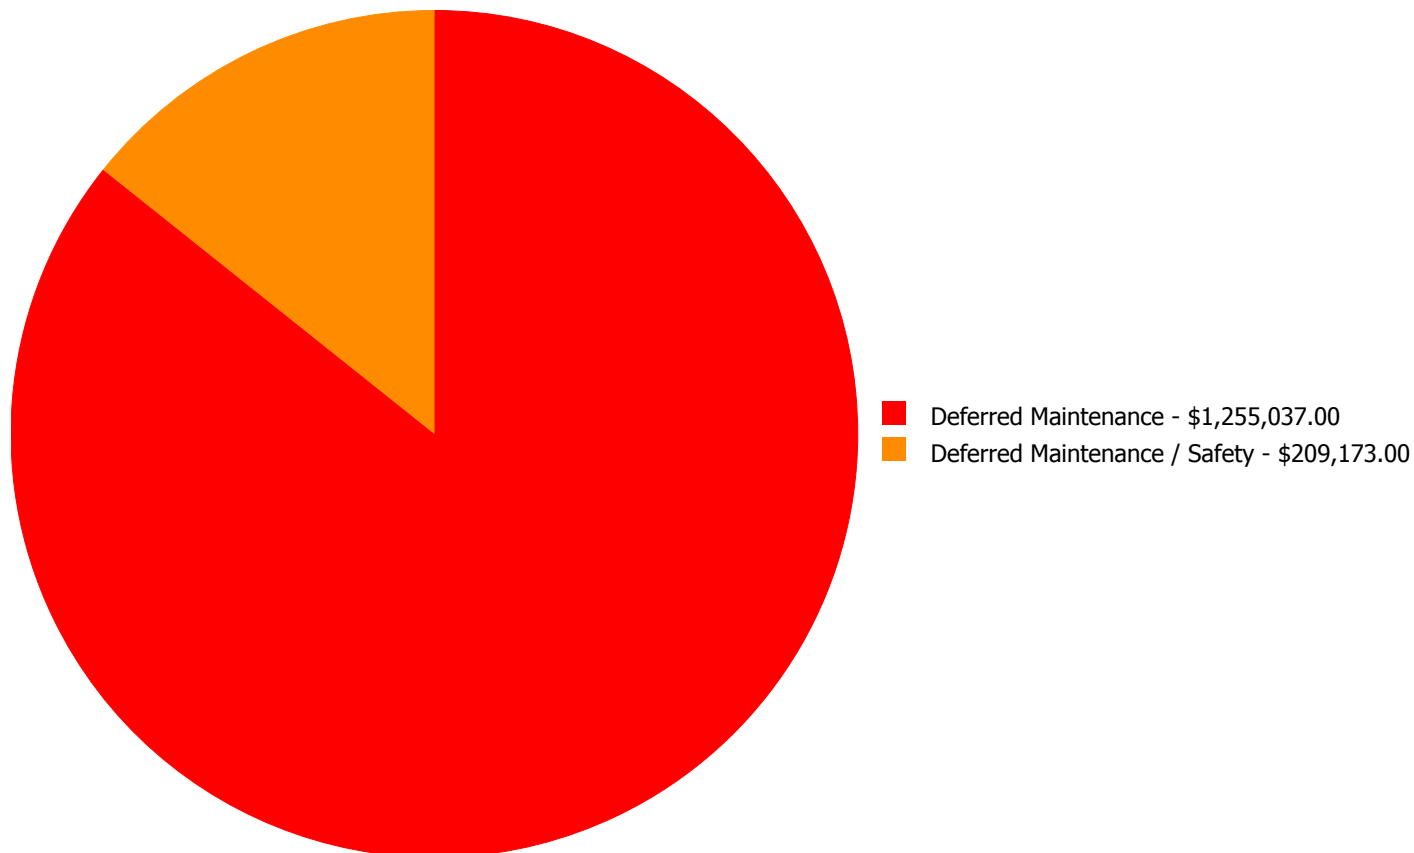
Deficiency Summary by Category

The following chart shows the total repair costs broken down by deficiency categories. Assessors assigned deficiencies to one of the following categories:

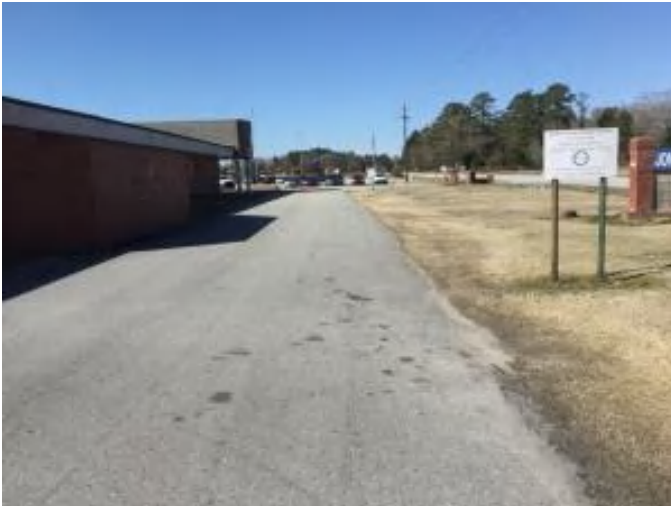
System: G2010 - Roadways

Location: Site
Distress: Beyond Service Life
Category: Deferred Maintenance
Priority: 3 - Necessary/Not Yet Critical (Years 2-5)
Correction: Renew System
Qty: 96,039.00
Unit of Measure: S.F.
Estimate: \$397,217.00
Assessor Name: Terence Davis
Date Created: 02/17/2017

Notes: Roadways are in worn condition. The service road at the east end of the site is unpaved. System renewal is recommended.

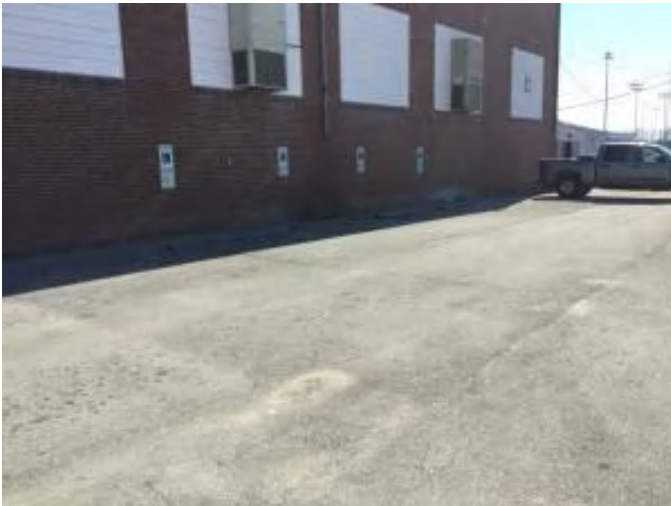
System: G2020 - Parking Lots

Location: Parking lots
Distress: Beyond Service Life
Category: Deferred Maintenance
Priority: 3 - Necessary/Not Yet Critical (Years 2-5)
Correction: Renew System
Qty: 96,039.00
Unit of Measure: S.F.
Estimate: \$170,085.00
Assessor Name: Terence Davis
Date Created: 02/17/2017

Notes: Parking lots, particularly the east parking lot, are in worn condition. The paving surface is uneven. Striping is faded. Edges are not curbed. Drainage patterns should be studied. System renewal is recommended.

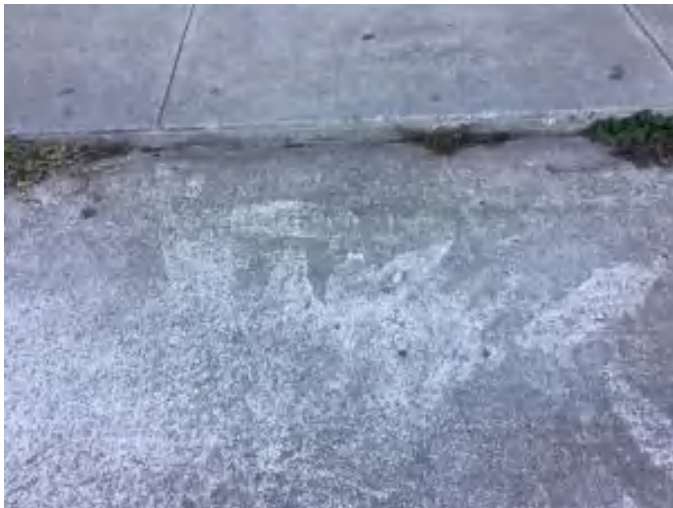
System: G2030 - Pedestrian Paving

Location: Site
Distress: Beyond Service Life
Category: Deferred Maintenance / Safety
Priority: 3 - Necessary/Not Yet Critical (Years 2-5)
Correction: Renew System
Qty: 96,039.00
Unit of Measure: S.F.
Estimate: \$209,173.00
Assessor Name: Terence Davis
Date Created: 02/17/2017

Notes: Sidewalks are in fair to poor condition, particularly around the main, ag, and media buildings. Differential settlement and cracking creates tripping hazards. System renewal is recommended.

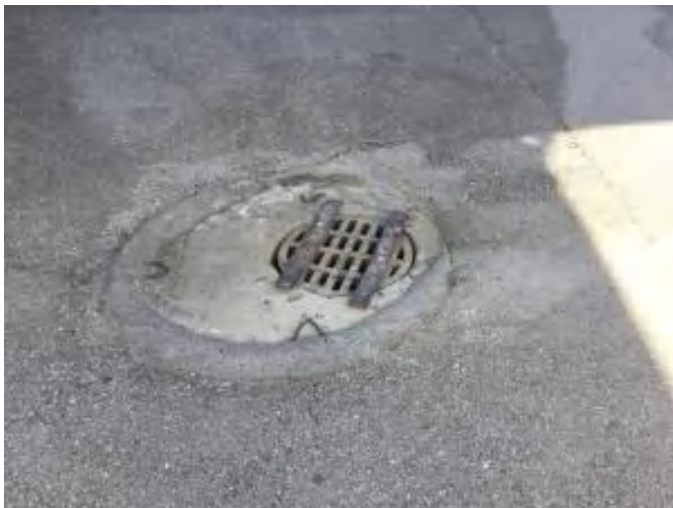
System: G3030 - Storm Sewer

Location: Site
Distress: Inadequate
Category: Deferred Maintenance
Priority: 3 - Necessary/Not Yet Critical (Years 2-5)
Correction: Renew System
Qty: 96,039.00
Unit of Measure: S.F.
Estimate: \$493,352.00
Assessor Name: Terence Davis
Date Created: 02/17/2017

Notes: Storm sewer facilities around the site are in adequate, leading to ponding in high traffic areas. System study and renewal is recommended.

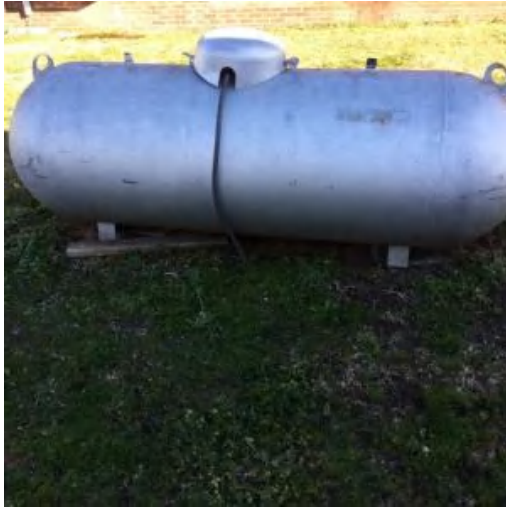
System: G3060 - Fuel Distribution

Location: Site
Distress: Beyond Service Life
Category: Deferred Maintenance
Priority: 3 - Necessary/Not Yet Critical (Years 2-5)
Correction: Renew System
Qty: 96,039.00
Unit of Measure: S.F.
Estimate: \$108,812.00
Assessor Name: Terence Davis
Date Created: 02/17/2017

Notes: Fuel distribution facilities are of varying age across the site, but in general are beyond their expected useful life. System renewal is recommended.

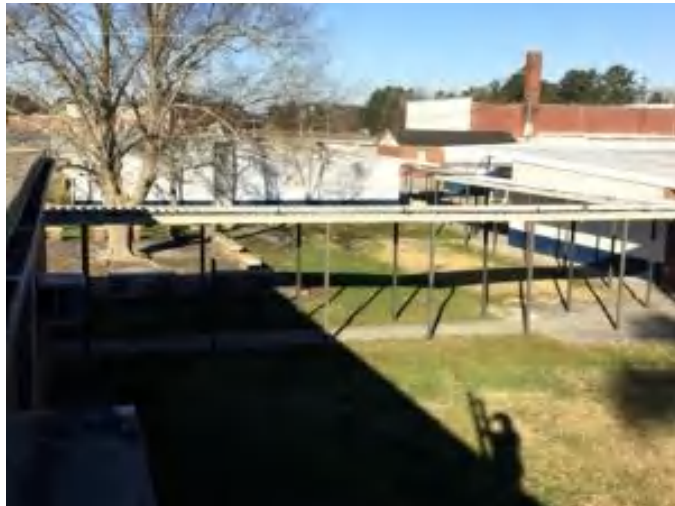
System: G2040950 - Covered Walkways

Location: Site
Distress: Beyond Service Life
Category: Deferred Maintenance
Priority: 4 - Recommended (Years 6-10)
Correction: Renew System
Qty: 96,039.00
Unit of Measure: S.F.
Estimate: \$85,571.00
Assessor Name: Terence Davis
Date Created: 02/17/2017

Notes: Covered walkways are in fair condition and beyond their expected useful life. System renewal is recommended.

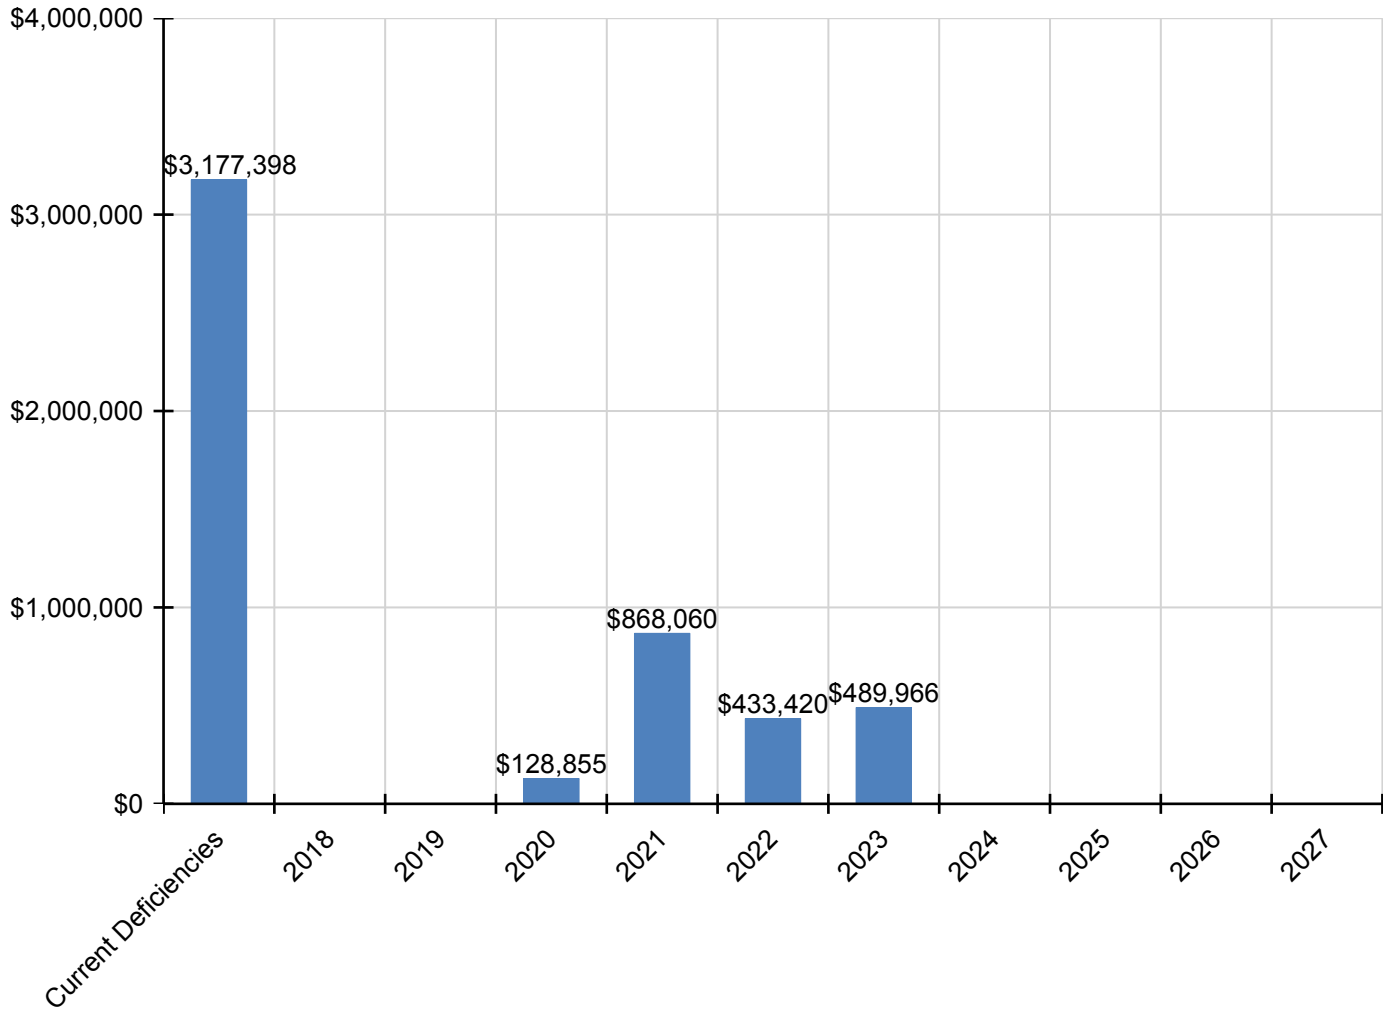
Forecasted Capital Renewal Requirement

The following chart shows the current building deficiencies and forecasting capital renewal or sustainment requirements over the next ten years.

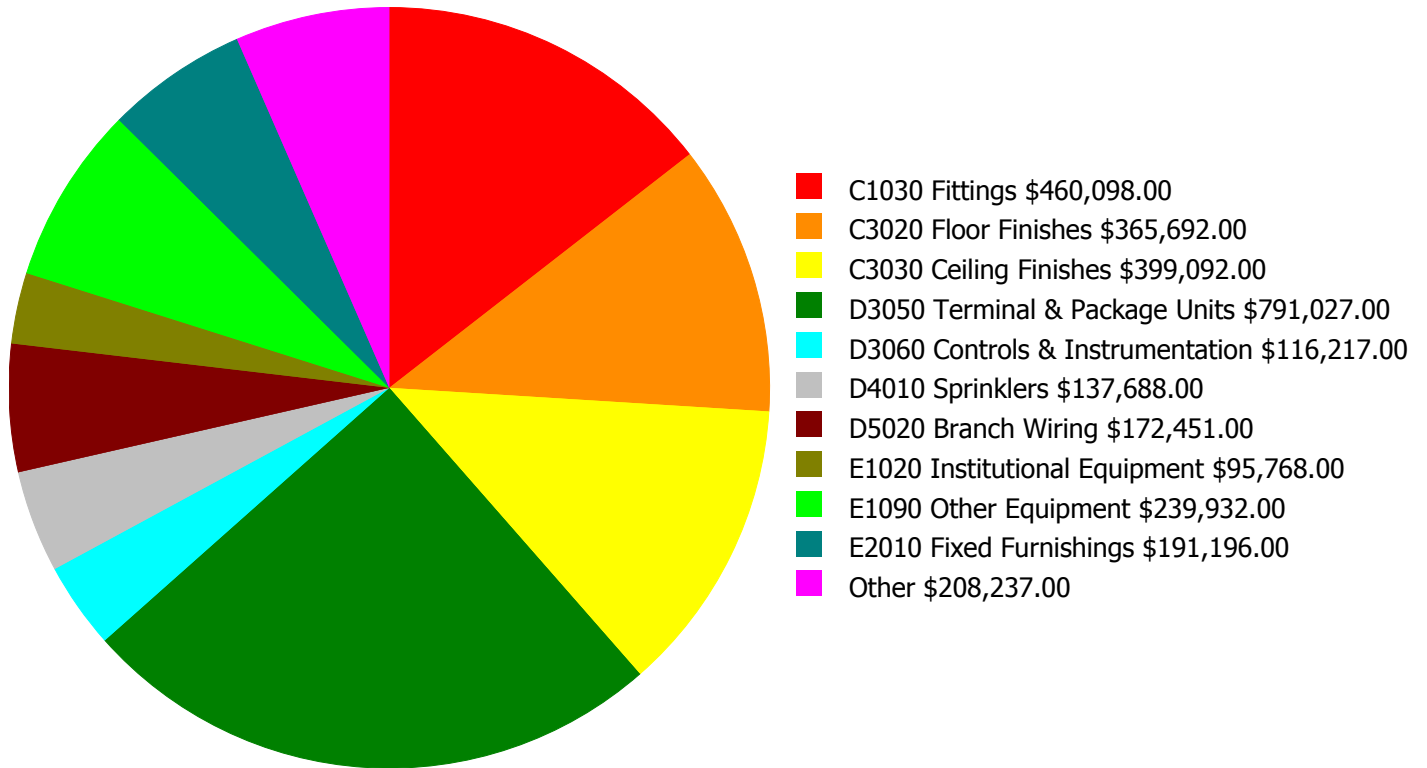
Deficiency Summary by System

Current deficiencies included assemblies that have reached or exceeded their design life or components of the assemblies that are in need of repair. Assemblies that have reached their design life are identified as current deficiencies and assigned the distress 'Beyond Useful Life'. The following chart lists all current deficiencies associated with this facility.

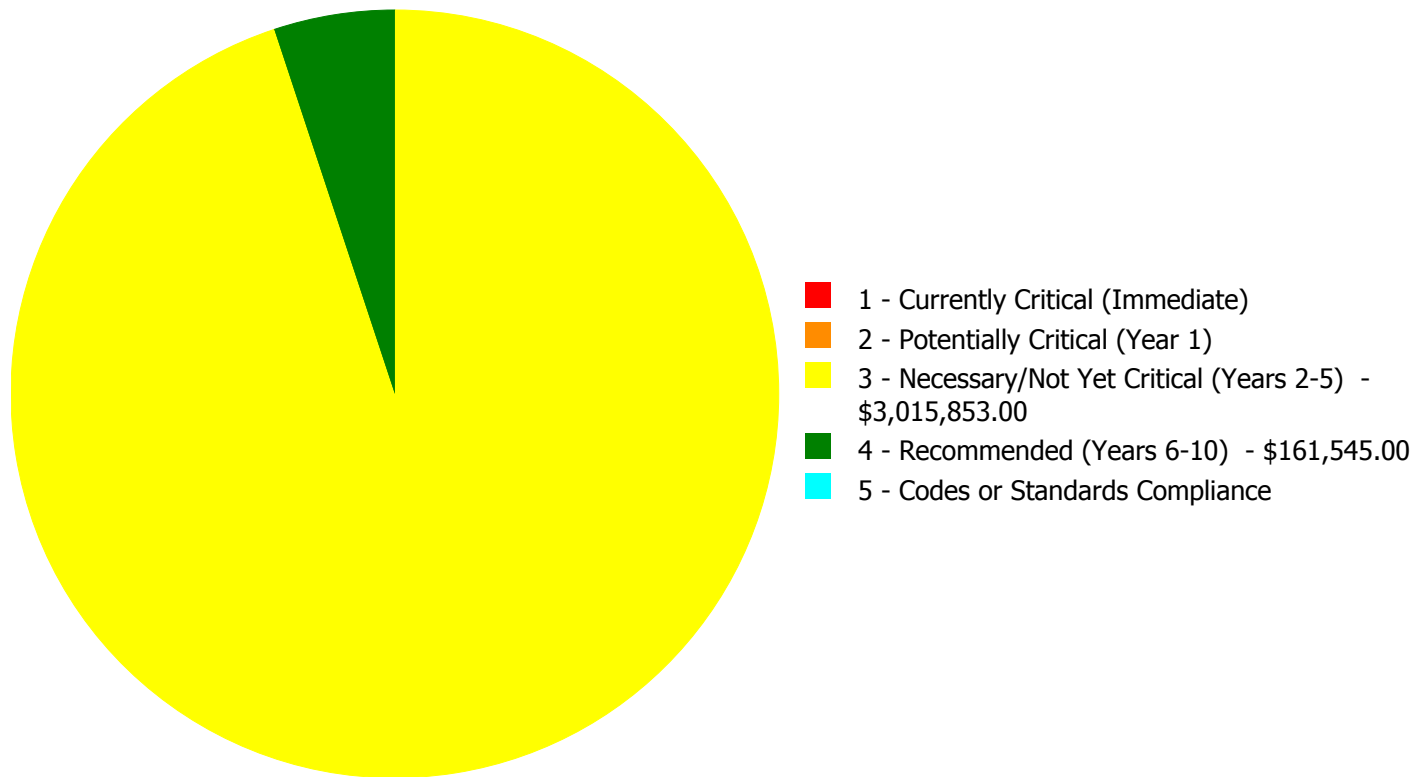
Deficiency Summary by Priority

The following chart shows the total repair costs broken down by priority. Assessors assigned deficiencies within eCOMET to one of the following priority categories:

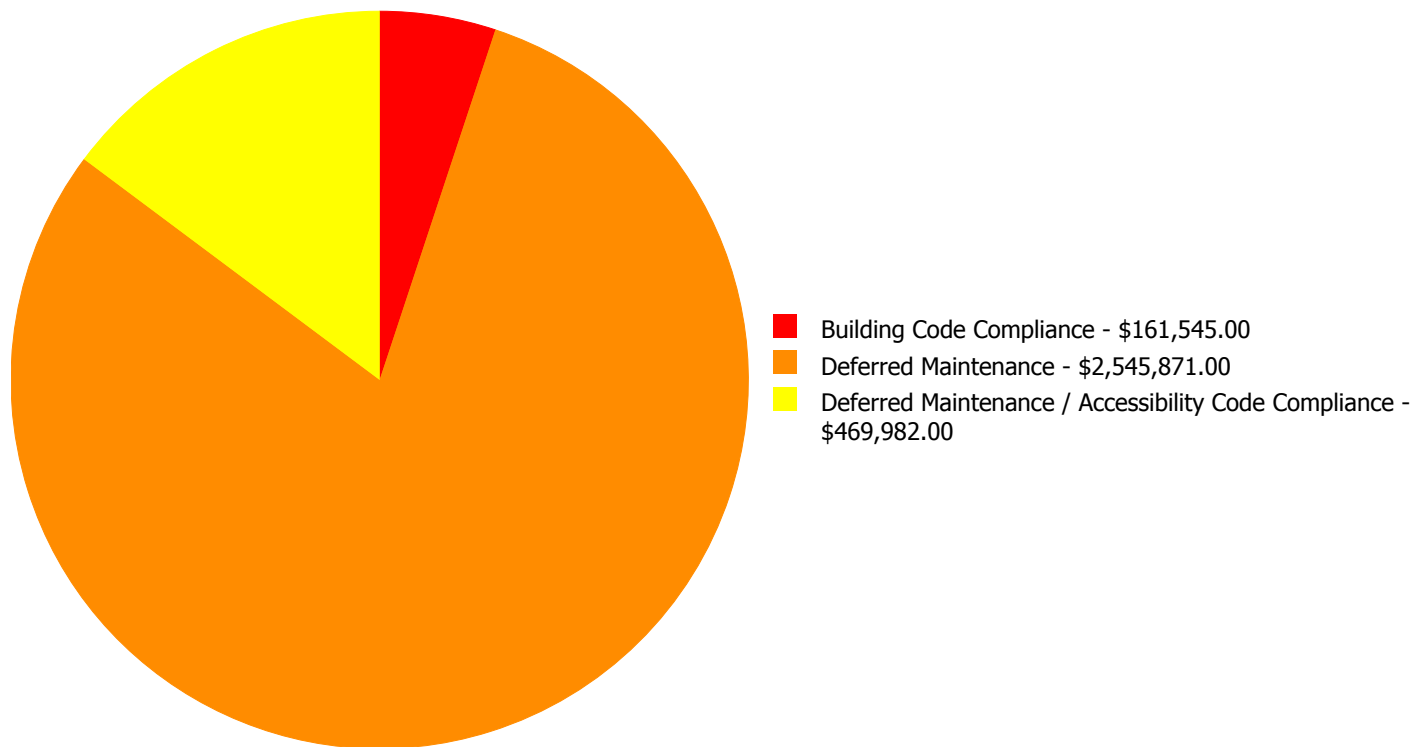
Deficiency Summary by Category

The following chart shows the total repair costs broken down by deficiency categories. Assessors assigned deficiencies to one of the following categories:

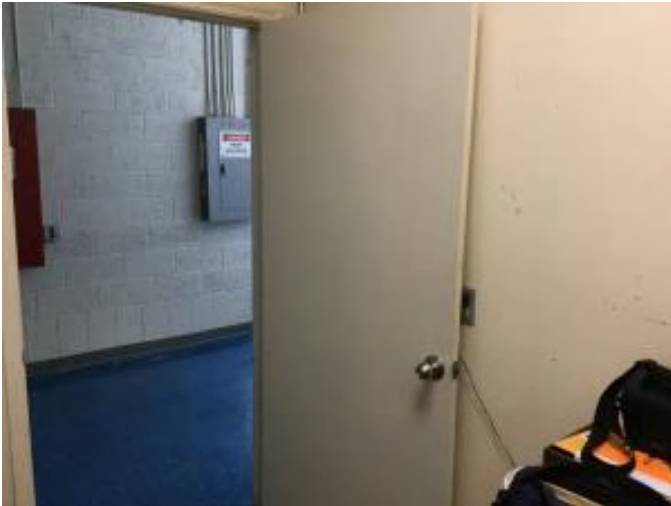
System: C1020 - Interior Doors

Location: Throughout the building
Distress: Beyond Service Life
Category: Deferred Maintenance / Accessibility Code Compliance
Priority: 3 - Necessary/Not Yet Critical (Years 2-5)
Correction: Renew System
Qty: 30,983.00
Unit of Measure: S.F.
Estimate: \$9,884.00
Assessor Name: Ann Buerger Linden
Date Created: 02/17/2017

Notes: Interior doors are typically original and beyond their expected useful life. Hardware is not ADA compliant. System renewal is recommended.

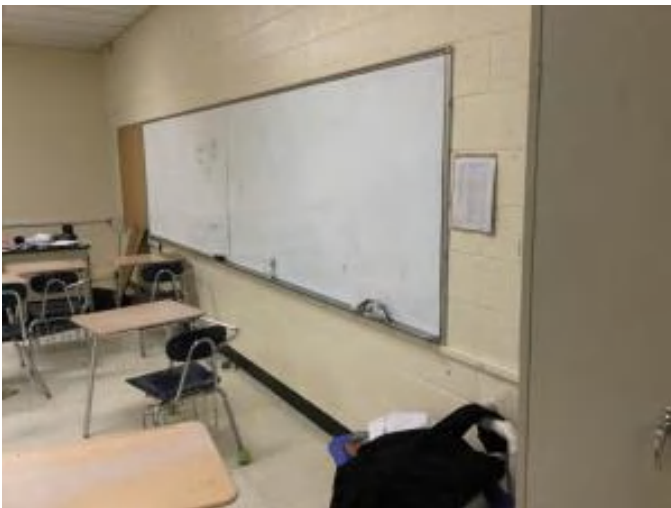
System: C1030 - Fittings

Location: Throughout the building
Distress: Beyond Service Life
Category: Deferred Maintenance / Accessibility Code Compliance
Priority: 3 - Necessary/Not Yet Critical (Years 2-5)
Correction: Renew System
Qty: 30,983.00
Unit of Measure: S.F.
Estimate: \$460,098.00
Assessor Name: Ann Buerger Linden
Date Created: 02/17/2017

Notes: Although main gang restrooms have been renovated with new toilet partitions, in general building fittings are expired. Signage is not up to ADA code. Whiteboards are stained. Locker rooms do not have proper fittings. System renewal is recommended.

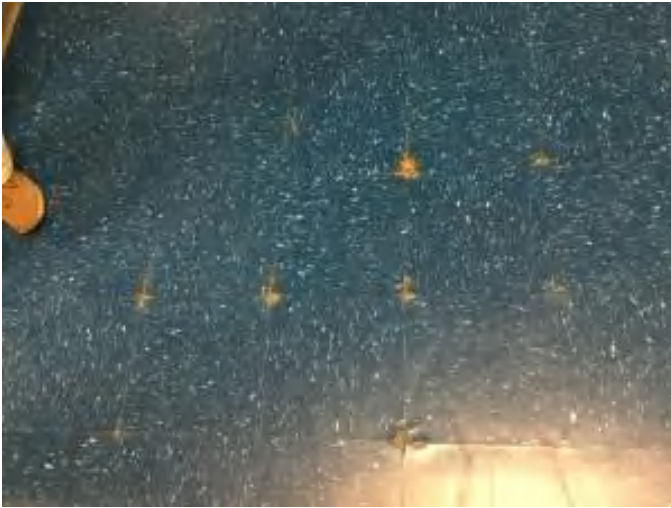
System: C3020 - Floor Finishes

Location: Throughout the building
Distress: Beyond Service Life
Category: Deferred Maintenance
Priority: 3 - Necessary/Not Yet Critical (Years 2-5)
Correction: Renew System
Qty: 30,983.00
Unit of Measure: S.F.
Estimate: \$365,692.00
Assessor Name: Ann Buerger Linden
Date Created: 02/17/2017

Notes: Floor finishes are generally beyond their expected life. Asbestos containing materials have been encapsulated beneath VCT. System renewal including complete asbestos abatement is recommended.

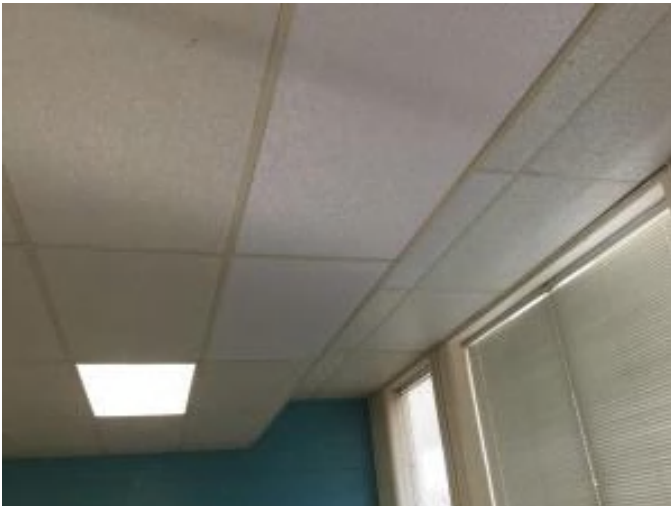
System: C3030 - Ceiling Finishes

Location: Throughout the building
Distress: Beyond Service Life
Category: Deferred Maintenance
Priority: 3 - Necessary/Not Yet Critical (Years 2-5)
Correction: Renew System
Qty: 30,983.00
Unit of Measure: S.F.
Estimate: \$399,092.00
Assessor Name: Ann Buerger Linden
Date Created: 02/28/2017

Notes: Ceiling finishes have exceeded their expected life. Grids are discolored. Tile are mismatched where replacements have been made piecemeal. System renewal is recommended.

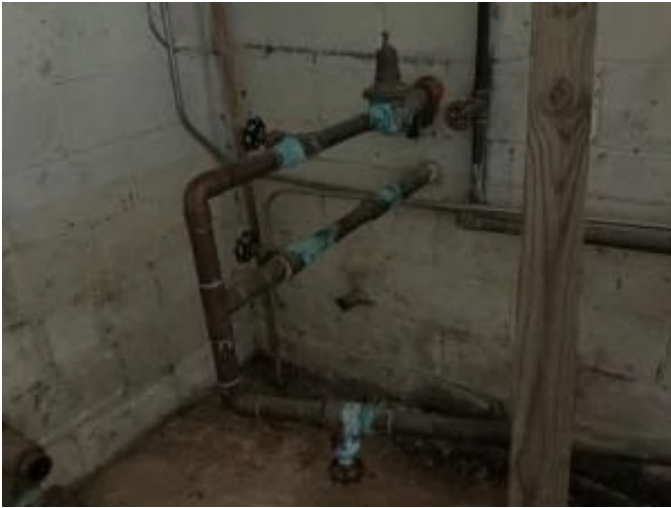
System: D2020 - Domestic Water Distribution

Location: Throughout the building
Distress: Beyond Service Life
Category: Deferred Maintenance
Priority: 3 - Necessary/Not Yet Critical (Years 2-5)
Correction: Renew System
Qty: 30,983.00
Unit of Measure: S.F.
Estimate: \$36,126.00
Assessor Name: Ann Buerger Linden
Date Created: 02/17/2017

Notes: The domestic water supply system is typically original. System renewal is recommended.

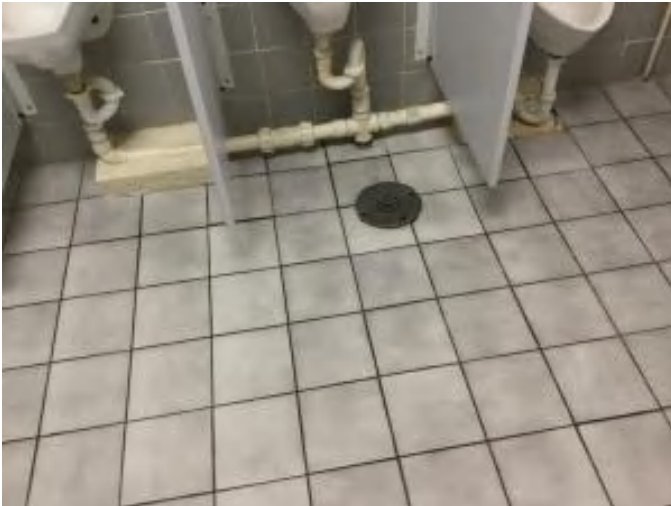
System: D2030 - Sanitary Waste

Location: Throughout the building
Distress: Beyond Service Life
Category: Deferred Maintenance
Priority: 3 - Necessary/Not Yet Critical (Years 2-5)
Correction: Renew System
Qty: 30,983.00
Unit of Measure: S.F.
Estimate: \$57,257.00
Assessor Name: Ann Buerger Linden
Date Created: 02/17/2017

Notes: The sanitary waste system is largely original. Piecemeal updates have been done over the years as needed, however the system as a whole is beyond its expected life. System renewal is recommended.

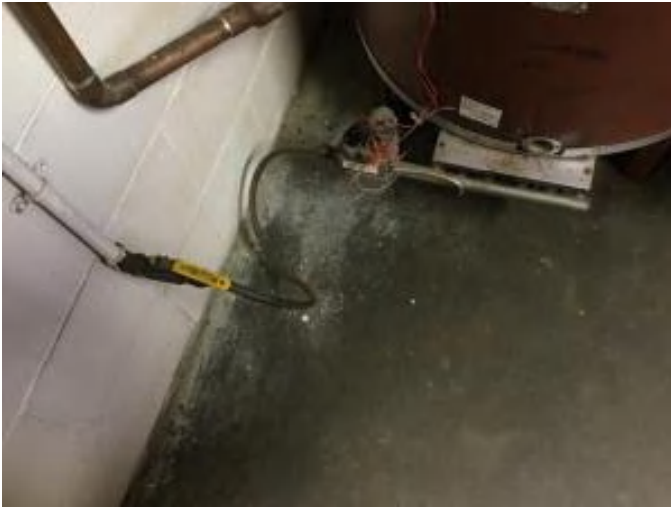
System: D2090 - Other Plumbing Systems - Propane

Location: Kitchen
Distress: Beyond Service Life
Category: Deferred Maintenance
Priority: 3 - Necessary/Not Yet Critical (Years 2-5)
Correction: Renew System
Qty: 30,983.00
Unit of Measure: S.F.
Estimate: \$5,453.00
Assessor Name: Ann Buerger Linden
Date Created: 02/17/2017

Notes: The propane plumbing system is beyond its expected life. System renewal is recommended.

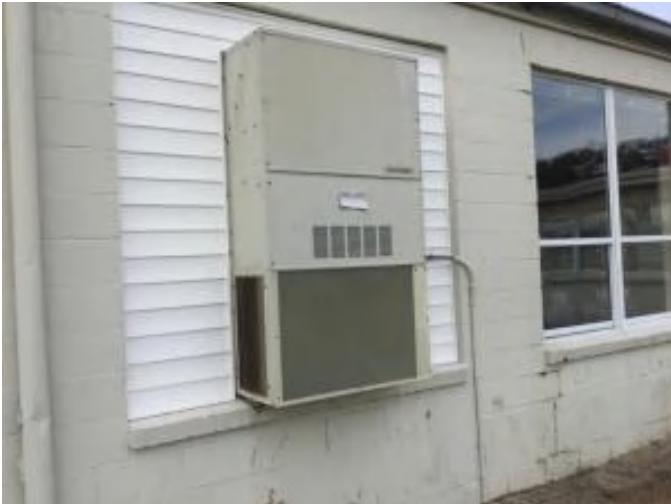
System: D3050 - Terminal & Package Units

Location: Throughout the building
Distress: Beyond Service Life
Category: Deferred Maintenance
Priority: 3 - Necessary/Not Yet Critical (Years 2-5)
Correction: Renew System
Qty: 30,983.00
Unit of Measure: S.F.
Estimate: \$791,027.00
Assessor Name: Ann Buerger Linden
Date Created: 02/17/2017

Notes: The HVAC system is beyond its expected useful life. Provide independent cooling for data rooms. System renewal is recommended.

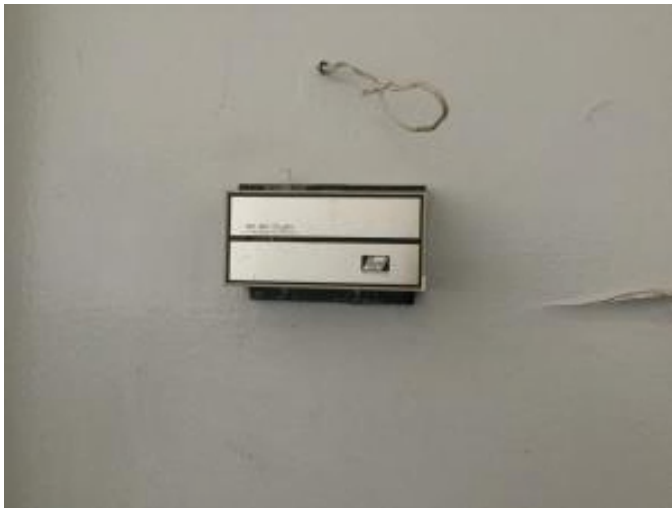
System: D3060 - Controls & Instrumentation

Location: Throughout the building
Distress: Beyond Service Life
Category: Deferred Maintenance
Priority: 3 - Necessary/Not Yet Critical (Years 2-5)
Correction: Renew System
Qty: 30,983.00
Unit of Measure: S.F.
Estimate: \$116,217.00
Assessor Name: Ann Buerger Linden
Date Created: 02/17/2017

Notes: Building controls are locally controlled. Installation of a modern digital system with remote monitoring and control capability for energy conservation is recommended.

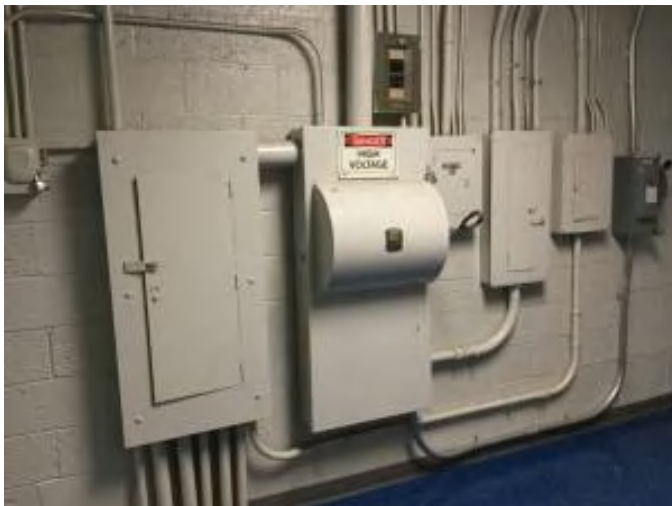
System: D5010 - Electrical Service/Distribution

Location: Electric service
Distress: Beyond Service Life
Category: Deferred Maintenance
Priority: 3 - Necessary/Not Yet Critical (Years 2-5)
Correction: Renew System
Qty: 30,983.00
Unit of Measure: S.F.
Estimate: \$57,597.00
Assessor Name: Ann Buerger Linden
Date Created: 02/17/2017

Notes: The main system was added onto in 1992 to support the HVAC renovation, however the original electric distribution system has not been replaced. Main switchgear is located in a corridor rather than a dedicated electrical equipment room. System renewal is recommended.

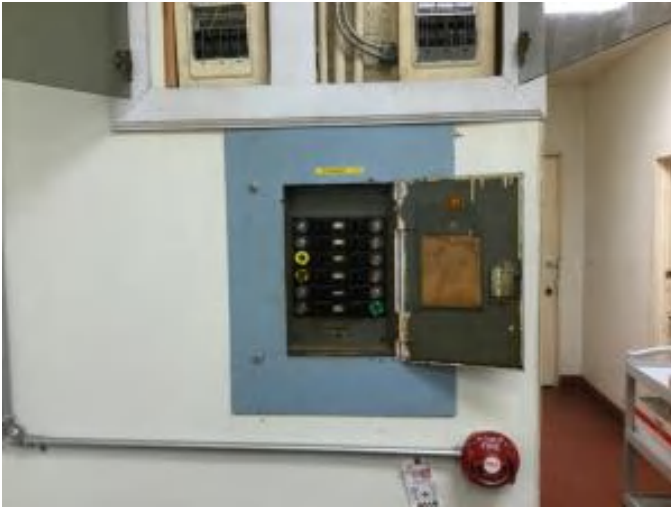
System: D5020 - Branch Wiring

Location: Throughout the building
Distress: Beyond Service Life
Category: Deferred Maintenance
Priority: 3 - Necessary/Not Yet Critical (Years 2-5)
Correction: Renew System
Qty: 30,983.00
Unit of Measure: S.F.
Estimate: \$172,451.00
Assessor Name: Ann Buerger Linden
Date Created: 02/17/2017

Notes: While outlet distribution is sufficient, circuits are overloaded. The system was added onto in 1992, but original components were not replaced. System renewal is recommended.

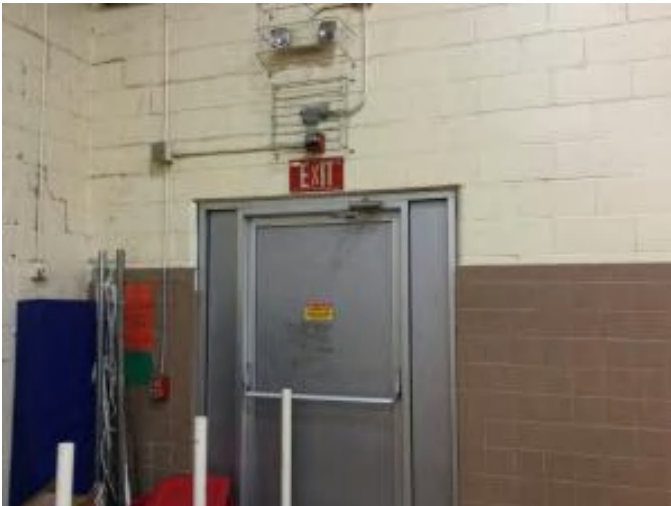
System: D5090 - Other Electrical Systems

Location: Throughout the building
Distress: Beyond Service Life
Category: Deferred Maintenance
Priority: 3 - Necessary/Not Yet Critical (Years 2-5)
Correction: Renew System
Qty: 30,983.00
Unit of Measure: S.F.
Estimate: \$18,063.00
Assessor Name: Ann Buerger Linden
Date Created: 02/17/2017

Notes: Egress lighting is beyond its expected useful life. System renewal is recommended.

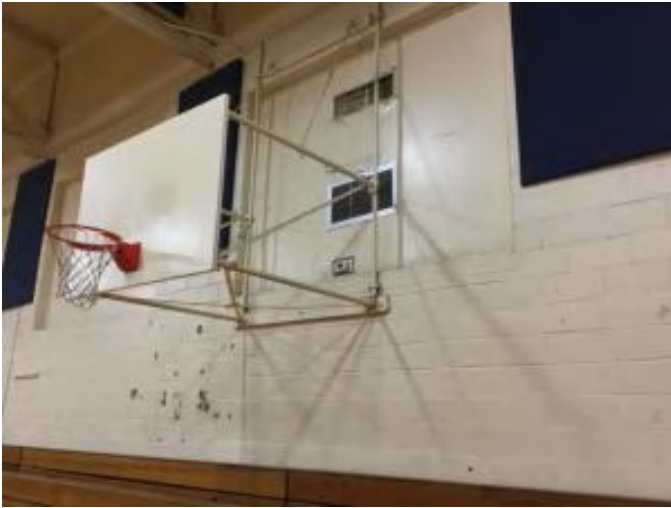
System: E1020 - Institutional Equipment

Location: Throughout the building
Distress: Beyond Service Life
Category: Deferred Maintenance
Priority: 3 - Necessary/Not Yet Critical (Years 2-5)
Correction: Renew System
Qty: 30,983.00
Unit of Measure: S.F.
Estimate: \$95,768.00
Assessor Name: Ann Buerger Linden
Date Created: 02/17/2017

Notes: Institutional equipment as a whole is beyond its expected life. In particular, gym bleachers, backboards, etc. are beyond their expected life.

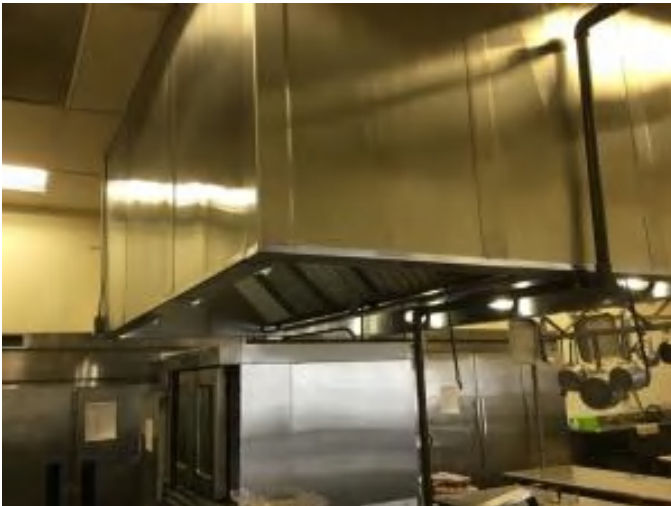
System: E1090 - Other Equipment

Location: Kitchen
Distress: Beyond Service Life
Category: Deferred Maintenance
Priority: 3 - Necessary/Not Yet Critical (Years 2-5)
Correction: Renew System
Qty: 30,983.00
Unit of Measure: S.F.
Estimate: \$239,932.00
Assessor Name: Ann Buerger Linden
Date Created: 02/17/2017

Notes: Kitchen equipment is typically beyond its expected life. System renewal is recommended.

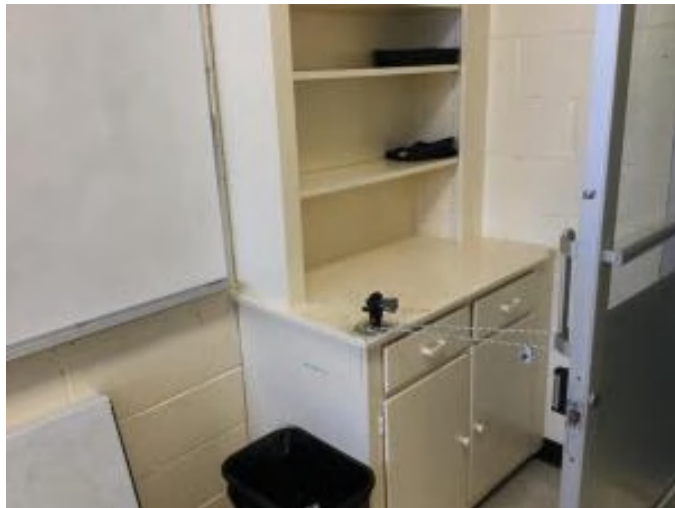
System: E2010 - Fixed Furnishings

Location: Throughout the building
Distress: Beyond Service Life
Category: Deferred Maintenance
Priority: 3 - Necessary/Not Yet Critical (Years 2-5)
Correction: Renew System
Qty: 30,983.00
Unit of Measure: S.F.
Estimate: \$191,196.00
Assessor Name: Ann Buerger Linden
Date Created: 02/17/2017

Notes: Fixed furnishings throughout the building are original or very old and in poor condition. System renewal is recommended.

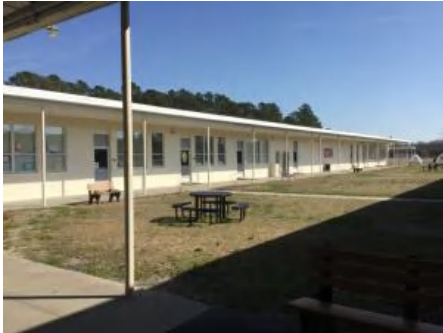
1). Northwest Elevation - Feb 16, 2017

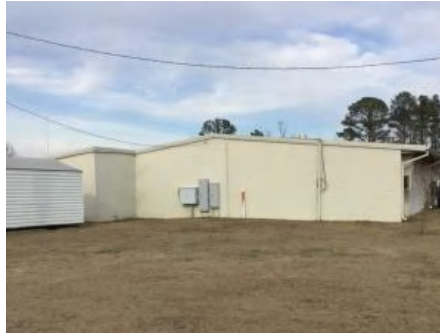
2). Southwest Elevation - Feb 16, 2017

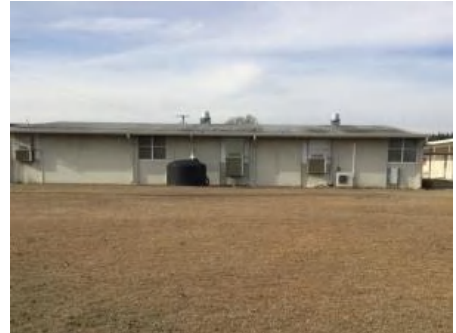
3). Southeast Elevation - Feb 16, 2017

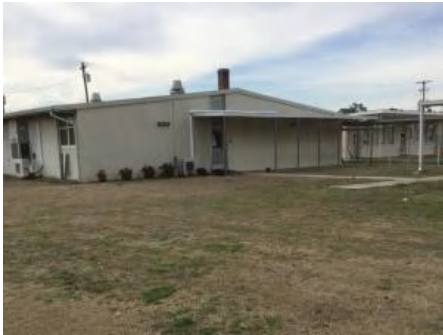
4). Northeast Elevation - Feb 16, 2017

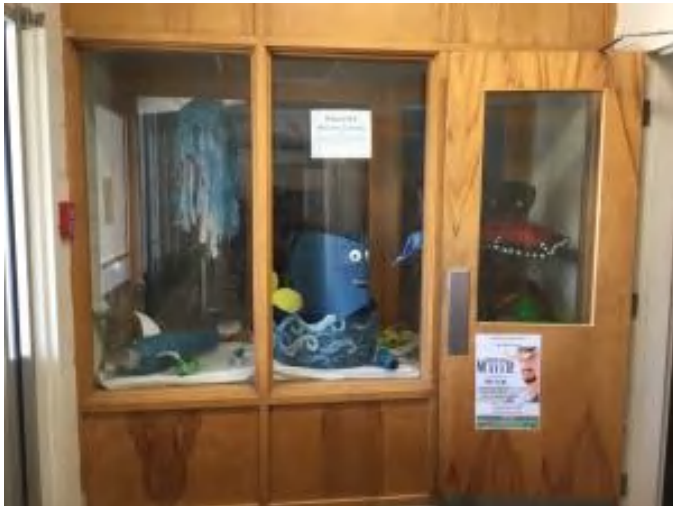
System: C1020 - Interior Doors

Location: Throughout the building
Distress: Beyond Service Life
Category: Deferred Maintenance
Priority: 3 - Necessary/Not Yet Critical (Years 2-5)
Correction: Renew System
Qty: 10,800.00
Unit of Measure: S.F.
Estimate: \$3,445.00
Assessor Name: Ann Buerger Linden
Date Created: 02/16/2017

Notes: Interior doors are beyond their expected useful life and do not have ADA compliant hardware. System renewal is recommended.

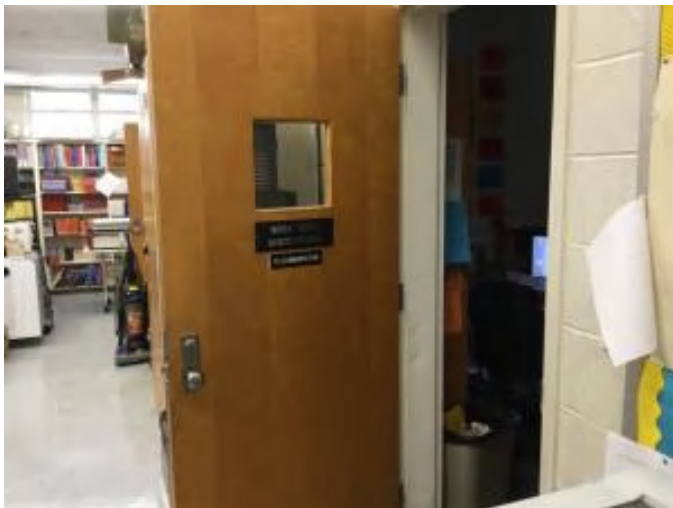
System: C1030 - Fittings

Location: Throughout the building
Distress: Beyond Service Life
Category: Deferred Maintenance
Priority: 3 - Necessary/Not Yet Critical (Years 2-5)
Correction: Renew System
Qty: 10,800.00
Unit of Measure: S.F.
Estimate: \$160,380.00
Assessor Name: Ann Buerger Linden
Date Created: 02/16/2017

Notes: Building signage does not meet current codes. The toilet room is not ADA compliant. System renewal is recommended.

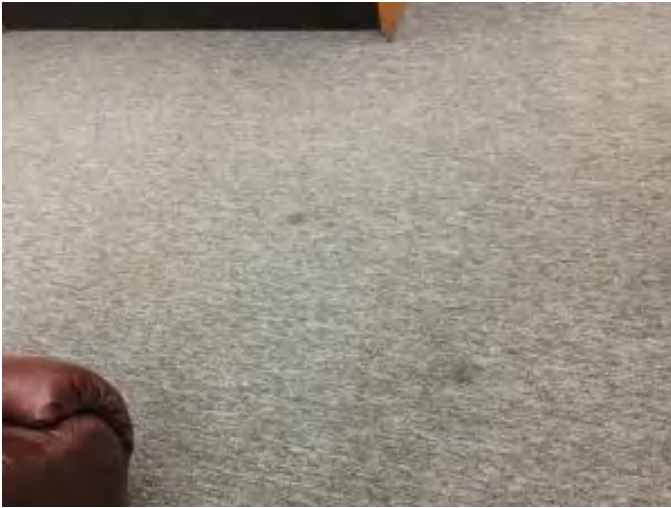
System: C3020 - Floor Finishes

Location: Throughout the building
Distress: Beyond Service Life
Category: Deferred Maintenance
Priority: 3 - Necessary/Not Yet Critical (Years 2-5)
Correction: Renew System
Qty: 10,800.00
Unit of Measure: S.F.
Estimate: \$127,472.00
Assessor Name: Ann Buerger Linden
Date Created: 02/16/2017

Notes: Floor finishes are beyond their expected useful life. some asbestos mastic may be present. System replacement including asbestos abatement is recommended.
