NC School District/520 Jones County/High School

Jones Senior High

Campus Assessment Report

March 8, 2017

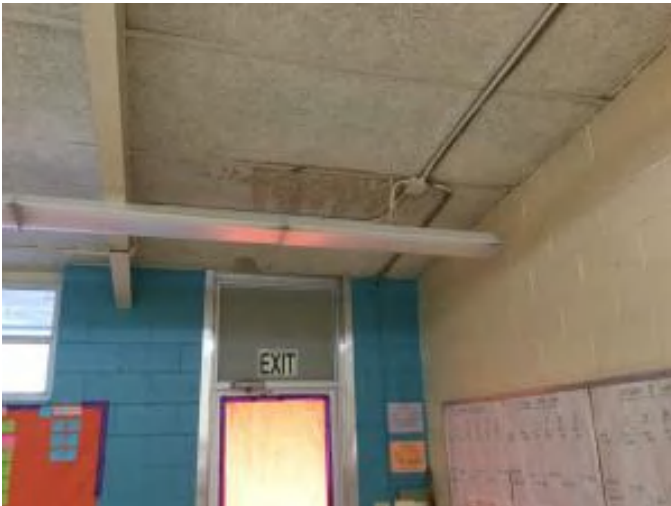
System: C3030 - Ceiling Finishes

Location: Throughout the building
Distress: Beyond Service Life
Category: Deferred Maintenance
Priority: 3 - Necessary/Not Yet Critical (Years 2-5)
Correction: Renew System
Qty: 10,800.00
Unit of Measure: S.F.
Estimate: \$139,115.00
Assessor Name: Ann Buerger Linden
Date Created: 02/16/2017

Notes: Ceiling finishes are in fair condition and beyond their expected useful life. System renewal is recommended.

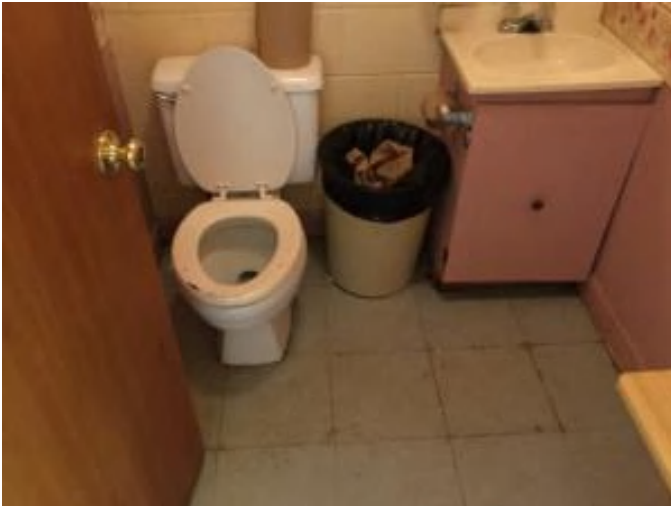
System: D2010 - Plumbing Fixtures

Location: Restrooms and workrooms
Distress: Beyond Service Life
Category: Deferred Maintenance
Priority: 3 - Necessary/Not Yet Critical (Years 2-5)
Correction: Renew System
Qty: 10,800.00
Unit of Measure: S.F.
Estimate: \$117,968.00
Assessor Name: Ann Buerger Linden
Date Created: 02/16/2017

Notes: Plumbing fixtures are believed to be original. Toilet rooms are not ADA compliant. System renewal is recommended.

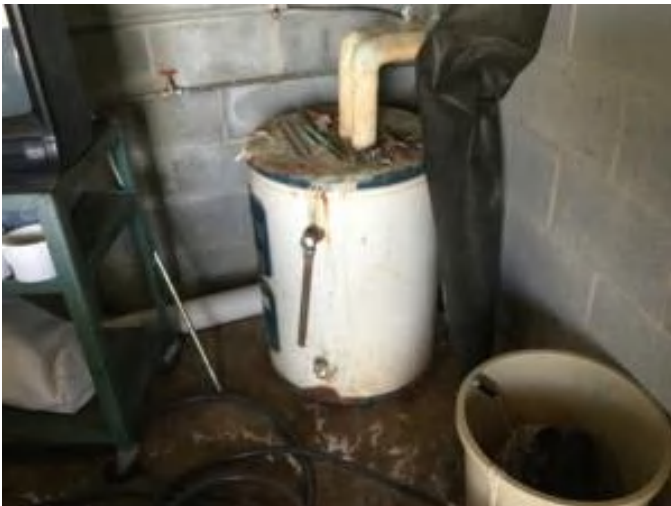
System: D2020 - Domestic Water Distribution

Location: Throughout the building
Distress: Beyond Service Life
Category: Deferred Maintenance
Priority: 3 - Necessary/Not Yet Critical (Years 2-5)
Correction: Renew System
Qty: 10,800.00
Unit of Measure: S.F.
Estimate: \$12,593.00
Assessor Name: Ann Buerger Linden
Date Created: 02/16/2017

Notes: The domestic water system is beyond its expected life. Though no active problems were observed or reported, renewal to ensure system integrity is recommended.

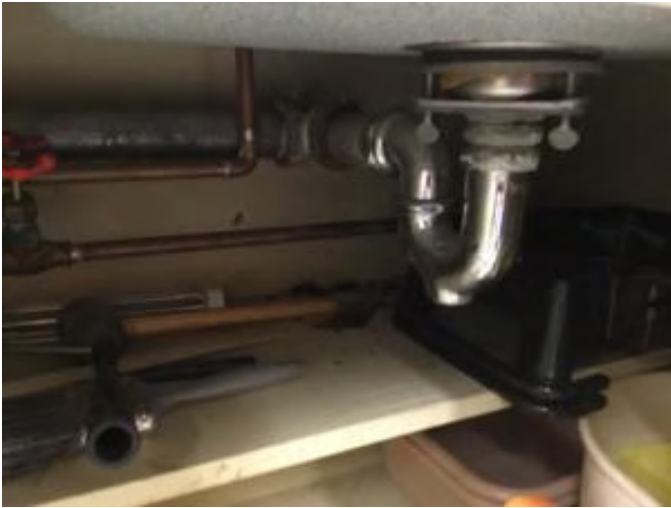
System: D2030 - Sanitary Waste

Location: Throughout the building
Distress: Beyond Service Life
Category: Deferred Maintenance
Priority: 3 - Necessary/Not Yet Critical (Years 2-5)
Correction: Renew System
Qty: 10,800.00
Unit of Measure: S.F.
Estimate: \$19,958.00
Assessor Name: Ann Buerger Linden
Date Created: 02/16/2017

Notes: The sanitary waste system is beyond its expected life. Though no active problems were observed or reported, renewal to ensure system integrity is recommended.

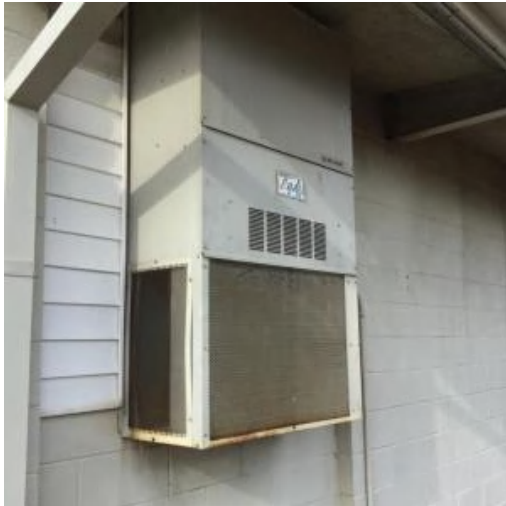
System: D3050 - Terminal & Package Units

Location: Throughout the building
Distress: Beyond Service Life
Category: Deferred Maintenance
Priority: 3 - Necessary/Not Yet Critical (Years 2-5)
Correction: Renew System
Qty: 10,800.00
Unit of Measure: S.F.
Estimate: \$275,735.00
Assessor Name: Ann Buerger Linden
Date Created: 02/16/2017

Notes: Bard window mounted units are beyond their expected service life. System renewal for system performance and energy efficiency is recommended.

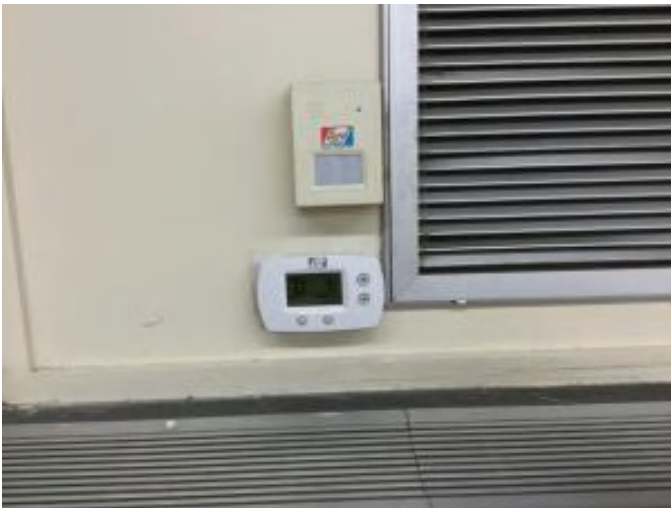
System: D3060 - Controls & Instrumentation

Location: Throughout the building
Distress: Beyond Service Life
Category: Deferred Maintenance
Priority: 3 - Necessary/Not Yet Critical (Years 2-5)
Correction: Renew System
Qty: 10,800.00
Unit of Measure: S.F.
Estimate: \$40,511.00
Assessor Name: Ann Buerger Linden
Date Created: 02/16/2017

Notes: Building controls are locally controlled. Installation of a modern digital system with remote monitoring and control capability for energy conservation is recommended.

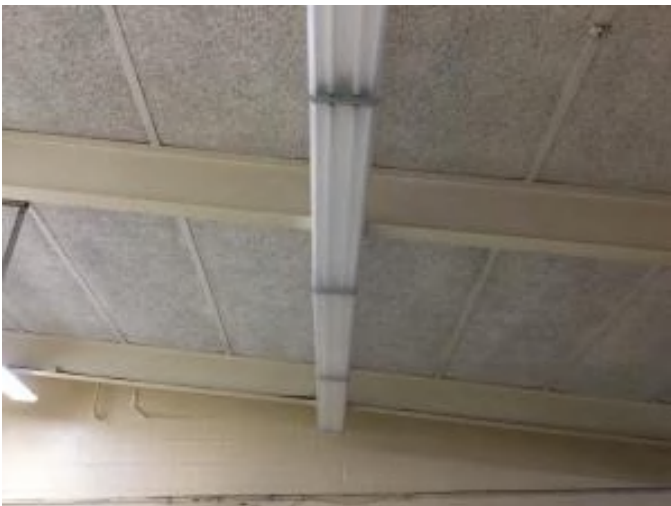
System: D5020 - Lighting

Location: Throughout the building
Distress: Beyond Service Life
Category: Deferred Maintenance
Priority: 3 - Necessary/Not Yet Critical (Years 2-5)
Correction: Renew System
Qty: 10,800.00
Unit of Measure: S.F.
Estimate: \$140,065.00
Assessor Name: Ann Buerger Linden
Date Created: 02/16/2017

Notes: Although lighting was upgraded in 2011 w/ T-8 lamps and ballasts, existing fixtures that are beyond their expected life were retrofitted. System renewal is recommended.

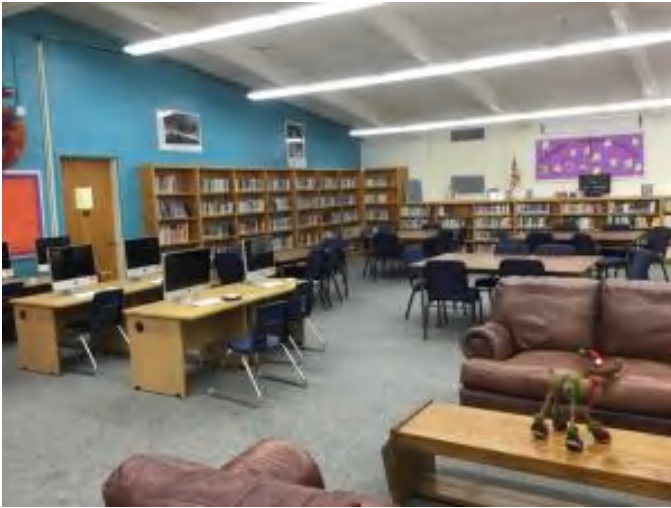
System: E1020 - Institutional Equipment

Location: Library
Distress: Beyond Service Life
Category: Deferred Maintenance
Priority: 3 - Necessary/Not Yet Critical (Years 2-5)
Correction: Renew System
Qty: 10,800.00
Unit of Measure: S.F.
Estimate: \$33,383.00
Assessor Name: Ann Buerger Linden
Date Created: 02/16/2017

Notes: Library equipment is typically original and beyond its expected useful life. System renewal is recommended.

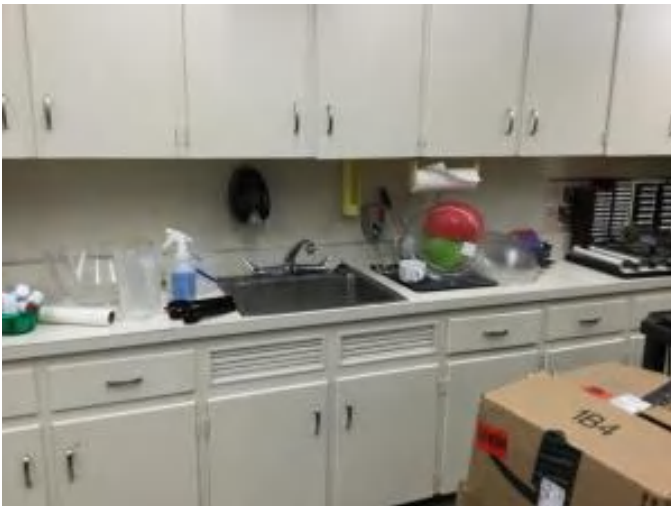
System: E2010 - Fixed Furnishings

Location: Throughout the building
Distress: Beyond Service Life
Category: Deferred Maintenance
Priority: 3 - Necessary/Not Yet Critical (Years 2-5)
Correction: Renew System
Qty: 10,800.00
Unit of Measure: S.F.
Estimate: \$66,647.00
Assessor Name: Ann Buerger Linden
Date Created: 02/16/2017

Notes: Fixed furnishings are beyond their expected life and in fair condition. System renewal is recommended.

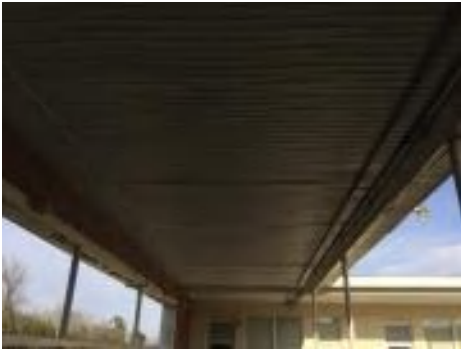
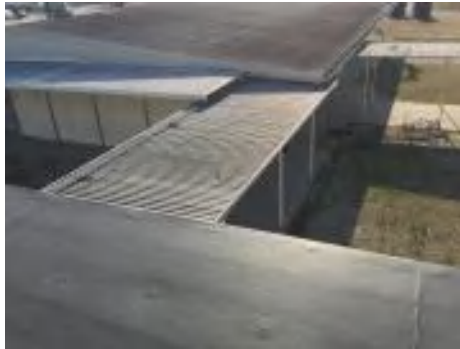
System: G2040950 - Covered Walkways

Note: Covered walkways do not have any observed deficiencies. Renewal date pushed 5 years.

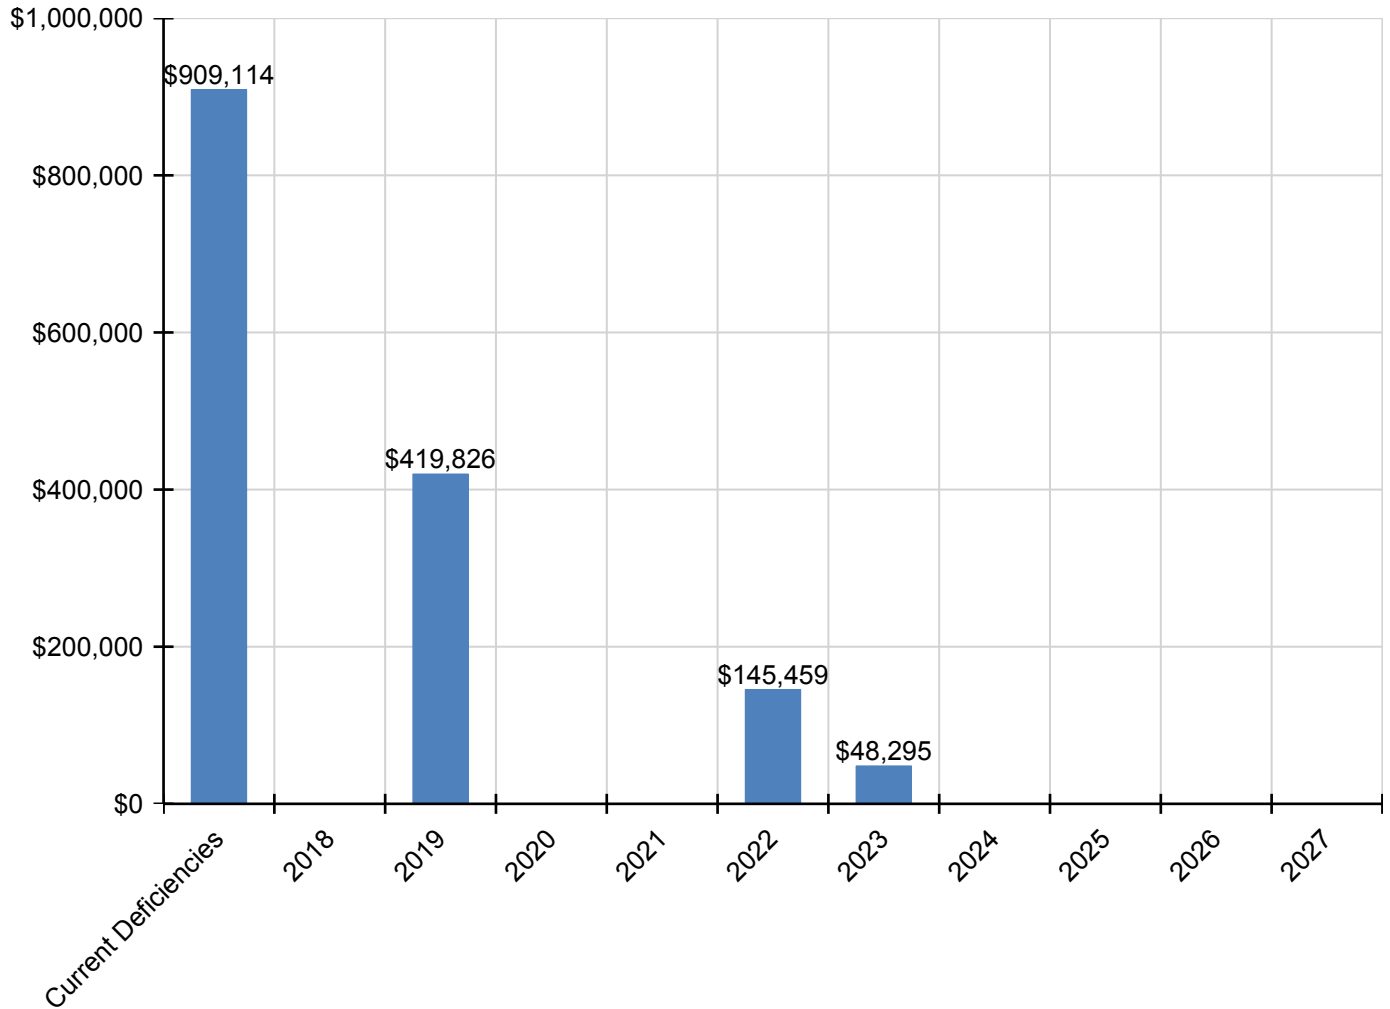
Forecasted Capital Renewal Requirement

The following chart shows the current building deficiencies and forecasting capital renewal or sustainment requirements over the next ten years.

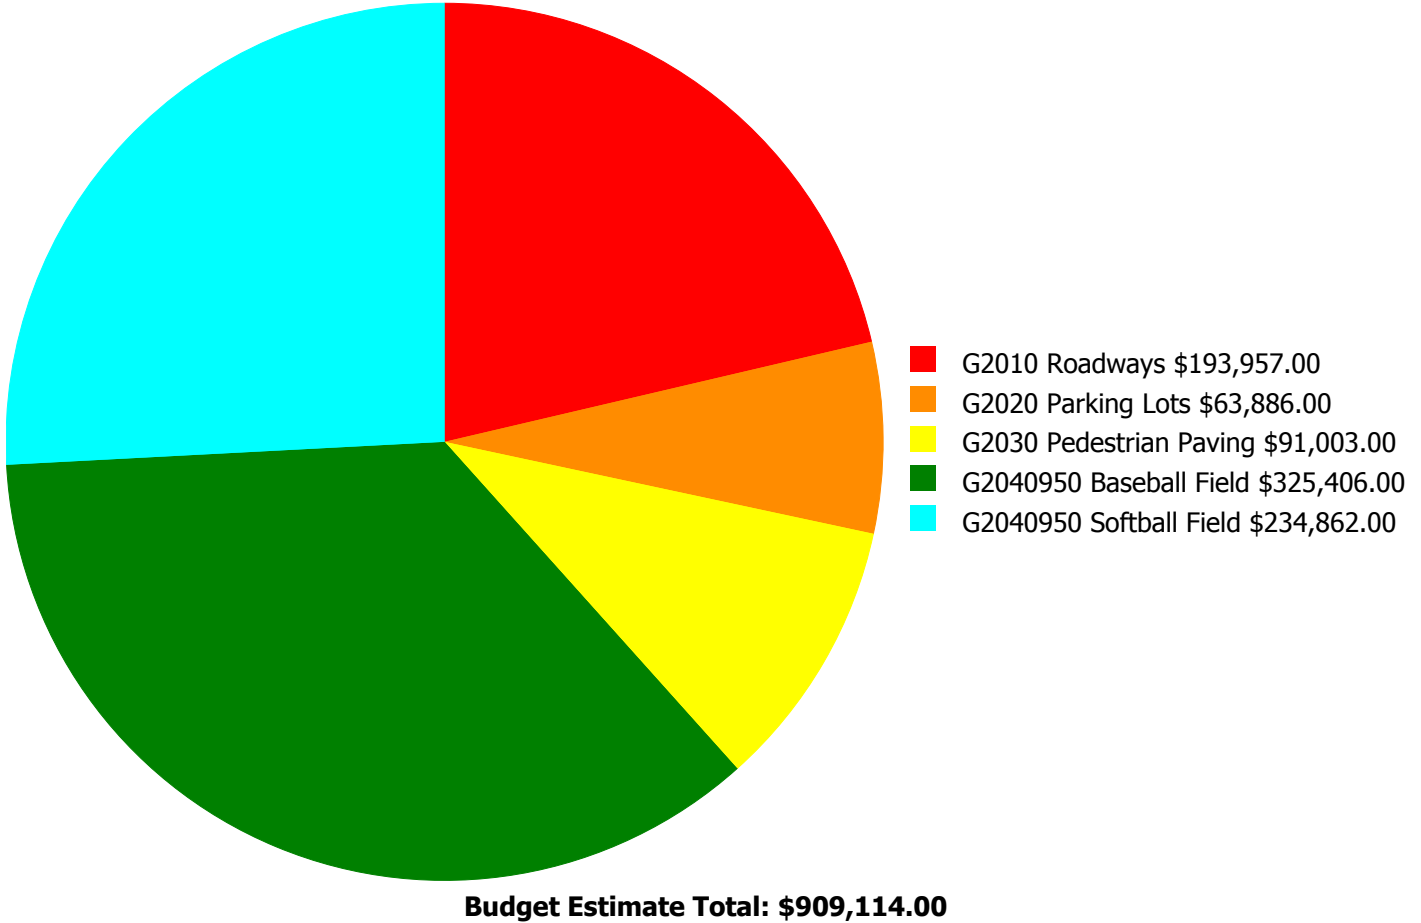
Deficiency Summary by System

Current deficiencies included assemblies that have reached or exceeded their design life or components of the assemblies that are in need of repair. Assemblies that have reached their design life are identified as current deficiencies and assigned the distress 'Beyond Useful Life'. The following chart lists all current deficiencies associated with this facility.

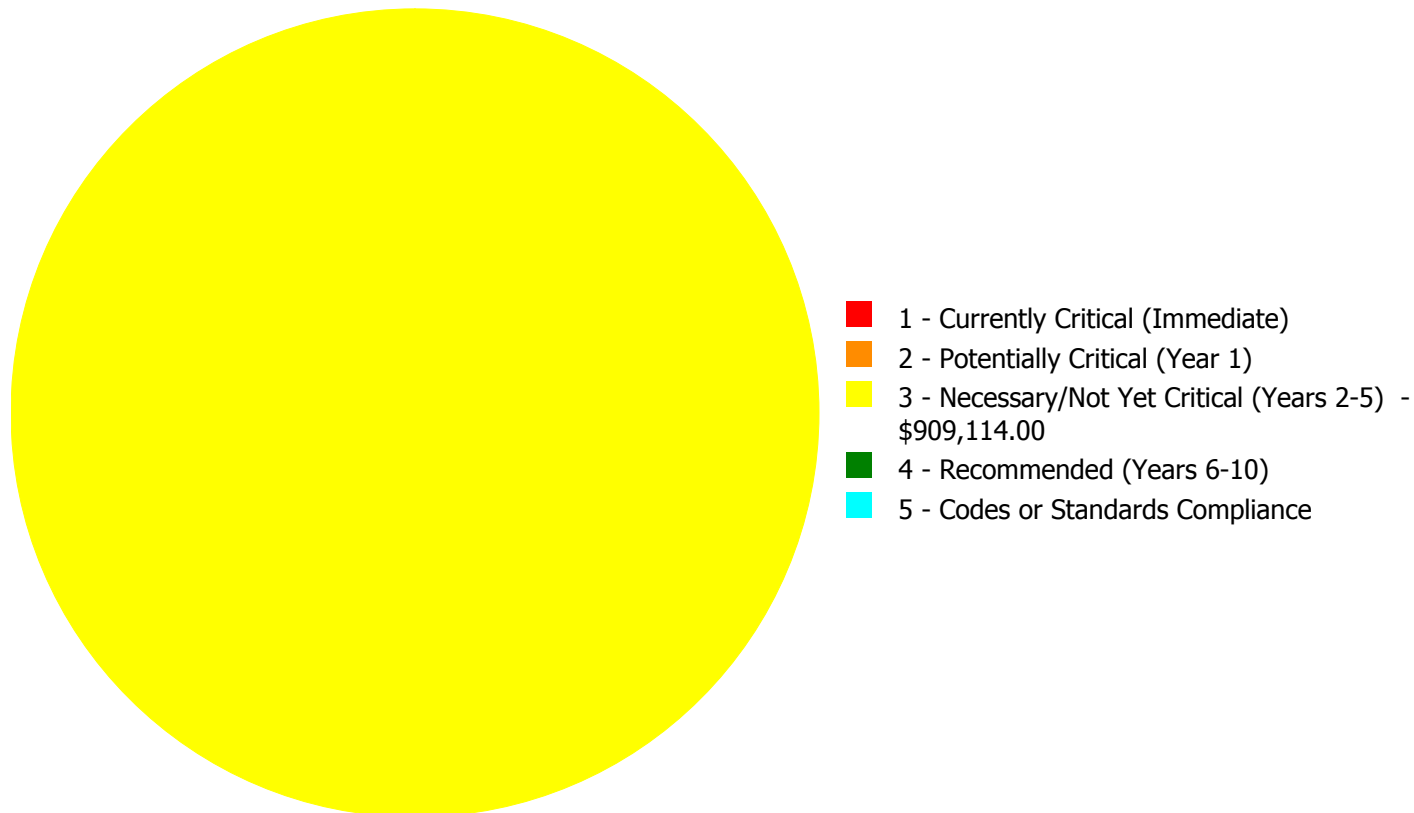
Deficiency Summary by Priority

The following chart shows the total repair costs broken down by priority. Assessors assigned deficiencies within eCOMET to one of the following priority categories:

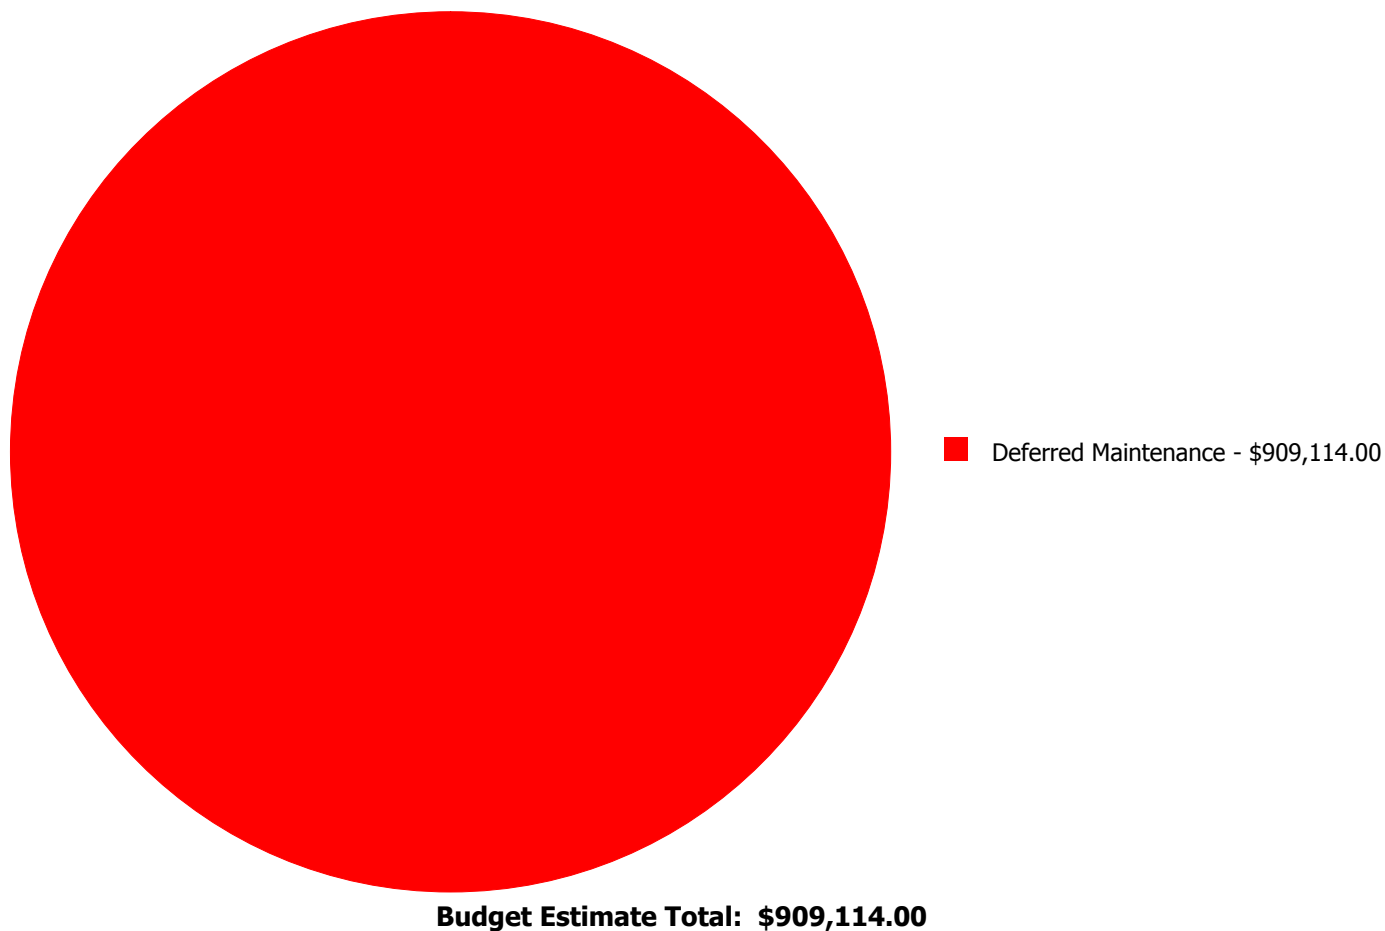
Deficiency Summary by Category

The following chart shows the total repair costs broken down by deficiency categories. Assessors assigned deficiencies to one of the following categories:

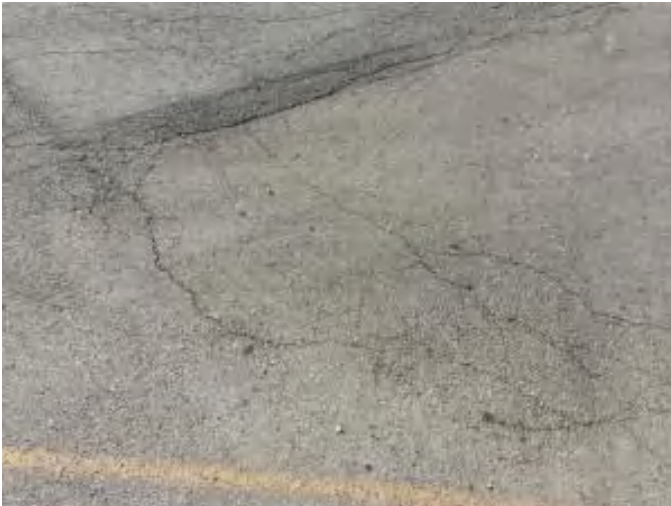
System: G2010 - Roadways

Notes: Roadways are beginning to degrade with some alligatoring and grainy surface. System renewal is recommended.

Location: Roadways
Distress: Beyond Service Life
Category: Deferred Maintenance
Priority: 3 - Necessary/Not Yet Critical (Years 2-5)
Correction: Renew System
Qty: 41,783.00
Unit of Measure: S.F.
Estimate: \$193,957.00
Assessor Name: Eduardo Lopez
Date Created: 02/16/2017

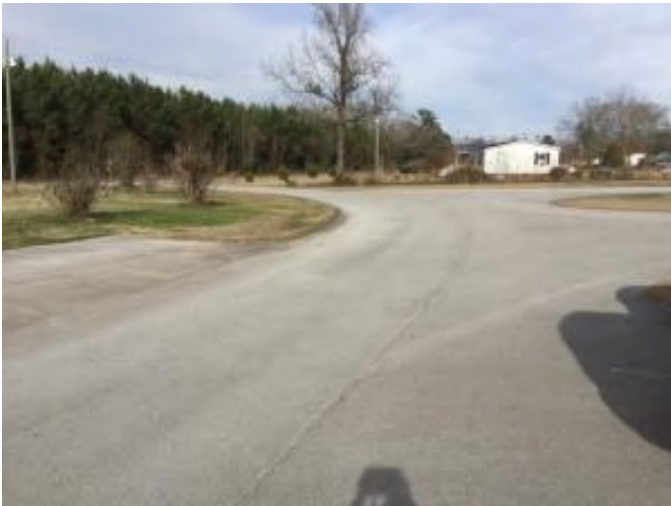
System: G2020 - Parking Lots

Notes: Parking lots are in fair condition. Surface has degraded somewhat. Striping is faded. Handicap space markings and signage is not up to code. There is no designated fire lane. System renewal is recommended.

Location: Parking lots
Distress: Beyond Service Life
Category: Deferred Maintenance
Priority: 3 - Necessary/Not Yet Critical (Years 2-5)
Correction: Renew System
Qty: 41,783.00
Unit of Measure: S.F.
Estimate: \$63,886.00
Assessor Name: Eduardo Lopez
Date Created: 02/16/2017

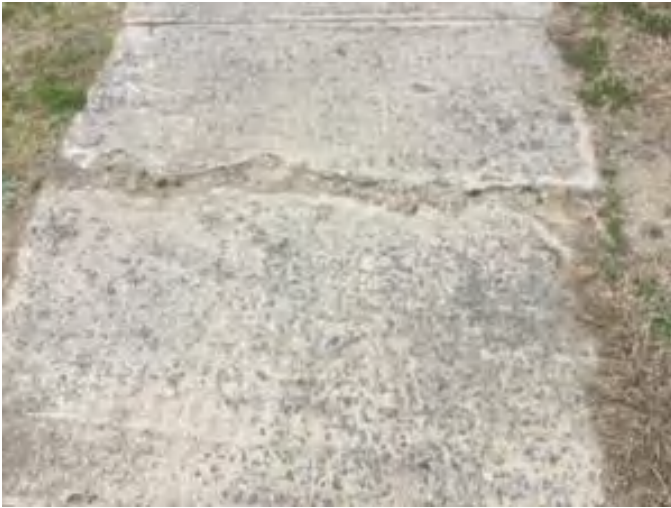
System: G2030 - Pedestrian Paving

Notes: Pedestrian concrete is in aged condition. Some cracking and differential settlement create trip hazards. Ramps to exterior doors do not meet ADA codes. System renewal is recommended.

Location: Site pedestrian concrete
Distress: Beyond Service Life
Category: Deferred Maintenance
Priority: 3 - Necessary/Not Yet Critical (Years 2-5)
Correction: Renew System
Qty: 41,783.00
Unit of Measure: S.F.
Estimate: \$91,003.00
Assessor Name: Eduardo Lopez
Date Created: 02/16/2017

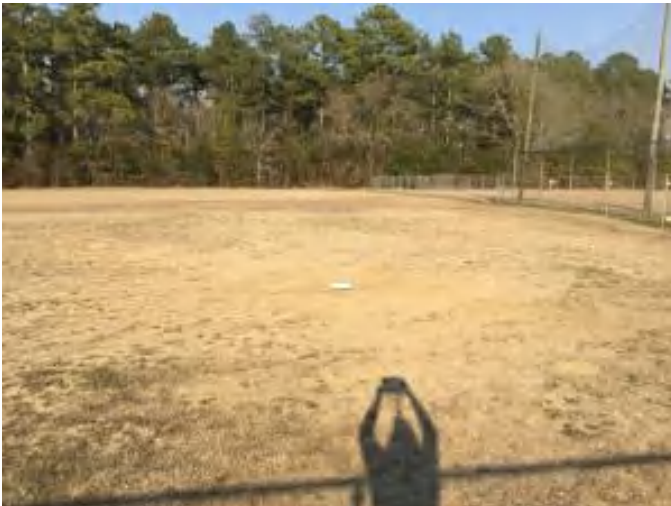
System: G2040950 - Baseball Field

Notes: Baseball fields are not up to modern standards. System renewal is recommended.

Location: West end of site
Distress: Beyond Service Life
Category: Deferred Maintenance
Priority: 3 - Necessary/Not Yet Critical (Years 2-5)
Correction: Renew System
Qty: 41,783.00
Unit of Measure: S.F.
Estimate: \$325,406.00
Assessor Name: Eduardo Lopez
Date Created: 02/16/2017

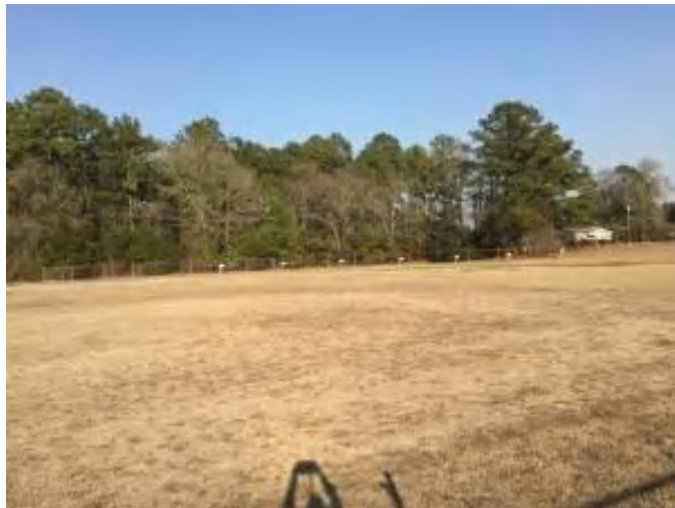
System: G2040950 - Softball Field

Notes: Softball fields are not up to modern facility standards. System renewal is recommended.

Location: West end of site
Distress: Beyond Service Life
Category: Deferred Maintenance
Priority: 3 - Necessary/Not Yet Critical (Years 2-5)
Correction: Renew System
Qty: 41,783.00
Unit of Measure: S.F.
Estimate: \$234,862.00
Assessor Name: Eduardo Lopez
Date Created: 02/16/2017

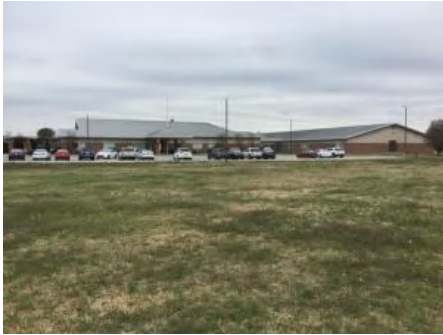
1). Southeast Elevation - Feb 06, 2017

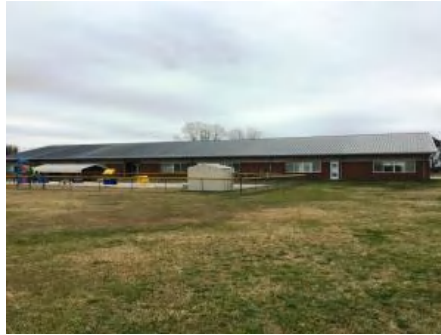
2). Northeast Elevation - Feb 06, 2017

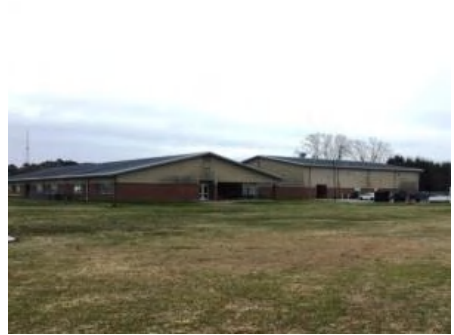
3). Northwest Elevation - Feb 06, 2017

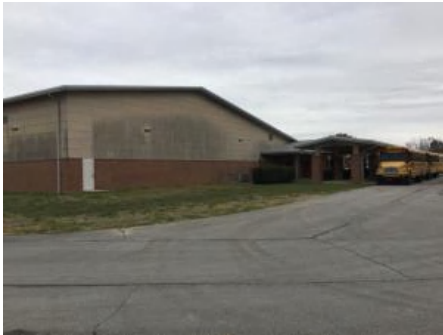
4). Southwest Elevation - Feb 06, 2017

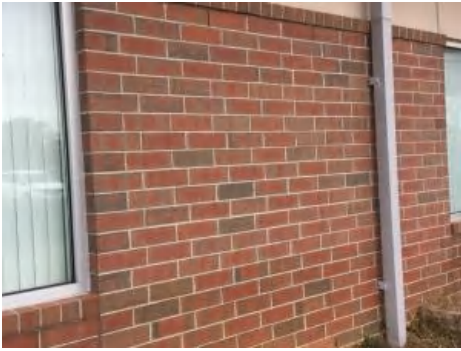
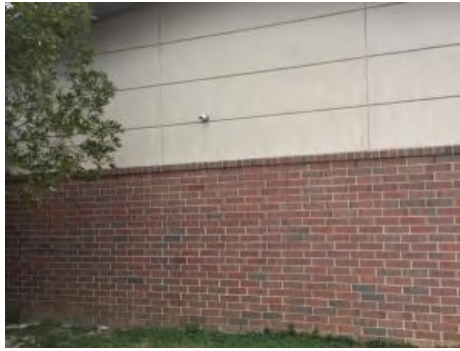
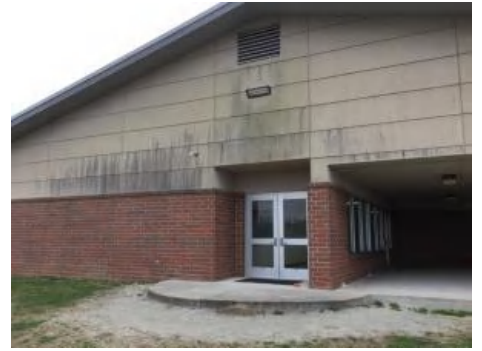
System: B2010 - Exterior Walls

Note: Scheduled for painting 2017.

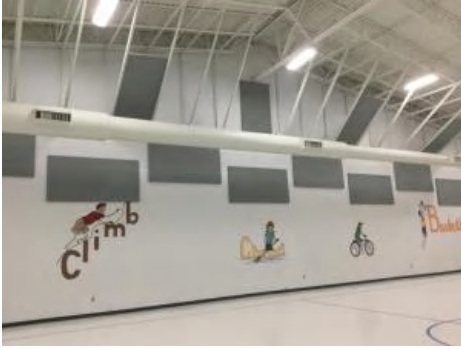
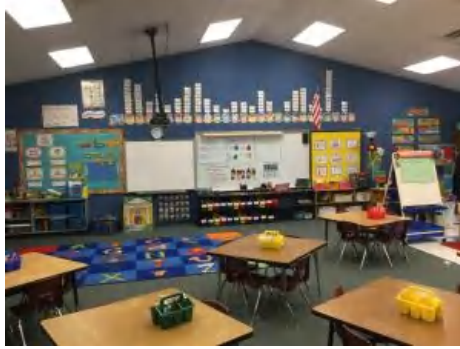
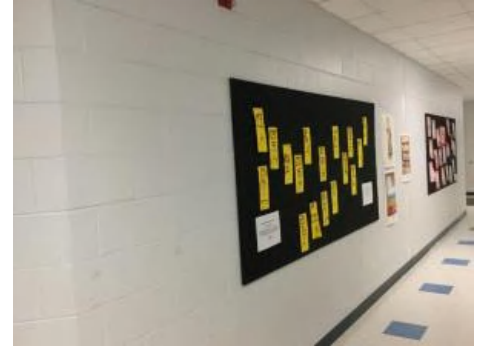
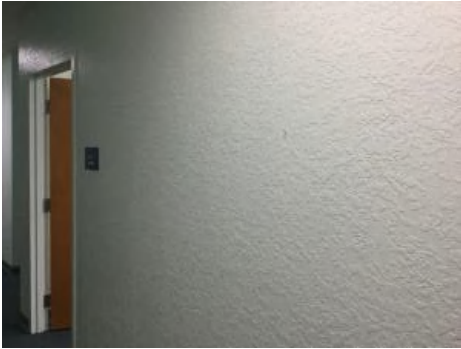
System: C3010 - Wall Finishes

Note: Interior painting is scheduled for 2017.

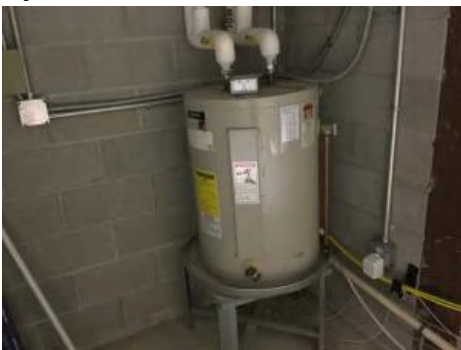
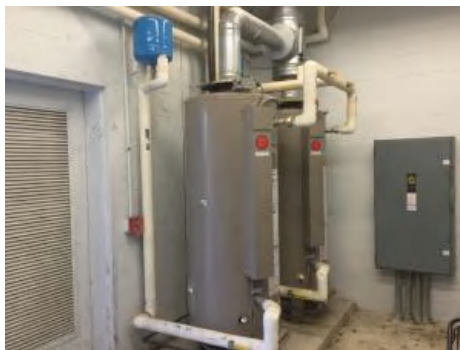
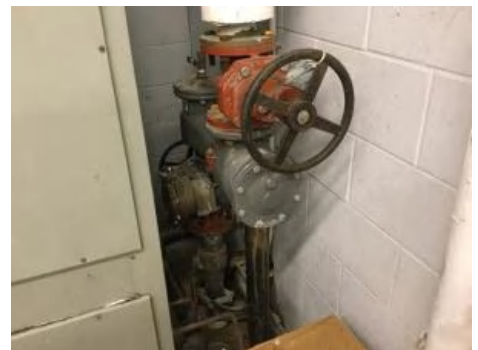
System: D2020 - Domestic Water Distribution

Note: Gas water heaters for kitchen. Electric water heaters elsewhere.

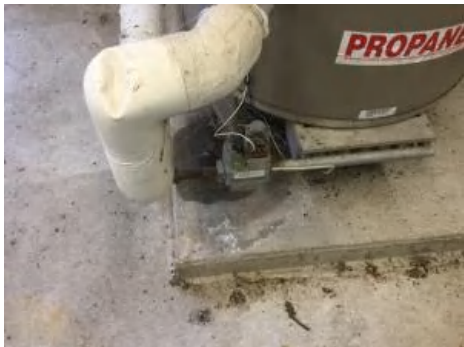
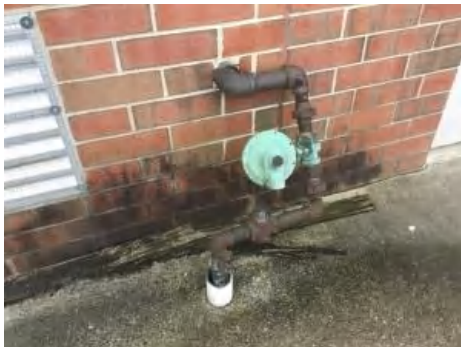
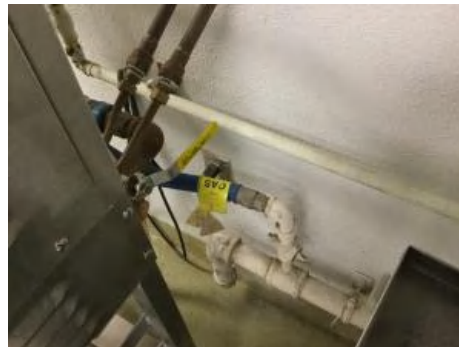
System: D2090 - Other Plumbing Systems -Propane

Note: Cooking fuel and kitchen hot water heaters.

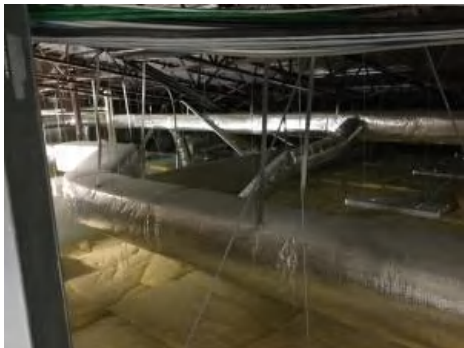
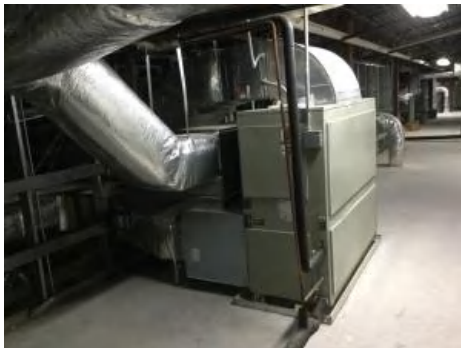
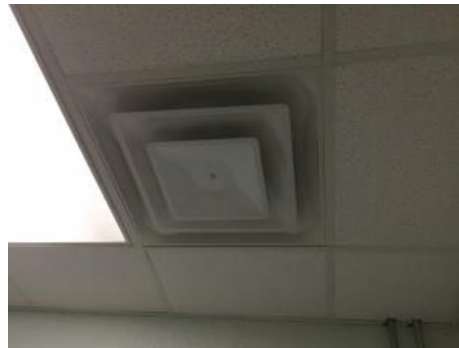
System: D3040 - Distribution Systems

Note: Condensate drain lines are piped to sewer pipes without air gap.

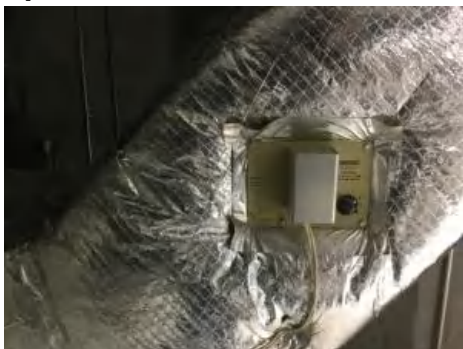
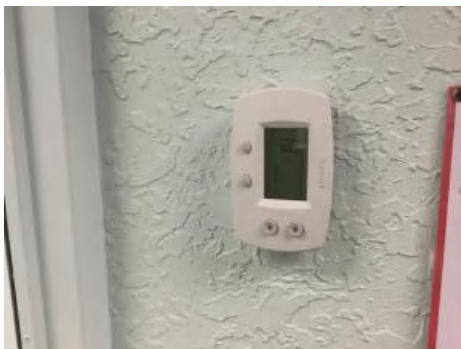
System: D3060 - Controls & Instrumentation

Note: Original proprietary system has been abandoned. Local thermostats are used.

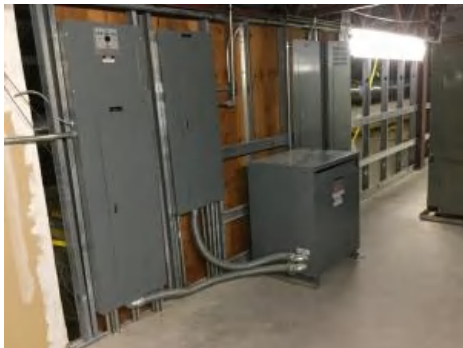
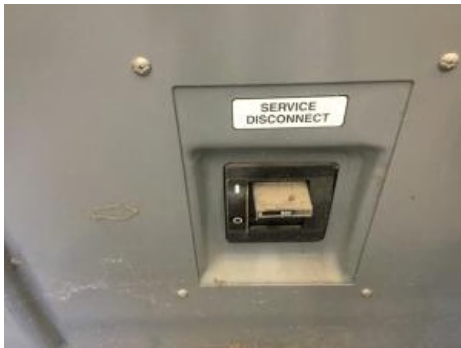
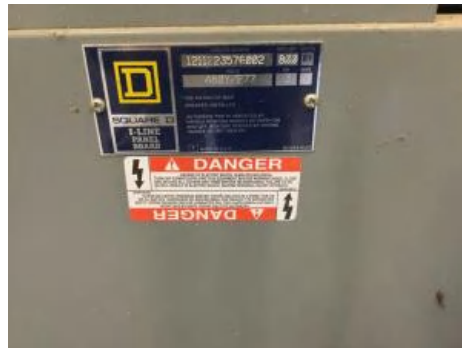
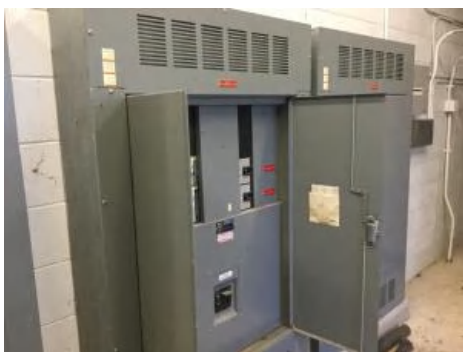
System: D5010 - Electrical Service/Distribution

Note: Two 800 amps services in parallel.

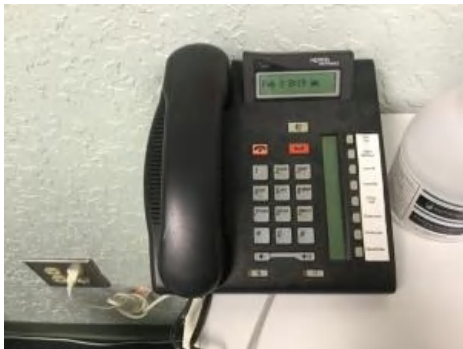
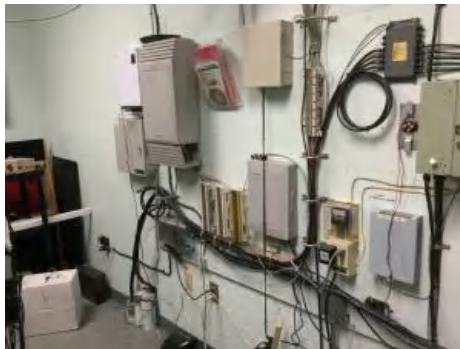
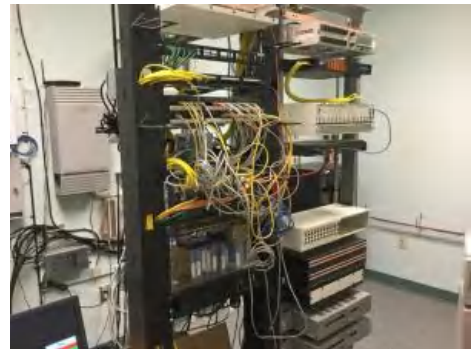
System: D5030920 - Data Communication

Note: PA upgraded 2016. All components not replaced.

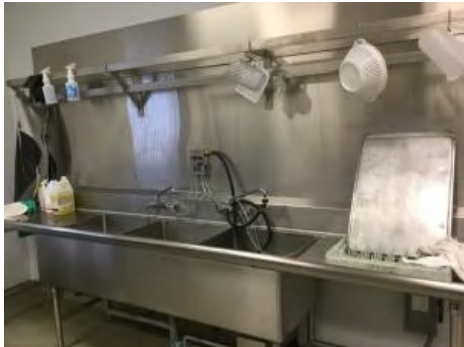
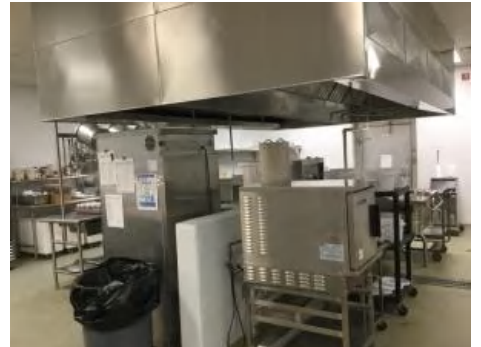
System: E1090 - Other Equipment

Note: Dishwasher abandoned in place.

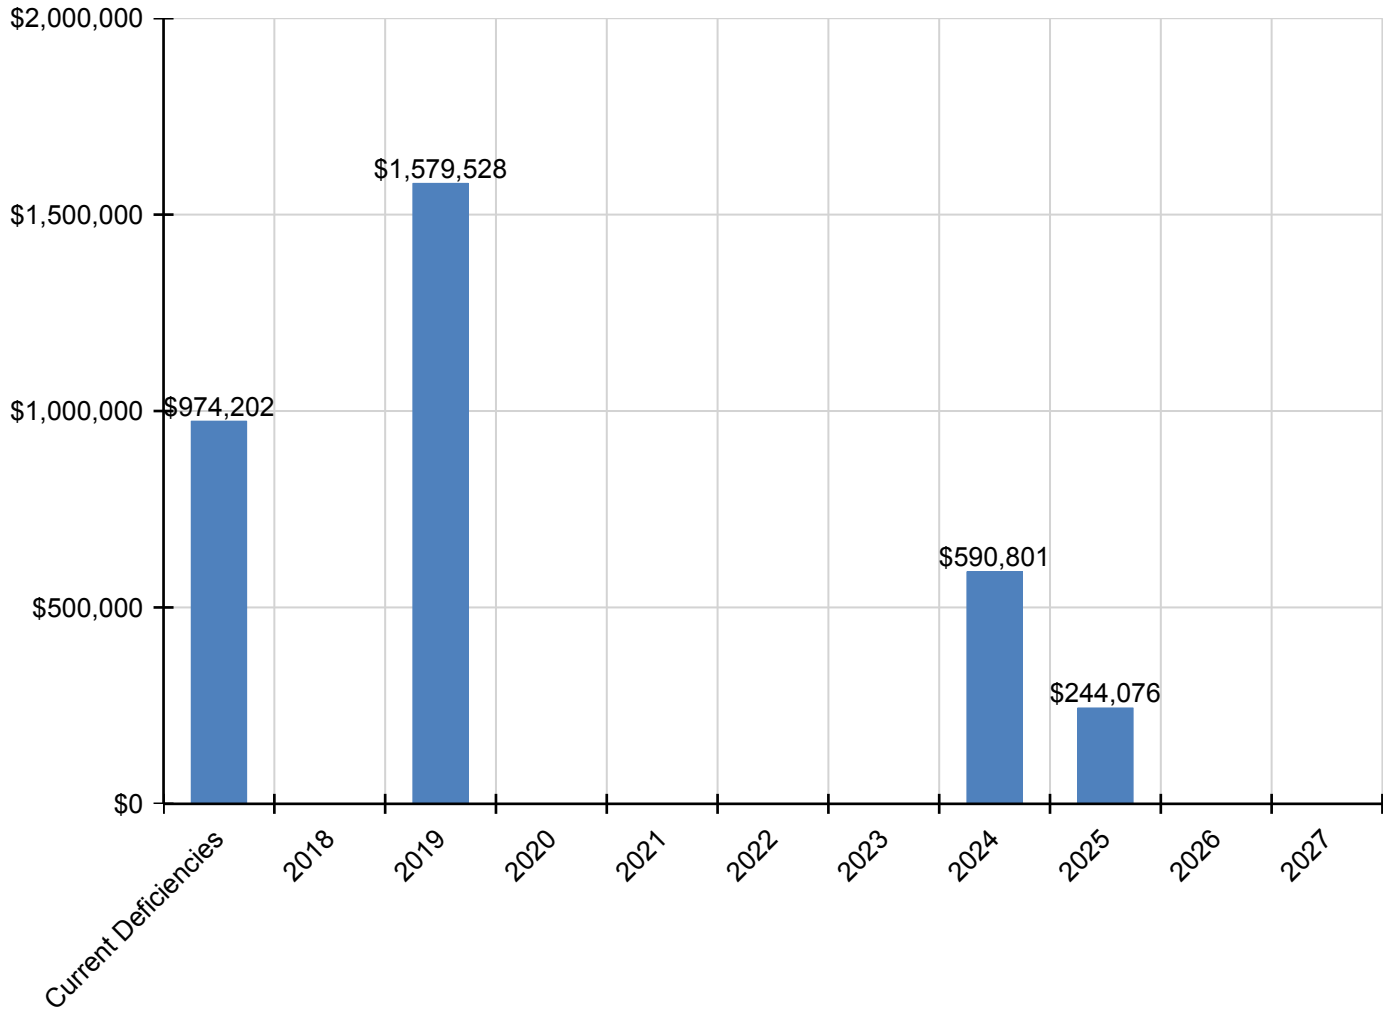
Forecasted Capital Renewal Requirement

The following chart shows the current building deficiencies and forecasting capital renewal or sustainment requirements over the next ten years.

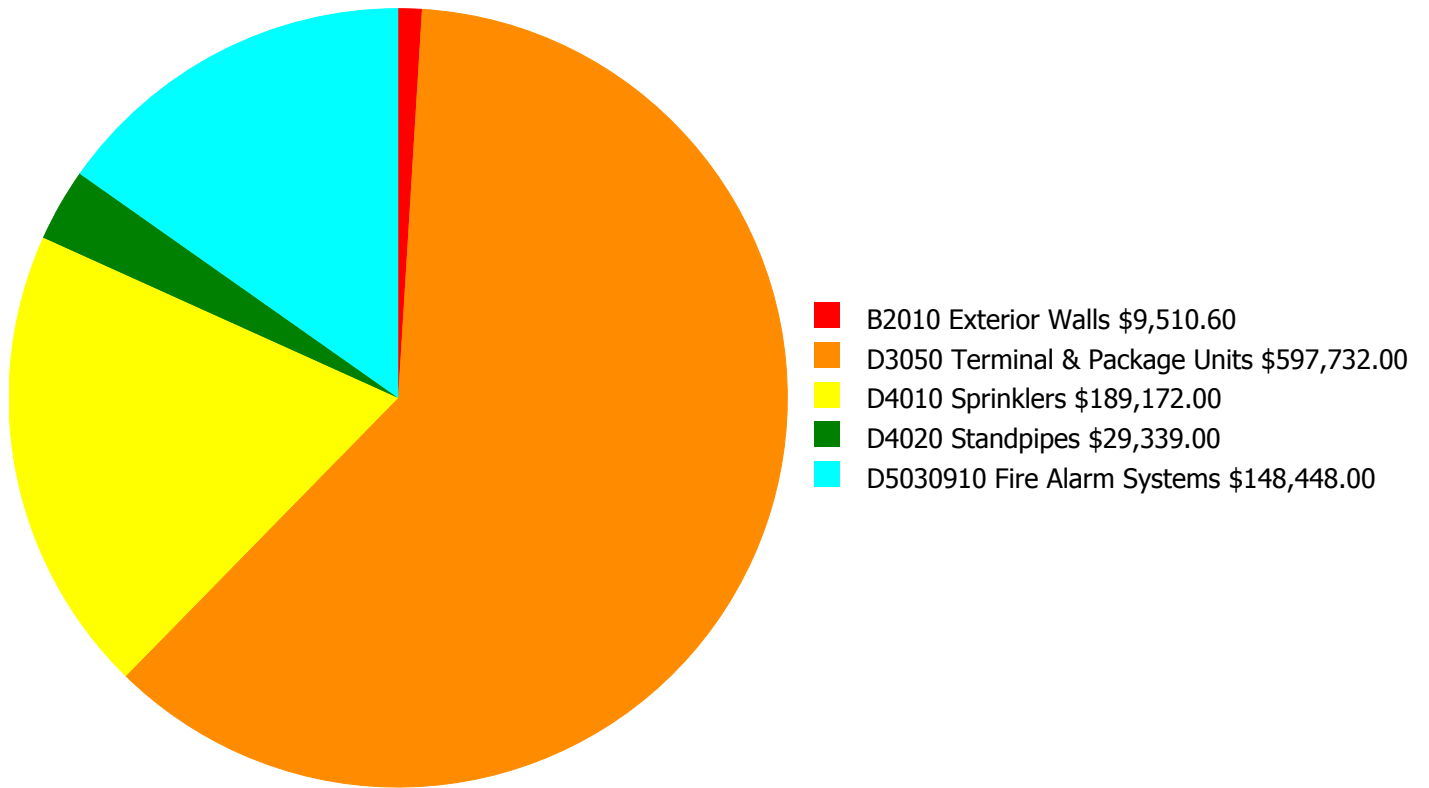
Deficiency Summary by System

Current deficiencies included assemblies that have reached or exceeded their design life or components of the assemblies that are in need of repair. Assemblies that have reached their design life are identified as current deficiencies and assigned the distress 'Beyond Useful Life'. The following chart lists all current deficiencies associated with this facility.

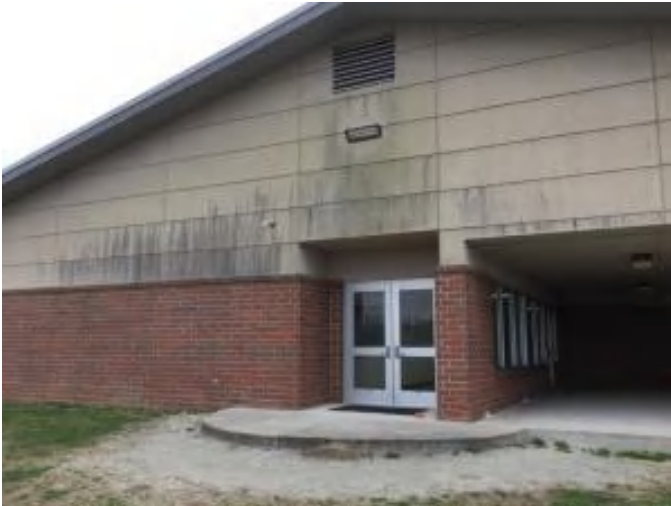
System: B2010 - Exterior Walls

Location: Stucco system
Distress: Damaged
Category: Deferred Maintenance / Appearance
Priority: 3 - Necessary/Not Yet Critical (Years 2-5)
Correction: Spray refinish exterior walls
Qty: 5,000.00
Unit of Measure: S.F.
Estimate: \$9,510.60
Assessor Name: Terence Davis
Date Created: 02/08/2017

Notes: Stucco walls are stained and dirty. Power washing and repainting is recommended.

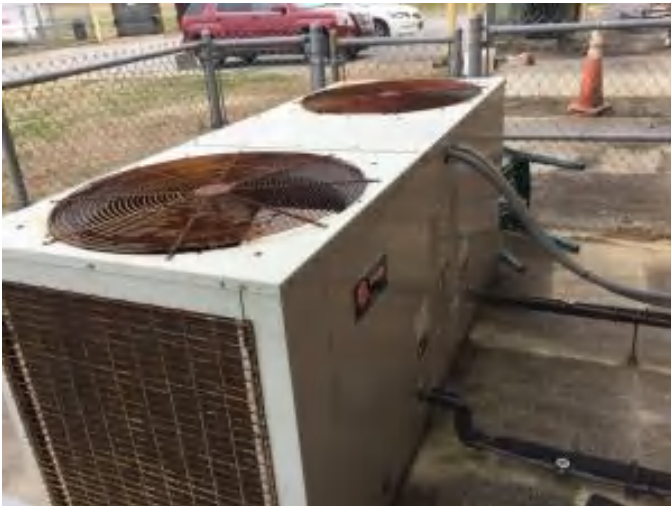
System: D3050 - Terminal & Package Units

Location: Throughout the building
Distress: Beyond Service Life
Category: Deferred Maintenance
Priority: 3 - Necessary/Not Yet Critical (Years 2-5)
Correction: Renew System
Qty: 39,809.00
Unit of Measure: S.F.
Estimate: \$597,732.00
Assessor Name: Terence Davis
Date Created: 02/07/2017

Notes: Heat pumps throughout the building are typically original and have exceeded their expected useful life. Dedicated cooling is not provided at data rooms. System replacement is recommended.

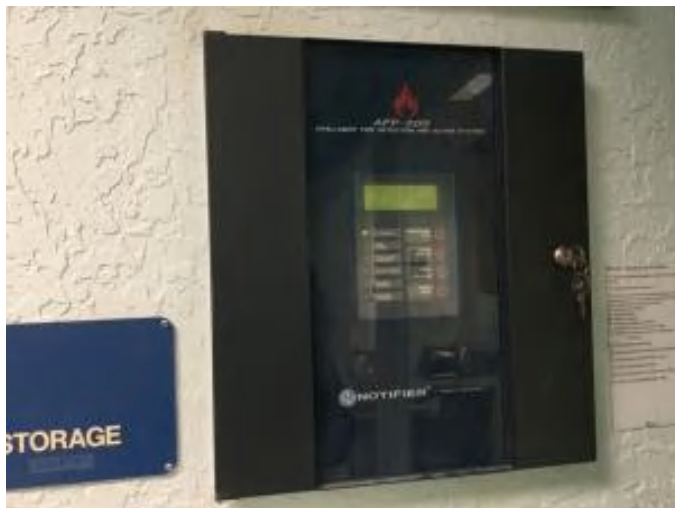
System: D5030910 - Fire Alarm Systems

Location: Throughout the building
Distress: Beyond Service Life
Category: Deferred Maintenance
Priority: 3 - Necessary/Not Yet Critical (Years 2-5)
Correction: Renew System
Qty: 39,809.00
Unit of Measure: S.F.
Estimate: \$148,448.00
Assessor Name: Terence Davis
Date Created: 02/07/2017

Notes: The fire alarm system is original and beyond its expected life. System renewal is recommended to ensure reliability of this life safety system.

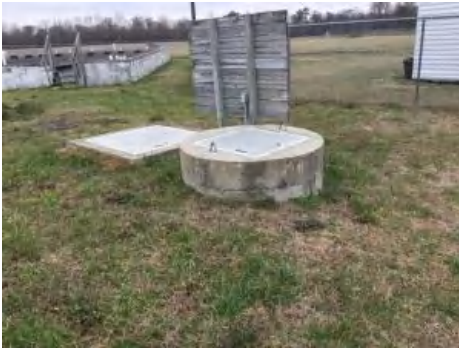
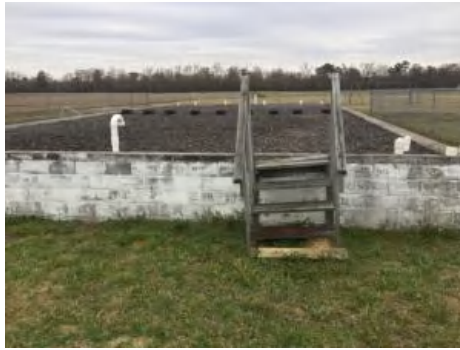
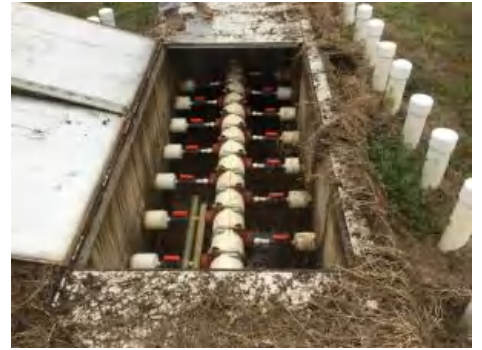
System: G3020 - Sanitary Sewer

Note: Sand filter, lift station, septic field.
