NC School District/520 Jones County/High School

Jones Senior High

Campus Assessment Report

March 8, 2017

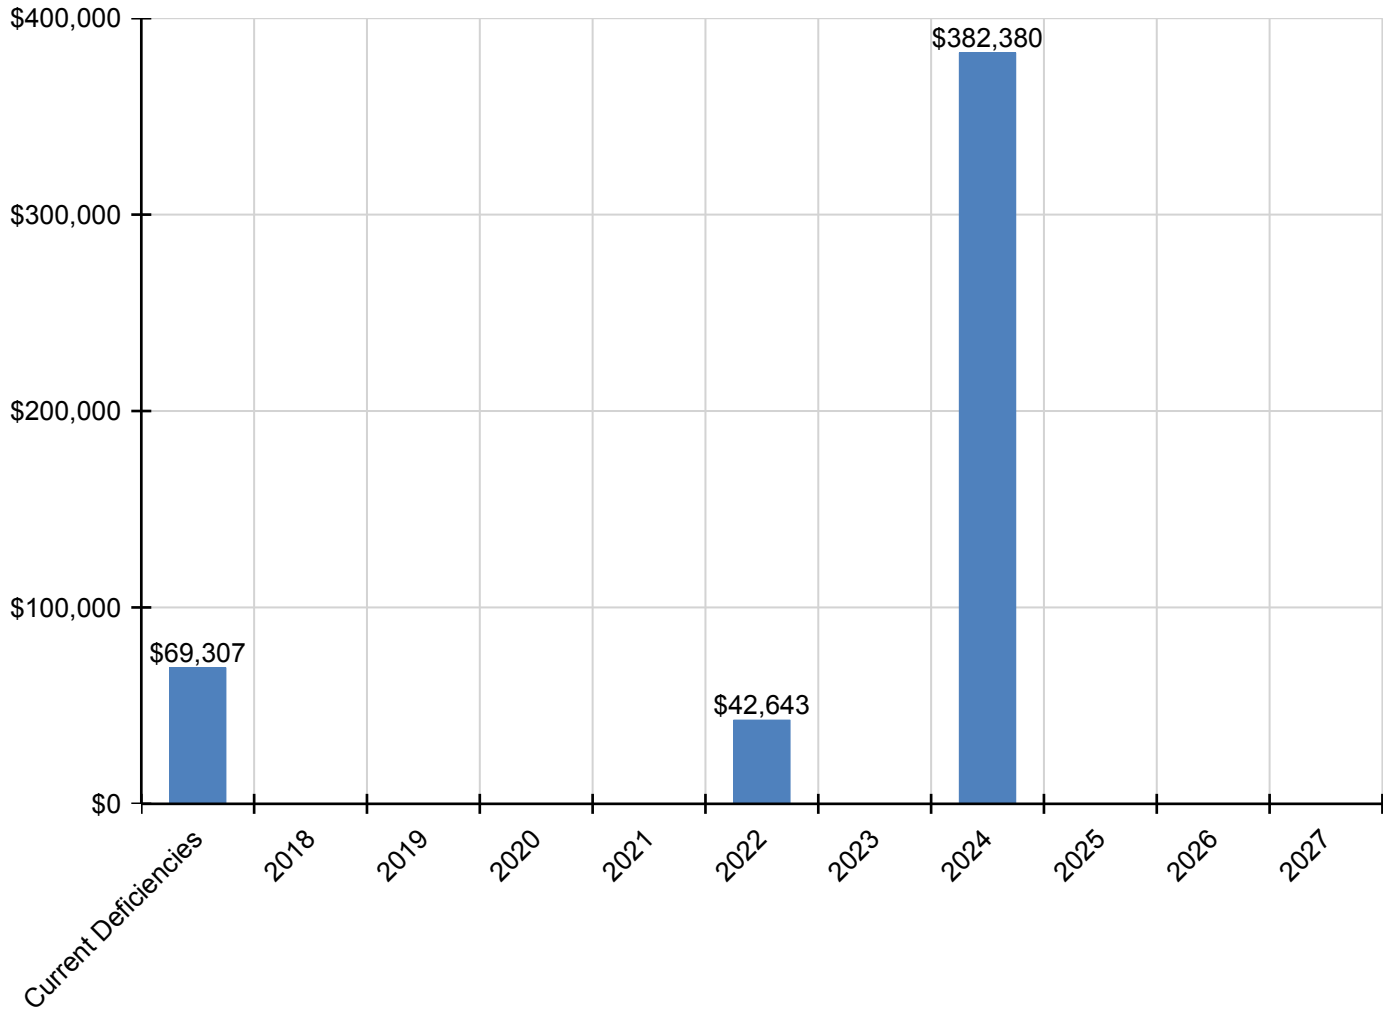
Forecasted Capital Renewal Requirement

The following chart shows the current building deficiencies and forecasting capital renewal or sustainment requirements over the next ten years.

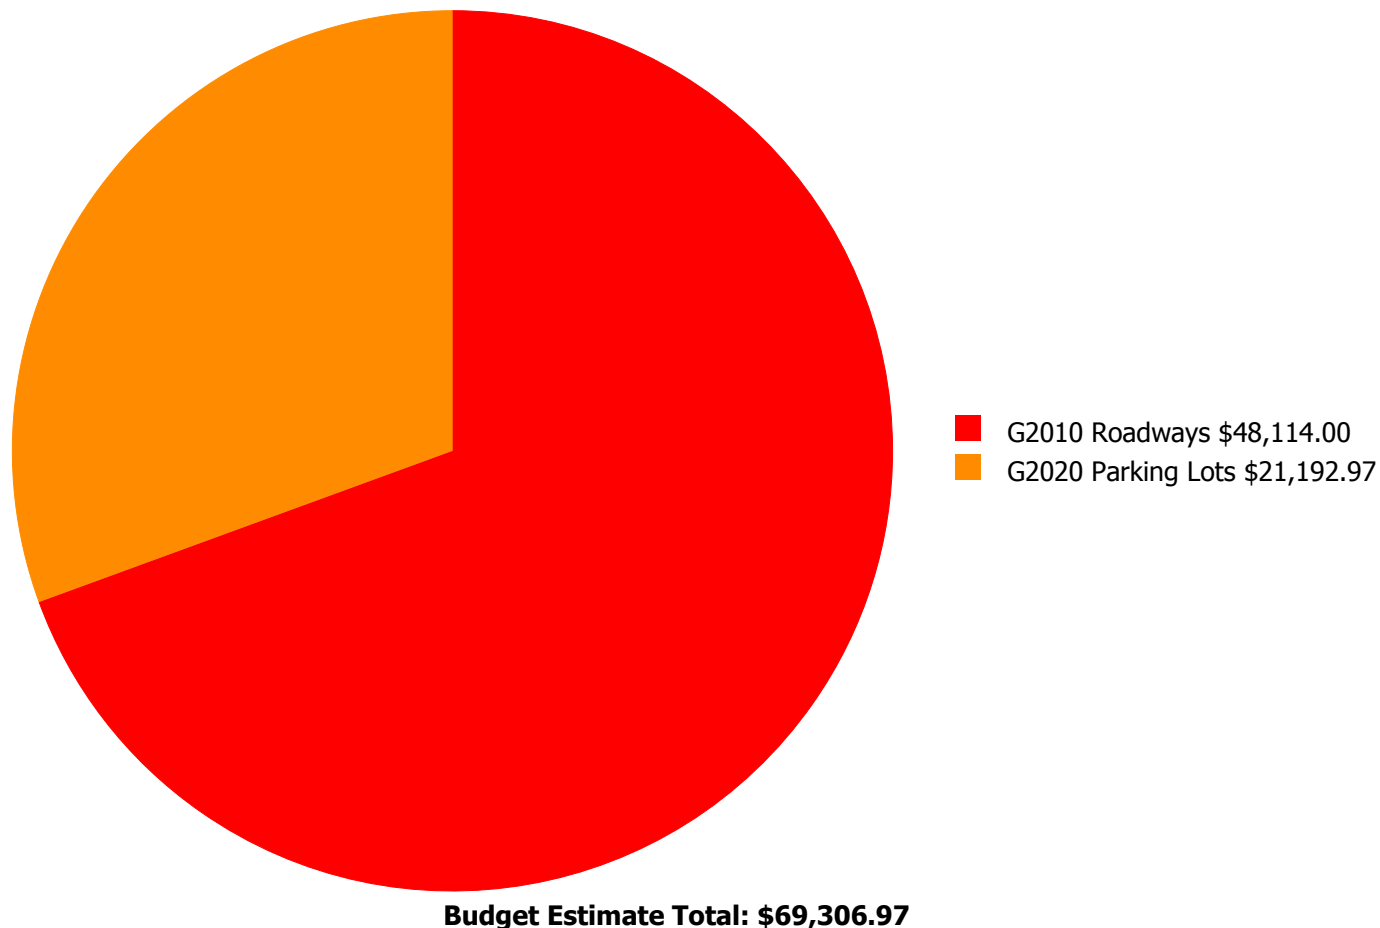
Deficiency Summary by System

Current deficiencies included assemblies that have reached or exceeded their design life or components of the assemblies that are in need of repair. Assemblies that have reached their design life are identified as current deficiencies and assigned the distress 'Beyond Useful Life'. The following chart lists all current deficiencies associated with this facility.

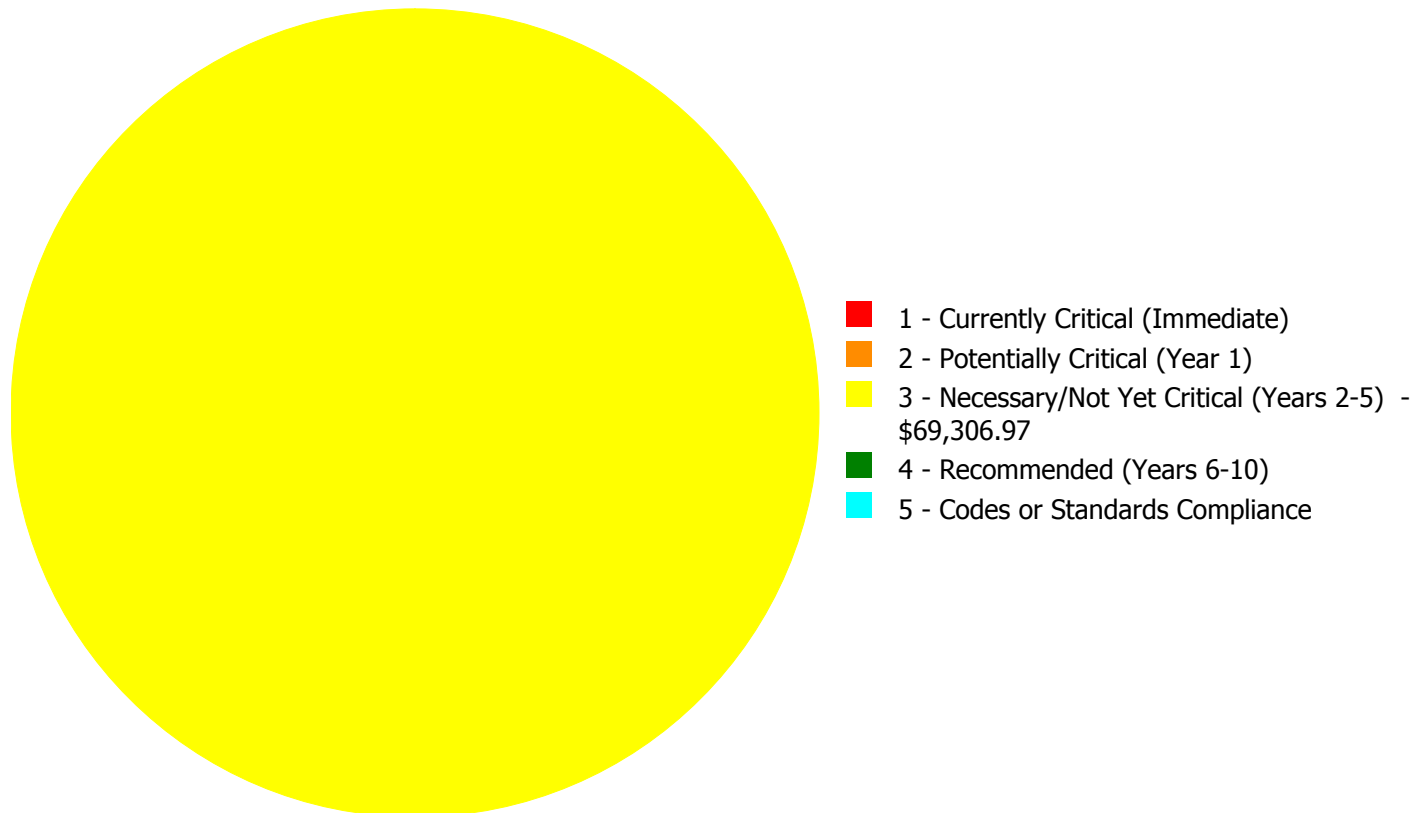
Deficiency Summary by Priority

The following chart shows the total repair costs broken down by priority. Assessors assigned deficiencies within eCOMET to one of the following priority categories:

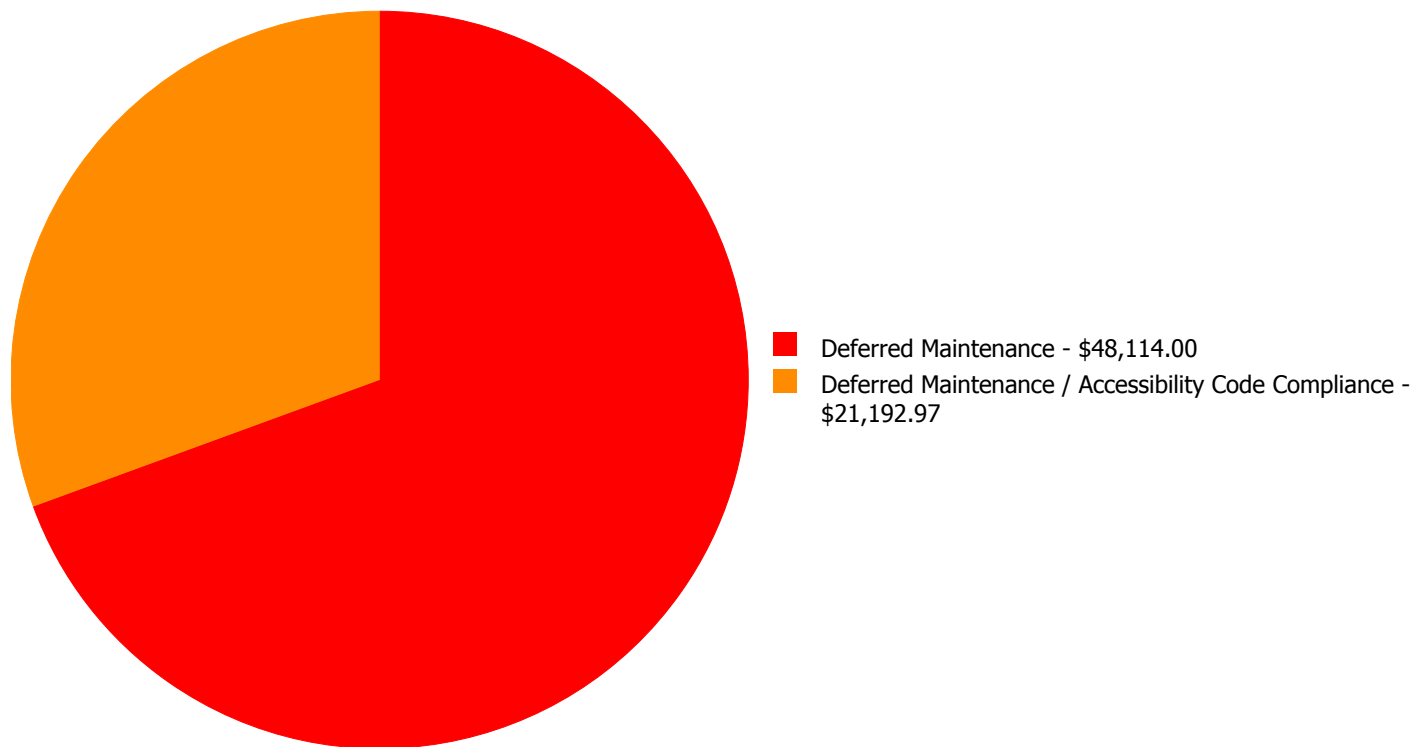
Deficiency Summary by Category

The following chart shows the total repair costs broken down by deficiency categories. Assessors assigned deficiencies to one of the following categories:

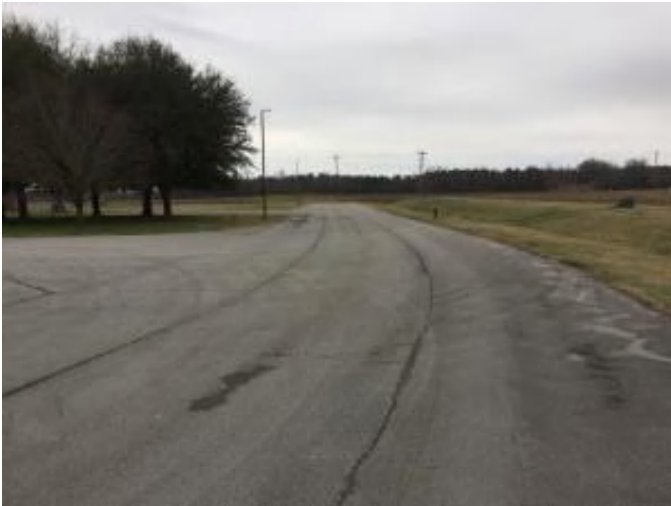
System: G2010 - Roadways

Location: Site roads
Distress: Damaged
Category: Deferred Maintenance
Priority: 3 - Necessary/Not Yet Critical (Years 2-5)
Correction: Resurface the roadway
Qty: 1,000.00
Unit of Measure: L.F.
Estimate: \$48,114.00
Assessor Name: Eduardo Lopez
Date Created: 02/08/2017

Notes: The asphaltic roadway is aged, and should be re-surfaced.

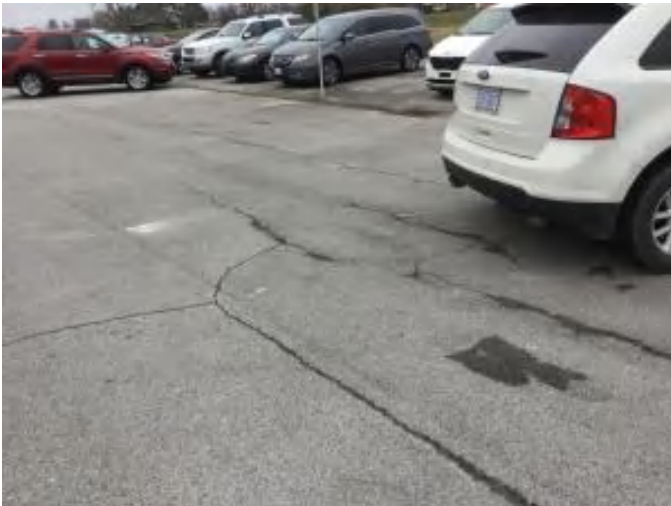
System: G2020 - Parking Lots

Location: Parking lots
Distress: Inadequate
Category: Deferred Maintenance / Accessibility Code Compliance
Priority: 3 - Necessary/Not Yet Critical (Years 2-5)
Correction: Parking lot repair and sealcoating
Qty: 24.00
Unit of Measure: M.S.F.
Estimate: \$21,192.97
Assessor Name: Eduardo Lopez
Date Created: 02/08/2017

Notes: The parking lot is beginning to show age. It should be crack filled and sealed to mitigate premature failure. Re-stripe the lot and provide ADA compliant markings and signage and a fire lane.

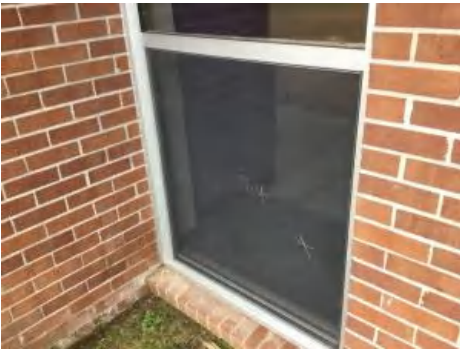
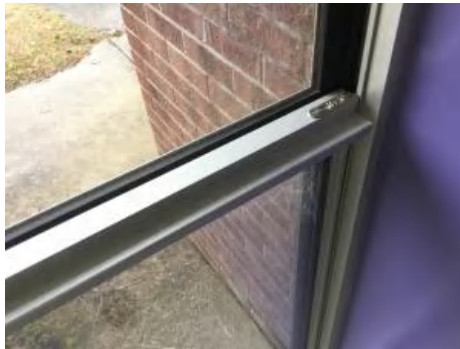
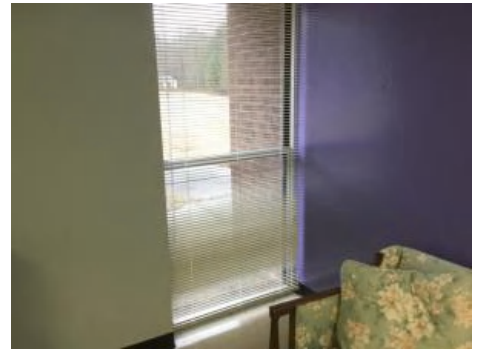
System: B2020 - Exterior Windows

Note: Exterior windows are believed to have been installed new in 1998. A few are losing seals and should be replaced on a maintenance basis.

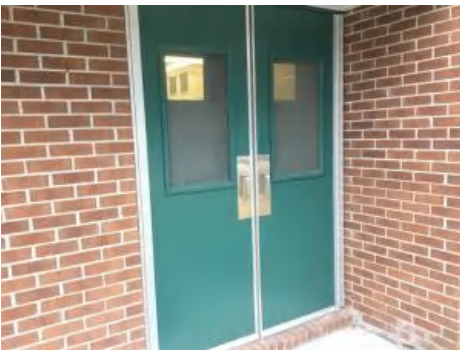
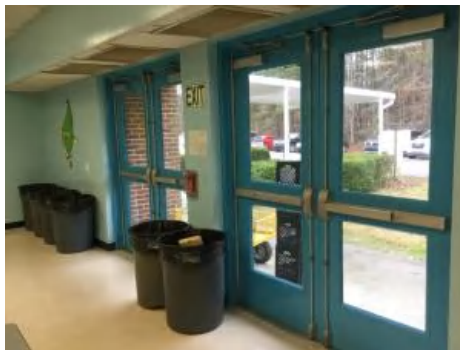
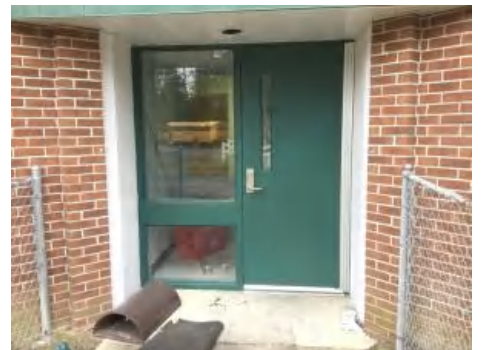
System: B2030 - Exterior Doors

Note: Exterior doors are believed to have been upgraded in the 1998 renovation. No deficiencies noted.

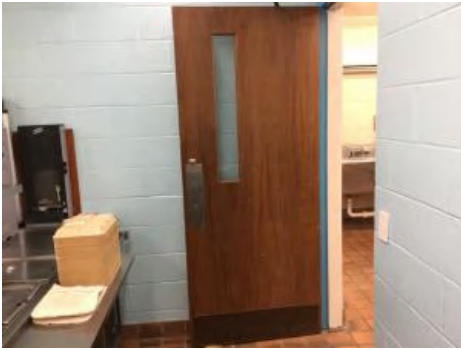
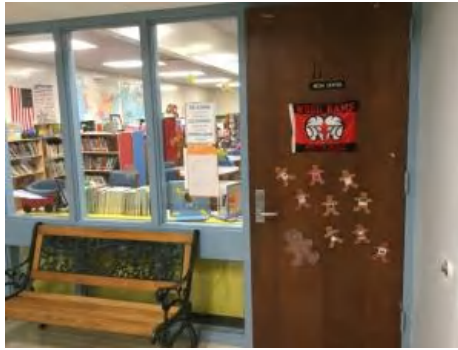
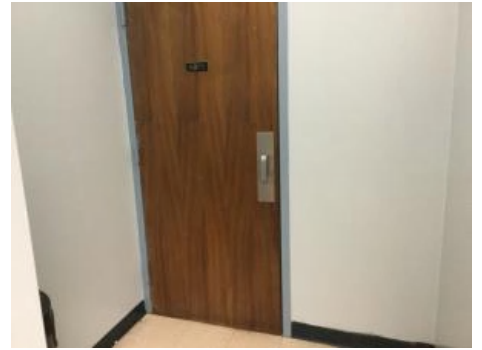
System: C1020 - Interior Doors

Note: Interior doors typically have lever hardware.

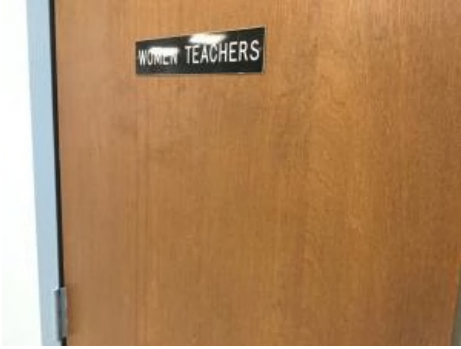
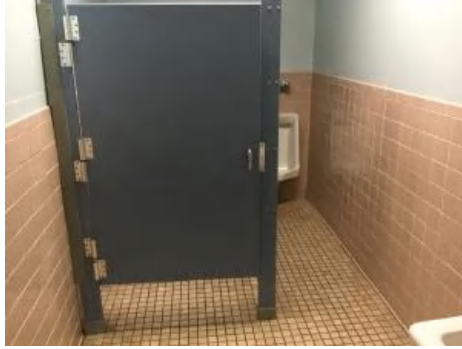
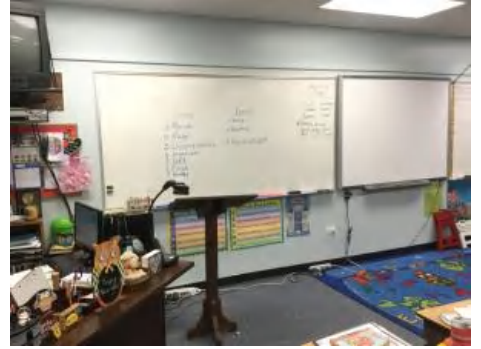
System: C1030 - Fittings

Note: Signage is not up to code. Toilet partitions and marker boards are in good condition. No manual deficiency entered as system expires in one year.

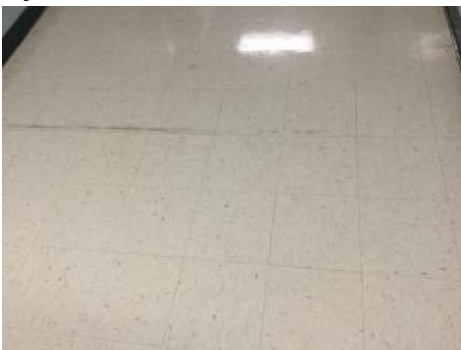
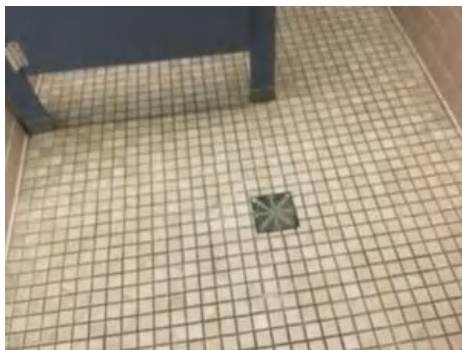
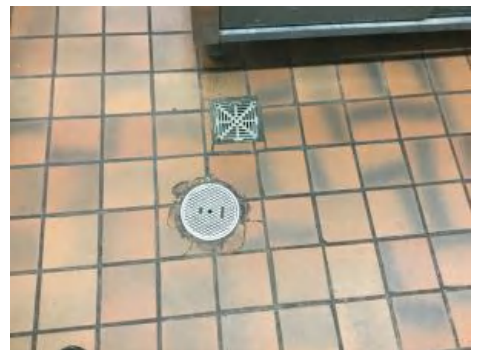
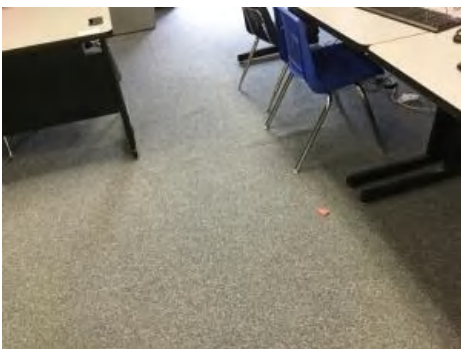
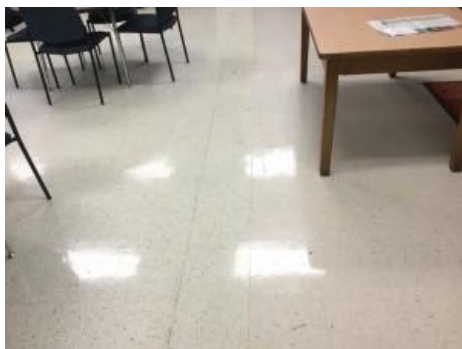
System: C3020 - Floor Finishes

Note: Carpet and VCT installed over VAT and asbestos mastic to encapsulate it in 1998. System expires in 1 year, so no manual deficiency entered.

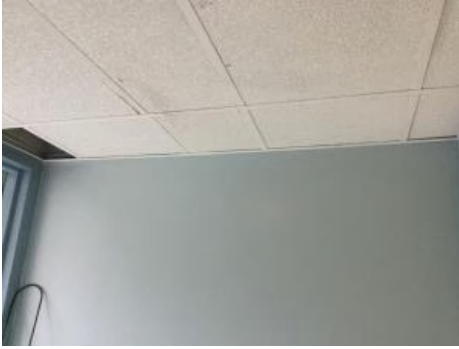
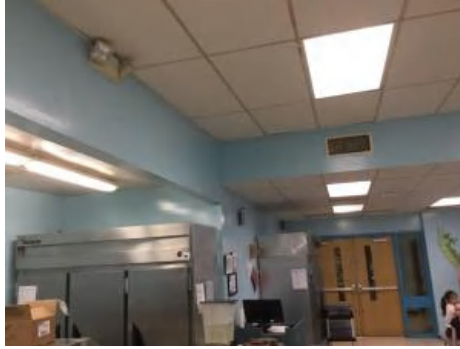
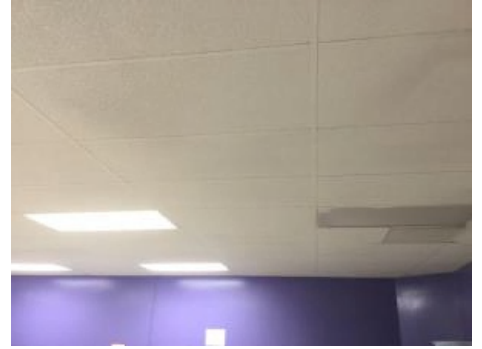
System: C3030 - Ceiling Finishes

Note: It appears that original ceiling tile and grid have been spray painted.

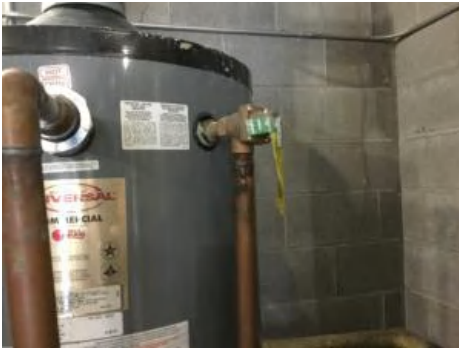
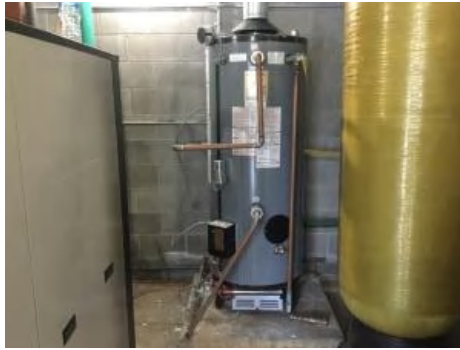
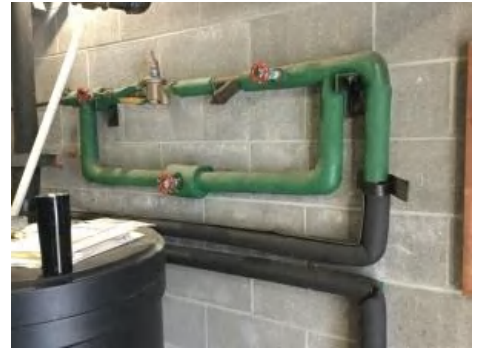
System: D2020 - Domestic Water Distribution

Note: No apparent or reported issues with water distribution system. Water heaters are up to date. System renewal put at 5 years.

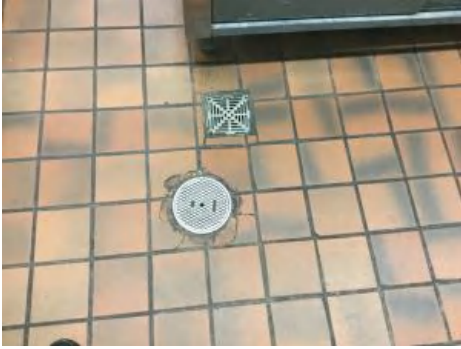
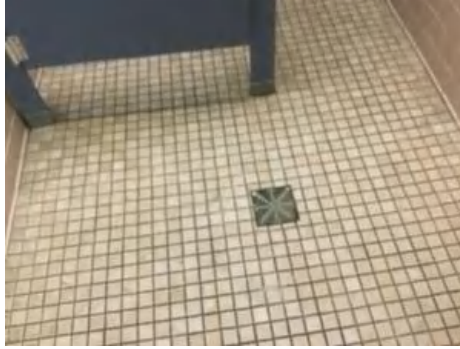
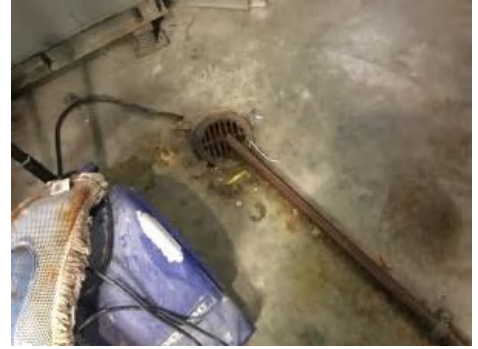
System: D2030 - Sanitary Waste

Note: No observed or reported problems with the sanitary waste system. System renewal set at 5 years hence.

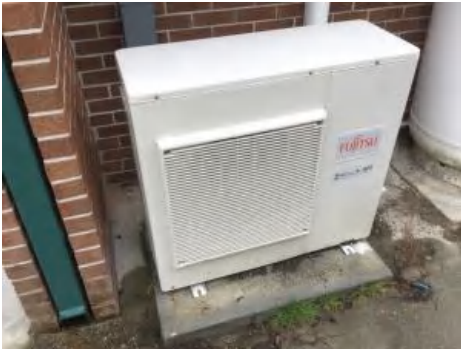
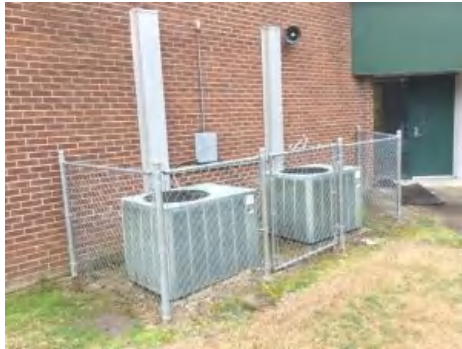
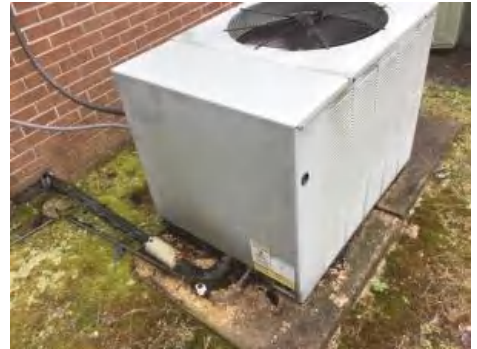
System: D3050 - Terminal & Package Units

Note: Air conditioning not included in 1998 upgrades. Community paid for retrofit of cooling coils in AHUs and condensing units in 2005.

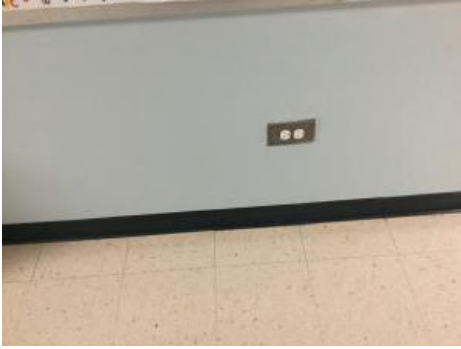
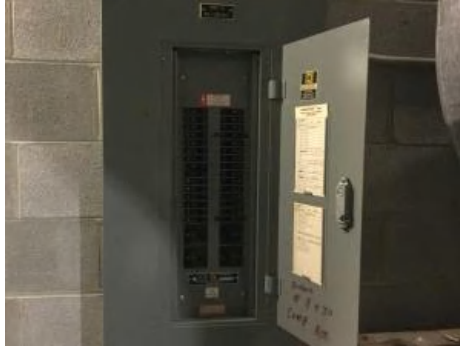
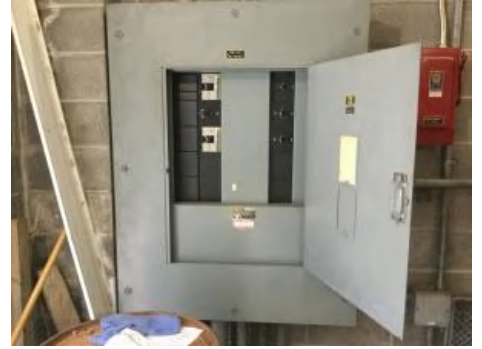
System: D5020 - Branch Wiring

Note: Deficiencies, if any, assumed to have been addressed in 1998 renovations. GFI outlets seen in wet areas. Sufficient power outlets for computer needs. Power strips used for surge protection. No use of extension cords observed.

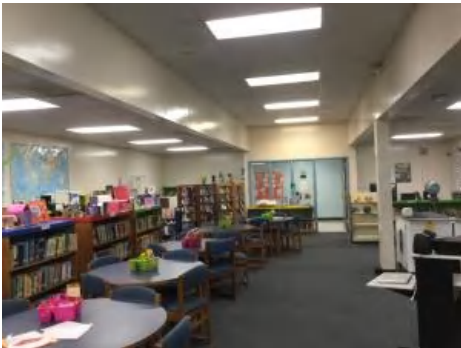
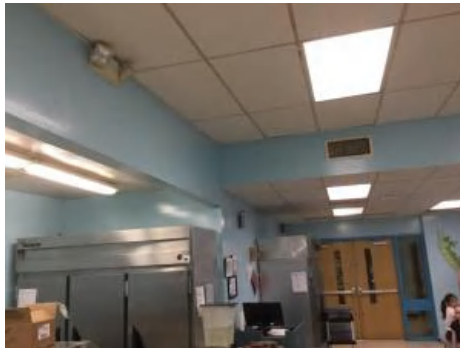
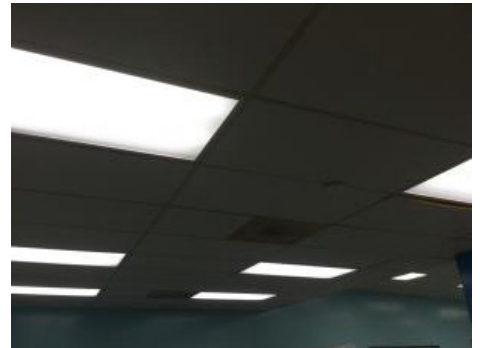
System: D5020 - Lighting

Note: Upgraded existing fixtures with new ballasts and T-8 lamps 2011.

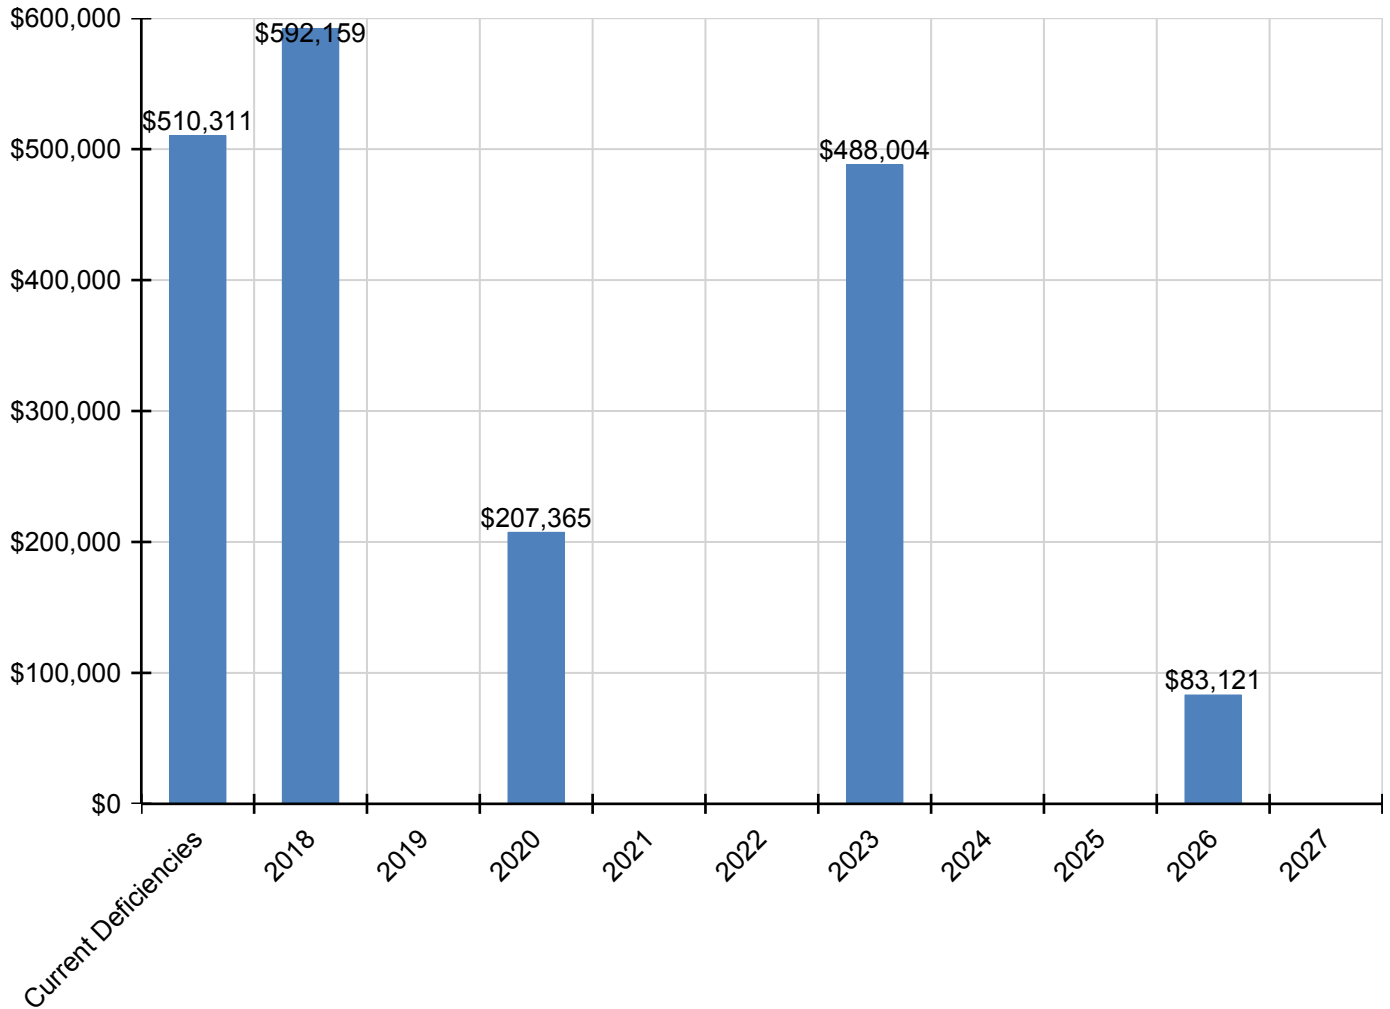
Forecasted Capital Renewal Requirement

The following chart shows the current building deficiencies and forecasting capital renewal or sustainment requirements over the next ten years.

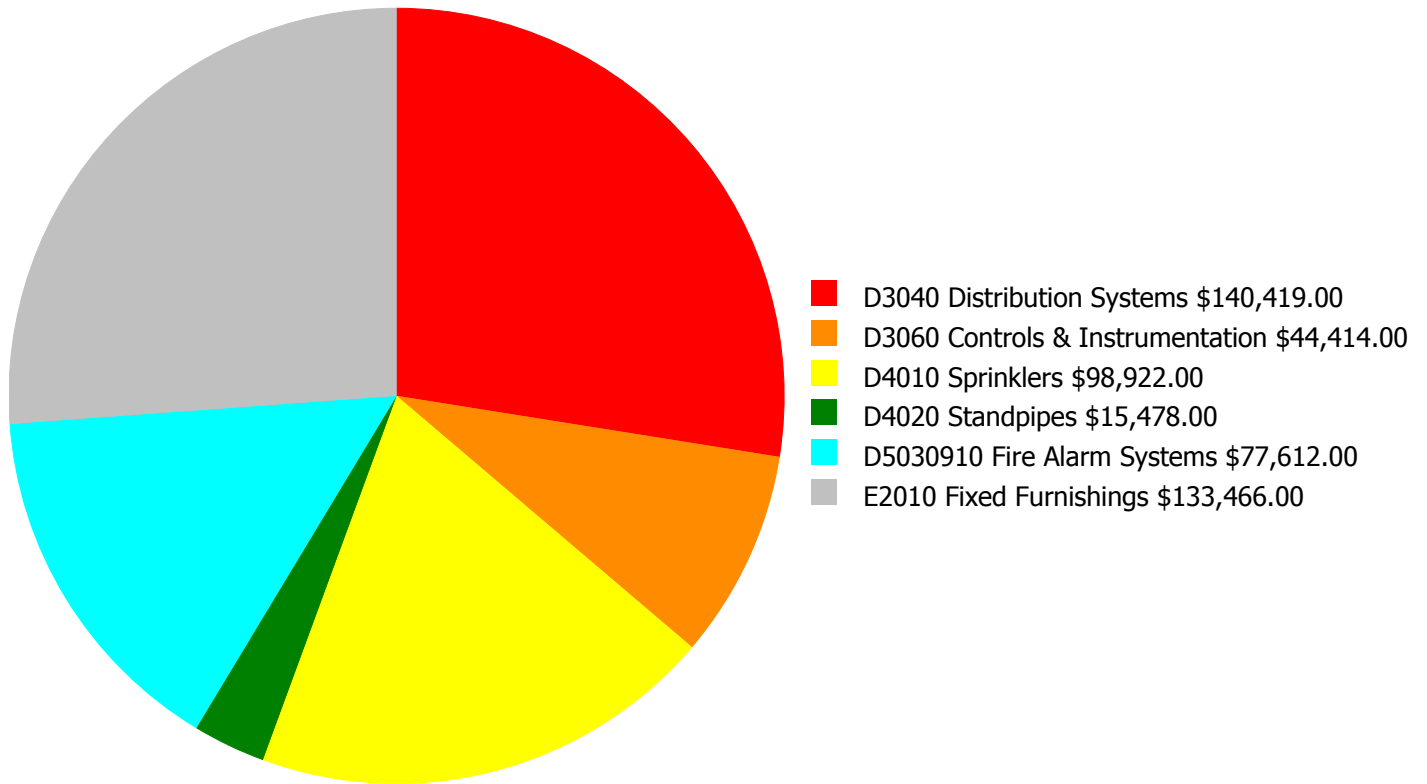
Deficiency Summary by System

Current deficiencies included assemblies that have reached or exceeded their design life or components of the assemblies that are in need of repair. Assemblies that have reached their design life are identified as current deficiencies and assigned the distress 'Beyond Useful Life'. The following chart lists all current deficiencies associated with this facility.

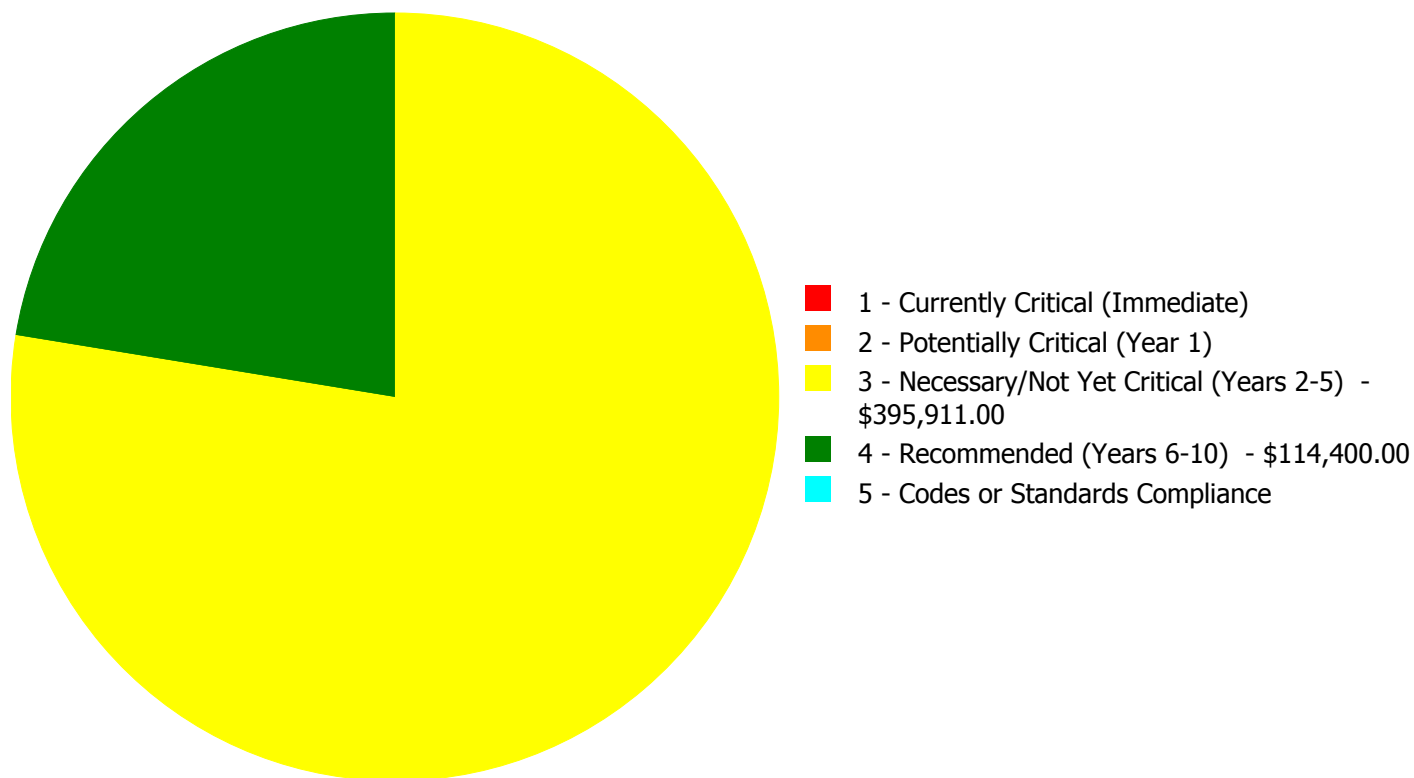
Deficiency Summary by Priority

The following chart shows the total repair costs broken down by priority. Assessors assigned deficiencies within eCOMET to one of the following priority categories:

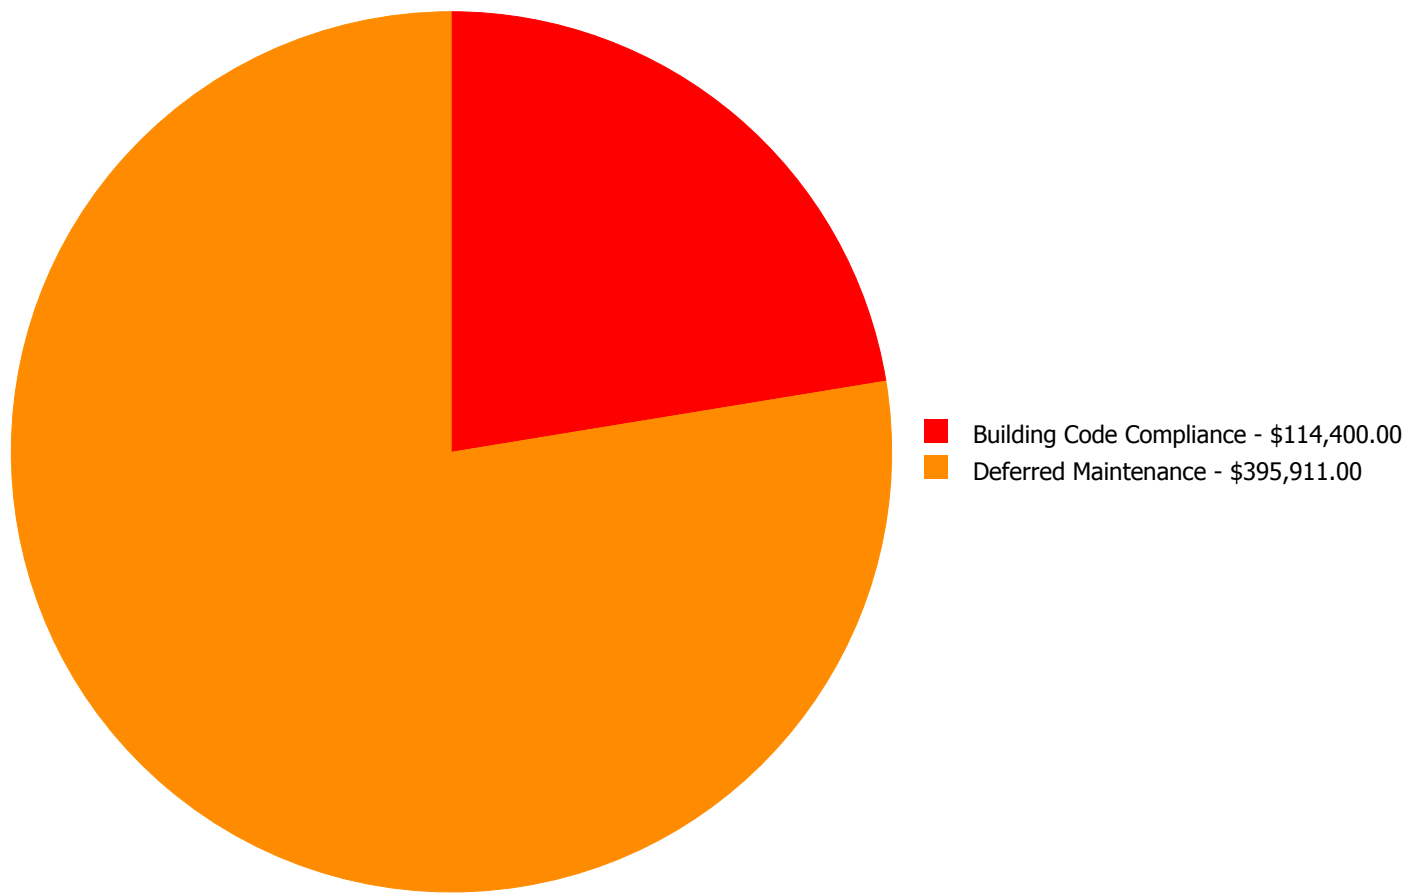
Deficiency Summary by Category

The following chart shows the total repair costs broken down by deficiency categories. Assessors assigned deficiencies to one of the following categories:

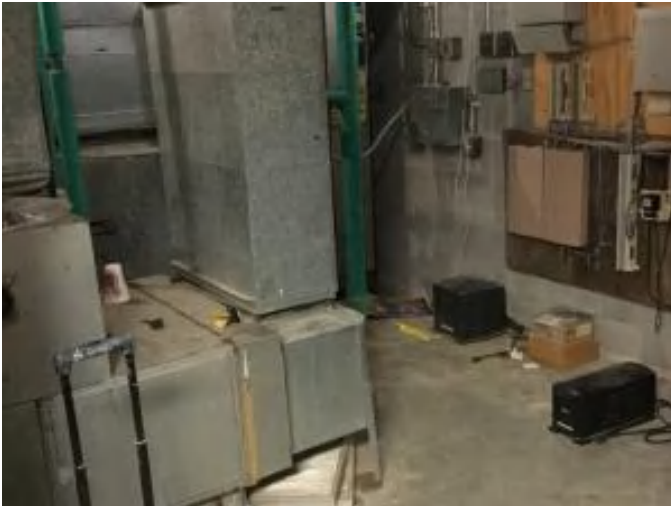
System: D3040 - Distribution Systems

Location: Throughout the building
Distress: Beyond Service Life
Category: Deferred Maintenance
Priority: 3 - Necessary/Not Yet Critical (Years 2-5)
Correction: Renew System
Qty: 20,392.00
Unit of Measure: S.F.
Estimate: \$140,419.00
Assessor Name: Ann Buerger Linden
Date Created: 02/08/2017

Notes: The air distribution system is aged, has internally lined ductwork, and should be replaced. Provide cooling supply to data closets. Toilet room exhaust systems are cruddy.

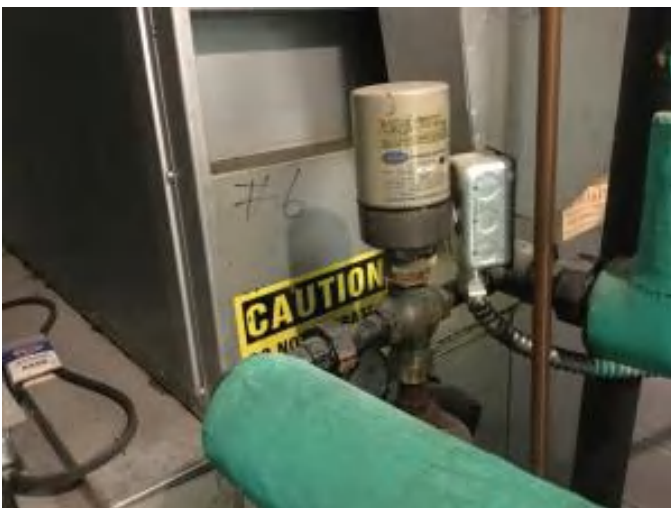
System: D3060 - Controls & Instrumentation

Location: Throughout the building
Distress: Beyond Service Life
Category: Deferred Maintenance
Priority: 3 - Necessary/Not Yet Critical (Years 2-5)
Correction: Renew System
Qty: 20,392.00
Unit of Measure: S.F.
Estimate: \$44,414.00
Assessor Name: Ann Buerger Linden
Date Created: 02/08/2017

Notes: Building controls are locally controlled. Installation of a modern digital system with remote monitoring and control capability for energy conservation is recommended.

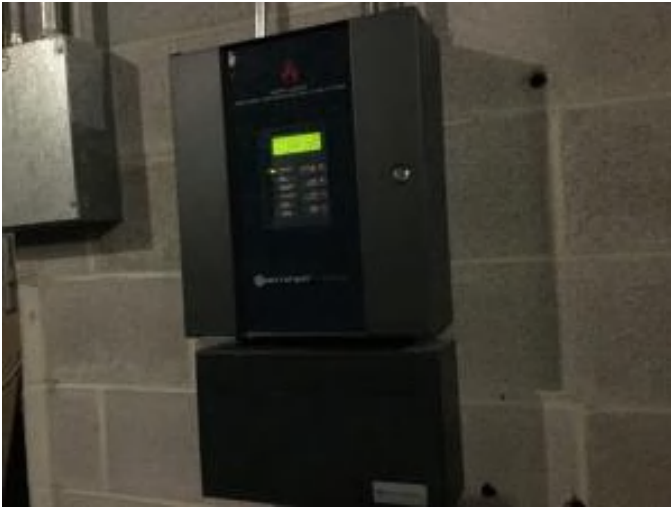
System: D5030910 - Fire Alarm Systems

Location: Throughout the building.
Distress: Beyond Service Life
Category: Deferred Maintenance
Priority: 3 - Necessary/Not Yet Critical (Years 2-5)
Correction: Renew System
Qty: 20,392.00
Unit of Measure: S.F.
Estimate: \$77,612.00
Assessor Name: Ann Buerger Linden
Date Created: 02/08/2017

Notes: The fire alarm system is beyond its expected life. System renewal is recommended to ensure reliability of this life safety system.

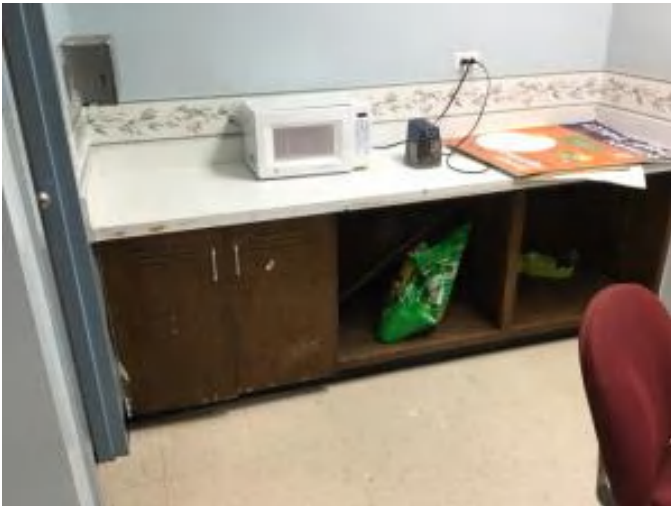
System: E2010 - Fixed Furnishings

Location: Throughout the building
Distress: Beyond Service Life
Category: Deferred Maintenance
Priority: 3 - Necessary/Not Yet Critical (Years 2-5)
Correction: Renew System
Qty: 20,392.00
Unit of Measure: S.F.
Estimate: \$133,466.00
Assessor Name: Ann Buerger Linden
Date Created: 02/08/2017

Notes: Fixed furnishings are typically original, are beyond their expected useful life and are showing wear and tear. System renewal is recommended.

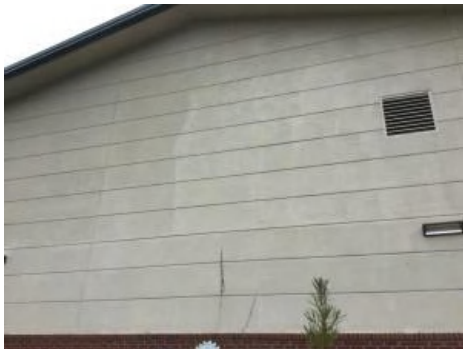
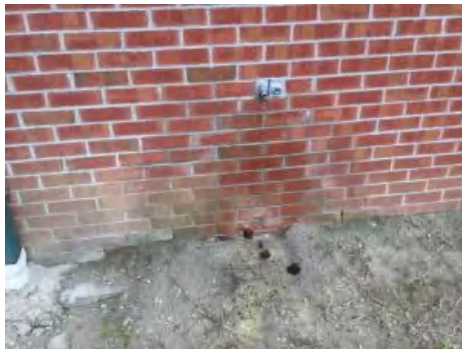
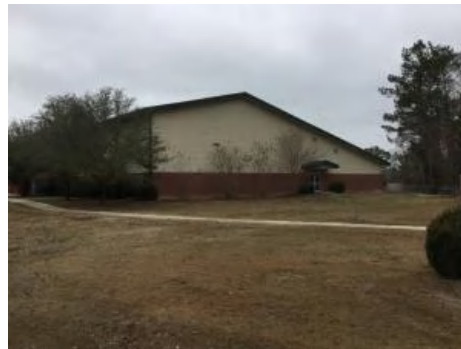
System: B2010 - Exterior Walls

Note: Walls painted 2016

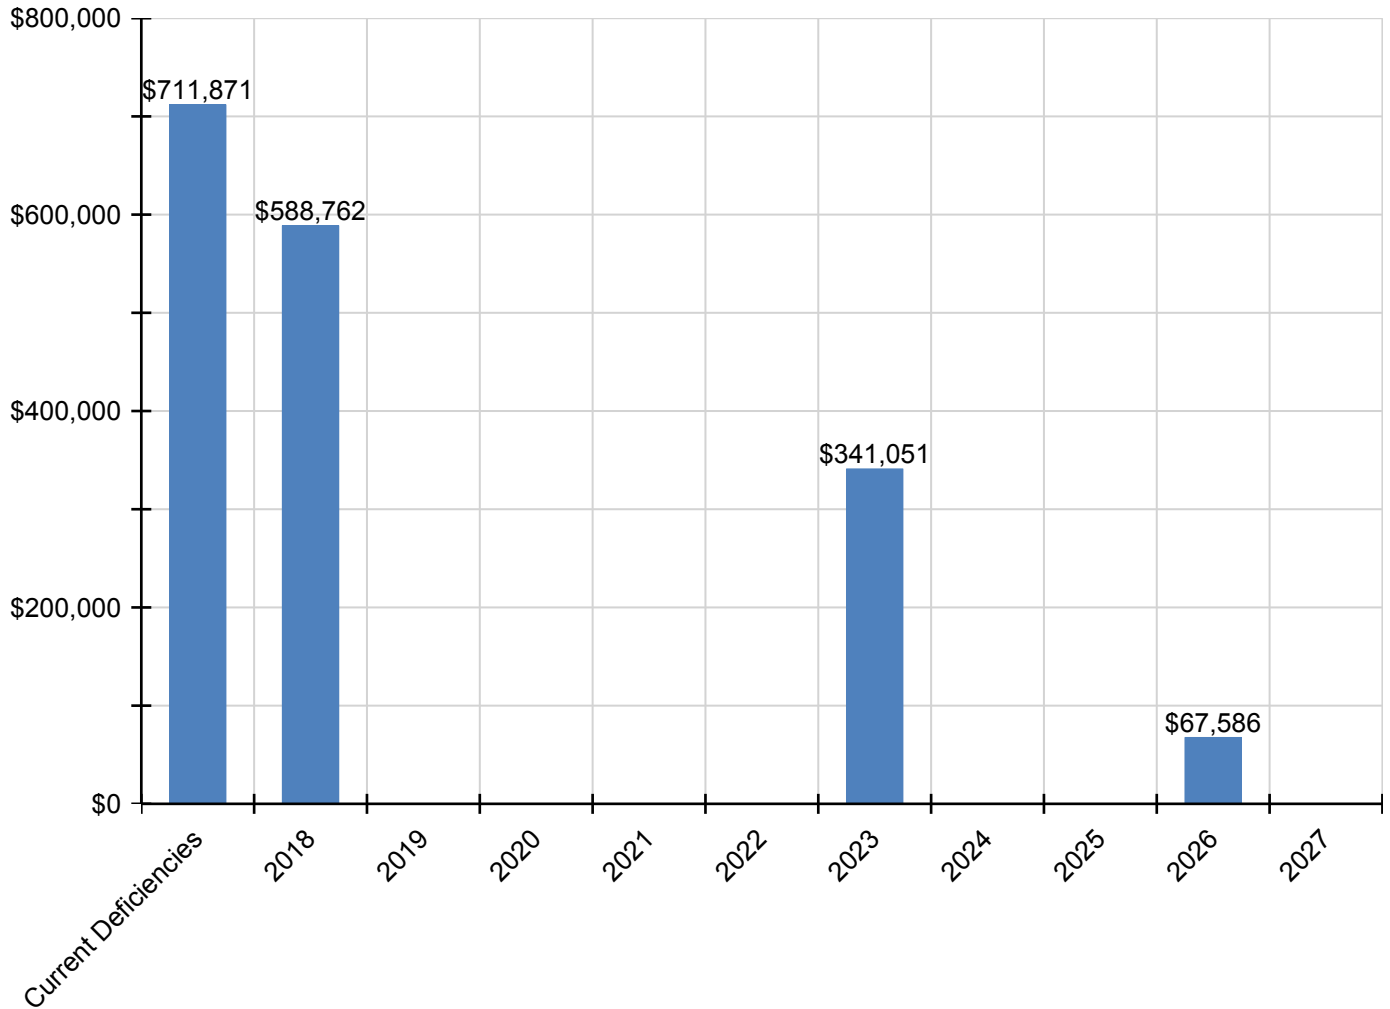
Forecasted Capital Renewal Requirement

The following chart shows the current building deficiencies and forecasting capital renewal or sustainment requirements over the next ten years.

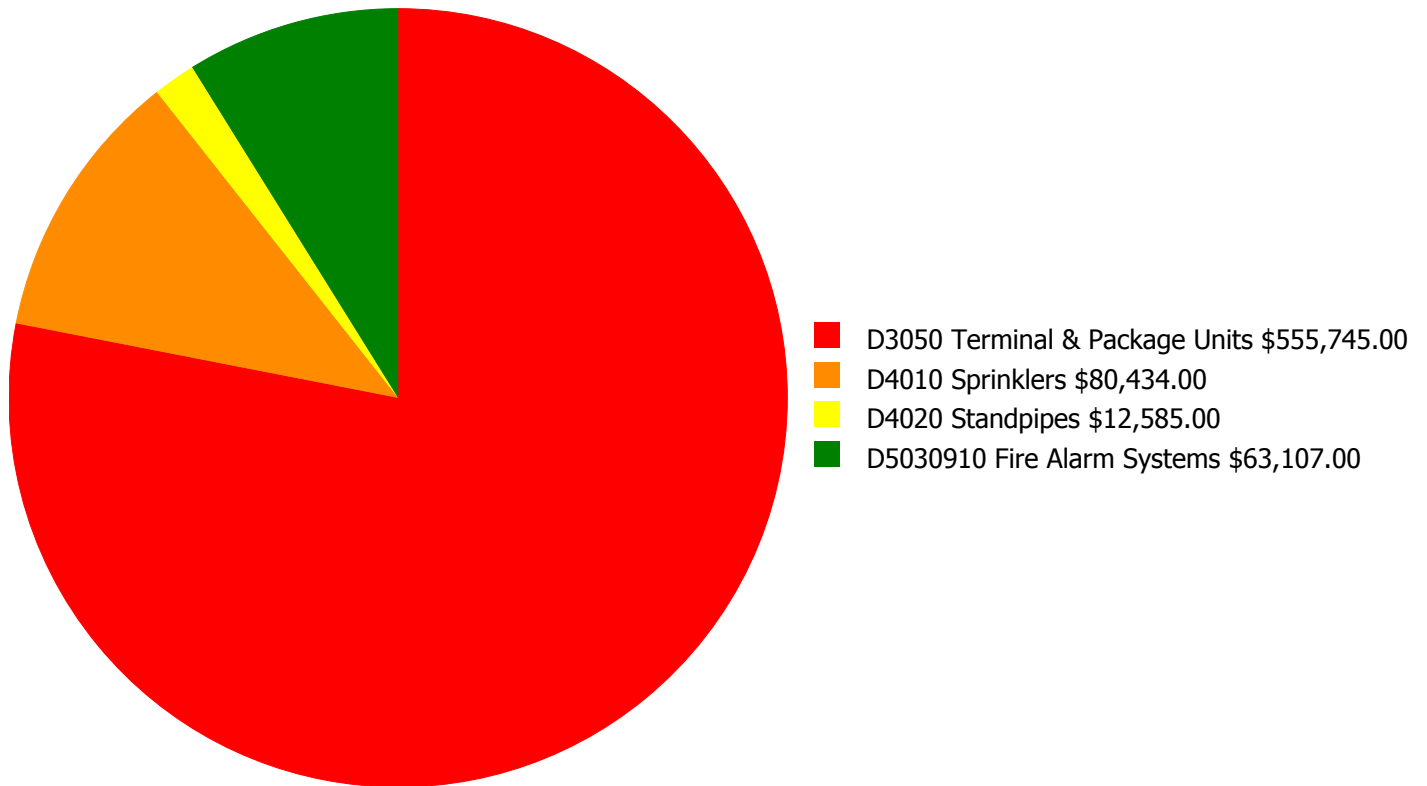
Deficiency Summary by System

Current deficiencies included assemblies that have reached or exceeded their design life or components of the assemblies that are in need of repair. Assemblies that have reached their design life are identified as current deficiencies and assigned the distress 'Beyond Useful Life'. The following chart lists all current deficiencies associated with this facility.

Budget Estimate Total: \$711,871.00
