NC School District/520 Jones County/High School

Jones Senior High

Campus Assessment Report

March 8, 2017

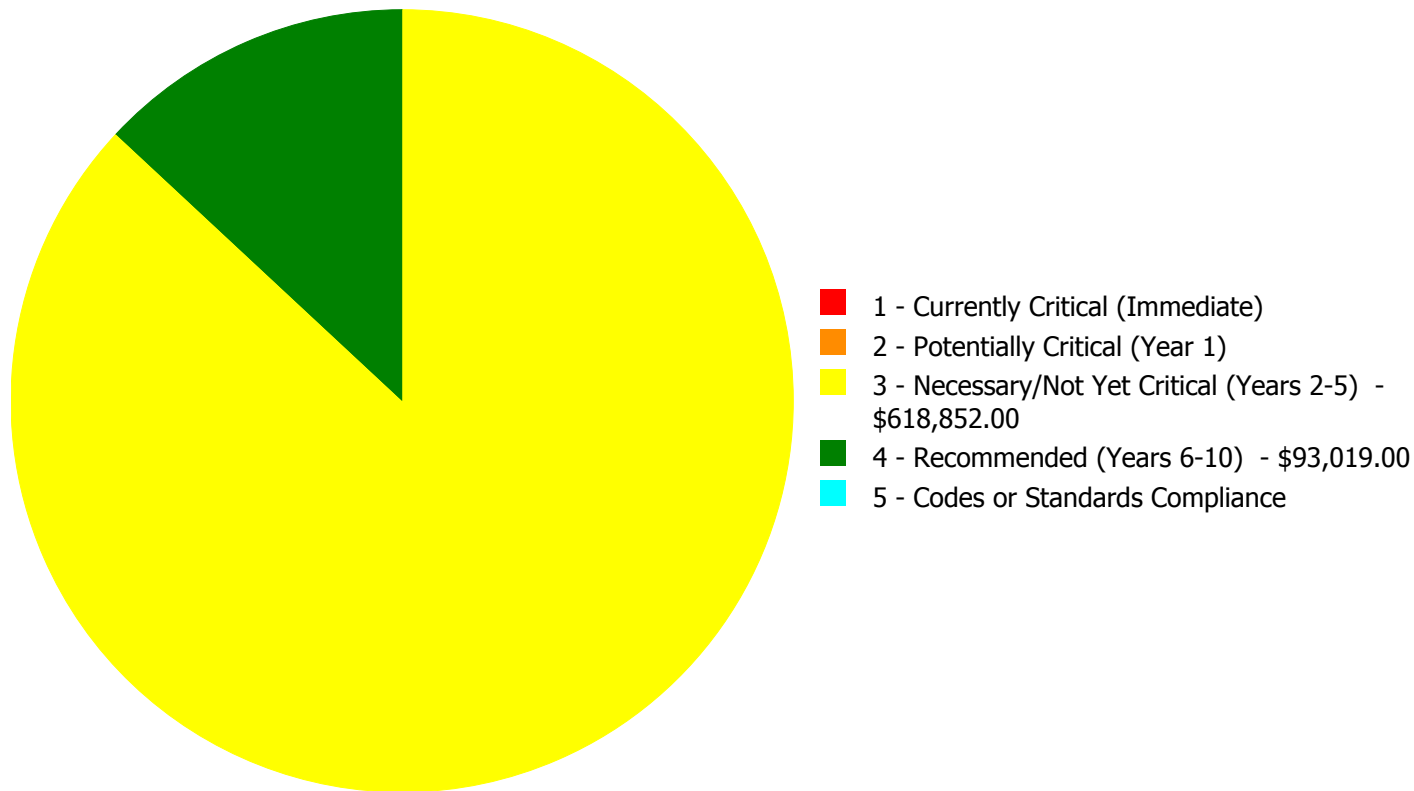
Deficiency Summary by Priority

The following chart shows the total repair costs broken down by priority. Assessors assigned deficiencies within eCOMET to one of the following priority categories:

Budget Estimate Total: \$711,871.00

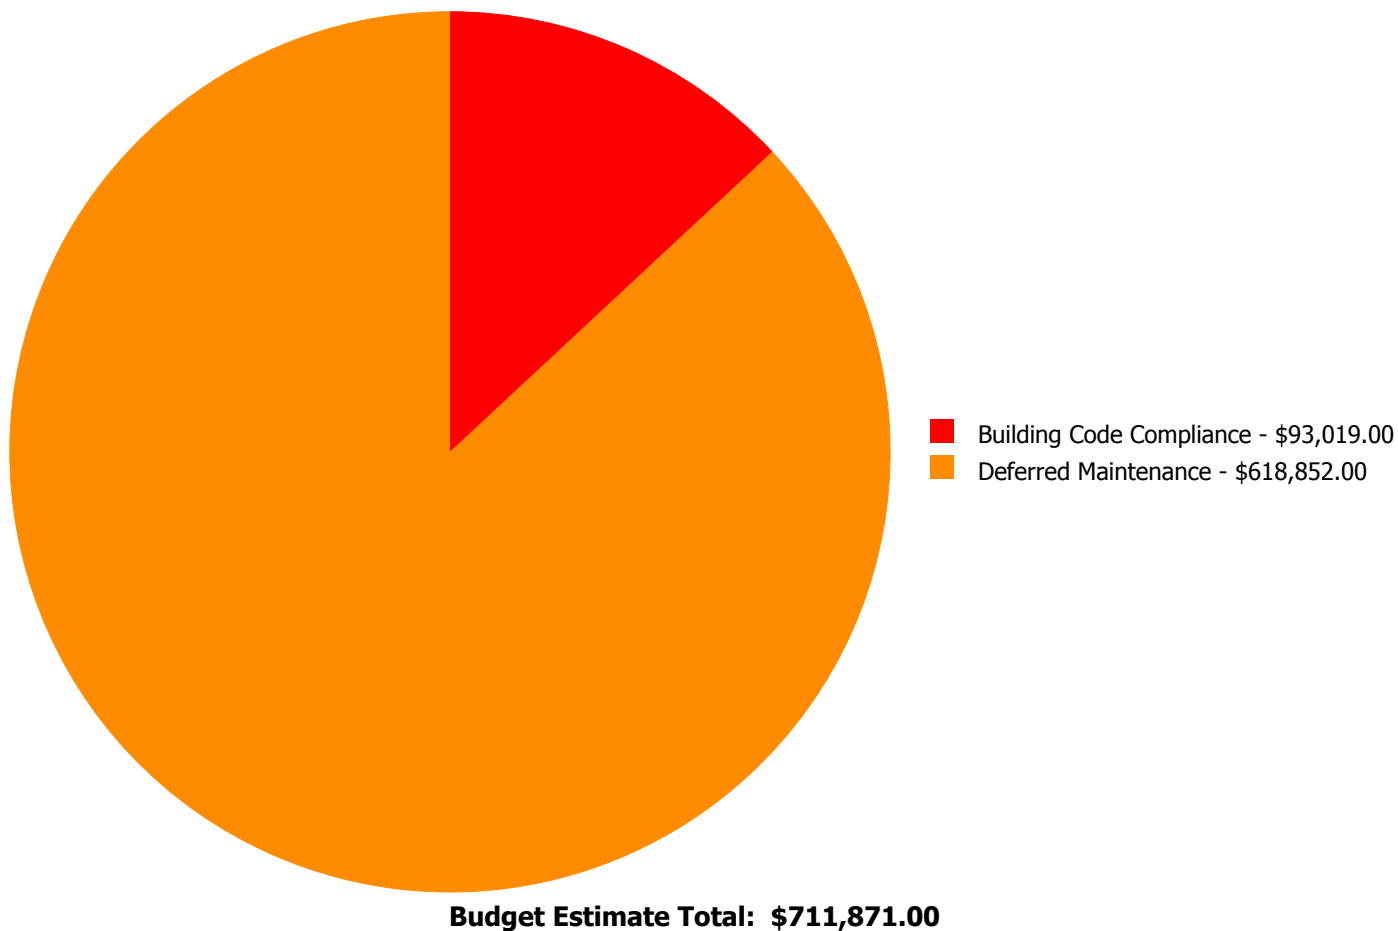
Deficiency Summary by Category

The following chart shows the total repair costs broken down by deficiency categories. Assessors assigned deficiencies to one of the following categories:

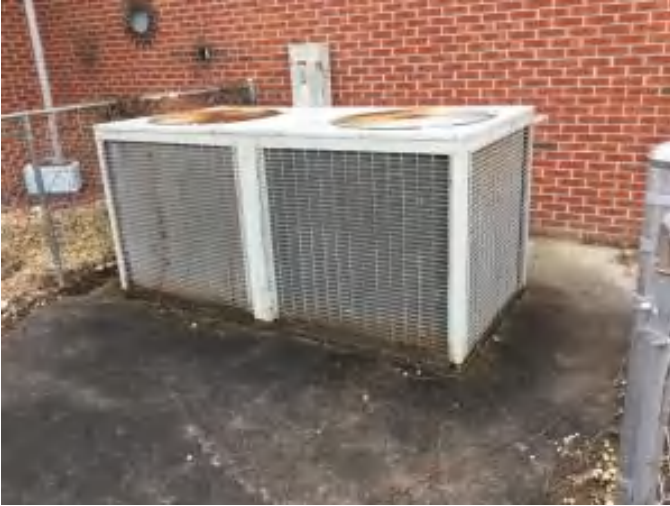
System: D3050 - Terminal & Package Units

Location: Throughout the building.
Distress: Beyond Service Life
Category: Deferred Maintenance
Priority: 3 - Necessary/Not Yet Critical (Years 2-5)
Correction: Renew System
Qty: 16,581.00
Unit of Measure: S.F.
Estimate: \$555,745.00
Assessor Name: Ann Buerger Linden
Date Created: 02/08/2017

Notes: Terminal and package units, mostly ground mounted heat pumps, have exceeded their expected useful life. System renewal is recommended to ensure system performance.

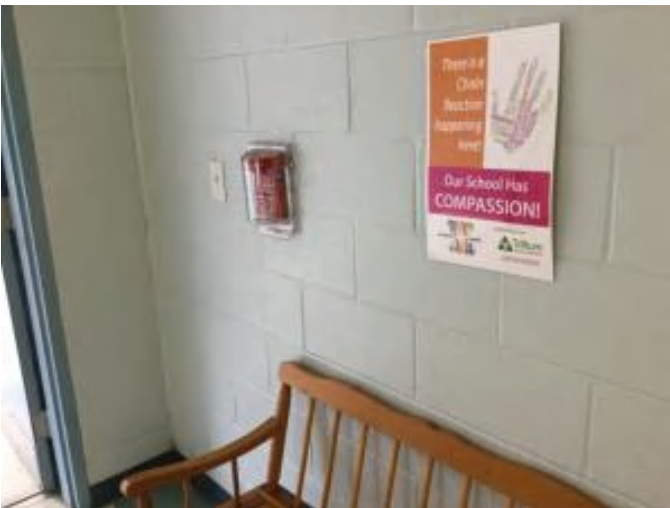
System: D5030910 - Fire Alarm Systems

Location: Throughout the building
Distress: Beyond Service Life
Category: Deferred Maintenance
Priority: 3 - Necessary/Not Yet Critical (Years 2-5)
Correction: Renew System
Qty: 16,581.00
Unit of Measure: S.F.
Estimate: \$63,107.00
Assessor Name: Ann Buerger Linden
Date Created: 02/08/2017

Notes: The fire alarm system is original and beyond its expected life. System renewal is recommended to ensure reliability of this life safety system.

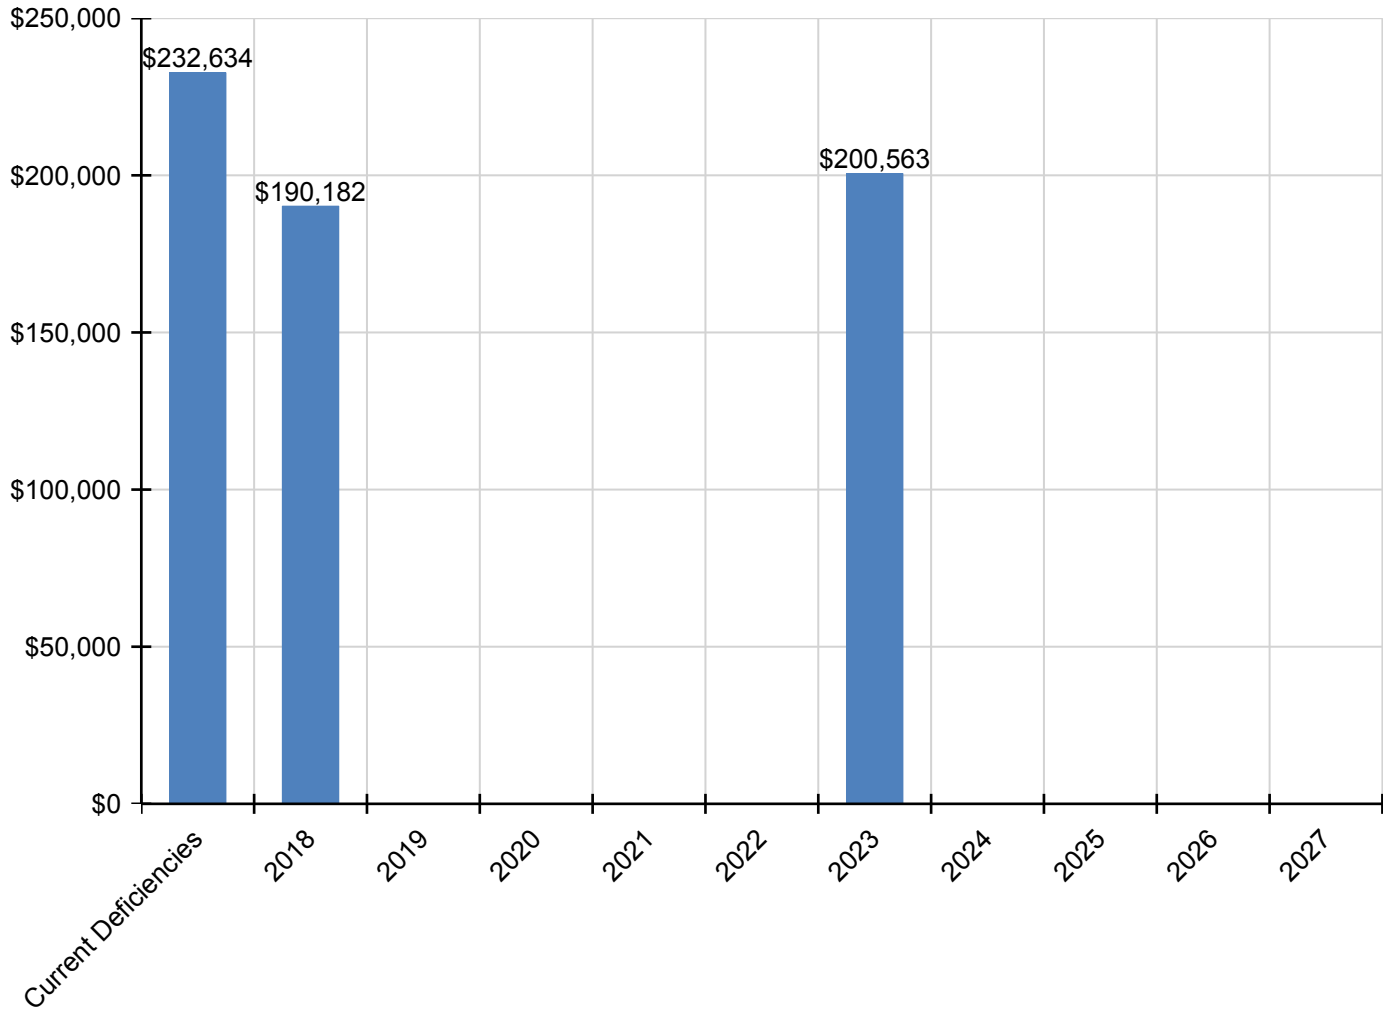
Forecasted Capital Renewal Requirement

The following chart shows the current building deficiencies and forecasting capital renewal or sustainment requirements over the next ten years.

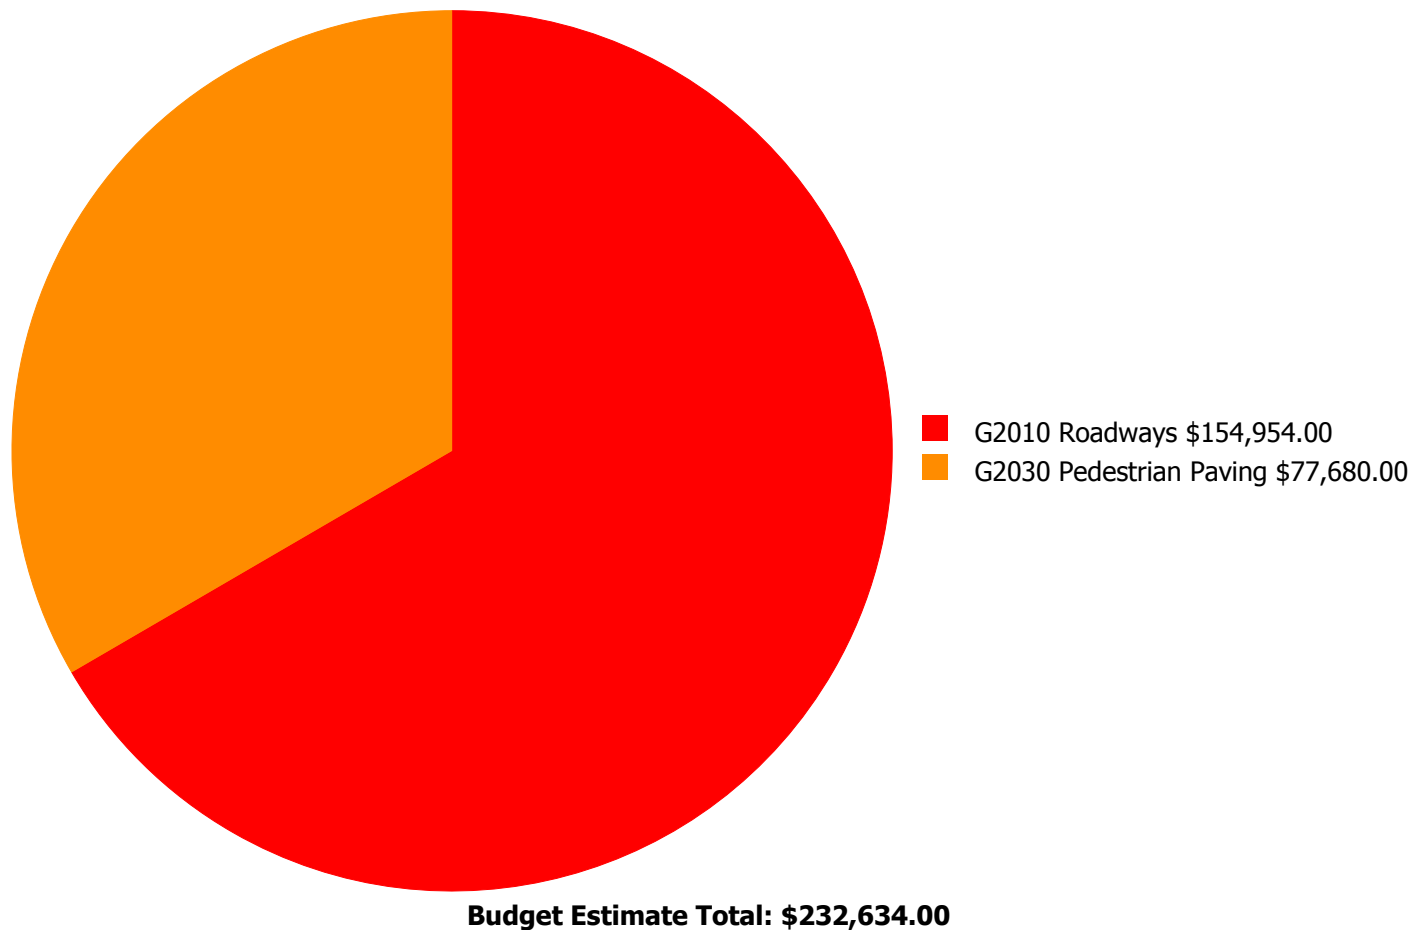
Deficiency Summary by System

Current deficiencies included assemblies that have reached or exceeded their design life or components of the assemblies that are in need of repair. Assemblies that have reached their design life are identified as current deficiencies and assigned the distress 'Beyond Useful Life'. The following chart lists all current deficiencies associated with this facility.

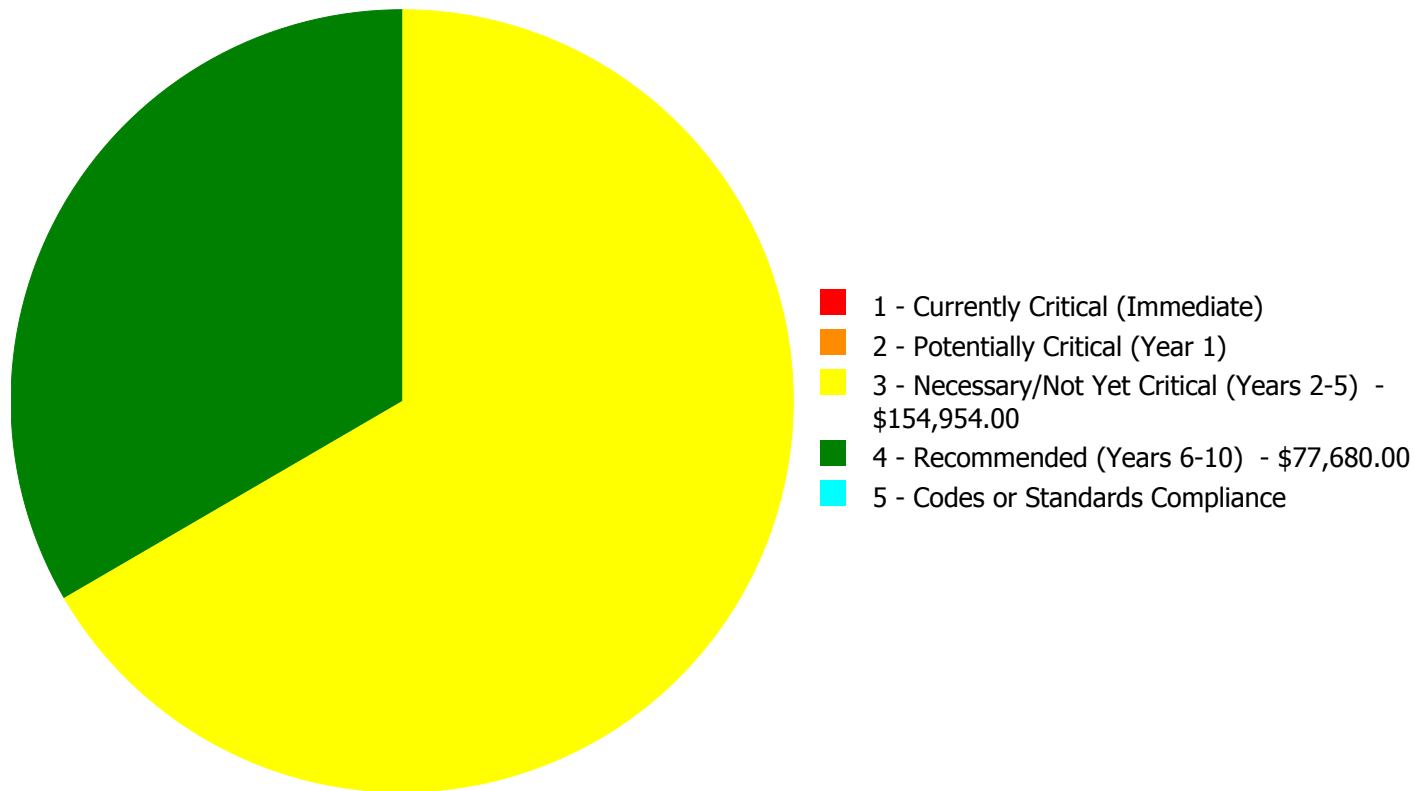
Deficiency Summary by Priority

The following chart shows the total repair costs broken down by priority. Assessors assigned deficiencies within eCOMET to one of the following priority categories:

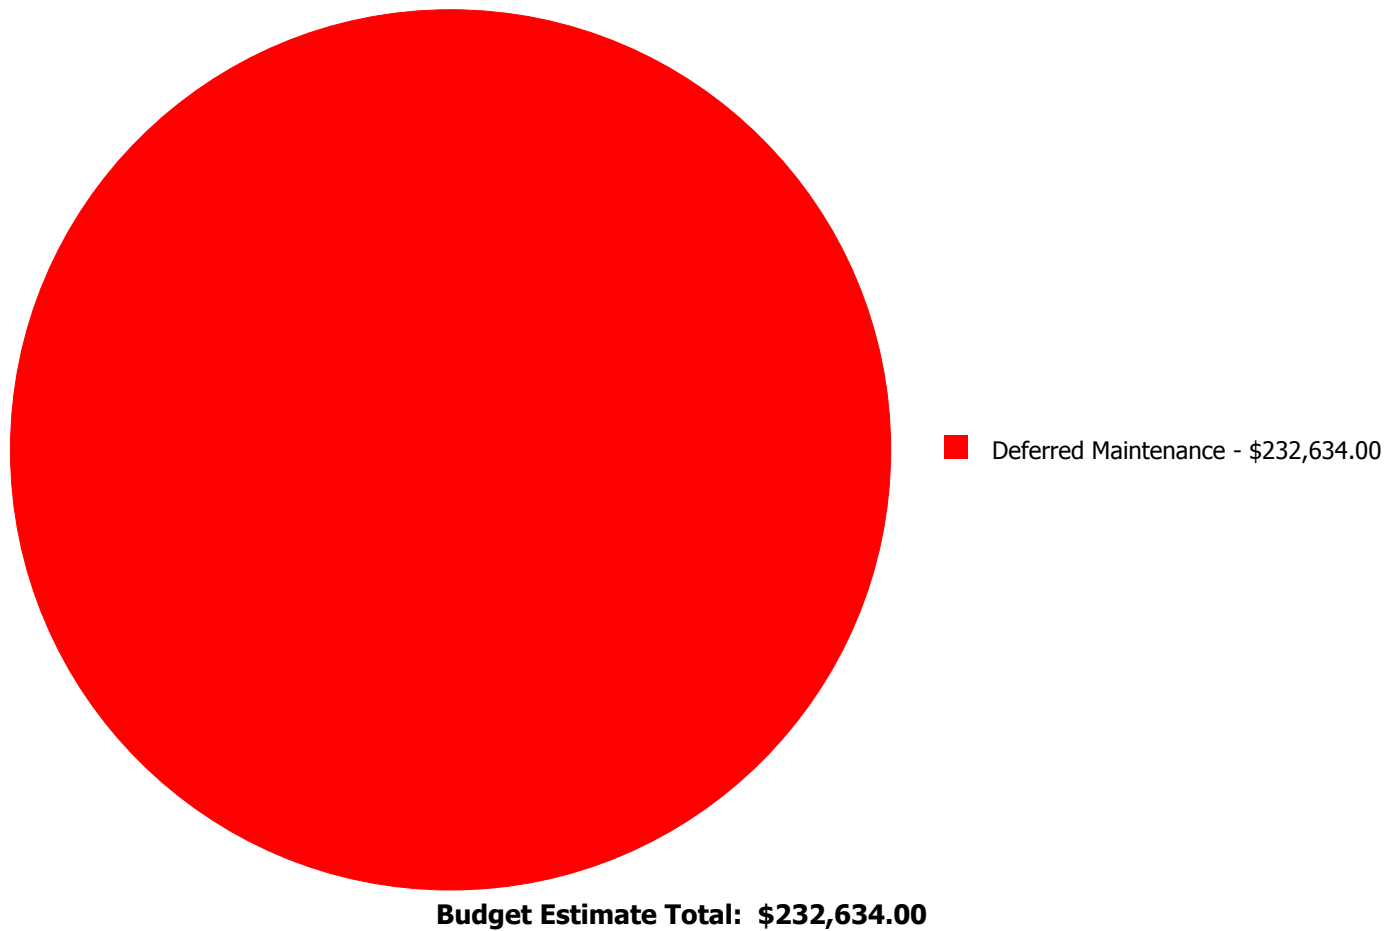
Deficiency Summary by Category

The following chart shows the total repair costs broken down by deficiency categories. Assessors assigned deficiencies to one of the following categories:

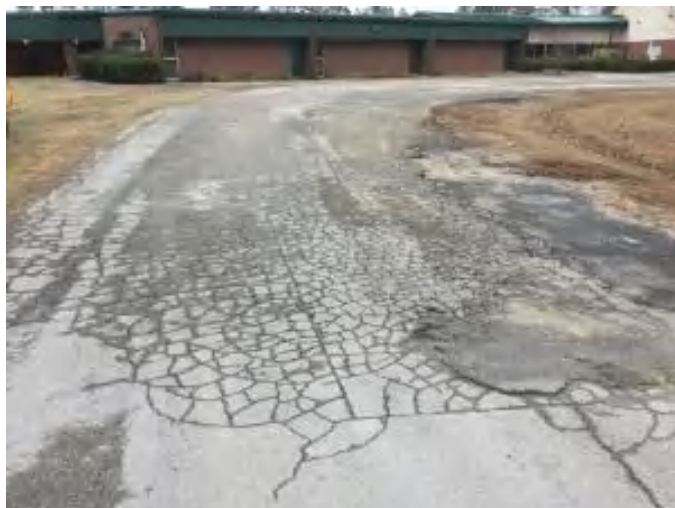
System: G2010 - Roadways

Location: Entrance drive - bus drop-off
Distress: Beyond Service Life
Category: Deferred Maintenance
Priority: 3 - Necessary/Not Yet Critical (Years 2-5)
Correction: Renew System
Qty: 36,973.00
Unit of Measure: S.F.
Estimate: \$154,954.00
Assessor Name: Ann Buerger Linden
Date Created: 02/08/2017

Notes: The asphaltic roadway is aged, has some repairs, and should be re-surfaced.

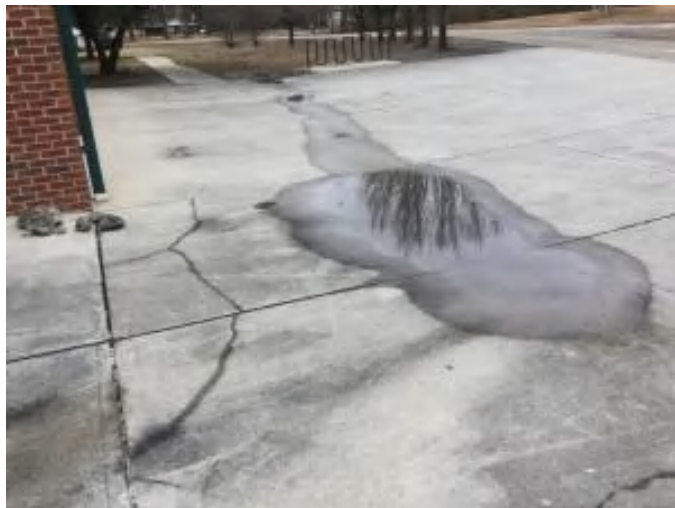
System: G2030 - Pedestrian Paving

Location: Site
Distress: Beyond Service Life
Category: Deferred Maintenance
Priority: 4 - Recommended (Years 6-10)
Correction: Renew System
Qty: 36,973.00
Unit of Measure: S.F.
Estimate: \$77,680.00
Assessor Name: Ann Buerger Linden
Date Created: 02/08/2017

Notes: The sidewalks are cracking and there is some ponding in settled areas. System renewal is recommended.

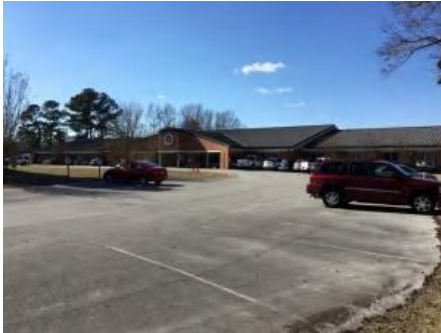
1). Southeast Elevation - Feb 15, 2017

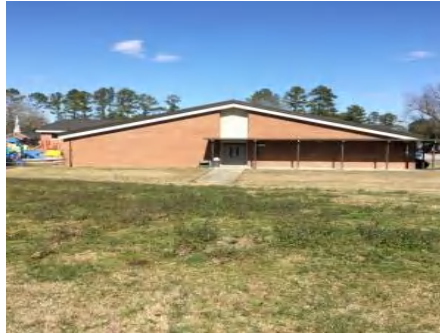
2). Southwest Elevation - Feb 15, 2017

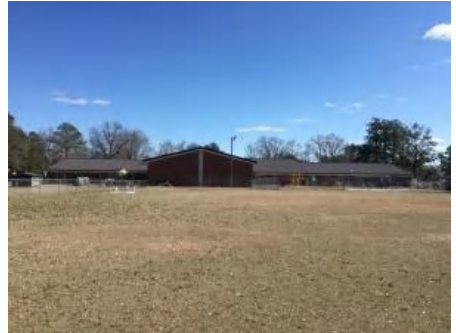
3). Northwest Elevation - Feb 15, 2017

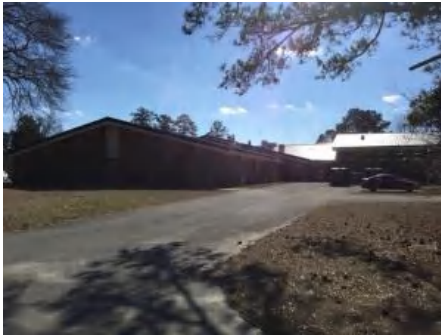
4). Northeast Elevation - Feb 15, 2017

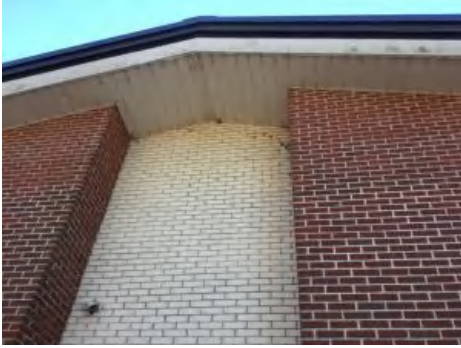
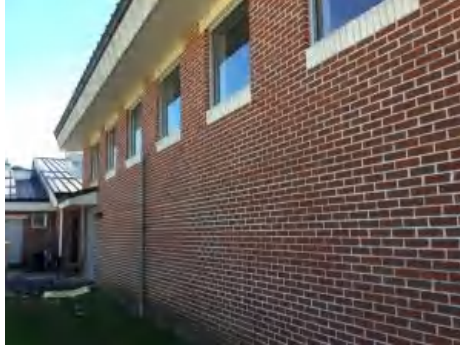
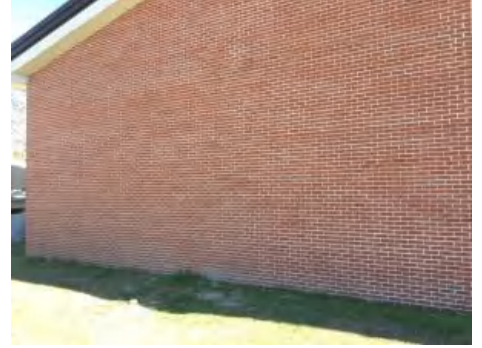
System: B2010 - Exterior Walls

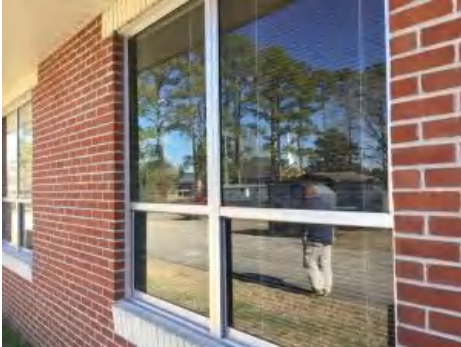
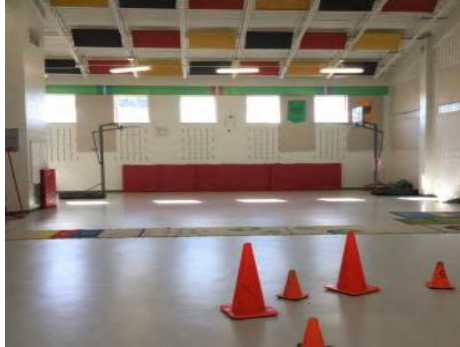
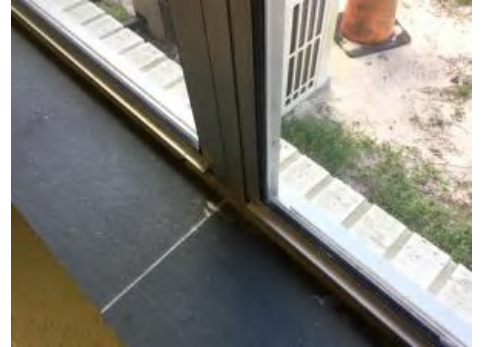
System: B2020 - Exterior Windows

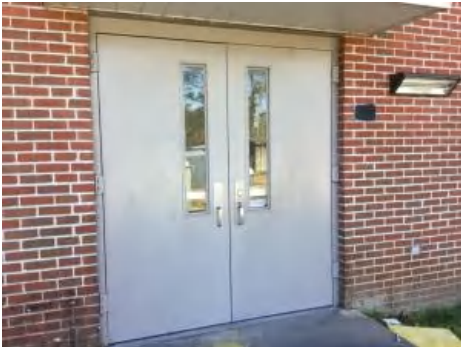
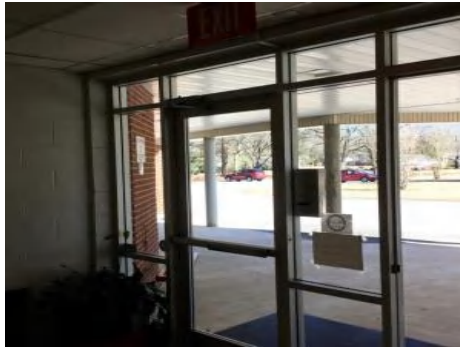
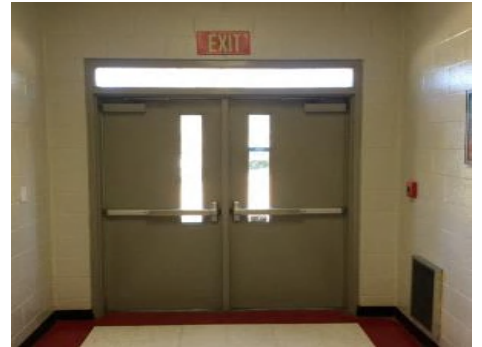
System: B2030 - Exterior Doors

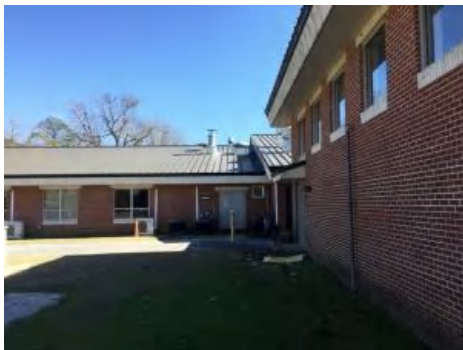
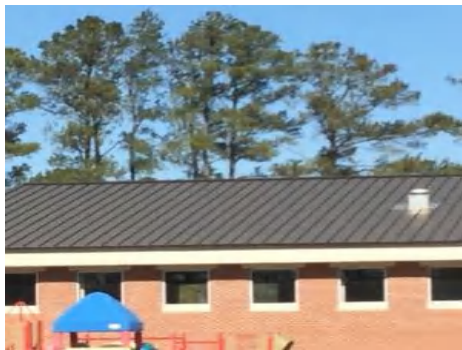
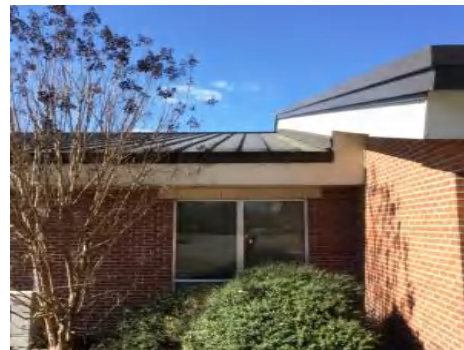
System: B3010130 - Preformed Metal Roofing

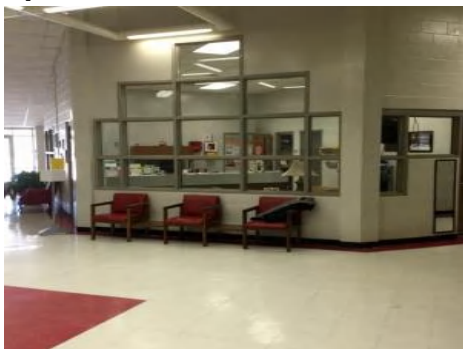
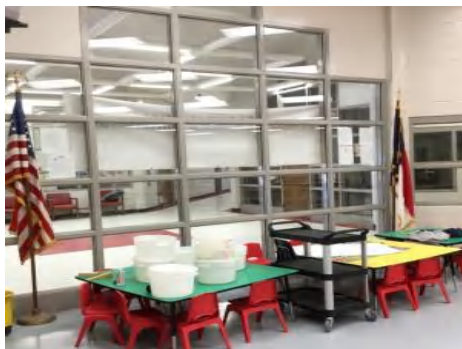
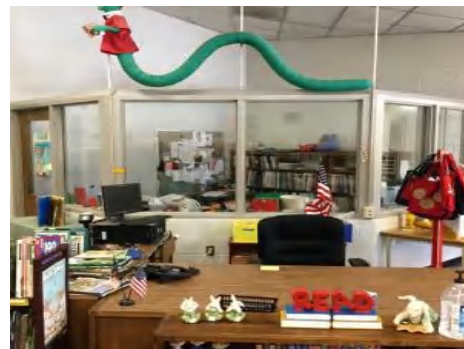
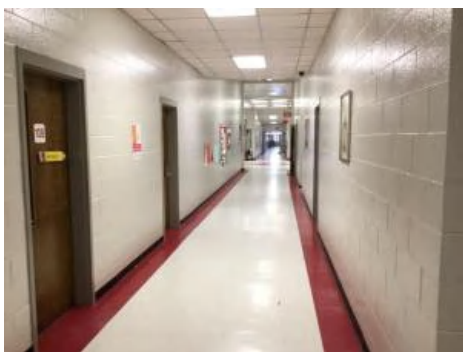
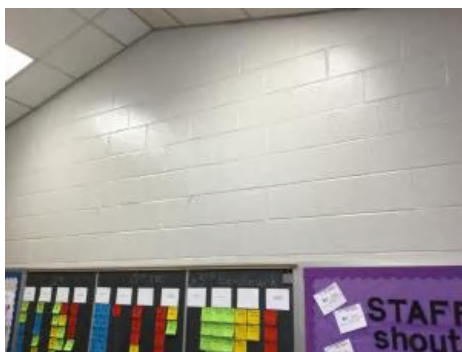
System: C1010 - Partitions

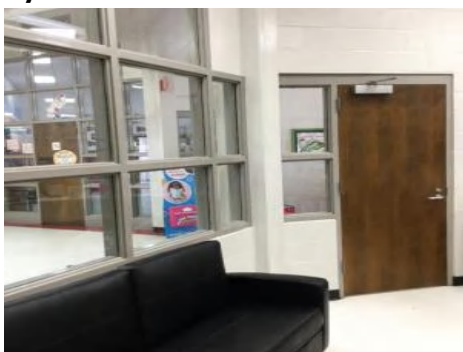
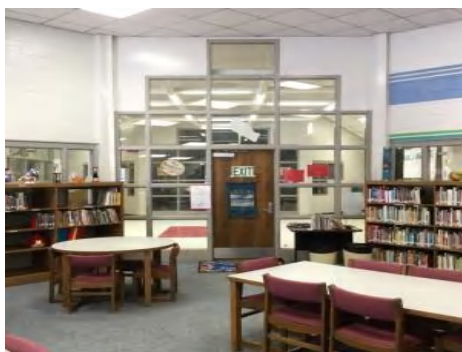
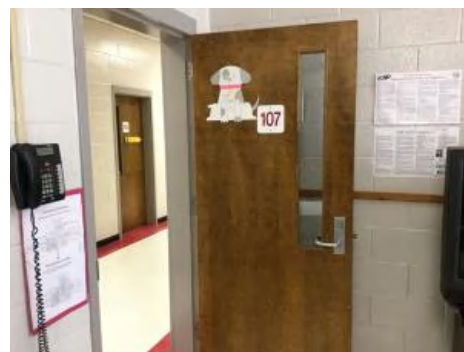
System: C1020 - Interior Doors

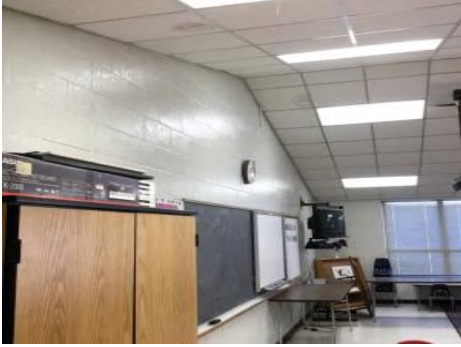
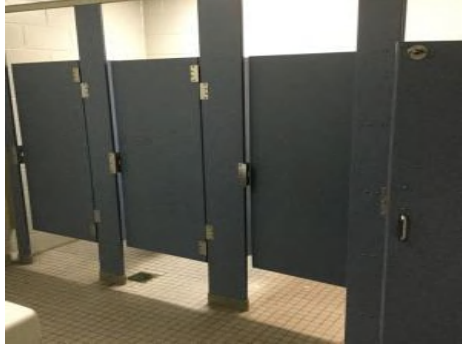
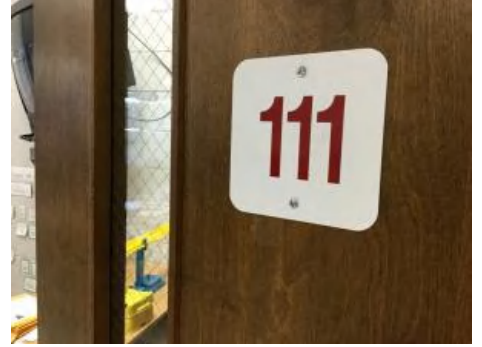
System: C1030 - Fittings

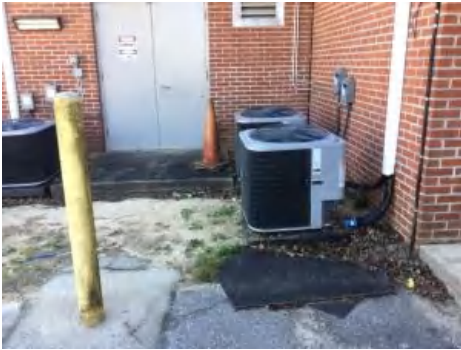
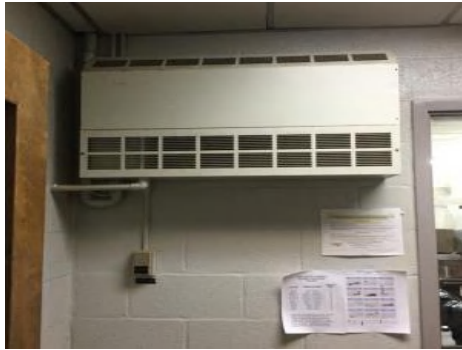
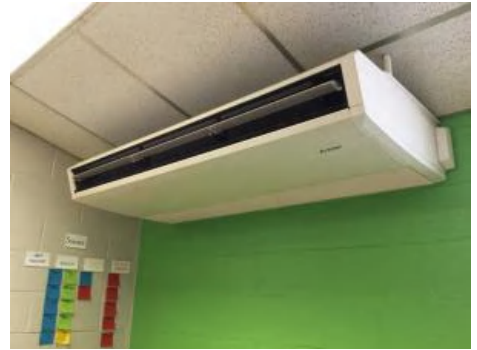
System: D3050 - Terminal & Package Units

Note: Classrooms, media center, cafeteria, and halls replaced 2014.

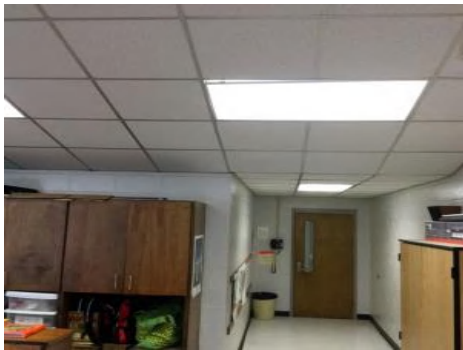
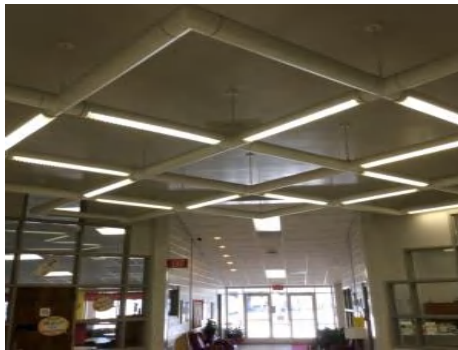
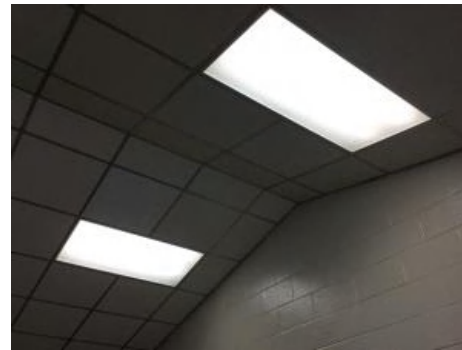
System: D5020 - Lighting

Note: Lighting upgraded to T-8 lamps and ballasts in existing fixtures, 2011.

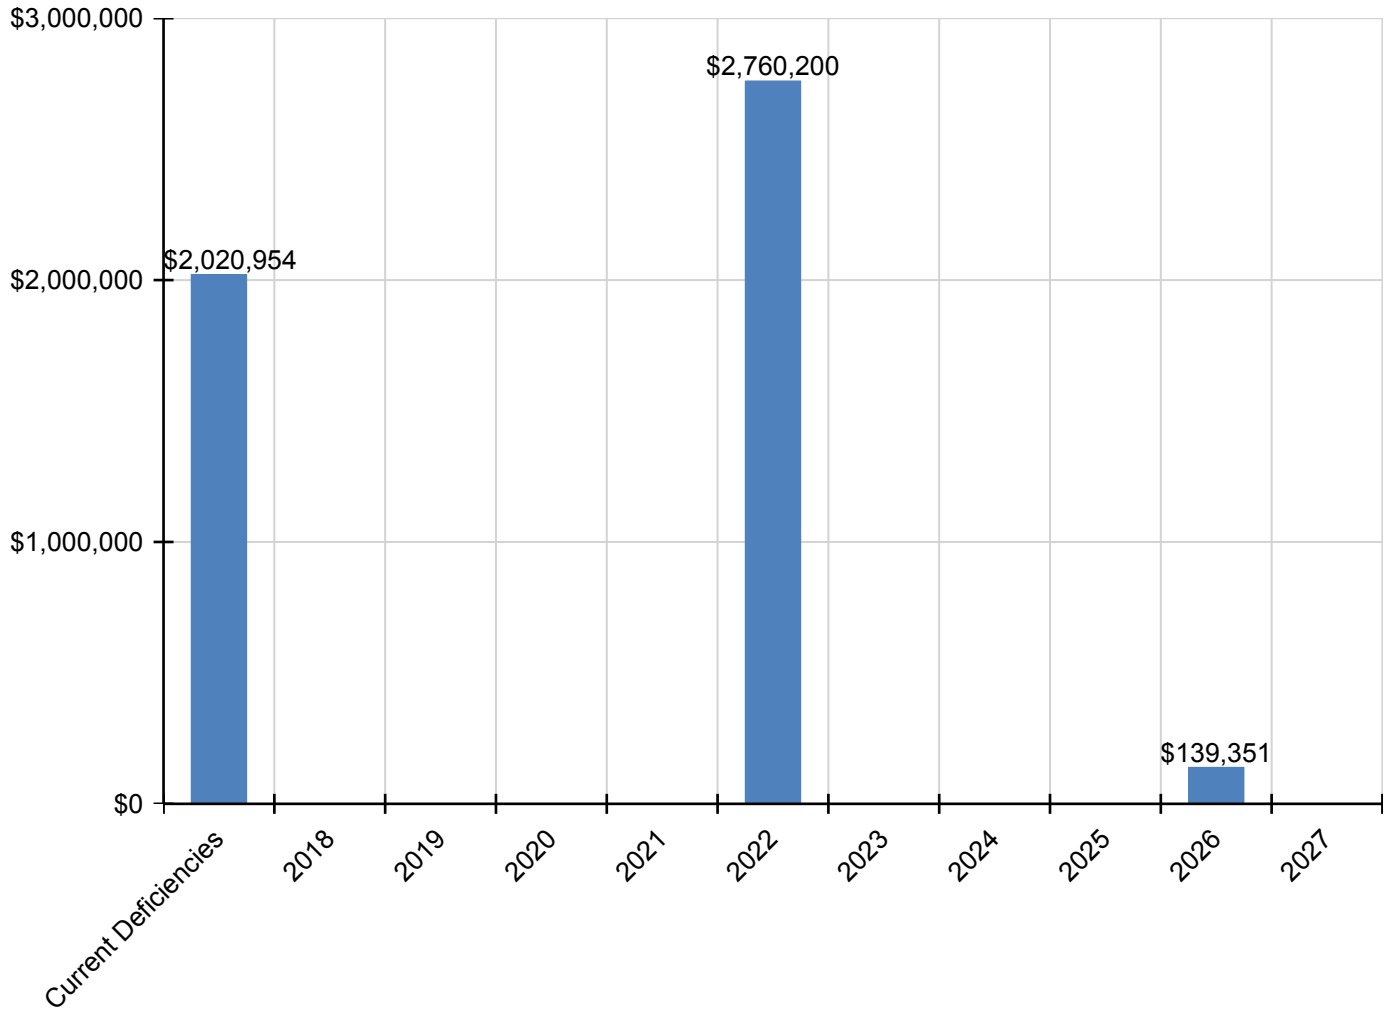
Forecasted Capital Renewal Requirement

The following chart shows the current building deficiencies and forecasting capital renewal or sustainment requirements over the next ten years.

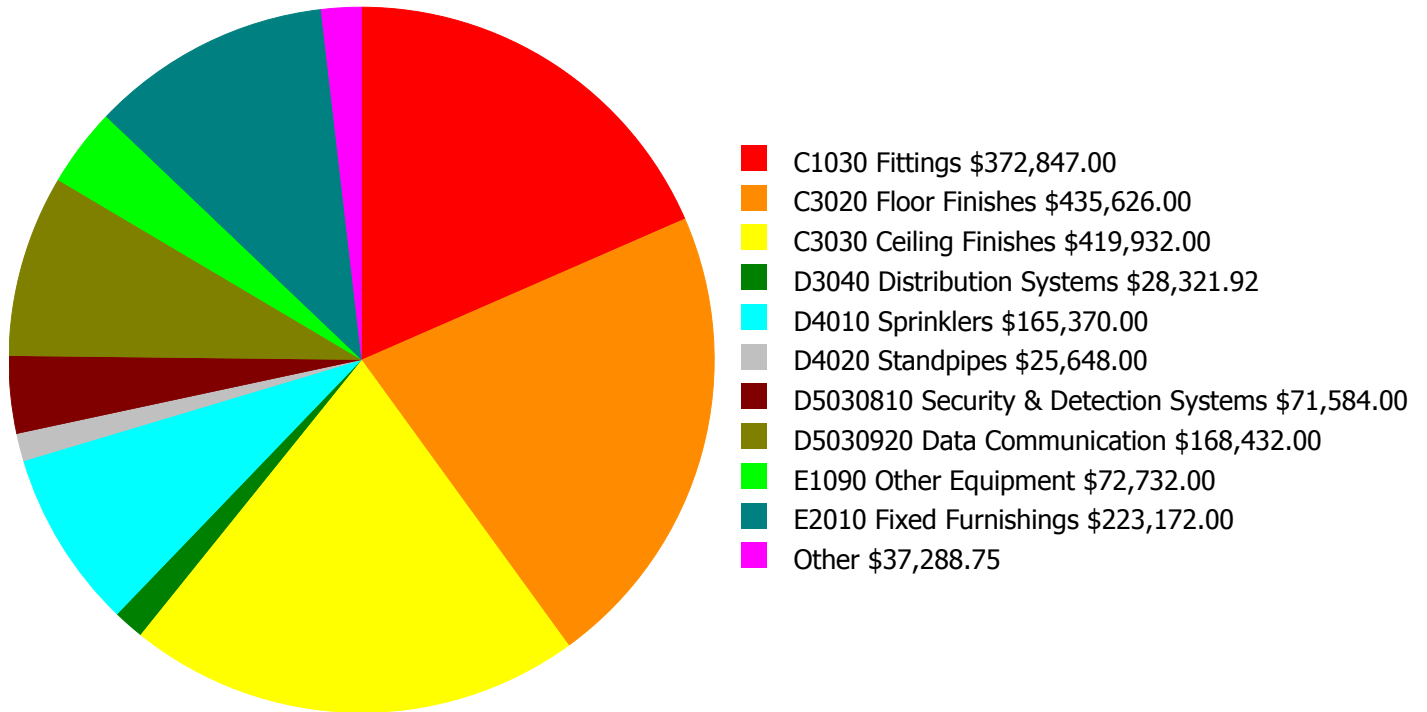
Deficiency Summary by System

Current deficiencies included assemblies that have reached or exceeded their design life or components of the assemblies that are in need of repair. Assemblies that have reached their design life are identified as current deficiencies and assigned the distress 'Beyond Useful Life'. The following chart lists all current deficiencies associated with this facility.

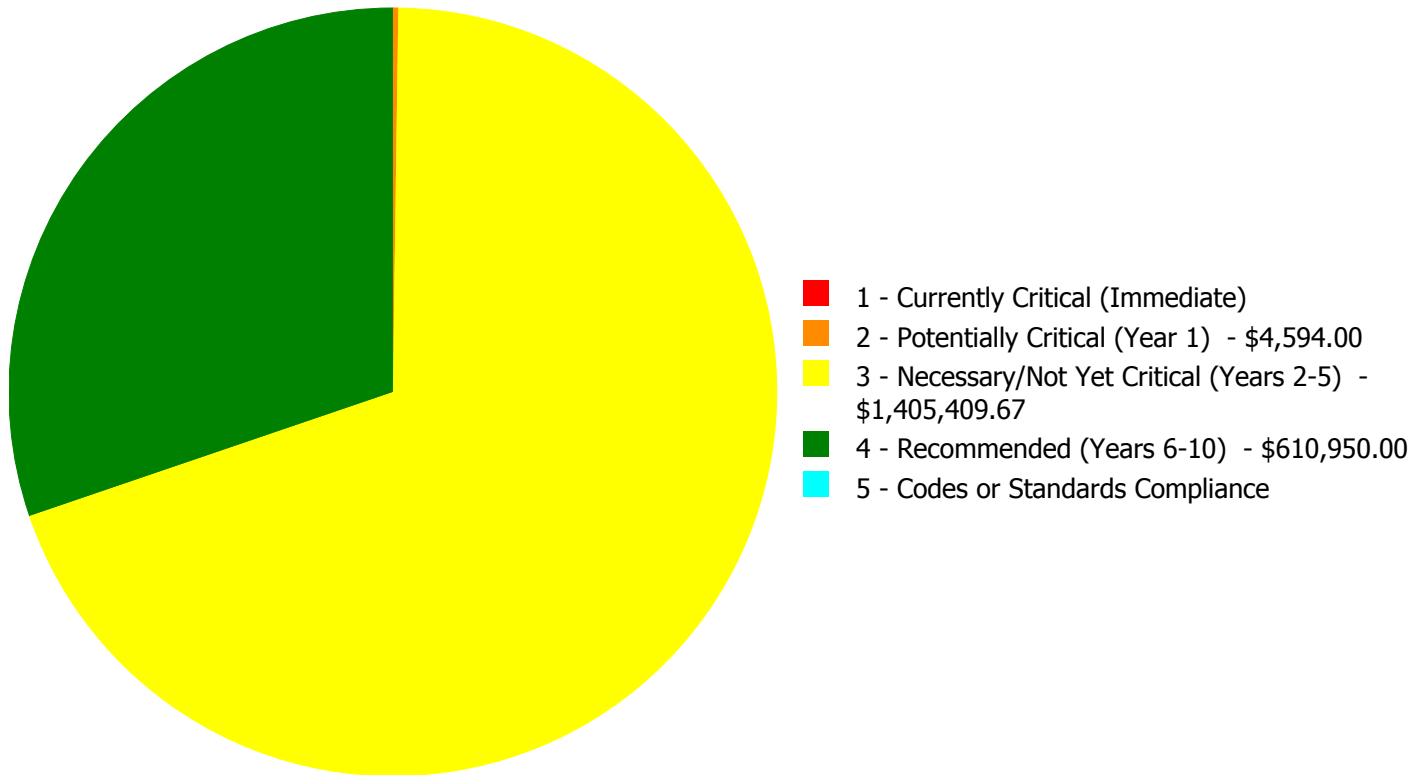
Deficiency Summary by Priority

The following chart shows the total repair costs broken down by priority. Assessors assigned deficiencies within eCOMET to one of the following priority categories:

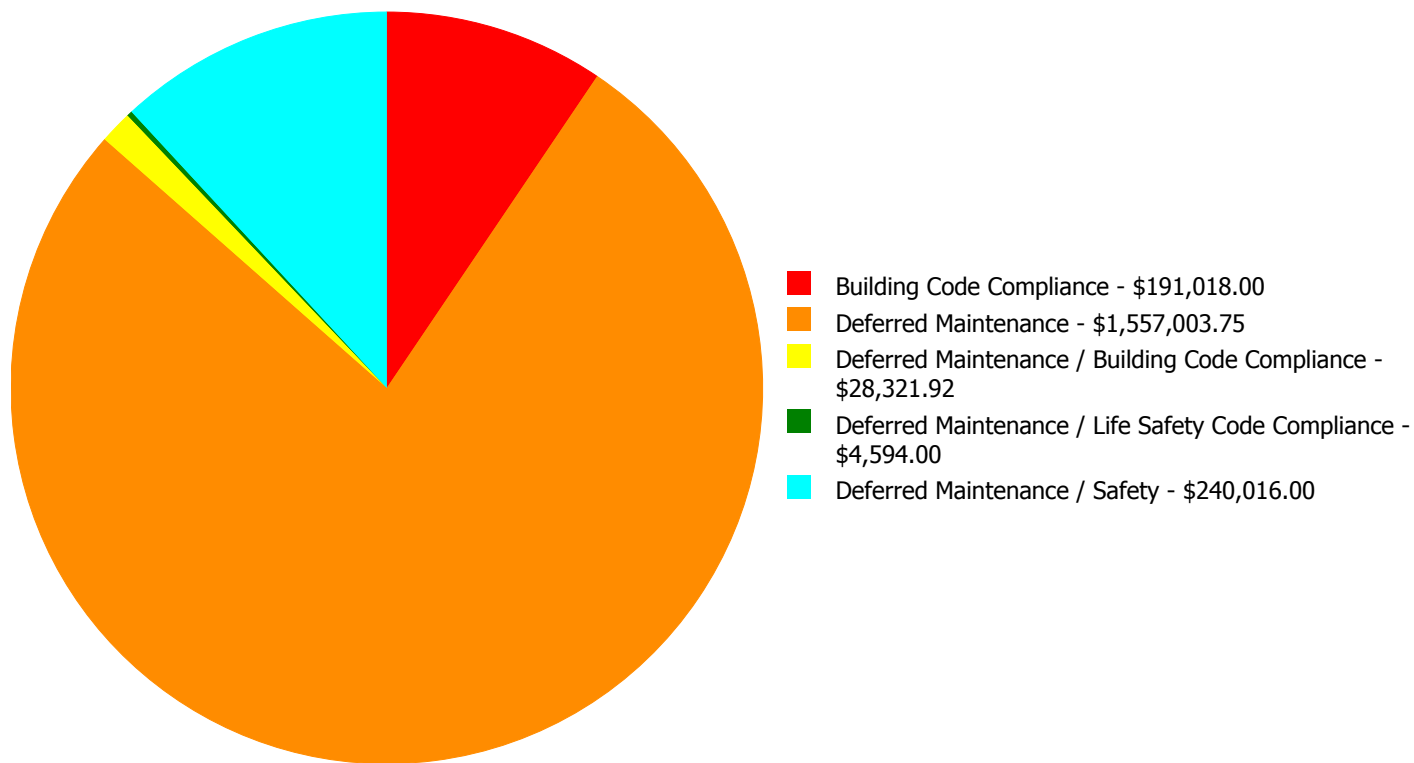
Deficiency Summary by Category

The following chart shows the total repair costs broken down by deficiency categories. Assessors assigned deficiencies to one of the following categories:

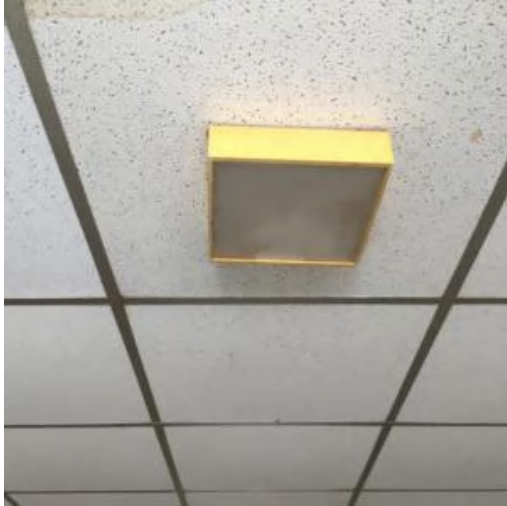
System: D5090 - Other Electrical Systems

Location: Throughout the building
Distress: Beyond Service Life
Category: Deferred Maintenance / Life Safety Code Compliance
Priority: 2 - Potentially Critical (Year 1)
Correction: Renew System
Qty: 34,800.00
Unit of Measure: S.F.
Estimate: \$4,594.00
Assessor Name: Ann Buerger Linden
Date Created: 01/31/2017

Notes: Emergency lighting is typically original, obsolete, and beyond its expected life. Repair parts are difficult to obtain. System renewal is recommended.

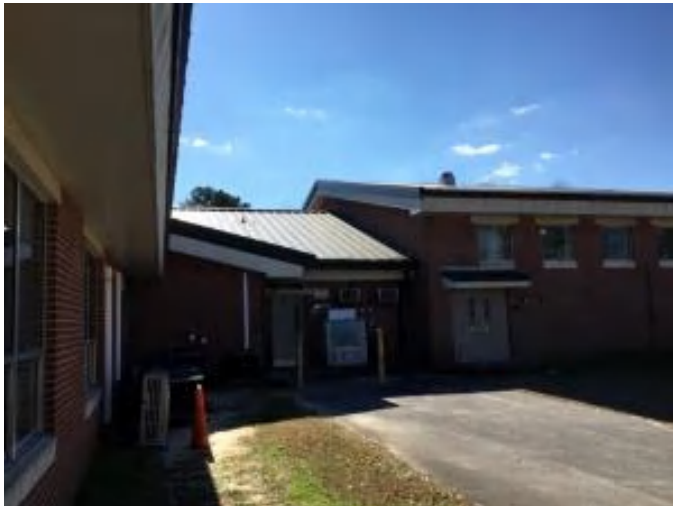
System: B3010130 - Preformed Metal Roofing

Location: Roof
Distress: Missing
Category: Deferred Maintenance
Priority: 3 - Necessary/Not Yet Critical (Years 2-5)
Correction: Install gutters and downspouts
Qty: 1,500.00
Unit of Measure: L.F.
Estimate: \$21,210.75
Assessor Name: Ann Buerger Linden
Date Created: 02/15/2017

Notes: The roof does not typically have gutters and downspouts at the roof edge, creating localized flooding problems and dumping water onto ground mounted HVAC equipment. Addition of gutters and downspouts is recommended.

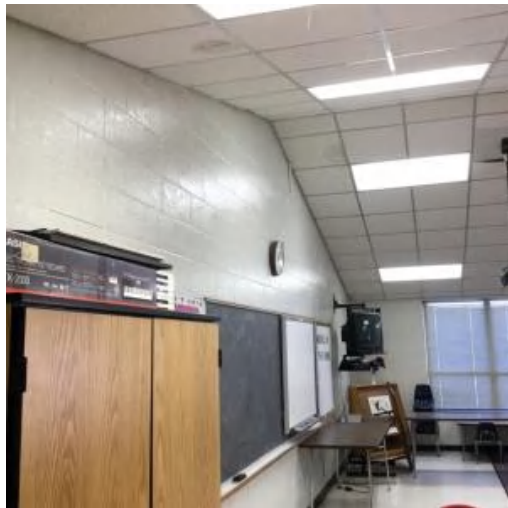
System: C1030 - Fittings

Location: Throughout the bulding
Distress: Beyond Service Life
Category: Deferred Maintenance
Priority: 3 - Necessary/Not Yet Critical (Years 2-5)
Correction: Renew System
Qty: 34,800.00
Unit of Measure: S.F.
Estimate: \$372,847.00
Assessor Name: Ann Buerger Linden
Date Created: 01/31/2017

Notes: Most fittings in the building are original and beyond their expected life. Some blackboards are present. Whiteboards are beginning to be stained. Room signage is not up to code. Toilet partitions do look newer. System renewal is recommended.

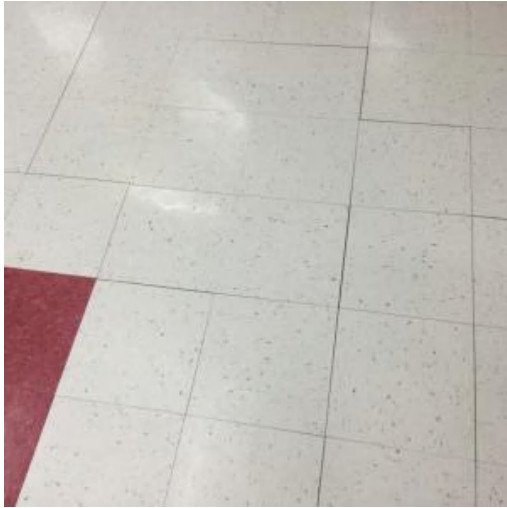
System: C3020 - Floor Finishes

Location: Throughout the building
Distress: Beyond Service Life
Category: Deferred Maintenance
Priority: 3 - Necessary/Not Yet Critical (Years 2-5)
Correction: Renew System
Qty: 34,800.00
Unit of Measure: S.F.
Estimate: \$435,626.00
Assessor Name: Ann Buerger Linden
Date Created: 01/31/2017

Notes: Floor finishes are typically original and are in fair condition. Joints in VCT are separating. Cracks and control joints in concrete are telegraphing through tile. Carpeting is worn. System renewal, with attention to floor prep, is recommended.

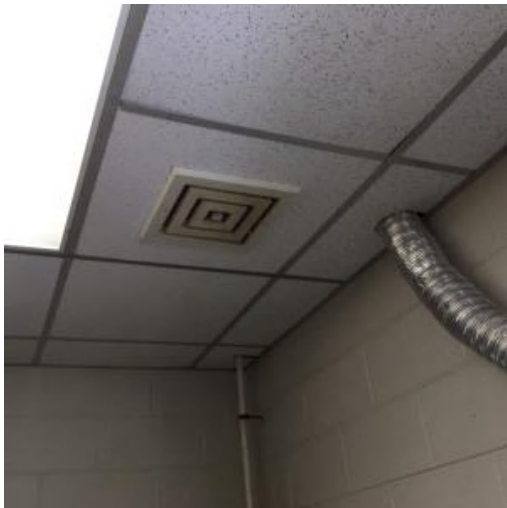
System: D3040 - Distribution Systems

Location: Toilet rooms
Distress: Failing
Category: Deferred Maintenance / Building Code Compliance
Priority: 3 - Necessary/Not Yet Critical (Years 2-5)
Correction: Replace roof mounted exhaust fan, 800 CFM exhaust fan
Qty: 12.00
Unit of Measure: Ea.
Estimate: \$28,321.92
Assessor Name: Ann Buerger Linden
Date Created: 02/15/2017

Notes: Exhaust fans reportedly do not work. Replace fans in toilet rooms.

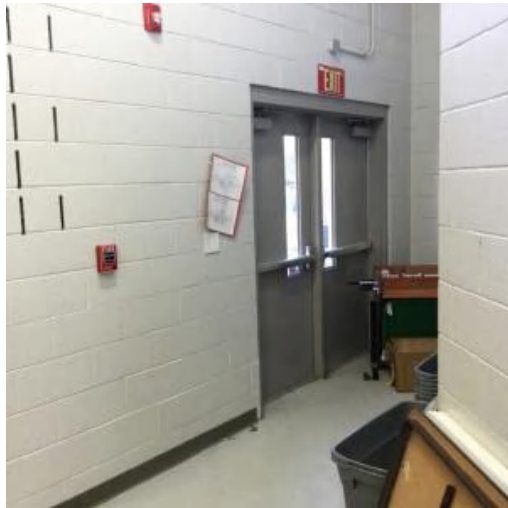
System: D5030810 - Security & Detection Systems

Location: Throughout the building
Distress: Inadequate
Category: Deferred Maintenance / Safety
Priority: 3 - Necessary/Not Yet Critical (Years 2-5)
Correction: Renew System
Qty: 34,800.00
Unit of Measure: S.F.
Estimate: \$71,584.00
Assessor Name: Ann Buerger Linden
Date Created: 01/31/2017

Notes: Security cameras do not cover all areas of the building (gym is not covered) or building exterior. Improvements in camera range are needed. System renewal is recommended.

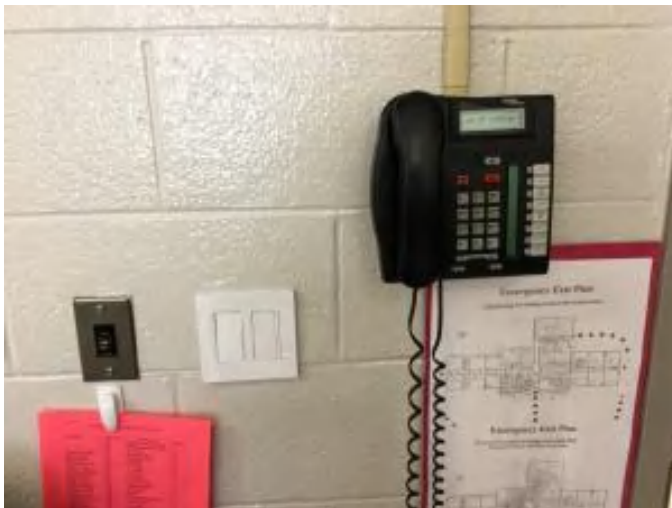
System: D5030920 - Data Communication

Location: Throughout the building
Distress: Beyond Service Life
Category: Deferred Maintenance / Safety
Priority: 3 - Necessary/Not Yet Critical (Years 2-5)
Correction: Renew System
Qty: 34,800.00
Unit of Measure: S.F.
Estimate: \$168,432.00
Assessor Name: Ann Buerger Linden
Date Created: 01/31/2017

Notes: The PA system does not function. Announcements need to be made on a room by room basis via telephone. System renewal is recommended.
