NC School District/520 Jones County/High School

Jones Senior High

Campus Assessment Report

March 8, 2017

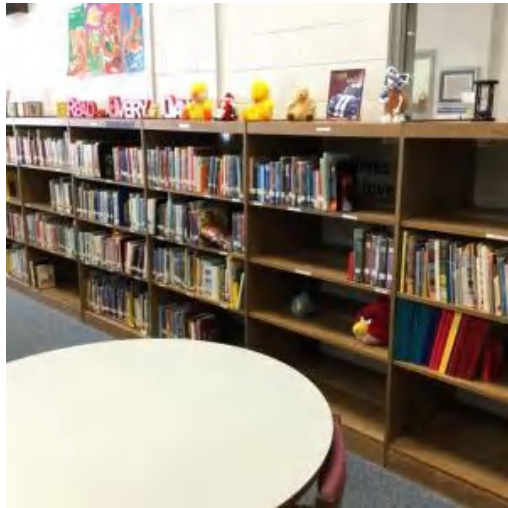
System: E1020 - Institutional Equipment

Location: Throughout the bulding
Distress: Beyond Service Life
Category: Deferred Maintenance
Priority: 3 - Necessary/Not Yet Critical (Years 2-5)
Correction: Renew System
Qty: 34,800.00
Unit of Measure: S.F.
Estimate: \$11,484.00
Assessor Name: Ann Buerger Linden
Date Created: 01/31/2017

Notes: Library equipment and other institutional equipment is typically original and in fair condition. System renewal is recommended.

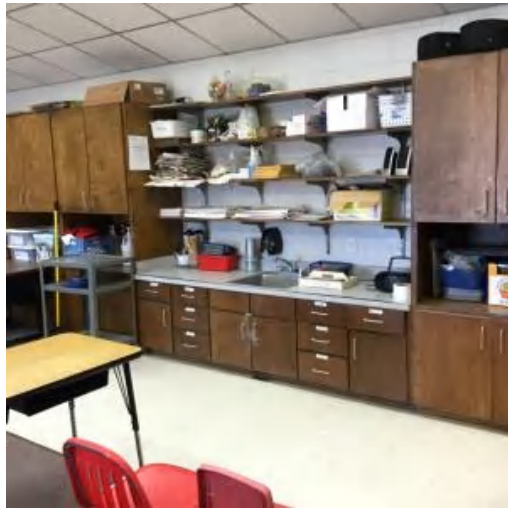
System: E2010 - Fixed Furnishings

Location: Throughout the building
Distress: Beyond Service Life
Category: Deferred Maintenance
Priority: 3 - Necessary/Not Yet Critical (Years 2-5)
Correction: Renew System
Qty: 34,800.00
Unit of Measure: S.F.
Estimate: \$223,172.00
Assessor Name: Ann Buerger Linden
Date Created: 01/31/2017

Notes: Classroom millwork and other fixed furnishing throughout the building is original and in well maintained but worn condition. System renewal is recommended.

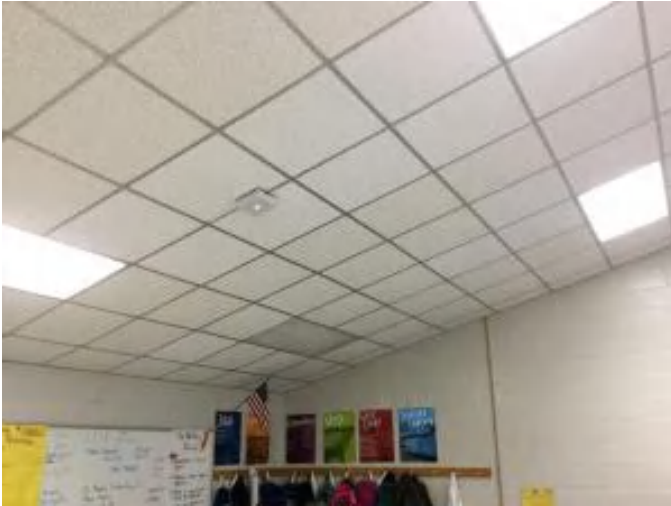
System: C3030 - Ceiling Finishes

Location: Throughout the building
Distress: Beyond Service Life
Category: Deferred Maintenance
Priority: 4 - Recommended (Years 6-10)
Correction: Renew System
Qty: 34,800.00
Unit of Measure: S.F.
Estimate: \$419,932.00
Assessor Name: Ann Buerger Linden
Date Created: 01/31/2017

Notes: Although well maintained in fair to good condition, the ceiling system is beyond its expected useful life and system renewal is recommended.

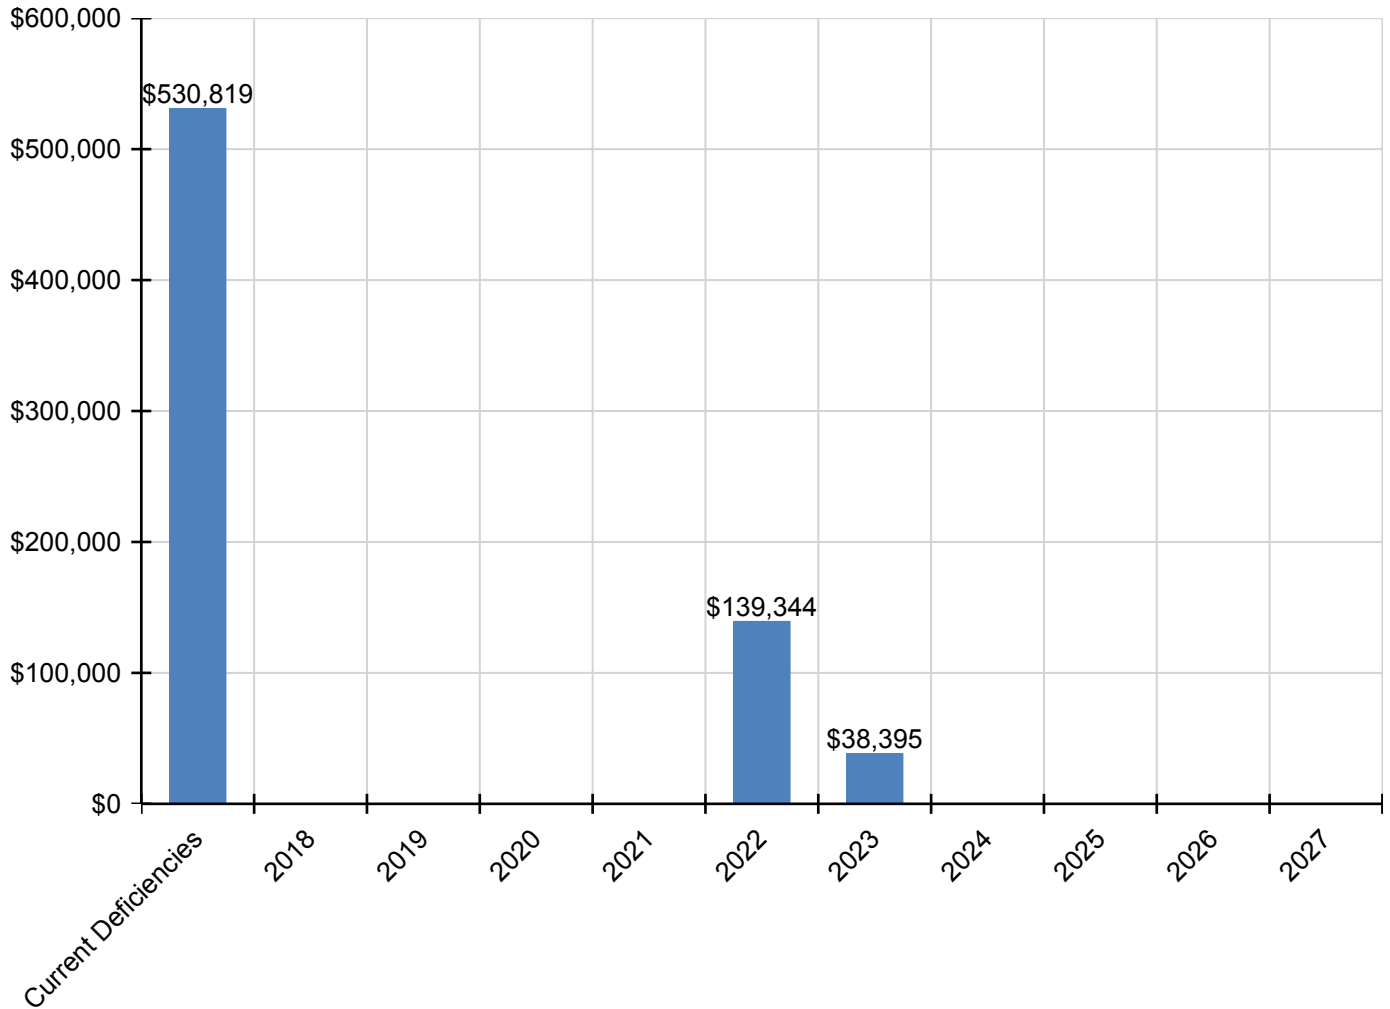
Forecasted Capital Renewal Requirement

The following chart shows the current building deficiencies and forecasting capital renewal or sustainment requirements over the next ten years.

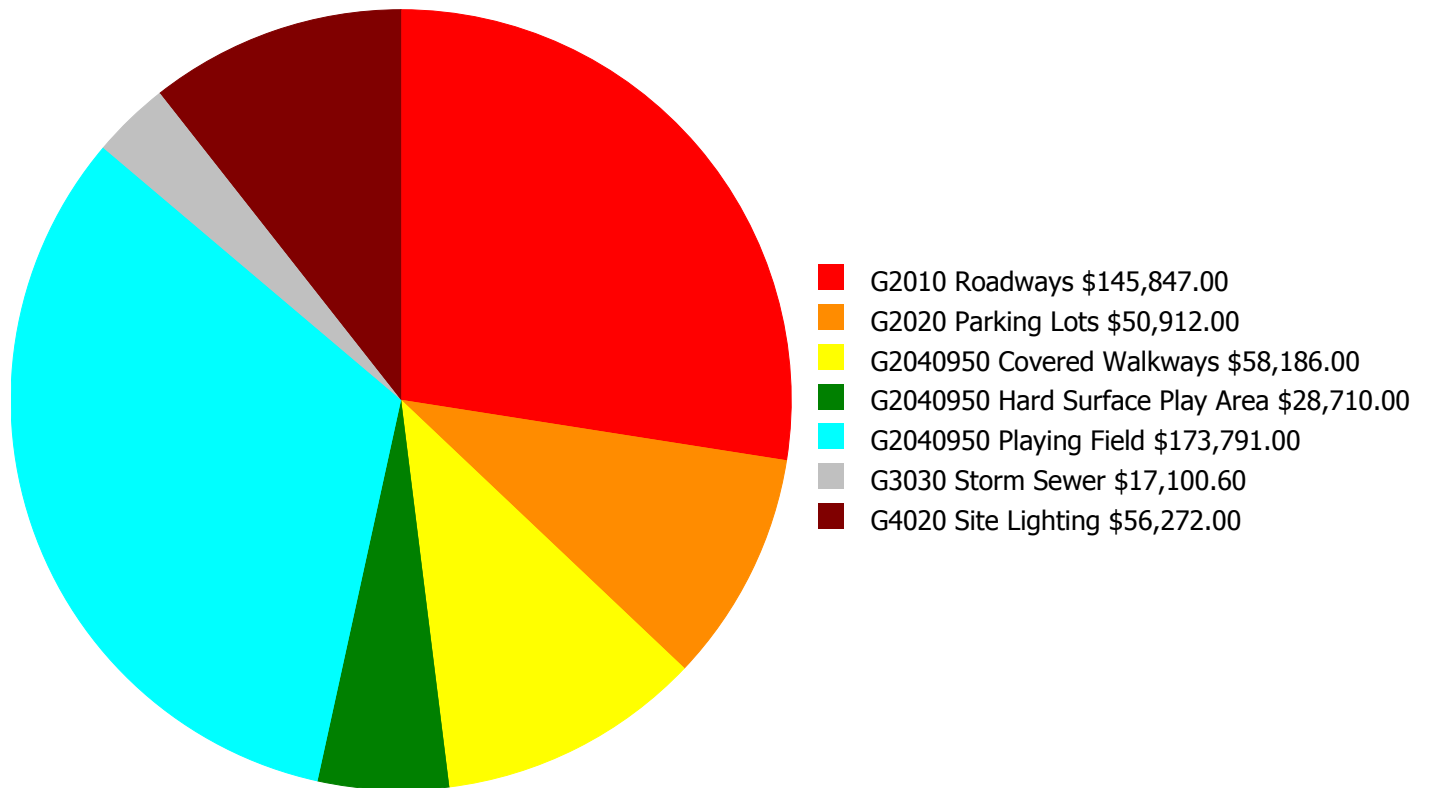
Deficiency Summary by System

Current deficiencies included assemblies that have reached or exceeded their design life or components of the assemblies that are in need of repair. Assemblies that have reached their design life are identified as current deficiencies and assigned the distress 'Beyond Useful Life'. The following chart lists all current deficiencies associated with this facility.

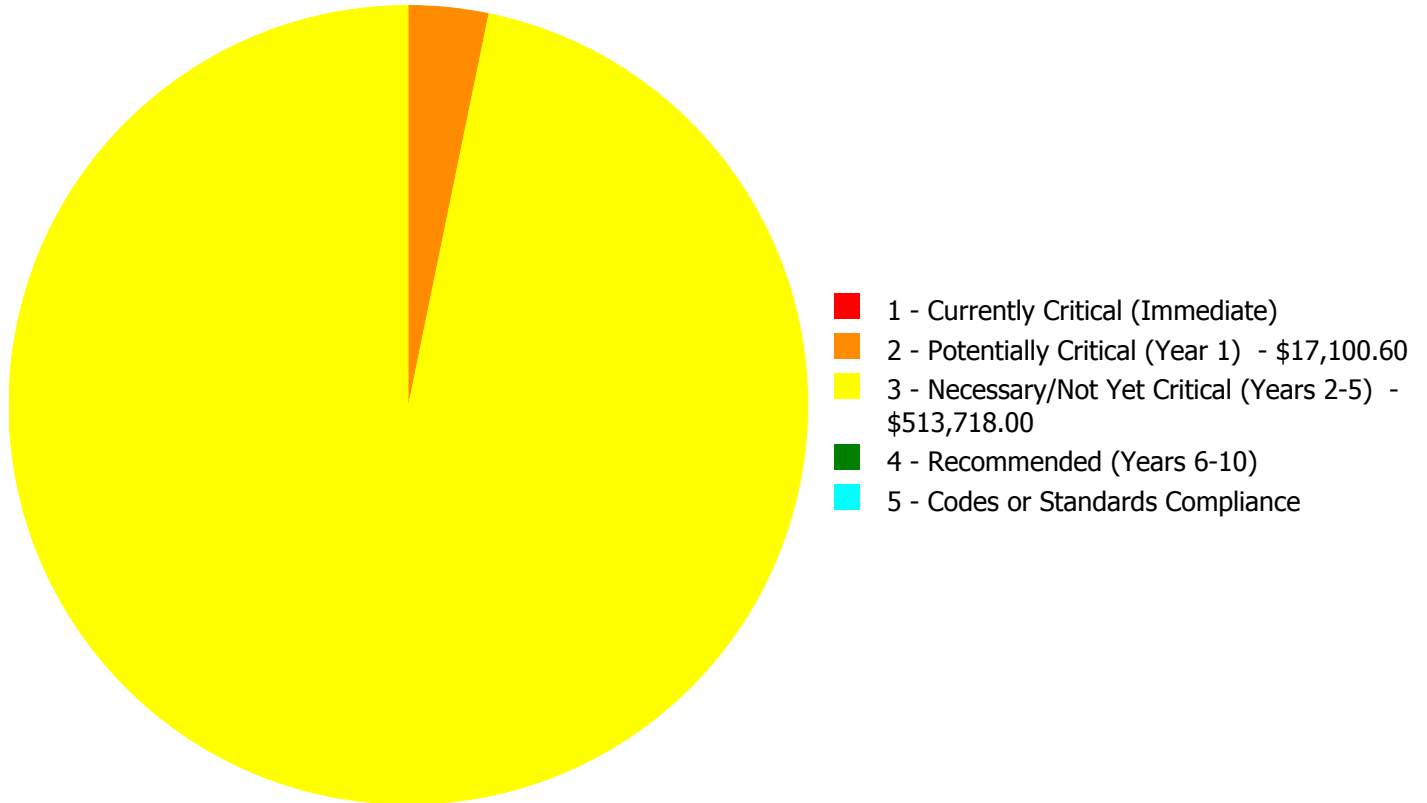
Deficiency Summary by Priority

The following chart shows the total repair costs broken down by priority. Assessors assigned deficiencies within eCOMET to one of the following priority categories:

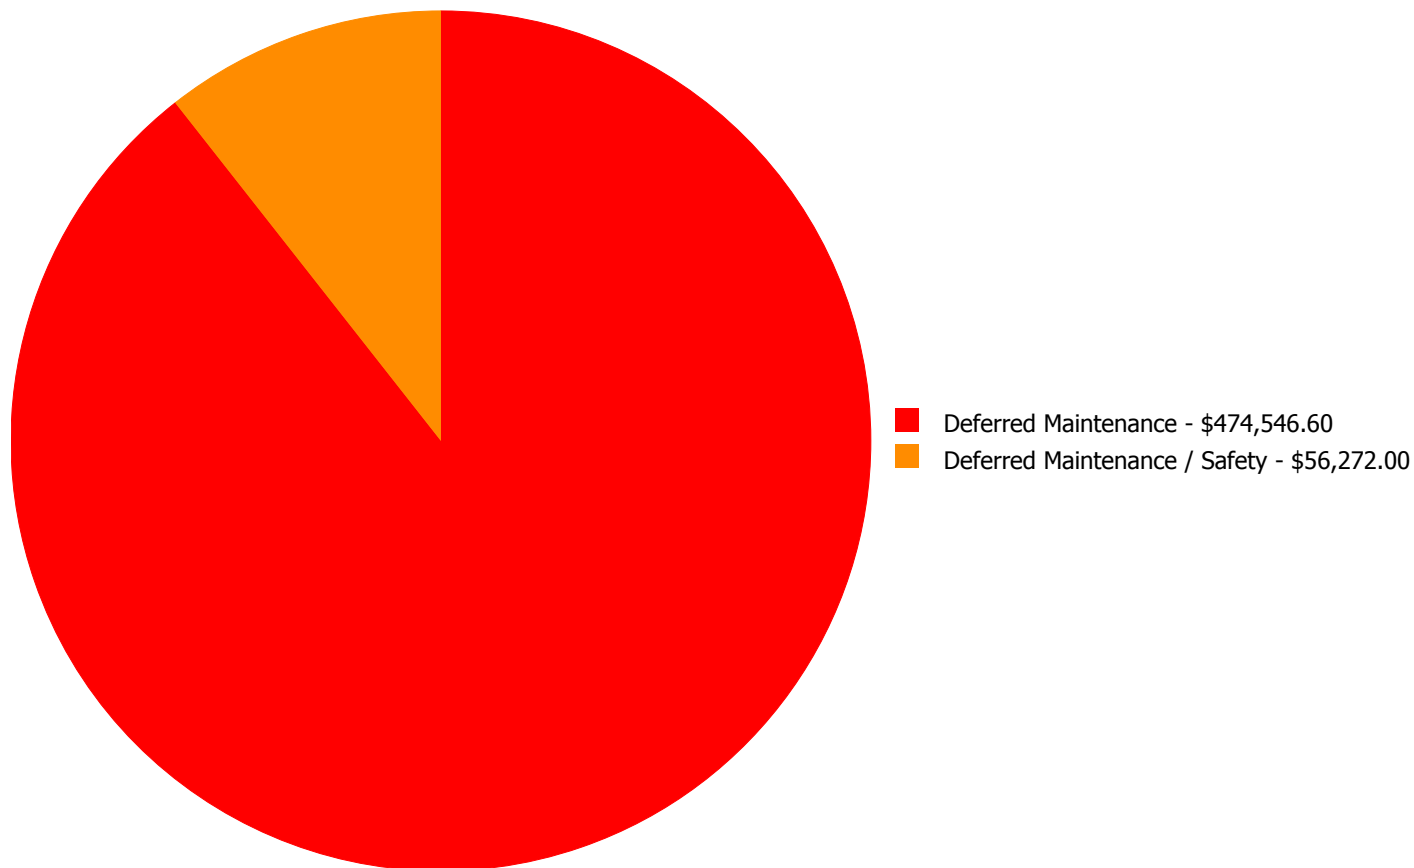
Deficiency Summary by Category

The following chart shows the total repair costs broken down by deficiency categories. Assessors assigned deficiencies to one of the following categories:

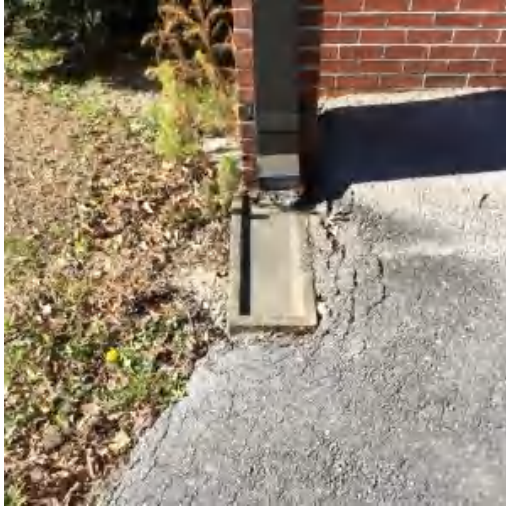
System: G3030 - Storm Sewer

Location: Around the building
Distress: Inadequate
Category: Deferred Maintenance
Priority: 2 - Potentially Critical (Year 1)
Correction: Repair storm sewer system
Qty: 1,500.00
Unit of Measure: L.F.
Estimate: \$17,100.60
Assessor Name: Ann Buerger Linden
Date Created: 02/15/2017

Notes: Storm sewers are not directly connected to roof downspouts, creating localized flooding problems. Extension of the on-site collection system to capture roof downspouts is recommended.

Note: Storm water collection from roof is inadequate.

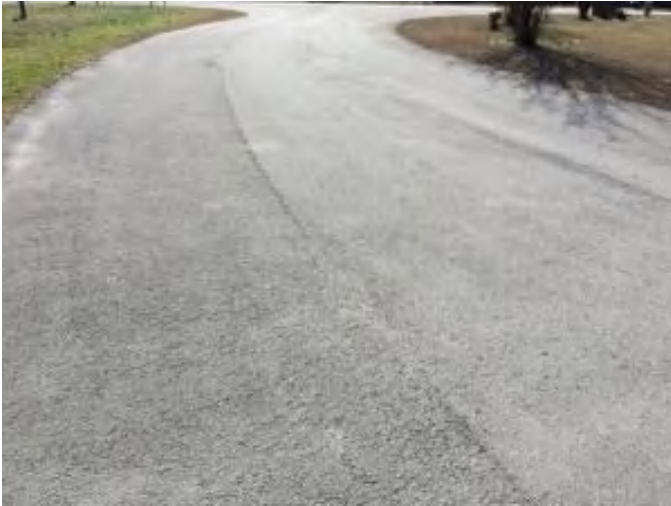
System: G2010 - Roadways

Location: Site roads
Distress: Beyond Service Life
Category: Deferred Maintenance
Priority: 3 - Necessary/Not Yet Critical (Years 2-5)
Correction: Renew System
Qty: 34,800.00
Unit of Measure: S.F.
Estimate: \$145,847.00
Assessor Name: Ann Buerger Linden
Date Created: 01/31/2017

Notes: Site roads have exceeded their expected useful life with some cracking and grainy surfaces. System renewal is recommended.

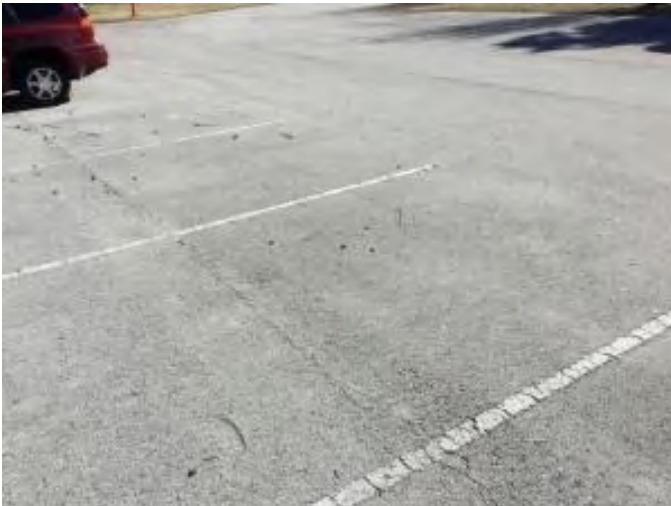
System: G2020 - Parking Lots

Location: Parking lots
Distress: Beyond Service Life
Category: Deferred Maintenance
Priority: 3 - Necessary/Not Yet Critical (Years 2-5)
Correction: Renew System
Qty: 34,800.00
Unit of Measure: S.F.
Estimate: \$50,912.00
Assessor Name: Ann Buerger Linden
Date Created: 01/31/2017

Notes: Parking lots have exceeded their expected life. Surfaces are grainy with some cracking. Striping is faded. System renewal is recommended.

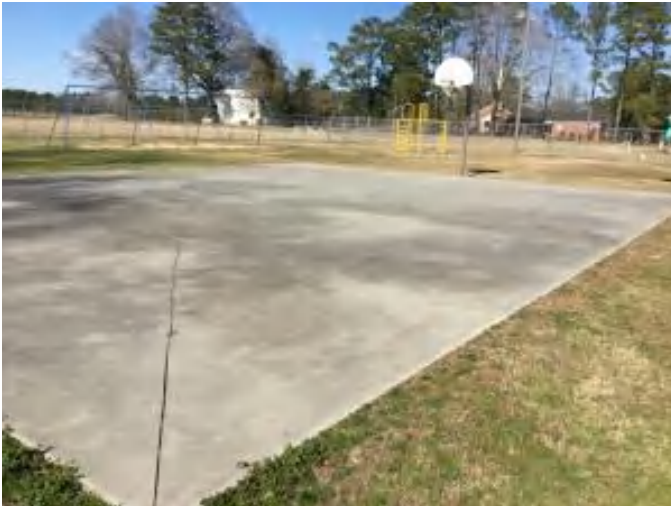
System: G2040950 - Hard Surface Play Area

Location: Playground
Distress: Beyond Service Life
Category: Deferred Maintenance
Priority: 3 - Necessary/Not Yet Critical (Years 2-5)
Correction: Renew System
Qty: 34,800.00
Unit of Measure: S.F.
Estimate: \$28,710.00
Assessor Name: Ann Buerger Linden
Date Created: 01/31/2017

Notes: The basketball court is cracked. System renewal is recommended.

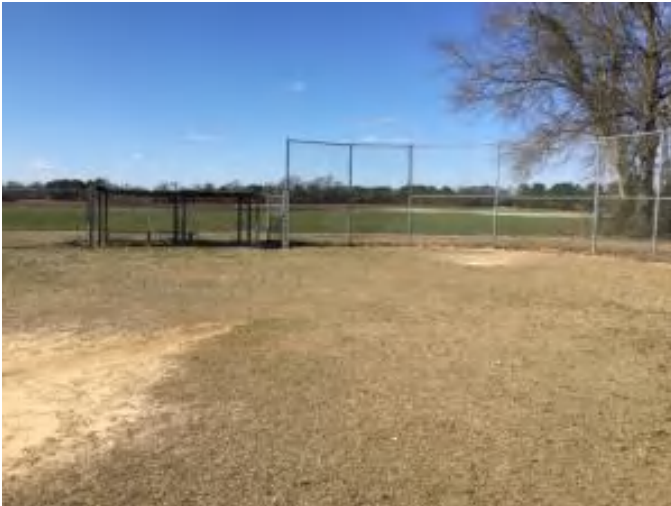
System: G2040950 - Playing Field

Location: Rear of site
Distress: Beyond Service Life
Category: Deferred Maintenance
Priority: 3 - Necessary/Not Yet Critical (Years 2-5)
Correction: Renew System
Qty: 34,800.00
Unit of Measure: S.F.
Estimate: \$173,791.00
Assessor Name: Ann Buerger Linden
Date Created: 01/31/2017

Notes: The playing field is worn and beyond its expected life. Dugouts are poorly constructed. System renewal is recommended.

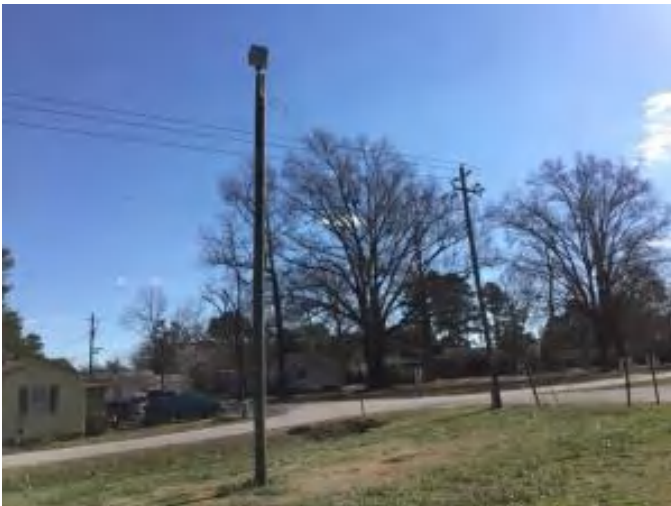
System: G4020 - Site Lighting

Location: Site, parking lots
Distress: Inadequate
Category: Deferred Maintenance / Safety
Priority: 3 - Necessary/Not Yet Critical (Years 2-5)
Correction: Renew System
Qty: 34,800.00
Unit of Measure: S.F.
Estimate: \$56,272.00
Assessor Name: Ann Buerger Linden
Date Created: 02/15/2017

Notes: Site lighting is inadequate for safety. System renewal is recommended.

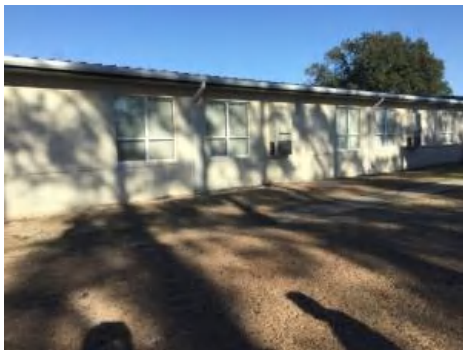
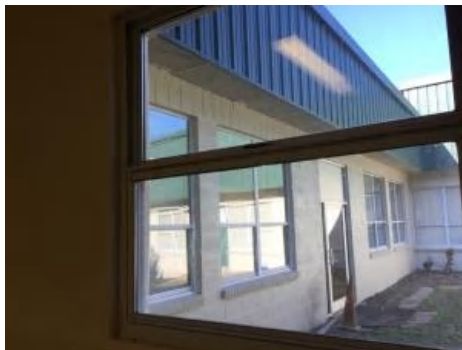
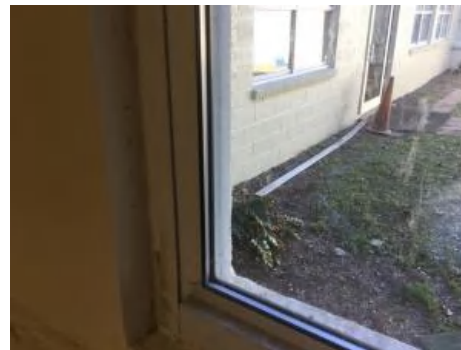
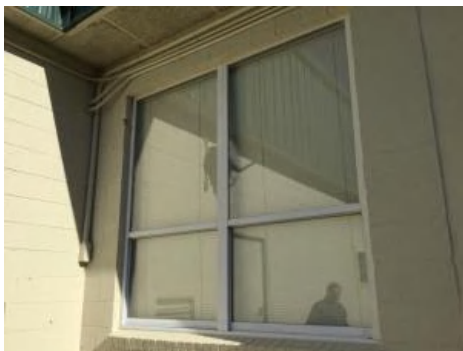
System: B2020 - Exterior Windows

Note: Assumed install date with installation of Bard HVAC units.

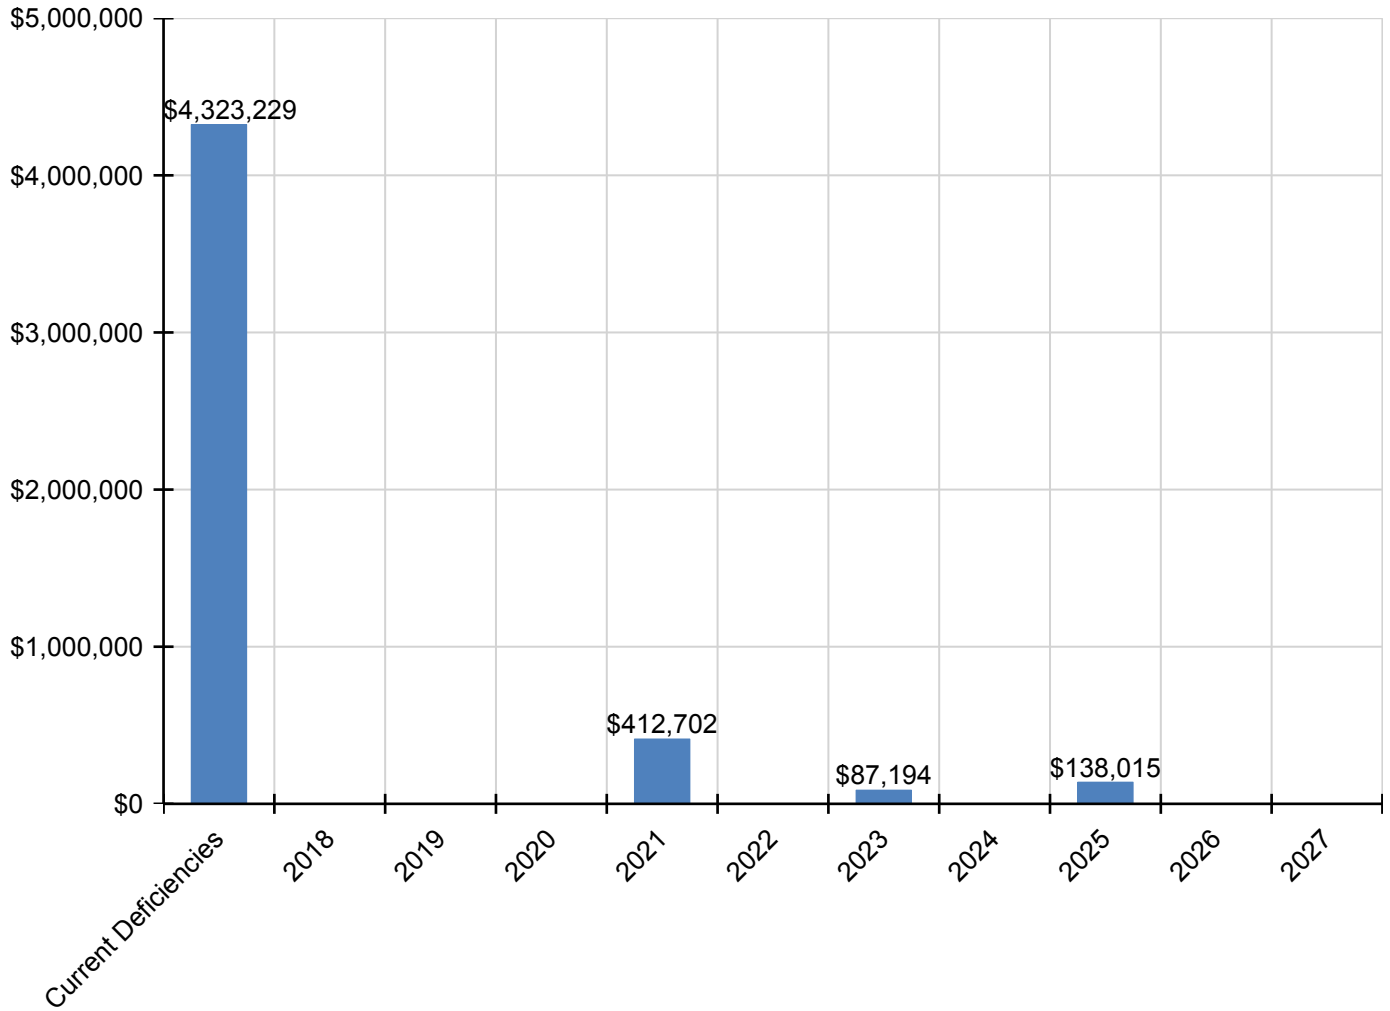
Forecasted Capital Renewal Requirement

The following chart shows the current building deficiencies and forecasting capital renewal or sustainment requirements over the next ten years.

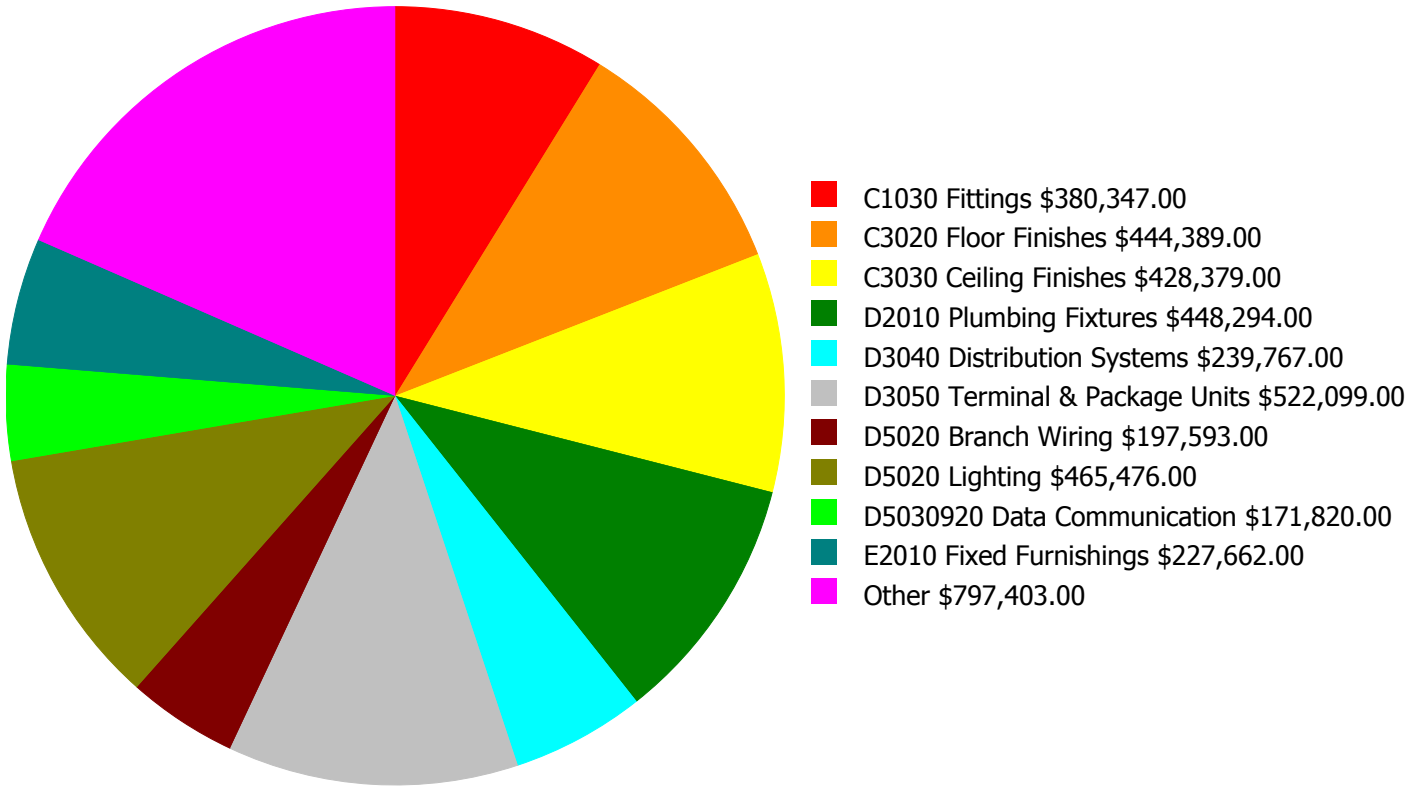
Deficiency Summary by System

Current deficiencies included assemblies that have reached or exceeded their design life or components of the assemblies that are in need of repair. Assemblies that have reached their design life are identified as current deficiencies and assigned the distress 'Beyond Useful Life'. The following chart lists all current deficiencies associated with this facility.

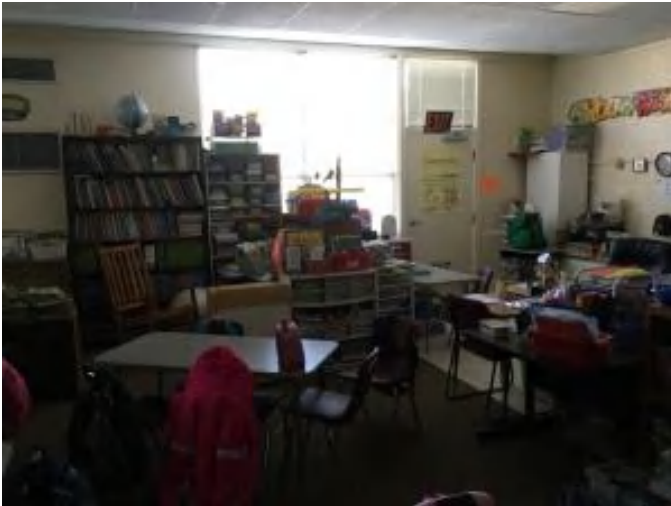
System: B2030 - Exterior Doors

Location: Throughout the building
Distress: Beyond Service Life
Category: Deferred Maintenance
Priority: 3 - Necessary/Not Yet Critical (Years 2-5)
Correction: Renew System
Qty: 35,500.00
Unit of Measure: S.F.
Estimate: \$40,612.00
Assessor Name: Terence Davis
Date Created: 02/15/2017

Notes: Exterior doors are generally in fair condition and beyond their expected useful life. Direct exit doors at classrooms have reverse swing. System renewal is recommended.

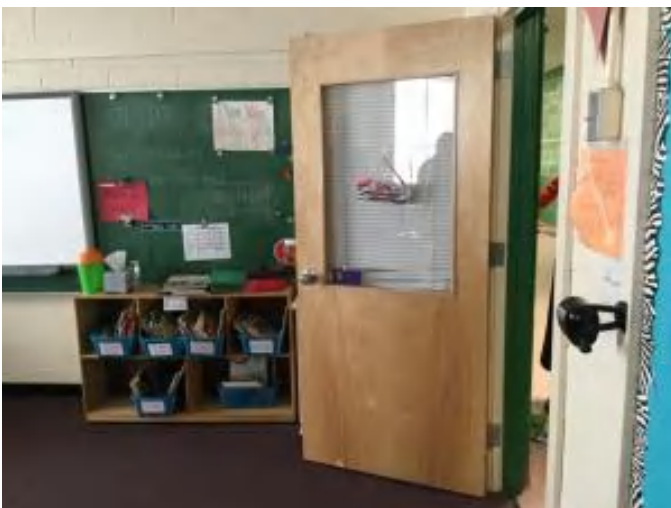
System: C1020 - Interior Doors

Location: Throughout the building
Distress: Beyond Service Life
Category: Deferred Maintenance
Priority: 3 - Necessary/Not Yet Critical (Years 2-5)
Correction: Renew System
Qty: 35,500.00
Unit of Measure: S.F.
Estimate: \$98,797.00
Assessor Name: Terence Davis
Date Created: 02/15/2017

Notes: Interior doors are in aged condition and do not have ADA compliant hardware. System renewal is recommended.

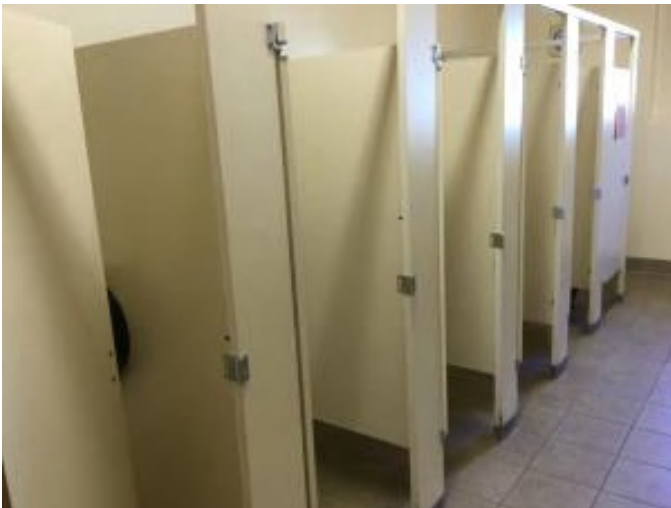
System: C1030 - Fittings

Location: Throughout the building
Distress: Beyond Service Life
Category: Deferred Maintenance
Priority: 3 - Necessary/Not Yet Critical (Years 2-5)
Correction: Renew System
Qty: 35,500.00
Unit of Measure: S.F.
Estimate: \$380,347.00
Assessor Name: Terence Davis
Date Created: 02/15/2017

Notes: Fittings are generally beyond their expected useful life. Signage is not up to current codes. Toilet partitions are deteriorating.

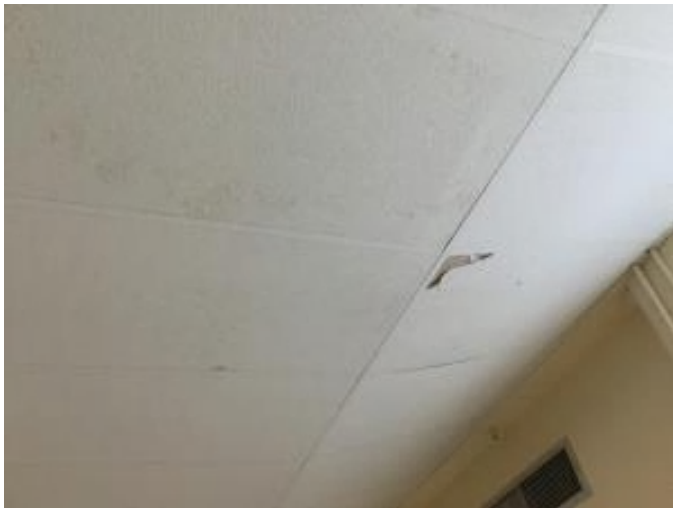
System: C3030 - Ceiling Finishes

Location: Throughout the building
Distress: Beyond Service Life
Category: Deferred Maintenance
Priority: 3 - Necessary/Not Yet Critical (Years 2-5)
Correction: Renew System
Qty: 35,500.00
Unit of Measure: S.F.
Estimate: \$428,379.00
Assessor Name: Terence Davis
Date Created: 02/15/2017

Notes: Ceilings are beyond their expected life. It appears that some acoustical tile ceilings have been spray painted. Painting acoustical tiles reduces their acoustical properties. System replacement is recommended.

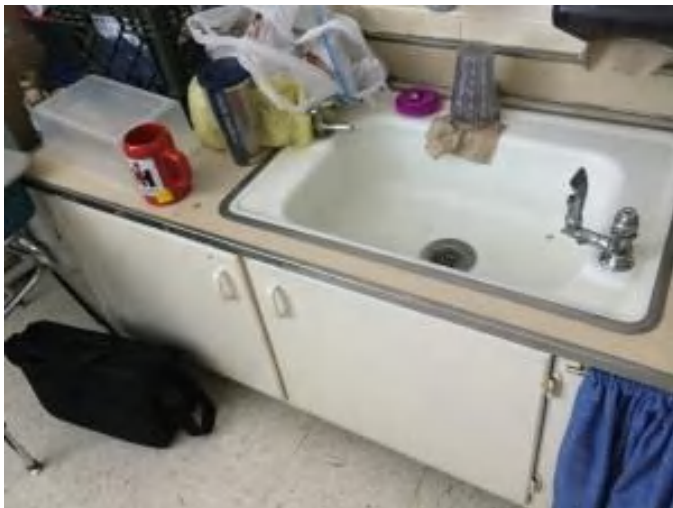
System: D2010 - Plumbing Fixtures

Location: Throughout the building
Distress: Beyond Service Life
Category: Deferred Maintenance
Priority: 3 - Necessary/Not Yet Critical (Years 2-5)
Correction: Renew System
Qty: 35,500.00
Unit of Measure: S.F.
Estimate: \$448,294.00
Assessor Name: Terence Davis
Date Created: 02/15/2017

Notes: Though some fixtures have been updated, there are many obsolete fixtures throughout the building. There are no ADA compliant restrooms in the building. System renewal is recommended.

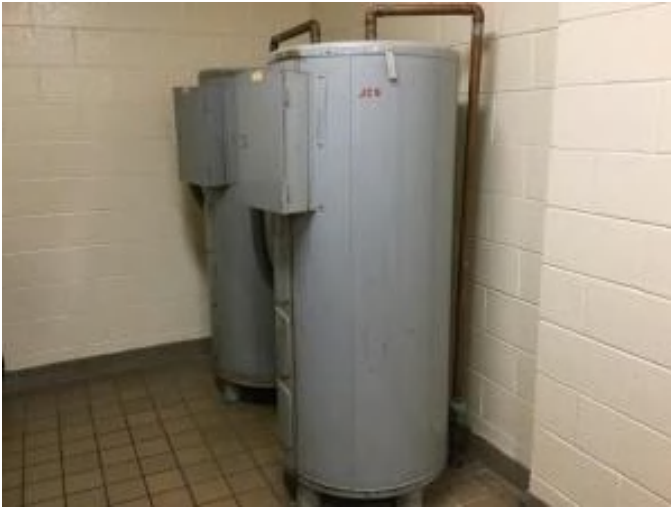
System: D2020 - Domestic Water Distribution

Location: Throughout the building
Distress: Beyond Service Life
Category: Deferred Maintenance
Priority: 3 - Necessary/Not Yet Critical (Years 2-5)
Correction: Renew System
Qty: 35,500.00
Unit of Measure: S.F.
Estimate: \$38,269.00
Assessor Name: Terence Davis
Date Created: 02/15/2017

Notes: The domestic water distribution system is well beyond its expected life. System renewal is recommended.

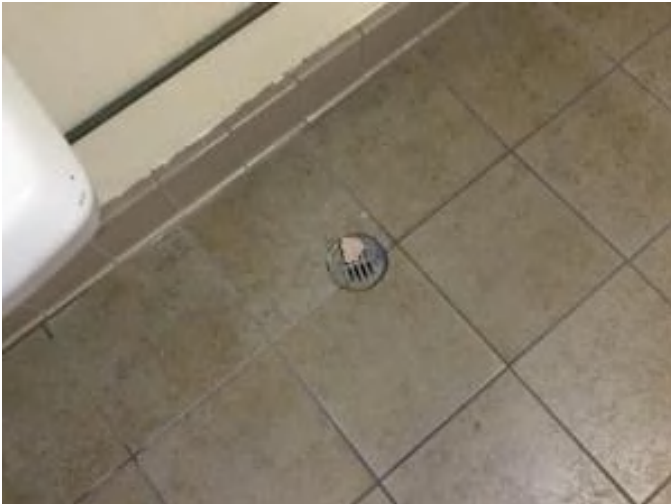
System: D2030 - Sanitary Waste

Location: Throughout the building
Distress: Beyond Service Life
Category: Deferred Maintenance
Priority: 3 - Necessary/Not Yet Critical (Years 2-5)
Correction: Renew System
Qty: 35,500.00
Unit of Measure: S.F.
Estimate: \$60,137.00
Assessor Name: Terence Davis
Date Created: 02/15/2017

Notes: The sanitary waste system has not been replaced since original construction, and is therefore beyond its expected useful life. System renewal is recommended.

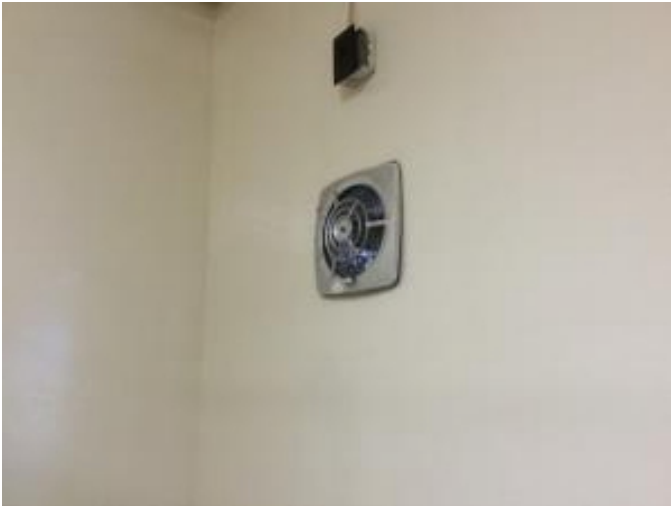
System: D3040 - Distribution Systems

Location: Throughout the building
Distress: Beyond Service Life
Category: Deferred Maintenance
Priority: 3 - Necessary/Not Yet Critical (Years 2-5)
Correction: Renew System
Qty: 35,500.00
Unit of Measure: S.F.
Estimate: \$239,767.00
Assessor Name: Terence Davis
Date Created: 02/15/2017

Notes: Toilet exhaust systems are obsolete. Other distribution systems are expired. No air conditioning is provided in corridors. System renewal is recommended.

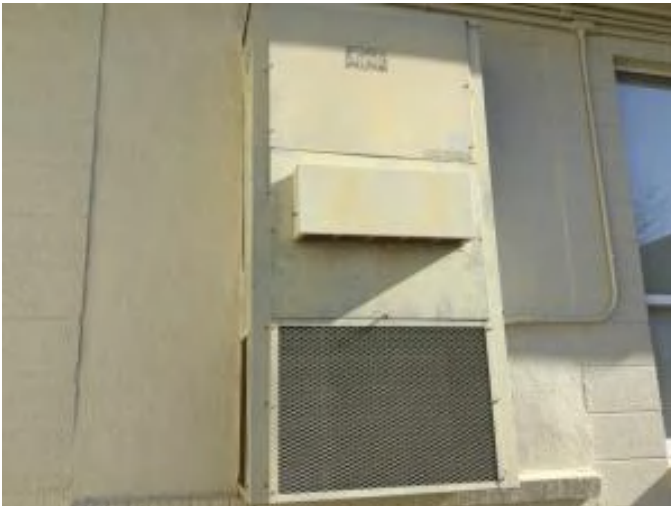
System: D3050 - Terminal & Package Units

Location: Throughout the building
Distress: Beyond Service Life
Category: Deferred Maintenance / Energy
Priority: 3 - Necessary/Not Yet Critical (Years 2-5)
Correction: Renew System
Qty: 35,500.00
Unit of Measure: S.F.
Estimate: \$522,099.00
Assessor Name: Terence Davis
Date Created: 02/15/2017

Notes: Window mounted package units are beyond their expected life. There is no independent cooling for the MDF. Corridors are not conditioned. System renewal is recommended.

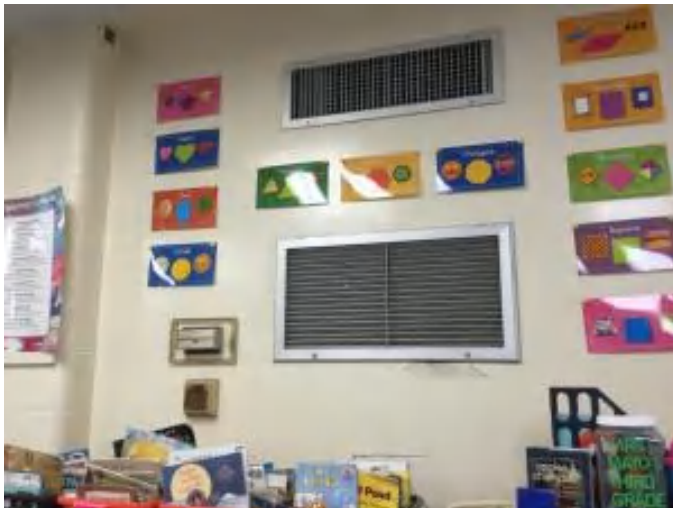
System: D3060 - Controls & Instrumentation

Location: Throughout the building
Distress: Beyond Service Life
Category: Deferred Maintenance
Priority: 3 - Necessary/Not Yet Critical (Years 2-5)
Correction: Renew System
Qty: 35,500.00
Unit of Measure: S.F.
Estimate: \$75,757.00
Assessor Name: Terence Davis
Date Created: 02/15/2017

Notes: Building HVAC controls are beyond their expected life. They are locally controlled. Installation of a modern digital system with remote monitoring and control capability for energy conservation is recommended.

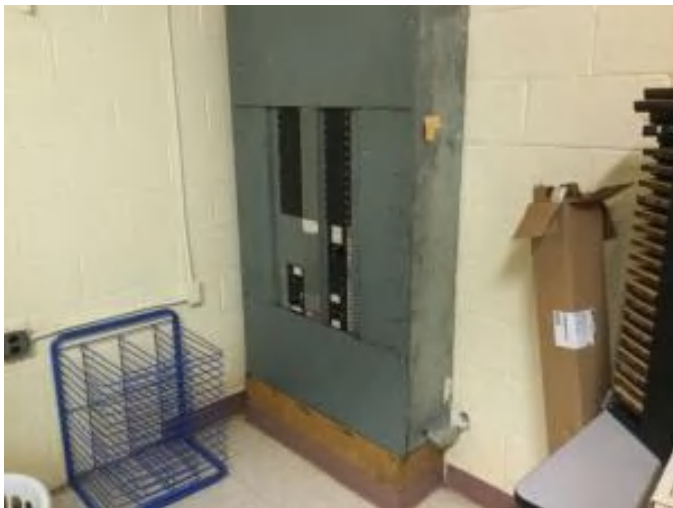
System: D5010 - Electrical Service/Distribution

Location: Main electric services
Distress: Beyond Service Life
Category: Deferred Maintenance
Priority: 3 - Necessary/Not Yet Critical (Years 2-5)
Correction: Renew System
Qty: 35,500.00
Unit of Measure: S.F.
Estimate: \$65,995.00
Assessor Name: Terence Davis
Date Created: 02/15/2017

Notes: The main electric distribution system, consisting of two services, is beyond its expected useful life and in need of renewal.

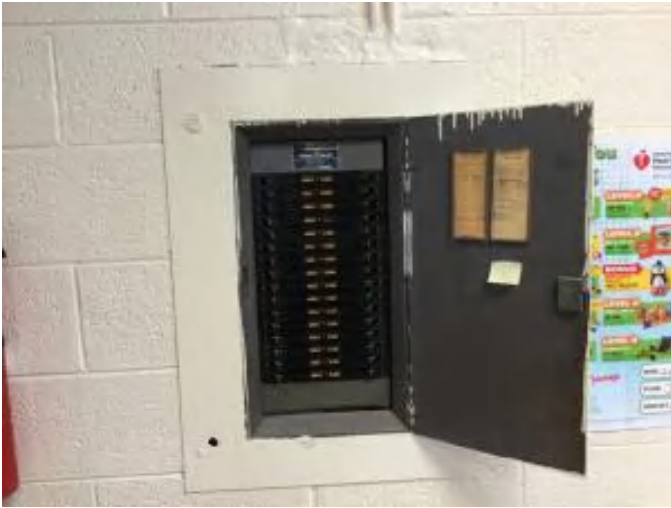
System: D5020 - Branch Wiring

Location: Throughout the building
Distress: Beyond Service Life
Category: Deferred Maintenance
Priority: 3 - Necessary/Not Yet Critical (Years 2-5)
Correction: Renew System
Qty: 35,500.00
Unit of Measure: S.F.
Estimate: \$197,593.00
Assessor Name: Terence Davis
Date Created: 02/15/2017

Notes: Branch wiring is expired. There are insufficient outlets throughout the building. System renewal is recommended.

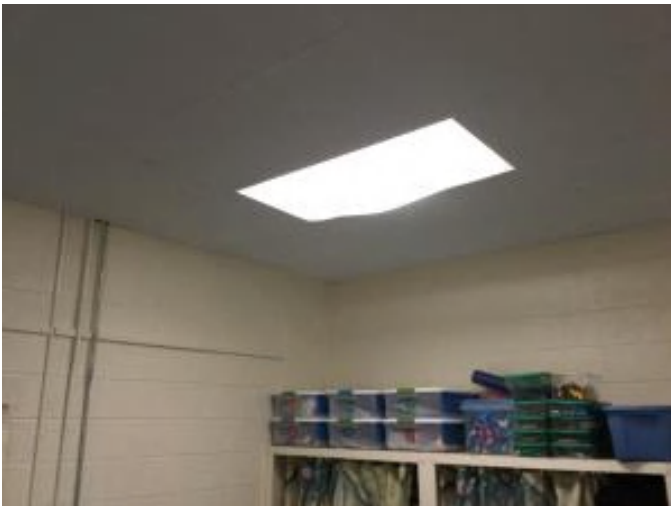
System: D5020 - Lighting

Location: Throughout the building
Distress: Beyond Service Life
Category: Deferred Maintenance
Priority: 3 - Necessary/Not Yet Critical (Years 2-5)
Correction: Renew System
Qty: 35,500.00
Unit of Measure: S.F.
Estimate: \$465,476.00
Assessor Name: Terence Davis
Date Created: 02/15/2017

Notes: A lighting upgrade in 2011 replaced ballasts and lamps, but did not typically replace fixtures and the system is now considered expired with renewal recommended.

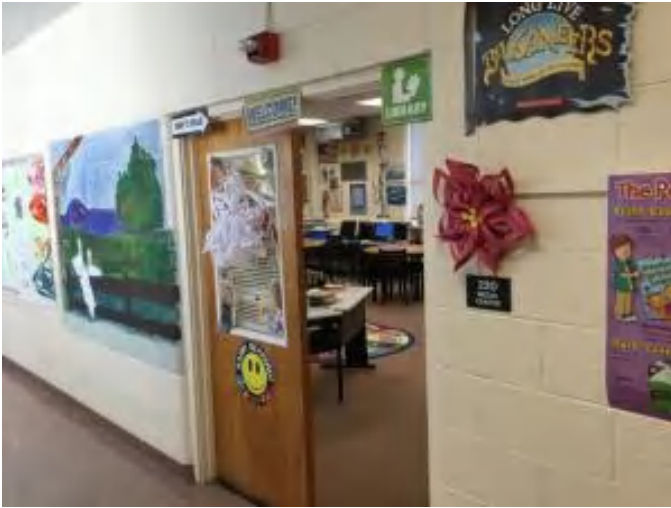
System: D5030910 - Fire Alarm Systems

Location: Throughout the building
Distress: Beyond Service Life
Category: Deferred Maintenance
Priority: 3 - Necessary/Not Yet Critical (Years 2-5)
Correction: Renew System
Qty: 35,500.00
Unit of Measure: S.F.
Estimate: \$132,380.00
Assessor Name: Terence Davis
Date Created: 02/15/2017

Notes: The fire alarm system is of an unknown date, however is assumed to be beyond its expected life. Strobes and annunciators not seen in restrooms. System renewal is recommended.

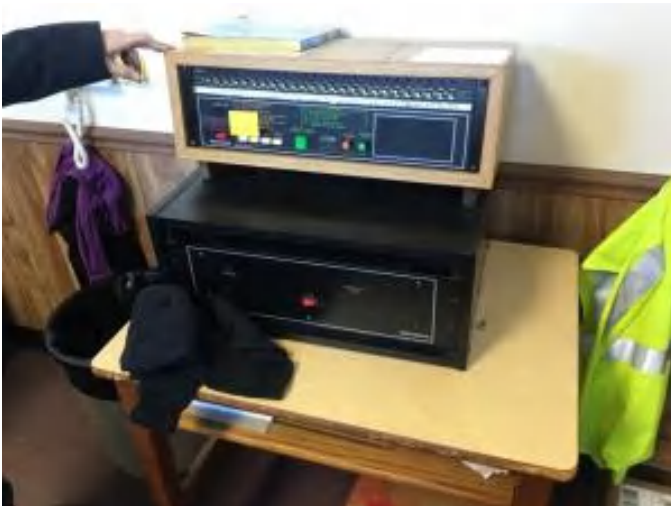
System: D5030920 - Data Communication

Location: Throughout the building
Distress: Beyond Service Life
Category: Deferred Maintenance
Priority: 3 - Necessary/Not Yet Critical (Years 2-5)
Correction: Renew System
Qty: 35,500.00
Unit of Measure: S.F.
Estimate: \$171,820.00
Assessor Name: Terence Davis
Date Created: 02/15/2017

Notes: The PA system does not function. Announcements need to be made on a room by room basis via telephone. System renewal is recommended.

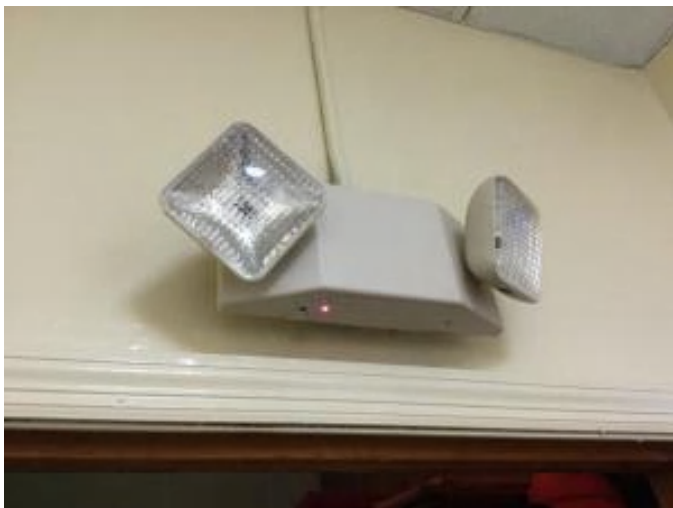
System: D5090 - Other Electrical Systems

Location: Throughout the building
Distress: Beyond Service Life
Category: Deferred Maintenance
Priority: 3 - Necessary/Not Yet Critical (Years 2-5)
Correction: Renew System
Qty: 35,500.00
Unit of Measure: S.F.
Estimate: \$4,686.00
Assessor Name: Terence Davis
Date Created: 02/15/2017

Notes: Emergency and egress lighting is beyond its expected useful life. System coverage should be reviewed as some exit signage does not appear to be illuminated. System renewal is recommended.

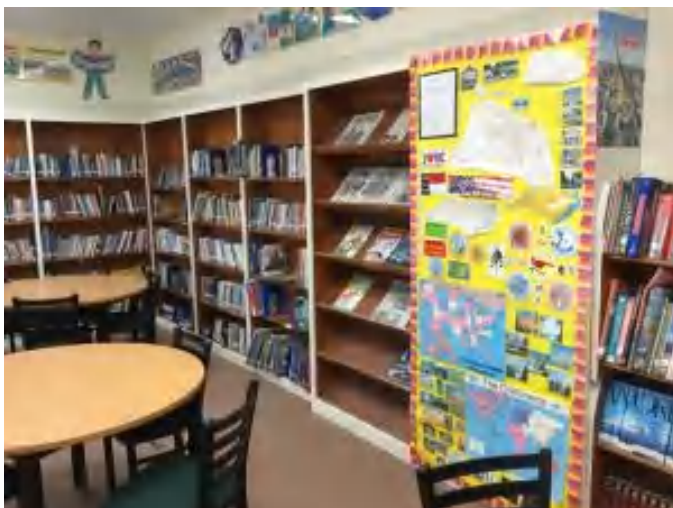
System: F1020 - Institutional Equipment

Location: Library and classrooms
Distress: Beyond Service Life
Category: Deferred Maintenance
Priority: 3 - Necessary/Not Yet Critical (Years 2-5)
Correction: Renew System
Qty: 35,500.00
Unit of Measure: S.F.
Estimate: \$11,715.00
Assessor Name: Terence Davis
Date Created: 02/15/2017

Notes: Institutional equipment is generally beyond its expected life. System renewal is recommended.

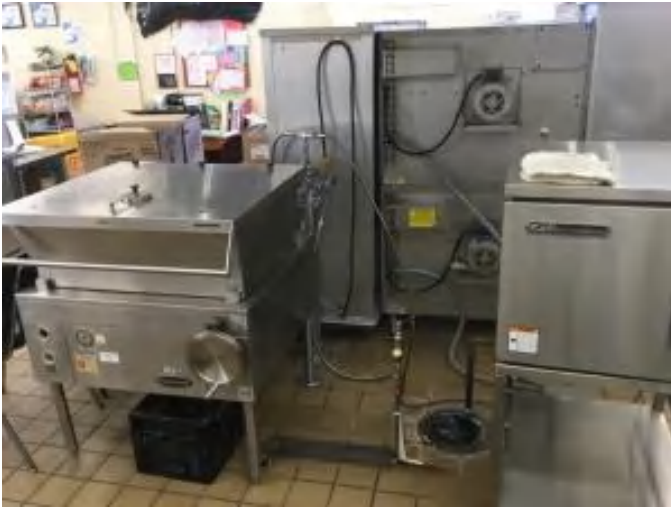
System: E1090 - Other Equipment

Location: Kitchen
Distress: Beyond Service Life
Category: Deferred Maintenance
Priority: 3 - Necessary/Not Yet Critical (Years 2-5)
Correction: Renew System
Qty: 35,500.00
Unit of Measure: S.F.
Estimate: \$74,195.00
Assessor Name: Terence Davis
Date Created: 02/15/2017

Notes: Kitchen equipment is generally well beyond its expected service life and should be replaced.

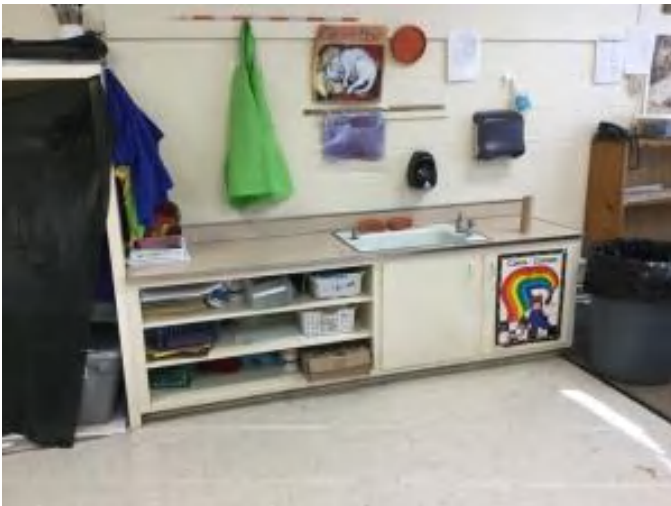
System: E2010 - Fixed Furnishings

Location: Throughout the building
Distress: Beyond Service Life
Category: Deferred Maintenance
Priority: 3 - Necessary/Not Yet Critical (Years 2-5)
Correction: Renew System
Qty: 35,500.00
Unit of Measure: S.F.
Estimate: \$227,662.00
Assessor Name: Terence Davis
Date Created: 02/15/2017

Notes: Fixed furnishings are beyond their expected life and are in poor condition. System renewal is recommended.

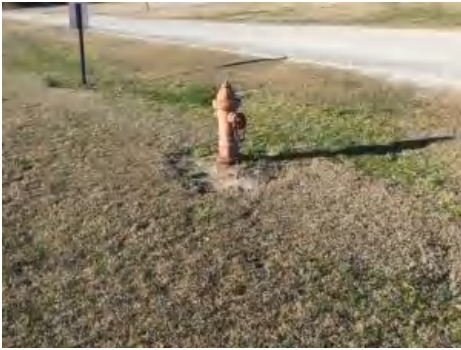
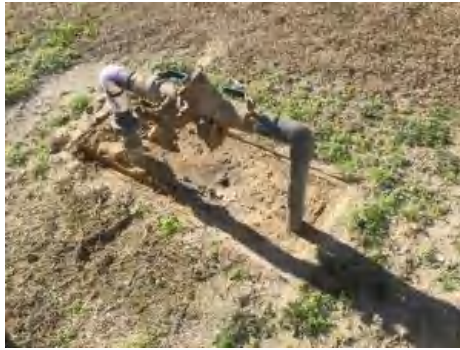
System: G3010 - Water Supply

Note: Assumed new lines installed with kitchen addition in 1970. There is a backflow preventer on site.

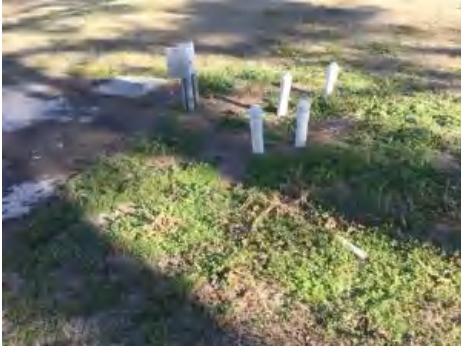
System: G3020 - Sanitary Sewer

Note: Septic system. Engineered system. Lines added 1990.

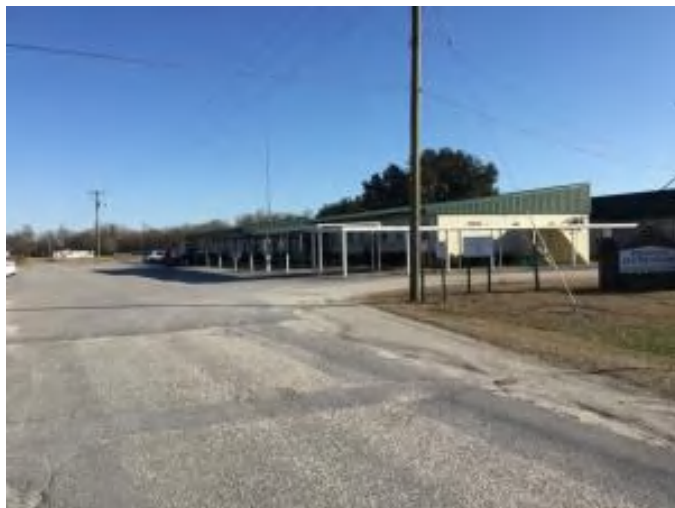
System: G4020 - Site Lighting

Location: Site
Distress: Inadequate
Category: Deferred Maintenance / Safety
Priority: 2 - Potentially Critical (Year 1)
Correction: Renew System
Qty: 35,500.00
Unit of Measure: S.F.
Estimate: \$57,404.00
Assessor Name: Ann Buerger Linden
Date Created: 02/15/2017

Notes: Site lighting coverage is inadequate. The system is beyond its expected life. System renewal is recommended.
