NC School District/520 Jones County/High School

Jones Senior High

Campus Assessment Report

March 8, 2017

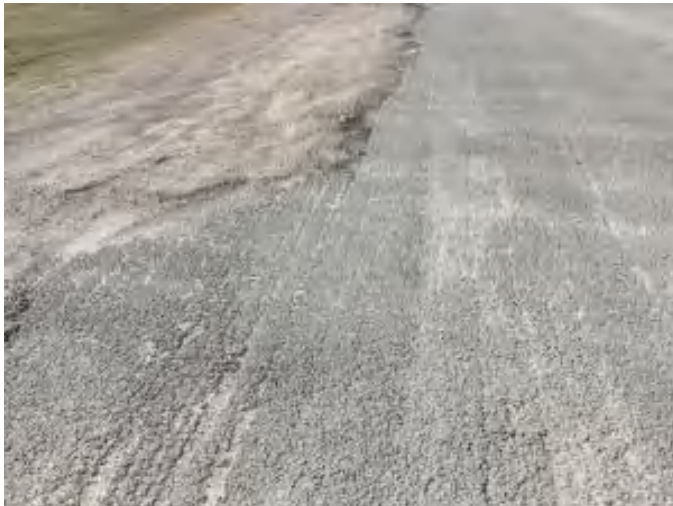
System: G2010 - Roadways

Location: Roadways
Distress: Beyond Service Life
Category: Deferred Maintenance
Priority: 3 - Necessary/Not Yet Critical (Years 2-5)
Correction: Renew System
Qty: 35,500.00
Unit of Measure: S.F.
Estimate: \$148,781.00
Assessor Name: Ann Buerger Linden
Date Created: 02/15/2017

Notes: Roadways are in fair condition with grainy surface and some cracking. Edges are not curbed and are unraveling.. Pavement markings are faded or non-existent. Directional signage is insufficient.. System renewal is recommended.

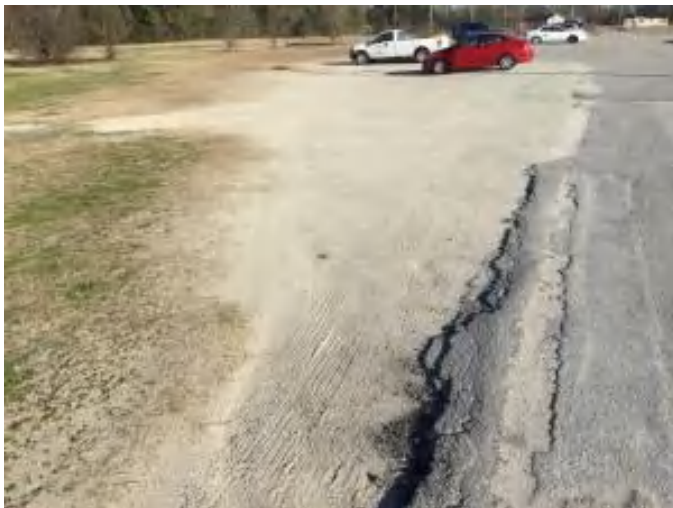
System: G2020 - Parking Lots

Location: Parking lots
Distress: Beyond Service Life
Category: Deferred Maintenance
Priority: 3 - Necessary/Not Yet Critical (Years 2-5)
Correction: Renew System
Qty: 35,500.00
Unit of Measure: S.F.
Estimate: \$51,937.00
Assessor Name: Ann Buerger Linden
Date Created: 02/15/2017

Notes: Parking lots are in fair condition with grainy surface. There are no curbs. There are insufficient paved spaces to accommodate daily needs Striping is faded or not present. ADA parking is inadequate. Fire lane designation is inadequate. System renewal is recommended.

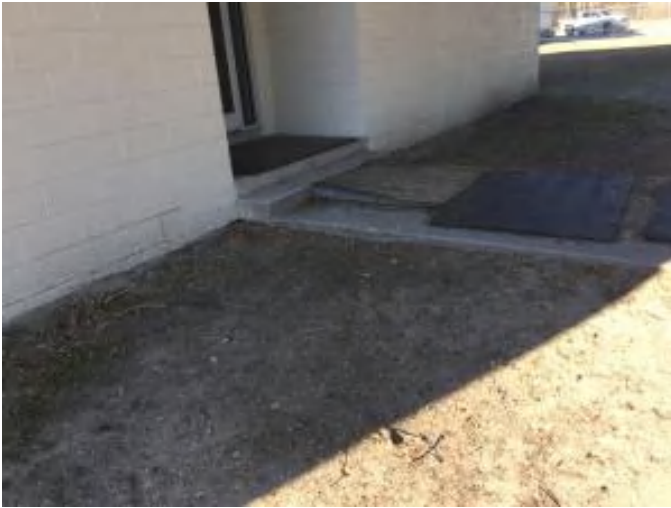
System: G2030 - Pedestrian Paving

Location: Site sidewalks
Distress: Beyond Service Life
Category: Deferred Maintenance
Priority: 3 - Necessary/Not Yet Critical (Years 2-5)
Correction: Renew System
Qty: 35,500.00
Unit of Measure: S.F.
Estimate: \$74,586.00
Assessor Name: Ann Buerger Linden
Date Created: 02/15/2017

Notes: Site sidewalks are in fair condition with some cracking and worn surfaces. The approach to the southeast exit used to access playgrounds is not accessible. System renewal is recommended.

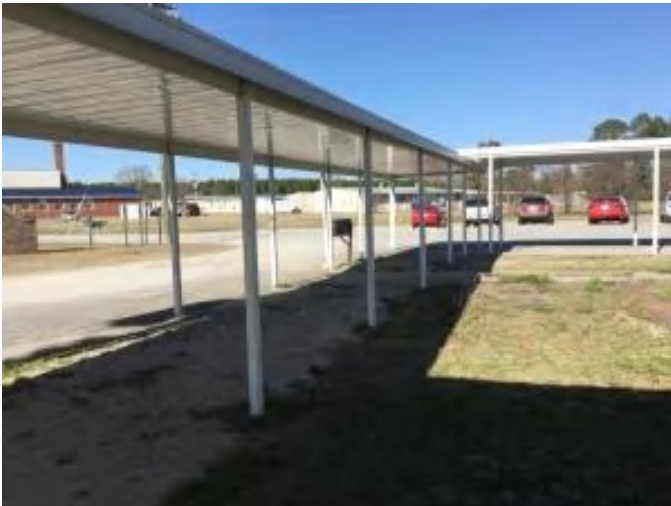
System: G2040950 - Covered Walkways

Location: Site
Distress: Inadequate
Category: Deferred Maintenance
Priority: 3 - Necessary/Not Yet Critical (Years 2-5)
Correction: Renew System
Qty: 35,500.00
Unit of Measure: S.F.
Estimate: \$59,356.00
Assessor Name: Ann Buerger Linden
Date Created: 02/15/2017

Notes: Covered walkways are inadequate with no lighting and missing pavement in some locations. System renewal is recommended.

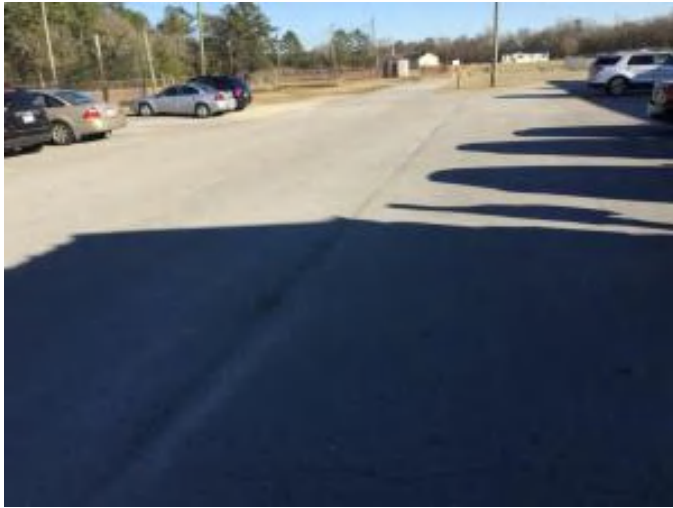
System: G3030 - Storm Sewer

Location: Site
Distress: Missing
Category: Deferred Maintenance
Priority: 3 - Necessary/Not Yet Critical (Years 2-5)
Correction: Renew System
Qty: 35,500.00
Unit of Measure: S.F.
Estimate: \$177,287.00
Assessor Name: Ann Buerger Linden
Date Created: 02/15/2017

Notes: Storm drainage on the flat site is inadequate with considerable ponding after storms, and no evidence of a drainage system was found. System installation is recommended, including capturing discharge from roof downspouts.
