NC School District/830 Scotland County/High School

Scotland High

Campus Assessment Report

March 7, 2017

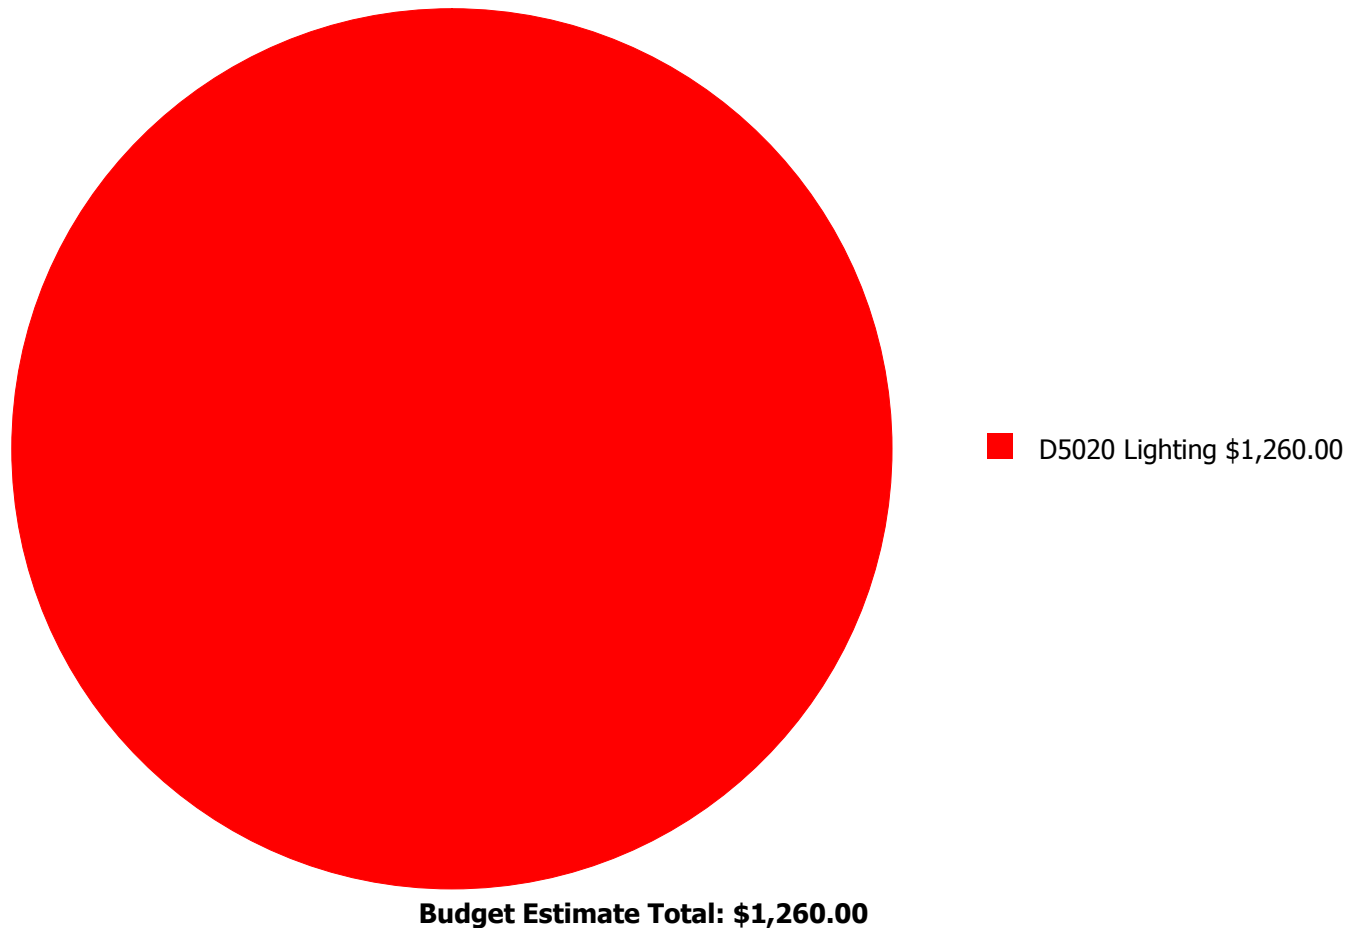
Deficiency Summary by System

Current deficiencies included assemblies that have reached or exceeded their design life or components of the assemblies that are in need of repair. Assemblies that have reached their design life are identified as current deficiencies and assigned the distress 'Beyond Useful Life'. The following chart lists all current deficiencies associated with this facility.

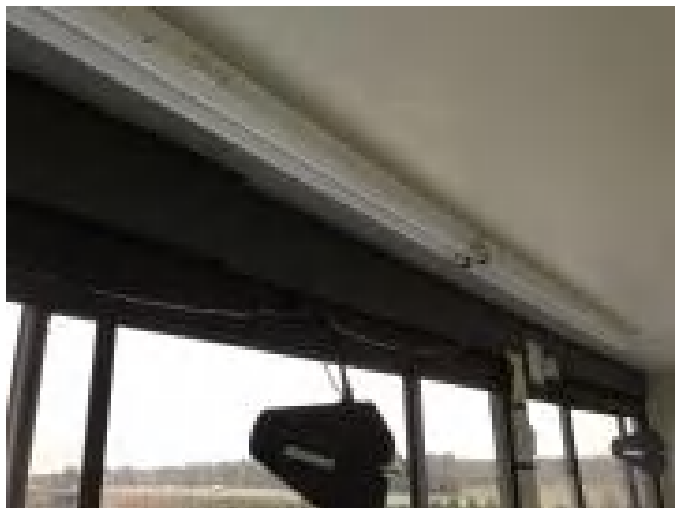
System: D5020 - Lighting

Location: Throughout Building
Distress: Beyond Service Life
Category: Deferred Maintenance
Priority: 3 - Necessary/Not Yet Critical (Years 2-5)
Correction: Renew System
Qty: 320.00
Unit of Measure: S.F.
Estimate: \$1,260.00
Assessor Name: Eduardo Lopez
Date Created: 01/10/2017

Notes: The lighting system is beyond its service life and should be replaced.

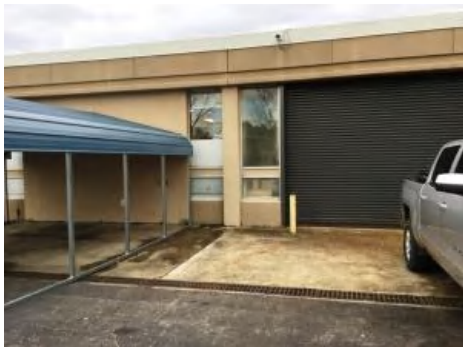
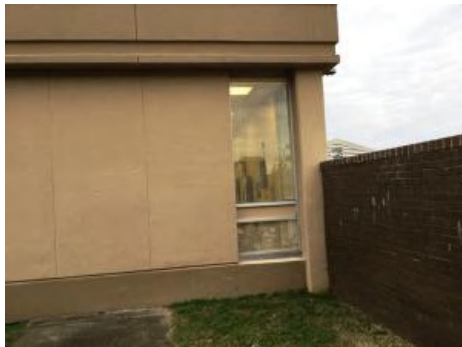
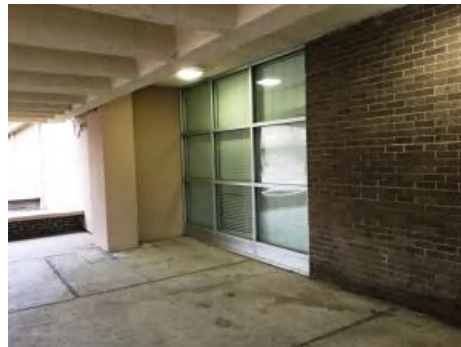
System: B2020 - Exterior Windows

Note: The exterior windows are beyond their service life and should be replaced.

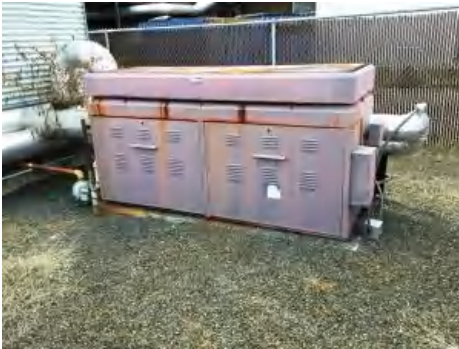
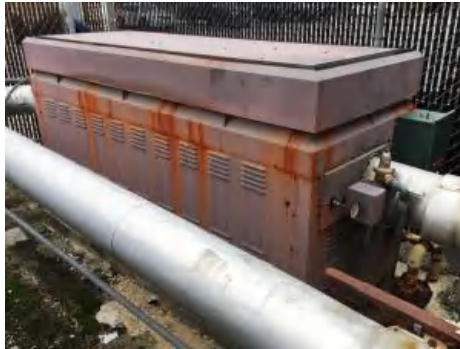
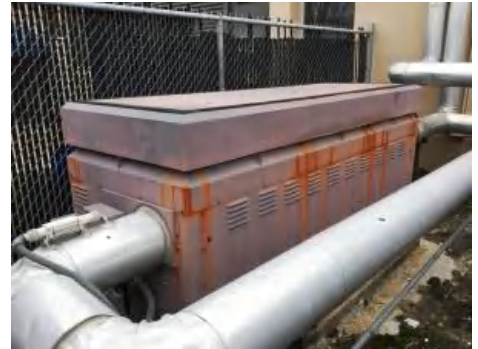
System: D3020 - Heat Generating Systems

Note: The heat generating systems are beyond their service life and should be replaced.

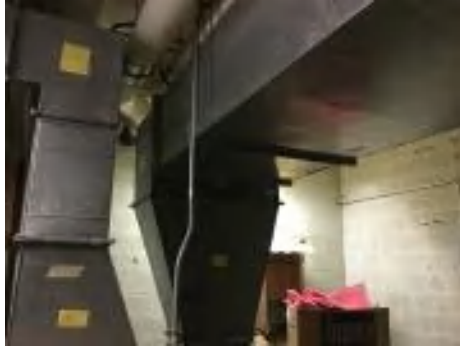
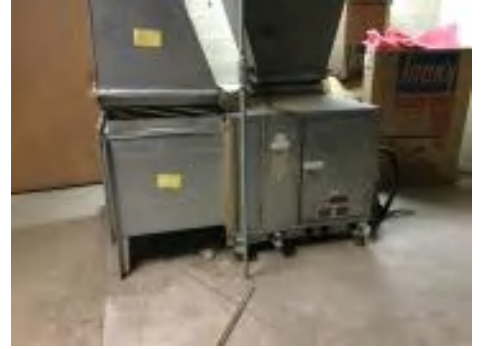
System: D3040 - Distribution Systems

Note: The distribution system is beyond its service life and should be replaced.

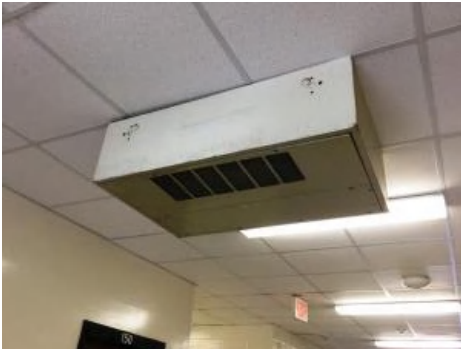
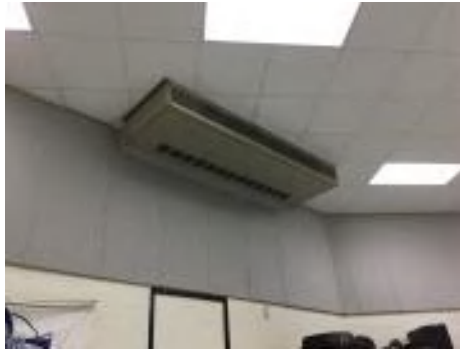
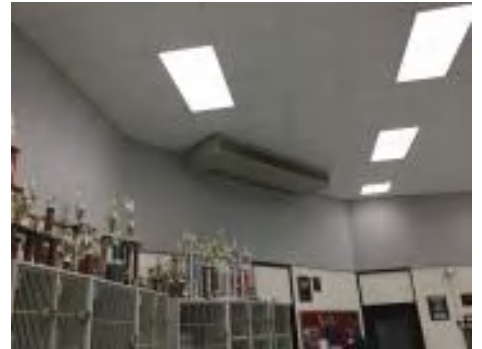
System: D3050 - Terminal & Package Units

Note: The terminal and package units are beyond their service life and should be replaced.

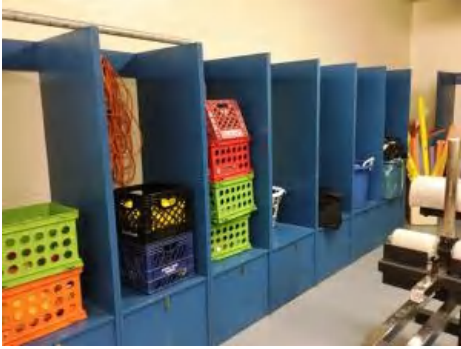
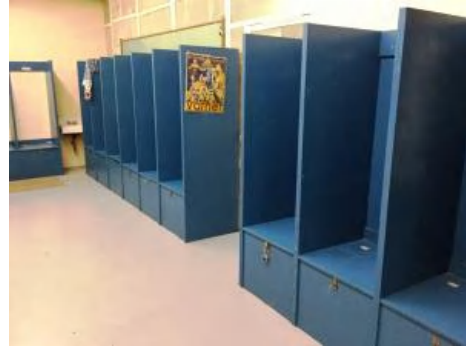
System: E2010 - Fixed Furnishings

Note: The fixed furnishings are beyond their service life and should be replaced.

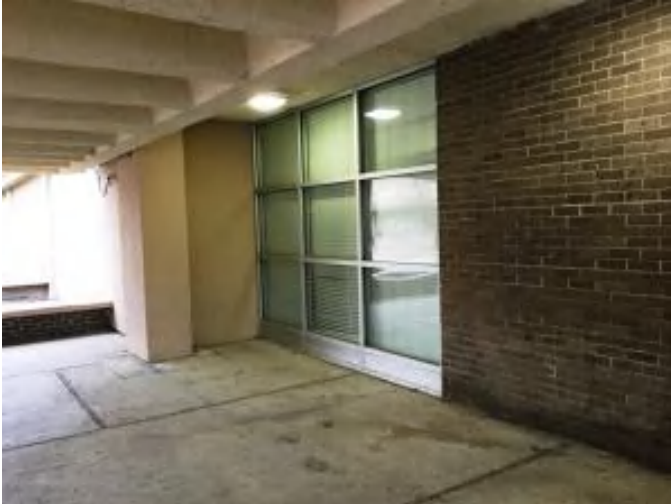
System: B2020 - Exterior Windows

Location: Exterior Walls
Distress: Beyond Service Life
Category: Deferred Maintenance
Priority: 3 - Necessary/Not Yet Critical (Years 2-5)
Correction: Renew System
Qty: 43,100.00
Unit of Measure: S.F.
Estimate: \$605,900.00
Assessor Name: Eduardo Lopez
Date Created: 02/13/2017

Notes: The exterior windows are beyond their service life and should be replaced.

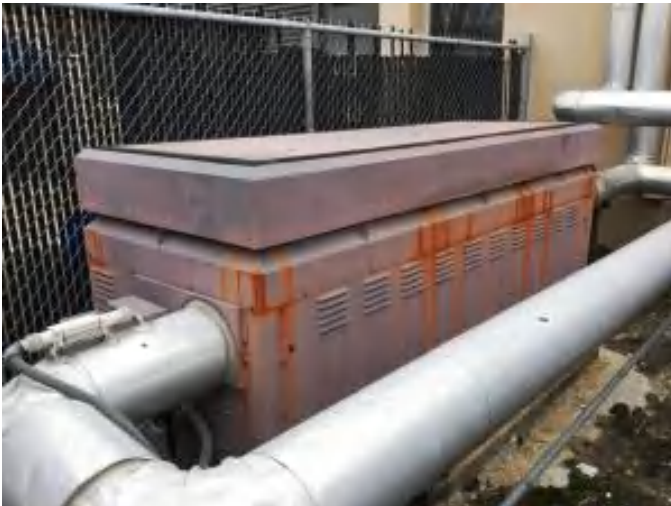
System: D3020 - Heat Generating Systems

Location: Throughout Building
Distress: Beyond Service Life
Category: Deferred Maintenance
Priority: 3 - Necessary/Not Yet Critical (Years 2-5)
Correction: Renew System
Qty: 43,100.00
Unit of Measure: S.F.
Estimate: \$328,551.00
Assessor Name: Eduardo Lopez
Date Created: 02/13/2017

Notes: The heat generating systems are beyond their service life and should be replaced.

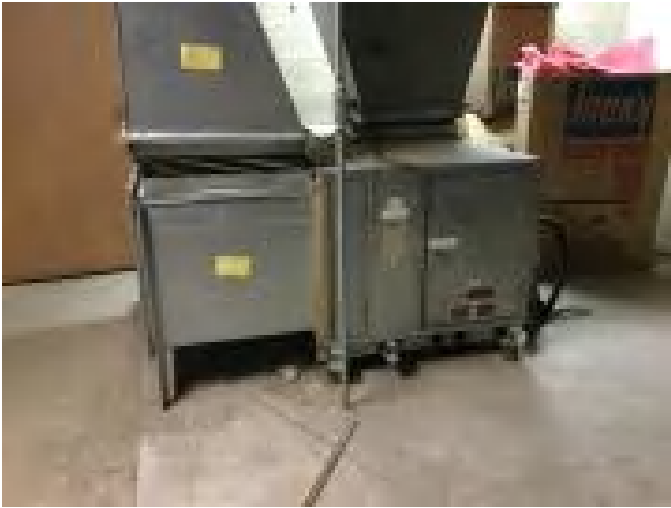
System: D3040 - Distribution Systems

Location: Throughout Building
Distress: Beyond Service Life
Category: Deferred Maintenance
Priority: 3 - Necessary/Not Yet Critical (Years 2-5)
Correction: Renew System
Qty: 43,100.00
Unit of Measure: S.F.
Estimate: \$396,822.00
Assessor Name: Eduardo Lopez
Date Created: 02/13/2017

Notes: The distribution system is beyond its service life and should be replaced.

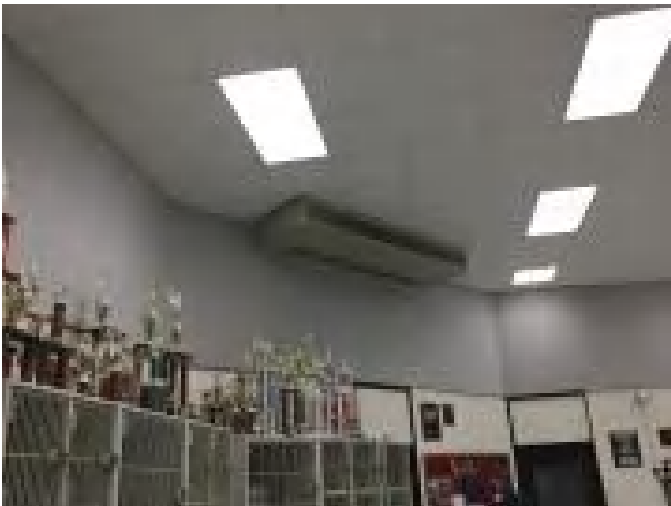
System: D3050 - Terminal & Package Units

Location: Throughout Building
Distress: Beyond Service Life
Category: Deferred Maintenance
Priority: 3 - Necessary/Not Yet Critical (Years 2-5)
Correction: Renew System
Qty: 43,100.00
Unit of Measure: S.F.
Estimate: \$1,263,002.00
Assessor Name: Eduardo Lopez
Date Created: 02/13/2017

Notes: The terminal and package units are beyond their service life and should be replaced.

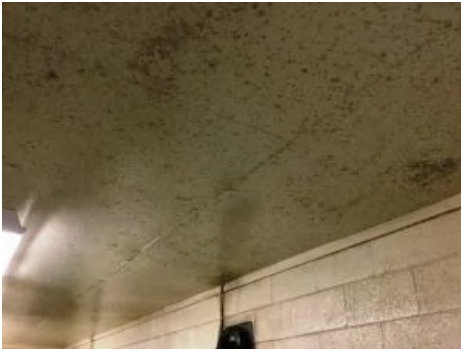
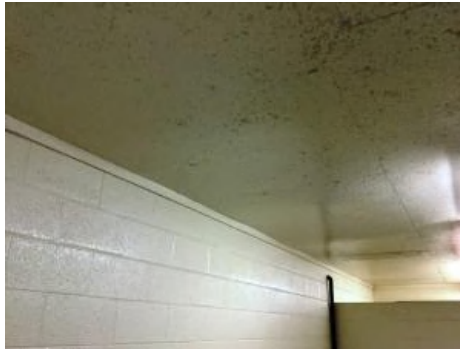
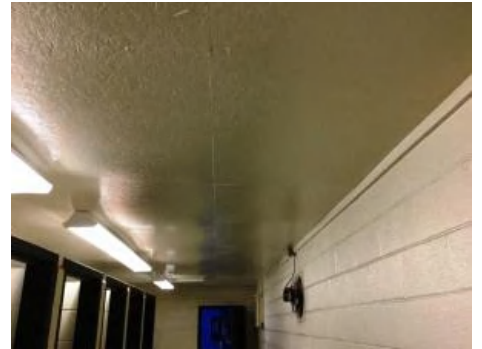
System: C3030 - Ceiling Finishes

Note: The ceiling finishes are beyond their service life and should be replaced.

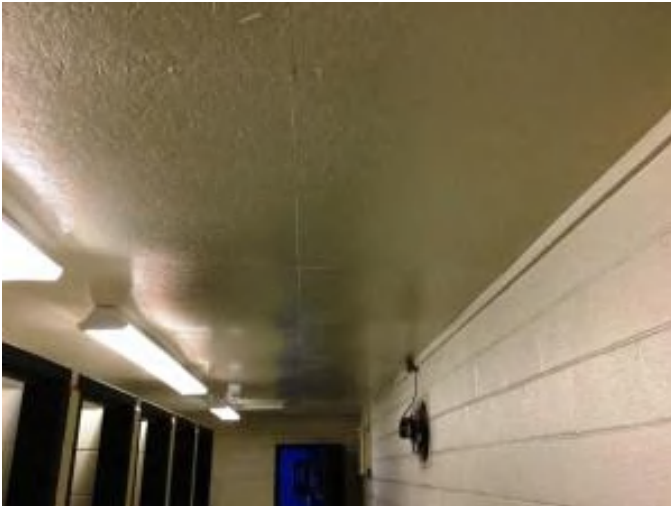
System: C3030 - Ceiling Finishes

Location: Throughout Building
Distress: Beyond Service Life
Category: Deferred Maintenance
Priority: 3 - Necessary/Not Yet Critical (Years 2-5)
Correction: Renew System
Qty: 450.00
Unit of Measure: S.F.
Estimate: \$4,717.00
Assessor Name: Eduardo Lopez
Date Created: 01/10/2017

Notes: The ceiling finishes are beyond their service life and should be replaced.

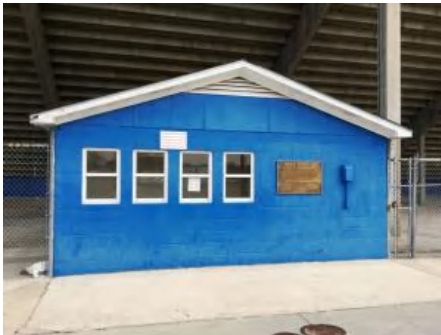
1). South Elevation - Jan 10, 2017

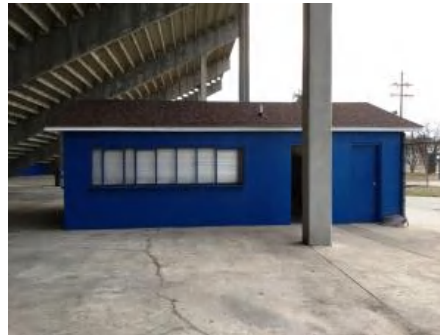
2). West Elevation - Jan 10, 2017

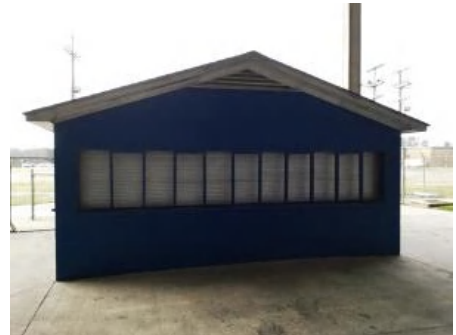
3). North Elevation - Jan 10, 2017

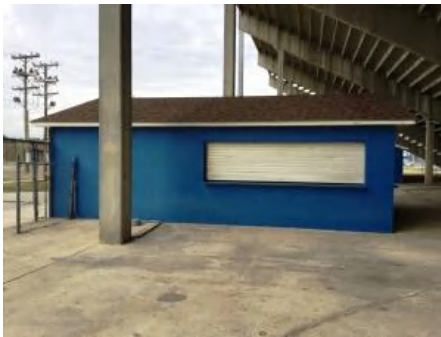
4). East Elevation - Jan 10, 2017

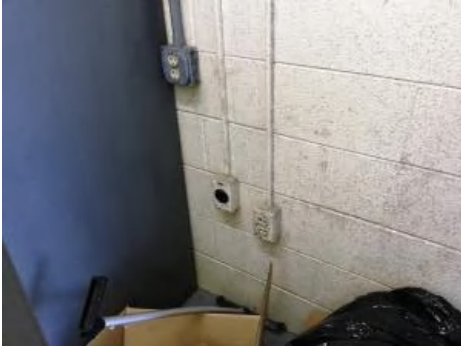
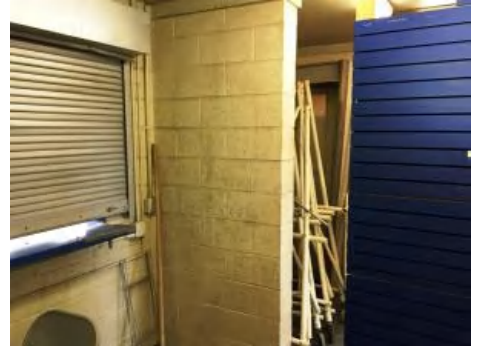
System: C3010 - Wall Finishes

Note: The wall finishes are beyond their service life and should be replaced.

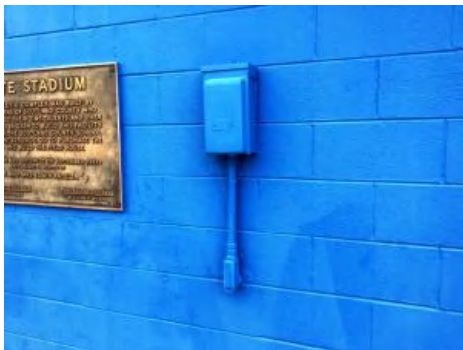
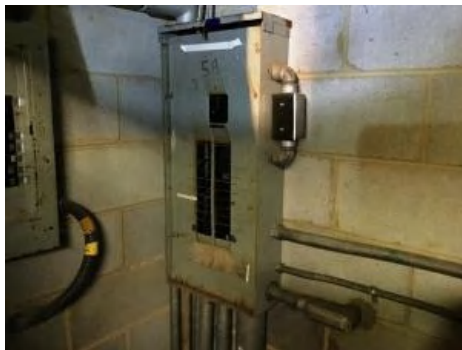
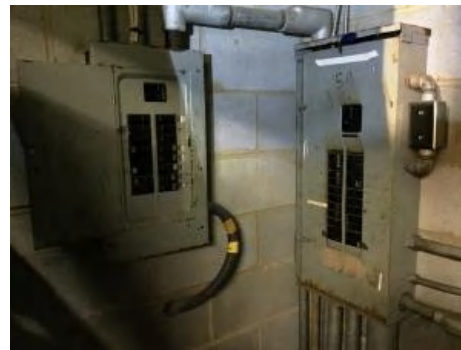
System: D5010 - Electrical Service/Distribution

Note: The electrical service distribution is beyond its service life and should be replaced.

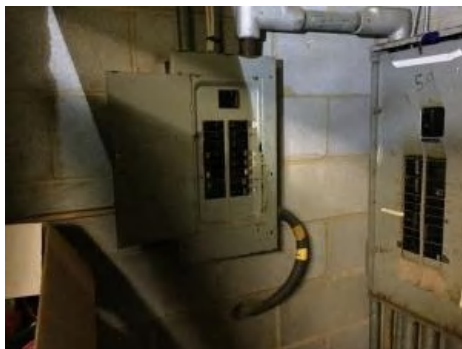
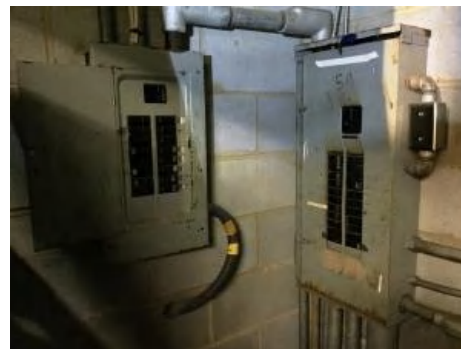
System: D5020 - Branch Wiring

Note: The branch wiring is beyond its service life and should be replaced.

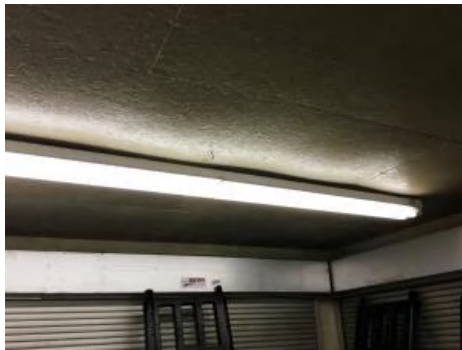
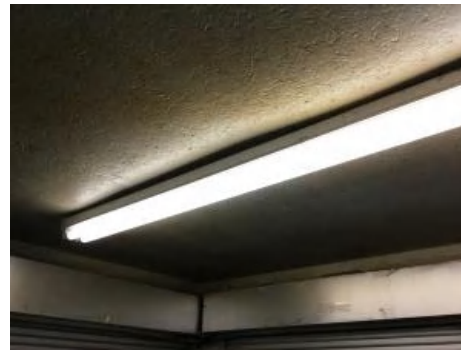
System: D5020 - Lighting

Note: The lighting system is beyond its service life and should be replaced.

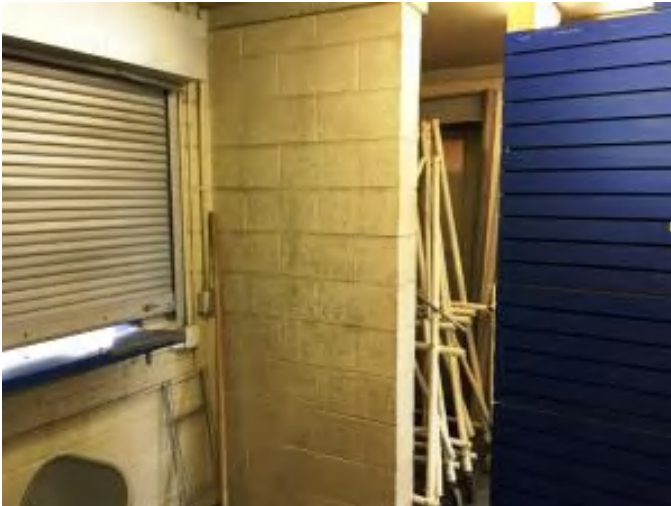
System: C3010 - Wall Finishes

Location: Throughout Building
Distress: Beyond Service Life
Category: Deferred Maintenance
Priority: 3 - Necessary/Not Yet Critical (Years 2-5)
Correction: Renew System
Qty: 460.00
Unit of Measure: S.F.
Estimate: \$2,586.00
Assessor Name: Terence Davis
Date Created: 01/10/2017

Notes: The wall finishes are beyond its service life and should be replaced.

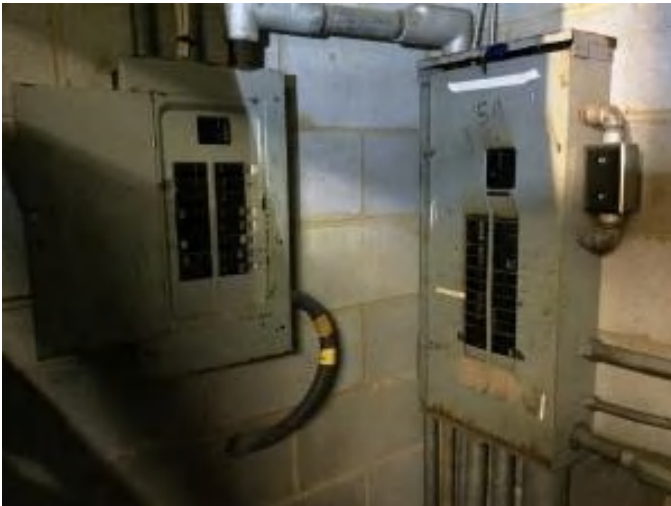
System: D5010 - Electrical Service/Distribution

Location: Throughout Building
Distress: Beyond Service Life
Category: Deferred Maintenance
Priority: 3 - Necessary/Not Yet Critical (Years 2-5)
Correction: Renew System
Qty: 460.00
Unit of Measure: S.F.
Estimate: \$1,564.00
Assessor Name: Terence Davis
Date Created: 01/10/2017

Notes: The electrical service distribution is beyond its service life and should be replaced.

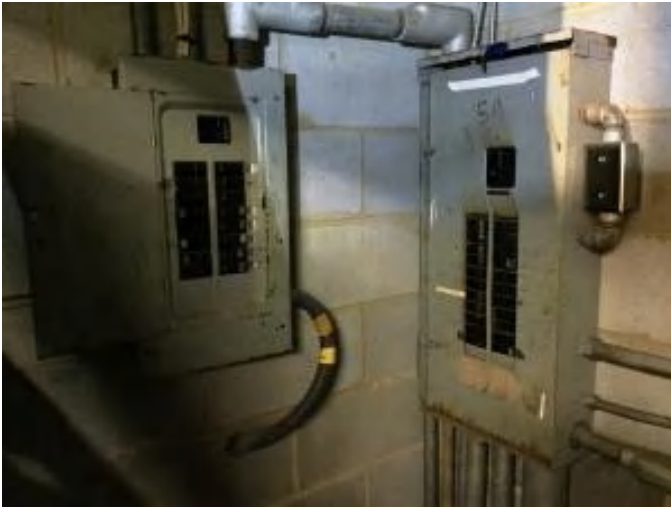
System: D5020 - Branch Wiring

Location: Throughout Building
Distress: Beyond Service Life
Category: Deferred Maintenance
Priority: 3 - Necessary/Not Yet Critical (Years 2-5)
Correction: Renew System
Qty: 460.00
Unit of Measure: S.F.
Estimate: \$1,811.00
Assessor Name: Terence Davis
Date Created: 01/10/2017

Notes: The branch wiring is beyond its service life and should be replaced.

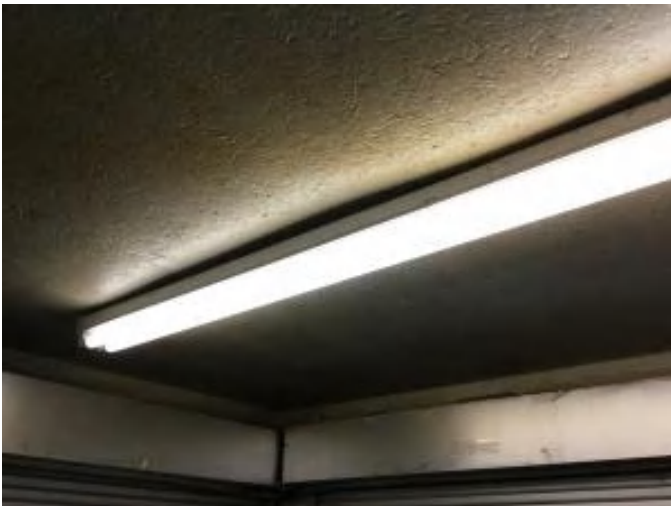
System: D5020 - Lighting

Location: Throughout Building
Distress: Beyond Service Life
Category: Deferred Maintenance
Priority: 3 - Necessary/Not Yet Critical (Years 2-5)
Correction: Renew System
Qty: 460.00
Unit of Measure: S.F.
Estimate: \$4,847.00
Assessor Name: Terence Davis
Date Created: 01/10/2017

Notes: The lighting system is beyond its service life and should be replaced.

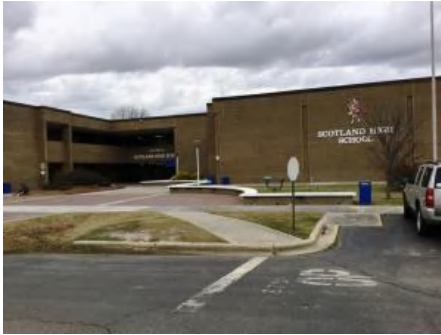
1). South Elevation - Jan 11, 2017

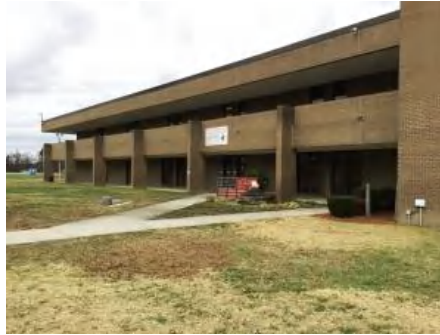
2). Southwest Elevation - Jan 11, 2017

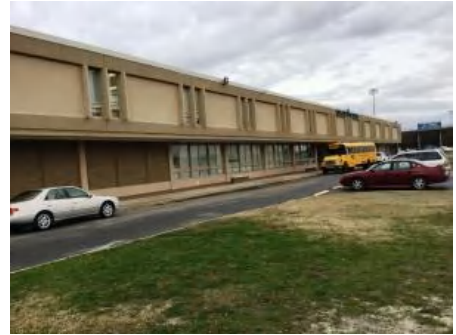
3). East Elevation - Jan 11, 2017

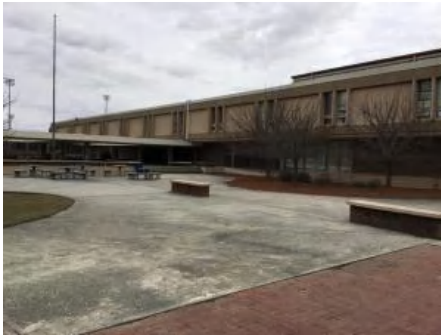
4). North Elevation - Jan 11, 2017

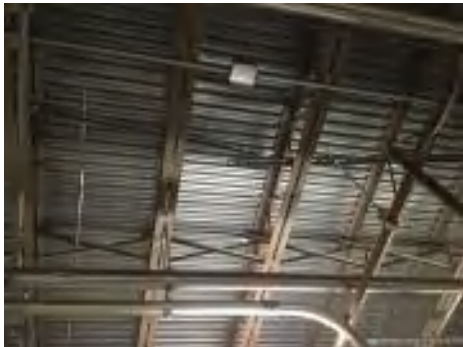
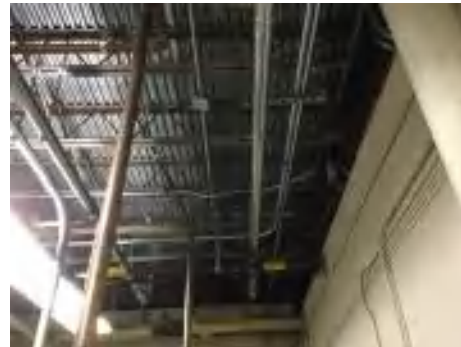
System: B1010 - Floor Construction

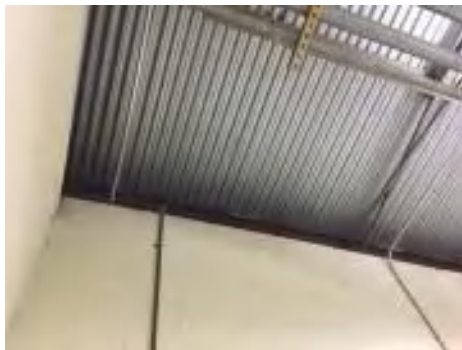
System: B1020 - Roof Construction

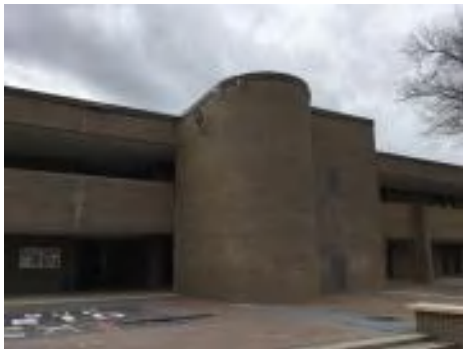
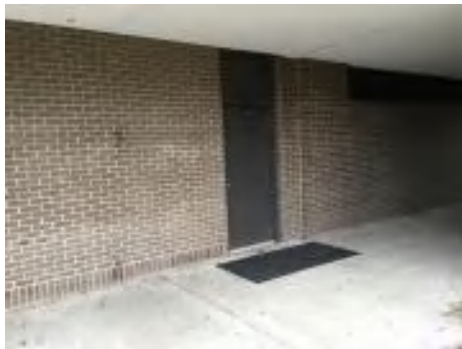
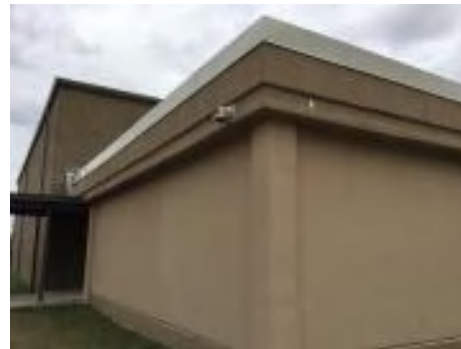
System: B2010 - Exterior Walls

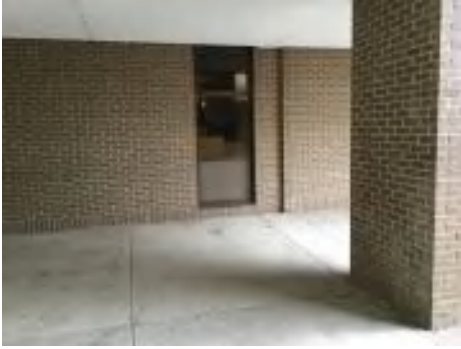
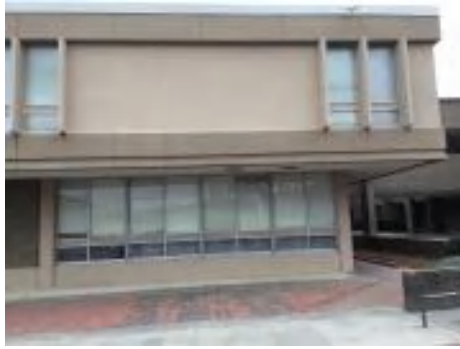
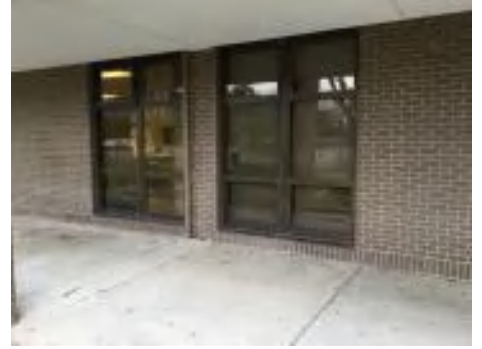
System: B2020 - Exterior Windows

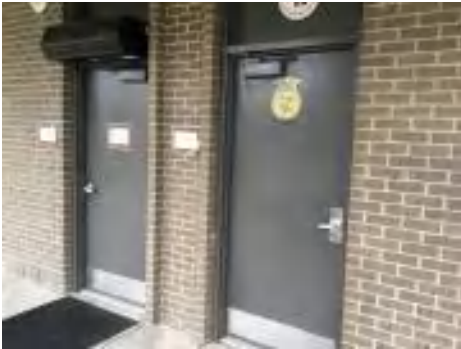
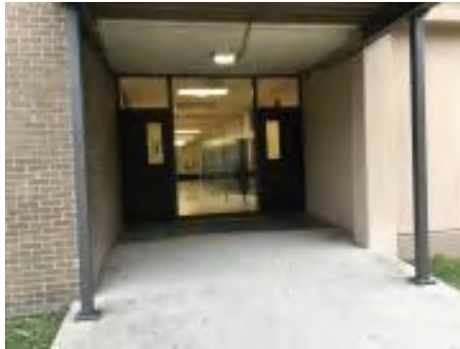
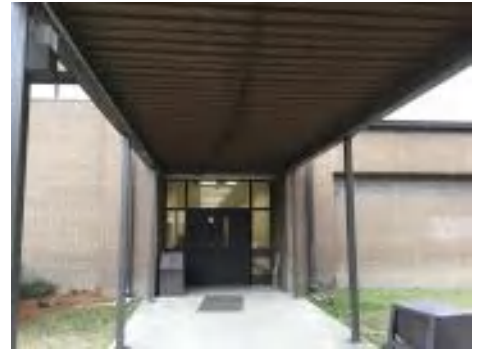
System: B2030 - Exterior Doors

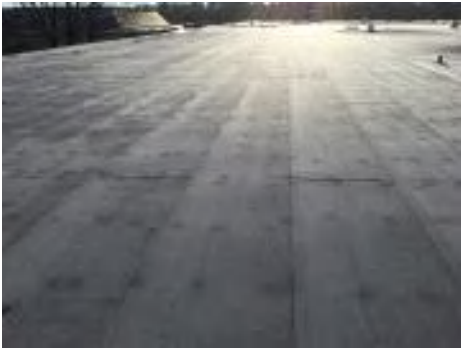
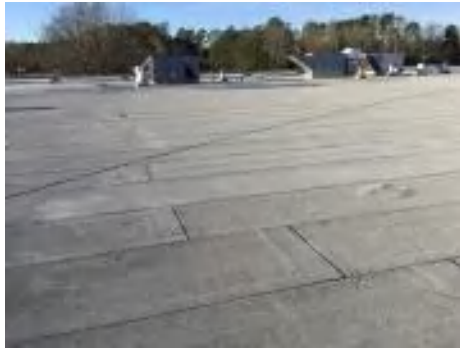
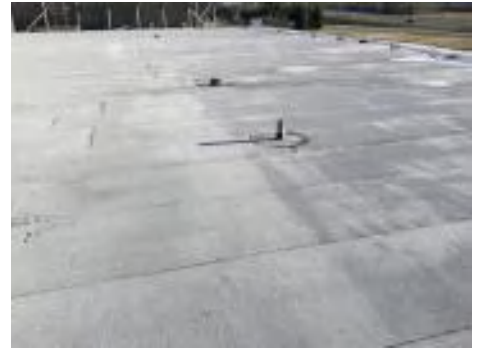
System: B3010120 - Single Ply Membrane

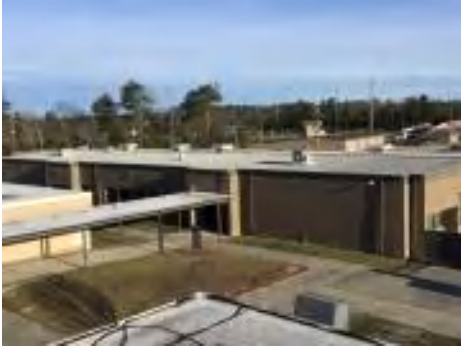
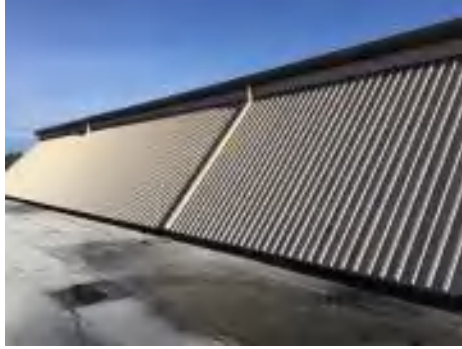
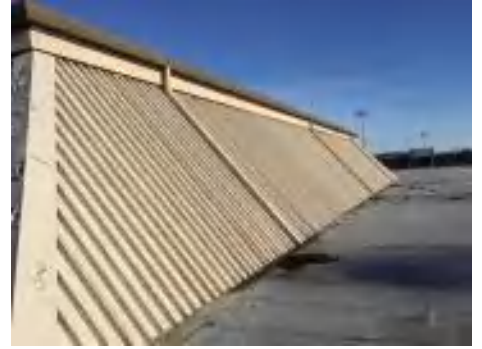
System: B3010130 - Preformed Metal Roofing

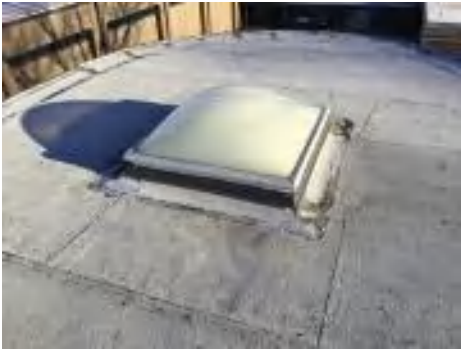
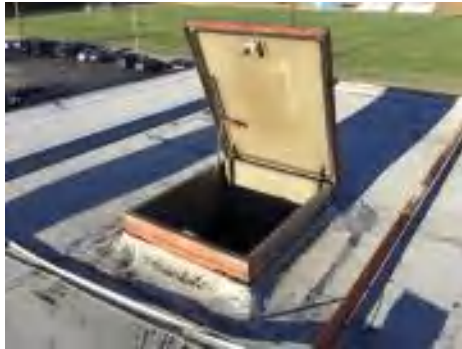
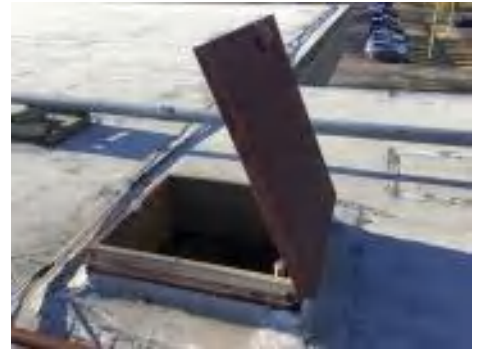
System: B3020 - Roof Openings

Note: The roof openings are beyond their service life and should be replaced.

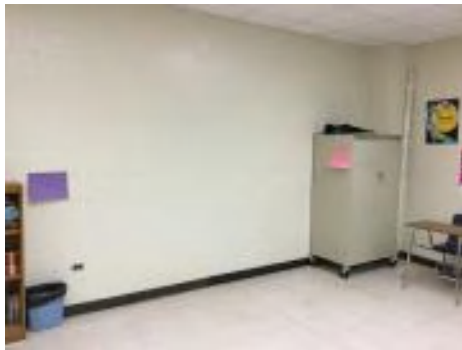
System: C1010 - Partitions

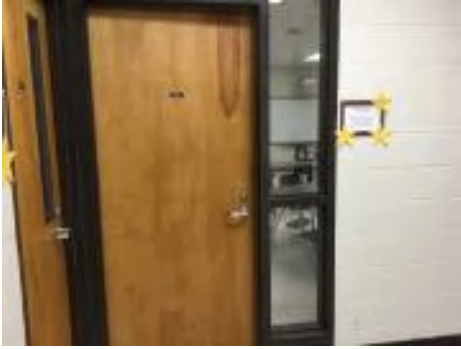
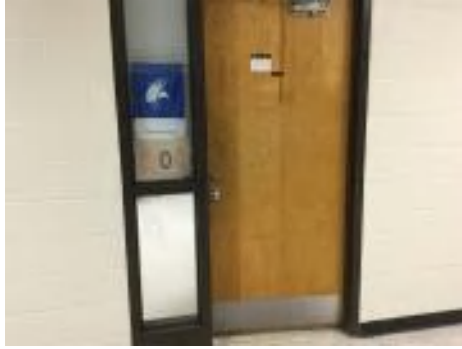
System: C1020 - Interior Doors

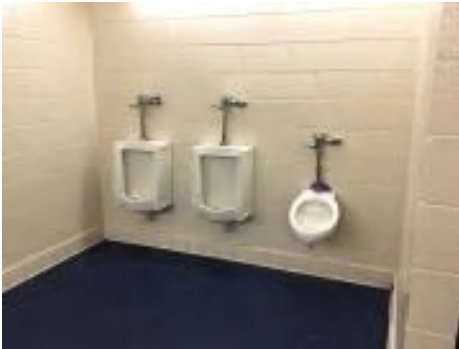
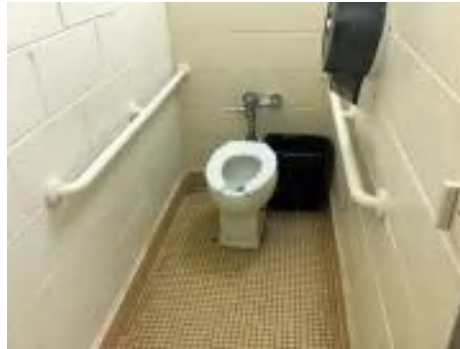
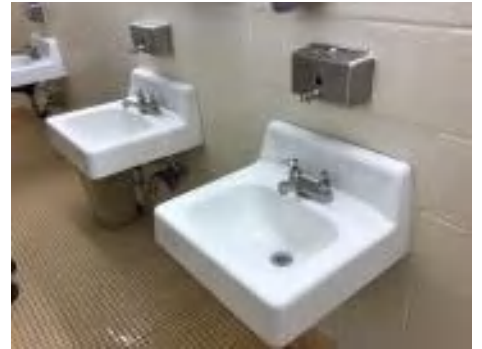
System: D2010 - Plumbing Fixtures

Note: The plumbing fixtures are beyond their service life and should be replaced.

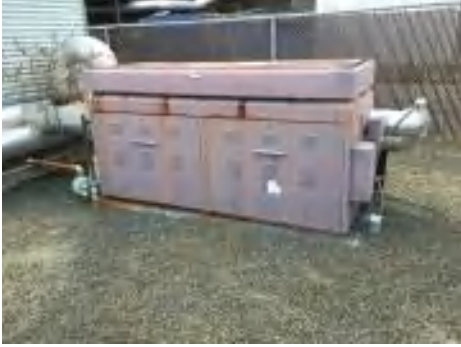
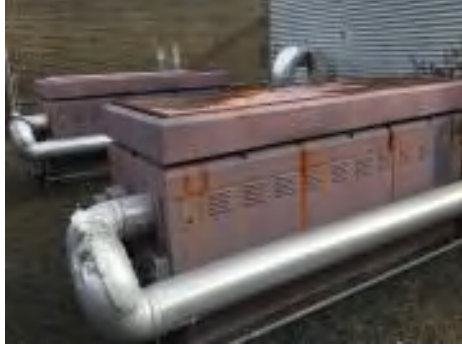
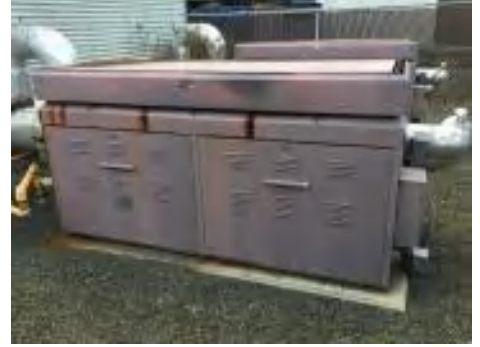
System: D3020 - Heat Generating Systems

Note: The heat generating systems are beyond their service life and should be replaced.

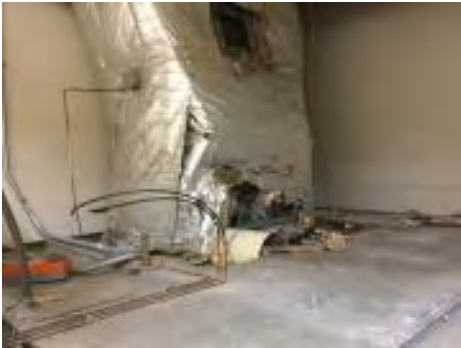
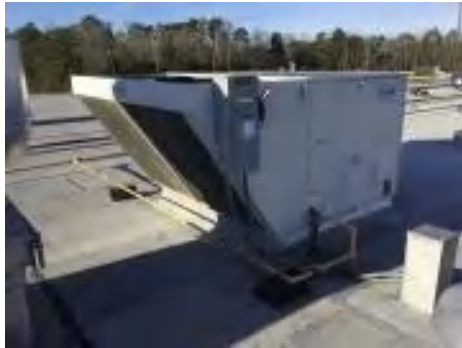
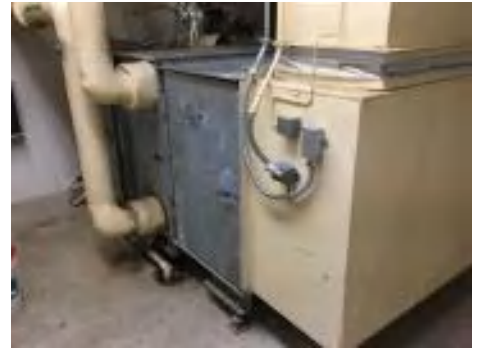
System: D3040 - Distribution Systems

Note: The distribution system is beyond its service life and should be replaced.

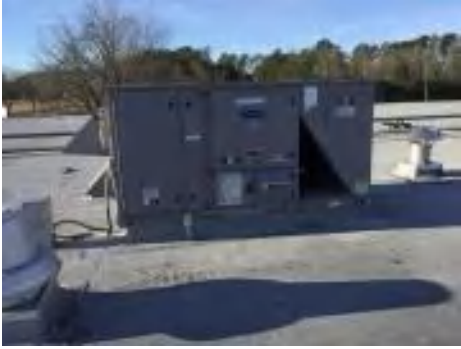
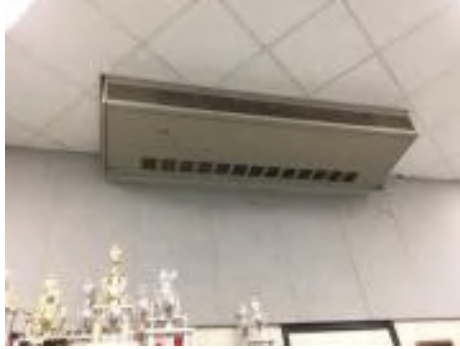
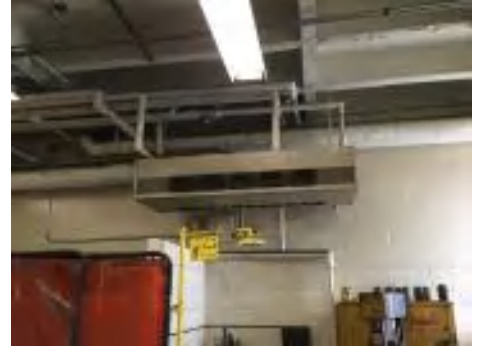
System: D3050 - Terminal & Package Units

Note: The terminal and package units are beyond their service life and should be replaced.

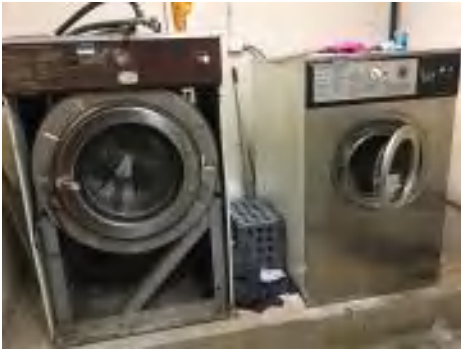
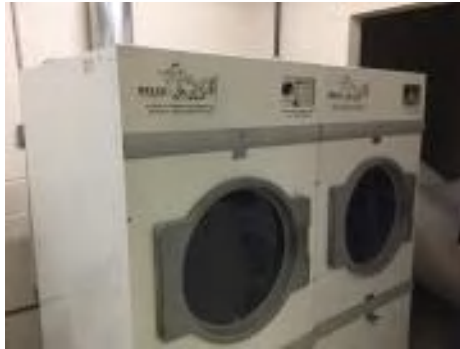
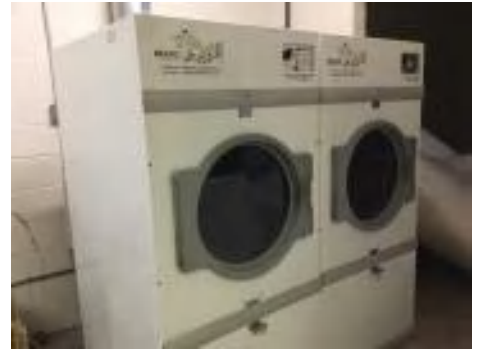
System: E1010 - Commercial Equipment

Note: The commercial equipment is beyond its service life and should be replaced.

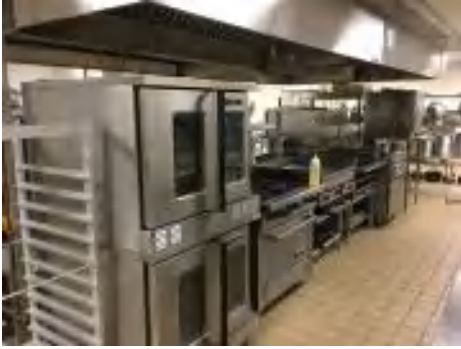
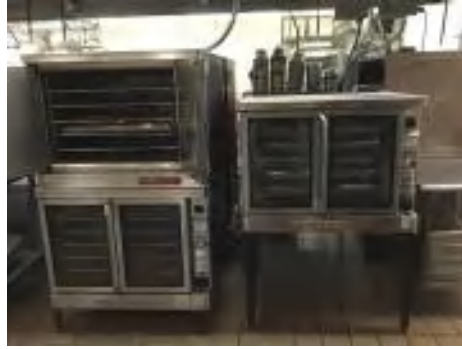
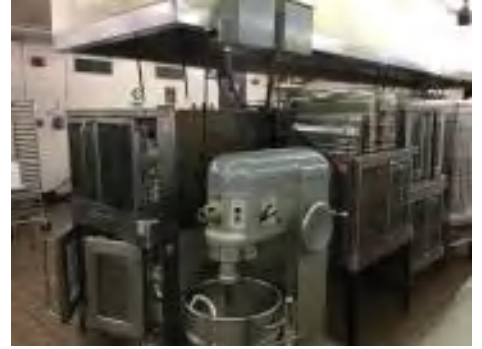
System: E1090 - Other Equipment

Note: The kitchen equipment is beyond its service life and should be replaced.

Notes: The kitchen equipment is beyond its service life and should be replaced.

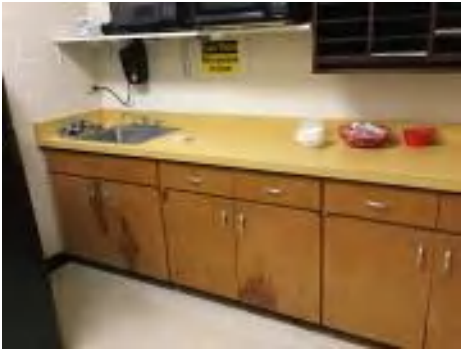
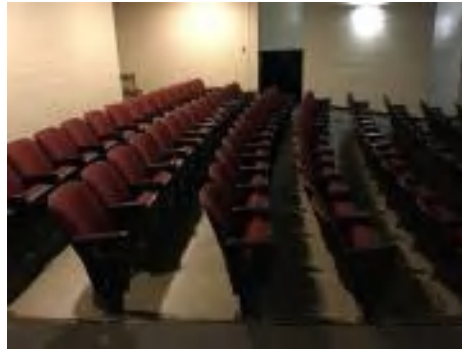
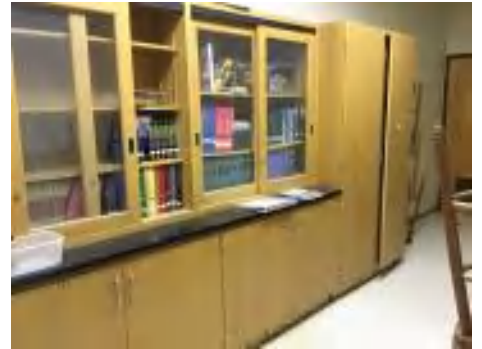
System: E2010 - Fixed Furnishings

Note: The fixed furnishings are beyond their service life and should be replaced.

Notes: The fixed furnishings are beyond their service life and should be replaced.

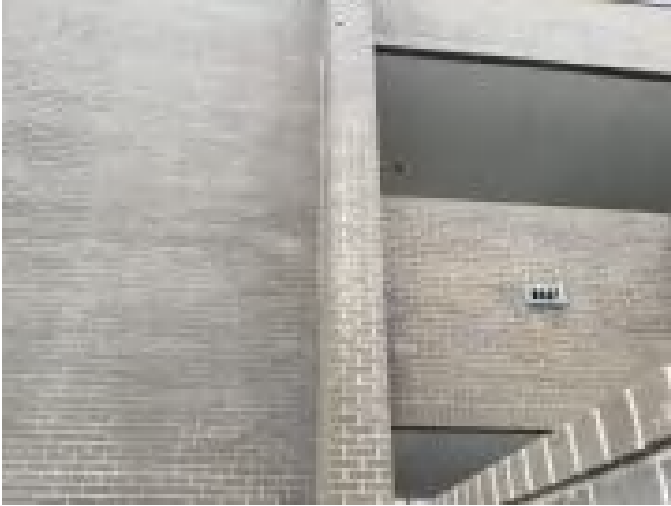
System: B2010 - Exterior Walls

Location: Exterior Walls
Distress: Damaged
Category: Safety / Building Code Compliance
Priority: 1 - Currently Critical (Immediate)
Correction: Engineering Study-2016-11-15 17:41:59
Qty: 1.00
Unit of Measure: Ea.
Estimate: \$13,200.00
Assessor Name: Terence Davis
Date Created: 01/06/2017

Notes: There are visible cracks on the exterior walls and it should be studied by a professional engineer.

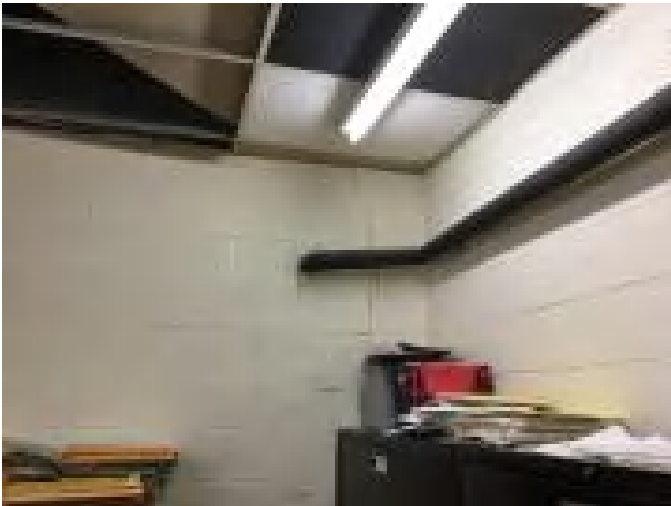
System: C1010 - Partitions

Location: Media Center
Distress: Failing
Category: Safety / Building Code Compliance
Priority: 1 - Currently Critical (Immediate)
Correction: Engineering Study
Qty: 1.00
Unit of Measure: Ea.
Estimate: \$13,200.00
Assessor Name: Terence Davis
Date Created: 01/06/2017

Notes: There are visible cracks on the partition wall and should be studied by a professional engineer.

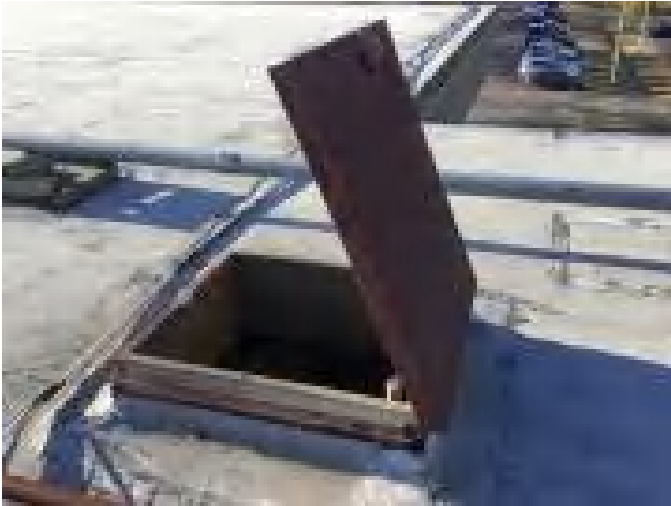
System: B3020 - Roof Openings

Location: Roof
Distress: Beyond Service Life
Category: Deferred Maintenance
Priority: 3 - Necessary/Not Yet Critical (Years 2-5)
Correction: Renew System
Qty: 178,900.00
Unit of Measure: S.F.
Estimate: \$41,326.00
Assessor Name: Terence Davis
Date Created: 12/30/2016

Notes: The roof openings are beyond their service life and should be replaced by OSHA complaint access.

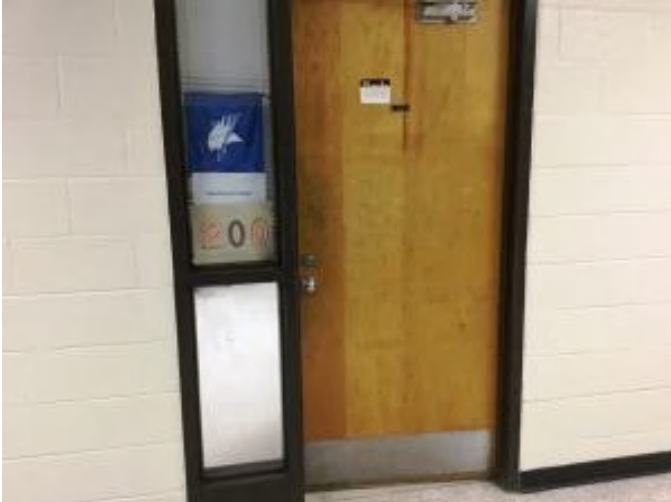
System: C1030 - Fittings

Location: Throughout Building
Distress: Inadequate
Category: Building Code Compliance
Priority: 3 - Necessary/Not Yet Critical (Years 2-5)
Correction: Replace signage and toilet partitions
Qty: 150.00
Unit of Measure: Ea.
Estimate: \$10,989.00
Assessor Name: Terence Davis
Date Created: 02/14/2017

Notes: The signage is not ADA compliant and should be replaced.

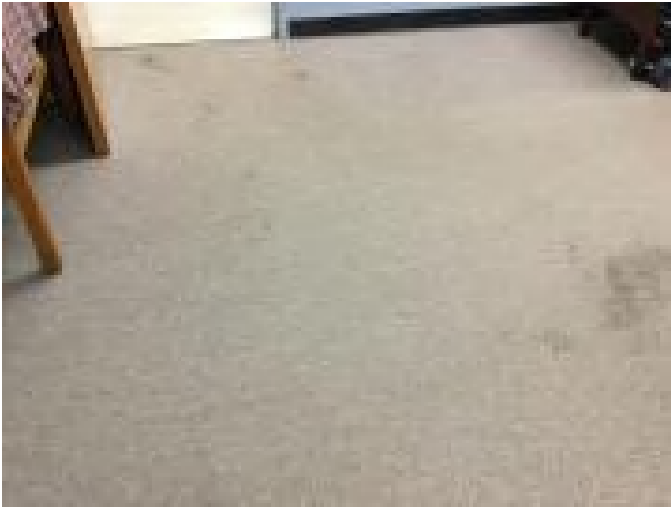
System: C3020 - Floor Finishes

Location: Throughout building
Distress: Beyond Service Life
Category: Deferred Maintenance / Appearance
Priority: 3 - Necessary/Not Yet Critical (Years 2-5)
Correction: Replace carpet
Qty: 1,851.11
Unit of Measure: S.Y.
Estimate: \$158,238.80
Assessor Name: Terence Davis
Date Created: 01/06/2017

Notes: The carpet is beyond its service life and should be replaced.

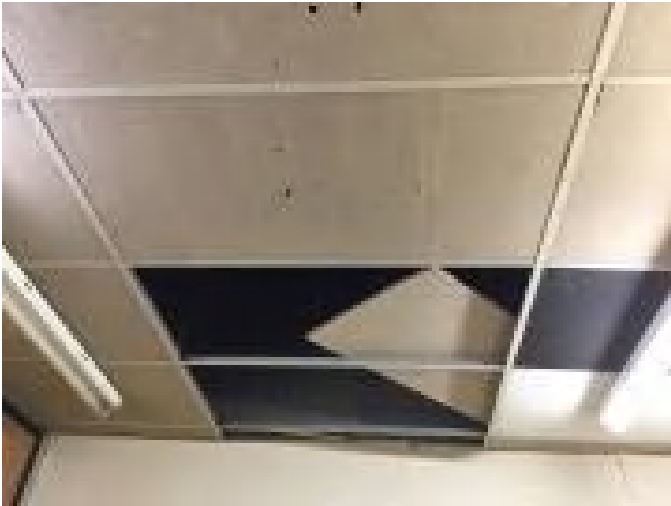
System: C3030 - Ceiling Finishes

Location: Throughout building
Distress: Beyond Service Life
Category: Deferred Maintenance / Appearance
Priority: 3 - Necessary/Not Yet Critical (Years 2-5)
Correction: Acoustic tile repairs - (2% of ceilings)
Qty: 47.20
Unit of Measure: C.S.F.
Estimate: \$50,403.94
Assessor Name: Terence Davis
Date Created: 01/06/2017

Notes: The acoustical ceiling tiles are beyond their service life and should be replaced.

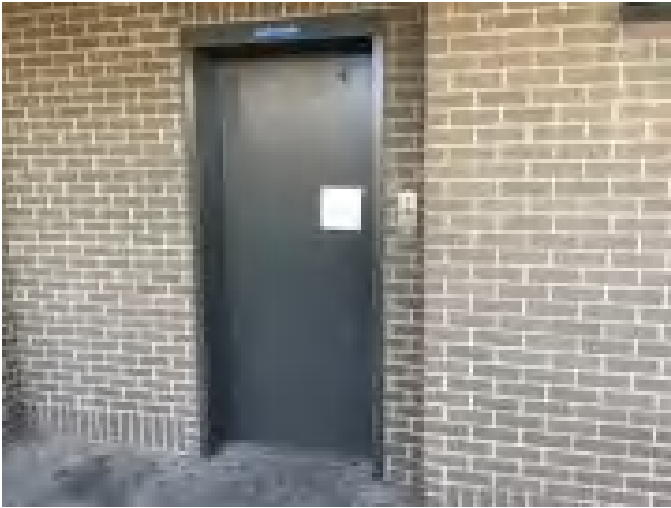
System: D1010 - Elevators and Lifts

Location: Throughout Building
Distress: Beyond Service Life
Category: Deferred Maintenance
Priority: 3 - Necessary/Not Yet Critical (Years 2-5)
Correction: Renew System
Qty: 178,900.00
Unit of Measure: S.F.
Estimate: \$192,854.00
Assessor Name: Terence Davis
Date Created: 12/30/2016

Notes: The elevators and lifts are beyond their service life and should be replaced.

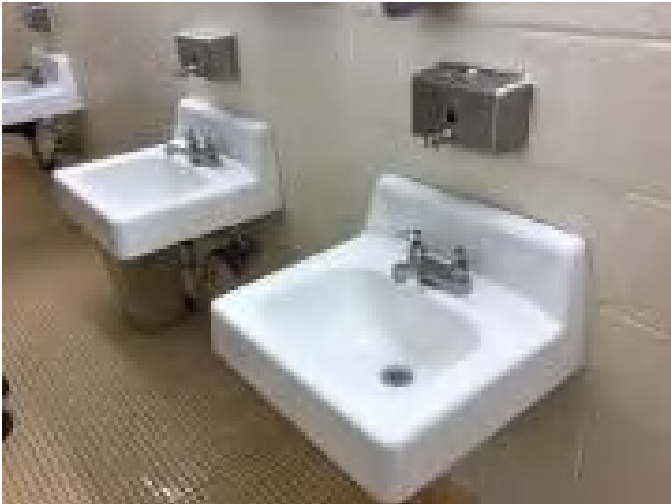
System: D2010 - Plumbing Fixtures

Location: Throughout Building
Distress: Beyond Service Life
Category: Deferred Maintenance
Priority: 3 - Necessary/Not Yet Critical (Years 2-5)
Correction: Renew System
Qty: 178,900.00
Unit of Measure: S.F.
Estimate: \$1,737,656.00
Assessor Name: Terence Davis
Date Created: 12/30/2016

Notes: The plumbing fixtures are beyond their service life and should be replaced.
