NC School District/830 Scotland County/High School

Scotland High

Campus Assessment Report

March 7, 2017

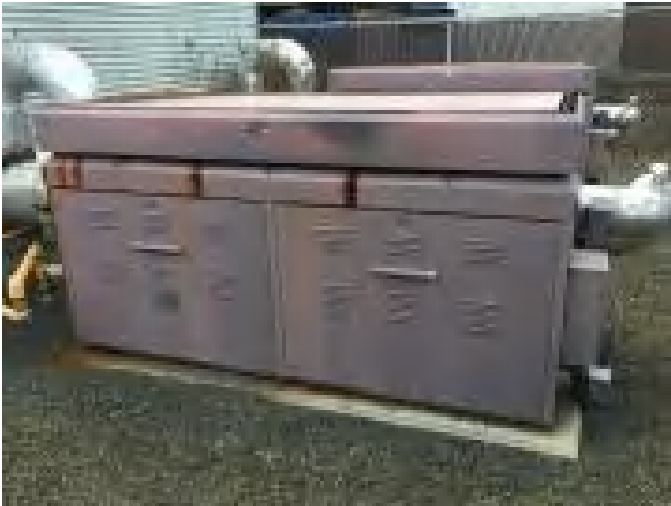
System: D3020 - Heat Generating Systems

Location: Throughout Building
Distress: Beyond Service Life
Category: Deferred Maintenance
Priority: 3 - Necessary/Not Yet Critical (Years 2-5)
Correction: Renew System
Qty: 178,900.00
Unit of Measure: S.F.
Estimate: \$1,363,755.00
Assessor Name: Terence Davis
Date Created: 12/30/2016

Notes: The heat generating systems are beyond their service life and should be replaced.

Note: The heat generating systems are beyond their service life and should be replaced.

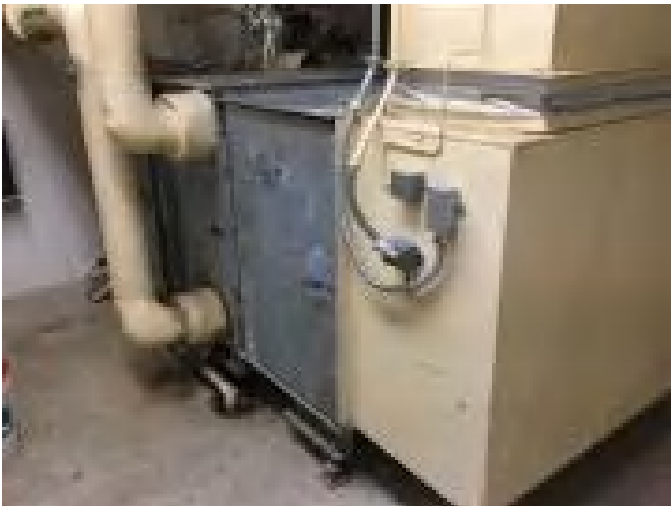
System: D3040 - Distribution Systems

Location: Throughout Building
Distress: Beyond Service Life
Category: Deferred Maintenance
Priority: 3 - Necessary/Not Yet Critical (Years 2-5)
Correction: Renew System
Qty: 178,900.00
Unit of Measure: S.F.
Estimate: \$1,647,132.00
Assessor Name: Terence Davis
Date Created: 12/30/2016

Notes: The distribution system is beyond its service life and should be replaced.

Note: The distribution system is beyond its service life and should be replaced.

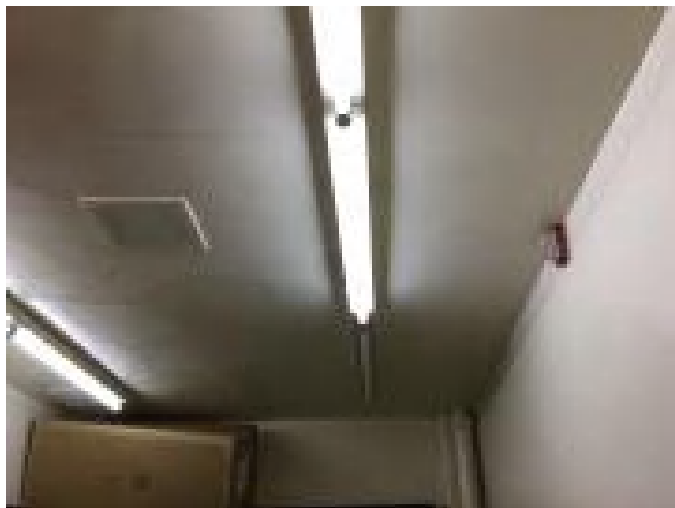
System: D5020 - Lighting

Location: Throughout building
Distress: Beyond Service Life
Category: Deferred Maintenance
Priority: 3 - Necessary/Not Yet Critical (Years 2-5)
Correction: Replace fluorescent fixture, lay-in, recess mtd, 2' x 4', two 40 W
Qty: 75.00
Unit of Measure: Ea.
Estimate: \$23,567.94
Assessor Name: Terence Davis
Date Created: 01/06/2017

Notes: The lighting fixtures are beyond their service life and should be replaced.

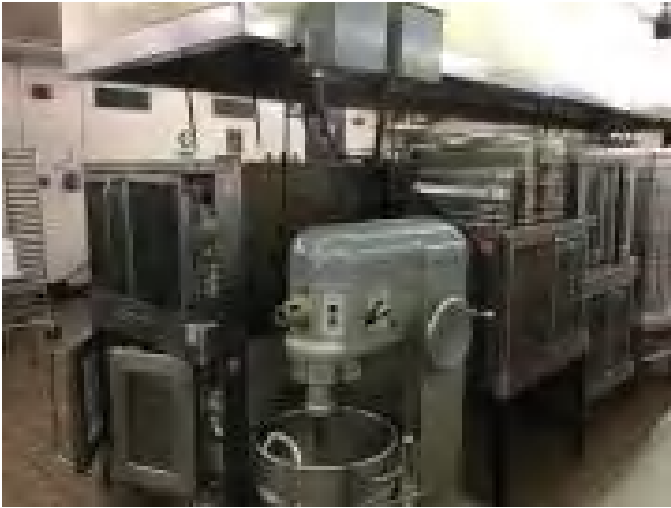
System: E1090 - Other Equipment

Location: Cafeteria and Home Economics Classrooms
Distress: Beyond Service Life
Category: Deferred Maintenance
Priority: 3 - Necessary/Not Yet Critical (Years 2-5)
Correction: Renew System
Qty: 178,900.00
Unit of Measure: S.F.
Estimate: \$1,054,794.00
Assessor Name: Terence Davis
Date Created: 12/30/2016

Notes: The kitchen equipment is beyond its service life and should be replaced.

Note: The kitchen equipment is beyond its service life and should be replaced.

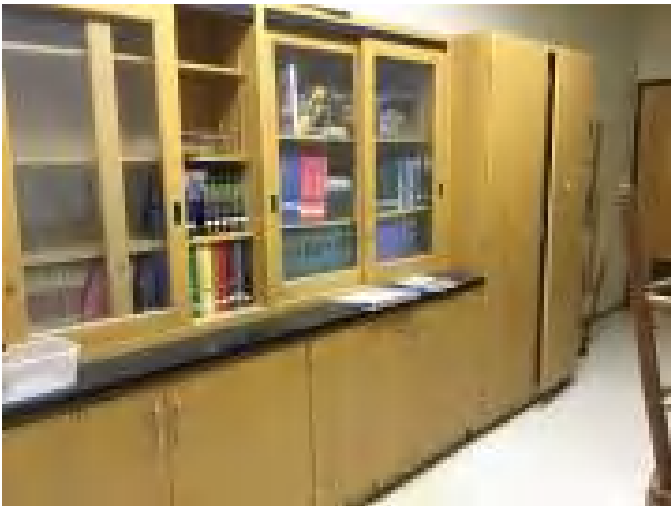
System: E2010 - Fixed Furnishings

Location: Throughout Building
Distress: Beyond Service Life
Category: Deferred Maintenance / Appearance
Priority: 3 - Necessary/Not Yet Critical (Years 2-5)
Correction: Renew System
Qty: 178,900.00
Unit of Measure: S.F.
Estimate: \$980,014.00
Assessor Name: Terence Davis
Date Created: 12/30/2016

Notes: The fixed furnishings are beyond their service life and should be replaced.

Note: The fixed furnishings are beyond their service life and should be replaced.

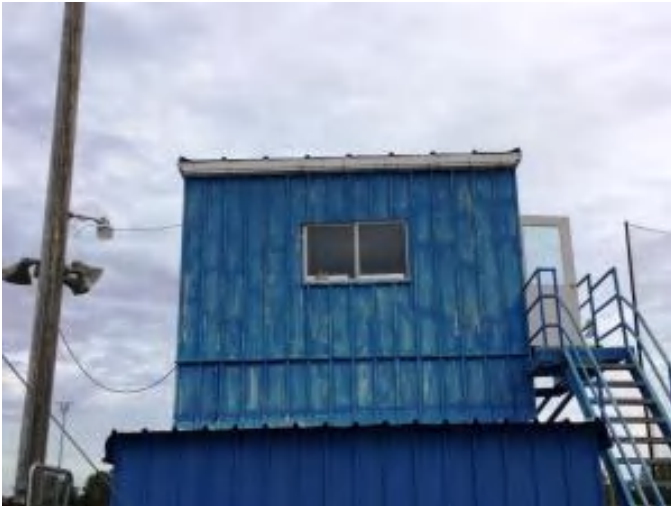
System: B2010 - Exterior Walls

Location: Exterior Walls
Distress: Beyond Service Life
Category: Deferred Maintenance / Appearance
Priority: 3 - Necessary/Not Yet Critical (Years 2-5)
Correction: Refinish aluminum siding, 2nd floor
Qty: 12.80
Unit of Measure: C.S.F.
Estimate: \$4,899.84
Assessor Name: Eduardo Lopez
Date Created: 01/11/2017

Notes: The exterior wall finish is in poor condition and should be replaced.

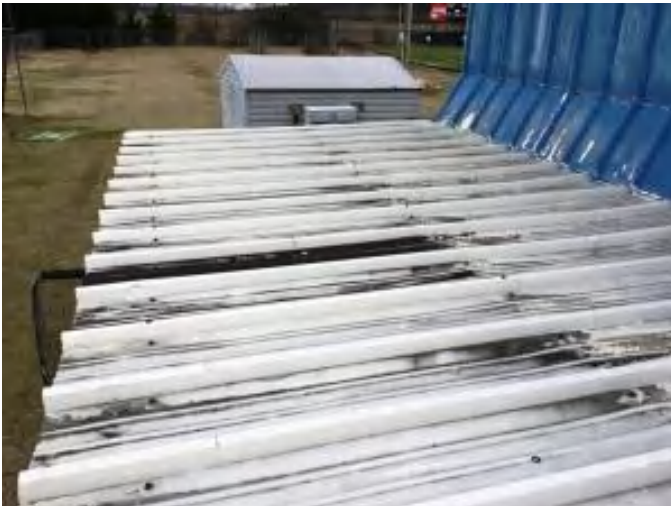
System: B3010130 - Preformed Metal Roofing

Location: Roof
Distress: Beyond Service Life
Category: Deferred Maintenance
Priority: 3 - Necessary/Not Yet Critical (Years 2-5)
Correction: Renew System
Qty: 430.00
Unit of Measure: S.F.
Estimate: \$5,732.00
Assessor Name: Eduardo Lopez
Date Created: 01/11/2017

Notes: The roof is beyond its service life and should be replaced.

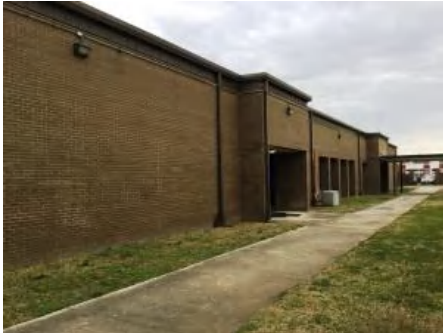
1). West Elevation - Feb 13, 2017

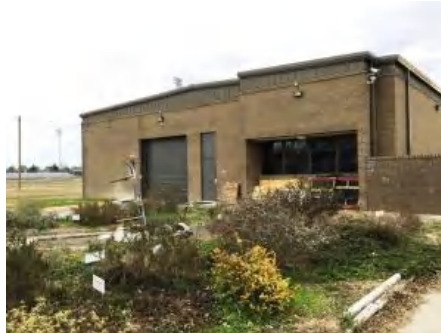
2). Northwest Elevation - Feb 13, 2017

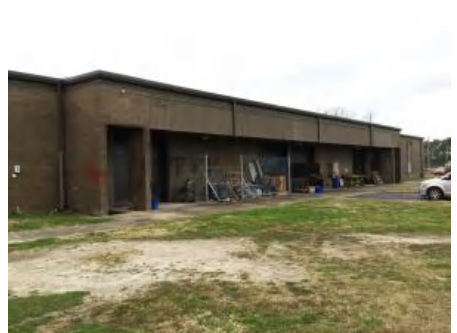
3). North Elevation - Feb 13, 2017

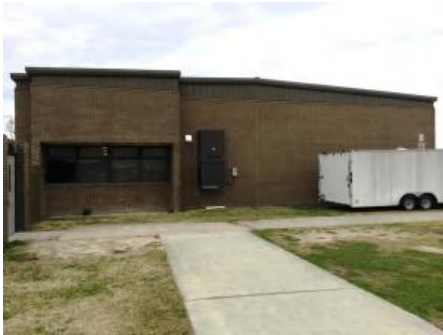
4). East Elevation - Feb 13, 2017

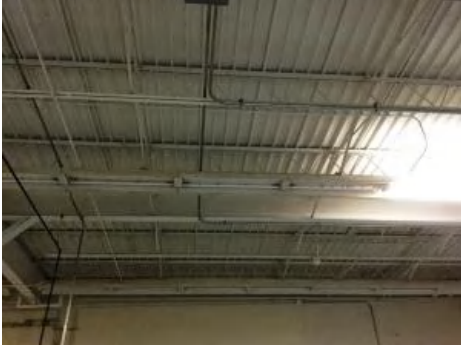
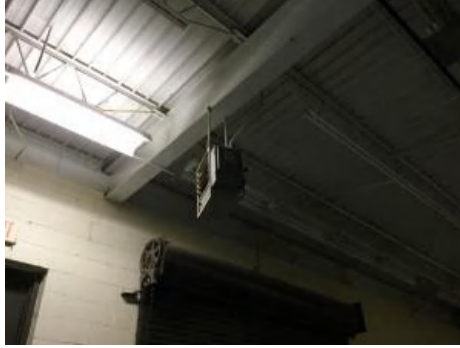
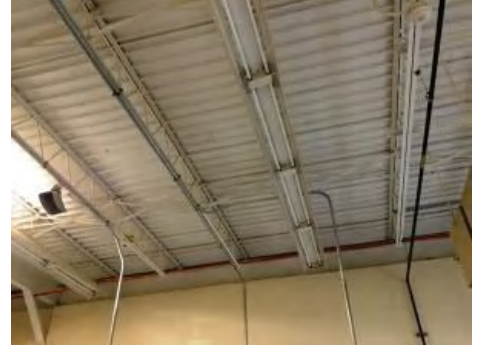
System: B1020 - Roof Construction

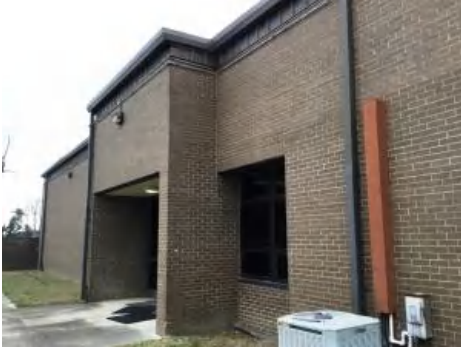
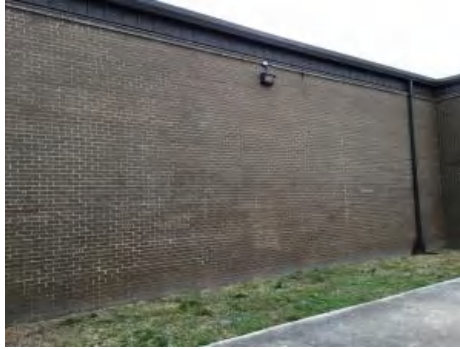
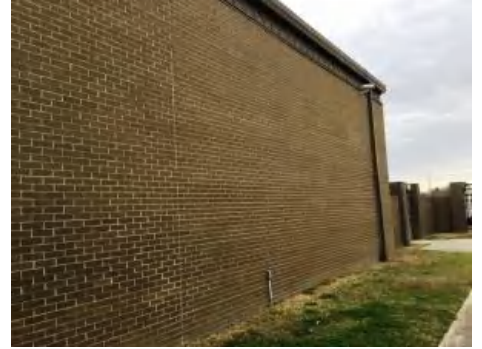
System: B2010 - Exterior Walls

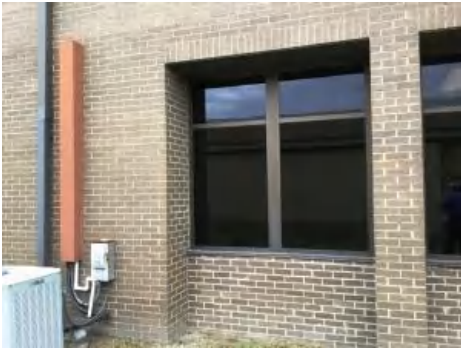
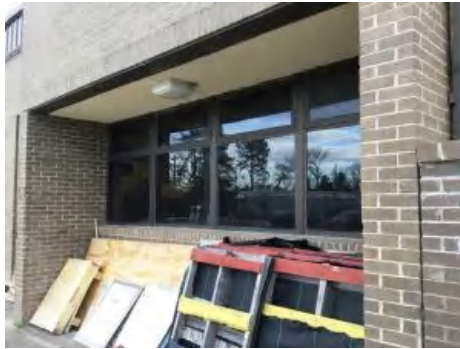
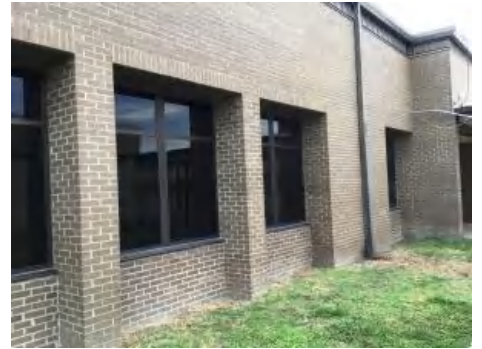
System: B2020 - Exterior Windows

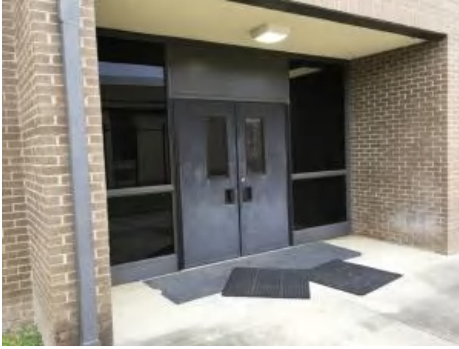
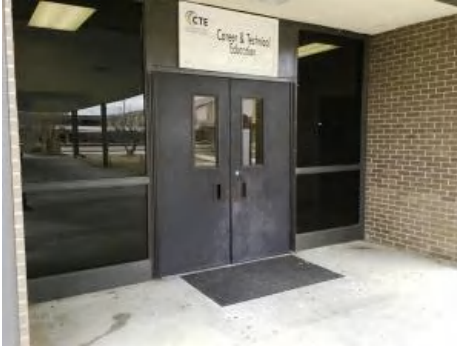
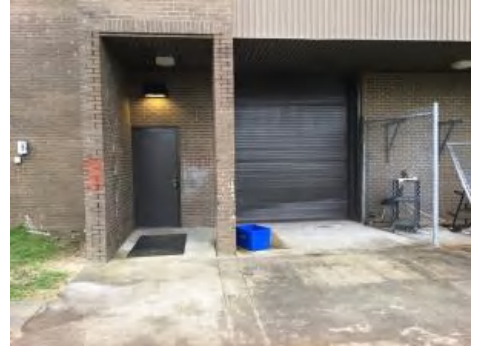
System: B2030 - Exterior Doors

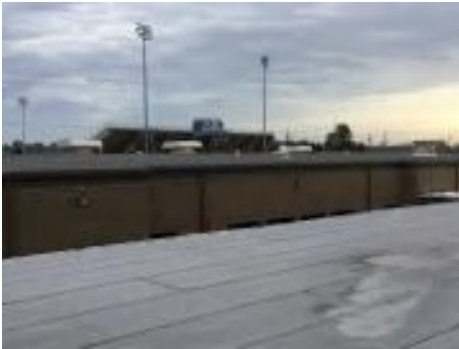
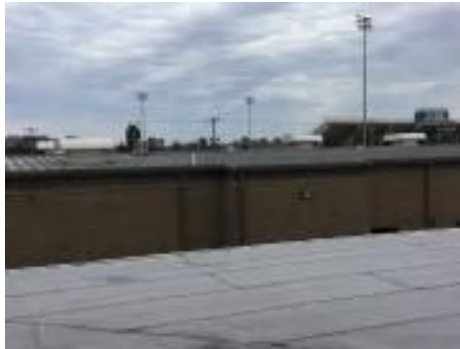
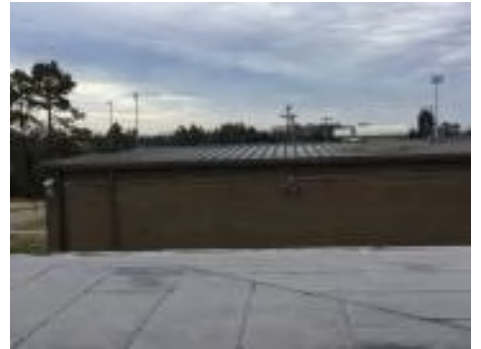
System: B3010130 - Preformed Metal Roofing

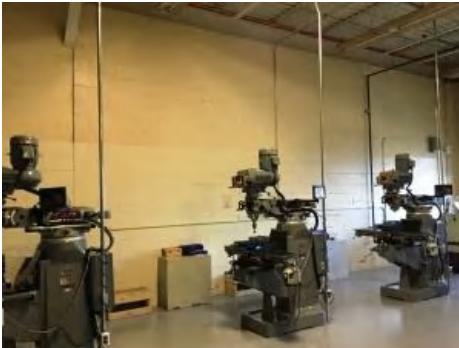
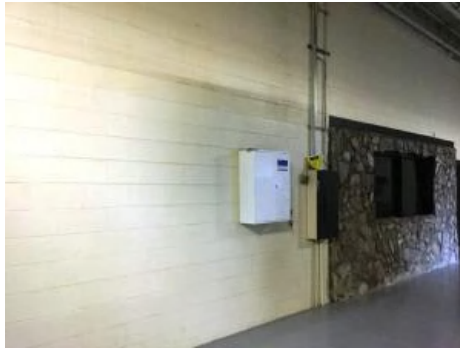
System: C1010 - Partitions

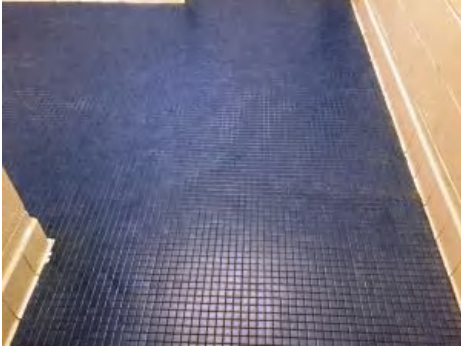
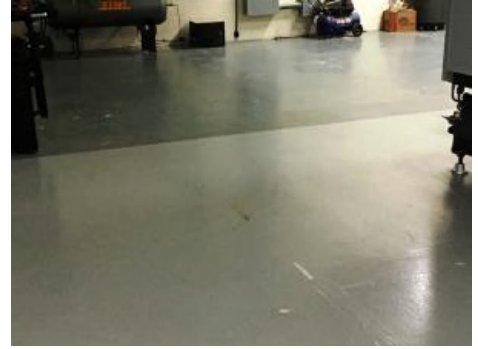
System: C3020 - Floor Finishes

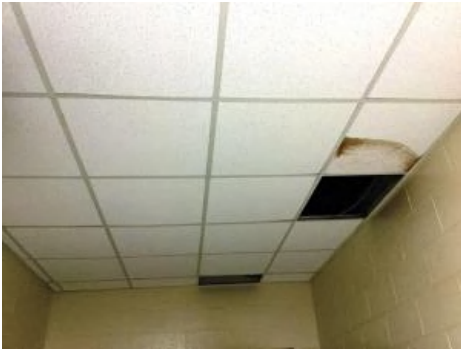
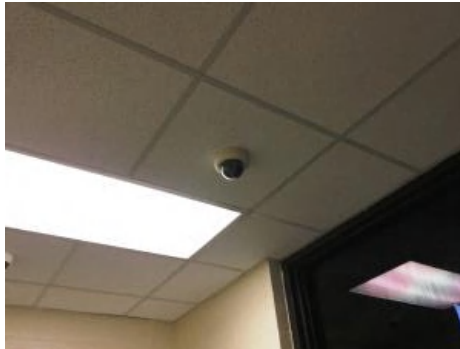
System: C3030 - Ceiling Finishes

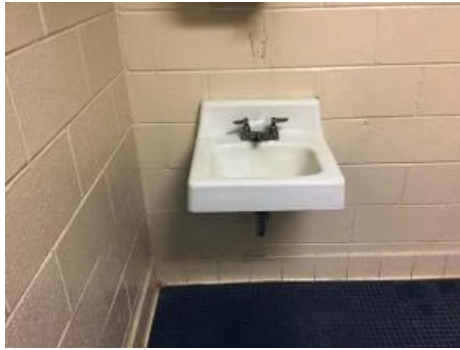
System: D2010 - Plumbing Fixtures

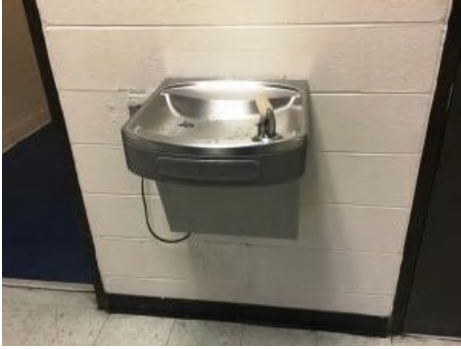
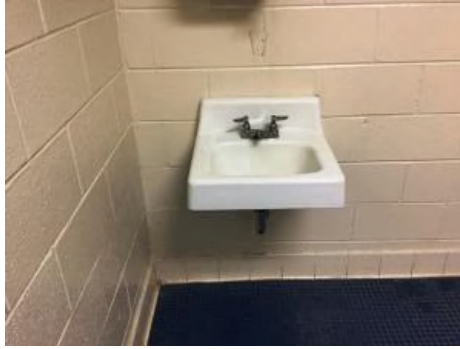
System: D2020 - Domestic Water Distribution

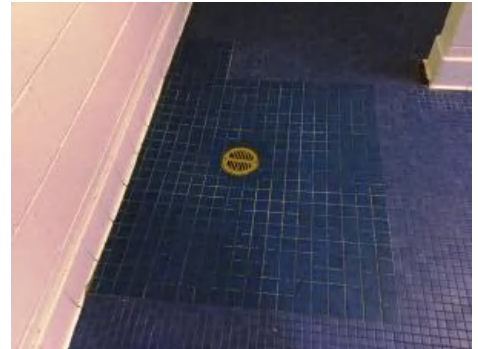
System: D2030 - Sanitary Waste

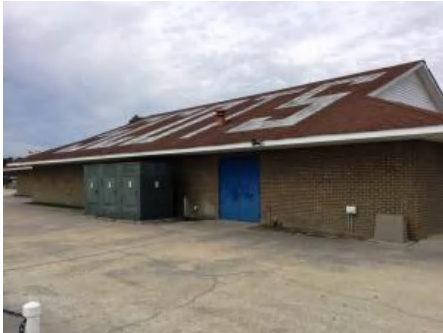
1). East Elevation - Jan 11, 2017

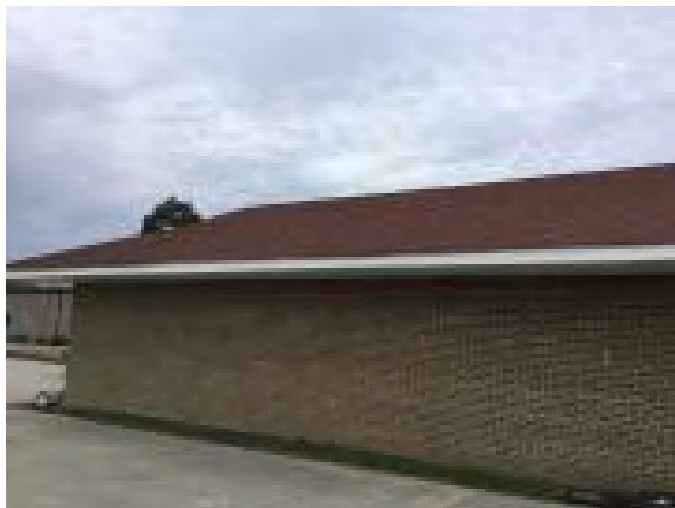
System: B3010140 - Asphalt Shingles

Location: Roof
Distress: Beyond Service Life
Category: Deferred Maintenance
Priority: 3 - Necessary/Not Yet Critical (Years 2-5)
Correction: Renew System
Qty: 6,000.00
Unit of Measure: S.F.
Estimate: \$37,843.00
Assessor Name: Eduardo Lopez
Date Created: 01/11/2017

Notes: The roof is beyond its service life and should be replaced.

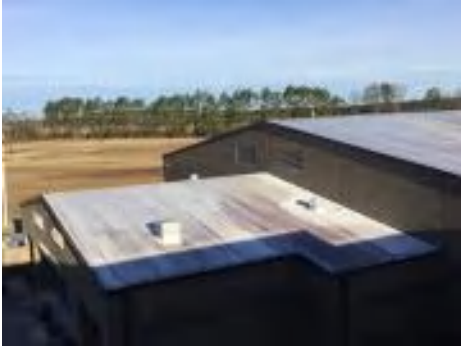
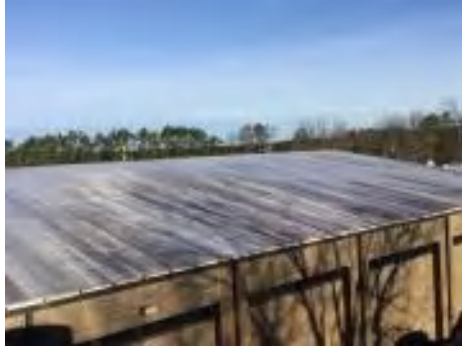
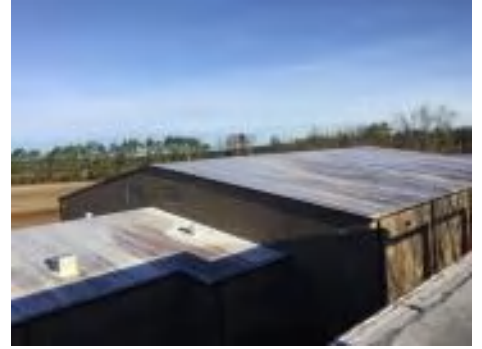
System: B3010120 - Single Ply Membrane

Note: The roof is beyond its service life and should be replaced.

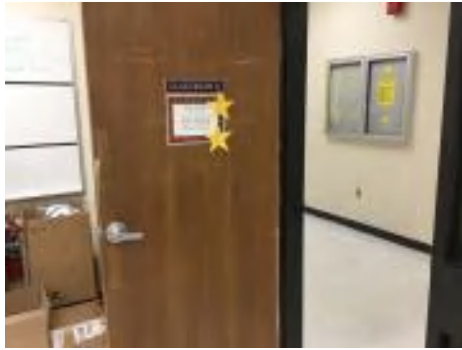
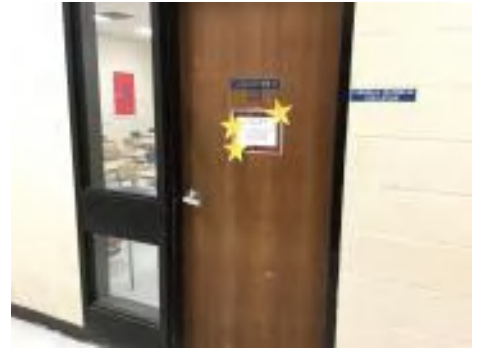
System: C1020 - Interior Doors

Note: The doors are in poor condition and should be replaced.

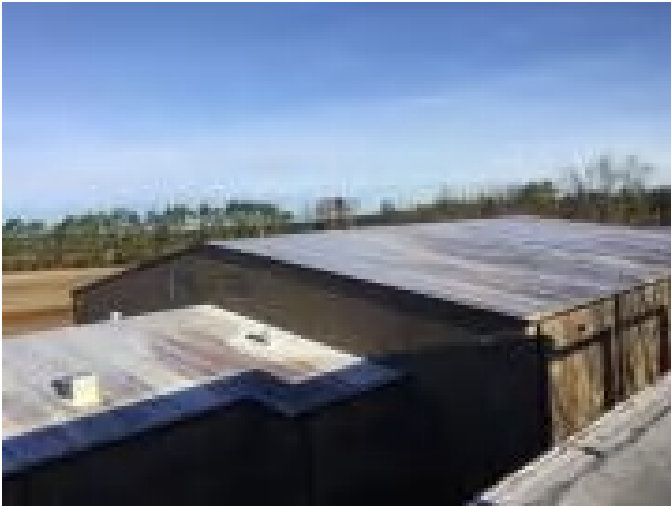
System: B3010120 - Single Ply Membrane

Location: Roof
Distress: Beyond Service Life
Category: Deferred Maintenance
Priority: 3 - Necessary/Not Yet Critical (Years 2-5)
Correction: Renew System
Qty: 28,500.00
Unit of Measure: S.F.
Estimate: \$298,395.00
Assessor Name: Terence Davis
Date Created: 01/05/2017

Notes: The roof is beyond its service life and should be replaced.

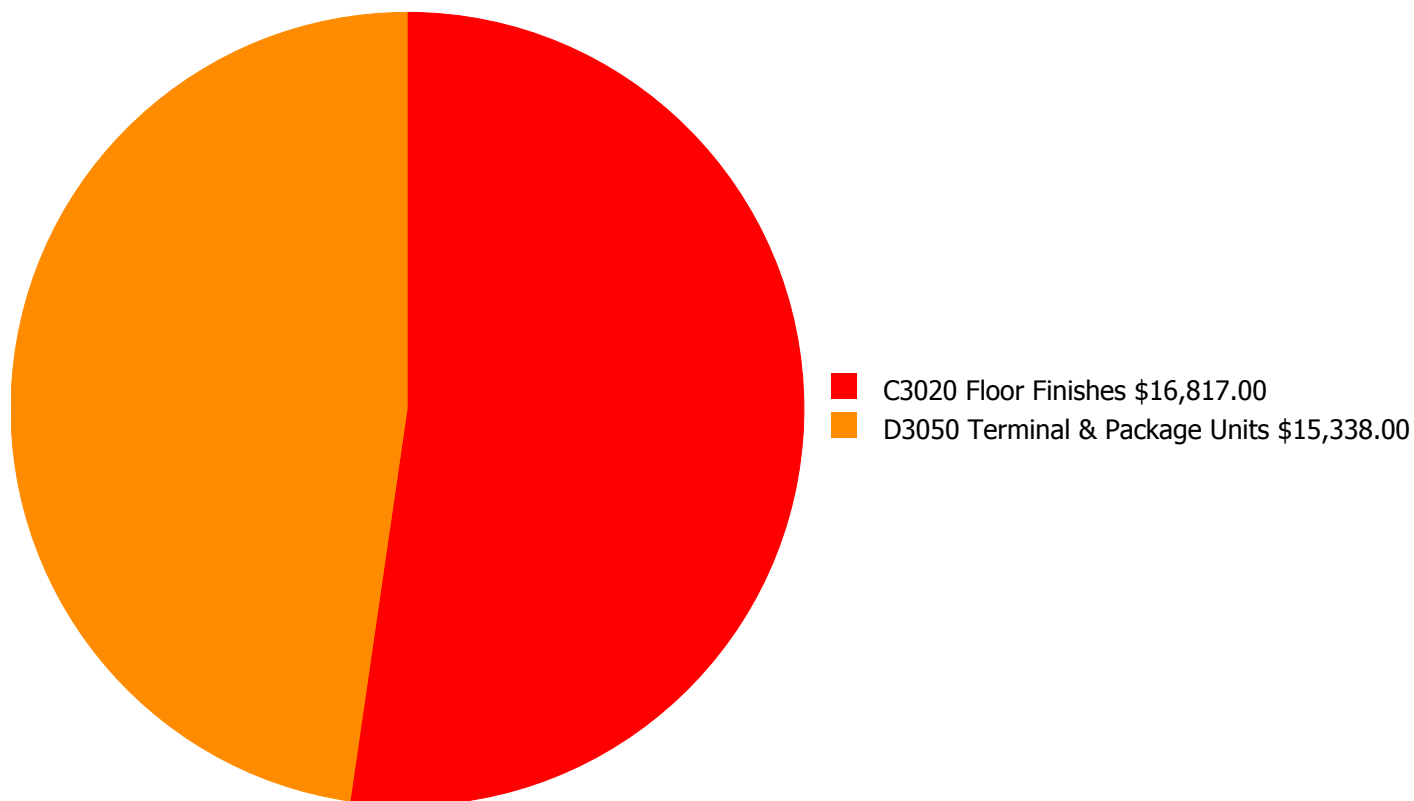
Deficiency Summary by System

Current deficiencies included assemblies that have reached or exceeded their design life or components of the assemblies that are in need of repair. Assemblies that have reached their design life are identified as current deficiencies and assigned the distress 'Beyond Useful Life'. The following chart lists all current deficiencies associated with this facility.

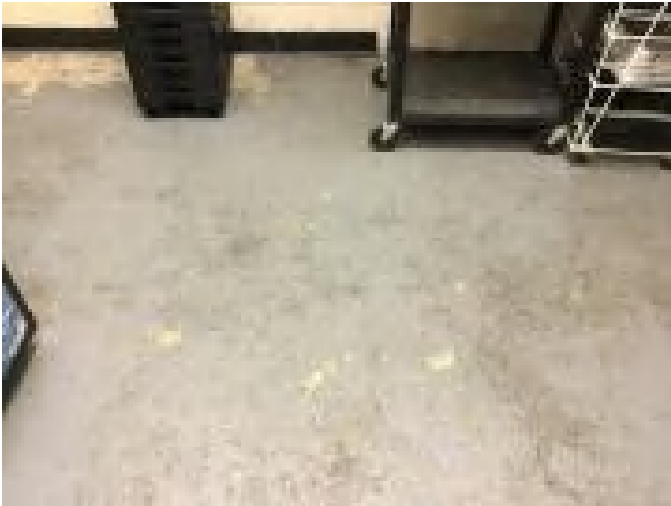
System: C3020 - Floor Finishes

Location: Throughout Building
Distress: Beyond Service Life
Category: Deferred Maintenance
Priority: 3 - Necessary/Not Yet Critical (Years 2-5)
Correction: Renew System
Qty: 1,200.00
Unit of Measure: S.F.
Estimate: \$16,817.00
Assessor Name: Eduardo Lopez
Date Created: 01/11/2017

Notes: The floor finishes are beyond their service life and should be replaced.

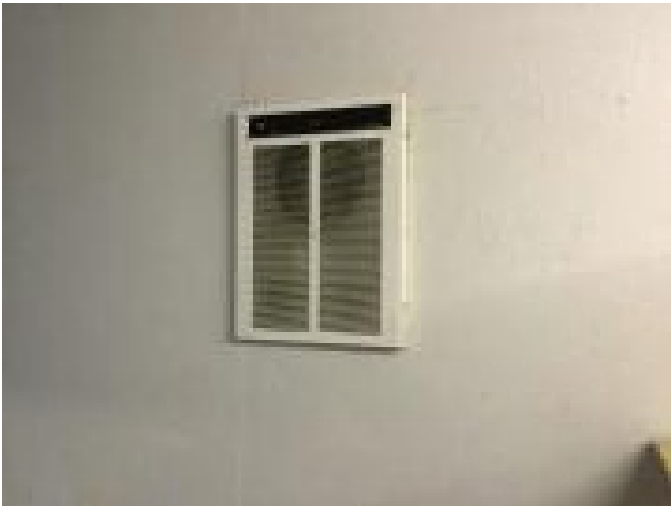
System: D3050 - Terminal & Package Units

Location: Throughout Building
Distress: Beyond Service Life
Category: Deferred Maintenance
Priority: 3 - Necessary/Not Yet Critical (Years 2-5)
Correction: Renew System
Qty: 1,200.00
Unit of Measure: S.F.
Estimate: \$15,338.00
Assessor Name: Eduardo Lopez
Date Created: 01/11/2017

Notes: The terminal and package units are beyond their service life and should be replaced.

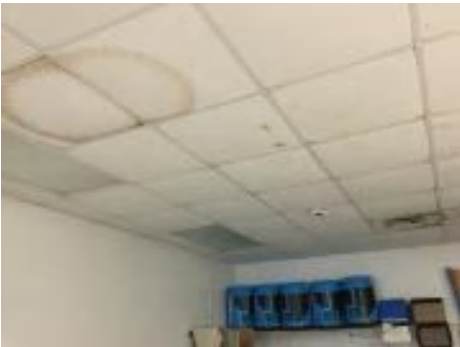
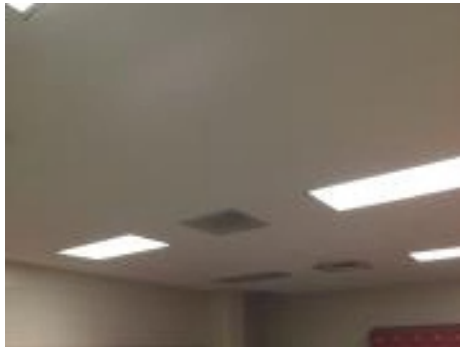
System: C3030 - Ceiling Finishes

Note: The acoustical ceiling tiles are beyond their service life and should be replaced.

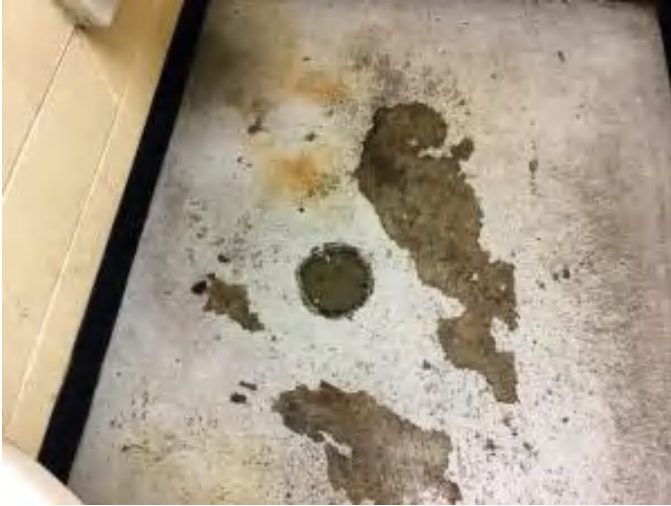
System: C3020 - Floor Finishes

Location: Mens Restroom
Distress: Damaged
Category: Deferred Maintenance
Priority: 3 - Necessary/Not Yet Critical (Years 2-5)
Correction: Replace epoxy flooring
Qty: 5.00
Unit of Measure: C.S.F.
Estimate: \$10,546.80
Assessor Name: Eduardo Lopez
Date Created: 01/11/2017

Notes: The epoxy flooring in the restroom area is in poor condition and should be replaced.

Note: The epoxy in the boys restroom is in poor condition and should be replaced.

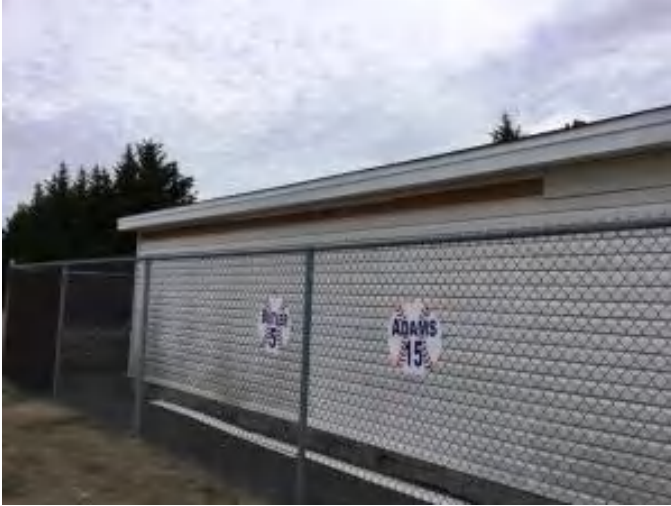
System: B2010 - Exterior Walls

Location: Exterior Walls
Distress: Damaged
Category: Deferred Maintenance / Building Code Compliance
Priority: 1 - Currently Critical (Immediate)
Correction: Replace hardboard panels, 1st floor
Qty: 2.00
Unit of Measure: C.S.F.
Estimate: \$1,716.53
Assessor Name: Eduardo Lopez
Date Created: 01/12/2017

Notes: The exterior siding is falling off and it is in poor condition and it should be replaced.

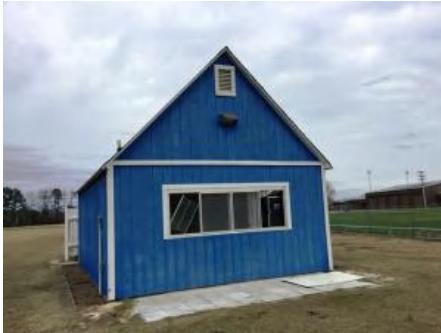
1). South Elevation - Jan 12, 2017

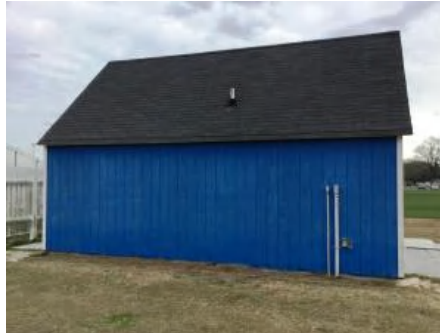
2). East Elevation - Jan 12, 2017

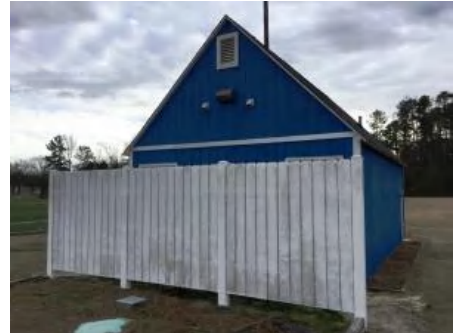
3). North Elevation - Jan 12, 2017

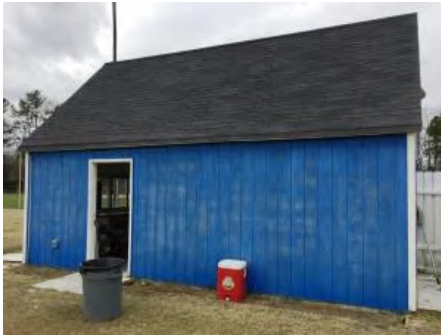
4). West Elevation - Jan 12, 2017

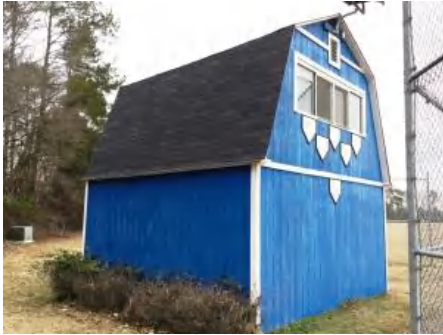
1). South Elevation - Jan 12, 2017

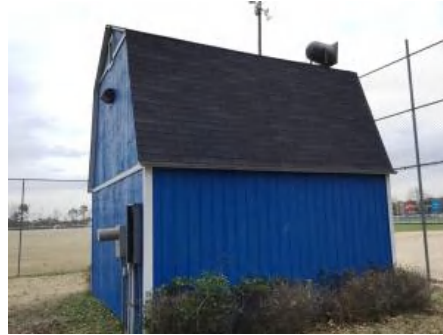
2). West Elevation - Jan 12, 2017

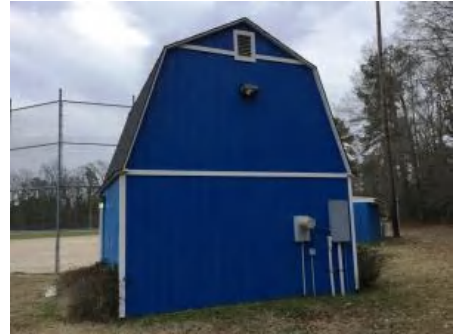
3). North Elevation - Jan 12, 2017

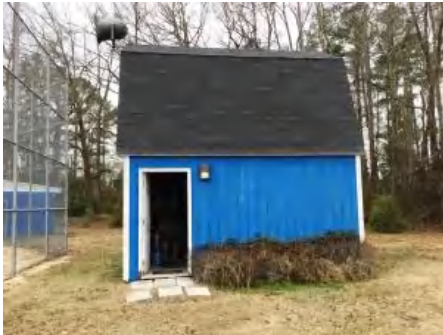
4). East Elevation - Jan 12, 2017

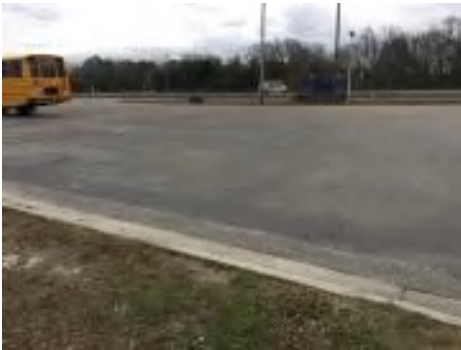
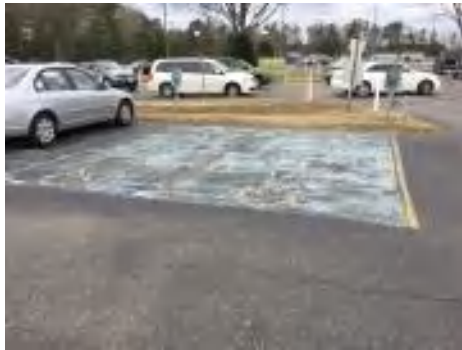
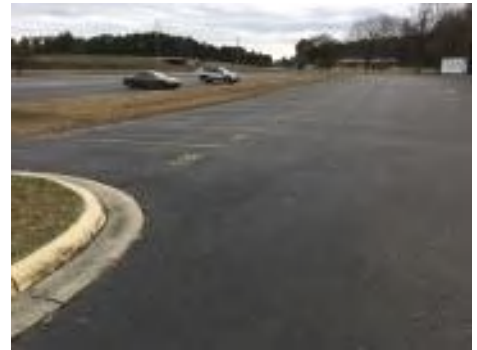
System: G2020 - Parking Lots

Note: The parking lot is beyond its service life and should be resealed, restriped and recoated.

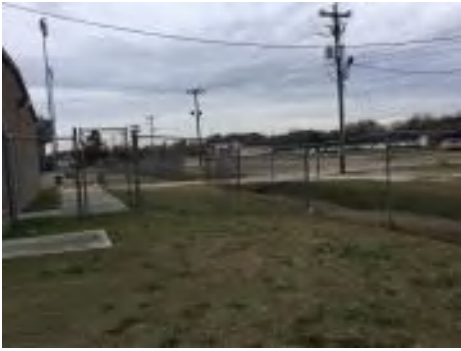
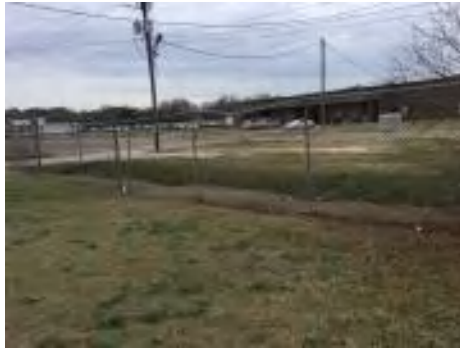
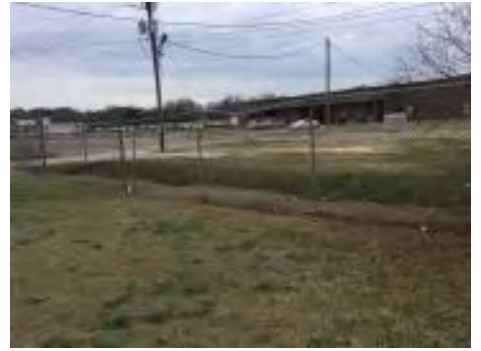
System: G2040105 - Fence & Guardrails

Note: The fences and guardrail are rusted and beyond their service life and should be replaced.

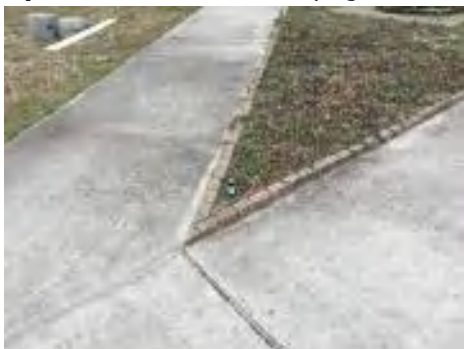
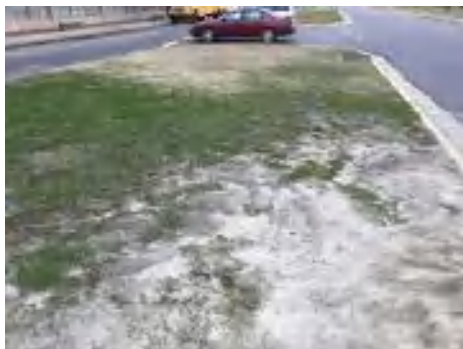
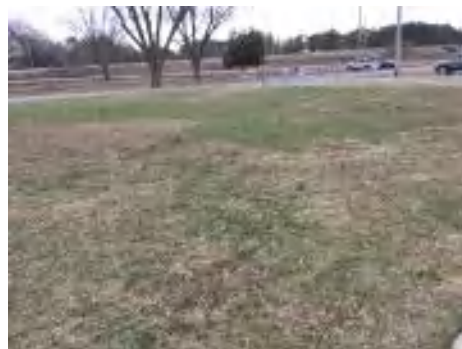
System: G2050 - Landscaping

Note: The landscaping is beyond its service life and should be replaced.

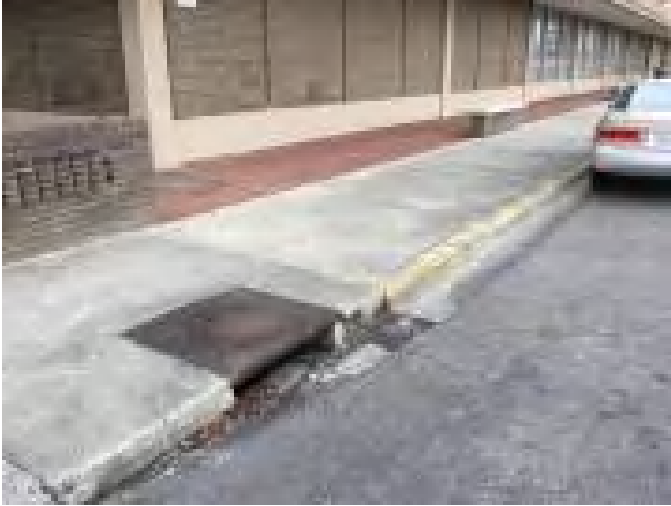
System: G2030 - Pedestrian Paving

Location: Site
Distress: Failing
Category: Life Safety Code Compliance
Priority: 1 - Currently Critical (Immediate)
Correction: Remove and replace concrete sidewalk, 4' wide
Qty: 250.00
Unit of Measure: L.F.
Estimate: \$12,696.06
Assessor Name: Somnath Das
Date Created: 01/09/2017

Notes: The pedestrian paving is undulating and has become a tripping hazard, the pedestrian paving should be replaced.

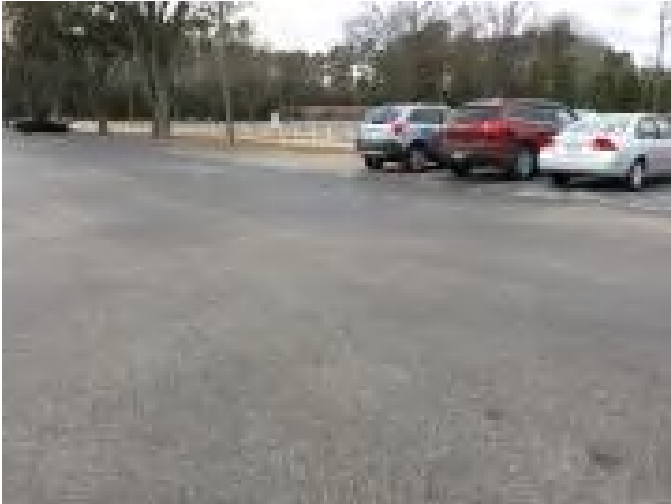
System: G2010 - Roadways

Location: Site
Distress: Failing
Category: Deferred Maintenance
Priority: 3 - Necessary/Not Yet Critical (Years 2-5)
Correction: Resurface the roadway
Qty: 100.00
Unit of Measure: L.F.
Estimate: \$17,160.00
Assessor Name: Somnath Das
Date Created: 01/09/2017

Notes: The roadways have cracks and it should be resealed and recoated.

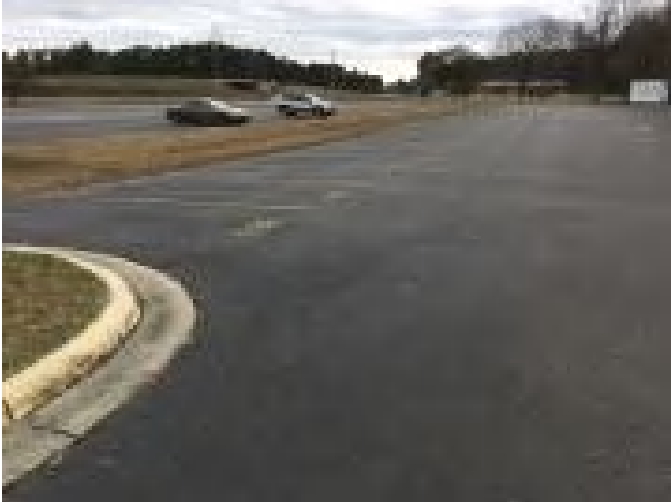
System: G2020 - Parking Lots

Location: Site
Distress: Beyond Service Life
Category: Deferred Maintenance
Priority: 3 - Necessary/Not Yet Critical (Years 2-5)
Correction: Renew System
Qty: 285,240.00
Unit of Measure: S.F.
Estimate: \$505,160.00
Assessor Name: Somnath Das
Date Created: 12/30/2016

Notes: The parking lot is beyond its service life and should be resealed, restriped and recoated.

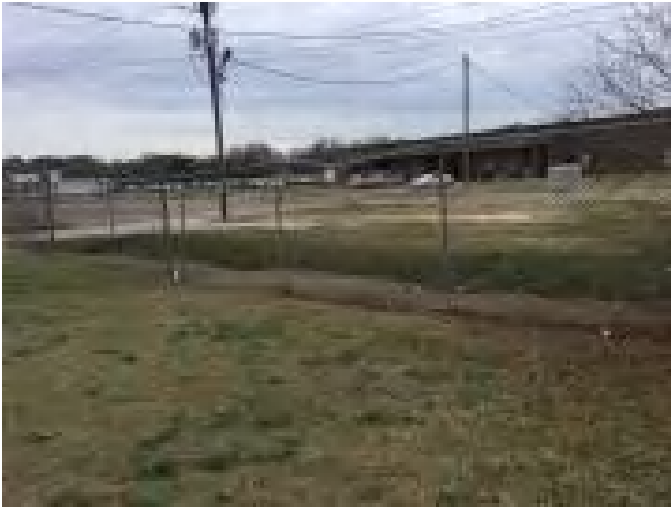
System: G2040105 - Fence & Guardrails

Location: Site
Distress: Beyond Service Life
Category: Deferred Maintenance
Priority: 3 - Necessary/Not Yet Critical (Years 2-5)
Correction: Renew System
Qty: 285,240.00
Unit of Measure: S.F.
Estimate: \$376,517.00
Assessor Name: Somnath Das
Date Created: 12/30/2016

Notes: The fences and guardrail are rusted and beyond their service life and should be replaced.

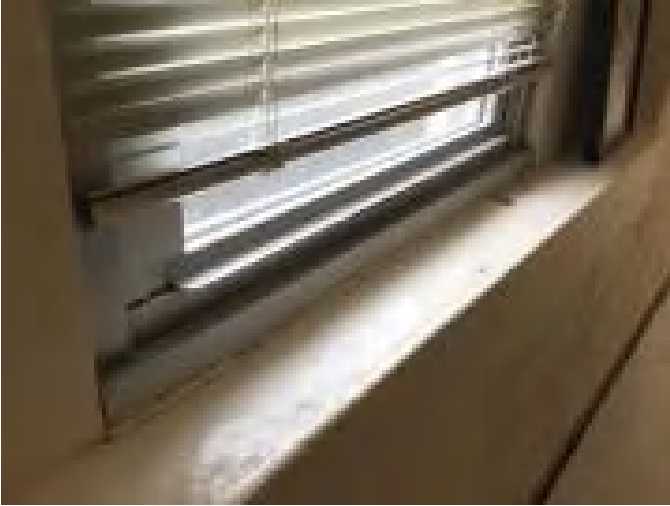
System: B2020 - Exterior Windows

Location: Throughout
Distress: Beyond Service Life
Category: Deferred Maintenance / Energy
Priority: 3 - Necessary/Not Yet Critical (Years 2-5)
Correction: Renew System
Qty: 28,806.00
Unit of Measure: S.F.
Estimate: \$297,537.00
Assessor Name: Terence Davis
Date Created: 12/23/2016

Notes: The aluminum frame, operable, single pane windows are aged, rusted, not energy efficient, and should be replaced.

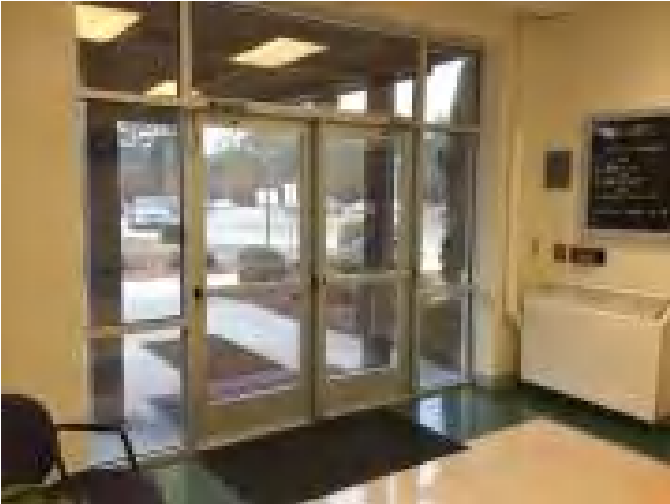
System: B2030 - Exterior Doors

Location: Throughout
Distress: Beyond Service Life
Category: Deferred Maintenance / Appearance
Priority: 3 - Necessary/Not Yet Critical (Years 2-5)
Correction: Renew System
Qty: 28,806.00
Unit of Measure: S.F.
Estimate: \$32,954.00
Assessor Name: Terence Davis
Date Created: 12/23/2016

Notes: The original exterior doors are aged, rusted, and should be replaced.

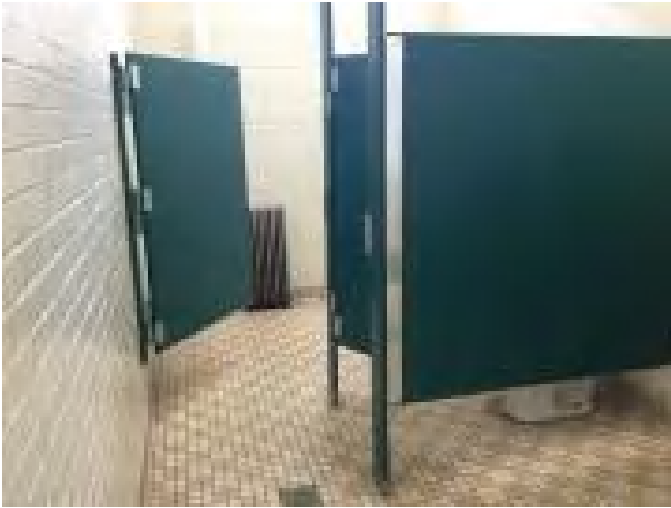
System: C1030 - Fittings

Location: Throughout
Distress: Beyond Service Life
Category: Deferred Maintenance / Accessibility Code Compliance
Priority: 3 - Necessary/Not Yet Critical (Years 2-5)
Correction: Renew System
Qty: 28,806.00
Unit of Measure: S.F.
Estimate: \$308,627.00
Assessor Name: Terence Davis
Date Created: 12/23/2016

Notes: The fittings throughout the building are aged, in marginal condition, and should be replaced.
Room signage is missing or non-ADA compliant.

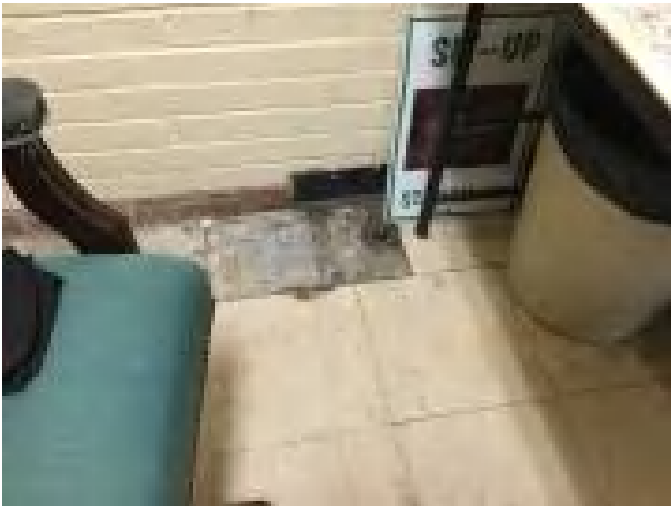
System: C3020 - Floor Finishes

Location: Throughout
Distress: Beyond Service Life
Category: Deferred Maintenance / Appearance
Priority: 3 - Necessary/Not Yet Critical (Years 2-5)
Correction: Renew System
Qty: 28,806.00
Unit of Measure: S.F.
Estimate: \$360,594.00
Assessor Name: Terence Davis
Date Created: 12/23/2016

Notes: The VCT flooring is aged, cracked, worn, and should be replaced.
The carpet is also aged, stained, frayed, and should be replace.

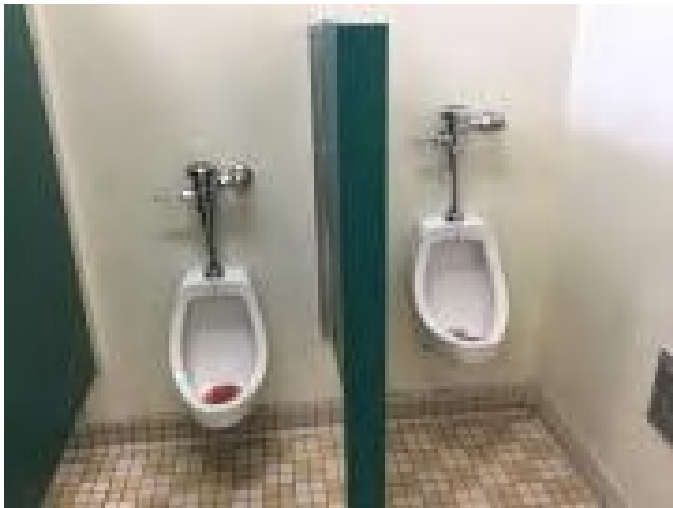
System: D2010 - Plumbing Fixtures

Location: Throughout
Distress: Beyond Service Life
Category: Deferred Maintenance
Priority: 3 - Necessary/Not Yet Critical (Years 2-5)
Correction: Renew System
Qty: 28,806.00
Unit of Measure: S.F.
Estimate: \$363,762.00
Assessor Name: Terence Davis
Date Created: 12/23/2016

Notes: Plumbing fixtures are in operational conditions. However, they are aged and should be replaced with a low-flow water fixtures.

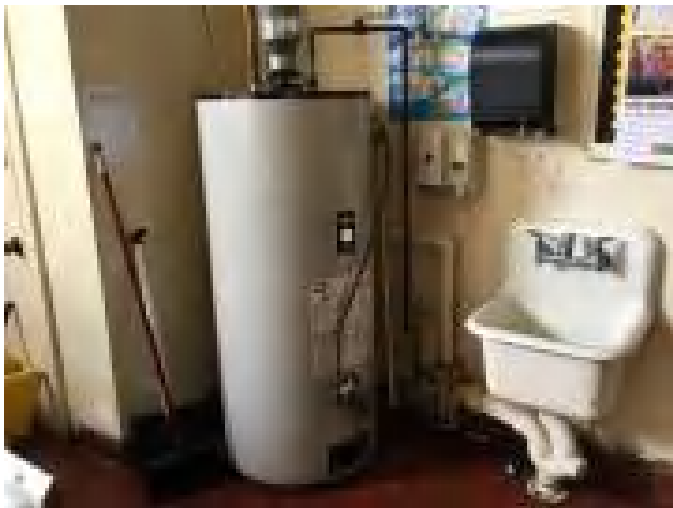
System: D2020 - Domestic Water Distribution

Location: Throughout
Distress: Beyond Service Life
Category: Deferred Maintenance
Priority: 3 - Necessary/Not Yet Critical (Years 2-5)
Correction: Renew System
Qty: 28,806.00
Unit of Measure: S.F.
Estimate: \$31,053.00
Assessor Name: Terence Davis
Date Created: 12/23/2016

Notes: The domestic water distribution system is aged and should be replaced.

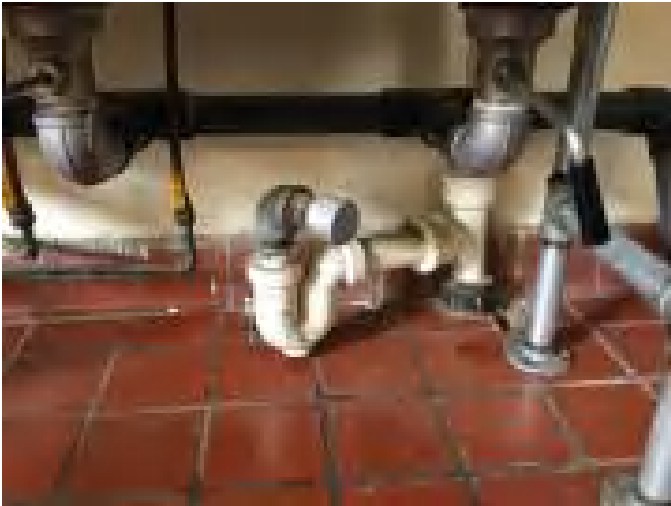
System: D2030 - Sanitary Waste

Location: Throughout
Distress: Beyond Service Life
Category: Deferred Maintenance
Priority: 3 - Necessary/Not Yet Critical (Years 2-5)
Correction: Renew System
Qty: 28,806.00
Unit of Measure: S.F.
Estimate: \$48,797.00
Assessor Name: Terence Davis
Date Created: 12/23/2016

Notes: The sanitary waste system is aged, has reported periodic failures, and should be replaced.

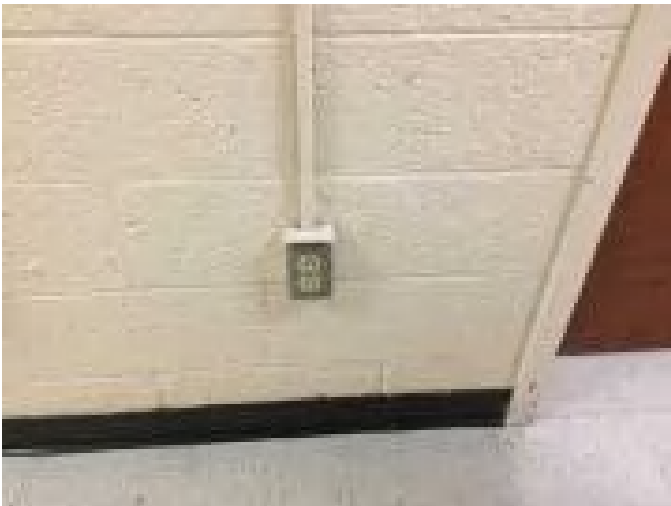
System: D5020 - Branch Wiring

Location: Throughout
Distress: Beyond Service Life
Category: Deferred Maintenance
Priority: 3 - Necessary/Not Yet Critical (Years 2-5)
Correction: Renew System
Qty: 28,806.00
Unit of Measure: S.F.
Estimate: \$160,334.00
Assessor Name: Terence Davis
Date Created: 12/23/2016

Notes: The original branch wiring system is operating, but is aged, in poor condition, and should be replaced.

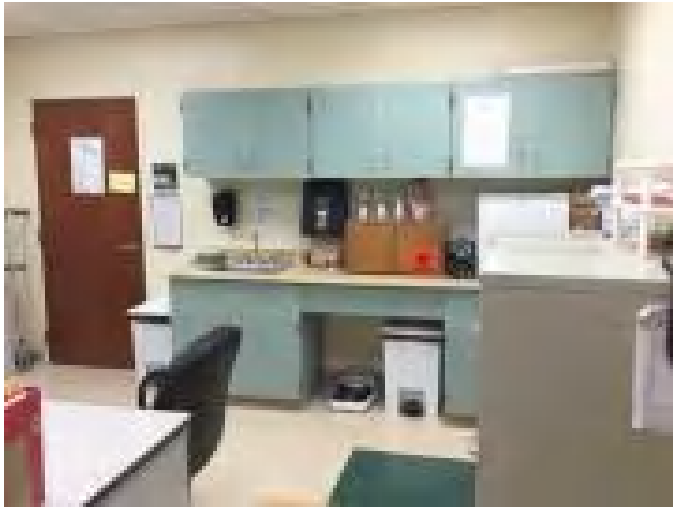
System: E2010 - Fixed Furnishings

Location: Throughout
Distress: Beyond Service Life
Category: Deferred Maintenance / Appearance
Priority: 3 - Necessary/Not Yet Critical (Years 2-5)
Correction: Renew System
Qty: 28,806.00
Unit of Measure: S.F.
Estimate: \$184,733.00
Assessor Name: Terence Davis
Date Created: 12/23/2016

Notes: The fixed furnishings are aged, in marginal condition, and should be replaced.

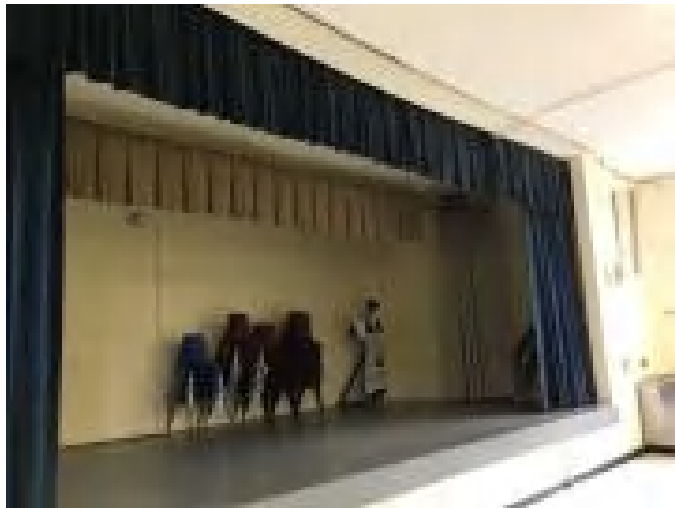
System: E1020 - Institutional Equipment

Location: Stage
Distress: Beyond Service Life
Category: Deferred Maintenance / Appearance
Priority: 4 - Recommended (Years 6-10)
Correction: Renew System
Qty: 28,806.00
Unit of Measure: S.F.
Estimate: \$9,506.00
Assessor Name: Terence Davis
Date Created: 12/23/2016

Notes: Theater equipment is aged and damaged and should be replaced.

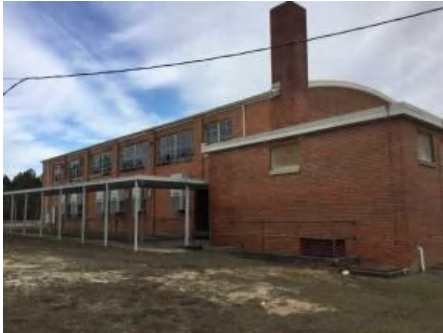
1). West Elevation - Jan 11, 2017

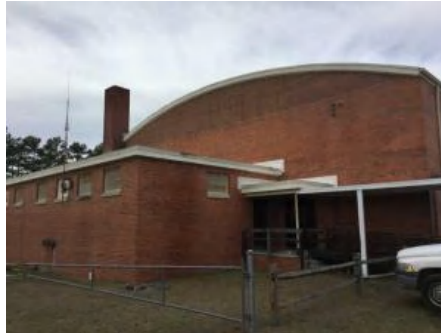
2). South Elevation - Jan 11, 2017
