NC School District/830 Scotland County/High School

Scotland High

Campus Assessment Report

March 7, 2017

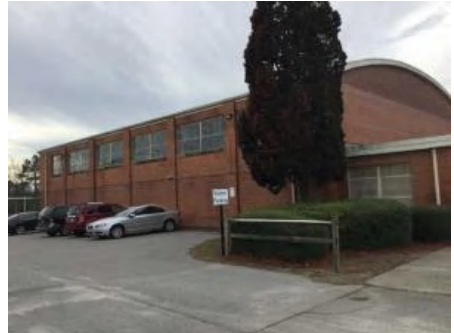
3). East Elevation - Jan 11, 2017

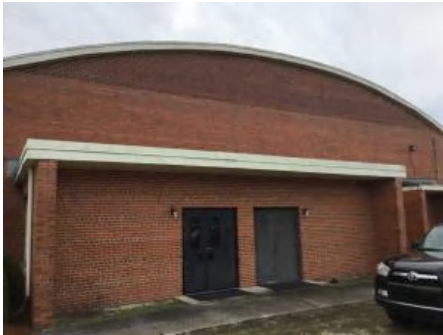
4). North Elevation - Jan 11, 2017

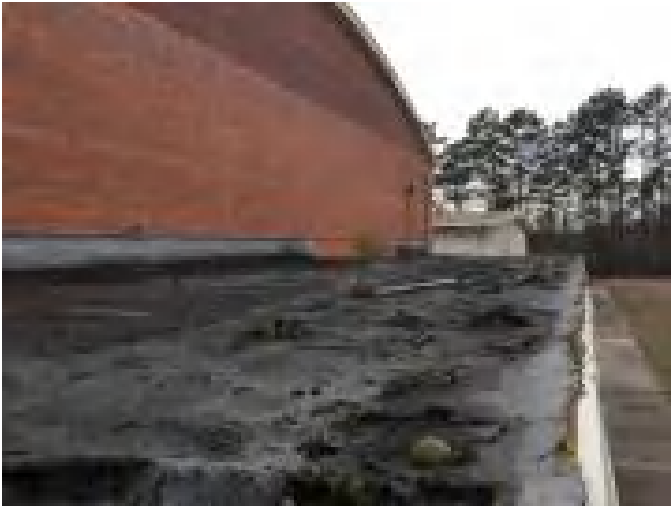
System: B3010105 - Built-Up

Location: Entry foyer
Distress: Beyond Service Life
Category: Deferred Maintenance
Priority: 2 - Potentially Critical (Year 1)
Correction: Renew System
Qty: 588.00
Unit of Measure: S.F.
Estimate: \$7,262.00
Assessor Name: Terence Davis
Date Created: 12/23/2016

Notes: Built-up roof covering is in deteriorating conditions with signs of cracks, bubbling, patches and reported water leaks through parapets and other areas.

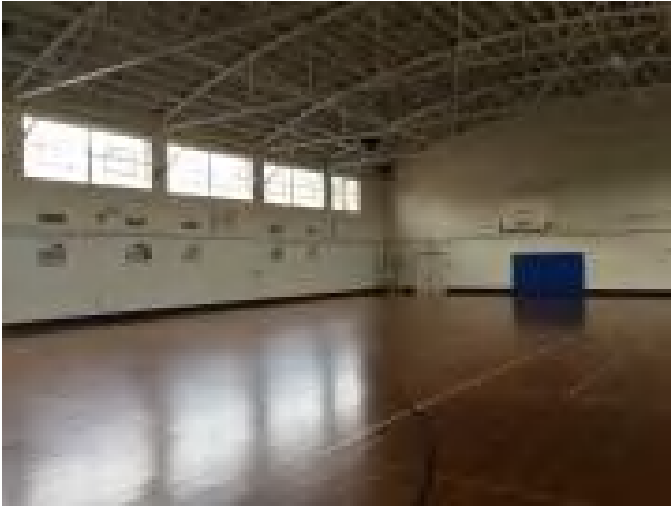
System: B2020 - Exterior Windows

Location: Throughout
Distress: Beyond Service Life
Category: Deferred Maintenance / Energy
Priority: 3 - Necessary/Not Yet Critical (Years 2-5)
Correction: Renew System
Qty: 8,688.00
Unit of Measure: S.F.
Estimate: \$89,738.00
Assessor Name: Terence Davis
Date Created: 12/23/2016

Notes: The aluminum frame, operable, single pane windows are aged, rusted, not energy efficient, and should be replaced.

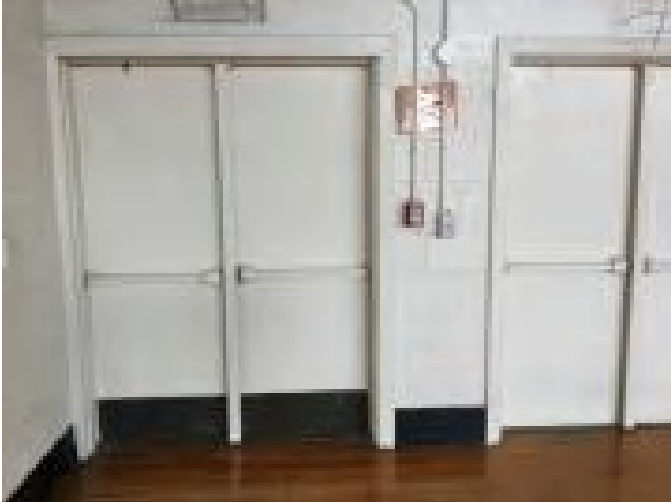
System: B2030 - Exterior Doors

Location: Throughout
Distress: Beyond Service Life
Category: Deferred Maintenance
Priority: 3 - Necessary/Not Yet Critical (Years 2-5)
Correction: Renew System
Qty: 8,688.00
Unit of Measure: S.F.
Estimate: \$9,939.00
Assessor Name: Terence Davis
Date Created: 12/23/2016

Notes: The original exterior doors are aged, rusted, and should be replaced.

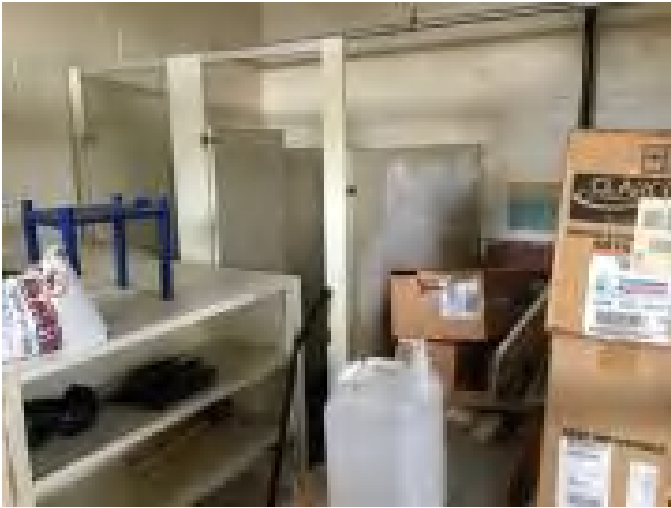
System: C1030 - Fittings

Location: Throughout
Distress: Beyond Service Life
Category: Deferred Maintenance / Accessibility Code Compliance
Priority: 3 - Necessary/Not Yet Critical (Years 2-5)
Correction: Renew System
Qty: 8,688.00
Unit of Measure: S.F.
Estimate: \$93,083.00
Assessor Name: Terence Davis
Date Created: 12/23/2016

Notes: The fittings throughout the building are aged, in marginal condition, handrails and room signage are ADA non-compliance and system should be replaced.

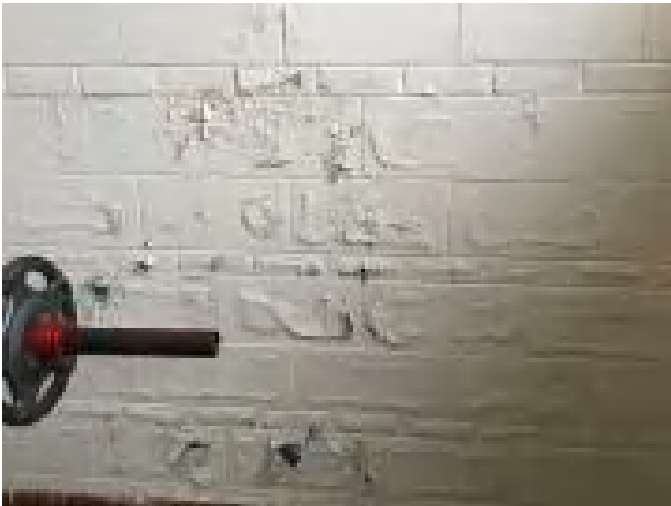
System: C3010 - Wall Finishes

Location: Throughout
Distress: Beyond Service Life
Category: Deferred Maintenance / Appearance
Priority: 3 - Necessary/Not Yet Critical (Years 2-5)
Correction: Renew System
Qty: 8,688.00
Unit of Measure: S.F.
Estimate: \$26,663.00
Assessor Name: Terence Davis
Date Created: 12/23/2016

Notes: The wall finishes are aged, scuffed, fading, stained, and should be replaced.

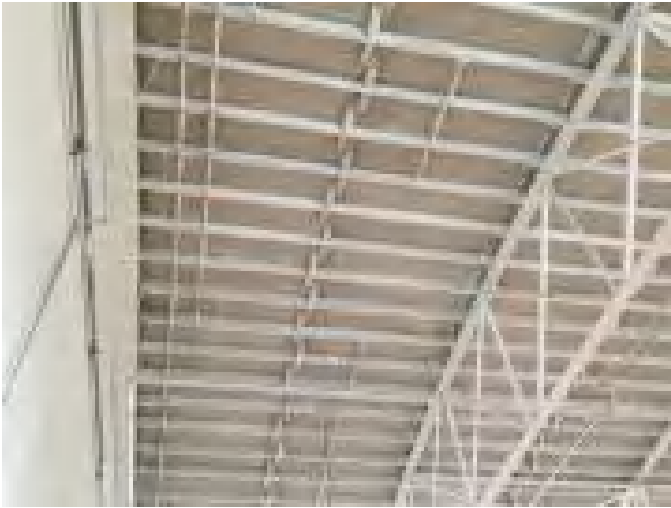
System: C3030 - Ceiling Finishes

Location: Gym
Distress: Beyond Service Life
Category: Deferred Maintenance / Appearance
Priority: 3 - Necessary/Not Yet Critical (Years 2-5)
Correction: Renew System
Qty: 8,688.00
Unit of Measure: S.F.
Estimate: \$104,838.00
Assessor Name: Terence Davis
Date Created: 12/23/2016

Notes: The original ceiling finishes are aged, failing and should be replaced.

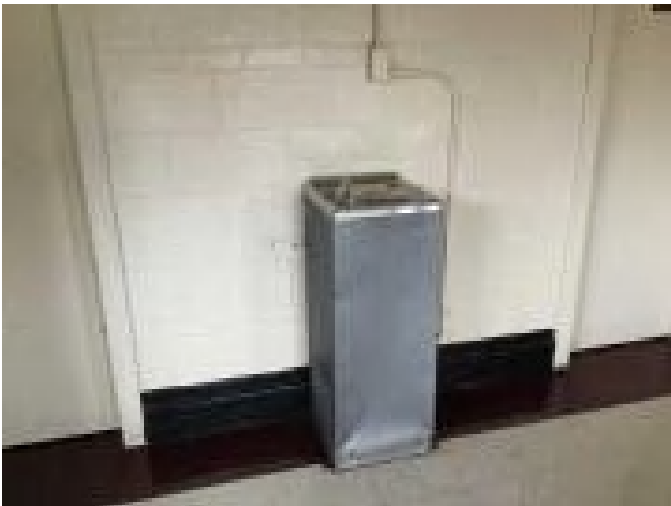
System: D2010 - Plumbing Fixtures

Location: Throughout
Distress: Beyond Service Life
Category: Deferred Maintenance
Priority: 3 - Necessary/Not Yet Critical (Years 2-5)
Correction: Renew System
Qty: 8,688.00
Unit of Measure: S.F.
Estimate: \$109,712.00
Assessor Name: Terence Davis
Date Created: 12/23/2016

Notes: Plumbing fixtures are in operational conditions. However, they are aged, not ADA compliant and should be replaced with a low-flow water fixtures.

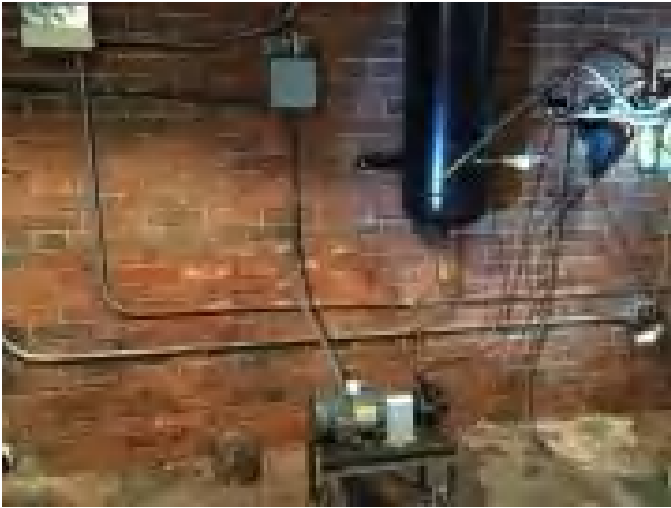
System: D2020 - Domestic Water Distribution

Location: Throughout
Distress: Beyond Service Life
Category: Deferred Maintenance
Priority: 3 - Necessary/Not Yet Critical (Years 2-5)
Correction: Renew System
Qty: 8,688.00
Unit of Measure: S.F.
Estimate: \$9,366.00
Assessor Name: Terence Davis
Date Created: 12/23/2016

Notes: The domestic water distribution system is aged and should be replaced.

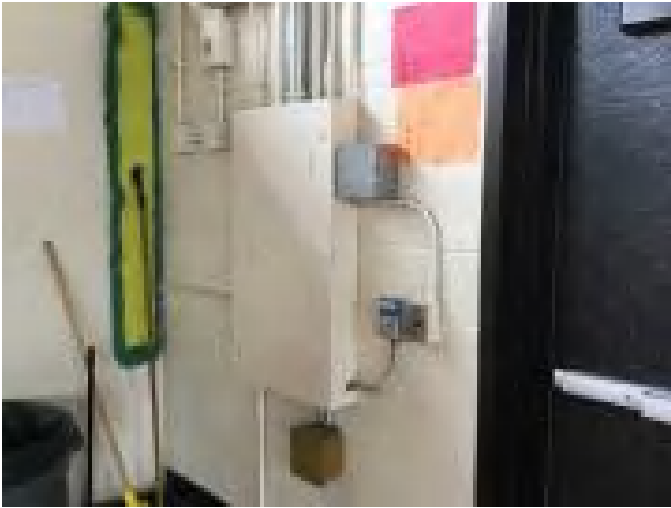
System: D5010 - Electrical Service/Distribution

Location: Throughout
Distress: Beyond Service Life
Category: Deferred Maintenance
Priority: 3 - Necessary/Not Yet Critical (Years 2-5)
Correction: Renew System
Qty: 8,688.00
Unit of Measure: S.F.
Estimate: \$16,151.00
Assessor Name: Terence Davis
Date Created: 12/23/2016

Notes: The original electrical distribution system is operating properly due to an aggressive maintenance program but is aged, in marginal condition, and should be replaced.

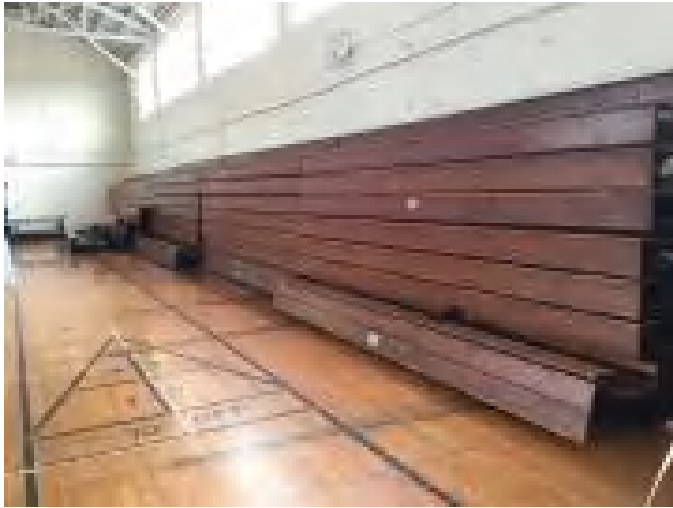
System: E1090 - Other Equipment

Location: Gym
Distress: Beyond Service Life
Category: Deferred Maintenance / Appearance
Priority: 3 - Necessary/Not Yet Critical (Years 2-5)
Correction: Renew System
Qty: 8,688.00
Unit of Measure: S.F.
Estimate: \$18,158.00
Assessor Name: Terence Davis
Date Created: 12/23/2016

Notes: The athletic equipment is aged, in marginal condition, and should be replaced.

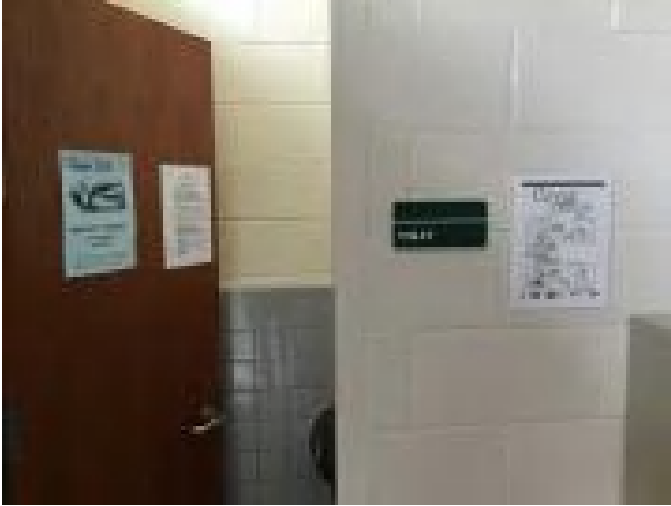
System: C1030 - Fittings

Location: Throughout
Distress: Beyond Service Life
Category: Deferred Maintenance / Accessibility Code Compliance
Priority: 2 - Potentially Critical (Year 1)
Correction: Renew System
Qty: 6,120.00
Unit of Measure: S.F.
Estimate: \$65,570.00
Assessor Name: Terence Davis
Date Created: 01/11/2017

Notes: The fittings throughout the building are aged, in marginal condition, handrails and room signage are ADA non-compliance and system should be replaced.

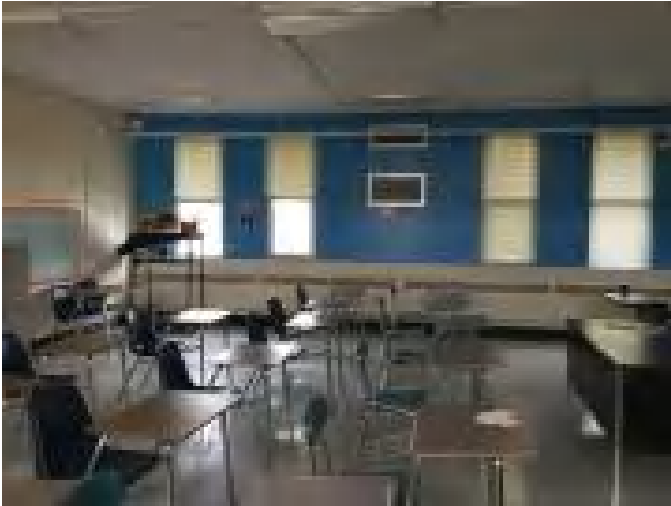
System: B2020 - Exterior Windows

Location: Throughout
Distress: Beyond Service Life
Category: Deferred Maintenance / Energy
Priority: 3 - Necessary/Not Yet Critical (Years 2-5)
Correction: Renew System
Qty: 6,120.00
Unit of Measure: S.F.
Estimate: \$63,213.00
Assessor Name: Terence Davis
Date Created: 01/11/2017

Notes: The aluminum frame, operable, single pane windows are aged, rusted, not energy efficient, and should be replaced.

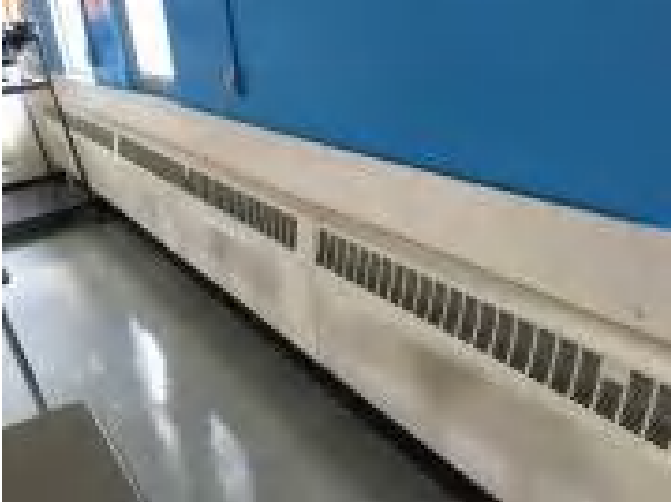
System: C3010 - Wall Finishes

Location: Throughout
Distress: Beyond Service Life
Category: Deferred Maintenance / Appearance
Priority: 3 - Necessary/Not Yet Critical (Years 2-5)
Correction: Renew System
Qty: 6,120.00
Unit of Measure: S.F.
Estimate: \$18,782.00
Assessor Name: Terence Davis
Date Created: 01/11/2017

Notes: The wall paint is damaged, fading, stained, and should be re-painted.

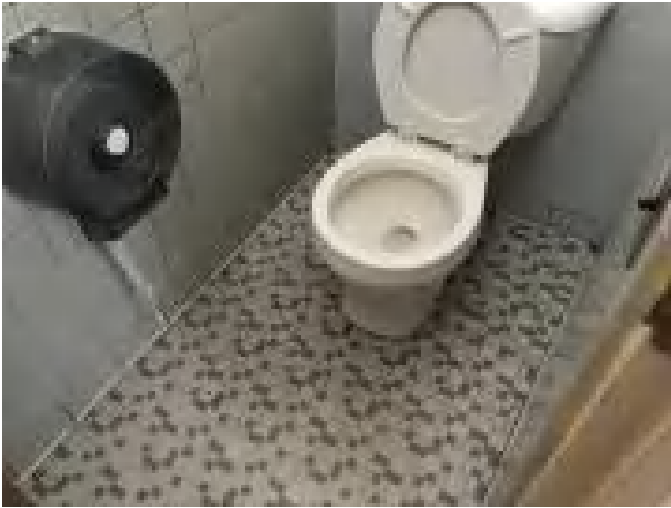
System: D2010 - Plumbing Fixtures

Location: Throughout
Distress: Beyond Service Life
Category: Deferred Maintenance / Accessibility Code Compliance
Priority: 3 - Necessary/Not Yet Critical (Years 2-5)
Correction: Renew System
Qty: 6,120.00
Unit of Measure: S.F.
Estimate: \$77,283.00
Assessor Name: Terence Davis
Date Created: 01/11/2017

Notes: Plumbing fixtures are in operational conditions. However, they are aged, not ADA compliant and should be replaced with a low-flow water fixtures.

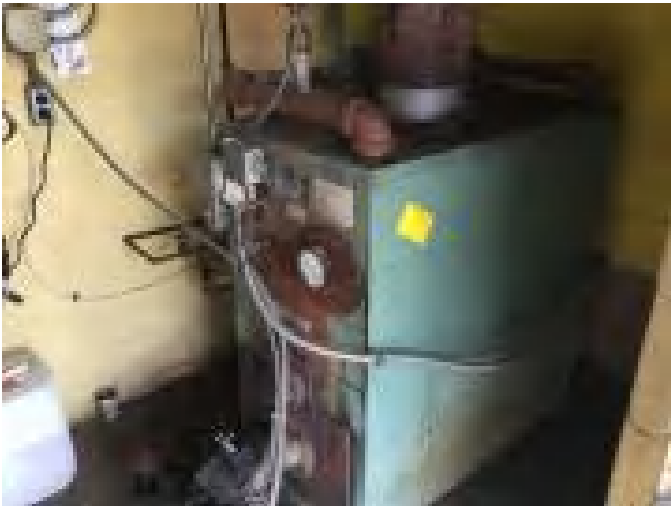
System: D3020 - Heat Generating Systems

Location: Boiler Rm
Distress: Beyond Service Life
Category: Deferred Maintenance / Energy
Priority: 3 - Necessary/Not Yet Critical (Years 2-5)
Correction: Renew System
Qty: 6,120.00
Unit of Measure: S.F.
Estimate: \$34,199.00
Assessor Name: Terence Davis
Date Created: 01/11/2017

Notes: The gas-fired boilers are operating poorly, aging, inefficient, becoming logistically unsupportable, and should be replaced with energy efficient models.

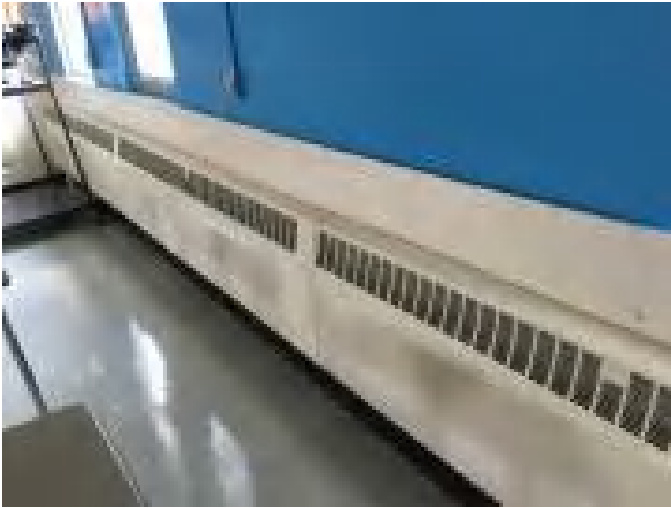
System: D3040 - Distribution Systems

Location: Throughout
Distress: Beyond Service Life
Category: Deferred Maintenance / Energy
Priority: 3 - Necessary/Not Yet Critical (Years 2-5)
Correction: Renew System
Qty: 6,120.00
Unit of Measure: S.F.
Estimate: \$41,334.00
Assessor Name: Terence Davis
Date Created: 01/11/2017

Notes: The radiator units are aged, becoming logistically unsupportable, and should be replaced.

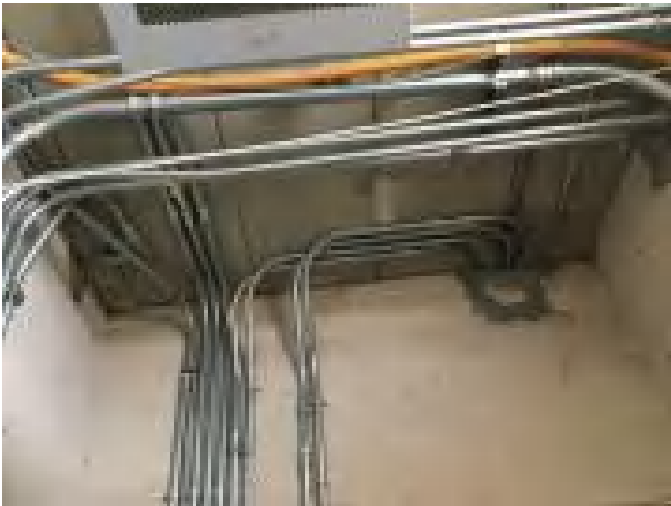
System: D5020 - Branch Wiring

Location: Throughout
Distress: Beyond Service Life
Category: Deferred Maintenance
Priority: 3 - Necessary/Not Yet Critical (Years 2-5)
Correction: Renew System
Qty: 6,120.00
Unit of Measure: S.F.
Estimate: \$34,064.00
Assessor Name: Terence Davis
Date Created: 01/11/2017

Notes: The original branch wiring system is operating, but is aged, in poor condition, and should be replaced.

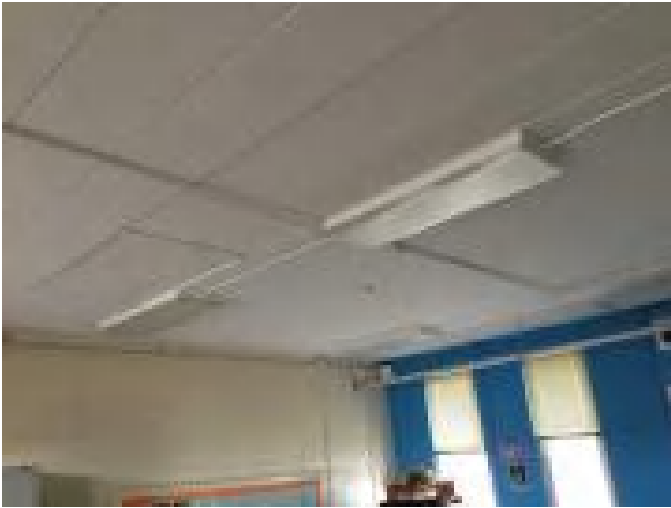
System: D5020 - Lighting

Location: Throughout
Distress: Beyond Service Life
Category: Deferred Maintenance / Energy
Priority: 3 - Necessary/Not Yet Critical (Years 2-5)
Correction: Renew System
Qty: 6,120.00
Unit of Measure: S.F.
Estimate: \$80,245.00
Assessor Name: Terence Davis
Date Created: 01/11/2017

Notes: The lighting system is operating, but is aged, in poor condition, and should be replaced.

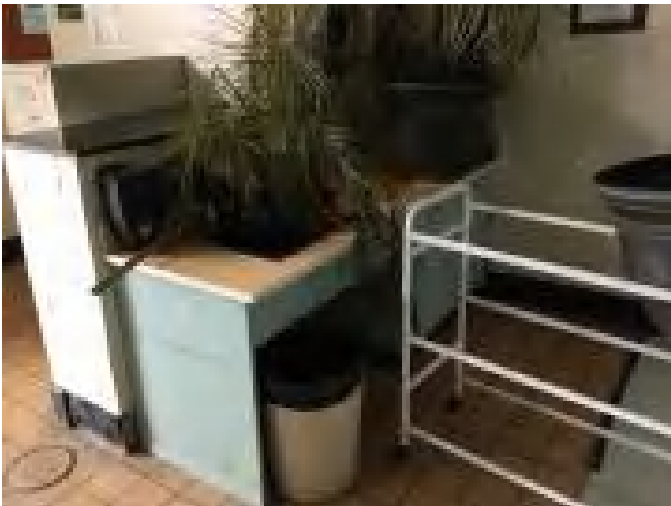
System: E2010 - Fixed Furnishings

Location: Throughout
Distress: Beyond Service Life
Category: Deferred Maintenance / Appearance
Priority: 3 - Necessary/Not Yet Critical (Years 2-5)
Correction: Renew System
Qty: 6,120.00
Unit of Measure: S.F.
Estimate: \$39,248.00
Assessor Name: Terence Davis
Date Created: 01/11/2017

Notes: The fixed furnishings are aged, in marginal condition, and should be replaced.

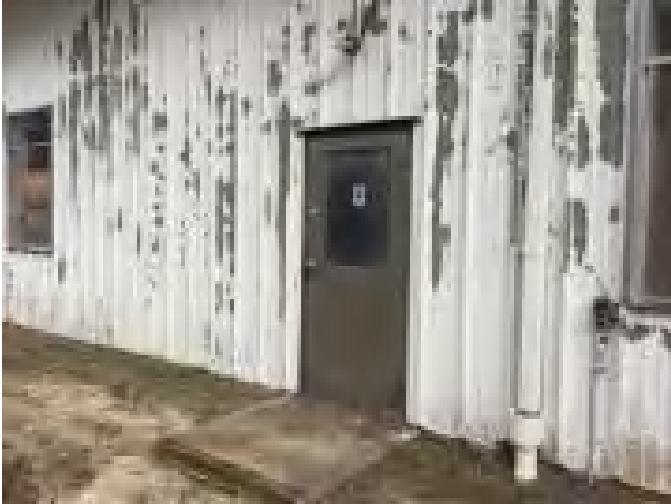
System: B2030 - Exterior Doors

Location: Throughout
Distress: Beyond Service Life
Category: Deferred Maintenance / Appearance
Priority: 3 - Necessary/Not Yet Critical (Years 2-5)
Correction: Renew System
Qty: 7,520.00
Unit of Measure: S.F.
Estimate: \$71,636.00
Assessor Name: Terence Davis
Date Created: 01/11/2017

Notes: The original exterior doors are aged, rusted, and should be replaced.

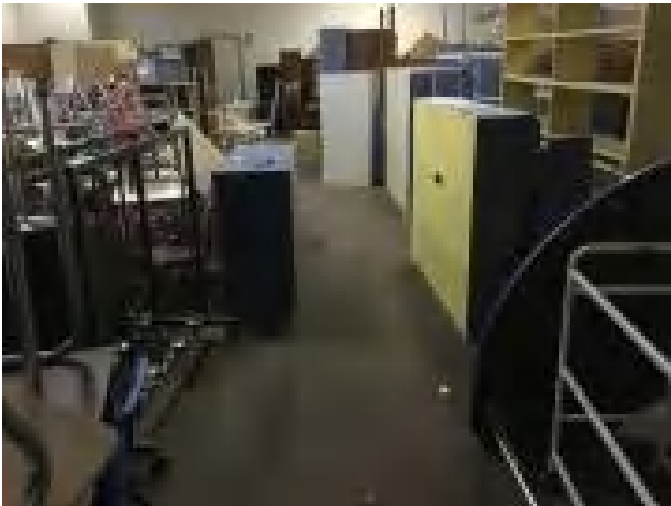
System: C3020 - Floor Finishes

Location: Portions of building
Distress: Beyond Service Life
Category: Deferred Maintenance / Appearance
Priority: 3 - Necessary/Not Yet Critical (Years 2-5)
Correction: Renew System
Qty: 7,520.00
Unit of Measure: S.F.
Estimate: \$172,223.00
Assessor Name: Terence Davis
Date Created: 01/11/2017

Notes: The carpet is stained, showing signs of early failure and should be replaced.

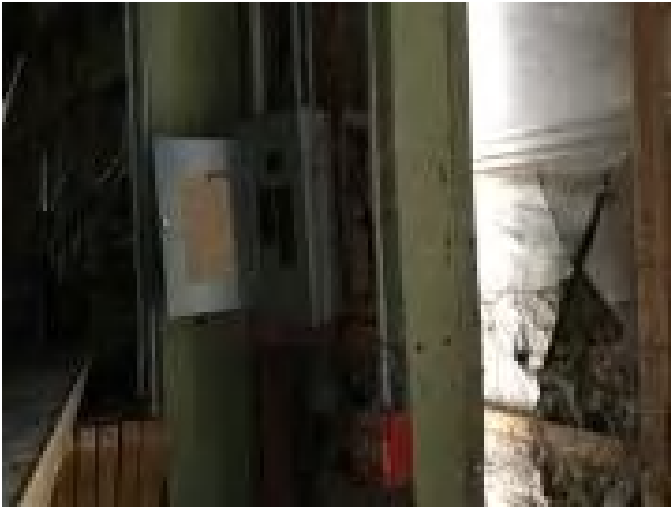
System: D5020 - Branch Wiring

Location: Throughout
Distress: Beyond Service Life
Category: Deferred Maintenance
Priority: 3 - Necessary/Not Yet Critical (Years 2-5)
Correction: Renew System
Qty: 7,520.00
Unit of Measure: S.F.
Estimate: \$29,614.00
Assessor Name: Terence Davis
Date Created: 01/11/2017

Notes: The original branch wiring system is operating, but is aged, in poor condition, and should be replaced.

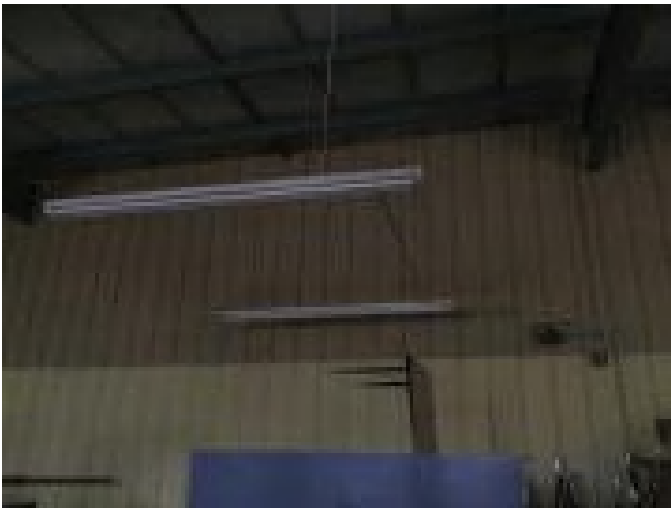
System: D5020 - Lighting

Location: Throughout
Distress: Beyond Service Life
Category: Deferred Maintenance / Energy
Priority: 3 - Necessary/Not Yet Critical (Years 2-5)
Correction: Renew System
Qty: 7,520.00
Unit of Measure: S.F.
Estimate: \$79,246.00
Assessor Name: Terence Davis
Date Created: 01/11/2017

Notes: The original lighting system is operating, but is aged, in poor condition, and should be replaced.

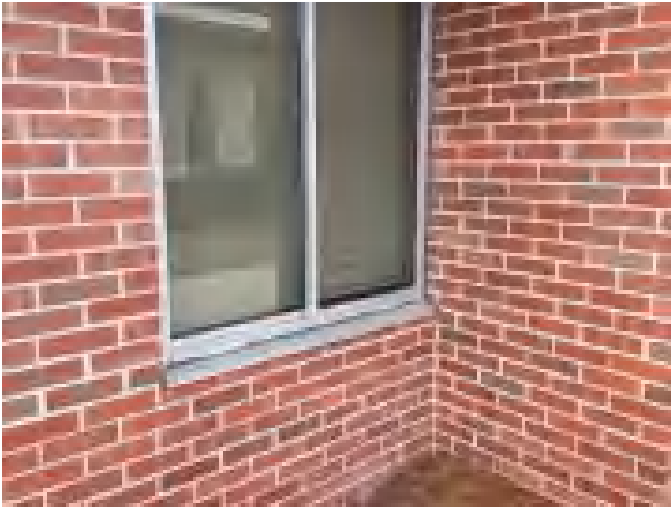
System: B2020 - Exterior Windows

Location: Throughout
Distress: Beyond Service Life
Category: Deferred Maintenance / Energy
Priority: 3 - Necessary/Not Yet Critical (Years 2-5)
Correction: Renew System
Qty: 3,762.00
Unit of Measure: S.F.
Estimate: \$38,858.00
Assessor Name: Terence Davis
Date Created: 01/11/2017

Notes: The aluminum frame, operable, single pane windows are aged, rusted, not energy efficient, and should be replaced.

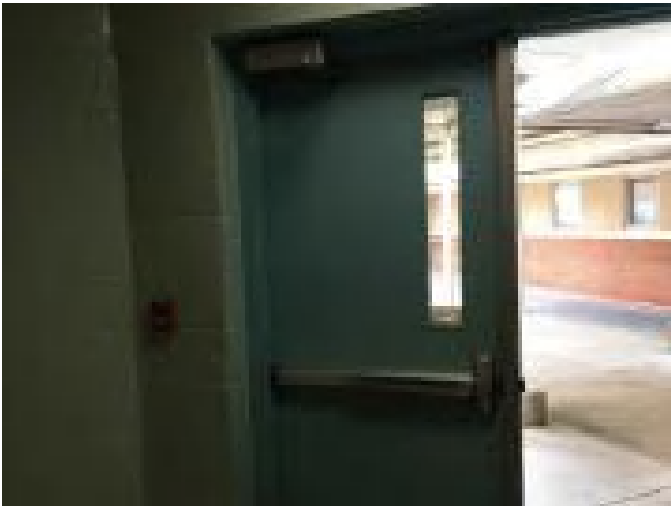
System: B2030 - Exterior Doors

Location: Throughout
Distress: Beyond Service Life
Category: Deferred Maintenance
Priority: 3 - Necessary/Not Yet Critical (Years 2-5)
Correction: Renew System
Qty: 3,762.00
Unit of Measure: S.F.
Estimate: \$4,304.00
Assessor Name: Terence Davis
Date Created: 01/11/2017

Notes: The original exterior doors are aged, rusted, and should be replaced.

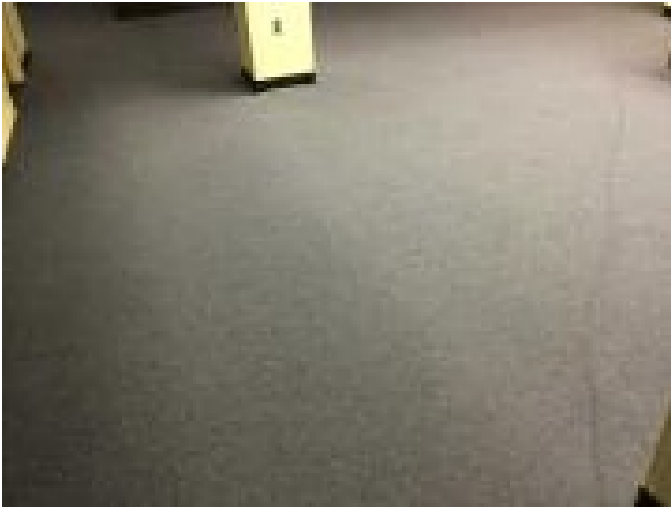
System: C3020 - Floor Finishes

Location: Media center
Distress: Beyond Service Life
Category: Deferred Maintenance / Appearance
Priority: 3 - Necessary/Not Yet Critical (Years 2-5)
Correction: Renew System
Qty: 3,762.00
Unit of Measure: S.F.
Estimate: \$47,093.00
Assessor Name: Terence Davis
Date Created: 01/11/2017

Notes: The carpet is aged, stained, frayed, and should be replaced.

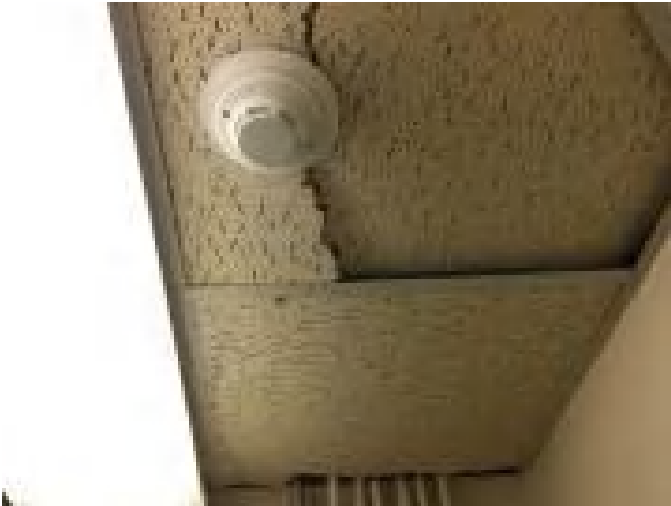
System: C3030 - Ceiling Finishes

Location: Throughout
Distress: Beyond Service Life
Category: Deferred Maintenance / Appearance
Priority: 3 - Necessary/Not Yet Critical (Years 2-5)
Correction: Renew System
Qty: 3,762.00
Unit of Measure: S.F.
Estimate: \$45,396.00
Assessor Name: Terence Davis
Date Created: 01/11/2017

Notes: The original ceiling finishes are aged, failing and should be replaced.

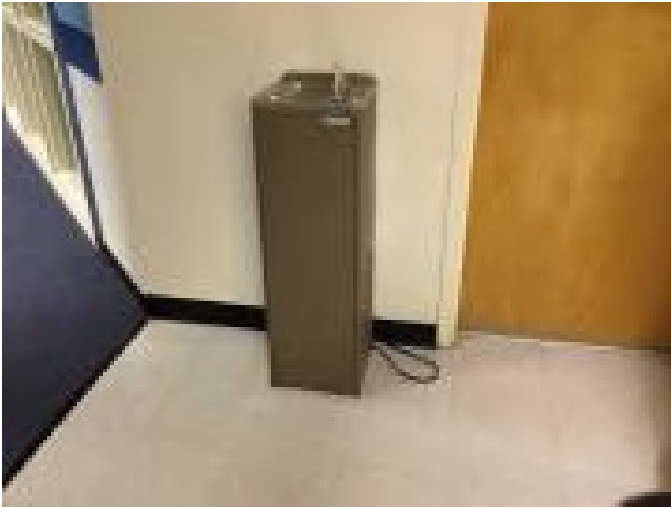
System: D2010 - Plumbing Fixtures

Location: Throughout
Distress: Beyond Service Life
Category: Deferred Maintenance / Accessibility Code Compliance
Priority: 3 - Necessary/Not Yet Critical (Years 2-5)
Correction: Renew System
Qty: 3,762.00
Unit of Measure: S.F.
Estimate: \$47,507.00
Assessor Name: Terence Davis
Date Created: 01/11/2017

Notes: Plumbing fixtures are in operational conditions. However, they are aged, not ADA compliant and should be replaced with a low-flow water fixtures.

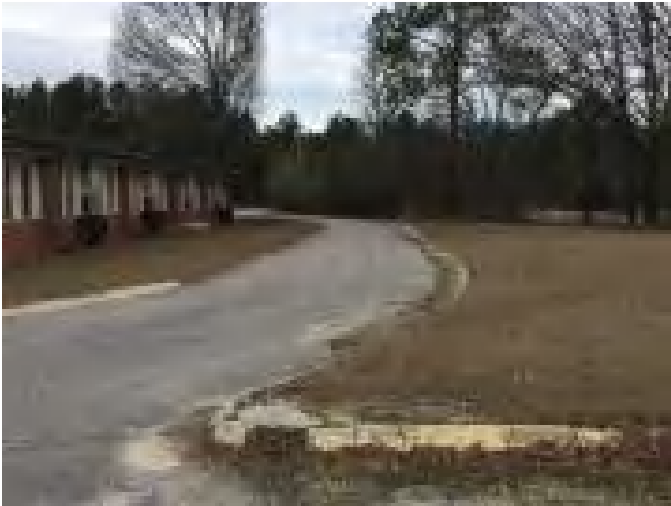
System: G2010 - Roadways

Location: Site
Distress: Beyond Service Life
Category: Deferred Maintenance / Building Code Compliance
Priority: 3 - Necessary/Not Yet Critical (Years 2-5)
Correction: Renew System
Qty: 54,896.00
Unit of Measure: S.F.
Estimate: \$230,069.00
Assessor Name: Eduardo Lopez
Date Created: 01/11/2017

Notes: The asphaltic roadway is aged, has many road cuts and repairs, and should be re-surfaced. Provide Fire lane markings per Local Code requirements.

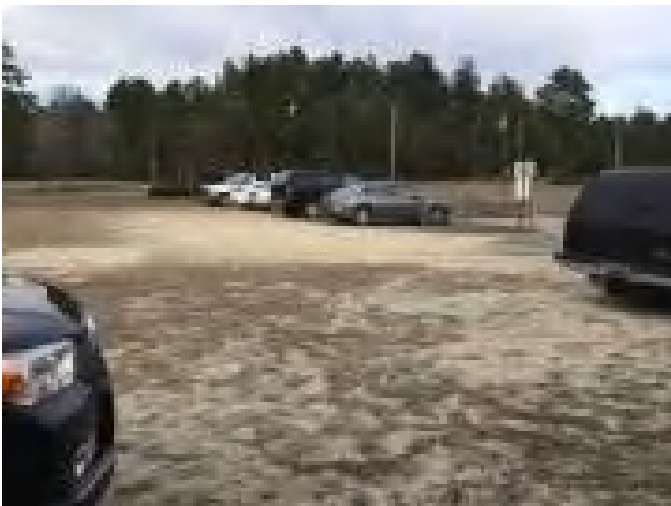
System: G2020 - Parking Lots

Location: Parking
Distress: Beyond Service Life
Category: Deferred Maintenance / Accessibility Code Compliance
Priority: 3 - Necessary/Not Yet Critical (Years 2-5)
Correction: Renew System
Qty: 54,896.00
Unit of Measure: S.F.
Estimate: \$80,313.00
Assessor Name: Eduardo Lopez
Date Created: 01/11/2017

Notes: The parking lot is aged, has many repairs and potholes, and should be replaced and re-striped. ADA signs height needs to be adjusted per minimum ADA standards.

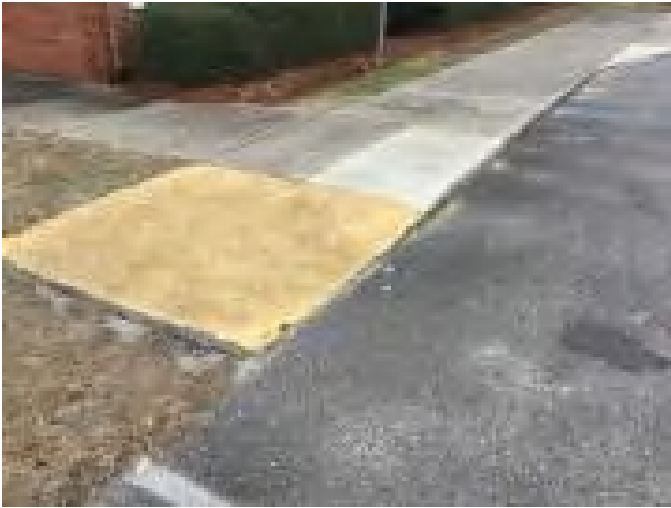
System: G2030 - Pedestrian Paving

Location: Entire site
Distress: Beyond Service Life
Category: Deferred Maintenance / Accessibility Code Compliance
Priority: 3 - Necessary/Not Yet Critical (Years 2-5)
Correction: Renew System
Qty: 54,896.00
Unit of Measure: S.F.
Estimate: \$115,337.00
Assessor Name: Eduardo Lopez
Date Created: 01/11/2017

Notes: The pedestrian paving and walkways are aged and showing inclement weather damage and should be replaced to include missing ADA standard markings and ramps.

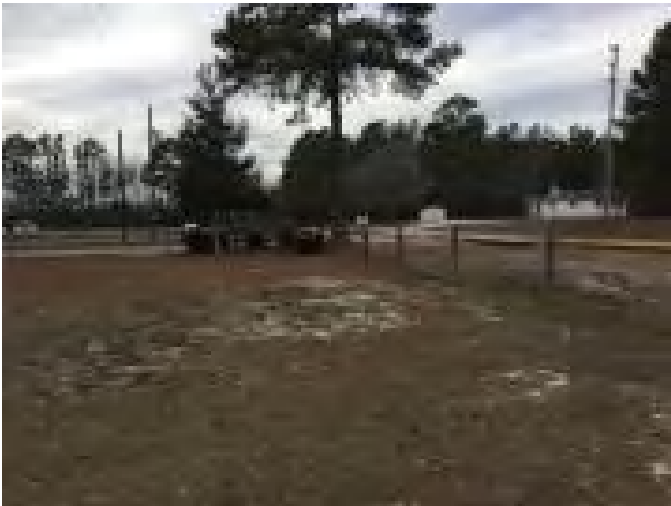
System: G2040105 - Fence & Guardrails

Location: Parking/roadways
Distress: Beyond Service Life
Category: Deferred Maintenance / Appearance
Priority: 3 - Necessary/Not Yet Critical (Years 2-5)
Correction: Renew System
Qty: 54,896.00
Unit of Measure: S.F.
Estimate: \$74,274.00
Assessor Name: Eduardo Lopez
Date Created: 01/11/2017

Notes: The fence and guardrails are failing, beyond expected life, and not longer an effective barrier and should be scheduled for replacement.

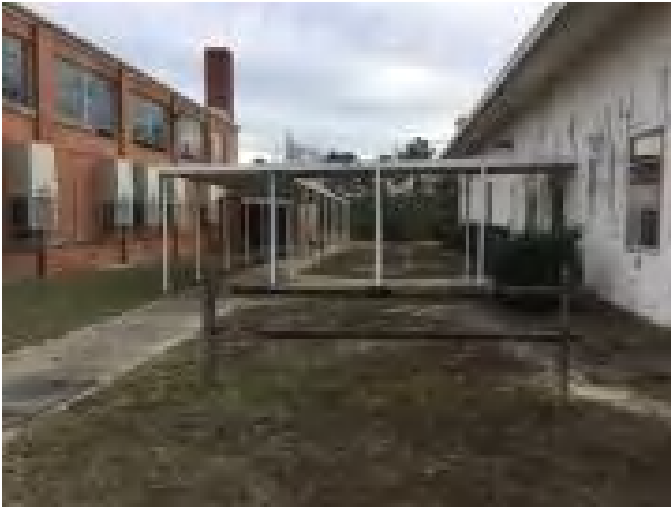
System: G2040950 - Covered Walkways

Location: Site
Distress: Beyond Service Life
Category: Deferred Maintenance / Appearance
Priority: 3 - Necessary/Not Yet Critical (Years 2-5)
Correction: Renew System
Qty: 54,896.00
Unit of Measure: S.F.
Estimate: \$91,786.00
Assessor Name: Eduardo Lopez
Date Created: 01/11/2017

Notes: The covered walkways are rusted, failing and beyond expected life and should be scheduled for replacement.

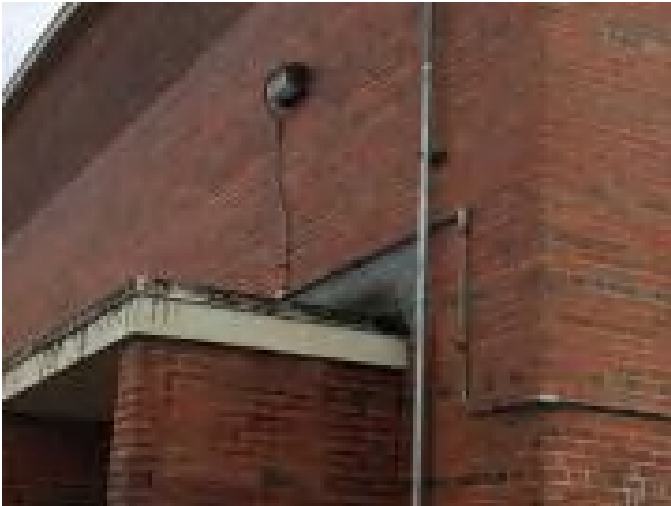
System: G4020 - Site Lighting

Location: Entire site
Distress: Inadequate
Category: Deferred Maintenance / Energy
Priority: 3 - Necessary/Not Yet Critical (Years 2-5)
Correction: Renew System
Qty: 54,896.00
Unit of Measure: S.F.
Estimate: \$88,767.00
Assessor Name: Eduardo Lopez
Date Created: 01/11/2017

Notes: Site Lighting is aged and does not adequately cover all areas and should be replaced.

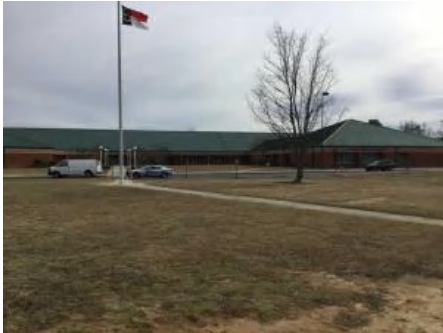
1). West Elevation - Jan 11, 2017

The photo album consists of the various cardinal directions of the building..

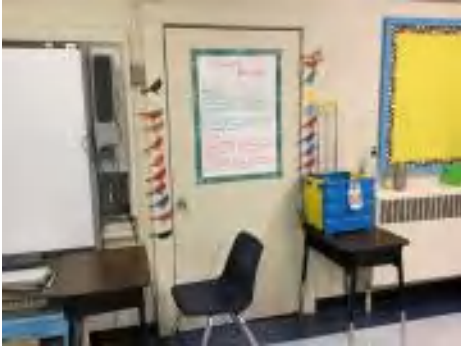
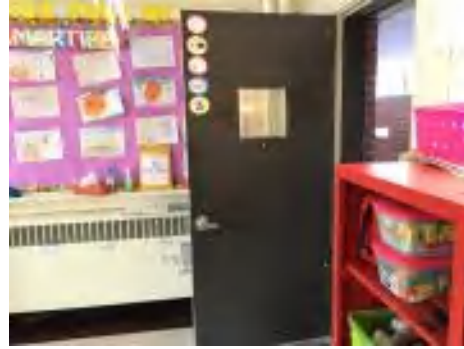
System: C1020 - Interior Doors

Note: The interior doors are beyond their service life and should be replaced, also while replacing the doors the hardware installed should be ADA compliant.

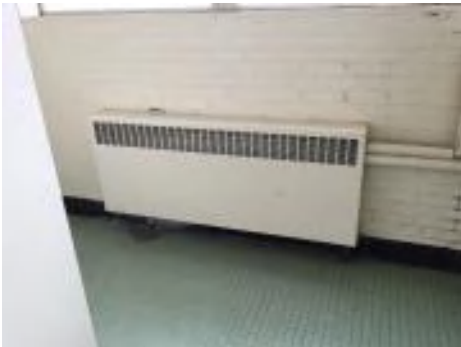
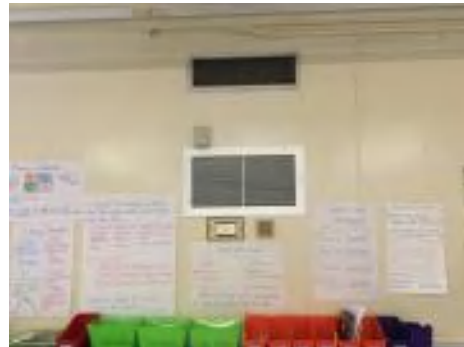
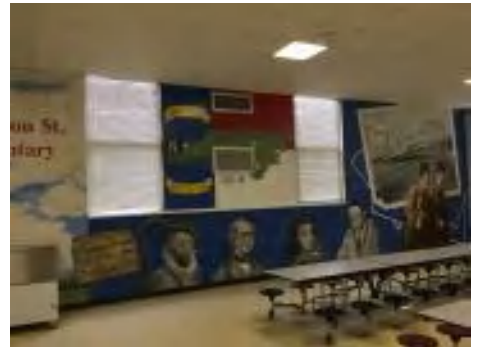
System: C3010 - Wall Finishes

Note: The wall finishes are beyond their service life and should be replaced.

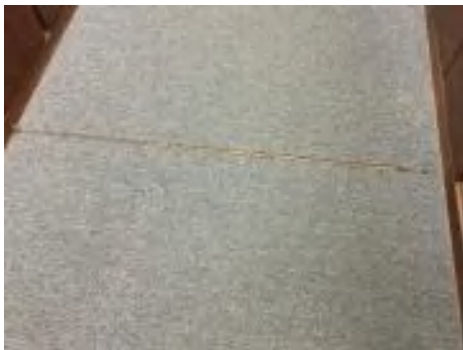
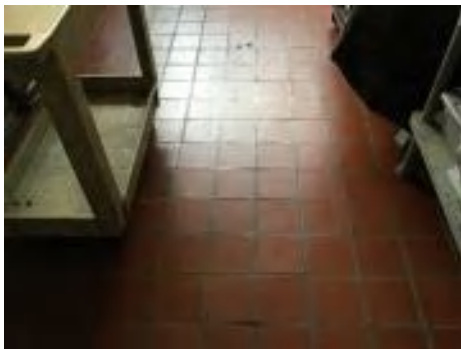
System: C3020 - Floor Finishes

Note: The carpet is in poor condition and should be replaced.

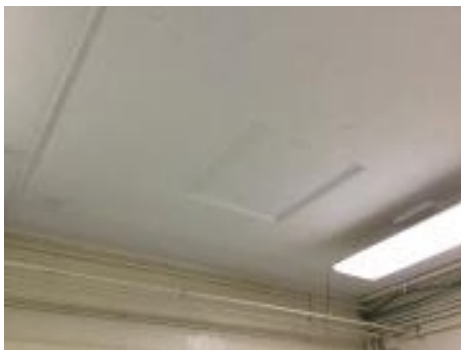
System: C3030 - Ceiling Finishes

Note: The acoustical ceiling tiles are beyond their service life and should be replaced.

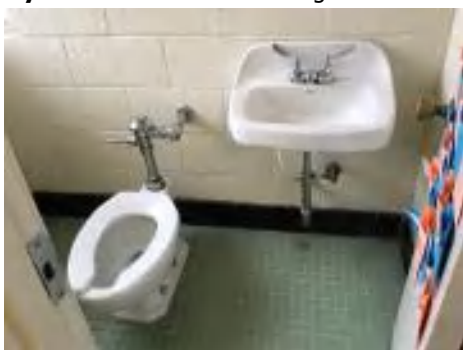
System: D2010 - Plumbing Fixtures

Note: The plumbing fixtures are beyond their service life and should be replaced.

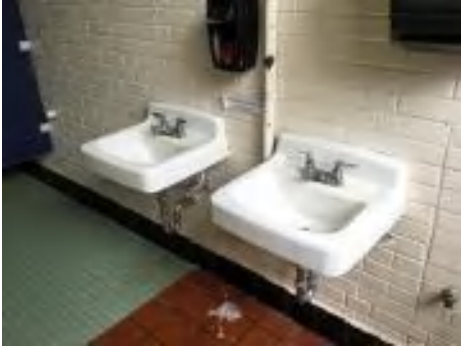
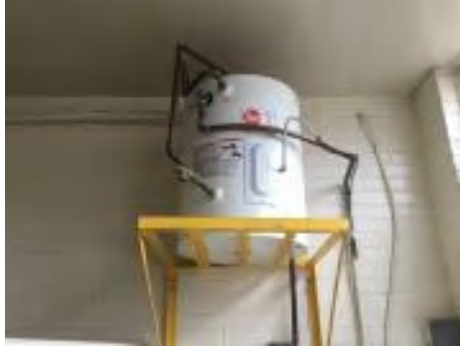
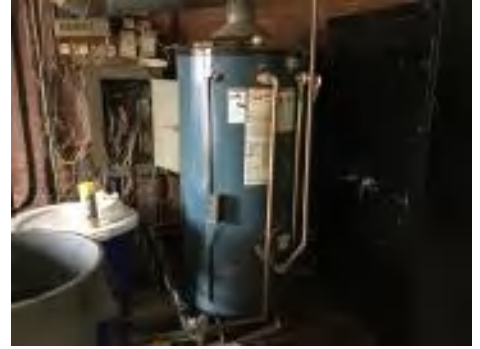
System: D2020 - Domestic Water Distribution

Note: The domestic water distribution system is beyond its service life and should be replaced.

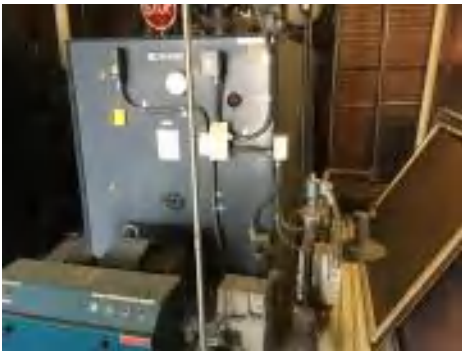
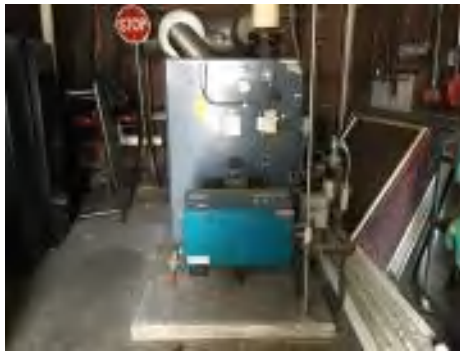
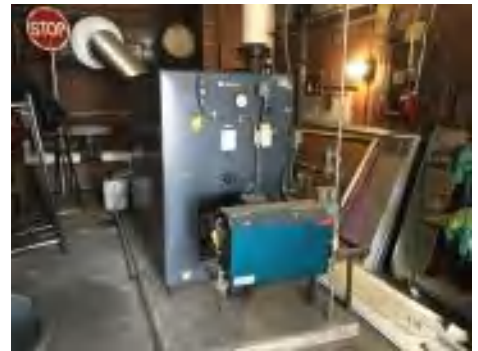
System: D3020 - Heat Generating Systems

Note: The heat generation system is beyond its service life and should be replaced.

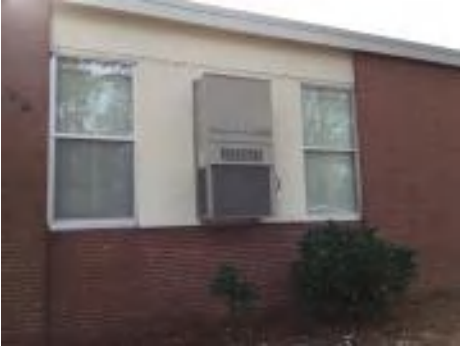
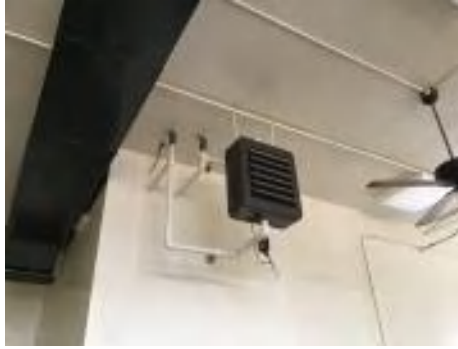
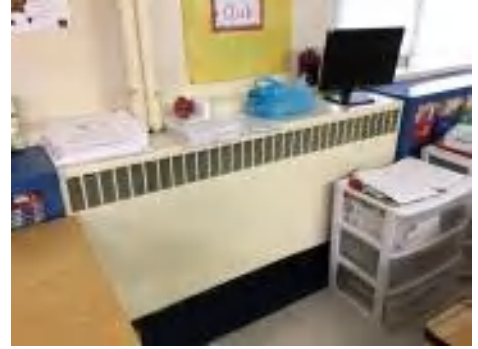
System: D3050 - Terminal & Package Units

Note: The radiating heating system is beyond its service life and should be replaced.

Notes: The radiating heaters are beyond their service life and should be replaced.

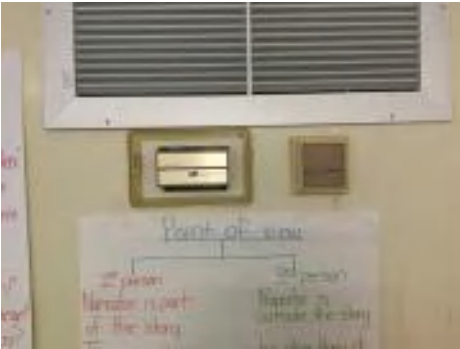
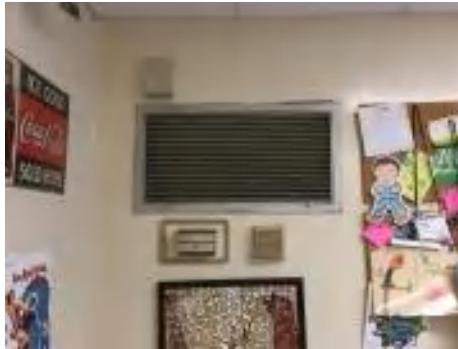
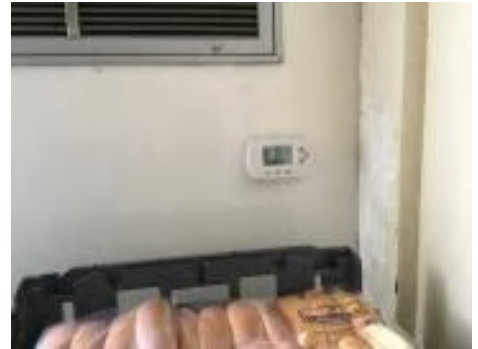
System: D3060 - Controls & Instrumentation

Note: The controls are beyond their service life and should be replaced.

Notes: The controls are beyond their service life and should be replaced.

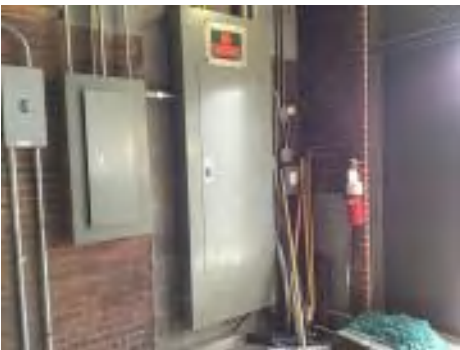
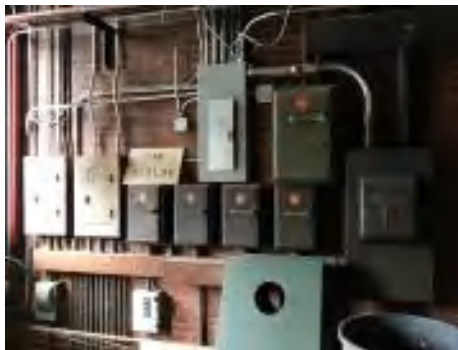
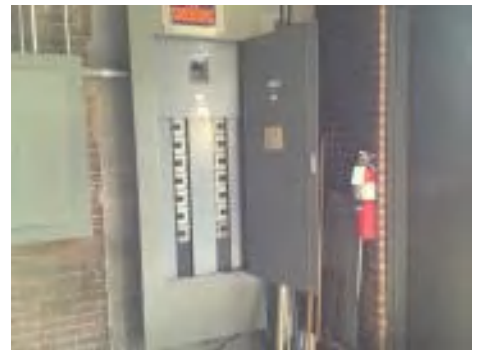
System: D5010 - Electrical Service/Distribution

Note: The electrical service distribution system is beyond its service life and should be replaced.

Notes: The electrical service distribution system is beyond its service life and should be replaced.

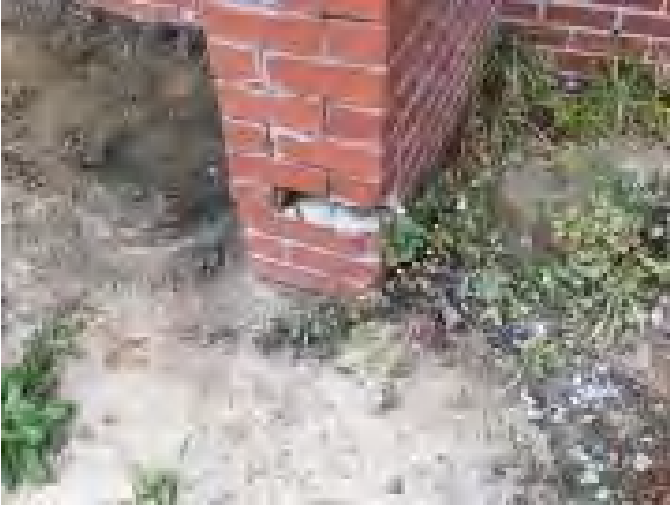
System: B2010 - Exterior Walls

Location: Exterior walls
Distress: Damaged
Category: Safety / Building Code Compliance
Priority: 1 - Currently Critical (Immediate)
Correction: Engineering Study-2016-11-15 17:41:59
Qty: 1.00
Unit of Measure: Ea.
Estimate: \$13,200.00
Assessor Name: Terence Davis
Date Created: 01/05/2017

Notes: There are multiple areas where the bricks are missing or there are visible cracks on the exterior walls, a professional engineer should study the problem.

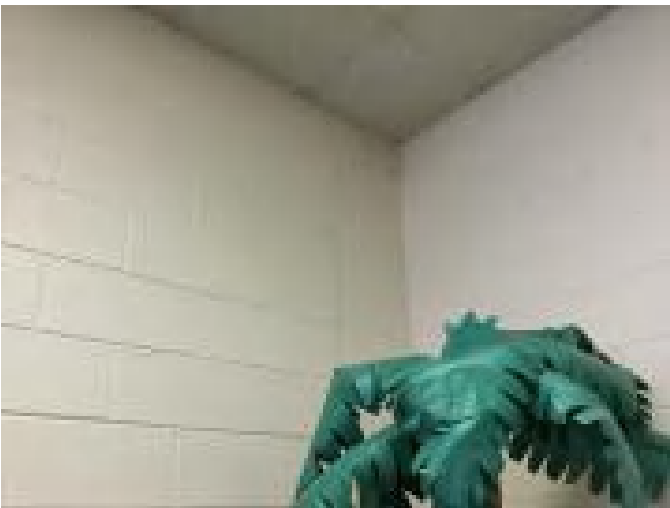
System: C1010 - Partitions

Location: Office and Media Center
Distress: Damaged
Category: Safety / Building Code Compliance
Priority: 1 - Currently Critical (Immediate)
Correction: Engineering Study
Qty: 1.00
Unit of Measure: Ea.
Estimate: \$13,200.00
Assessor Name: Terence Davis
Date Created: 01/05/2017

Notes: There are visible cracks on the partition wall which should be studied by a professional engineer.

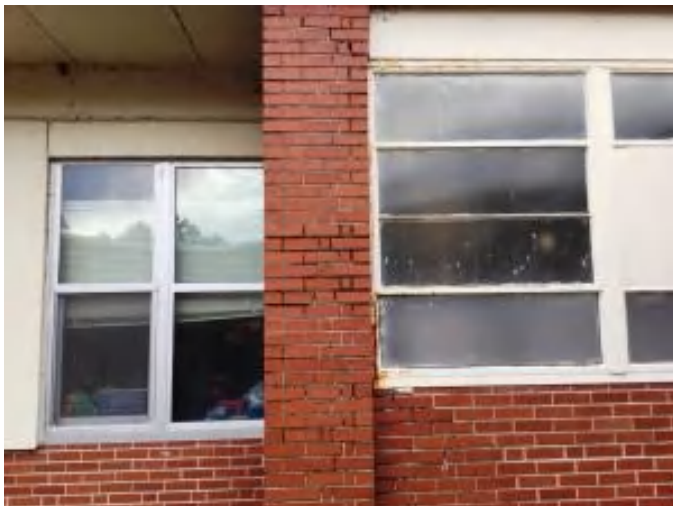
System: B2020 - Exterior Windows

Location: Exterior wall
Distress: Beyond Service Life
Category: Deferred Maintenance
Priority: 3 - Necessary/Not Yet Critical (Years 2-5)
Correction: Replace 3' x 4' aluminum window - 1st floor
Qty: 15.00
Unit of Measure: Ea.
Estimate: \$19,207.73
Assessor Name: Terence Davis
Date Created: 01/09/2017

Notes: The exterior windows on the cafeteria and few places on the original building are beyond their service life and should be replaced.

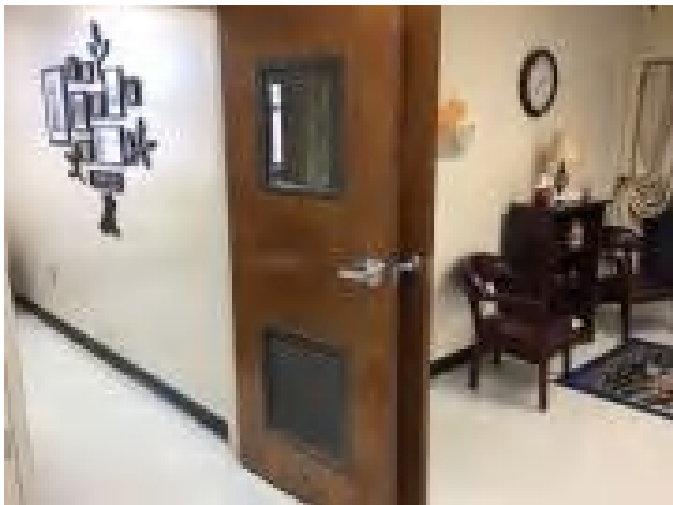
System: C1020 - Interior Doors

Location: Throughout Building
Distress: Beyond Service Life
Category: Deferred Maintenance
Priority: 3 - Necessary/Not Yet Critical (Years 2-5)
Correction: Renew System
Qty: 32,364.00
Unit of Measure: S.F.
Estimate: \$90,069.00
Assessor Name: Terence Davis
Date Created: 12/30/2016

Notes: The interior doors are beyond their service life and should be replaced, also while replacing the doors the hardware installed should be ADA compliant.
