NC School District/830 Scotland County/High School

Scotland High

Campus Assessment Report

March 7, 2017

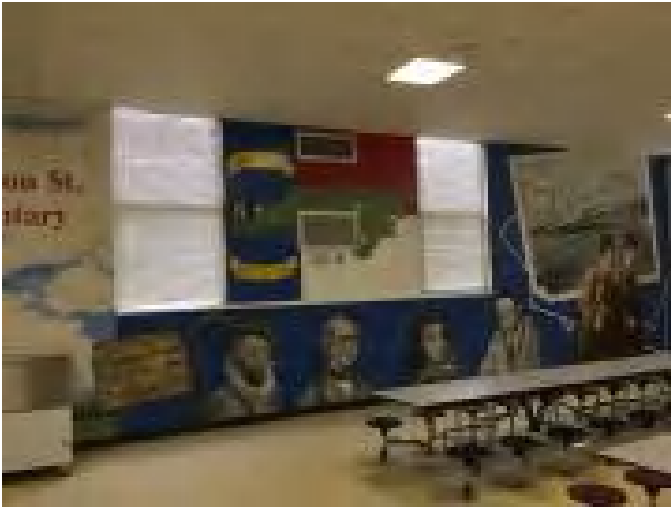
System: C3010 - Wall Finishes

Location: Throughout Building
Distress: Beyond Service Life
Category: Deferred Maintenance
Priority: 3 - Necessary/Not Yet Critical (Years 2-5)
Correction: Renew System
Qty: 32,364.00
Unit of Measure: S.F.
Estimate: \$99,325.00
Assessor Name: Terence Davis
Date Created: 12/30/2016

Notes: The wall finishes are beyond their service life and should be replaced.

Note: The wall finishes are beyond their service life and should be replaced.

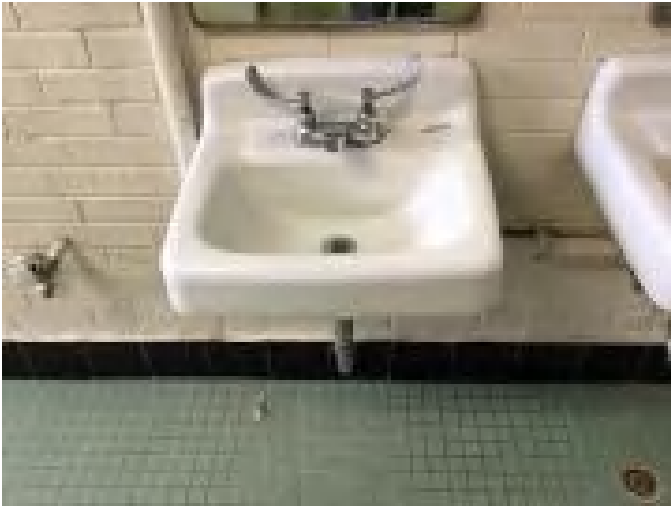
System: D2010 - Plumbing Fixtures

Location: Throughout Building
Distress: Beyond Service Life
Category: Deferred Maintenance
Priority: 3 - Necessary/Not Yet Critical (Years 2-5)
Correction: Renew System
Qty: 32,364.00
Unit of Measure: S.F.
Estimate: \$408,693.00
Assessor Name: Terence Davis
Date Created: 12/30/2016

Notes: The plumbing fixtures are beyond their service life and should be replaced.

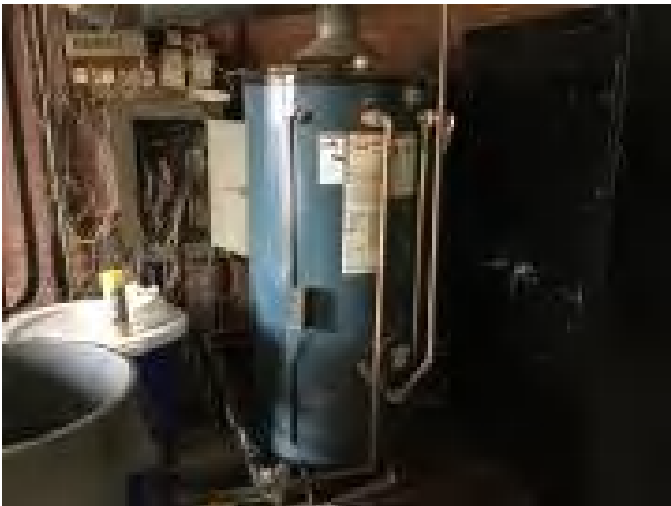
System: D2020 - Domestic Water Distribution

Location: Throughout Building
Distress: Beyond Service Life
Category: Deferred Maintenance
Priority: 3 - Necessary/Not Yet Critical (Years 2-5)
Correction: Renew System
Qty: 32,364.00
Unit of Measure: S.F.
Estimate: \$34,888.00
Assessor Name: Terence Davis
Date Created: 12/30/2016

Notes: The domestic water distribution system is beyond its service life and should be replaced.

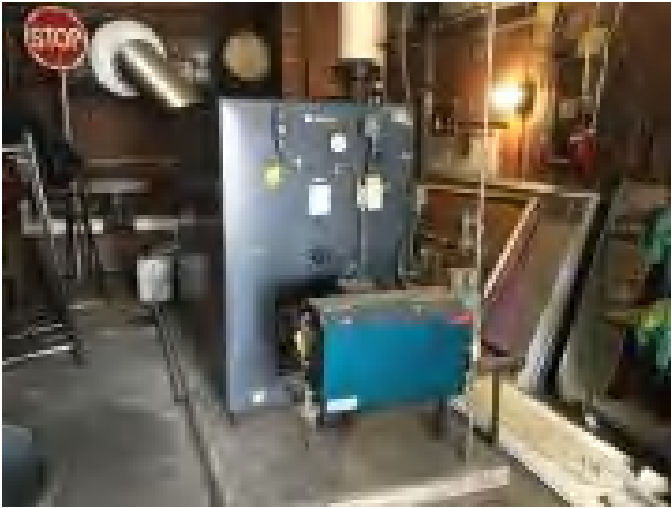
System: D3020 - Heat Generating Systems

Location: Throughout Building
Distress: Beyond Service Life
Category: Deferred Maintenance / Energy
Priority: 3 - Necessary/Not Yet Critical (Years 2-5)
Correction: Renew System
Qty: 32,364.00
Unit of Measure: S.F.
Estimate: \$180,850.00
Assessor Name: Terence Davis
Date Created: 12/30/2016

Notes: The heat generation system is beyond its service life and should be replaced.

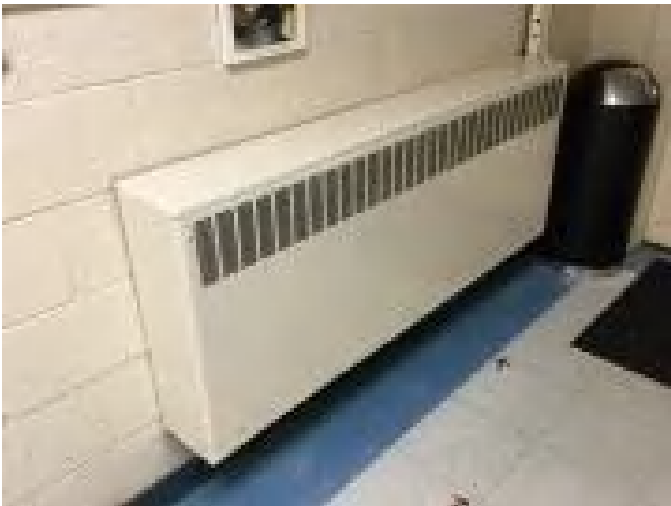
System: D3050 - Terminal & Package Units

Location: Throughout the building
Distress: Beyond Service Life
Category: Deferred Maintenance / Energy
Priority: 3 - Necessary/Not Yet Critical (Years 2-5)
Correction: Replace heat pump, thru-wall unit, 1.5 ton
Qty: 5.00
Unit of Measure: Ea.
Estimate: \$36,927.00
Assessor Name: Terence Davis
Date Created: 01/05/2017

Notes: The radiating heaters are beyond their service life and should be replaced.

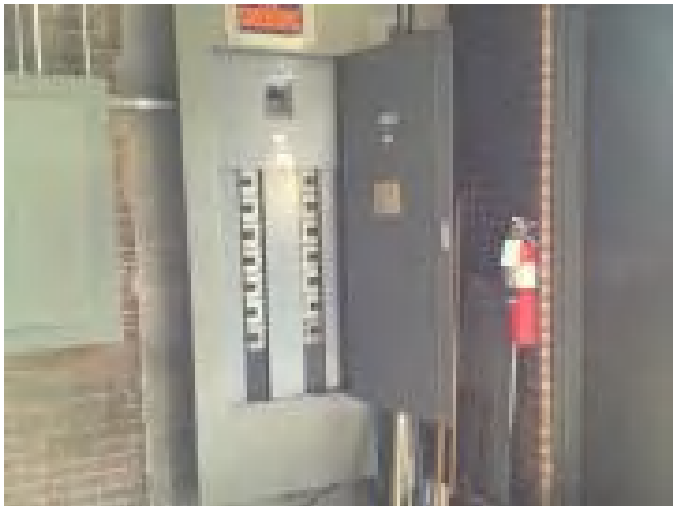
System: D5010 - Electrical Service/Distribution

Location: Throughout Building
Distress: Beyond Service Life
Category: Deferred Maintenance / Energy
Priority: 3 - Necessary/Not Yet Critical (Years 2-5)
Correction: Renew System
Qty: 32,364.00
Unit of Measure: S.F.
Estimate: \$60,165.00
Assessor Name: Terence Davis
Date Created: 12/30/2016

Notes: The electrical service distribution system is beyond its service life and should be replaced.

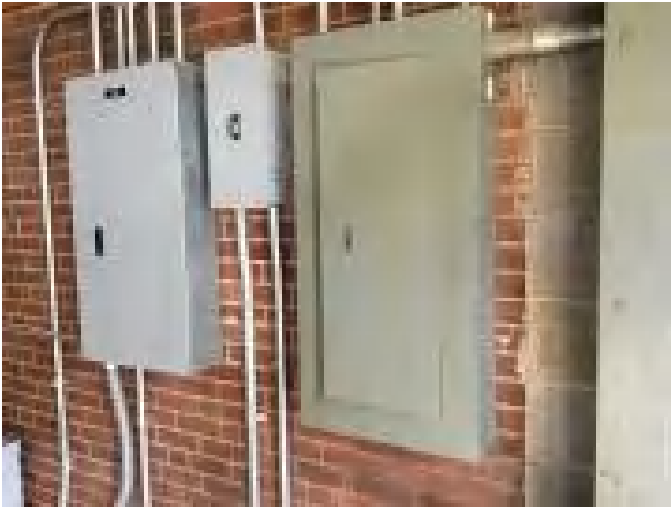
System: D5020 - Branch Wiring

Location: Throughout Building
Distress: Beyond Service Life
Category: Deferred Maintenance / Energy
Priority: 3 - Necessary/Not Yet Critical (Years 2-5)
Correction: Renew System
Qty: 32,364.00
Unit of Measure: S.F.
Estimate: \$180,138.00
Assessor Name: Terence Davis
Date Created: 12/30/2016

Notes: The branch wiring is beyond its service life and should be replaced.

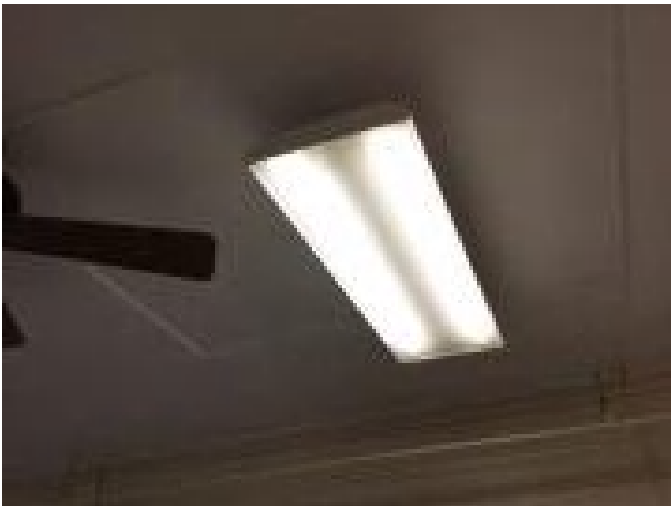
System: D5020 - Lighting

Location: Throughout Building
Distress: Beyond Service Life
Category: Deferred Maintenance / Energy
Priority: 3 - Necessary/Not Yet Critical (Years 2-5)
Correction: Renew System
Qty: 32,364.00
Unit of Measure: S.F.
Estimate: \$424,357.00
Assessor Name: Terence Davis
Date Created: 12/30/2016

Notes: The lighting system is beyond its service life and should be replaced.

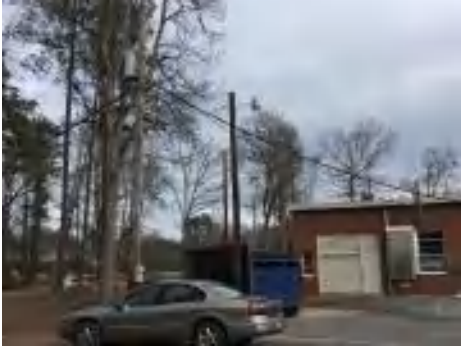
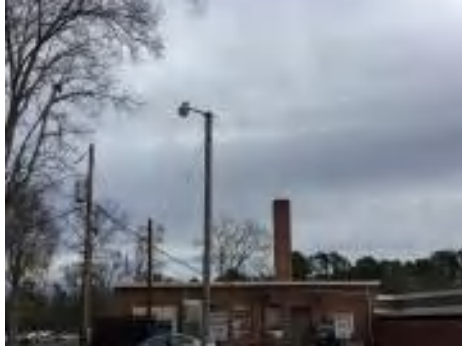
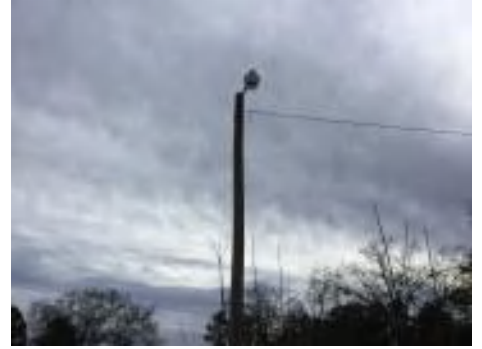
System: G4020 - Site Lighting

Note: The site lighting system is beyond its service life and should be replaced.

Notes: The site lighting system is beyond its service life and should be replaced.

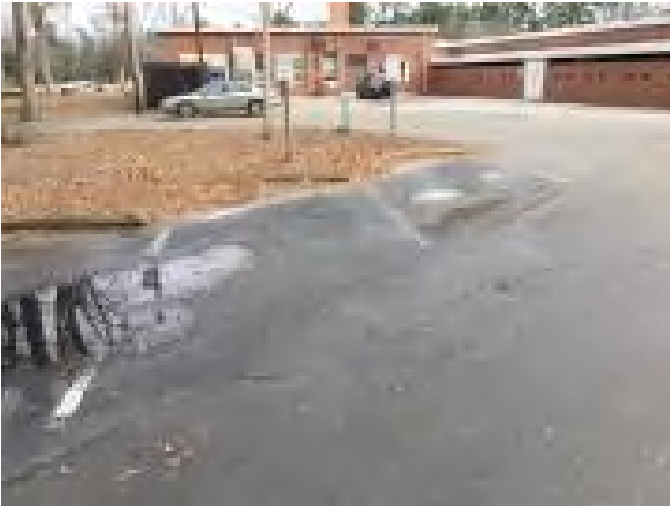
System: G2020 - Parking Lots

Location: Site
Distress: Beyond Service Life
Category: Deferred Maintenance
Priority: 3 - Necessary/Not Yet Critical (Years 2-5)
Correction: Parking lot repair and resurface
Qty: 4.00
Unit of Measure: M.S.F.
Estimate: \$5,431.06
Assessor Name: Eduardo Lopez
Date Created: 01/05/2017

Notes: The parking lot on the northwest side needs to be repaired and restriped.

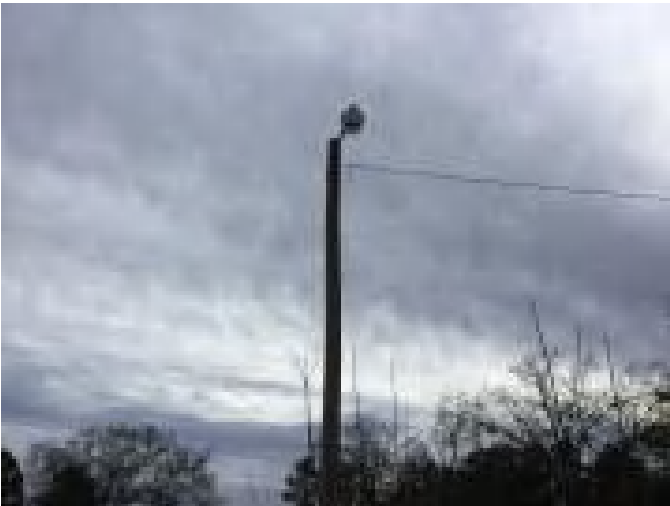
System: G4020 - Site Lighting

Location: Site
Distress: Beyond Service Life
Category: Deferred Maintenance
Priority: 3 - Necessary/Not Yet Critical (Years 2-5)
Correction: Renew System
Qty: 32,364.00
Unit of Measure: S.F.
Estimate: \$52,333.00
Assessor Name: Eduardo Lopez
Date Created: 12/30/2016

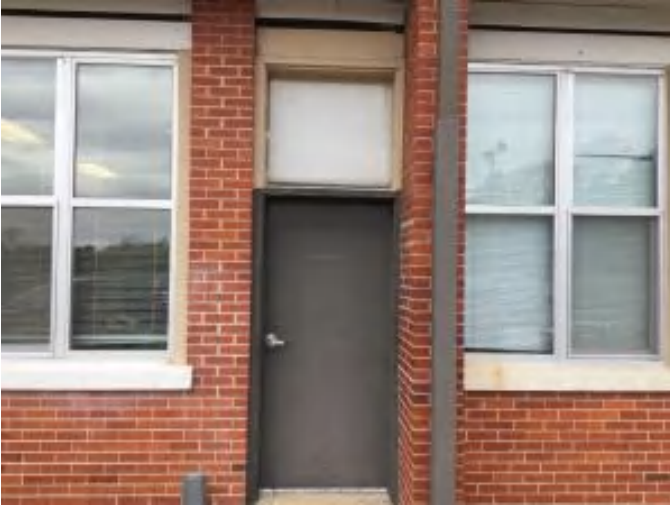
System: B2030 - Exterior Doors

Location: Exterior
Distress: Beyond Service Life
Category: Deferred Maintenance
Priority: 3 - Necessary/Not Yet Critical (Years 2-5)
Correction: Renew System
Qty: 12,000.00
Unit of Measure: S.F.
Estimate: \$14,124.00
Assessor Name: Terence Davis
Date Created: 01/13/2017

Notes: The original metal exterior doors are aged, rusted, damaged and should be replaced with energy efficient doors

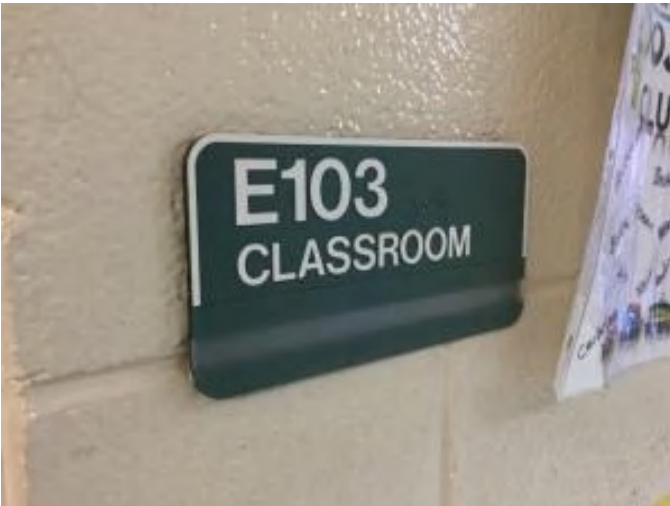
System: C1030 - Fittings

Location: Restrooms
Distress: Beyond Service Life
Category: Deferred Maintenance
Priority: 3 - Necessary/Not Yet Critical (Years 2-5)
Correction: Renew System
Qty: 12,000.00
Unit of Measure: S.F.
Estimate: \$131,208.00
Assessor Name: Terence Davis
Date Created: 01/12/2017

Notes: The bathroom fittings and toilet partitions are aged, worn, damaged and should be replaced. The original fittings are aged, and should be replaced. The room signs are inadequate, do not comply with present requirements and is recommended to replace them.

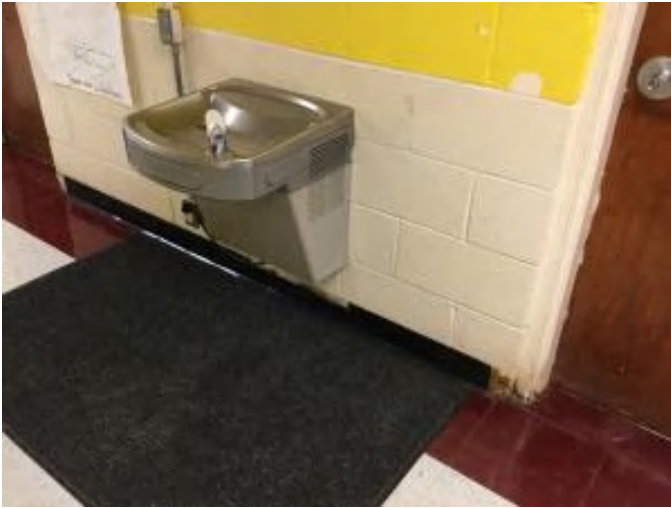
System: D2010 - Plumbing Fixtures

Location: Throughout the building
Distress: Beyond Service Life
Category: Deferred Maintenance
Priority: 3 - Necessary/Not Yet Critical (Years 2-5)
Correction: Renew System
Qty: 12,000.00
Unit of Measure: S.F.
Estimate: \$154,572.00
Assessor Name: Terence Davis
Date Created: 01/12/2017

Notes: The plumbing fixtures are original beyond its service life, not efficient or low flow fixtures.

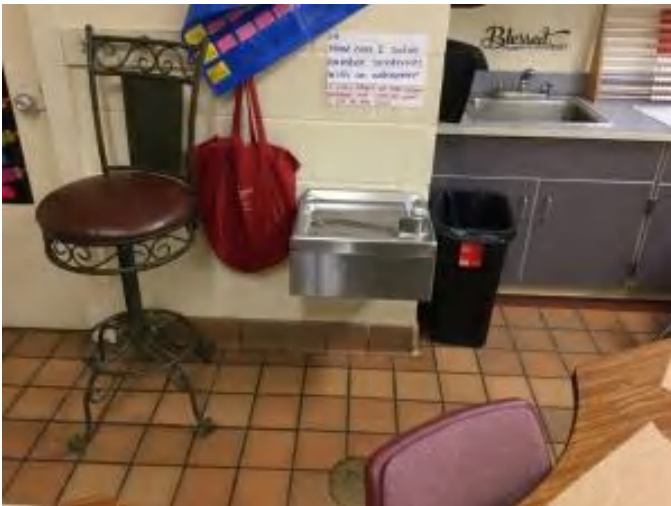
System: D2020 - Domestic Water Distribution

Location: Throughout the building.
Distress: Beyond Service Life
Category: Deferred Maintenance
Priority: 3 - Necessary/Not Yet Critical (Years 2-5)
Correction: Renew System
Qty: 12,000.00
Unit of Measure: S.F.
Estimate: \$13,068.00
Assessor Name: Terence Davis
Date Created: 01/13/2017

Notes: There are no reported issues or observed deficiencies with the domestic water piping. Due to the age of the pipe there can be internal pitting corrosion that may be a costly problem that leads to the formation of pinhole leaks and possible water contamination.

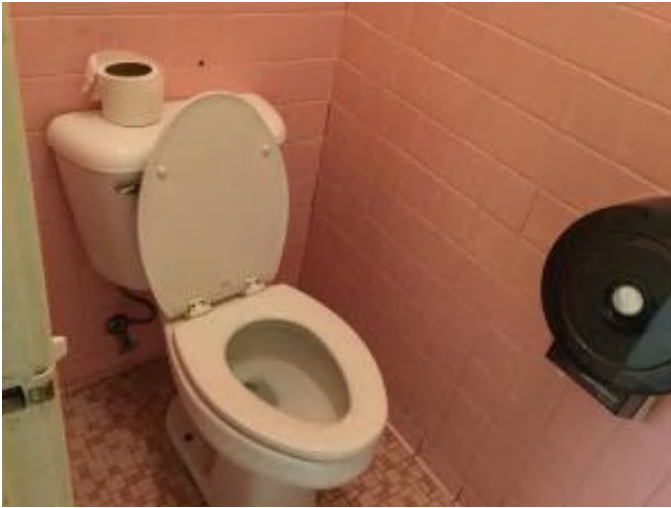
System: D2030 - Sanitary Waste

Location: Throughout the building
Distress: Beyond Service Life
Category: Deferred Maintenance
Priority: 3 - Necessary/Not Yet Critical (Years 2-5)
Correction: Renew System
Qty: 12,000.00
Unit of Measure: S.F.
Estimate: \$20,724.00
Assessor Name: Terence Davis
Date Created: 01/13/2017

Notes: There are no reported issues or observed deficiencies with the sanitary waste piping. The aging sanitary sewer piping is subject to leaks, infiltration, and it can even collapse in the interior walls. The system should be inspected with cameras to ensure that none of these deficiencies exist.

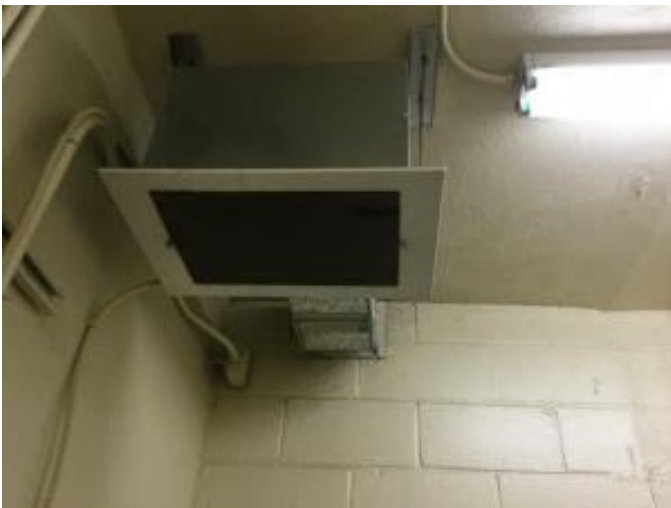
System: D3040 - Distribution Systems

Location: Throughout the building
Distress: Beyond Service Life
Category: Deferred Maintenance
Priority: 3 - Necessary/Not Yet Critical (Years 2-5)
Correction: Renew System
Qty: 12,000.00
Unit of Measure: S.F.
Estimate: \$82,632.00
Assessor Name: Terence Davis
Date Created: 01/13/2017

Notes: The exhaust fans, and hot water supply distribution system is aged, in marginal condition, and should be replaced.

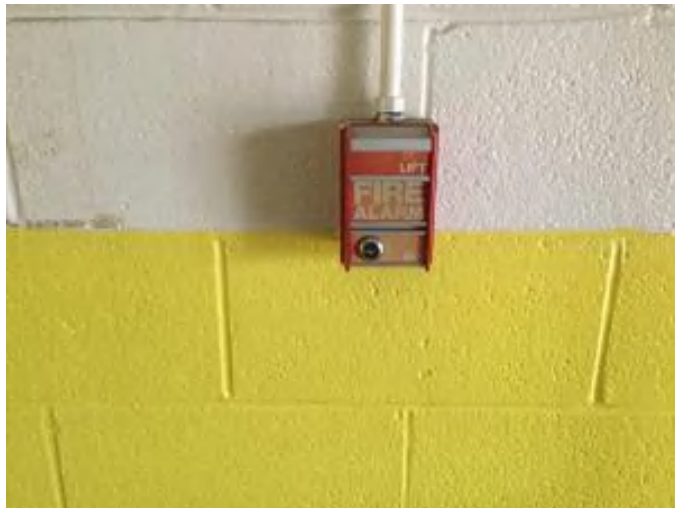
System: D5030910 - Fire Alarm Systems

Location: Throughout the building
Distress: Beyond Service Life
Category: Deferred Maintenance
Priority: 3 - Necessary/Not Yet Critical (Years 2-5)
Correction: Renew System
Qty: 12,000.00
Unit of Measure: S.F.
Estimate: \$45,672.00
Assessor Name: Terence Davis
Date Created: 01/13/2017

Notes: The original alarm system is operating but is aged. The system should be inspected and repaired or replaced to ensure that the life safety codes are preserved.

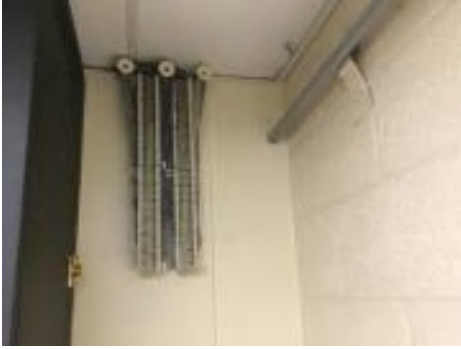
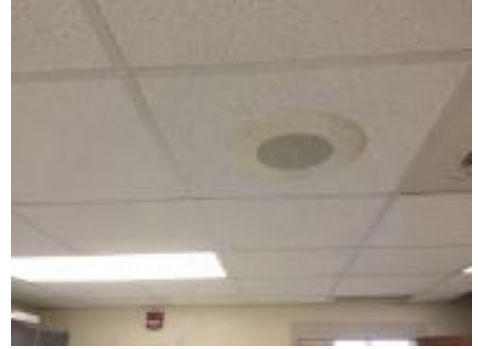
System: D5030920 - Data Communication

Note: Telephone and PA systems are separate.

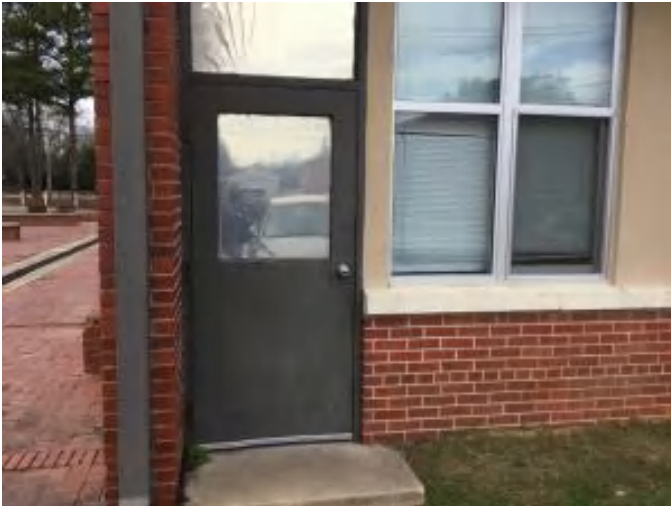
System: B2030 - Exterior Doors

Location: Throughout the building
Distress: Beyond Service Life
Category: Deferred Maintenance
Priority: 3 - Necessary/Not Yet Critical (Years 2-5)
Correction: Renew System
Qty: 33,000.00
Unit of Measure: S.F.
Estimate: \$37,026.00
Assessor Name: Terence Davis
Date Created: 01/10/2017

Notes: The original metal exterior doors are aged, rusted, damaged and should be replaced with energy efficient doors

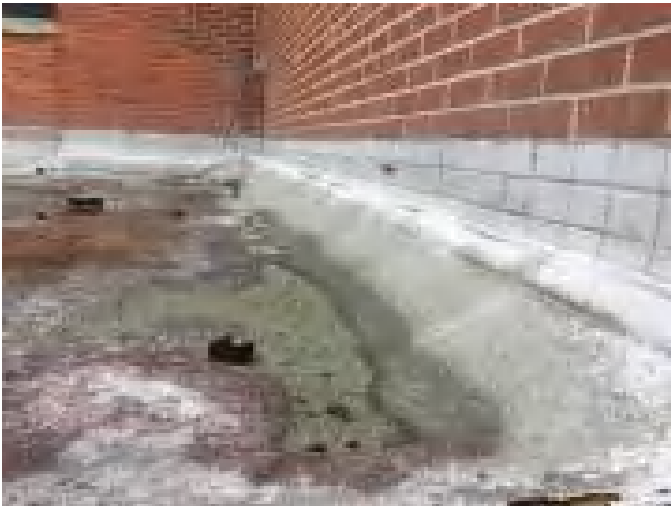
System: B3010105 - Foam Roofing

Location: Throughout the building
Distress: Beyond Service Life
Category: Deferred Maintenance
Priority: 3 - Necessary/Not Yet Critical (Years 2-5)
Correction: Renew System
Qty: 33,000.00
Unit of Measure: S.F.
Estimate: \$407,583.00
Assessor Name: Terence Davis
Date Created: 01/10/2017

Notes: The built-up roofing is aged, has reported leaks and should be replaced.

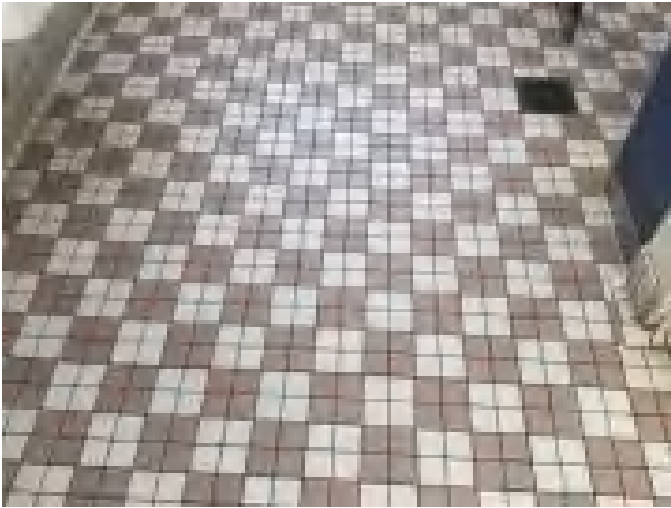
System: C3020 - Floor Finishes

Location: Throughout the building
Distress: Beyond Service Life
Category: Deferred Maintenance
Priority: 3 - Necessary/Not Yet Critical (Years 2-5)
Correction: Renew System
Qty: 33,000.00
Unit of Measure: S.F.
Estimate: \$404,745.00
Assessor Name: Terence Davis
Date Created: 01/13/2017

Notes: The flooring is beyond its service life and it should be replaced.

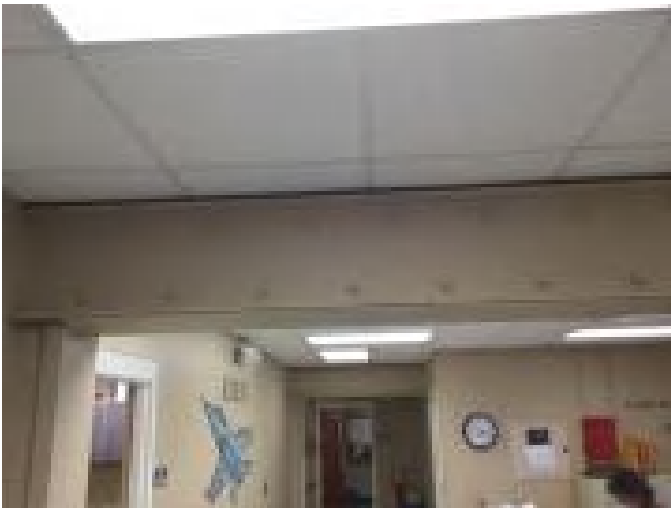
System: C3030 - Ceiling Finishes

Location: Throughout the building
Distress: Beyond Service Life
Category: Deferred Maintenance
Priority: 3 - Necessary/Not Yet Critical (Years 2-5)
Correction: Renew System
Qty: 33,000.00
Unit of Measure: S.F.
Estimate: \$389,862.00
Assessor Name: Terence Davis
Date Created: 01/10/2017

Notes: The ceiling finishes are beyond their service life and should be replaced.

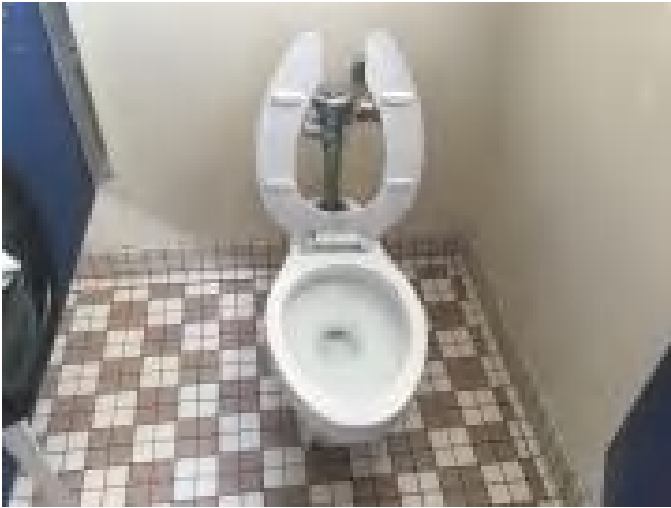
System: D2010 - Plumbing Fixtures

Location: Restrooms
Distress: Beyond Service Life
Category: Deferred Maintenance
Priority: 3 - Necessary/Not Yet Critical (Years 2-5)
Correction: Renew System
Qty: 33,000.00
Unit of Measure: S.F.
Estimate: \$408,738.00
Assessor Name: Terence Davis
Date Created: 01/13/2017

Notes: The plumbing fixtures are original beyond its service life, not efficient or low flow fixtures.

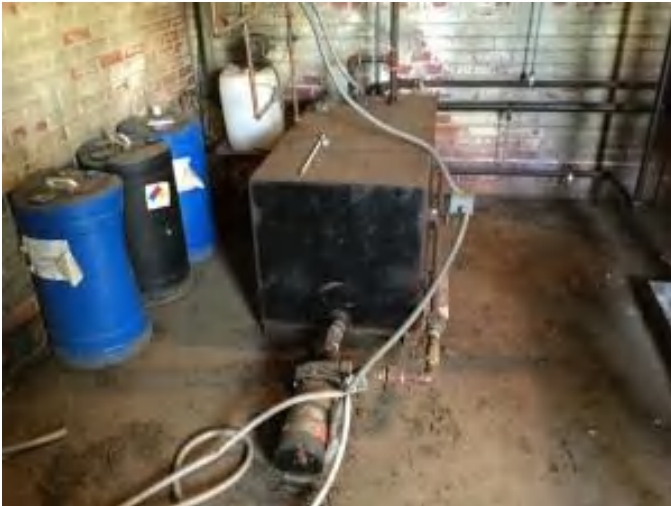
System: D2020 - Domestic Water Distribution

Location: Througihut the building
Distress: Beyond Service Life
Category: Deferred Maintenance
Priority: 3 - Necessary/Not Yet Critical (Years 2-5)
Correction: Renew System
Qty: 33,000.00
Unit of Measure: S.F.
Estimate: \$34,848.00
Assessor Name: Terence Davis
Date Created: 01/10/2017

Notes: There are no reported issues or observed deficiencies with the domestic water piping. Due to the age of the pipe there can be internal pitting corrosion that may be a costly problem that leads to the formation of pinhole leaks and possible water contamination.

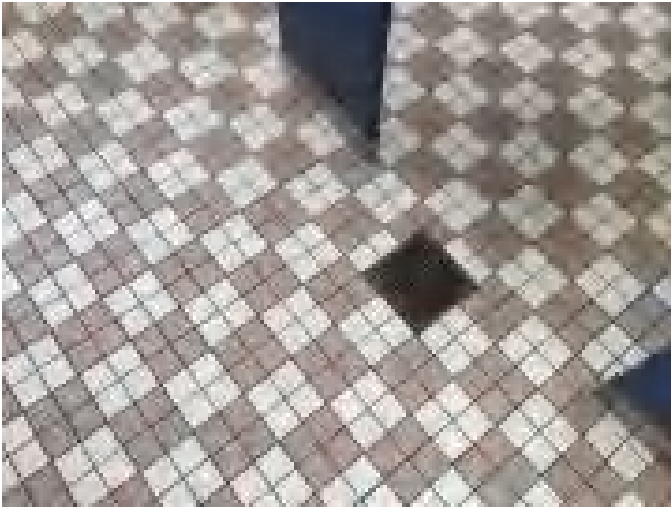
System: D2030 - Sanitary Waste

Location: Throughout the building
Distress: Beyond Service Life
Category: Deferred Maintenance
Priority: 3 - Necessary/Not Yet Critical (Years 2-5)
Correction: Renew System
Qty: 33,000.00
Unit of Measure: S.F.
Estimate: \$55,176.00
Assessor Name: Terence Davis
Date Created: 01/10/2017

Notes: There are no reported issues or observed deficiencies with the sanitary waste piping. The aging sanitary sewer piping is subject to leaks, infiltration, and it can even collapse in the interior walls. The system should be inspected with cameras to ensure that none of these deficiencies exist.

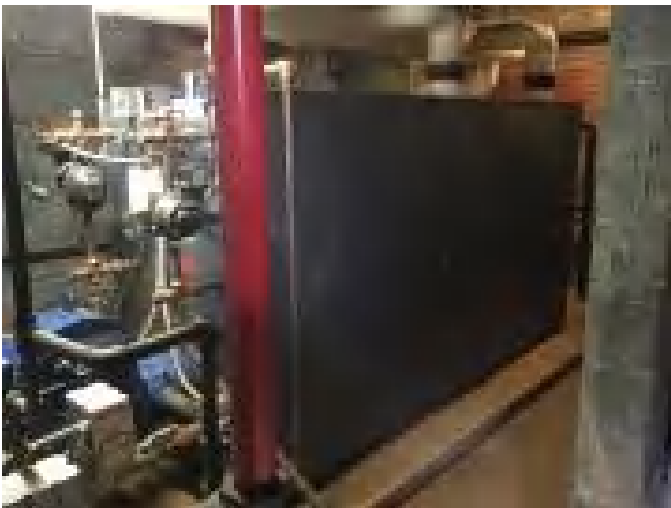
System: D3020 - Heat Generating Systems

Location: Mechanical Room
Distress: Beyond Service Life
Category: Deferred Maintenance
Priority: 3 - Necessary/Not Yet Critical (Years 2-5)
Correction: Renew System
Qty: 33,000.00
Unit of Measure: S.F.
Estimate: \$180,774.00
Assessor Name: Terence Davis
Date Created: 01/11/2017

Notes: The original gas fired boiler is aged, inefficient, and becoming logistically unsupportable and should be replaced with an energy efficient model.

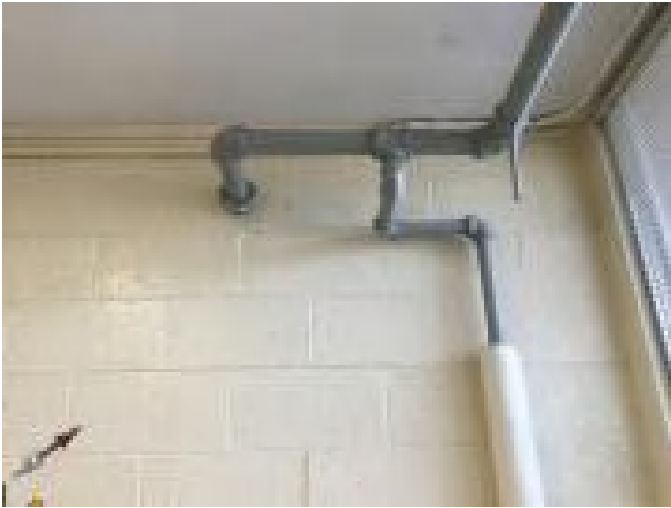
System: D3040 - Distribution Systems

Location: Throughout the building
Distress: Beyond Service Life
Category: Deferred Maintenance
Priority: 3 - Necessary/Not Yet Critical (Years 2-5)
Correction: Renew System
Qty: 33,000.00
Unit of Measure: S.F.
Estimate: \$218,526.00
Assessor Name: Terence Davis
Date Created: 01/11/2017

Notes: The exhaust fans, and hot water supply distribution system is aged, in marginal condition, and should be replaced.

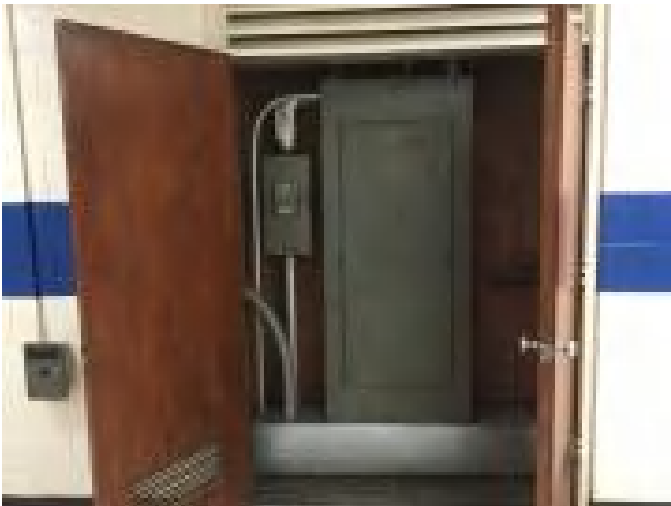
System: D5020 - Branch Wiring

Location: Throughout the building
Distress: Beyond Service Life
Category: Deferred Maintenance
Priority: 3 - Necessary/Not Yet Critical (Years 2-5)
Correction: Renew System
Qty: 33,000.00
Unit of Measure: S.F.
Estimate: \$181,137.00
Assessor Name: Terence Davis
Date Created: 01/13/2017

Notes: The original branch wiring system is operating but is aged, nearing capacity, and should be replaced.

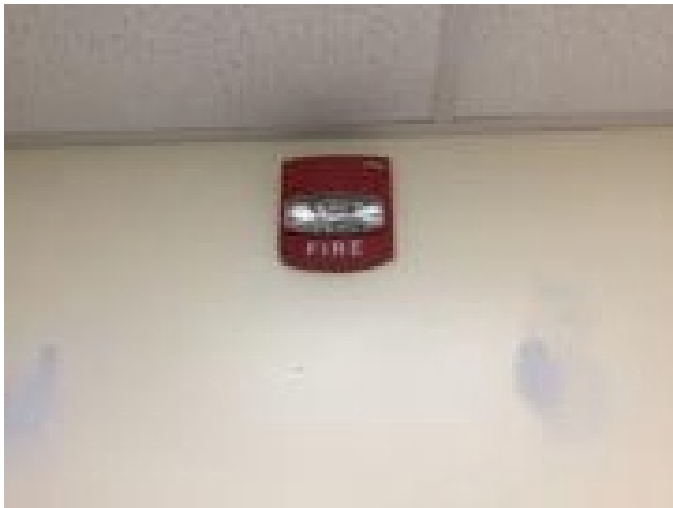
System: D5030910 - Fire Alarm Systems

Location: Throughout
Distress: Beyond Service Life
Category: Deferred Maintenance
Priority: 3 - Necessary/Not Yet Critical (Years 2-5)
Correction: Renew System
Qty: 33,000.00
Unit of Measure: S.F.
Estimate: \$120,153.00
Assessor Name: Terence Davis
Date Created: 01/10/2017

Notes: The original alarm system is operating but is aged. The system should be inspected and repaired or replaced to ensure that the life safety codes are preserved.

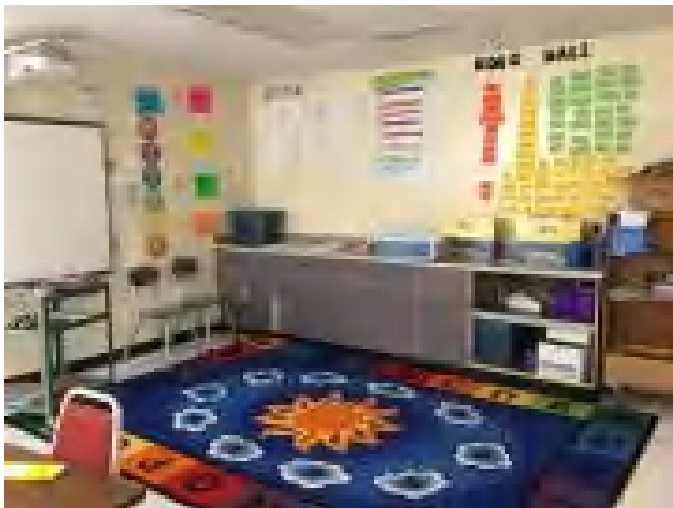
System: E2010 - Fixed Furnishings

Location: Classroom
Distress: Beyond Service Life
Category: Deferred Maintenance
Priority: 3 - Necessary/Not Yet Critical (Years 2-5)
Correction: Renew System
Qty: 33,000.00
Unit of Measure: S.F.
Estimate: \$207,636.00
Assessor Name: Terence Davis
Date Created: 01/13/2017

Notes: The building casework is aged and worn and should be replaced.

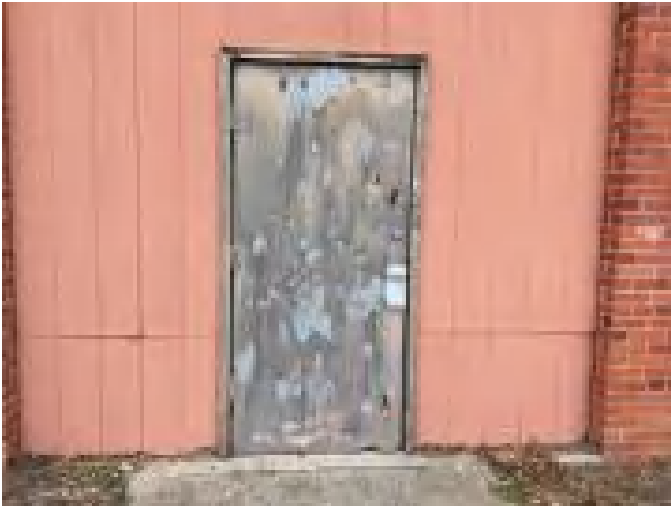
System: B2030 - Exterior Doors

Location: Exterior
Distress: Damaged
Category: Deferred Maintenance
Priority: 1 - Currently Critical (Immediate)
Correction: Renew System
Qty: 3,584.00
Unit of Measure: S.F.
Estimate: \$4,021.00
Assessor Name: Eduardo Lopez
Date Created: 01/10/2017

Notes: The original metal exterior doors are aged, rusted, damaged and should be replaced with energy efficient doors.

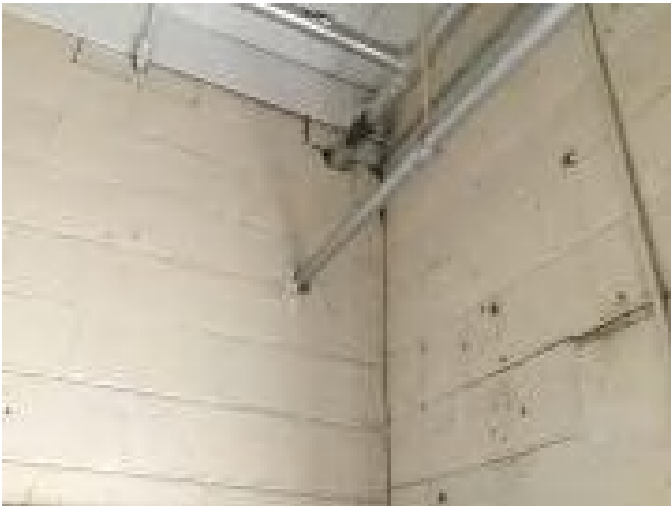
System: C3010 - Wall Finishes

Location: Throughout the building
Distress: Damaged
Category: Deferred Maintenance
Priority: 1 - Currently Critical (Immediate)
Correction: Renew System
Qty: 3,584.00
Unit of Measure: S.F.
Estimate: \$10,763.00
Assessor Name: Eduardo Lopez
Date Created: 01/10/2017

Notes: The original painted wall finish is aged, chipped, stained and should be replaced.

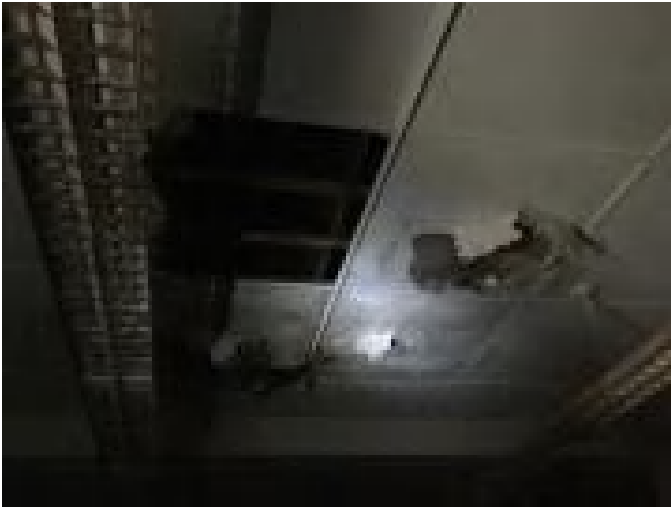
System: C3030 - Ceiling Finishes

Location: Throughout the building
Distress: Damaged
Category: Deferred Maintenance
Priority: 1 - Currently Critical (Immediate)
Correction: Renew System
Qty: 3,584.00
Unit of Measure: S.F.
Estimate: \$42,341.00
Assessor Name: Eduardo Lopez
Date Created: 01/10/2017

Notes: The original ceiling finish is aged, chipped, stained and should be replaced.

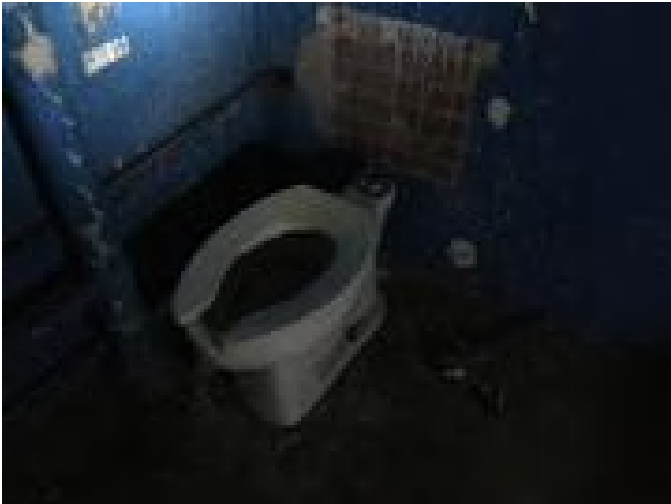
System: D2010 - Plumbing Fixtures

Location: Throughout the building
Distress: Beyond Service Life
Category: Deferred Maintenance
Priority: 1 - Currently Critical (Immediate)
Correction: Renew System
Qty: 3,584.00
Unit of Measure: S.F.
Estimate: \$44,391.00
Assessor Name: Eduardo Lopez
Date Created: 01/10/2017

Notes: The original plumbing fixtures are aged, chipped, stained, showing signs of failure and should be replaced.

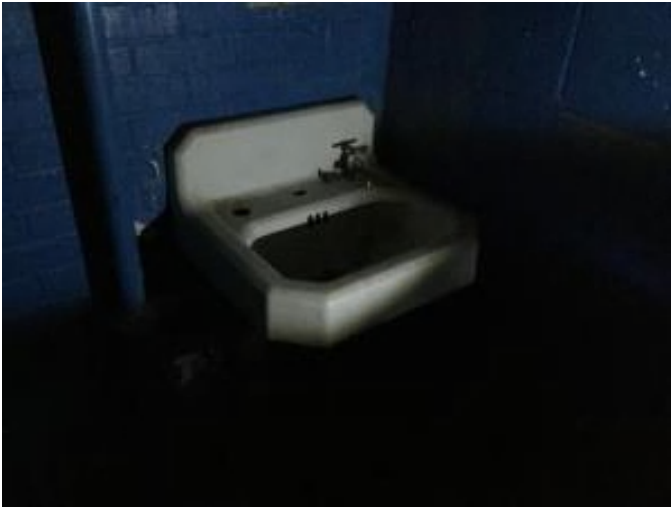
System: D2020 - Domestic Water Distribution

Location: Throughout the building
Distress: Failing
Category: Deferred Maintenance
Priority: 1 - Currently Critical (Immediate)
Correction: Renew System
Qty: 3,584.00
Unit of Measure: S.F.
Estimate: \$3,785.00
Assessor Name: Eduardo Lopez
Date Created: 01/10/2017

Notes: The original copper water distribution system is aged, corroded, has reported leaks and should be replaced.

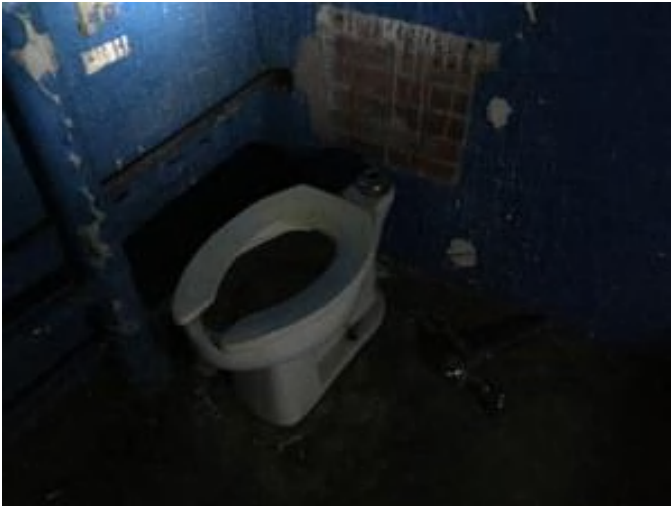
System: D2030 - Sanitary Waste

Location: Restroom
Distress: Beyond Service Life
Category: Deferred Maintenance
Priority: 1 - Currently Critical (Immediate)
Correction: Renew System
Qty: 3,584.00
Unit of Measure: S.F.
Estimate: \$5,992.00
Assessor Name: Eduardo Lopez
Date Created: 01/10/2017

Notes: The original sanitary waste system is operating but is in poor condition and should be replaced.

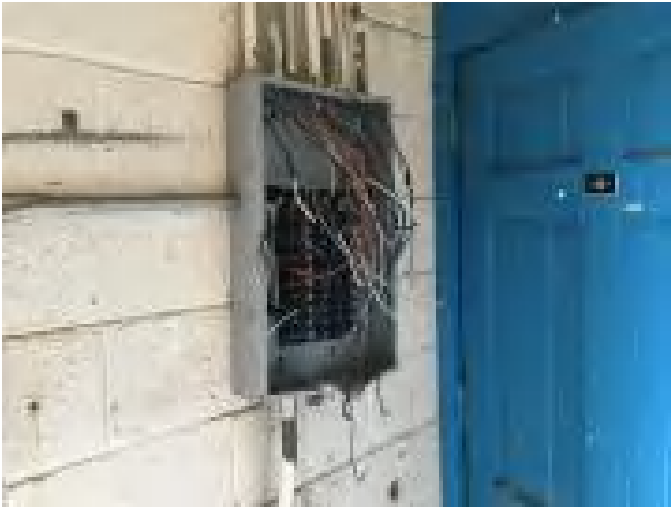
System: D5010 - Electrical Service/Distribution

Location: Throughout
Distress: Damaged
Category: Deferred Maintenance
Priority: 1 - Currently Critical (Immediate)
Correction: Renew System
Qty: 3,584.00
Unit of Measure: S.F.
Estimate: \$6,505.00
Assessor Name: Eduardo Lopez
Date Created: 01/10/2017

Notes: The original distribution wiring system is damaged, in poor condition and should be replaced.

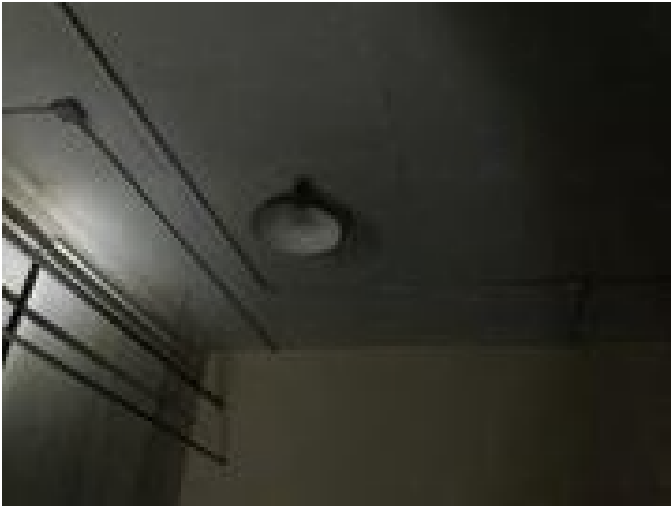
System: D5020 - Lighting

Location: Throughout the building
Distress: Beyond Service Life
Category: Deferred Maintenance
Priority: 1 - Currently Critical (Immediate)
Correction: Renew System
Qty: 3,584.00
Unit of Measure: S.F.
Estimate: \$45,890.00
Assessor Name: Eduardo Lopez
Date Created: 01/10/2017

Notes: The original lighting system is operating properly but is aged, inefficient, in poor condition and should be replaced with an energy efficient system.

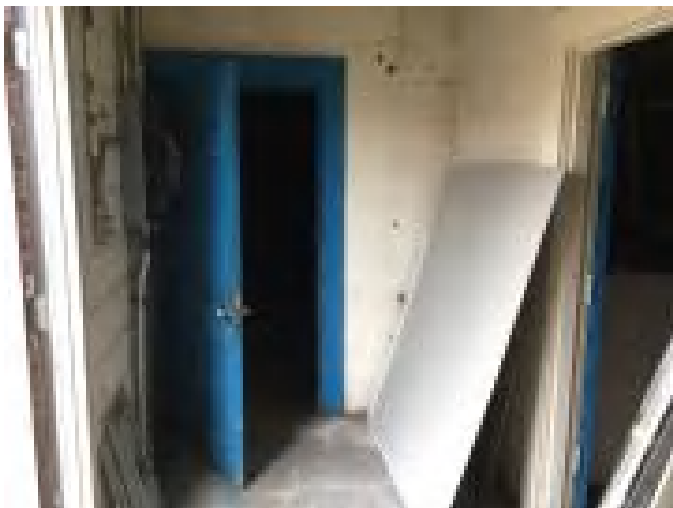
System: C1020 - Interior Doors

Location: Throughout the building
Distress: Damaged
Category: Deferred Maintenance
Priority: 3 - Necessary/Not Yet Critical (Years 2-5)
Correction: Renew System
Qty: 3,584.00
Unit of Measure: S.F.
Estimate: \$9,777.00
Assessor Name: Eduardo Lopez
Date Created: 01/10/2017

Notes: The original wood interior doors are aged, worn and should be replaced.

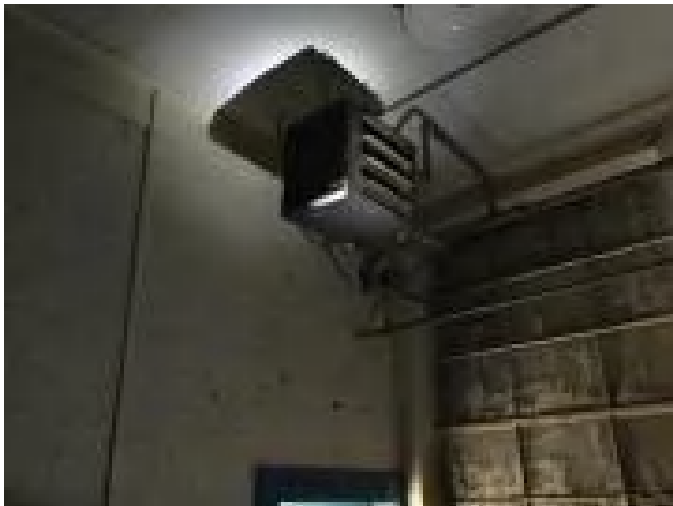
System: D3040 - Distribution Systems

Location: Throughout the building
Distress: Failing
Category: Deferred Maintenance
Priority: 3 - Necessary/Not Yet Critical (Years 2-5)
Correction: Renew System
Qty: 3,584.00
Unit of Measure: S.F.
Estimate: \$23,733.00
Assessor Name: Eduardo Lopez
Date Created: 01/10/2017

Notes: The original distribution system is operating but is in poor condition and should be replaced.

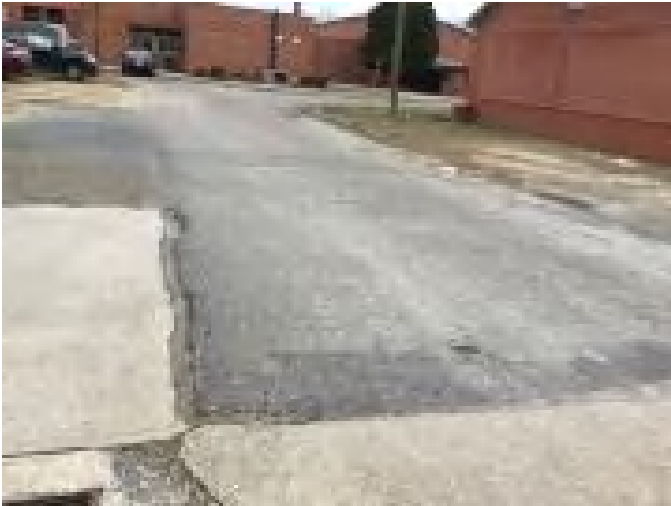
System: G2010 - Roadways

Location: Site
Distress: Damaged
Category: Deferred Maintenance
Priority: 3 - Necessary/Not Yet Critical (Years 2-5)
Correction: Renew System
Qty: 48,584.00
Unit of Measure: S.F.
Estimate: \$203,616.00
Assessor Name: Terence Davis
Date Created: 12/29/2016

Notes: The asphaltic roadways are aged, have many road cuts, pot holes, significant cracking, and need re-surfacing.

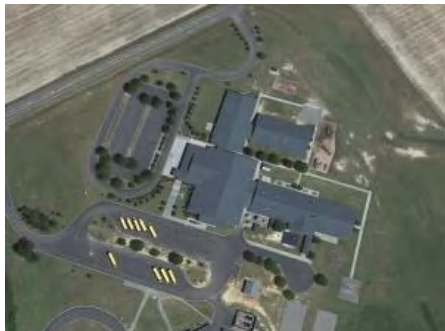
- 1). Aerial Image of Laurel Hill Elementary School - Feb 27, 2017

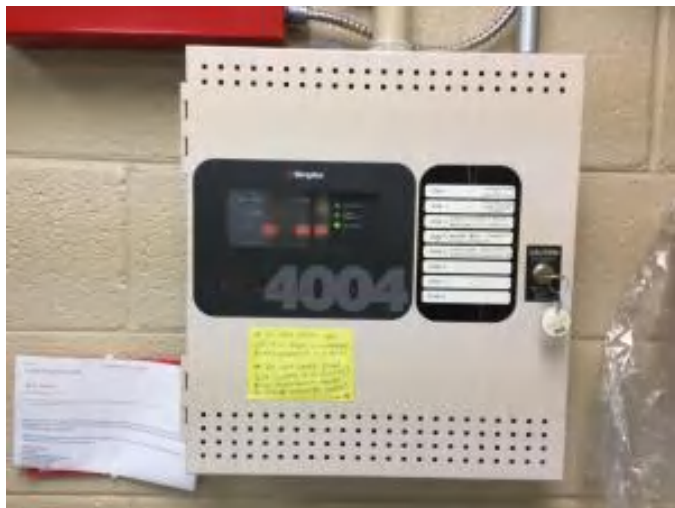
System: D5030910 - Fire Alarm Systems

Location: Throughout the building.
Distress: Beyond Service Life
Category: Building Code Compliance
Priority: 2 - Potentially Critical (Year 1)
Correction: Renew System
Qty: 20,692.00
Unit of Measure: S.F.
Estimate: \$78,754.00
Assessor Name: Eduardo Lopez
Date Created: 01/04/2017

Notes: The original fire alarm system operating as designed, but is beyond its service life and should be replaced.

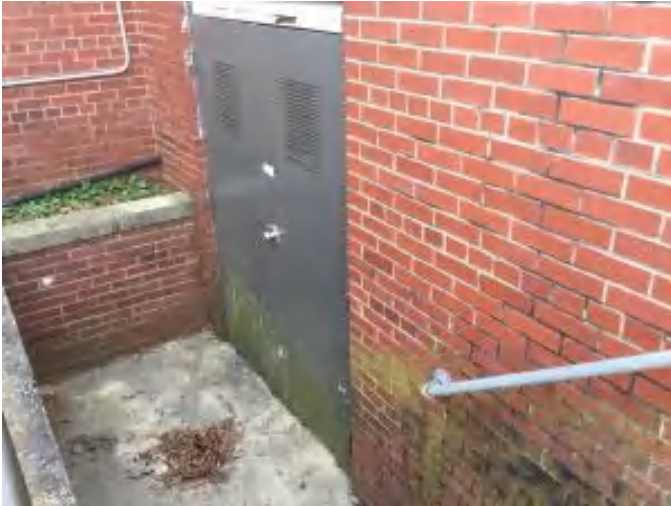
System: B2030 - Exterior Doors

Location: Exterior
Distress: Beyond Service Life
Category: Deferred Maintenance
Priority: 3 - Necessary/Not Yet Critical (Years 2-5)
Correction: Renew System
Qty: 20,692.00
Unit of Measure: S.F.
Estimate: \$24,354.00
Assessor Name: Eduardo Lopez
Date Created: 01/13/2017

Notes: The original metal exterior doors are aged, rusted, damaged and should be replaced with energy efficient doors

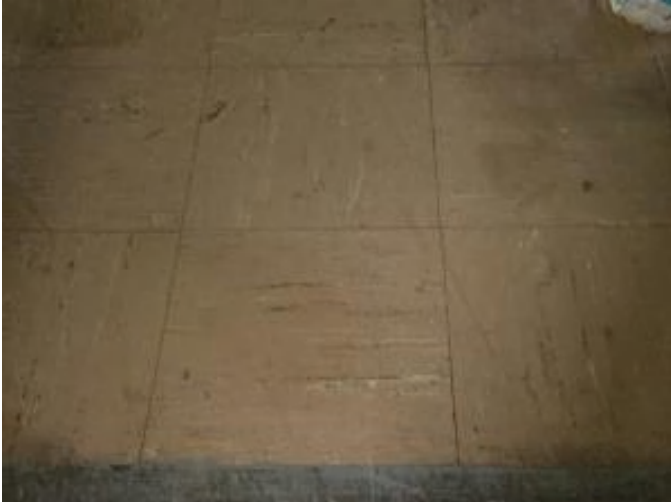
System: C3020 - Floor Finishes

Location: Throughout
Distress: Beyond Service Life
Category: Deferred Maintenance
Priority: 3 - Necessary/Not Yet Critical (Years 2-5)
Correction: Renew System
Qty: 20,692.00
Unit of Measure: S.F.
Estimate: \$264,030.00
Assessor Name: Eduardo Lopez
Date Created: 01/04/2017

Notes: The original flooring is in poor conditions, with different areas bubbling or separating seams, and should be replaced.

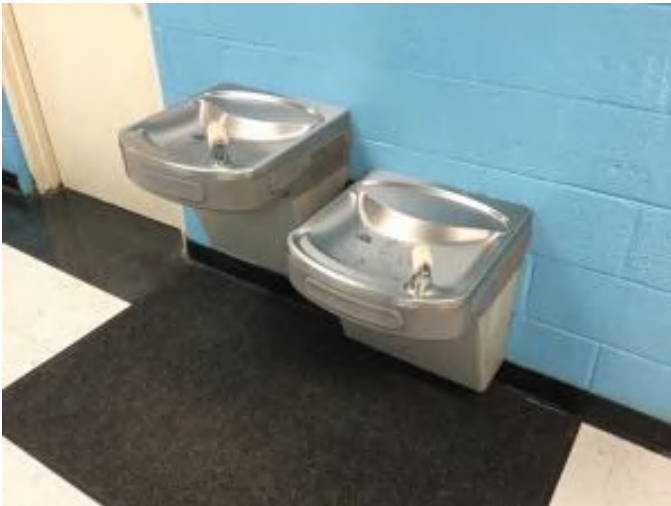
System: D2010 - Plumbing Fixtures

Location: Restroom/Classroom
Distress: Beyond Service Life
Category: Deferred Maintenance
Priority: 3 - Necessary/Not Yet Critical (Years 2-5)
Correction: Renew System
Qty: 20,692.00
Unit of Measure: S.F.
Estimate: \$266,534.00
Assessor Name: Eduardo Lopez
Date Created: 01/04/2017

Notes: The plumbing fixtures are original beyond its service life, not efficient or low flow fixtures.

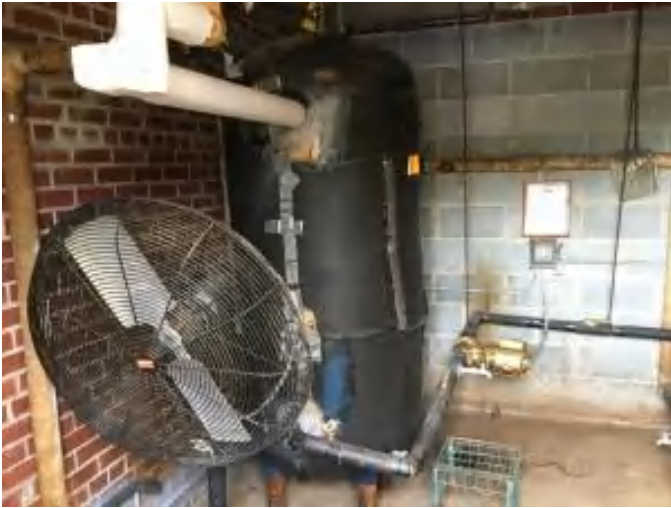
System: D2020 - Domestic Water Distribution

Location: Throughout the building.
Distress: Beyond Service Life
Category: Deferred Maintenance
Priority: 3 - Necessary/Not Yet Critical (Years 2-5)
Correction: Renew System
Qty: 20,692.00
Unit of Measure: S.F.
Estimate: \$22,534.00
Assessor Name: Eduardo Lopez
Date Created: 01/13/2017

Notes: There are no reported issues or observed deficiencies with the domestic water piping. Due to the age of the pipe there can be internal pitting corrosion that may be a costly problem that leads to the formation of pinhole leaks and possible water contamination.

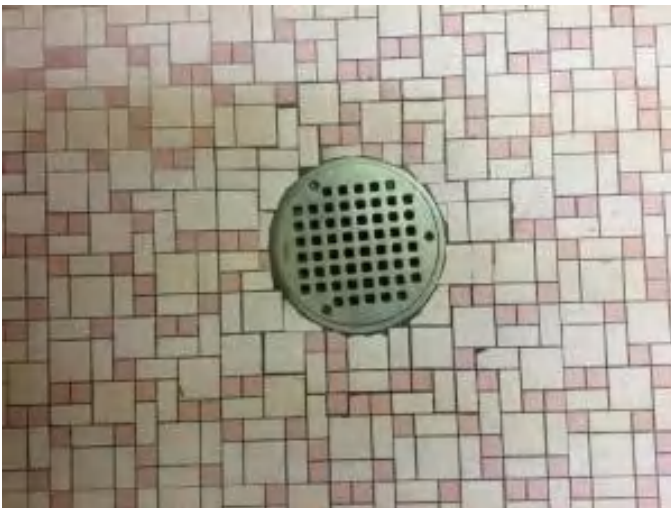
System: D2030 - Sanitary Waste

Location: Throughout the building
Distress: Beyond Service Life
Category: Deferred Maintenance
Priority: 3 - Necessary/Not Yet Critical (Years 2-5)
Correction: Renew System
Qty: 20,692.00
Unit of Measure: S.F.
Estimate: \$35,735.00
Assessor Name: Eduardo Lopez
Date Created: 01/13/2017

Notes: There are no reported issues or observed deficiencies with the sanitary waste piping. The aging sanitary sewer piping is subject to leaks, infiltration, and it can even collapse in the interior walls. The system should be inspected with cameras to ensure that none of these deficiencies exist.
