NC School District/830 Scotland County/High School

Scotland High

Campus Assessment Report

March 7, 2017

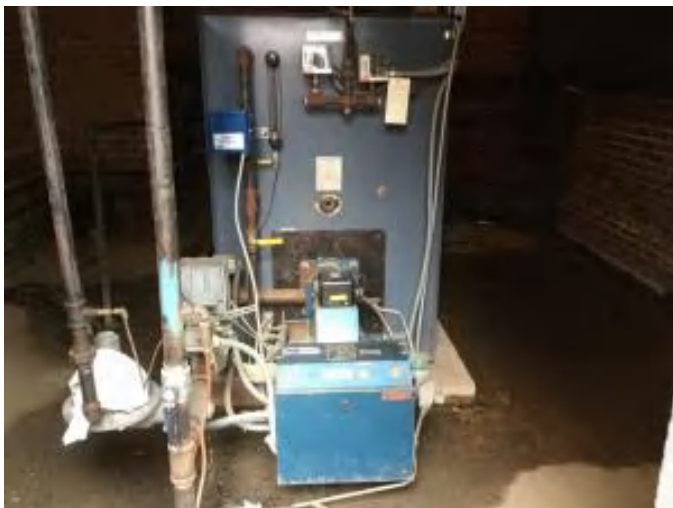
System: D3020 - Heat Generating Systems

Location: Mechanical Room
Distress: Beyond Service Life
Category: Deferred Maintenance
Priority: 3 - Necessary/Not Yet Critical (Years 2-5)
Correction: Renew System
Qty: 20,692.00
Unit of Measure: S.F.
Estimate: \$96,963.00
Assessor Name: Eduardo Lopez
Date Created: 01/09/2017

Notes: The original gas fired boiler is aged, rusted, inefficient, becoming logistically unsupportable and should be replaced with an energy efficient model.

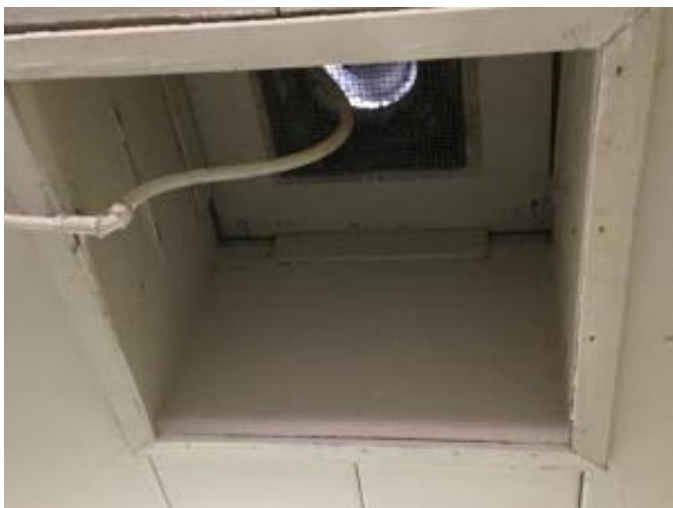
System: D3040 - Distribution Systems

Location: Throughout the building
Distress: Beyond Service Life
Category: Deferred Maintenance
Priority: 3 - Necessary/Not Yet Critical (Years 2-5)
Correction: Renew System
Qty: 20,692.00
Unit of Measure: S.F.
Estimate: \$142,485.00
Assessor Name: Eduardo Lopez
Date Created: 01/13/2017

Notes: The exhaust fans, and hot water supply distribution system is aged, in marginal condition, and should be replaced.

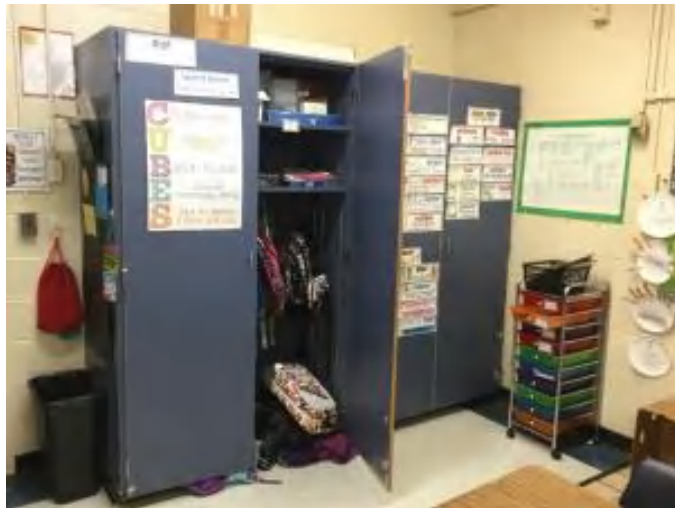
System: E2010 - Fixed Furnishings

Location: Classroom
Distress: Damaged
Category: Deferred Maintenance
Priority: 3 - Necessary/Not Yet Critical (Years 2-5)
Correction: Renew System
Qty: 20,692.00
Unit of Measure: S.F.
Estimate: \$135,429.00
Assessor Name: Eduardo Lopez
Date Created: 01/04/2017

Notes: The building casework is aged and worn and should be replaced.

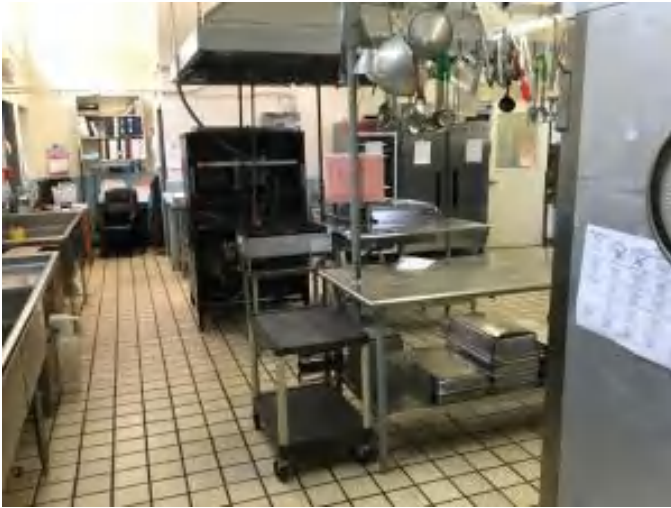
System: E1090 - Other Equipment

Location: Kitchen
Distress: Beyond Service Life
Category: Deferred Maintenance
Priority: 4 - Recommended (Years 6-10)
Correction: Renew System
Qty: 20,692.00
Unit of Measure: S.F.
Estimate: \$44,157.00
Assessor Name: Eduardo Lopez
Date Created: 01/04/2017

Notes: The kitchen equipment is beyond its expected service life, becoming logistically unsupportable and should be replaced.

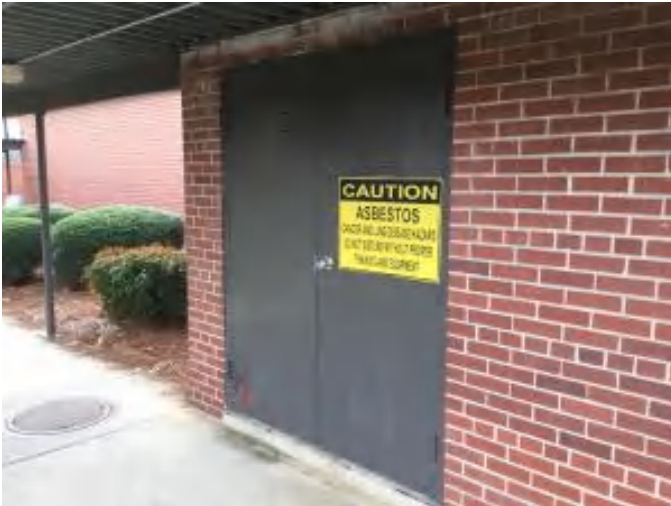
System: B2030 - Exterior Doors

Location: Exterior
Distress: Beyond Service Life
Category: Deferred Maintenance
Priority: 3 - Necessary/Not Yet Critical (Years 2-5)
Correction: Renew System
Qty: 10,300.00
Unit of Measure: S.F.
Estimate: \$12,123.00
Assessor Name: Eduardo Lopez
Date Created: 01/13/2017

Notes: The original metal exterior doors are aged, rusted, damaged and should be replaced with energy efficient doors

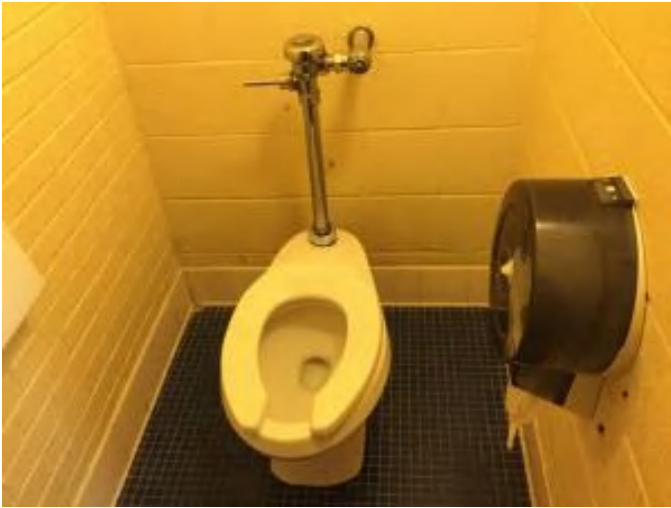
System: D2010 - Plumbing Fixtures

Location: Restrooms
Distress: Beyond Service Life
Category: Deferred Maintenance
Priority: 3 - Necessary/Not Yet Critical (Years 2-5)
Correction: Renew System
Qty: 10,300.00
Unit of Measure: S.F.
Estimate: \$132,674.00
Assessor Name: Eduardo Lopez
Date Created: 01/04/2017

Notes: The plumbing fixtures are original, not efficient or low flow fixtures.

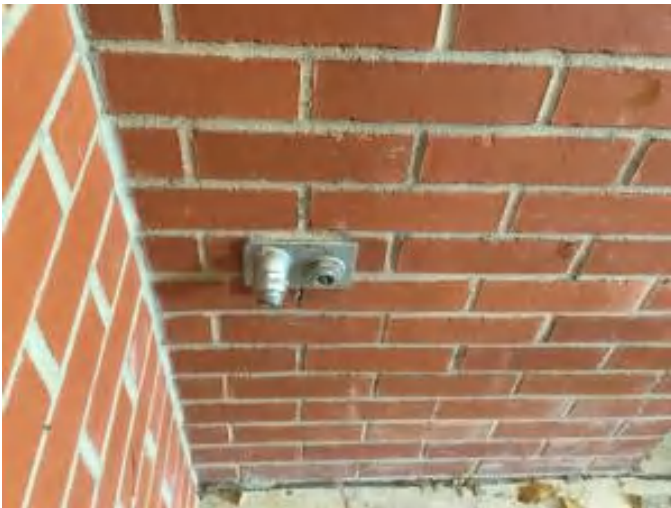
System: D2020 - Domestic Water Distribution

Location: Throughout the building
Distress: Beyond Service Life
Category: Deferred Maintenance
Priority: 3 - Necessary/Not Yet Critical (Years 2-5)
Correction: Renew System
Qty: 10,300.00
Unit of Measure: S.F.
Estimate: \$11,217.00
Assessor Name: Eduardo Lopez
Date Created: 01/13/2017

Notes: There are no reported issues or observed deficiencies with the domestic water piping. Due to the age of the pipe there can be internal pitting corrosion that may be a costly problem that leads to the formation of pinhole leaks and possible water contamination.

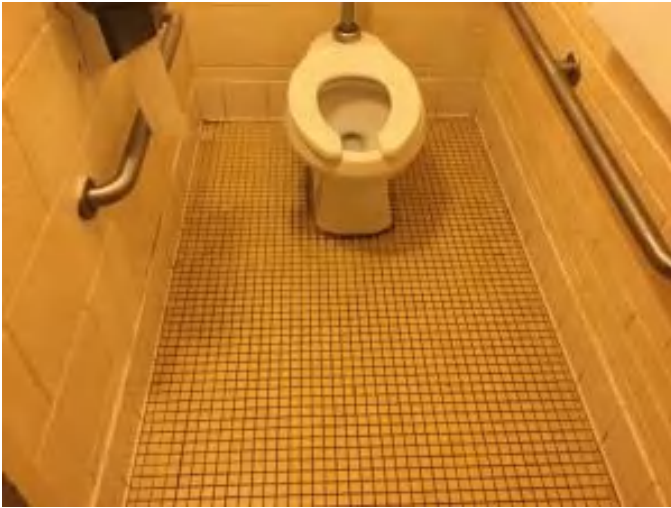
System: D2030 - Sanitary Waste

Location: Throughout the building
Distress: Beyond Service Life
Category: Deferred Maintenance
Priority: 3 - Necessary/Not Yet Critical (Years 2-5)
Correction: Renew System
Qty: 10,300.00
Unit of Measure: S.F.
Estimate: \$17,788.00
Assessor Name: Eduardo Lopez
Date Created: 01/13/2017

Notes: There are no reported issues or observed deficiencies with the sanitary waste piping. The aging sanitary sewer piping is subject to leaks, infiltration, and it can even collapse in the interior walls. The system should be inspected with cameras to ensure that none of these deficiencies exist.

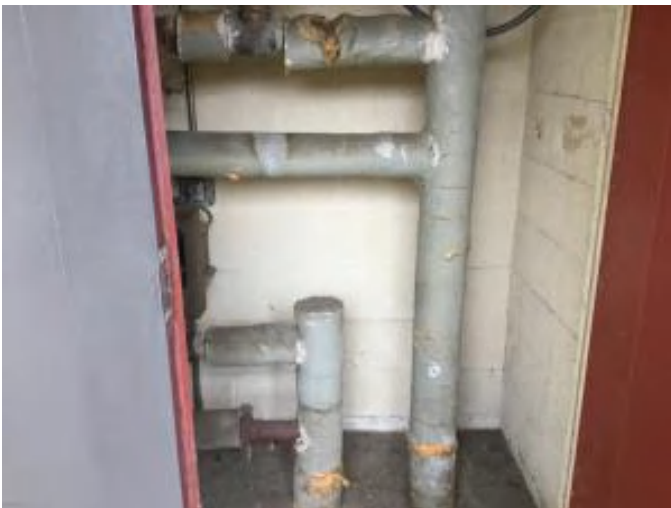
System: D3040 - Distribution Systems

Location: Throughout the building
Distress: Beyond Service Life
Category: Deferred Maintenance
Priority: 3 - Necessary/Not Yet Critical (Years 2-5)
Correction: Renew System
Qty: 10,300.00
Unit of Measure: S.F.
Estimate: \$70,926.00
Assessor Name: Eduardo Lopez
Date Created: 01/13/2017

Notes: The exhaust fans, and hot water supply distribution system is aged, in marginal condition, and should be replaced.

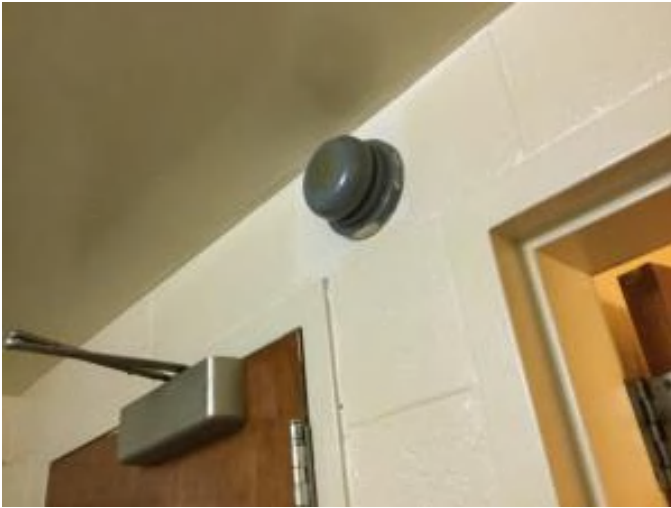
System: D5030910 - Fire Alarm Systems

Location: Throughout
Distress: Beyond Service Life
Category: Building Code Compliance
Priority: 3 - Necessary/Not Yet Critical (Years 2-5)
Correction: Renew System
Qty: 10,300.00
Unit of Measure: S.F.
Estimate: \$39,202.00
Assessor Name: Eduardo Lopez
Date Created: 01/04/2017

Notes: The original alarm system is operating but is aged. The system should be inspected and repaired or replaced to ensure that the life safety codes are preserved.

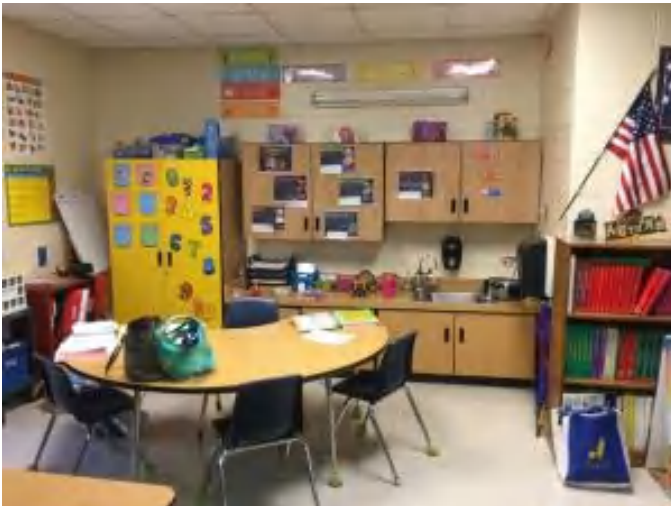
System: E2010 - Fixed Furnishings

Location: Classrooms
Distress: Damaged
Category: Deferred Maintenance
Priority: 3 - Necessary/Not Yet Critical (Years 2-5)
Correction: Renew System
Qty: 10,300.00
Unit of Measure: S.F.
Estimate: \$67,414.00
Assessor Name: Eduardo Lopez
Date Created: 01/04/2017

Notes: The building casework is aged and worn and should be replaced.

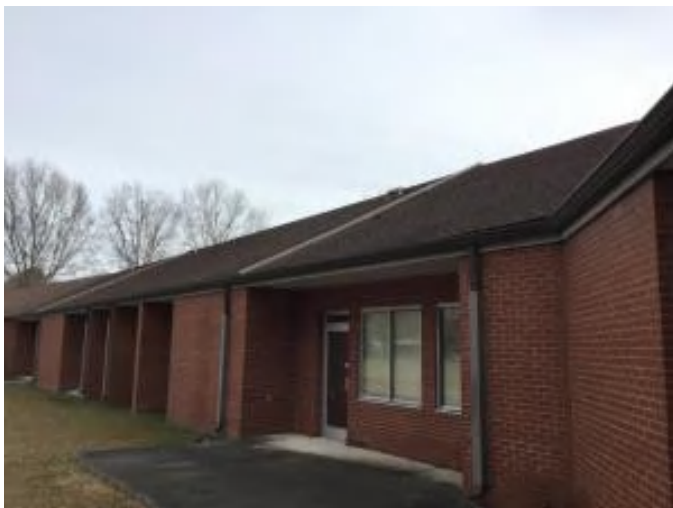
System: B3010140 - Asphalt Shingles

Location: Roof
Distress: Damaged
Category: Deferred Maintenance
Priority: 3 - Necessary/Not Yet Critical (Years 2-5)
Correction: Renew System
Qty: 16,000.00
Unit of Measure: S.F.
Estimate: \$100,915.00
Assessor Name: Terence Davis
Date Created: 01/10/2017

Notes: The roofing is aged, has reported leaks and should be replaced.

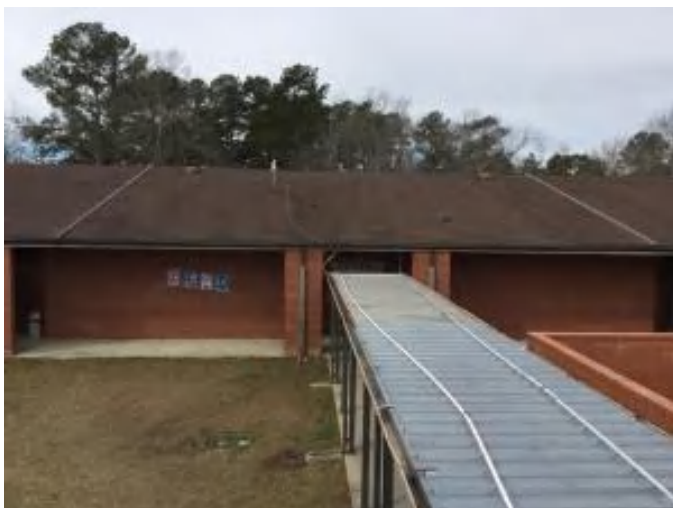
System: B3020 - Roof Openings

Location: 1983 Media Center
Distress: Beyond Service Life
Category: Deferred Maintenance
Priority: 3 - Necessary/Not Yet Critical (Years 2-5)
Correction: Renew System
Qty: 16,000.00
Unit of Measure: S.F.
Estimate: \$8,448.00
Assessor Name: Terence Davis
Date Created: 02/21/2017

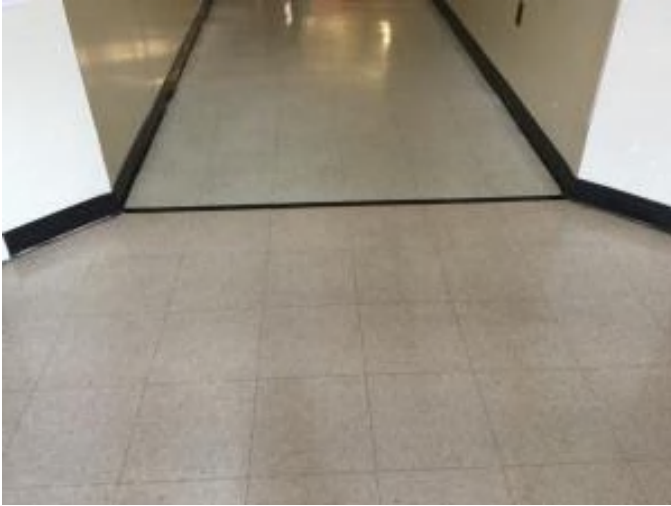
System: C3020 - Floor Finishes

Location: Throughout the building
Distress: Beyond Service Life
Category: Deferred Maintenance
Priority: 3 - Necessary/Not Yet Critical (Years 2-5)
Correction: Renew System
Qty: 16,000.00
Unit of Measure: S.F.
Estimate: \$204,160.00
Assessor Name: Terence Davis
Date Created: 01/04/2017

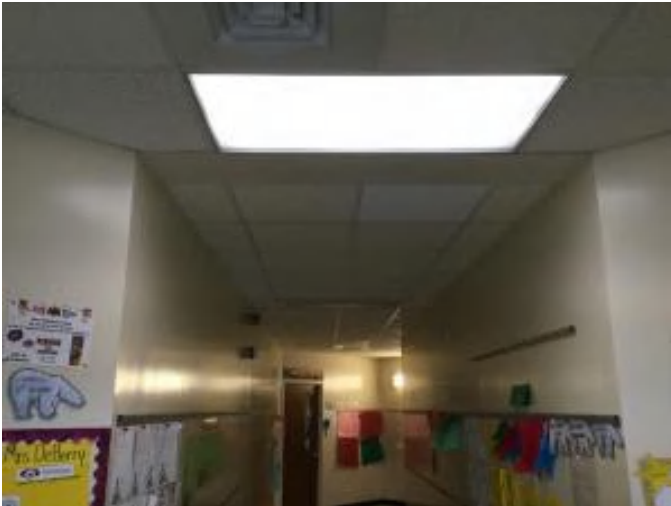
System: C3030 - Ceiling Finishes

Location: Throughout the building
Distress: Beyond Service Life
Category: Deferred Maintenance
Priority: 3 - Necessary/Not Yet Critical (Years 2-5)
Correction: Renew System
Qty: 16,000.00
Unit of Measure: S.F.
Estimate: \$196,944.00
Assessor Name: Terence Davis
Date Created: 01/04/2017

Notes: The ceiling finishes are beyond their service life and should be replaced.

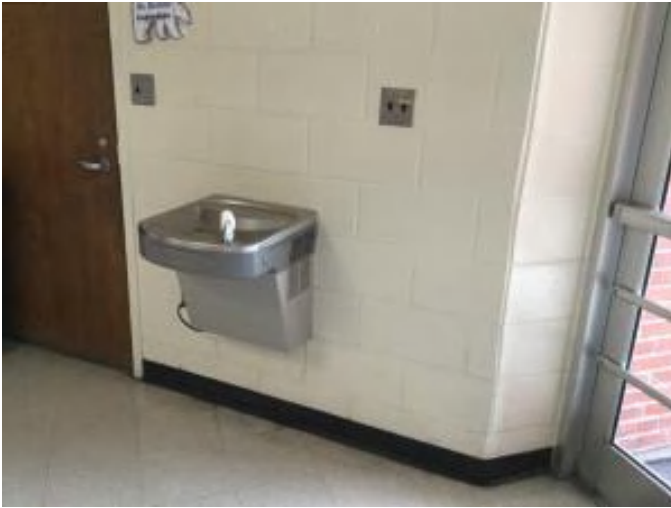
System: D2010 - Plumbing Fixtures

Location: Restroom
Distress: Beyond Service Life
Category: Deferred Maintenance
Priority: 3 - Necessary/Not Yet Critical (Years 2-5)
Correction: Renew System
Qty: 16,000.00
Unit of Measure: S.F.
Estimate: \$206,096.00
Assessor Name: Terence Davis
Date Created: 01/04/2017

Notes: The plumbing fixtures are original, not efficient or low flow fixtures.

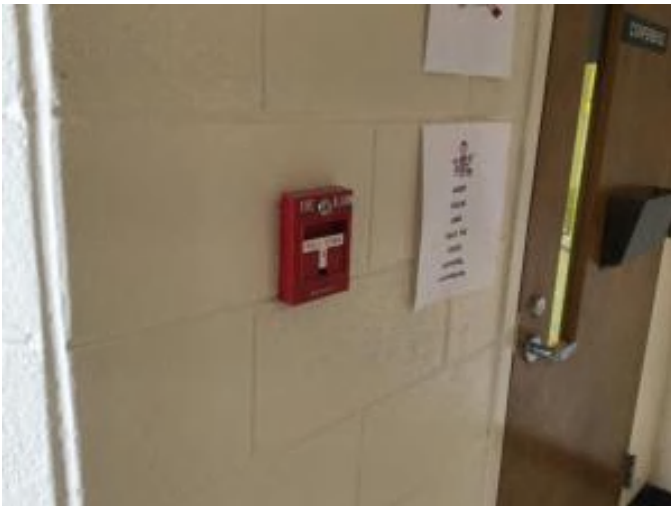
System: D5030910 - Fire Alarm Systems

Location: Throughout
Distress: Beyond Service Life
Category: Deferred Maintenance
Priority: 3 - Necessary/Not Yet Critical (Years 2-5)
Correction: Renew System
Qty: 16,000.00
Unit of Measure: S.F.
Estimate: \$60,896.00
Assessor Name: Terence Davis
Date Created: 01/04/2017

Notes: The original alarm system is operating but is aged. The system should be inspected and repaired or replaced to ensure that the life safety codes are preserved.

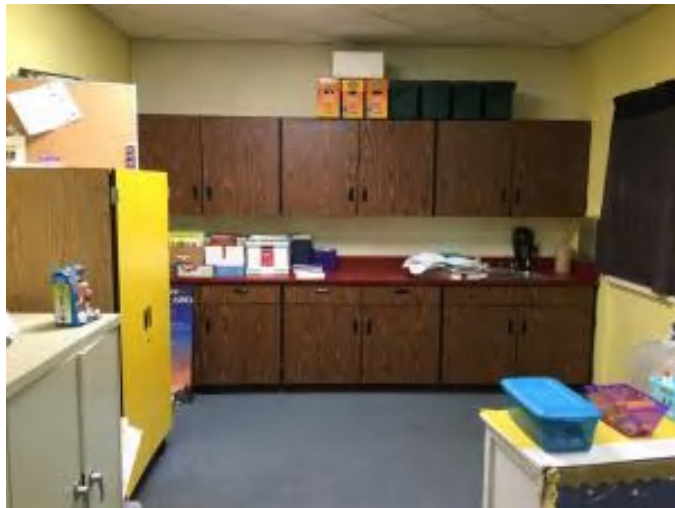
System: E2010 - Fixed Furnishings

Location: Classrooms
Distress: Damaged
Category: Deferred Maintenance
Priority: 3 - Necessary/Not Yet Critical (Years 2-5)
Correction: Renew System
Qty: 16,000.00
Unit of Measure: S.F.
Estimate: \$104,720.00
Assessor Name: Terence Davis
Date Created: 01/04/2017

Notes: The building casework is aged and worn and should be replaced.

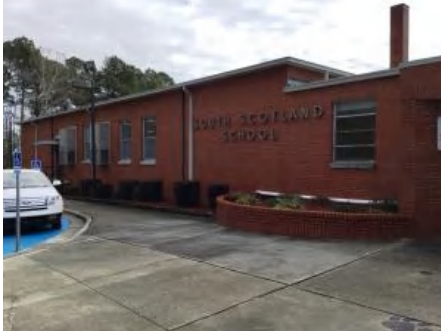
1). North Elevation - Feb 10, 2017

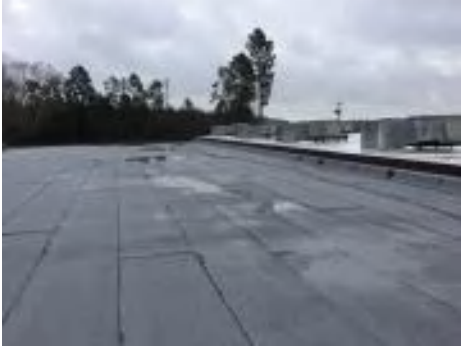
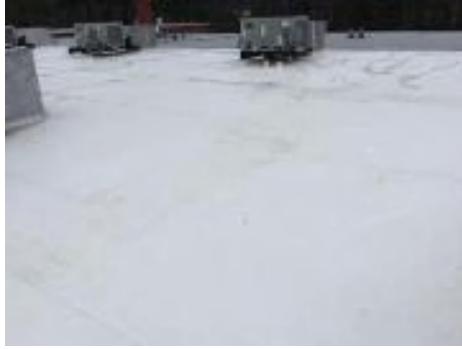
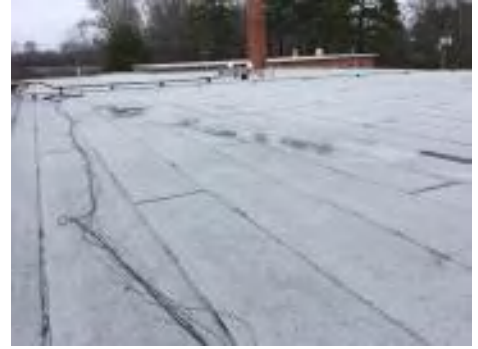
System: B3010120 - Single Ply Membrane

Note: The TPO was installed in 2015

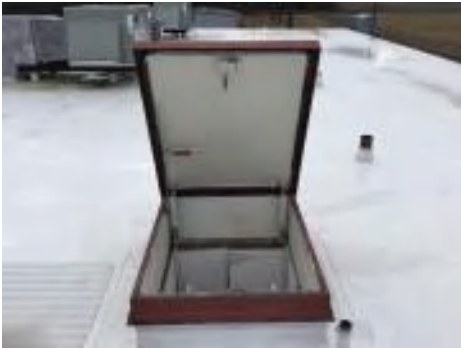
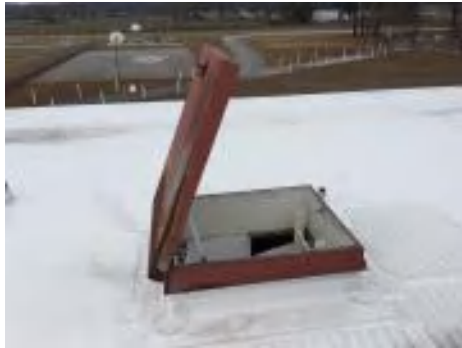
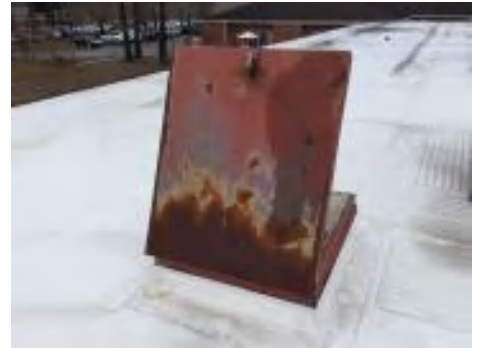
System: B3020 - Roof Openings

Note: The roof opening is beyond its service life and should be replaced with an OSHA compliant access hatch.

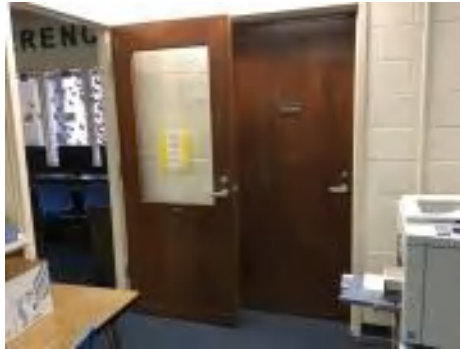
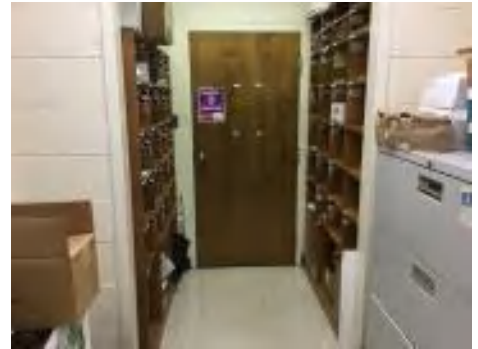
System: C1020 - Interior Doors

Note: The interior doors are beyond their service life and should be replaced.

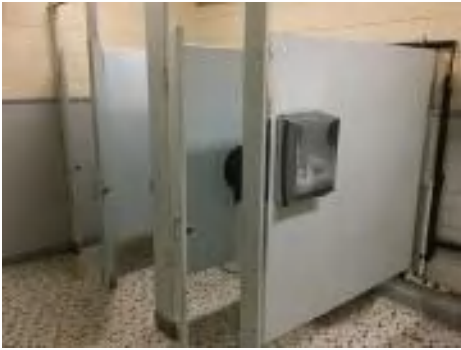
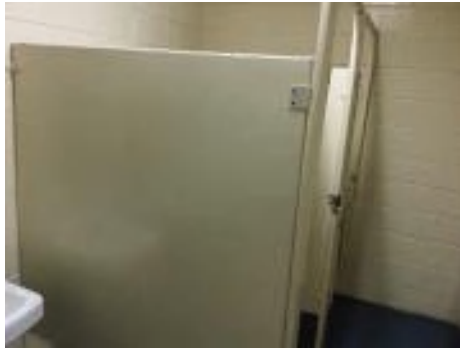
System: C1030 - Fittings

Note: The fittings are beyond their service life and should be replaced.

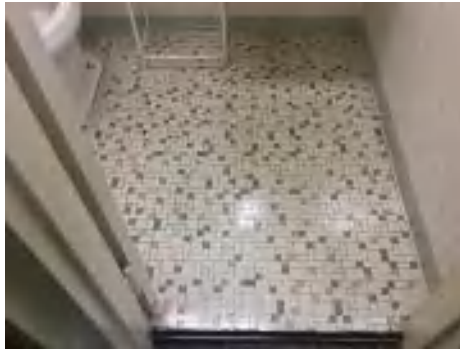
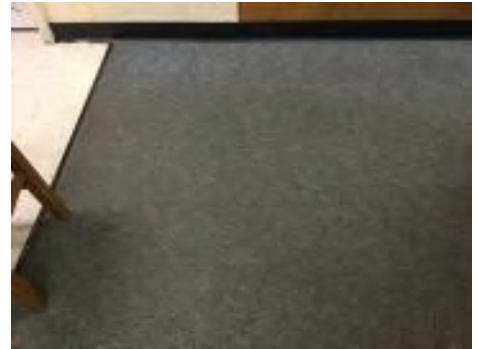
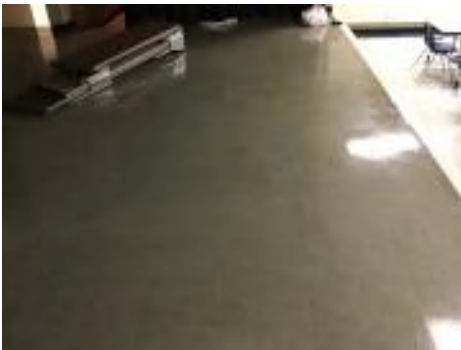
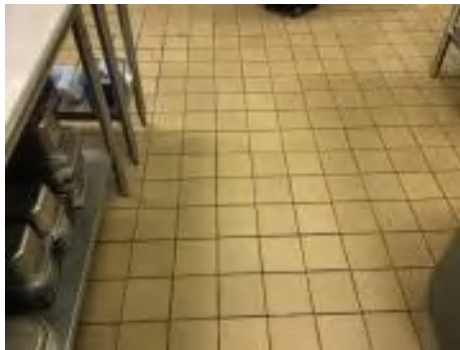
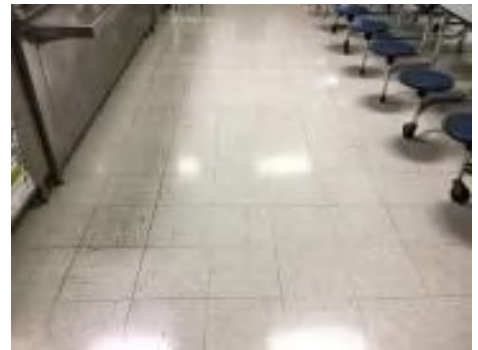
System: C3020 - Floor Finishes

Note: The carpet is beyond its service life and should be replaced.

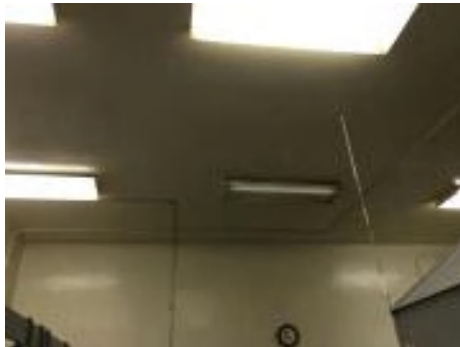
System: C3030 - Ceiling Finishes

Note: The acoustical ceiling tiles are beyond their service life and should be replaced.

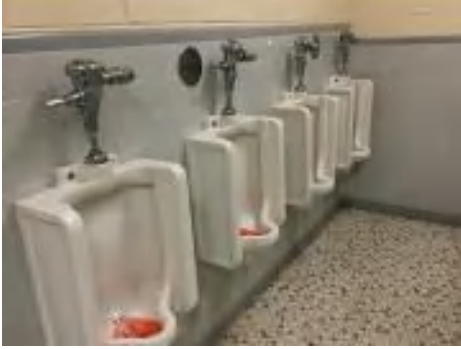
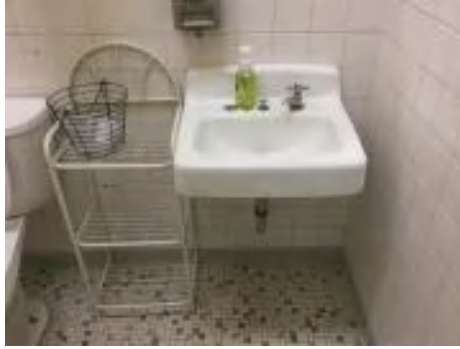
System: D2010 - Plumbing Fixtures

Note: The plumbing fixtures are beyond their service life and should be replaced.

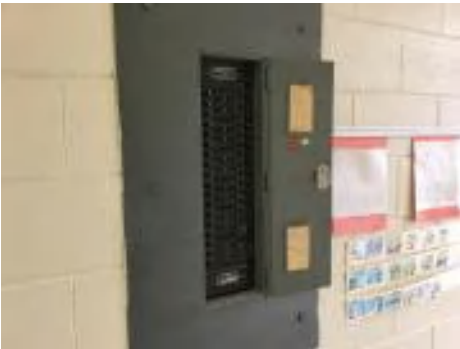
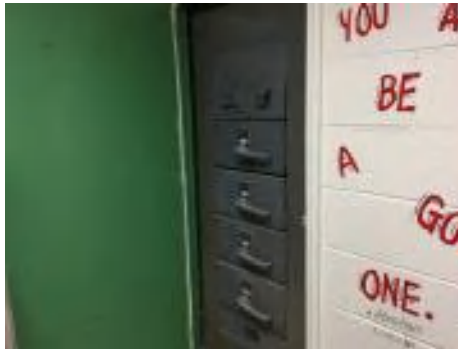
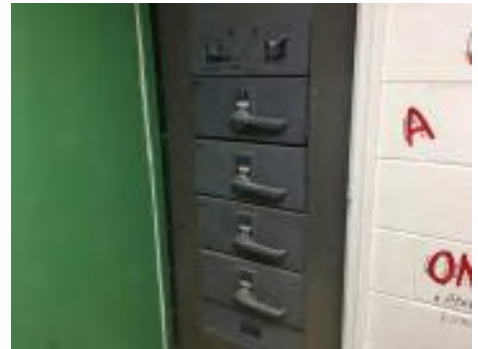
System: D5010 - Electrical Service/Distribution

Note: The main electrical system is beyond its service life and should be replaced.

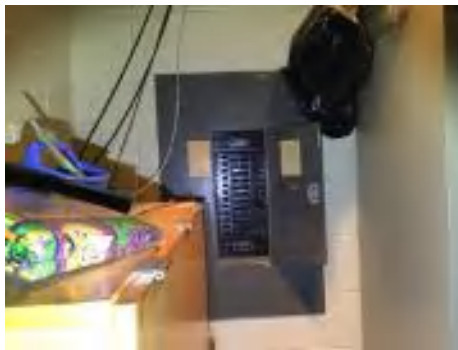
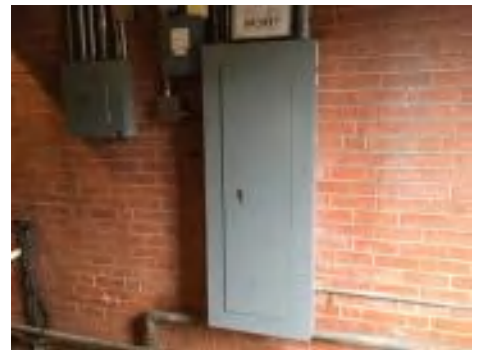
System: D5020 - Branch Wiring

Note: The branch wiring system is beyond its service life and should be replaced.

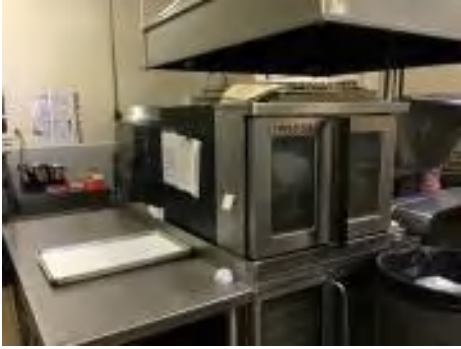
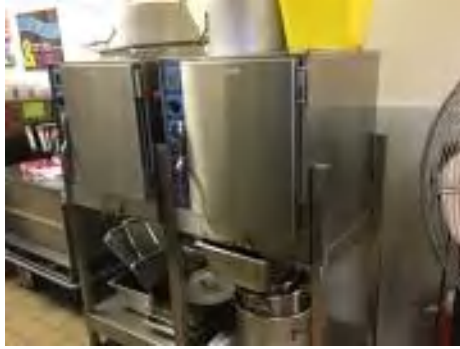
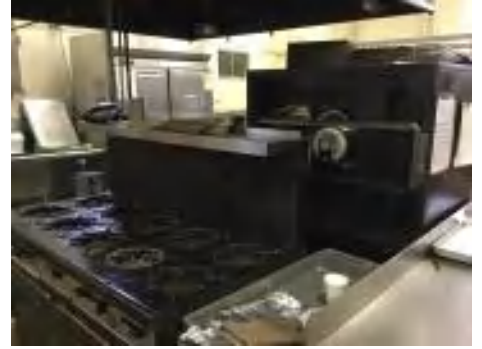
System: E1090 - Other Equipment

Note: The kitchen equipment is beyond its service life and should be replaced.

Notes: The kitchen equipment is beyond its service life and should be replaced.

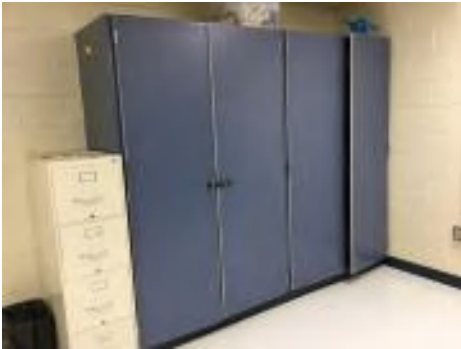
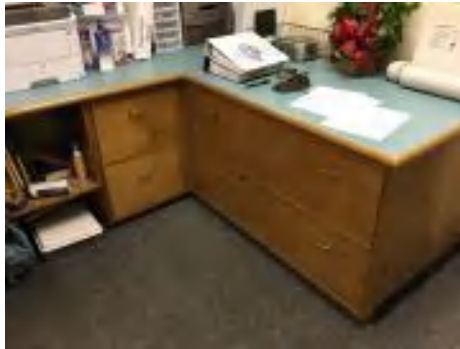
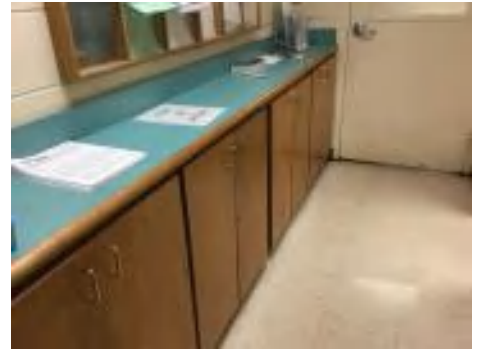
System: E2010 - Fixed Furnishings

Note: The fixed furnishings are beyond their service life and should be replaced.

Notes: The fixed furnishings are beyond their service life and should be replaced.

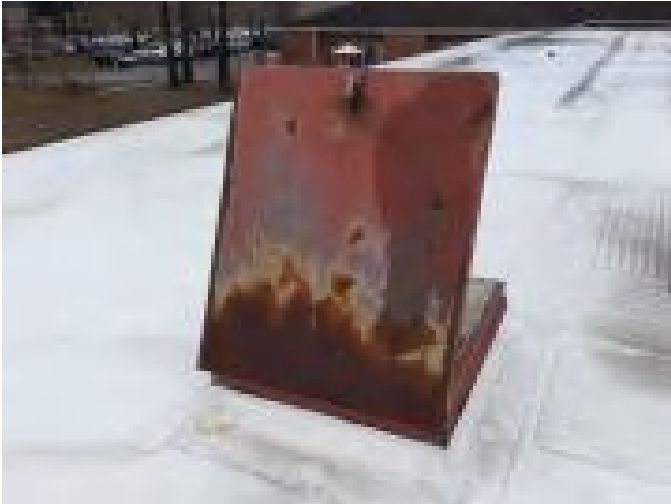
System: B3020 - Roof Openings

Location: Roof
Distress: Beyond Service Life
Category: Deferred Maintenance
Priority: 3 - Necessary/Not Yet Critical (Years 2-5)
Correction: Renew System
Qty: 42,369.00
Unit of Measure: S.F.
Estimate: \$13,516.00
Assessor Name: Terence Davis
Date Created: 12/30/2016

Notes: The roof opening is beyond its service life and should be replaced with an OSHA compliant access hatch.

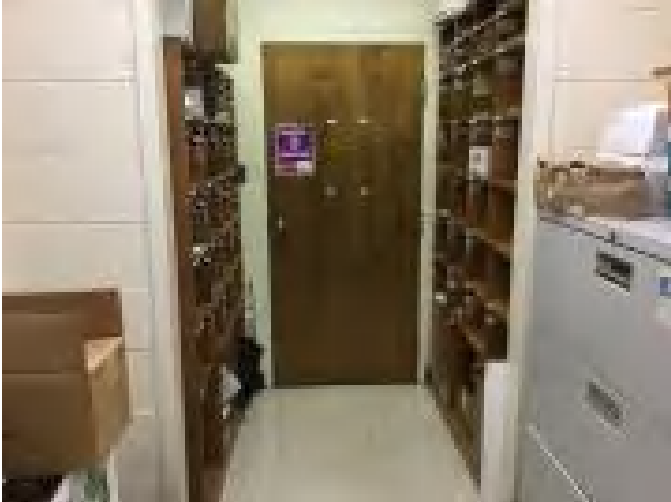
System: C1020 - Interior Doors

Location: Throughout Building
Distress: Beyond Service Life
Category: Deferred Maintenance
Priority: 3 - Necessary/Not Yet Critical (Years 2-5)
Correction: Renew System
Qty: 42,369.00
Unit of Measure: S.F.
Estimate: \$117,913.00
Assessor Name: Terence Davis
Date Created: 12/30/2016

Notes: The interior doors are beyond their service life and should be replaced.

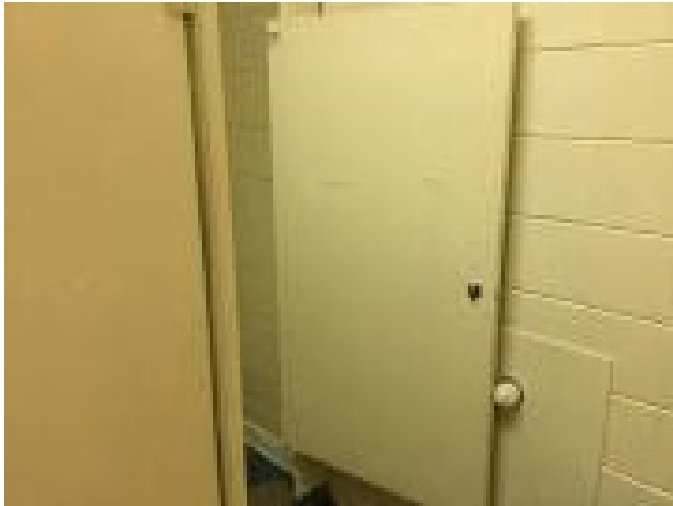
System: C1030 - Fittings

Location: Throughout Building
Distress: Beyond Service Life
Category: Deferred Maintenance
Priority: 3 - Necessary/Not Yet Critical (Years 2-5)
Correction: Renew System
Qty: 42,369.00
Unit of Measure: S.F.
Estimate: \$453,941.00
Assessor Name: Terence Davis
Date Created: 12/30/2016

Notes: The fittings are beyond their service life and should be replaced.

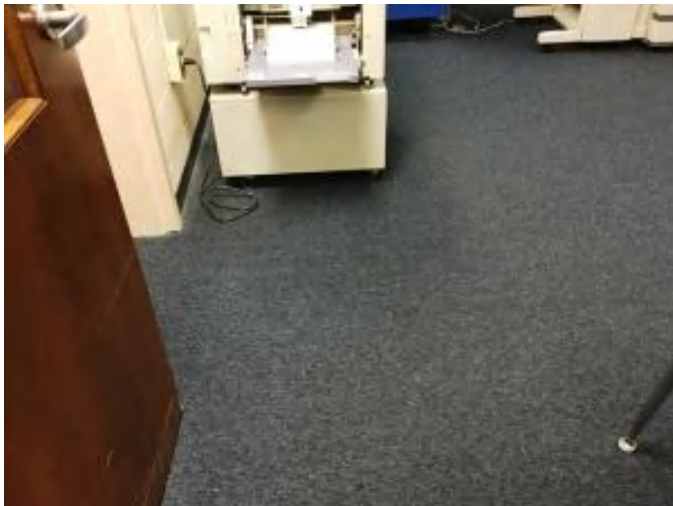
System: C3020 - Floor Finishes

Location: Media Center
Distress: Beyond Service Life
Category: Deferred Maintenance
Priority: 3 - Necessary/Not Yet Critical (Years 2-5)
Correction: Replace carpet
Qty: 100.00
Unit of Measure: S.Y.
Estimate: \$8,548.32
Assessor Name: Terence Davis
Date Created: 02/10/2017

Notes: The carpet is beyond its service life and should be replaced.

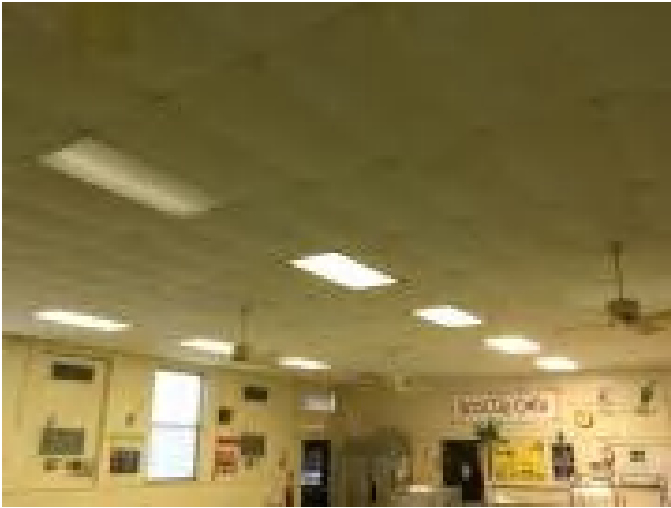
System: C3030 - Ceiling Finishes

Location: Throughout Building
Distress: Beyond Service Life
Category: Deferred Maintenance
Priority: 3 - Necessary/Not Yet Critical (Years 2-5)
Correction: Renew System
Qty: 42,369.00
Unit of Measure: S.F.
Estimate: \$511,267.00
Assessor Name: Terence Davis
Date Created: 12/30/2016

Notes: The acoustical ceiling tiles are beyond their service life and should be replaced.

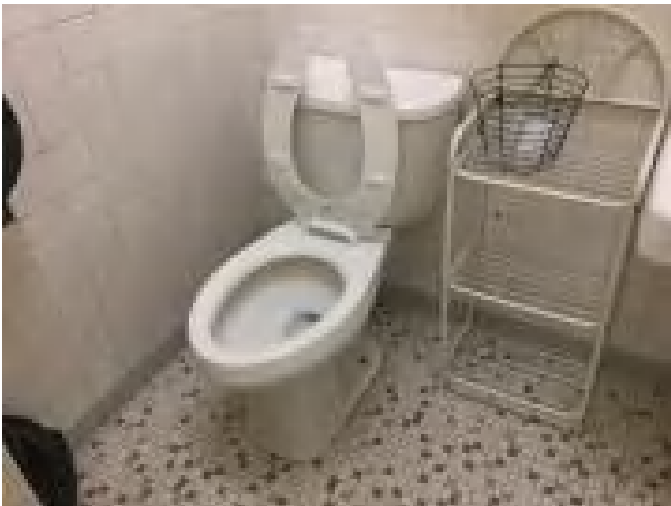
System: D2010 - Plumbing Fixtures

Location: Throughout Building
Distress: Beyond Service Life
Category: Deferred Maintenance
Priority: 3 - Necessary/Not Yet Critical (Years 2-5)
Correction: Renew System
Qty: 42,369.00
Unit of Measure: S.F.
Estimate: \$535,036.00
Assessor Name: Terence Davis
Date Created: 12/30/2016

Notes: The plumbing fixtures are beyond their service life and should be replaced.

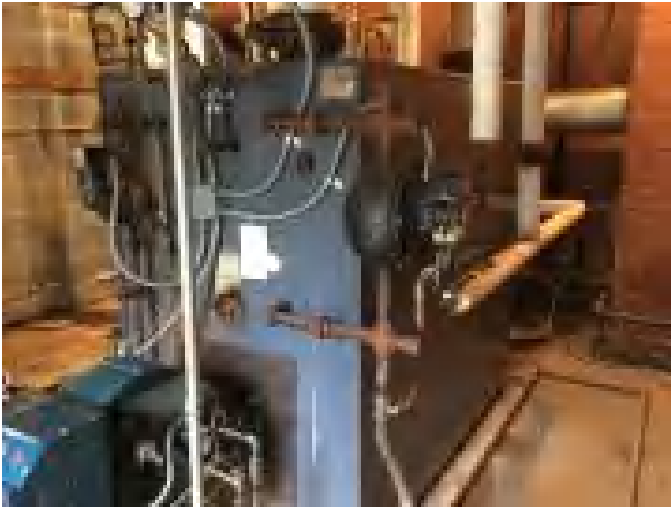
System: D3020 - Heat Generating Systems

Location: Mechanical Room
Distress: Beyond Service Life
Category: Deferred Maintenance
Priority: 3 - Necessary/Not Yet Critical (Years 2-5)
Correction: Renew System
Qty: 42,369.00
Unit of Measure: S.F.
Estimate: \$236,758.00
Assessor Name: Terence Davis
Date Created: 12/30/2016

Notes: The heat generating systems is beyond their service life and should be replaced.

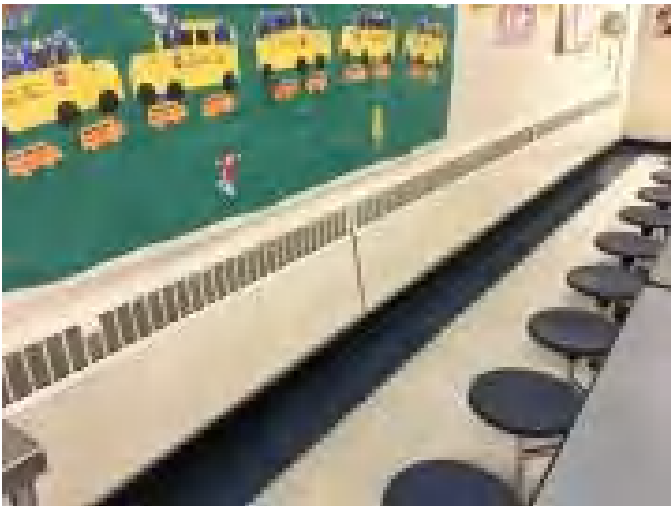
System: D3050 - Terminal & Package Units

Location: Throughout the building
Distress: Beyond Service Life
Category: Deferred Maintenance
Priority: 3 - Necessary/Not Yet Critical (Years 2-5)
Correction: Replace baseboard heater units
Qty: 25.00
Unit of Measure: Ea.
Estimate: \$9,042.00
Assessor Name: Terence Davis
Date Created: 01/04/2017

Notes: The unit heaters and the radiating heaters are beyond their service life and should be replaced.

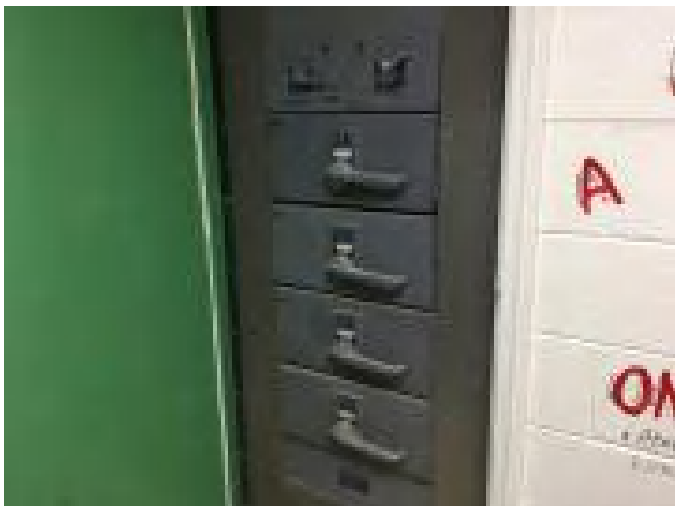
System: D5010 - Electrical Service/Distribution

Location: Throughout Building
Distress: Beyond Service Life
Category: Deferred Maintenance
Priority: 3 - Necessary/Not Yet Critical (Years 2-5)
Correction: Renew System
Qty: 42,369.00
Unit of Measure: S.F.
Estimate: \$78,764.00
Assessor Name: Terence Davis
Date Created: 12/30/2016

Notes: The main electrical system is beyond its service life and should be replaced.

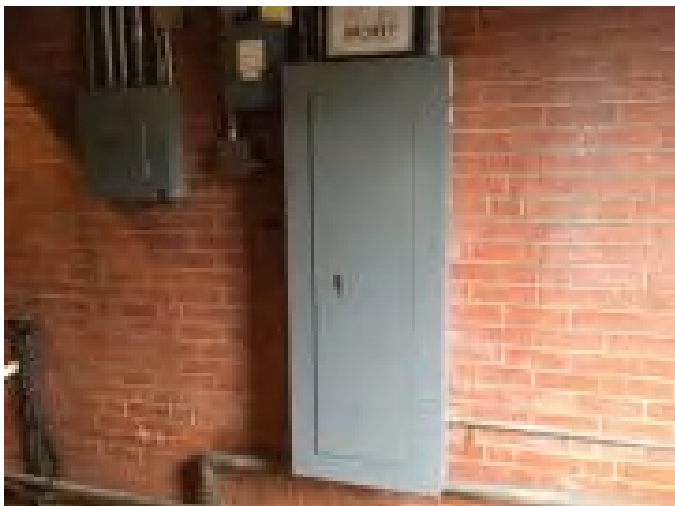
System: D5020 - Branch Wiring

Location: Throughout Building
Distress: Beyond Service Life
Category: Deferred Maintenance
Priority: 3 - Necessary/Not Yet Critical (Years 2-5)
Correction: Renew System
Qty: 42,369.00
Unit of Measure: S.F.
Estimate: \$235,826.00
Assessor Name: Terence Davis
Date Created: 12/30/2016

Notes: The branch wiring system is beyond its service life and should be replaced.

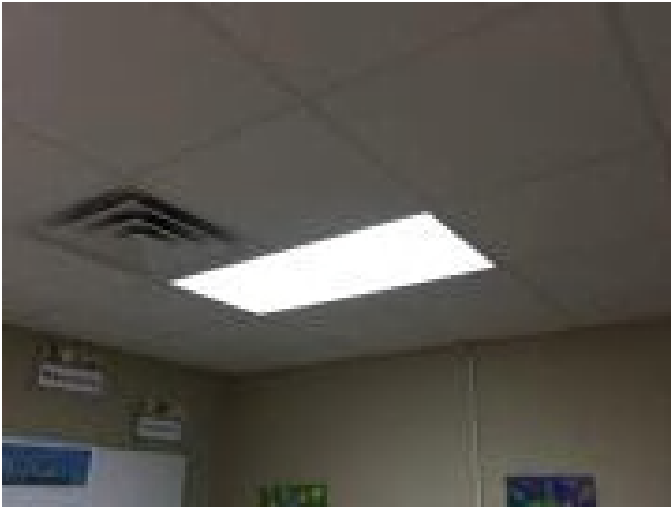
System: D5020 - Lighting

Location: Throughout Building
Distress: Beyond Service Life
Category: Deferred Maintenance
Priority: 3 - Necessary/Not Yet Critical (Years 2-5)
Correction: Renew System
Qty: 42,369.00
Unit of Measure: S.F.
Estimate: \$555,542.00
Assessor Name: Terence Davis
Date Created: 12/30/2016

Notes: The lights are primarily T-12's and are beyond their service life and they get replaced by T-8's as per needs basis.

Note: The lights are primarily T-12's and are beyond their service life and they get replaced by T-8's as per needs basis.

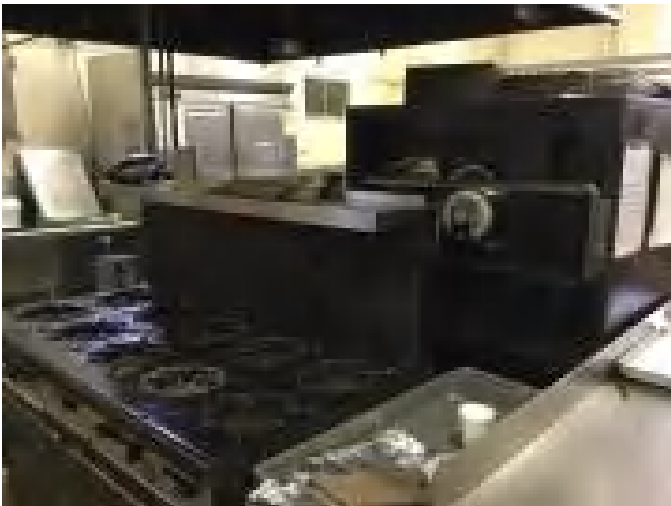
System: E1090 - Other Equipment

Location: Kitchen
Distress: Beyond Service Life
Category: Deferred Maintenance
Priority: 3 - Necessary/Not Yet Critical (Years 2-5)
Correction: Renew System
Qty: 42,369.00
Unit of Measure: S.F.
Estimate: \$88,551.00
Assessor Name: Terence Davis
Date Created: 12/30/2016

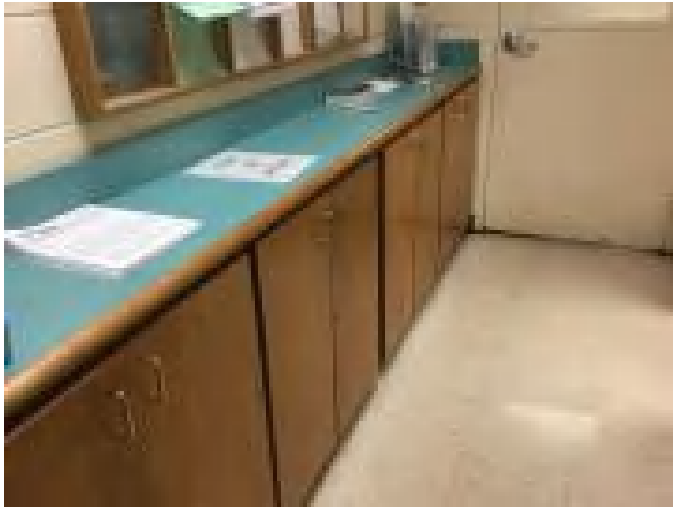
System: E2010 - Fixed Furnishings

Location: Throughout Building
Distress: Beyond Service Life
Category: Deferred Maintenance
Priority: 3 - Necessary/Not Yet Critical (Years 2-5)
Correction: Renew System
Qty: 42,369.00
Unit of Measure: S.F.
Estimate: \$271,712.00
Assessor Name: Terence Davis
Date Created: 12/30/2016

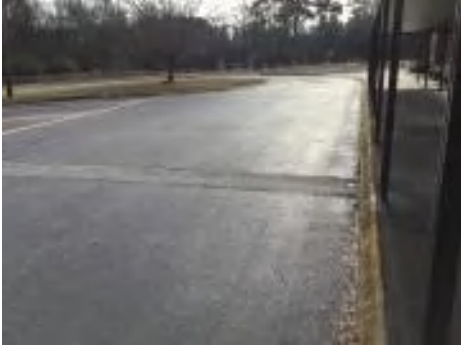
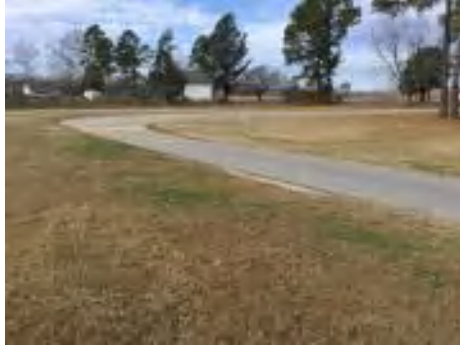
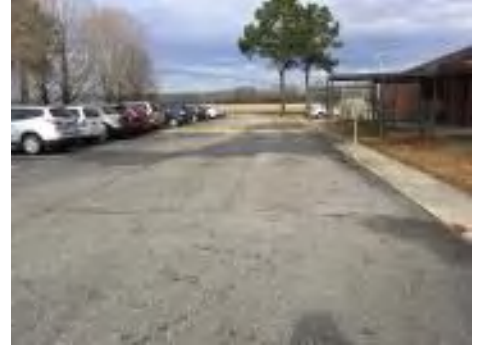
System: G2010 - Roadways

Note: The roads need to be resealed.

Notes: The roadways are cracking and they need to be resurfaced and resealed.

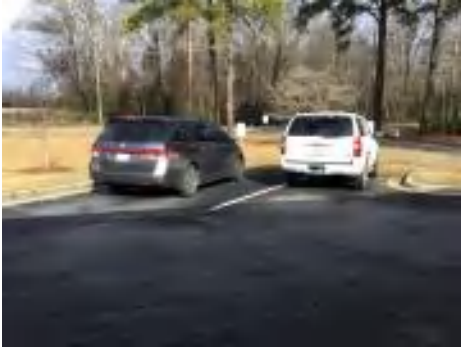
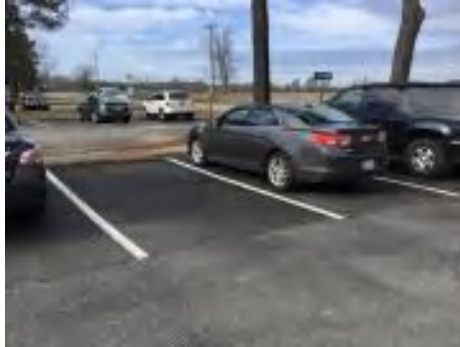
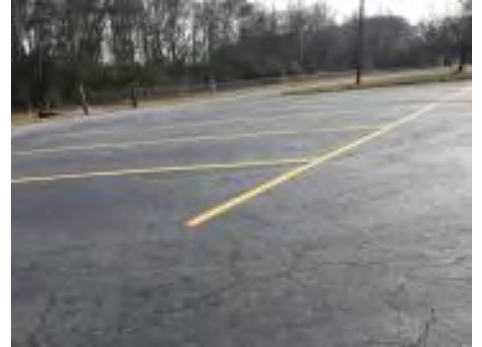
System: G2020 - Parking Lots

Note: The parking striping was done in 2014.

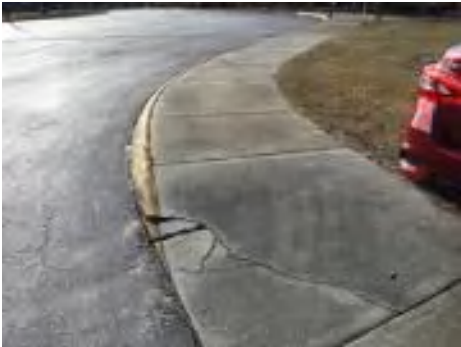
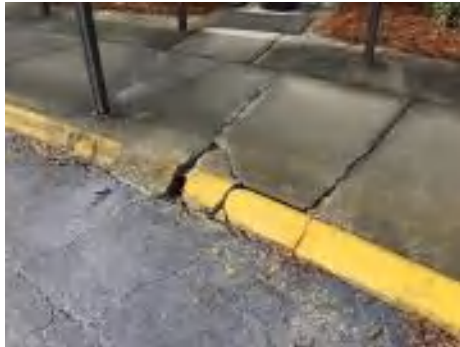
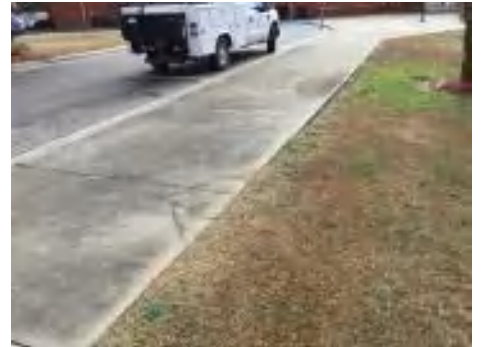
System: G2030 - Pedestrian Paving

Note: The pedestrian paving is cracked and beyond its service life and should be replaced.

Notes: The pedestrian paving is cracked and beyond its service life and should be replaced.

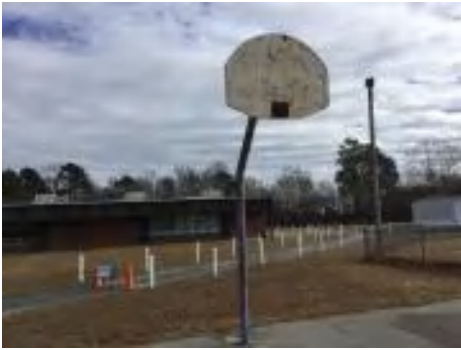
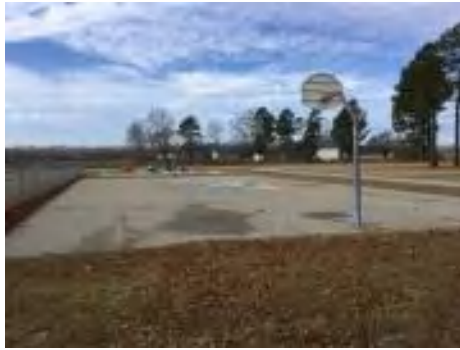
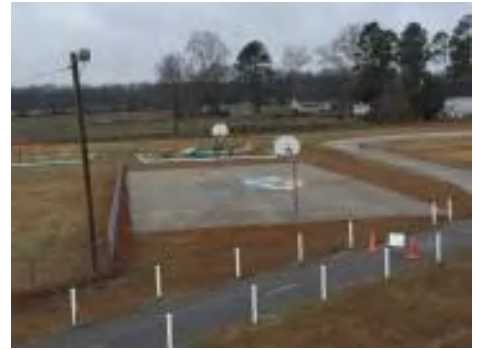
System: G2040950 - Hard Surface Play Area

Note: The hard surface is beyond its service life and should be replaced.

Notes: The hard surface is beyond its service life and should be replaced.

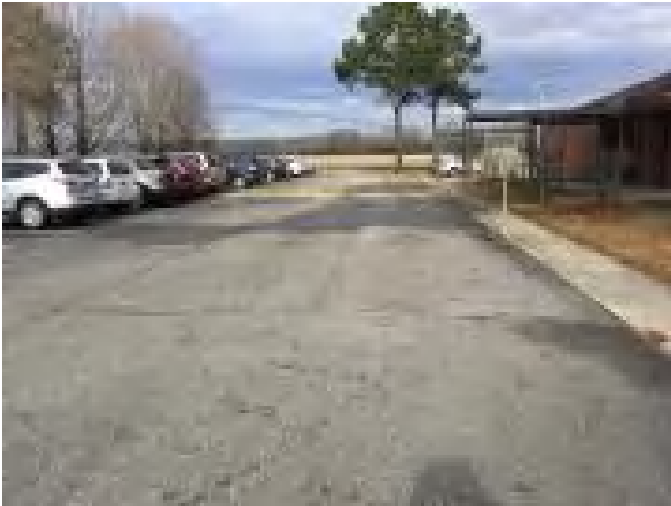
System: G2010 - Roadways

Location: Site
Distress: Failing
Category: Deferred Maintenance
Priority: 3 - Necessary/Not Yet Critical (Years 2-5)
Correction: Resurface the roadway
Qty: 100.00
Unit of Measure: L.F.
Estimate: \$17,160.00
Assessor Name: Eduardo Lopez
Date Created: 01/05/2017

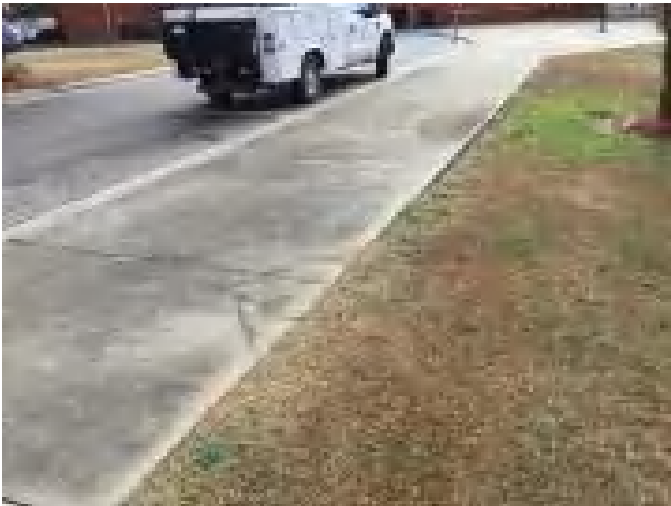
System: G2030 - Pedestrian Paving

Location: Site
Distress: Beyond Service Life
Category: Deferred Maintenance
Priority: 3 - Necessary/Not Yet Critical (Years 2-5)
Correction: Renew System
Qty: 42,369.00
Unit of Measure: S.F.
Estimate: \$89,017.00
Assessor Name: Eduardo Lopez
Date Created: 02/10/2017

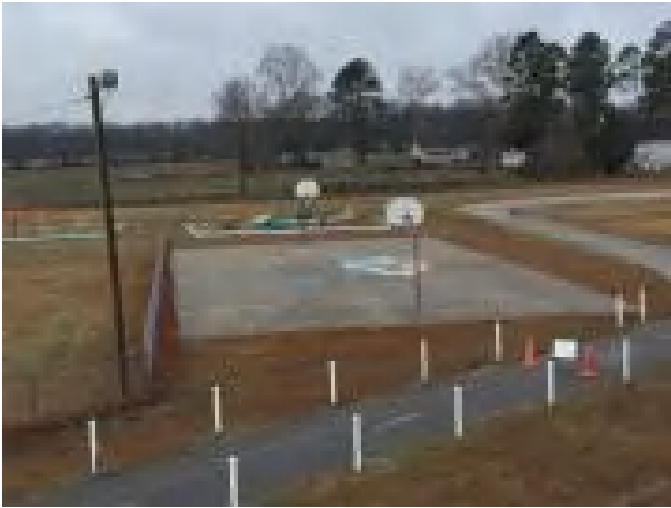
System: G2040950 - Hard Surface Play Area

Location: Site
Distress: Beyond Service Life
Category: Deferred Maintenance
Priority: 3 - Necessary/Not Yet Critical (Years 2-5)
Correction: Renew System
Qty: 42,369.00
Unit of Measure: S.F.
Estimate: \$34,954.00
Assessor Name: Eduardo Lopez
Date Created: 02/10/2017
