NC School District/830 Scotland County/High School

Scotland High

Campus Assessment Report

March 7, 2017

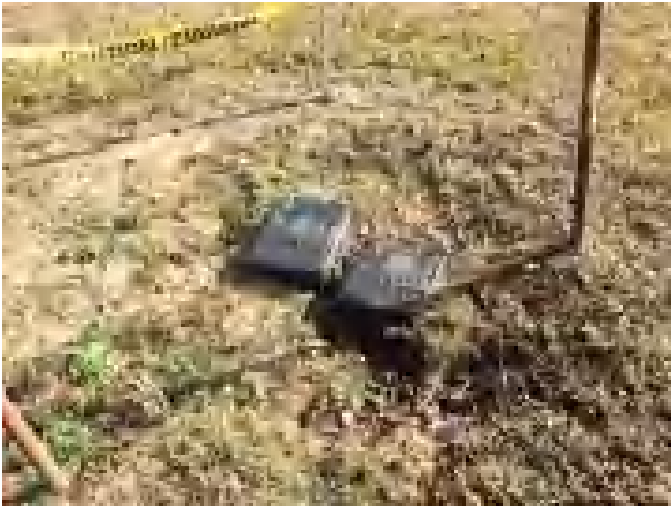
System: G3010 - Water Supply

Location: Site
Distress: Beyond Service Life
Category: Deferred Maintenance
Priority: 3 - Necessary/Not Yet Critical (Years 2-5)
Correction: Renew System
Qty: 42,369.00
Unit of Measure: S.F.
Estimate: \$109,058.00
Assessor Name: Eduardo Lopez
Date Created: 02/10/2017

Notes: The water supply system is beyond its service life and should be replaced.

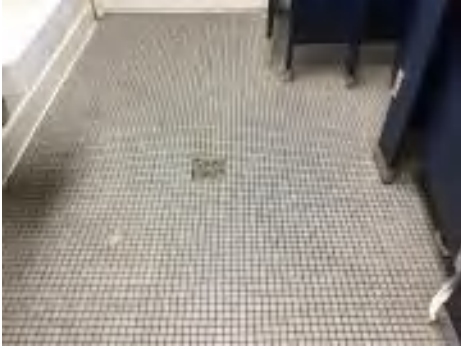
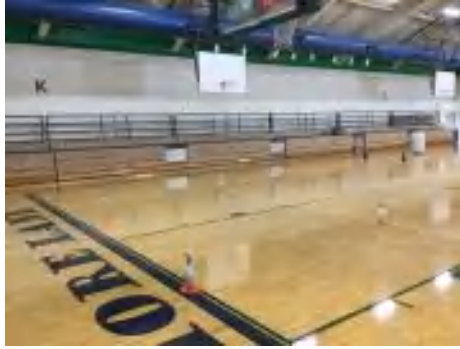
System: C3020 - Floor Finishes

Note: Replace as needed. Entire system need to be upgraded.

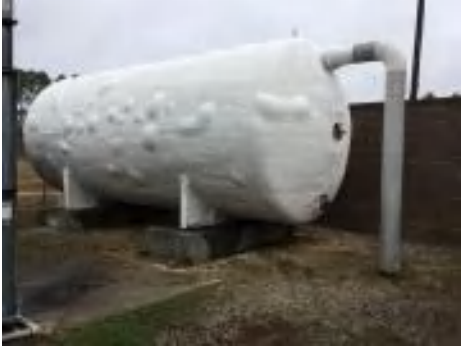
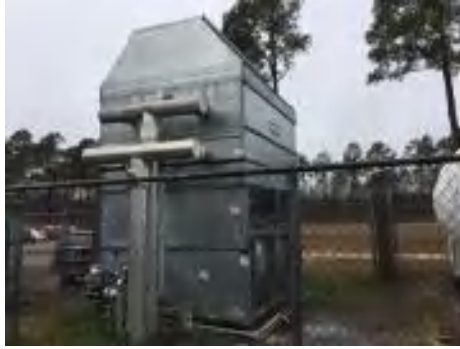
System: D3030 - Cooling Generating Systems

Note: Cooling tower replaced around 2011

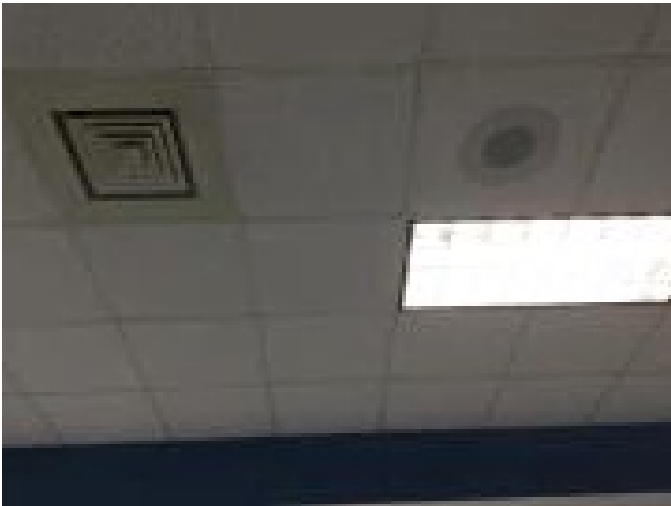
System: C3030 - Ceiling Finishes

Location: Throughout the building
Distress: Failing
Category: Deferred Maintenance
Priority: 3 - Necessary/Not Yet Critical (Years 2-5)
Correction: Renew System
Qty: 80,000.00
Unit of Measure: S.F.
Estimate: \$965,360.00
Assessor Name: Eduardo Lopez
Date Created: 01/12/2017

Notes: The original ceiling finishes are aged, failing and should be replaced.

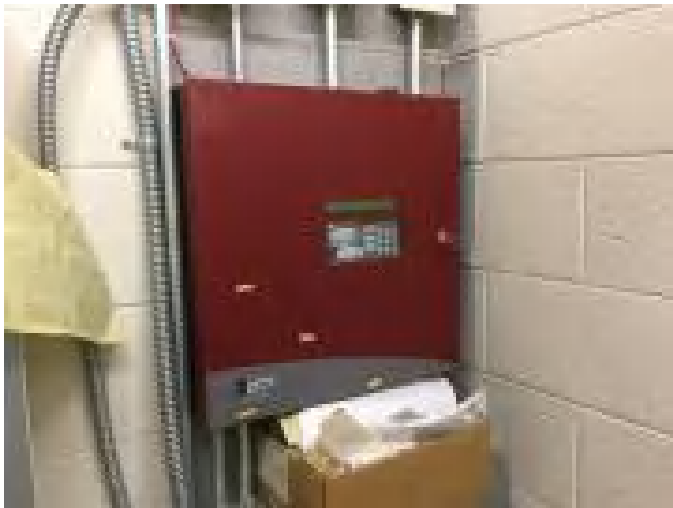
System: D5030910 - Fire Alarm Systems

Location: Throughout the building
Distress: Beyond Service Life
Category: Deferred Maintenance
Priority: 3 - Necessary/Not Yet Critical (Years 2-5)
Correction: Renew System
Qty: 80,000.00
Unit of Measure: S.F.
Estimate: \$298,320.00
Assessor Name: Eduardo Lopez
Date Created: 01/12/2017

Notes: The original alarm system is operating but is aged. The system should be inspected and repaired or replaced to ensure that the life safety codes are preserved.

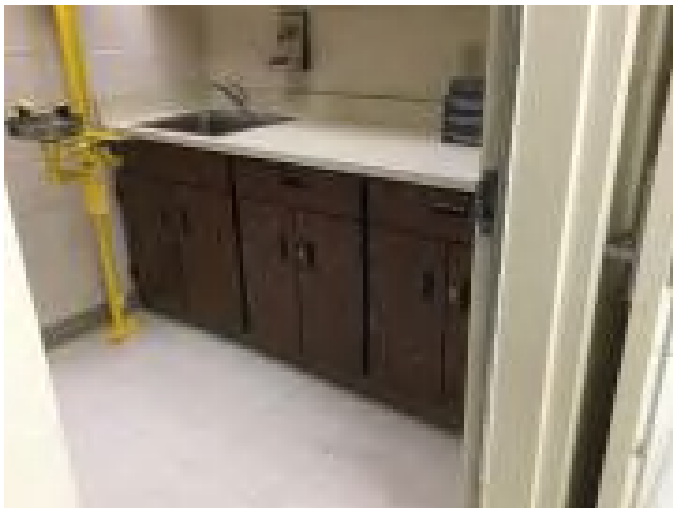
System: E2010 - Fixed Furnishings

Location: Throughout the building
Distress: Damaged
Category: Deferred Maintenance
Priority: 3 - Necessary/Not Yet Critical (Years 2-5)
Correction: Renew System
Qty: 80,000.00
Unit of Measure: S.F.
Estimate: \$513,040.00
Assessor Name: Eduardo Lopez
Date Created: 01/12/2017

Notes: The building casework is aged and worn and should be replaced.

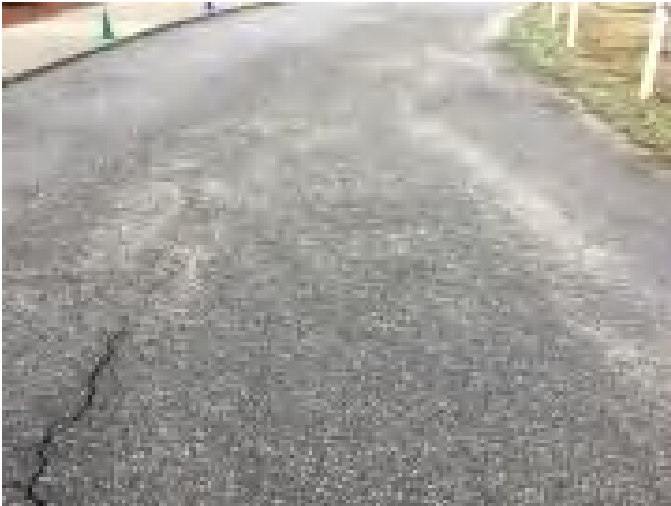
System: G2010 - Roadways

Location: Site
Distress: Beyond Service Life
Category: Deferred Maintenance
Priority: 3 - Necessary/Not Yet Critical (Years 2-5)
Correction: Renew System
Qty: 80,000.00
Unit of Measure: S.F.
Estimate: \$335,280.00
Assessor Name: Eduardo Lopez
Date Created: 01/12/2017

Notes: The asphalt roadways are aged, have many road cuts, significant cracking, and need re-surfacing.

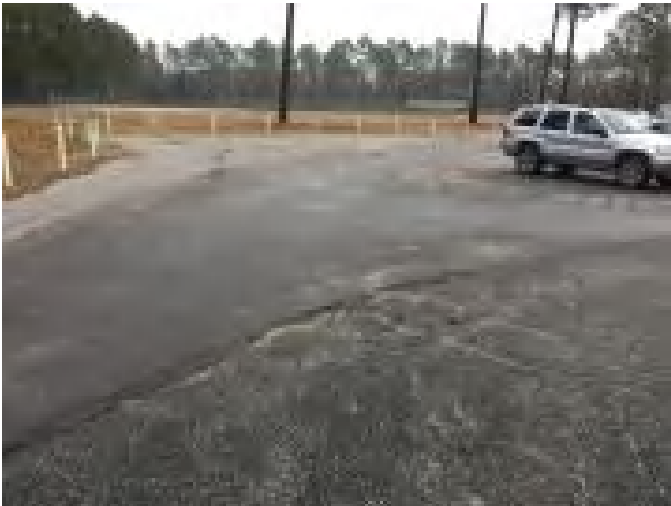
System: G2020 - Parking Lots

Location: Site
Distress: Beyond Service Life
Category: Deferred Maintenance
Priority: 3 - Necessary/Not Yet Critical (Years 2-5)
Correction: Renew System
Qty: 80,000.00
Unit of Measure: S.F.
Estimate: \$117,040.00
Assessor Name: Eduardo Lopez
Date Created: 01/12/2017

Notes: The asphalt parking lots are aged, have cuts and repairs, and should be re-surfaced and re striped.

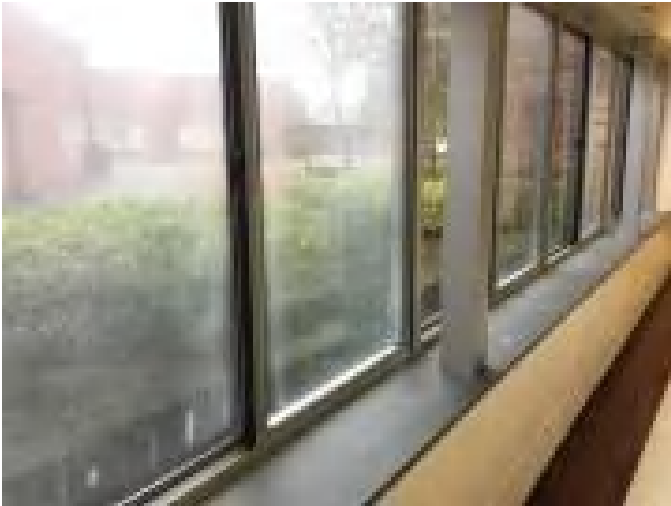
System: B2020 - Exterior Windows

Location: Throughout
Distress: Beyond Service Life
Category: Deferred Maintenance / Energy
Priority: 3 - Necessary/Not Yet Critical (Years 2-5)
Correction: Renew System
Qty: 48,960.00
Unit of Measure: S.F.
Estimate: \$495,475.00
Assessor Name: Terence Davis
Date Created: 01/11/2017

Notes: The aluminum frame, operable, single pane windows are aged, not energy efficient, and should be replaced.

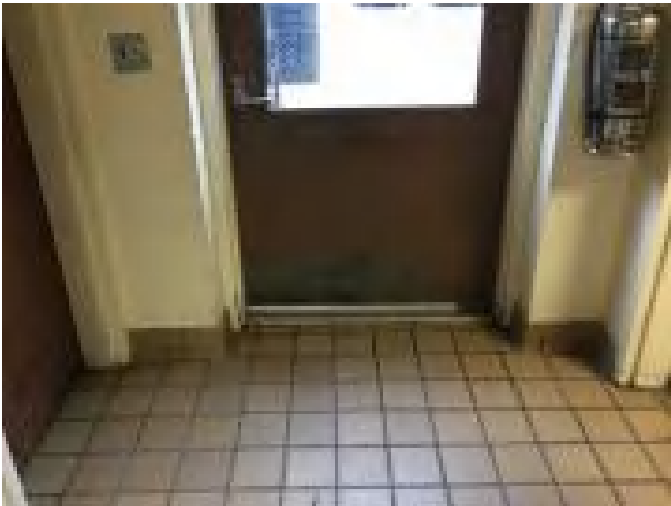
System: B2030 - Exterior Doors

Location: Throughout
Distress: Beyond Service Life
Category: Deferred Maintenance
Priority: 3 - Necessary/Not Yet Critical (Years 2-5)
Correction: Renew System
Qty: 48,960.00
Unit of Measure: S.F.
Estimate: \$54,933.00
Assessor Name: Terence Davis
Date Created: 01/11/2017

Notes: The original exterior doors are aged, rusted, and should be replaced.

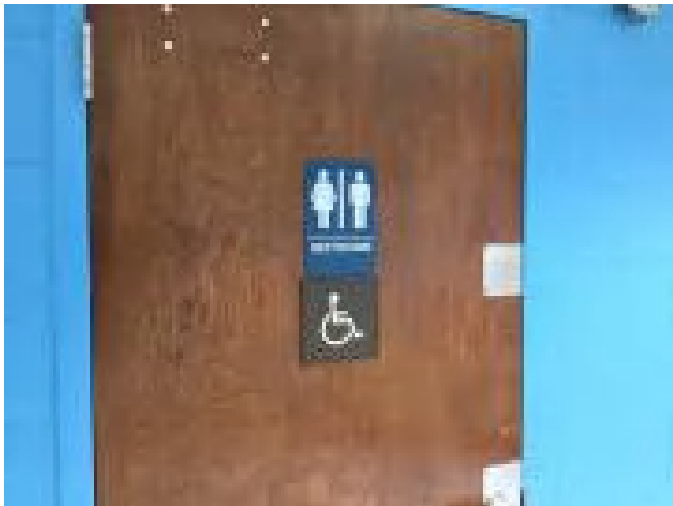
System: C1030 - Fittings

Location: Throughout
Distress: Beyond Service Life
Category: Deferred Maintenance
Priority: 3 - Necessary/Not Yet Critical (Years 2-5)
Correction: Renew System
Qty: 48,960.00
Unit of Measure: S.F.
Estimate: \$513,786.00
Assessor Name: Terence Davis
Date Created: 01/11/2017

Notes: The original fittings are aged, rusted and should be replaced.

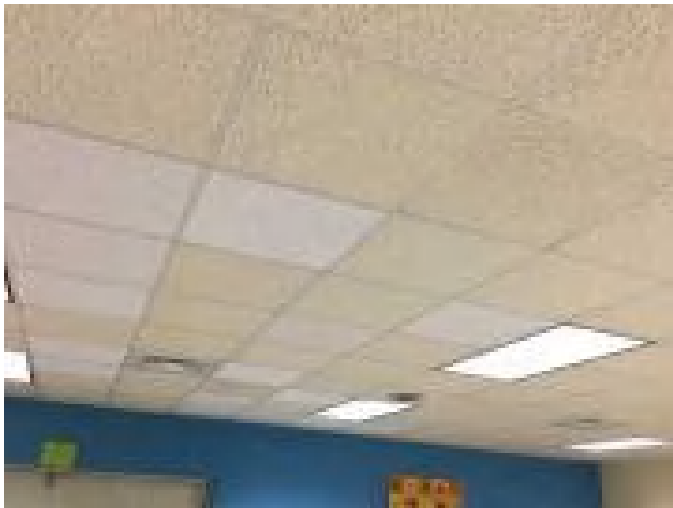
System: C3030 - Ceiling Finishes

Location: Throughout
Distress: Beyond Service Life
Category: Deferred Maintenance / Appearance
Priority: 3 - Necessary/Not Yet Critical (Years 2-5)
Correction: Renew System
Qty: 48,960.00
Unit of Measure: S.F.
Estimate: \$578,413.00
Assessor Name: Terence Davis
Date Created: 01/11/2017

Notes: The ceiling tiles have been replaced as needed. However the grid shows signs of aging and most tiles are sagging or damaged and should be replaced.

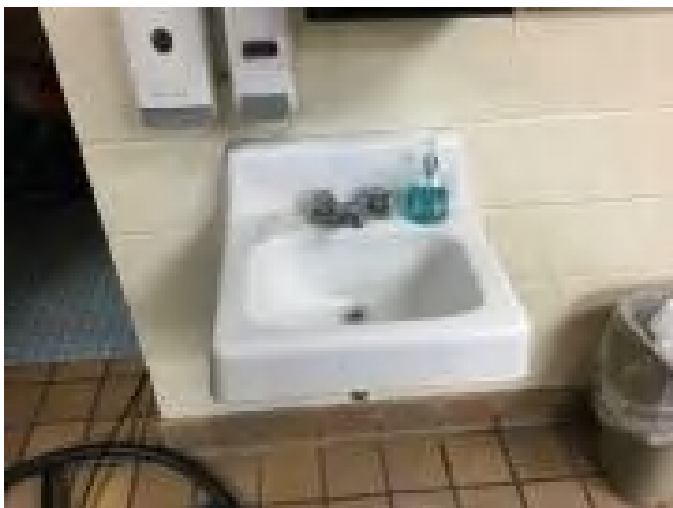
System: D2010 - Plumbing Fixtures

Location: Throughout
Distress: Beyond Service Life
Category: Deferred Maintenance / Energy
Priority: 3 - Necessary/Not Yet Critical (Years 2-5)
Correction: Renew System
Qty: 48,960.00
Unit of Measure: S.F.
Estimate: \$606,419.00
Assessor Name: Terence Davis
Date Created: 01/11/2017

Notes: Plumbing fixtures are in operational conditions. However, they are aged and should be replaced with a low-flow water fixtures.

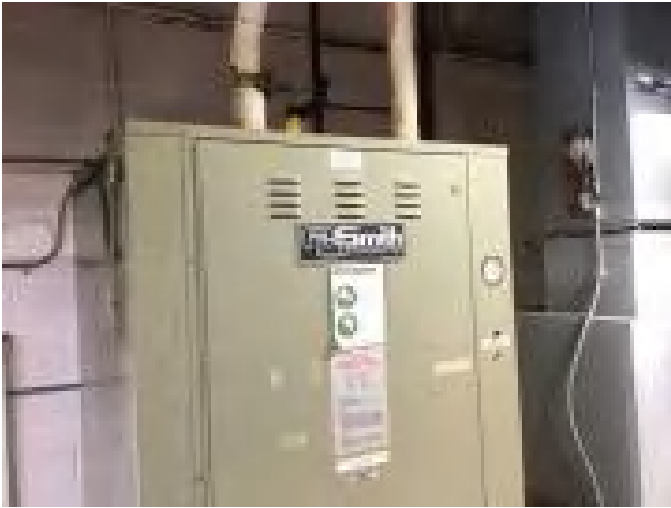
System: D2020 - Domestic Water Distribution

Location: Throughout
Distress: Beyond Service Life
Category: Deferred Maintenance
Priority: 3 - Necessary/Not Yet Critical (Years 2-5)
Correction: Renew System
Qty: 48,960.00
Unit of Measure: S.F.
Estimate: \$51,702.00
Assessor Name: Terence Davis
Date Created: 01/11/2017

Notes: The domestic water distribution system is aged and should be replaced.

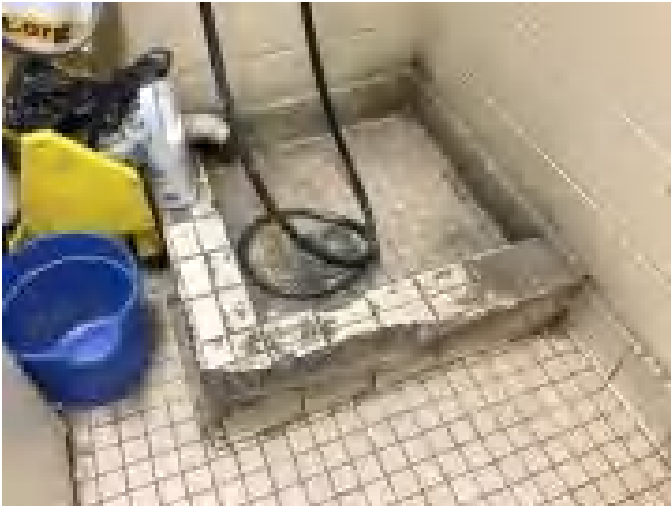
System: D2030 - Sanitary Waste

Location: Throughout
Distress: Beyond Service Life
Category: Deferred Maintenance
Priority: 3 - Necessary/Not Yet Critical (Years 2-5)
Correction: Renew System
Qty: 48,960.00
Unit of Measure: S.F.
Estimate: \$81,861.00
Assessor Name: Terence Davis
Date Created: 01/11/2017

Notes: The sanitary waste system is aged, has reported periodic failures, and should be replaced.

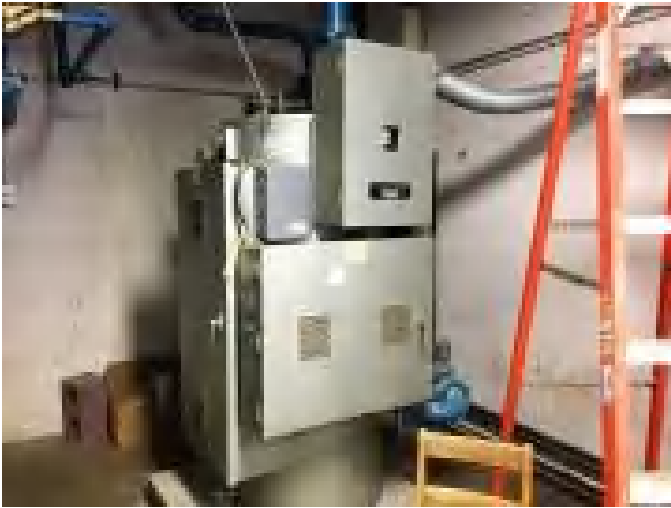
System: D3020 - Heat Generating Systems

Location: Mechanical Room
Distress: Beyond Service Life
Category: Deferred Maintenance
Priority: 3 - Necessary/Not Yet Critical (Years 2-5)
Correction: Renew System
Qty: 48,960.00
Unit of Measure: S.F.
Estimate: \$268,203.00
Assessor Name: Terence Davis
Date Created: 01/11/2017

Notes: The electric boiler is operating properly and are in fair condition but; is aging, inefficient, becoming logistically unsupportable, and should be replaced with energy efficient model.

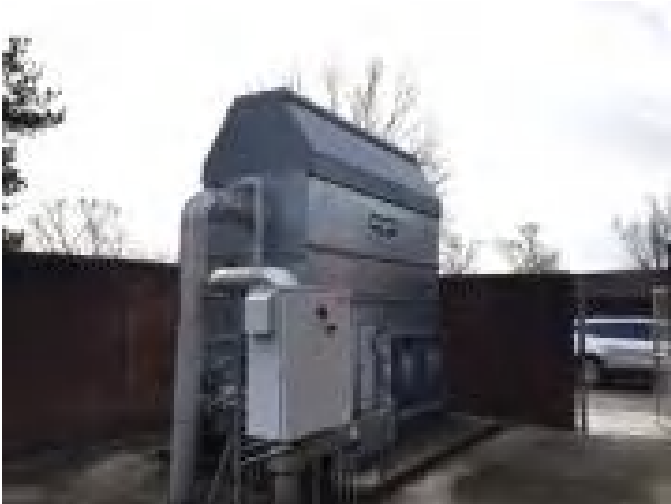
System: D3030 - Cooling Generating Systems

Location: Chiller yard
Distress: Beyond Service Life
Category: Deferred Maintenance
Priority: 3 - Necessary/Not Yet Critical (Years 2-5)
Correction: Renew System
Qty: 48,960.00
Unit of Measure: S.F.
Estimate: \$277,897.00
Assessor Name: Terence Davis
Date Created: 01/11/2017

Notes: Chiller is aging and logistically unsupportable, and should be replaced with an energy efficient model.

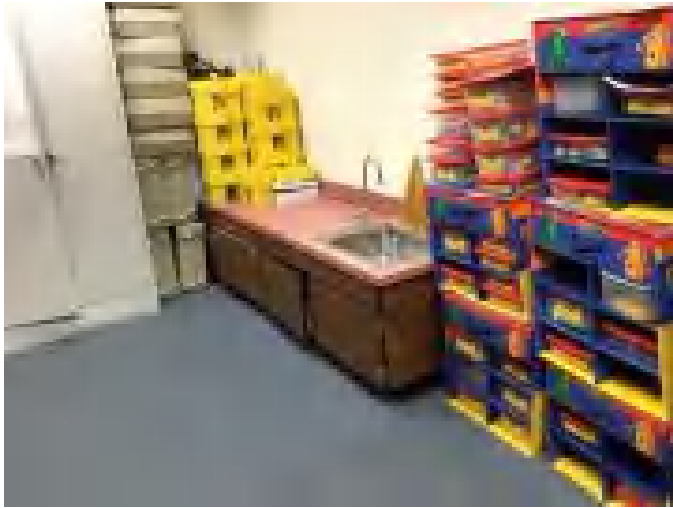
System: E2010 - Fixed Furnishings

Location: Throughout
Distress: Beyond Service Life
Category: Deferred Maintenance / Appearance
Priority: 3 - Necessary/Not Yet Critical (Years 2-5)
Correction: Renew System
Qty: 48,960.00
Unit of Measure: S.F.
Estimate: \$308,056.00
Assessor Name: Terence Davis
Date Created: 01/11/2017

Notes: The fixed furnishings are aged, in marginal condition, and should be replaced.

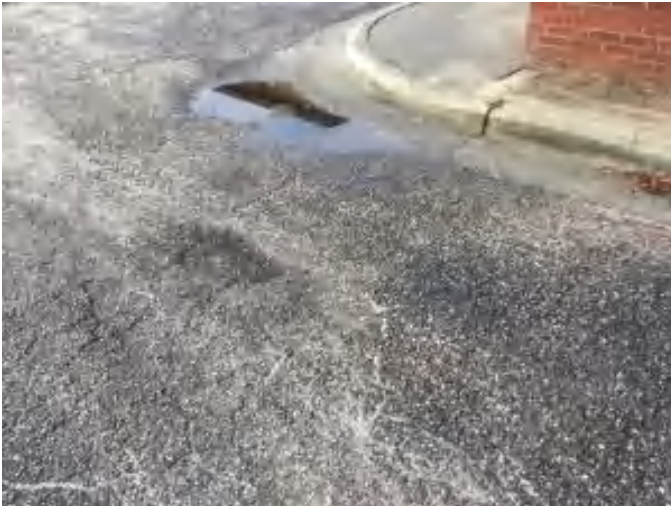
System: G2010 - Roadways

Location: Entire site
Distress: Beyond Service Life
Category: Deferred Maintenance
Priority: 3 - Necessary/Not Yet Critical (Years 2-5)
Correction: Renew System
Qty: 73,960.00
Unit of Measure: S.F.
Estimate: \$309,966.00
Assessor Name: Terence Davis
Date Created: 01/11/2017

Notes: The asphaltic roadway is aged, has many road cuts and repairs, and should be re-surfaced.

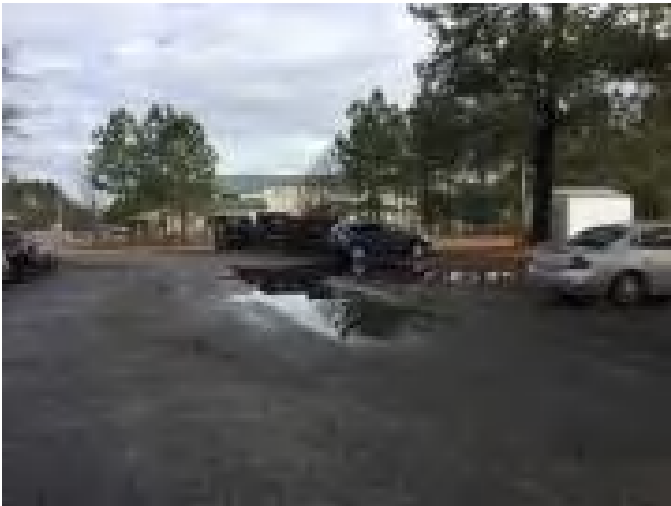
System: G2020 - Parking Lots

Location: North and East sides
Distress: Beyond Service Life
Category: Deferred Maintenance
Priority: 3 - Necessary/Not Yet Critical (Years 2-5)
Correction: Renew System
Qty: 73,960.00
Unit of Measure: S.F.
Estimate: \$108,203.00
Assessor Name: Terence Davis
Date Created: 01/11/2017

Notes: The majority of the parking lot is aged, has many repairs and potholes, and should be re-surfaced.
